**ALANSON SWAN  
HOUSE**  
Cuyahoga Valley National  
Recreation Area  
**HISTORIC STRUCTURES  
REPORT  
ARCHITECTURAL DATA  
SECTION**

**Prepared by**  
**S. Elizabeth Sasser**  
Historical Architect

**March 1987**

National Park Service  
Denver Service Center  
Williamsport Preservation Training Center

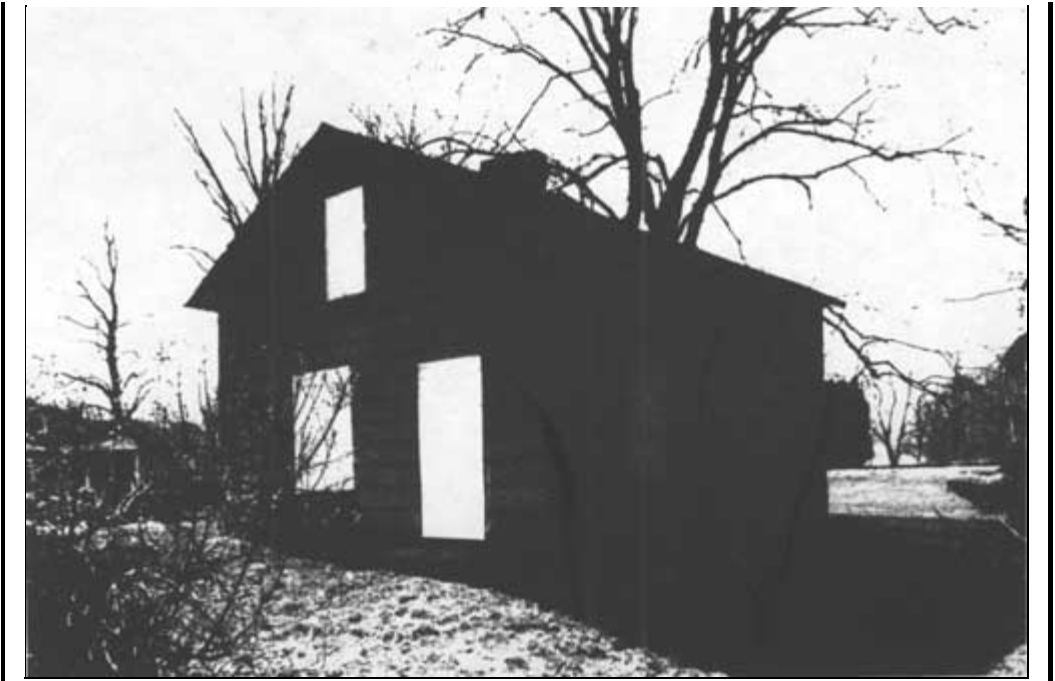
NORTH AND EAST ELEVATIONS OF MAIN WING

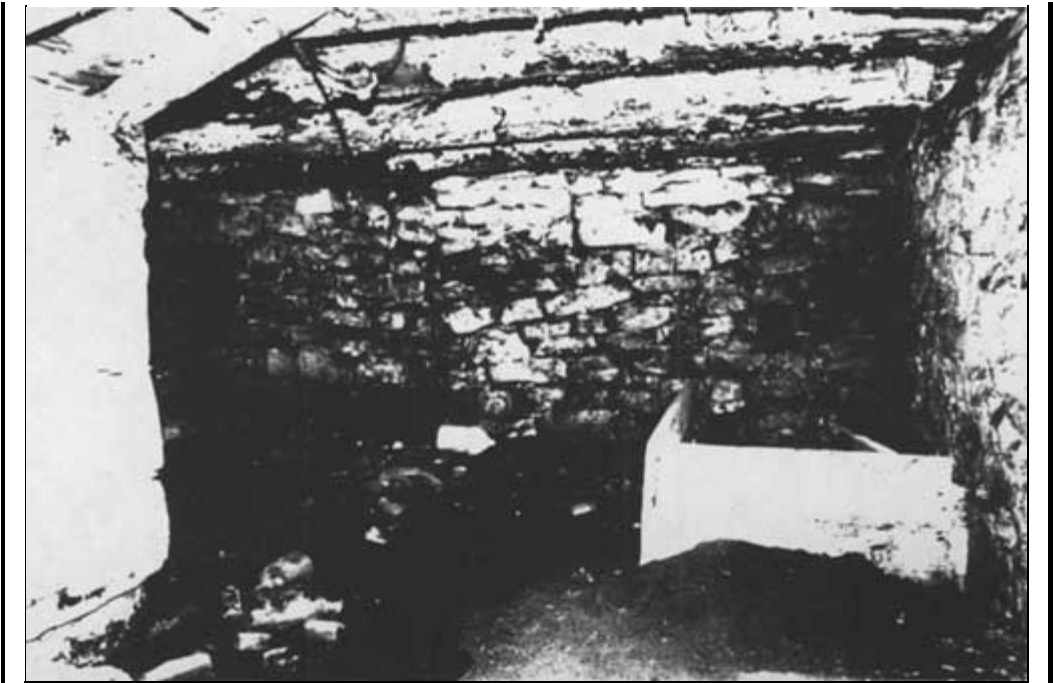
10. Room 001 North wall of Cellar

Uncoursed rubble stone foundation wall, approximately 6 ft high. when this photograph was taken in March 1986, the wall had developed a bulge at its midsection, with a lateral displacement of about 2'-0". The upper third of the wall collapsed in September 1986, leaving the north sill beam unsupported except at its extreme ends over a span of approximately 9'-0".
