# Inventory of Coastal Engineering Projects in Colonial National Historical Park

Natural Resource Technical Report NPS/NRSS/GRD/NRTR—2013/690

Kate Dallas

March 2013

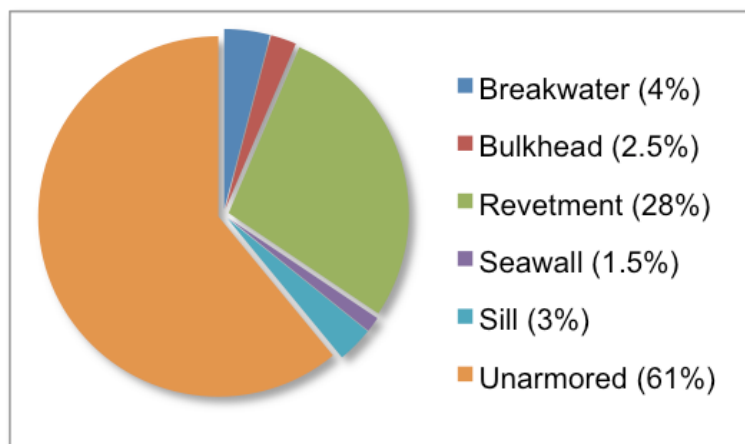
Thirty-nine percent of the roughly 39 km (24 mi) of shoreline within COLO is armored by coastal structures (excludes all structures adjacent to the park) (Figure 2). Approximately 28% of the 27 km (17 mi) of shoreline in the Jamestown unit, which includes Jamestown Island and the northern James River shoreline, is armored by coastal structures (Figure 3). Jamestown Island itself has roughly 13 km (8 mi) of shoreline and is 37% armored.

**Figure 2.** Percent of shoreline armored (by structure type) and unarmored in COLO (excludes overlapping structures and all structures adjacent to the park).

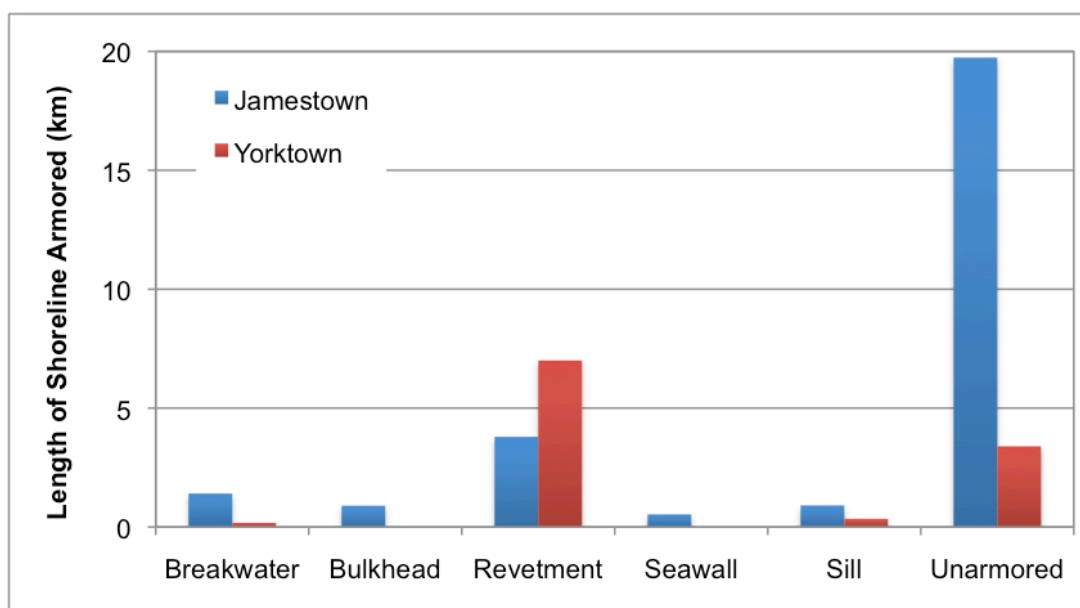
The Yorktown unit has the greatest percentage of armored shoreline in the park, with 66% of its 11.5 km (7 mi) shoreline armored (Figure 3). In addition, beach nourishment projects placed a minimum of 30,000 m<sup>3</sup> (39,000 yd<sup>3</sup>) of sediment on park beaches from 1985 to 2009 (minimum because not all projects were documented) and fill projects impacted roughly 0.48 km<sup>2</sup> (118 ac) of subaerial and submerged land within the park between 1931 and 1955.

**Figure 3.** Length of shoreline armored (by structure type) and unarmored in the two units of COLO (excludes overlapping structures and all structures adjacent to the park).

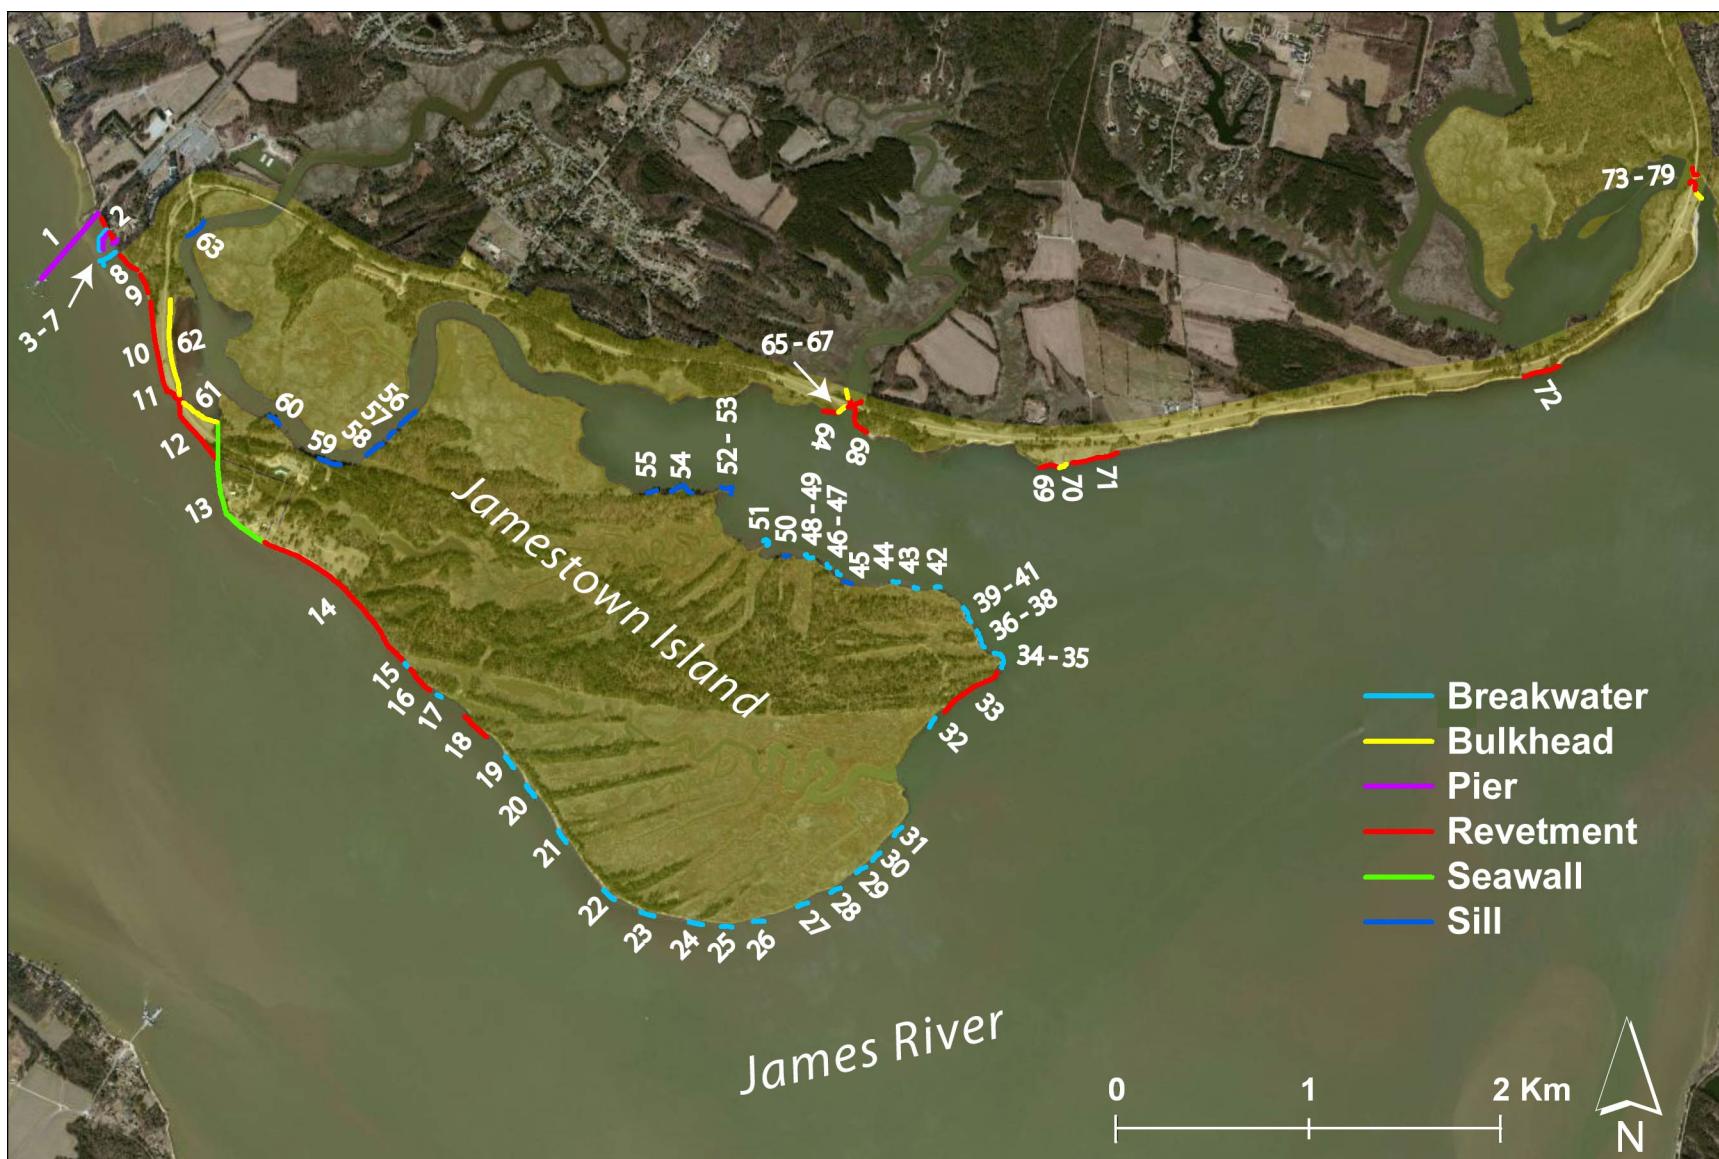
**Figure 6.** Map of coastal structures in the Jamestown unit. Yellow shading shows the park boundary (image from ESRI Bing Maps basemap layer 2012).

The Jamestown Settlement property is located between the ferry pier and the park and has two breakwaters, two piers, and two sections of revetment (#2–7 Figure 6). The first structure installed was a small timber pier in 1992 by Crofton Diving Corporation as a temporary location for the museum's ships before construction of the main pier. Tidewater Construction Company built the southern rock breakwater, main timber pier, earth and rock breakwater, and both rock revetments in 1994 at a cost of roughly \$1,500,000 (Michael Shuflat, Jamestown-Yorktown Foundation, email, 2/8/12). These structures were built to provide safe mooring for the museum's three replica ships.

Revetments around the bridge supports are also present on both sides of Mill and College creeks, but their installation dates are unknown. Historic aerial images show that the Mill Creek revetment predates the late 1980s. Three rock revetments and one timber bulkhead are also present along the shoreline between Mill Creek and College Creek, but no background information could be found on these structures (#69–72 Figure 6).

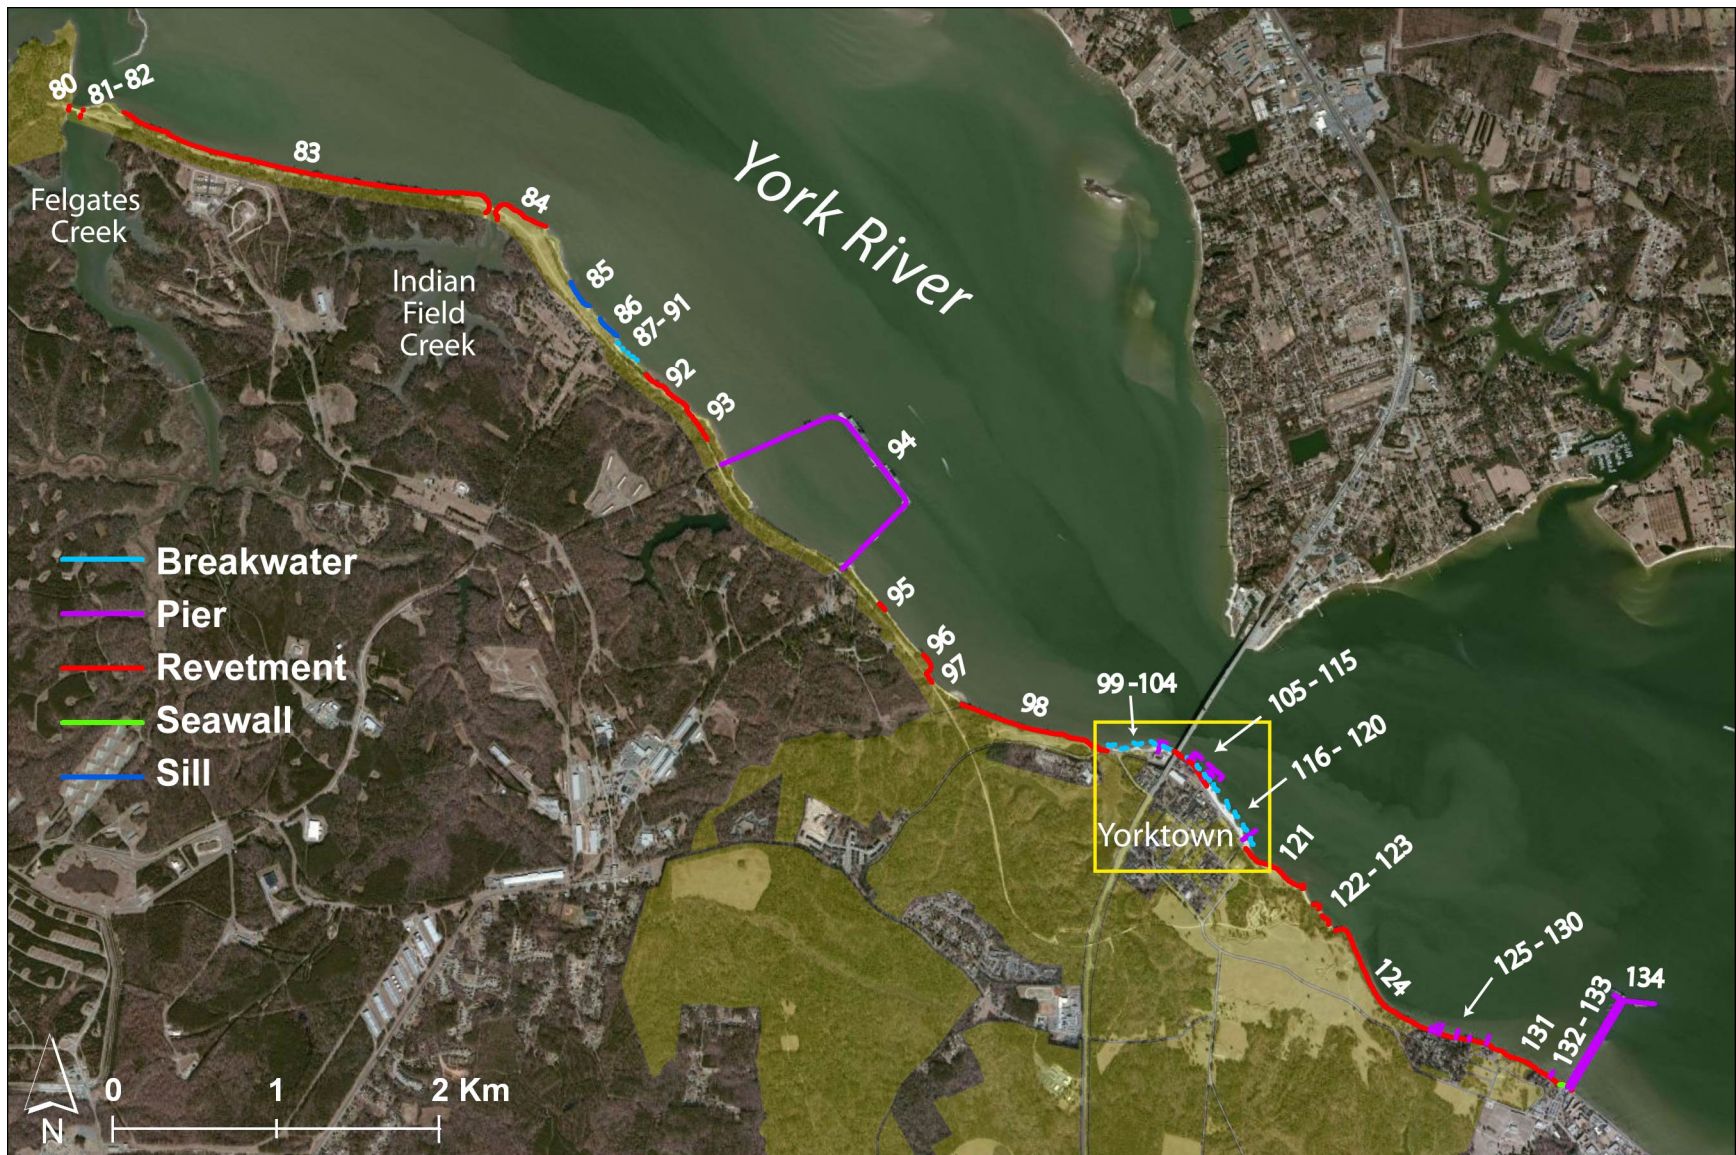
**Figure 9.** Map of coastal structures in the Yorktown unit. Yellow shading shows the park boundary. The yellow box is enlarged in Figure 12 (image from ESRI Bing Maps basemap layer 2012).

Downriver from Indian Field Creek there is a revetment and two sills (#85–86 Figure 9). No information could be found on the revetment, but historic park maps show that the sills existed in 1962 (Dorothy Geyer, email, 5/3/12).

Continuing along the shoreline, there are five small breakwaters, called the NPS breakwaters (#87–91 Figure 9 and Figure 11). These breakwaters were constructed in 1985 of broken concrete to control shoreline erosion (NPS 2011). However, the low elevation of these breakwaters (0.6 to 0.9 m MLLW [2 to 3 ft]) provides little protection during storms (NPS 2011).

Downriver from the picnic area there are three naturally occurring headlands, known as Point of Rocks (Figure 5). These headlands were hardened with revetment in the early 1960s and reinforced in 1979 (#122 & 123 Figure 9) (Hardaway et al. 1992). Spiral-shaped pocket beaches exist behind the headlands and have reached a dynamic equilibrium over the past 50 years

(Hardaway et al. 2006). Continuing downstream, private property is intermingled with NPS property to the park boundary at the U.S. Coast Guard Training Center. Most of this section has been treated with a rock revetment (#124 & 131 Figure 9). Historic drawings show that a revetment was built along some of this section in the late 1930s (NPS 1937) and repaired circa 1979 (USDT 1979). Adjacent to the southern end of the park is the U.S. Coast Guard pier, which extends 630 m (2,070 ft) offshore (full pier length is 1,530 m [5,020 ft]) (#134 Figure 9). Historic nautical charts show the pier was built prior to 1943 and was extended by 1967 (NOAA 2012).

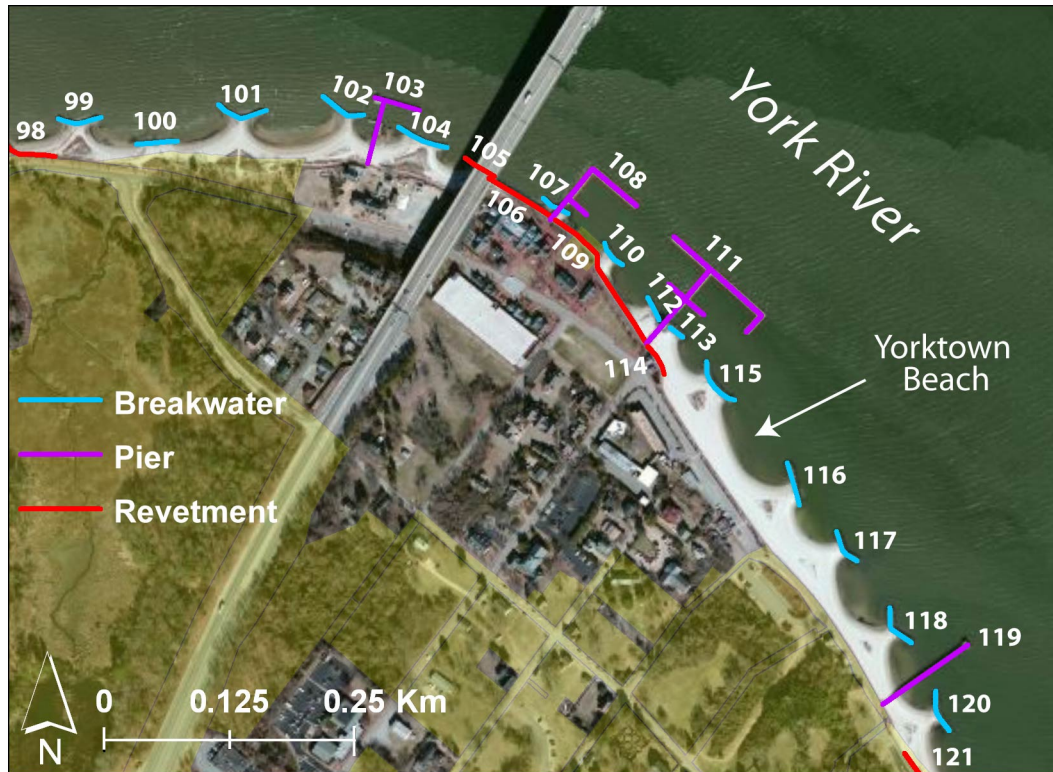
Continued erosion of Yorktown Beach led to the development of a breakwater system. Twelve breakwaters and a revetment were installed in four phases from 1994 to 2005 (Figures 12 & 13). In phase one, two breakwaters (#115 & 116 Figure 12) were installed in September 1994 (Milligan et al. 1996). In the fall/winter of 1998–1999 phase two was implemented and two additional breakwaters (#117 & 118 Figure 12 and Figure 13) were built on the southern end of the beach (VHB 1998). Phase three began in June 2000 and included three new breakwaters (#110, 112, and 113 Figure 12) and a revetment (#109 & 114 Figure 12) (Hardaway et al. 2005).

In 2005, three additional breakwaters were added to the northern reach (#99 & 101, 102, & 104 Figure 12) and one at the very southern end (#120 Figure 12) (VHB 2004). The two floating docks were also built in 2005 (#108 & 111 Figure 12). Lastly, a small rock breakwater was built on the northern end close to the shore in 2006 or 2007 (#100 Figure 12) (VHB 2006). All of the breakwaters were accompanied by small beach nourishment projects.

**Figure 12.** Map of coastal structures in Yorktown. Yellow shading shows the park boundary (image from ESRI Bing Maps basemap layer 2012).

The Yorktown breakwater field is a system of fourteen breakwaters (#99–102, 104, 107, 110, 112, 113, 115–118, and 120 Figure 12) installed along the Yorktown shoreline between 1994–2005 that affect the local sediment transport and landscape. These structures, unlike those found along Jamestown Island, were designed and built to maintain a sandy beach for recreation as well as stabilize the eroding shoreline (Milligan et al. 1996). As is typical with these installations, beach nourishment was also employed to further stabilize the backshore upon their initial construction.

Beyond limiting sediment to the system, the breakwaters also impact local hydrodynamics. Sand has been impounded leeward of the structures creating tombolos (Figure 12), amplifying circulation patterns between structures. During periods of intense wave action this system of structures can be potentially hazardous to recreational users as strong rip currents may develop (Silvester and Hsu 1993).

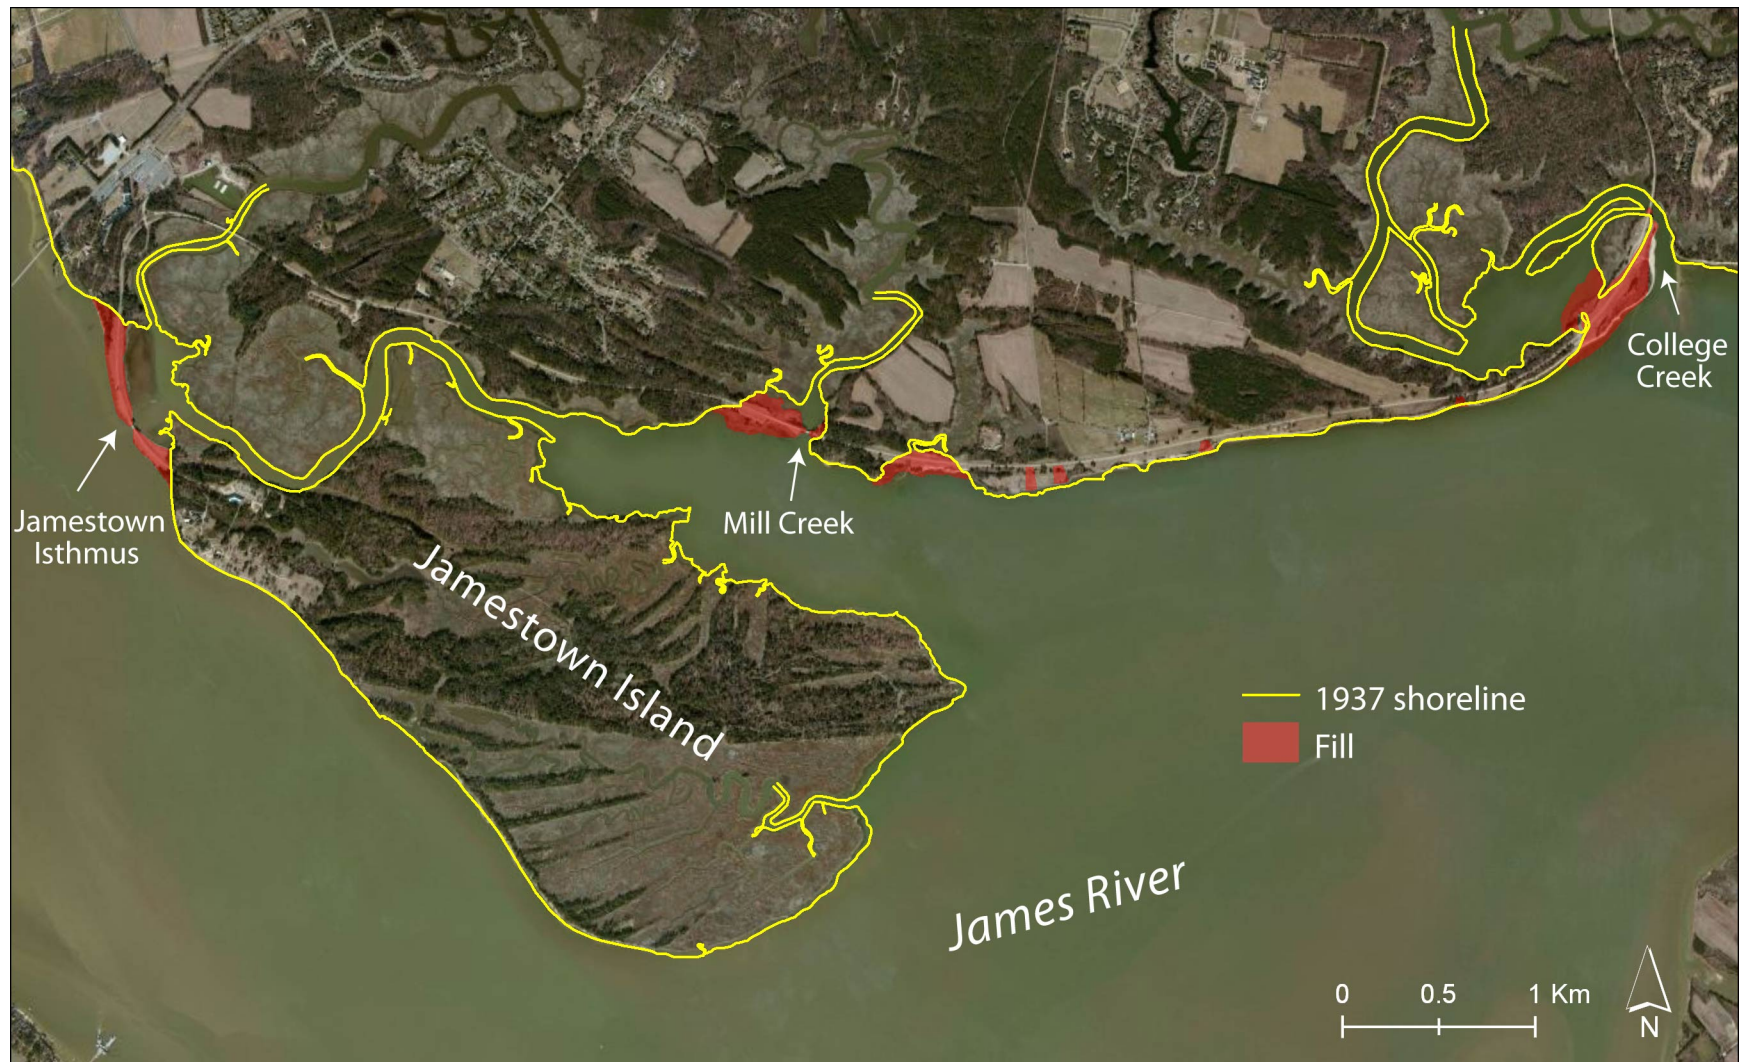
Prior to the late 18<sup>th</sup> century Jamestown Island was connected to the mainland by a narrow isthmus. Over time the isthmus was breached and the island became separated. The isthmus was rebuilt from March to November 1955 with sediment dredged from the James River (HAER 1995a). When complete, the fill spanned nearly 915 m (3,000 ft) and was constructed to an elevation of 2.4 m (8 ft) with an embankment crest width of 12 m (40 ft) (HAER 1995a) (Figure 14).

The mouths of College Creek (512,750 m<sup>3</sup> [670,648 yd<sup>3</sup>]) and Mill Creek (266,700 m<sup>3</sup> [348,833 yd<sup>3</sup>]), and five other locations between College and Mill Creeks (total of 443,840 m<sup>3</sup> [580,519 yd<sup>3</sup>]) (proposed volumes from NPS 1941) were filled with sediment dredged from the James River in 1955 for parkway construction (HAER 1995b) (Figure 14).

**Figure 14.** The 1937 Jamestown shoreline overlain on a recent aerial photograph. Comparison of the historic shoreline with the image shows where fill was placed at the Jamestown Isthmus and the mouths of Mill Creek and College Creek. Other fill locations along the northern James River shoreline are very approximate and are from NPS (1941) (1937 shoreline from S. Hardaway, image ESRI Bing Maps basemap layer 2012).

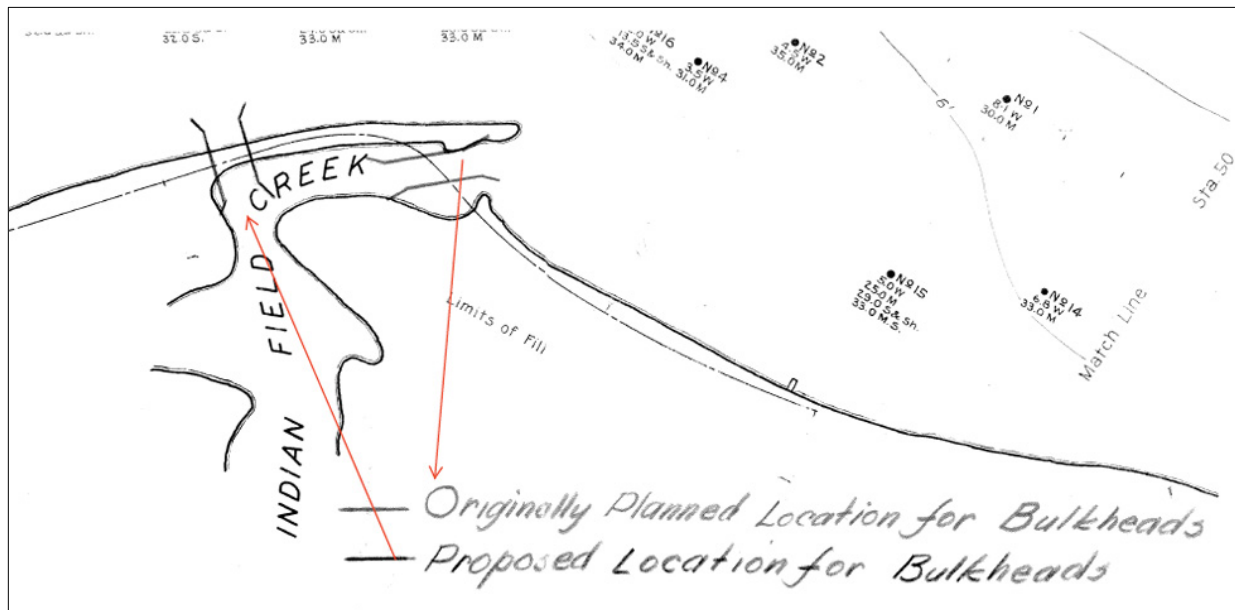
Along the York River, the mouths of Felgates Creek and Indian Field Creek were filled in August 1931 for construction of the Colonial Parkway at a cost of \$197,300 (HAER 1988). The creek mouths were filled with sand and gravel removed from the bottom of the York River (NPS 2011). Fill length was 365 m (1,200 ft) and 1,340 m (4,400 ft) at Felgates Creek and Indian Field Creek, respectively, and included a 30-meter (100 ft) wide embankment that was 3 m (11 ft) above sea level (HAER 1995b). During construction the mouth of Indian Field Creek was rerouted to the north (the mouth had previously faced east adjacent to a historic spit) (Figure 15) (USACE 1931).

**Figure 15.** United States Corps of Engineers plan drawing showing the rerouting of the mouth of Indian Field Creek in the 1930s (USACE 1931).

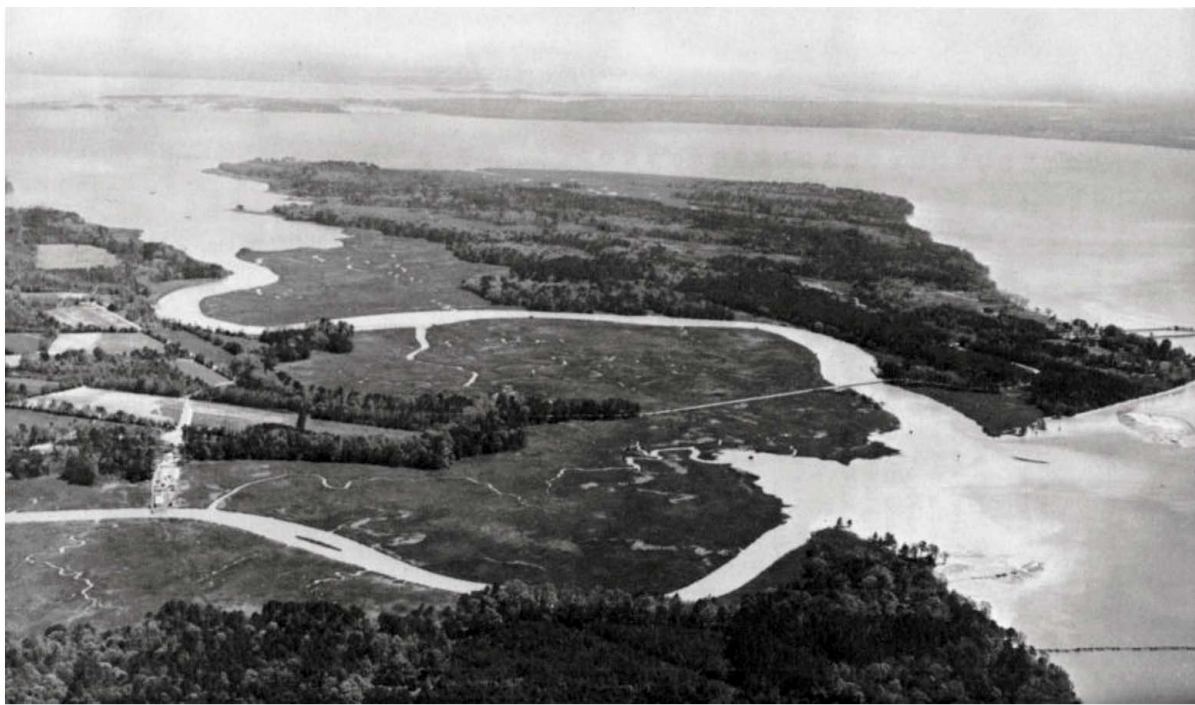
Jamestown Island was historically connected to the mainland by a natural, narrow isthmus. The land bridge gradually eroded until it became fully separated in the late 18th century (Figure 18) (John Milner Associates et al. 2006). Upon the demise of the isthmus, Sandy Bay began to encroach upon the marshlands of Back River due to wave action, while a confluence developed between Back River and Powhatan Creek (Johnson et al. 2001). These actions occurred until the isthmus was artificially re-developed in 1955 (Figure 19) for the 350th anniversary of the Jamestown settlement. The incorporation of this substantial amount of fill altered tidal currents and terrestrial river flow from the Back River and Powhatan Creek into the James River.

**Figure 18.** Historic aerial image of the Jamestown Island area (exact date unknown, but it does predate construction of the artificial isthmus in 1955). Jamestown Island is in the middle of the image with the James River in the distance. View is to the southeast (from Cotter and Hudson 2005).

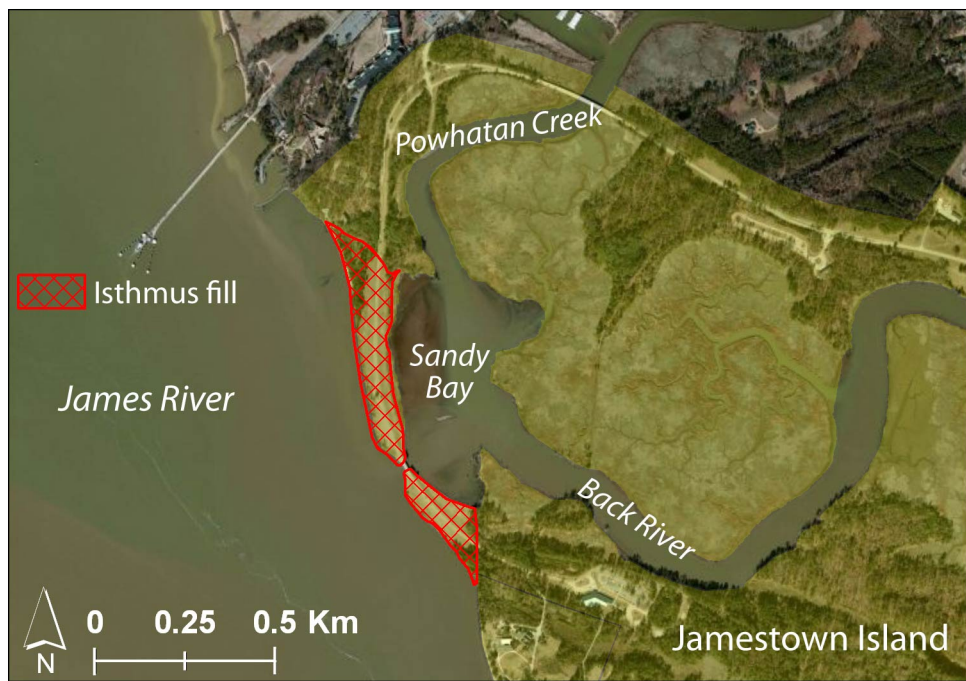
**Figure 19.** Aerial image of the Jamestown Island isthmus area. Yellow shading shows park boundary (image ESRI Bing Maps basemap layer 2012).

Since its construction, the isthmus has protected the Back River marshes and split the flow of Powhatan Creek into the Back and James rivers. If natural processes had continued unimpeded it is likely that both shorelines along with the Back River marsh system would have experienced further retreat. The change in flow patterns now affords less sediment into Sandy Bay and allows for littoral transport along the shoreline. The current isthmus consists of local sediments mined from the James River and contrasts with the surrounding Jamestown Island marshlands and pine-oak forests (HAER 1995a, Johnson et al. 2001).

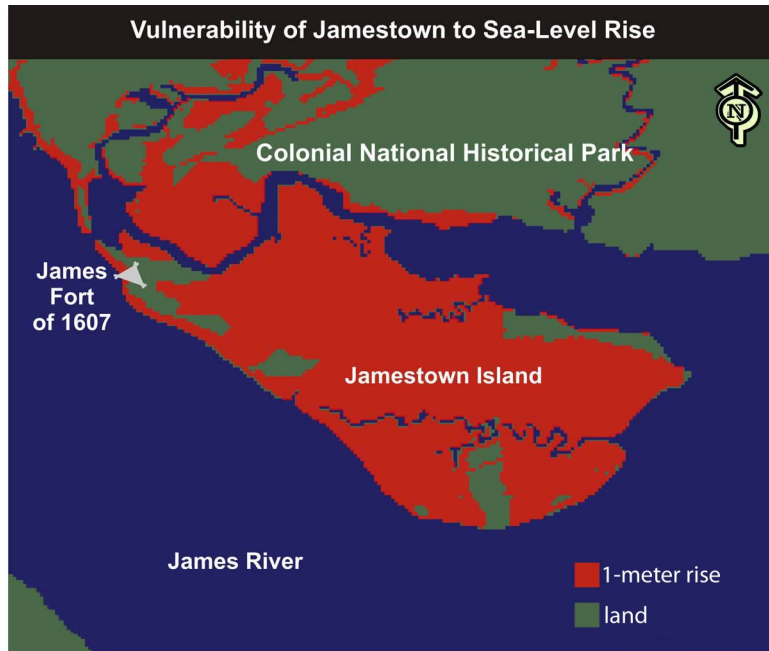
Much of the park's backshore environment (in particular the marshes and low upland banks of Jamestown Island) is at an elevation of less than 1 m (3.2 ft) above sea level (Figure 20) (Saunders et al. 2010). These low-lying lands are susceptible to increased erosion and flooding in light of the Intergovernmental Panel on Climate Change's sea level rise projections of 0.18 to 0.59 m (0.59 to 1.9 ft) by 2100 (IPCC 2007). Hurricane Isabel in 2003 clearly illustrated the park's vulnerability to inundation when storm surge breached revetments as high as 2 m (6 ft) along the York River and flooded the Visitor Center and Glasshouse remains on Jamestown Island (Thornberry-Ehrlich 2005, Saunders et al. 2010).

**Figure 20.** Vulnerability of Jamestown Island to sea level rise. Red shading represents areas that would be inundated with a 1-meter (3.2 ft) rise in sea level (adapted from Saunders et al. 2010).
