ARCHITECTURAL CONSERVATION REPORT

*MASONRY STABILIZATION*  
*AT TYUONYI PUEBLO (LA 00082)*  
*2007*

# **Bandelier National Monument**

### *Masonry Stabilization at Tyuonyi Pueblo, 2007*

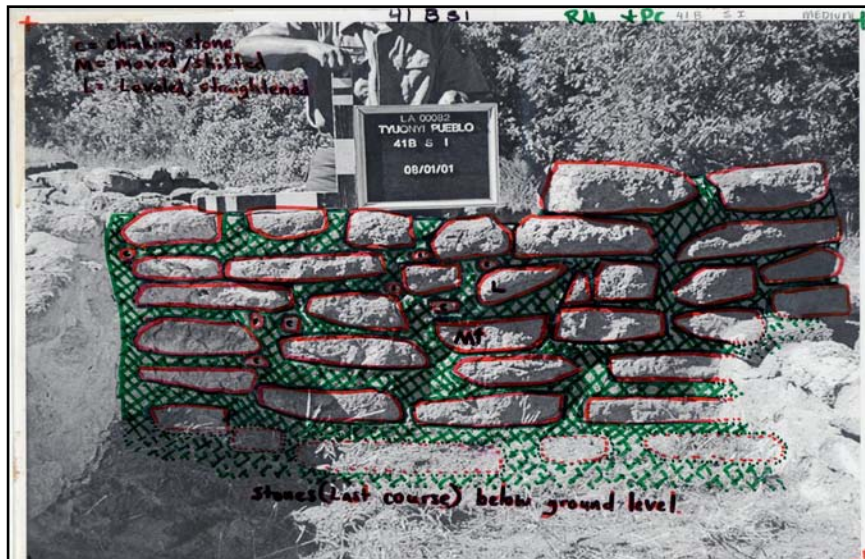
**Figure 3:** Digital images of the walls taken during the 2001 documentation were printed and inserted into acetate sleeves. Workers used colored permanent markers to indicate where mortar (green) had been replaced and stones (red) were moved and/or re-laid. Other notes were included in the graphic documentation to explain important features.

The post-care stage began by documenting the treated walls surrounding a compartment (see Fig. 3). Then, the crew cleaned out all rubble and debris (such as spilled mortar and trash), compacted the earth at the base of the wall, re-graded the floor to maintain a positive drainage away from the walls, and swept the floor to remove footprints (which may tempt a visitor to enter the room). Any artifacts found during treatment were documented and replaced. Finally, an inspection by the lead mason (Walt Morris) or the Bandelier liaison (Marty Davenport) finalized the completion.
