# **Graffiti Mitigation at Bandelier National Monument**

**Prepared for the National Park Service  
by the School of Architecture and Planning  
University of New Mexico, 2010**

# Graffiti Mitigation

## Frijoles Canyon Cavates 2010

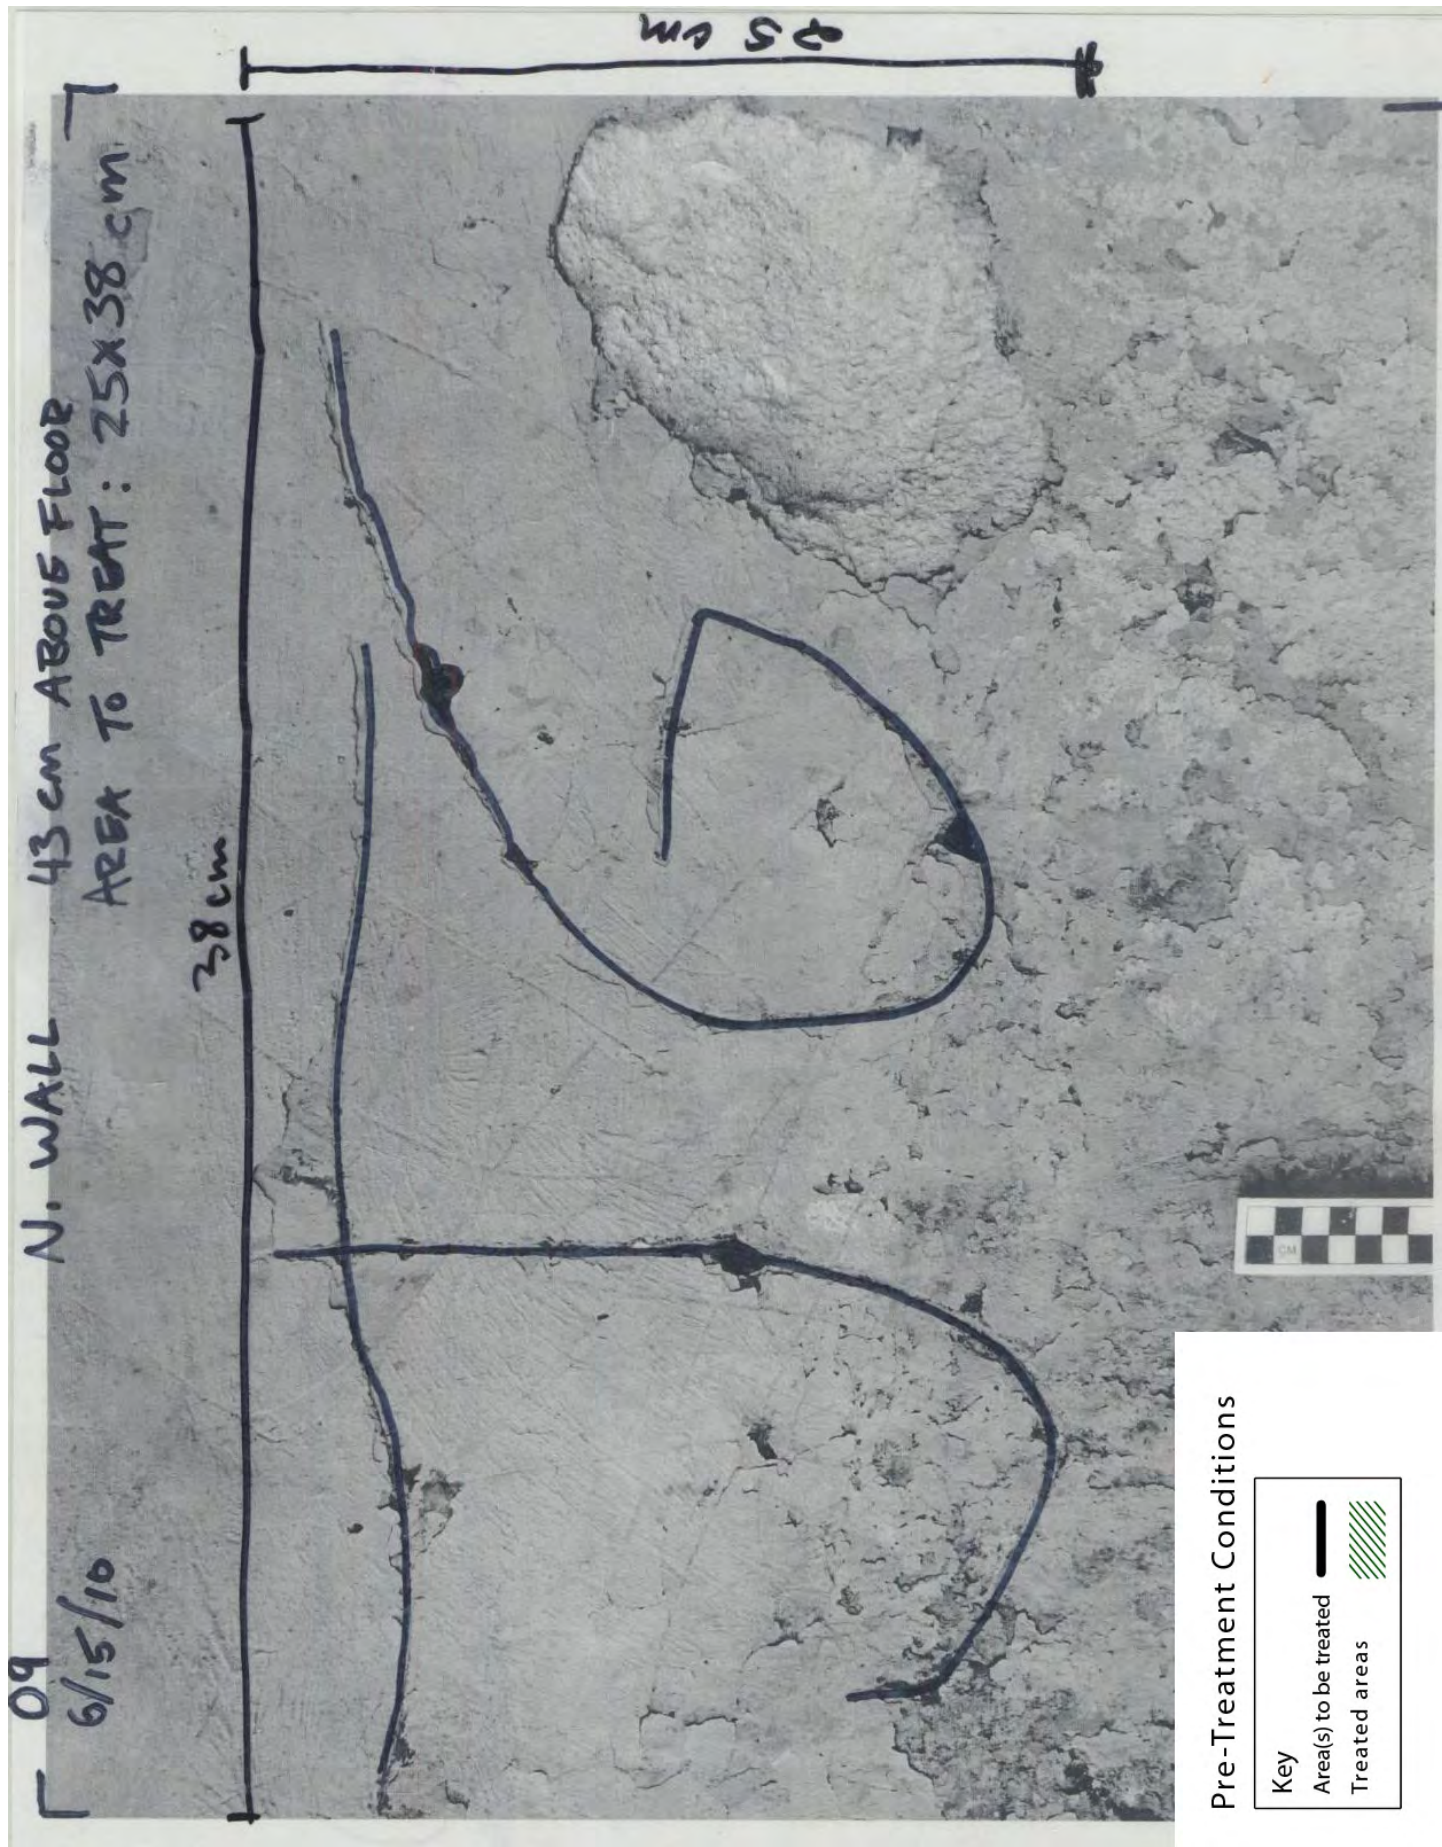
**Treatment location:** south wall**Height from floor:** 43 cm**Type of graffiti:** incised**Substrate:** earthen plaster and tuff**Area of damage (l x h):**

**Number of plaster layers penetrated:** 3**Is tuff exposed?** yes**Additional incision damage? (describe):** flaking of plaster around incision**New graffiti since 2004? (photo comparison):** no**Notes:**

1. Removed loose tuff particles and dust from incised graffiti with small brush and air bulb.
2. Wet the treatment area with water.
3. Applied a slip (watery mortar consisting of clay #2 : wash silt (1:1) to the scratched area.
4. Filled the graffiti with multiple thin layers of mortar (clay #2 : wash silt (1:1) and pressed it into the void with a microspatula, compacting the mortar.
5. Finished plaster infill by marking it with a bamboo skewer and stiff dry brushes to match surrounding texture.
6. Applied a slip with a small sponge (clay #2 : clay #1 : wash silt (1:1:2) to match the original plaster texture and color.

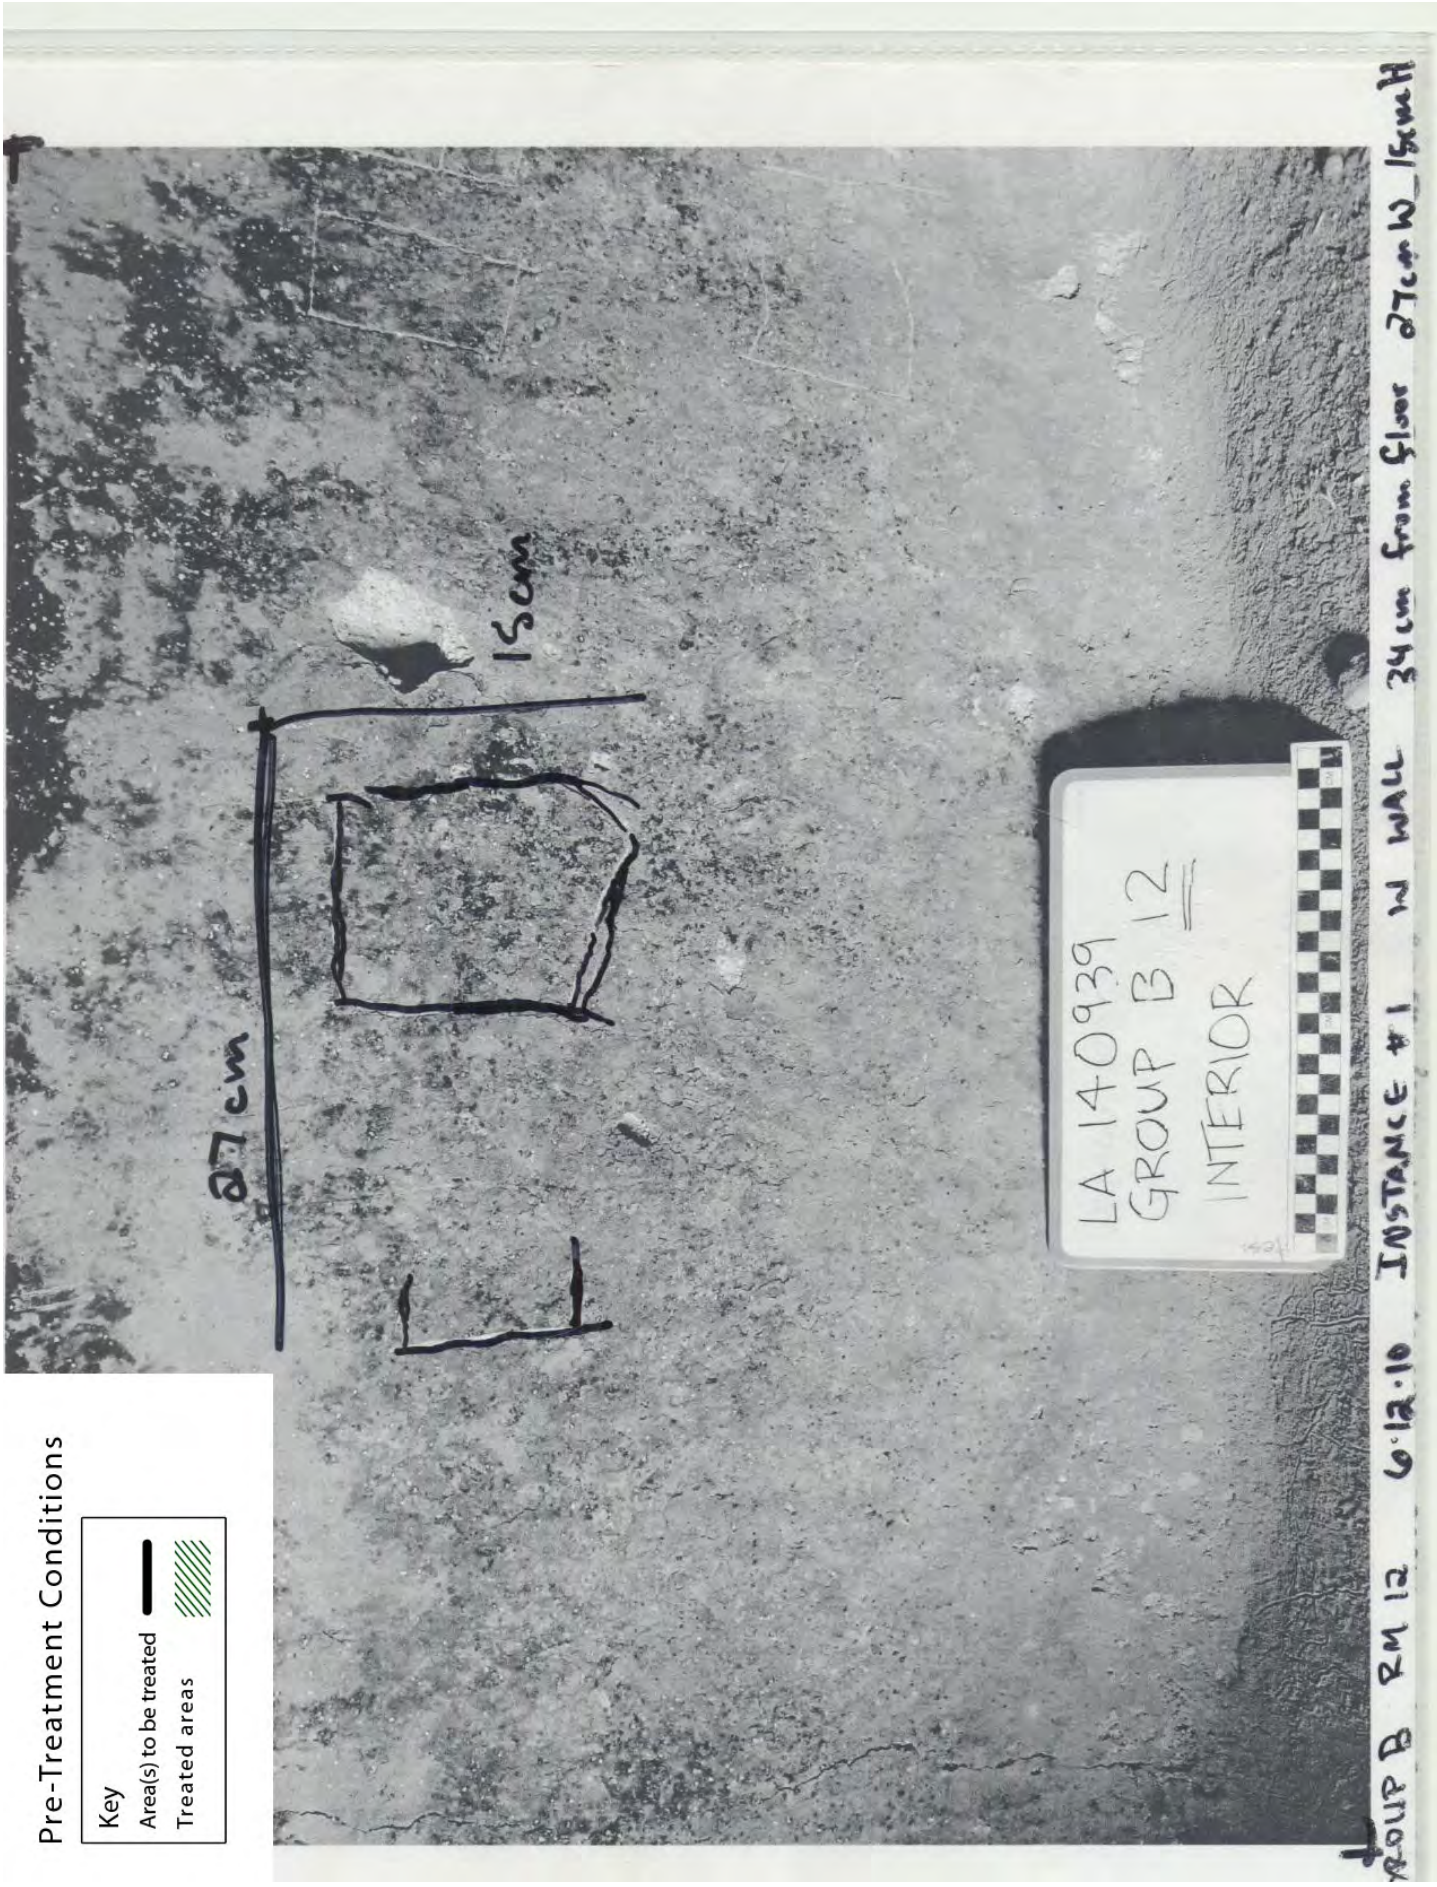
Pre-Treatment Conditions

**Treatment location:** west wall**Height from floor:** 34 cm**Type of graffiti:** incised**Substrate:** earthen plaster and tuff**Area of damage** (l x h):

**Number of plaster layers penetrated:** 3**Is tuff exposed?** yes**Additional incision damage? (describe):** flaking of plaster around incision**New graffiti since 2004? (photo comparison):** no

1. Removed loose tuff particles and dust from incised graffiti with small brush and air bulb.
2. Wet the treatment area with water.
3. Applied a slip (watery mortar consisting of clay #2 : wash silt (1:1) to the scratched area.
4. Filled the graffiti with multiple thin layers of mortar (clay #2 : wash silt (1:1) and pressed it into the void with a microspatula, compacting the mortar.
5. Finished plaster infill by marking the surface with a bamboo skewer and dabbing a very light coating of slip onto the repair with a small sponge to match the original plaster texture and color.

Paint (pigment in water) was lightly stippled onto the infilled treatment area to match the surrounding sooted plaster. Only the repair was inpainted.

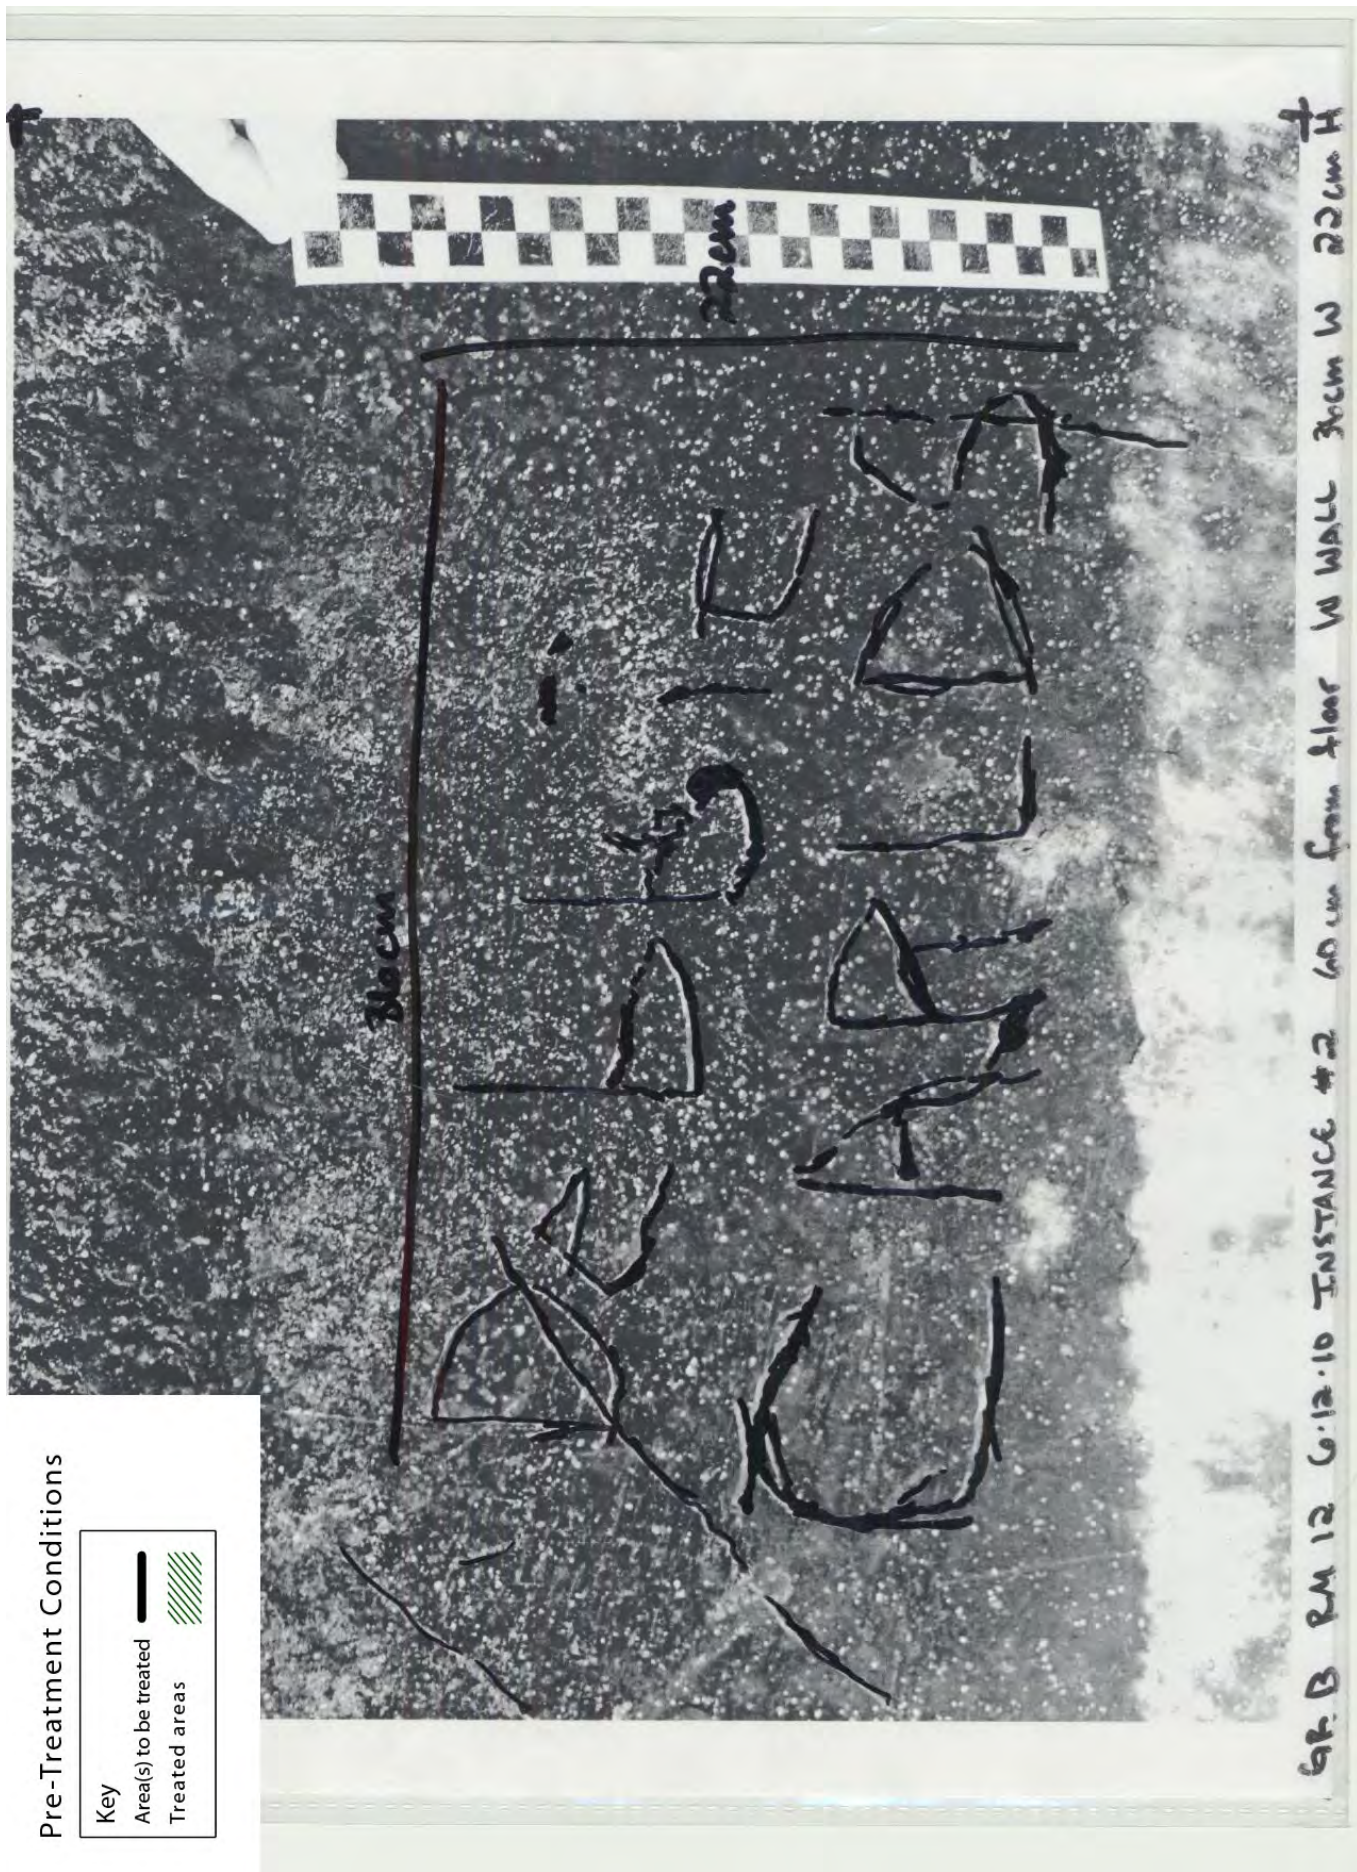
Pre-Treatment Conditions

**Treatment location:** west wall**Height from floor:** 60 cm**Type of graffiti:** incised**Substrate:** earthen plaster and tuff**Area of damage** (l x h):  
36 cm X 22 cm**Depth of Incision** (deep x across):  
1 mm X 1-2 mm**Number of plaster layers penetrated:** 1**Is tuff exposed?** no**Additional incision damage? (describe):** none**New graffiti since 2004? (photo comparison):** no

1. Removed loose tuff particles and dust from incised graffiti with small brush and air bulb.
2. Wet the treatment area with water.
3. Applied a slip (watery mortar consisting of clay #2 : wash silt (1:1) to the scratched area.
4. Filled the graffiti with multiple thin layers of mortar (clay #2 : wash silt (1:1) and pressed it into the void with a microspatula, compacting the mortar.
5. Finished plaster infill by dabbing a very light coating of slip onto the repair with a small sponge to match the original plaster texture and color.

1. Lightly stippled the paint (pigment in water) onto the infilled treatment area to match the surrounding sooted plaster. Only the repair was inpainted.
2. Applied sieved grey tuff with a dry brush to further camouflage infill.

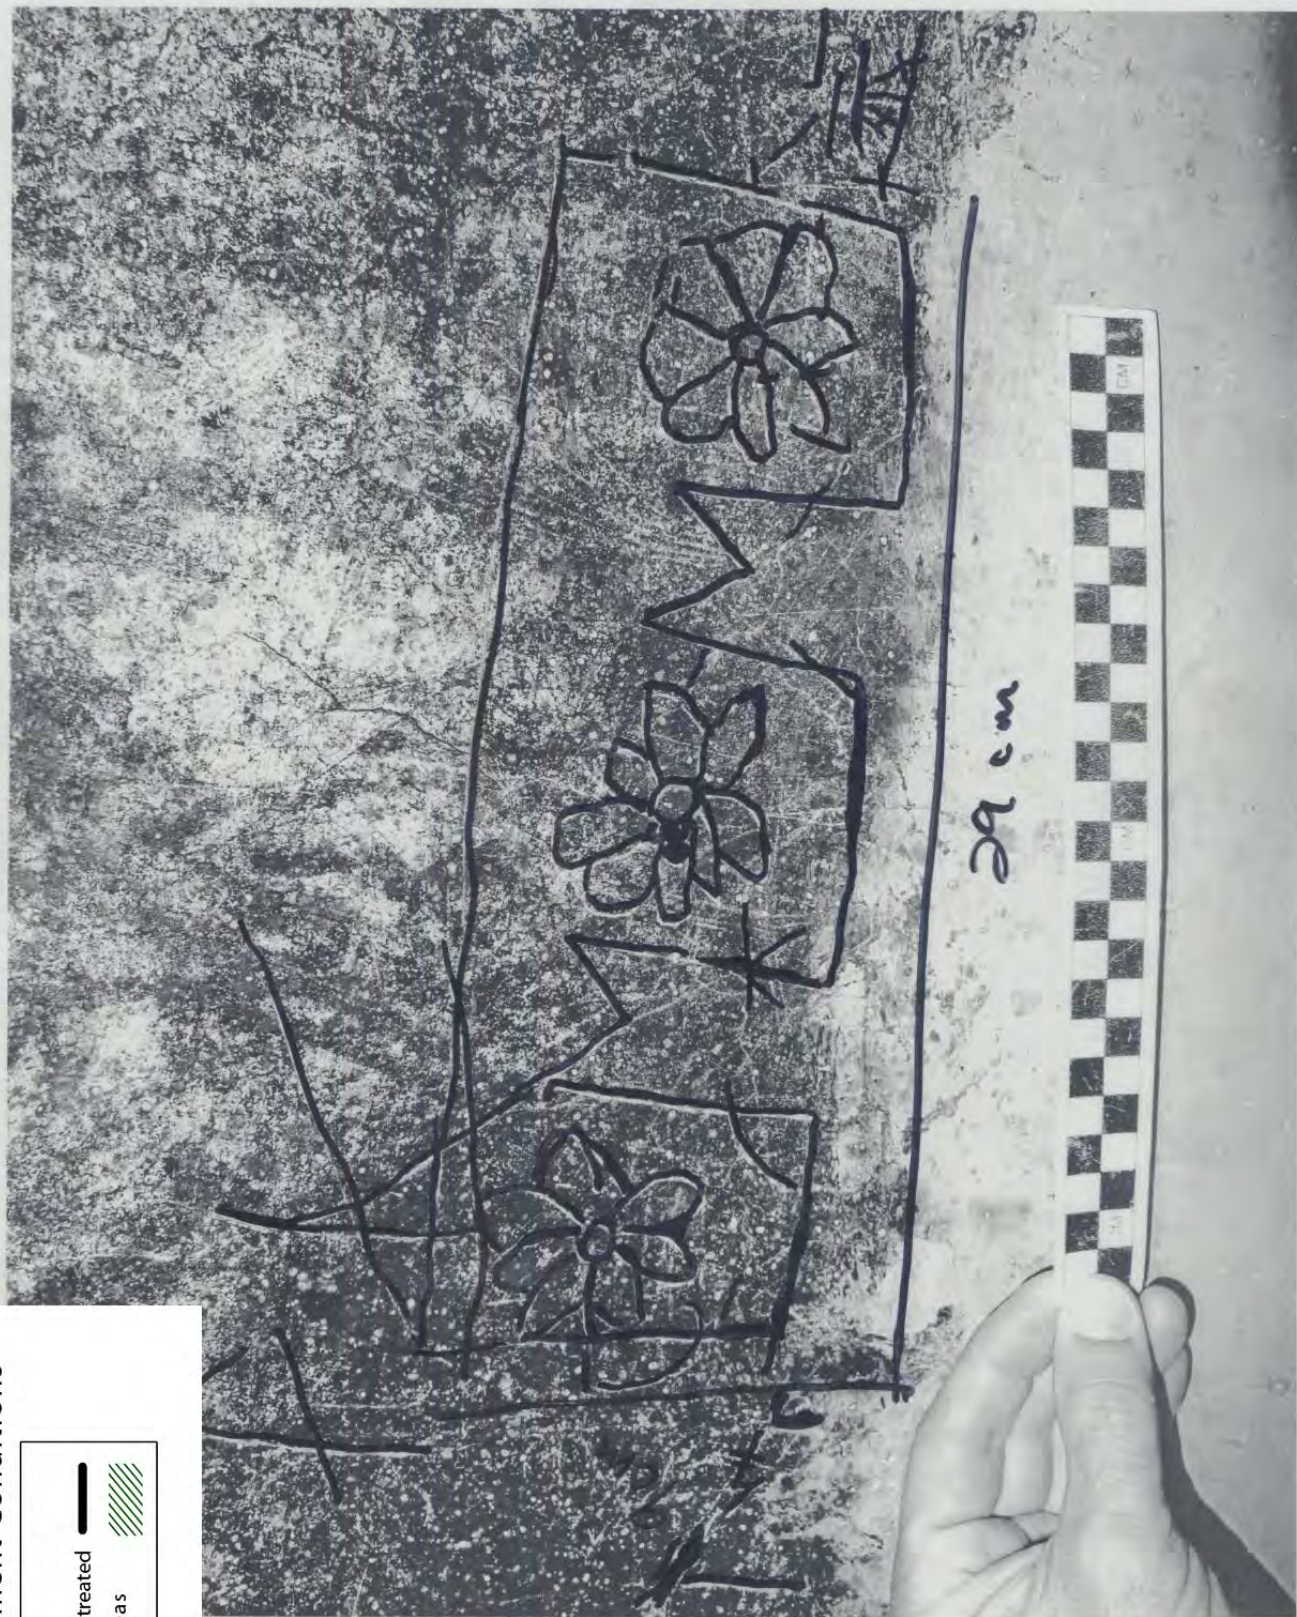
Group B RM 12 INSTANCE # 4

NORTH WALL ~ 63 cm from floor

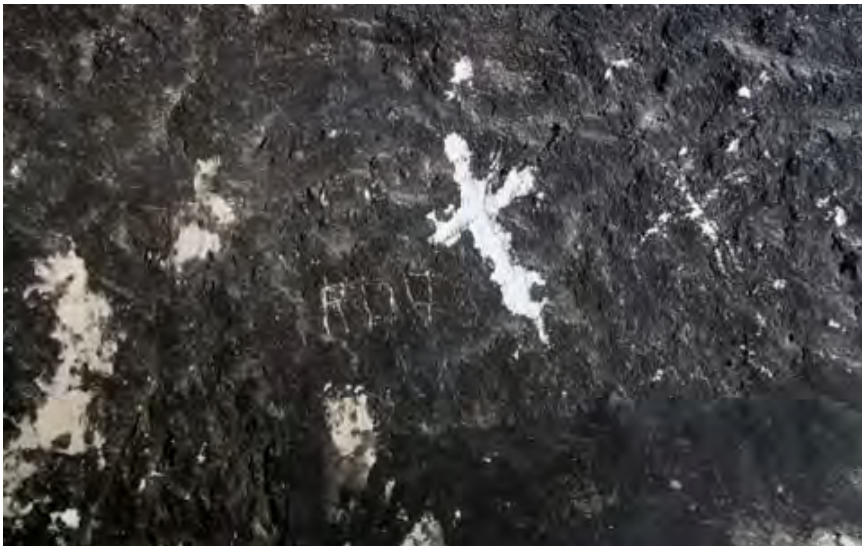
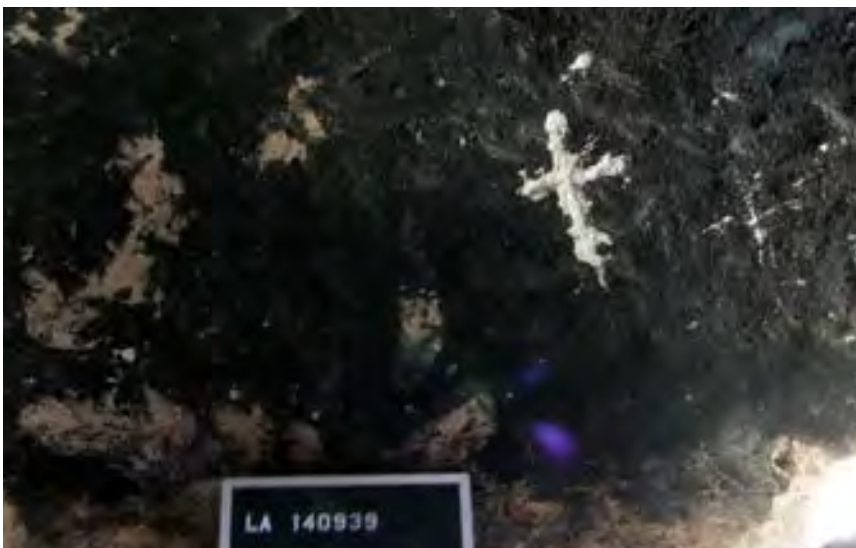
Cavate BG132  
06/16/10

East wall Graffiti  
Conservator: R. Adler

118 cm from floor  
21 cm L x 9 cm H

1. Used natural bristle brushes and sponges to apply a watery mix of pigment in various concentrations to match surrounding sooted tuff.
2. Applied dry pigment with paintbrushes.
3. Applied sieved grey tuff with a dry brush to further camouflage infill.

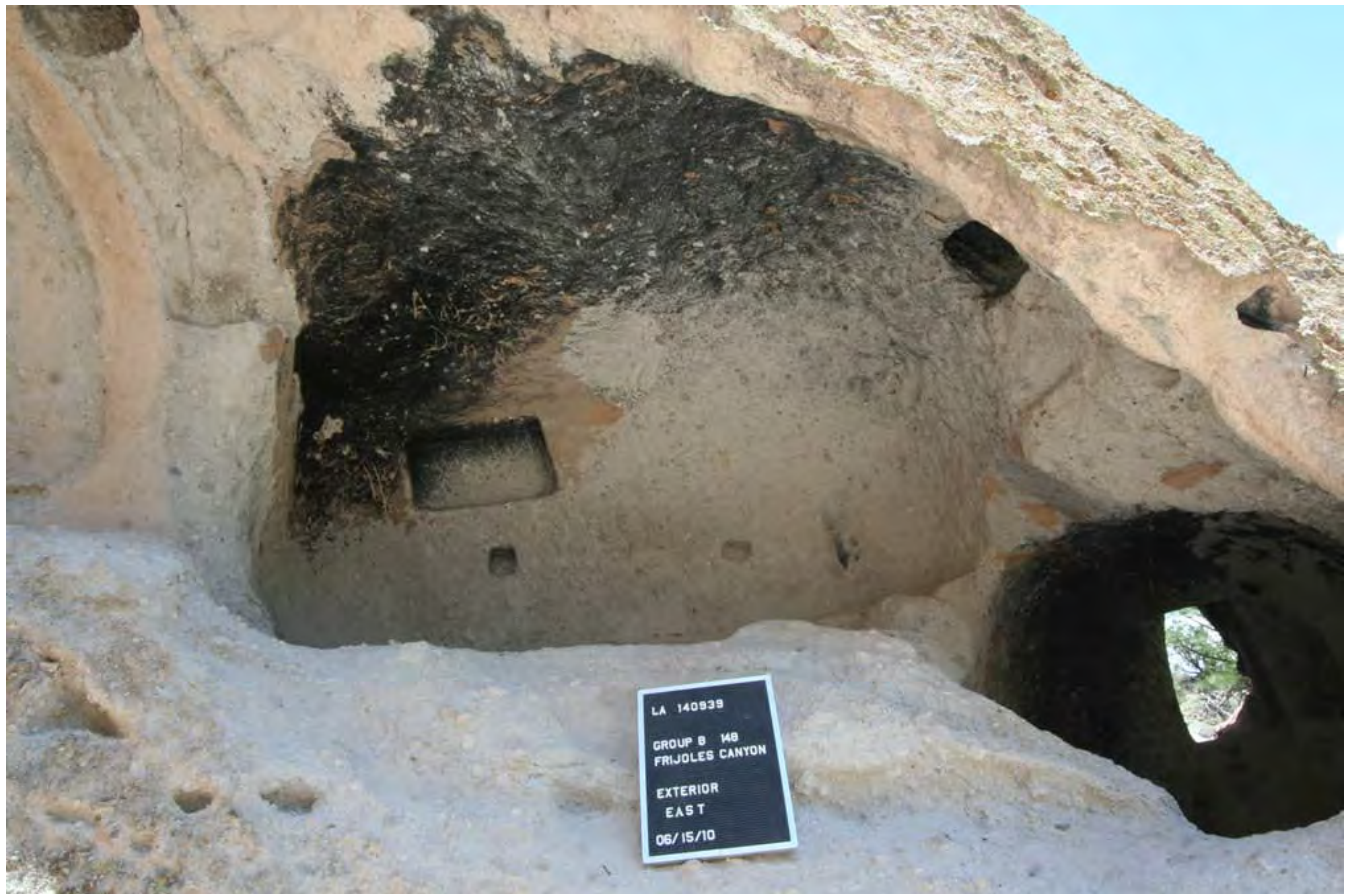
Room 148 is a small cavate in poor to fair condition. Very little of the plaster dado remains. The cavate is largely exposed with only two walls intact.

Periodic comparison of treatment areas with post-treatment images is needed to evaluate change in appearance and presence of new graffiti. Mortar, slip, or pigment may need to be reapplied since the cavate is extremely exposed to sunlight and wind-blown particle abrasion.

1. Removed loose tuff particles and dust from incised graffiti with small brush and air bulb.
2. Wet the treatment area with water.
3. Applied a hydraulic lime slip to the area.
4. Filled the graffiti with multiple thin layers of hydraulic lime mortar and pressed it into the void with a microspatula to compact the mortar.
5. Finished plaster infill by texturing with a small rock and bamboo skewers to aid in matching the original texture.
6. Used natural bristle brushes and sponges to apply a watery mix of pigment (Williamsburg Ivory Black and Williamsburg Lamp Black) in various concentrations to match surrounding sooted tuff
7. Applied dry pigment with paintbrushes to match surrounding area.
8. Applied sieved grey tuff with a dry brush to further camouflage infill.

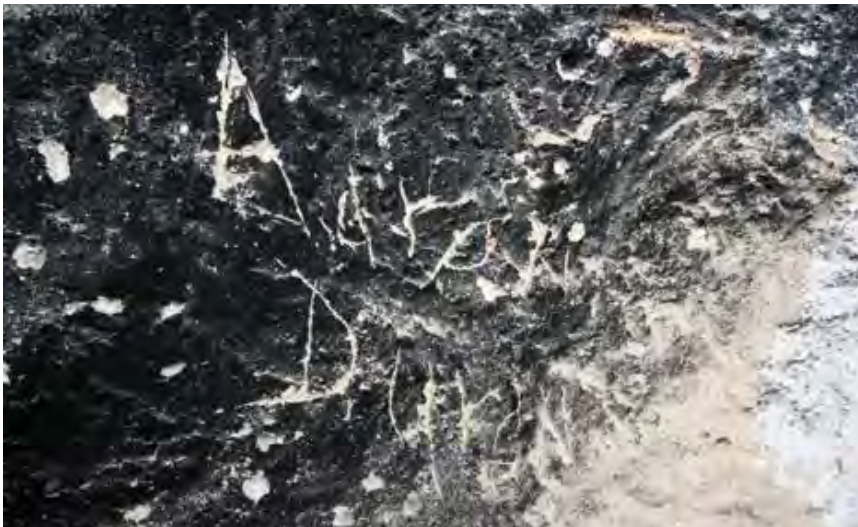
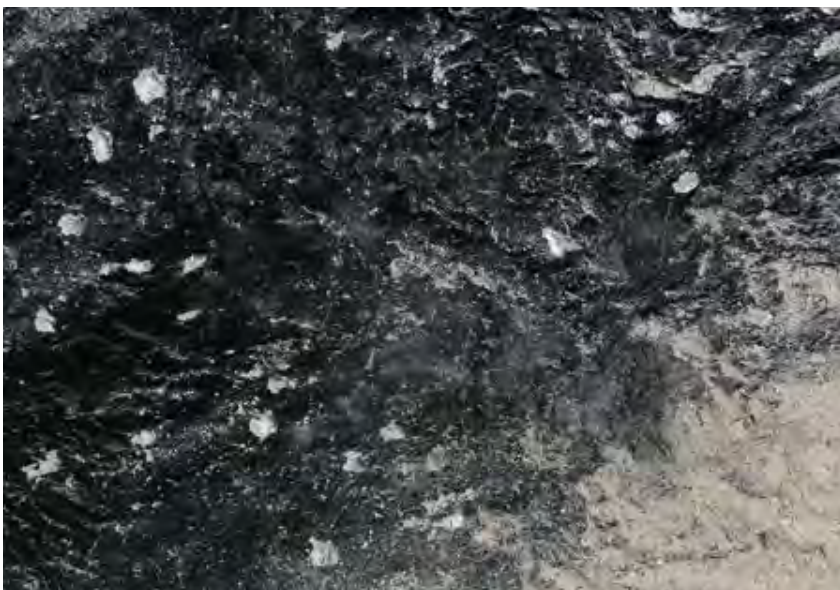
Cavate BG148  
06/16/10

CEILING SCARFITI  
CONSERVATORS: J. HOLOSWORDY  
A. CROSSEN

137 cm from ground  
40 cm by x 45 cm H

1. Removed loose tuff particles and dust from incised graffiti with small brush and air bulb.
2. Wet the treatment area with water.
3. Applied a slip to the area.
4. Filled the graffiti with multiple thin layers of mortar and pressed it into the void with a microspatula to compact the mortar.
5. Finished plaster infill by texturing with a small rock and bamboo skewers to aid in matching original texture.

1. Used natural bristle brushes and sponges to apply a watery mix of pigment in various concentrations to match surrounding sooted tuff.
2. Applied dry pigment with paintbrushes.
3. Applied sieved grey tuff with a dry brush to further camouflage infill.

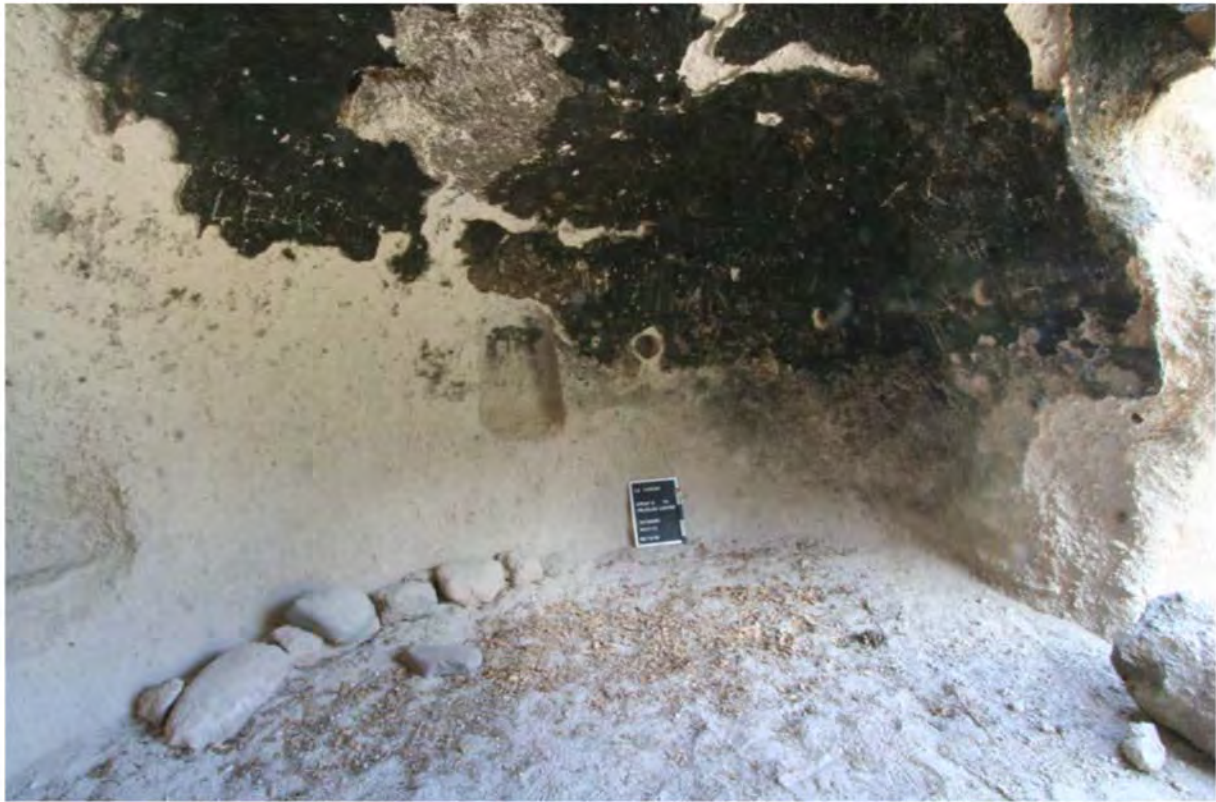
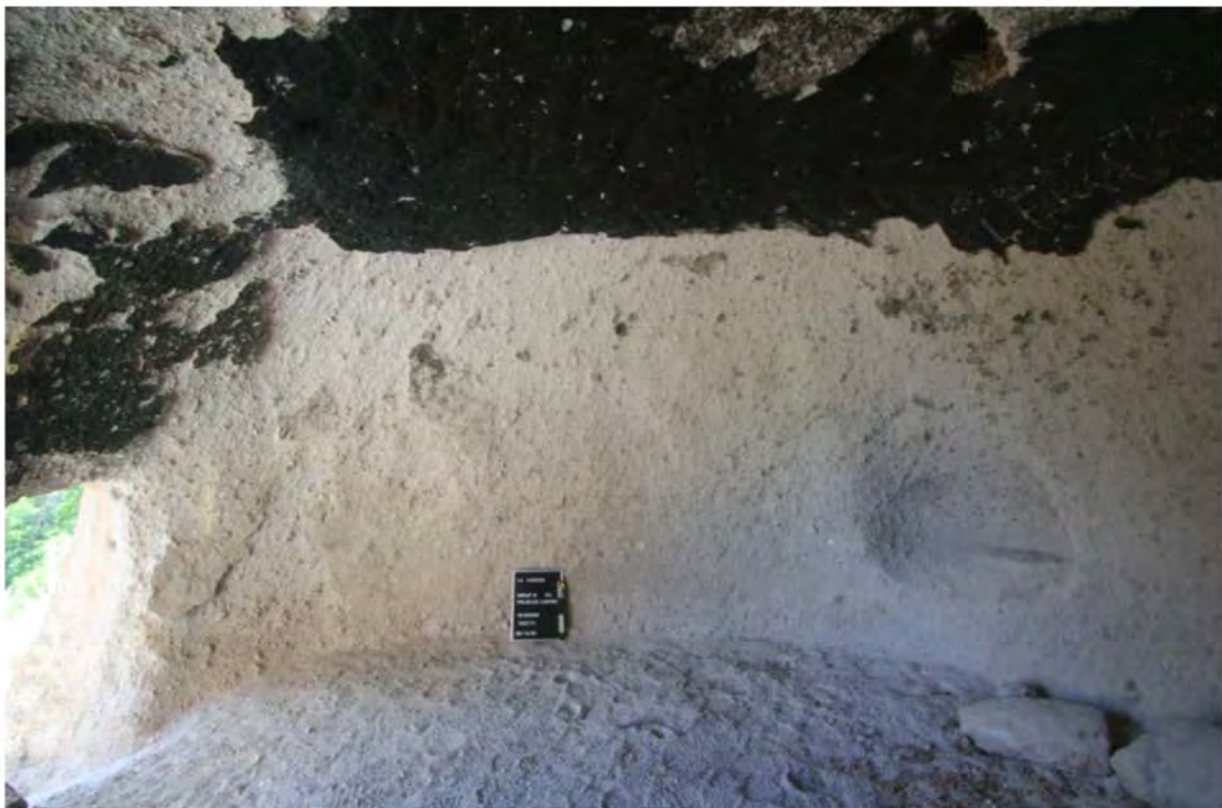
Cavate 151 is a large room covered in graffiti. The cavate is in poor condition, with few remnants of plaster on the walls, and several large losses on the ceiling.

Periodic comparison of treatment areas with post-treatment images is needed to evaluate change in appearance and presence of new graffiti. Mortar, slip, or pigment may need to be reapplied since the cavate is open and exposed to sunlight and wind-blown particle abrasion.

1. Removed loose tuff particles and dust from incised graffiti with small brush and air bulb.
2. Wet the treatment area with water.
3. Applied a hydraulic lime slip to the treatment area.
4. Filled the graffiti with multiple thin layers of hydraulic lime mortar and pressed it into the void with a piece of pumice. The rock compacted the mortar and gave it an uneven texture.
5. Stippled a mixture of black pigment and water along edges of repair mortar to blend the sharp lines with the surrounding sooted tuff.
6. Brushed or sprayed one coat of a 25% acrylic emulsion (Rhoplex) in water (V?V) to the surface of the repair mortar to ensure paint and pigment adhesion.
7. Sponged or brushed dry pigments (black, yellow, grey) on the repair surface to match the repair to the surrounding granular texture and color of the tuff.

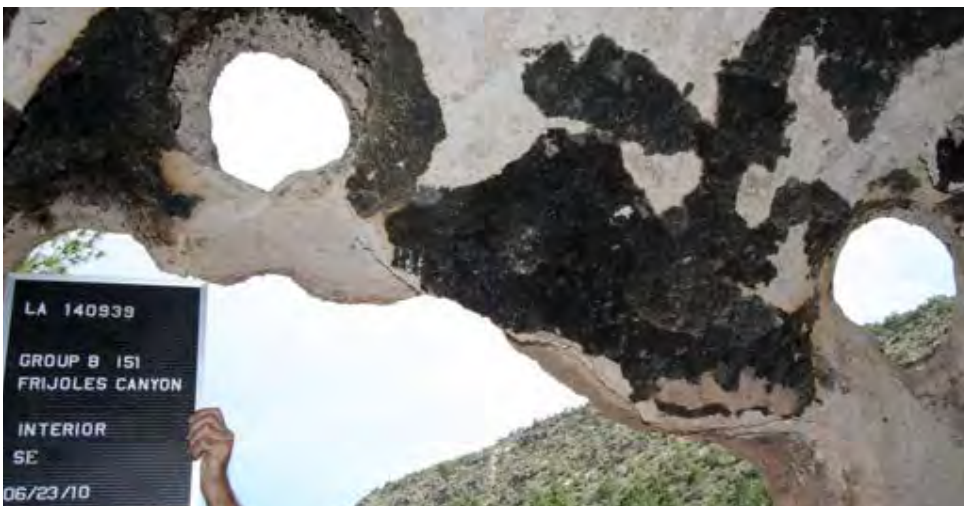
Detail 1

**Treatment location:** south ceiling**Height from floor:** 184 cm**Type of graffiti:** incised**Substrate:** tuff**Area of damage** (l x h):  
15 cm X 18 cm**Depth of Incision** (deep x across):  
1-10 mm X 1-15 mm**Number of plaster layers penetrated:** none**Is tuff exposed?** yes**Additional incision damage? (describe):** none**New graffiti since 2004? (photo comparison):** no**Notes:**

B-151

S ceiling

1. Removed loose tuff particles and dust from incised graffiti with small brush and air bulb.
2. Wet the treatment area with water.
3. Applied a slip (watery mortar consisting of wash silt : hydrated hydraulic lime (HHL) (2:1) to the scratched area.
4. Filled the graffiti with multiple thin layers of mortar and pressed it into the void with a piece of pumice. The rock compacted the mortar and gave it an uneven texture.

1. Stippled black watercolor along edges of repair mortar to blend the sharp lines with the surrounding sooted tuff.
2. Brushed or sprayed one coat of the acrylic emulsion in water to the surface of the repair mortar to ensure paint and pigment adhesion.
3. Sponged or brushed dry black pigments on the repair surface to match the repair to the surrounding granular texture and color of the tuff.

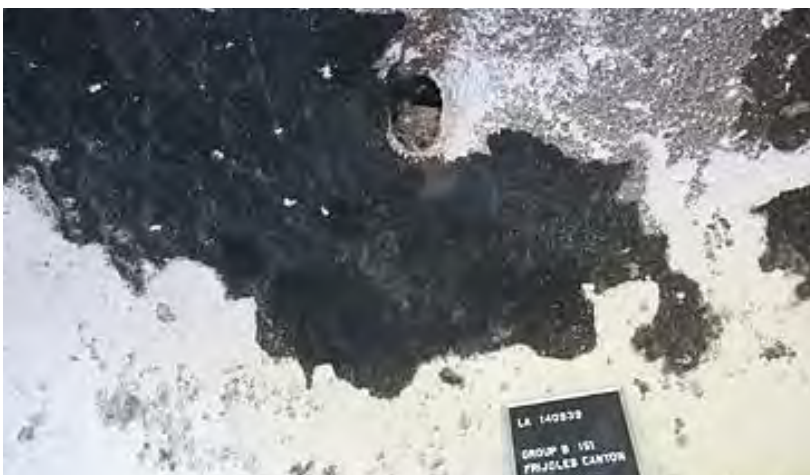
Detail 3

**Treatment location:** north ceiling**Height from floor:** 180 cm**Type of graffiti:** incised**Substrate:** tuff**Area of damage** (l x h):  
72 cm X 36 cm**Depth of Incision** (deep x across):  
1-2 mm X 1-10 mm**Number of plaster layers penetrated:** none**Is tuff exposed?** yes**Additional incision damage? (describe):** flaking of soot layer around incisions**New graffiti since 2004? (photo comparison):** no**Notes:**

B-151  
06/15

N CEILING  
180 cm from floor

W 36 cm  
L 72 cm

1. Removed loose tuff particles and dust from incised graffiti with small brush and air bulb.
2. Wet the treatment area with water.
3. Applied a slip (watery mortar consisting of wash silt : hydrated hydraulic lime (HHL) (2:1) to the scratched area.
4. Filled the graffiti with multiple thin layers of mortar and pressed it into the void with a piece of pumice. The rock compacted the mortar and gave it an uneven texture.

1. Stippled black watercolor along edges of repair mortar to blend the sharp lines with the surrounding sooted tuff.
2. Brushed or sprayed one coat of the acrylic emulsion to the surface of the repair mortar to ensure paint and pigment adhesion.
3. Sponged or brushed dry black pigments and watercolors on the repair surface to match the repair to the surrounding granular texture and color of the tuff.

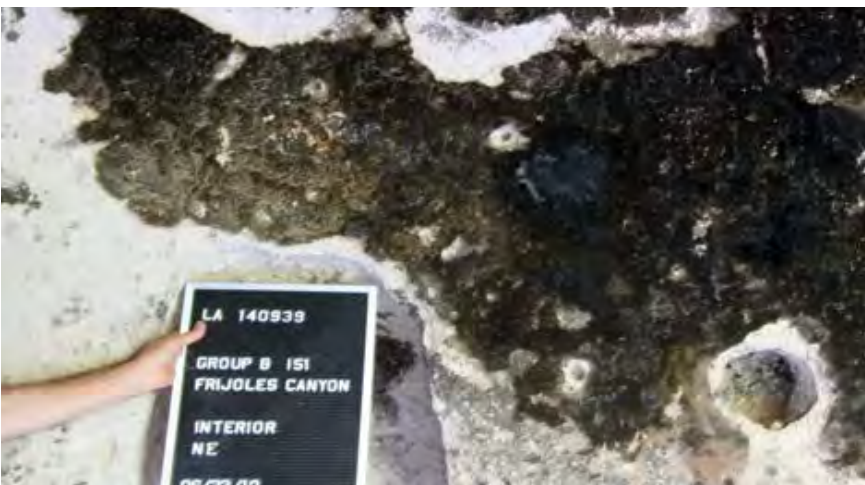
Detail 4

**Treatment location:** northeast wall**Height from floor:** 124 cm**Type of graffiti:** incised**Substrate:** tuff**Area of damage** (l x h):  
60 cm X 60 cm**Depth of Incision** (deep x across):  
1-4 mm X 1-4 mm**Number of plaster layers penetrated:** none**Is tuff exposed?** yes**Additional incision damage? (describe):** flaking of soot layer around incisions**New graffiti since 2004? (photo comparison):** no**Notes:**

B-151 NE Wall  
6/15 124cm From Floor

60 cm wide  
60 cm tall

1. Removed loose tuff particles and dust from incised graffiti with small brush and air bulb.
2. Wet the treatment area with water.
3. Applied a slip (watery mortar consisting of wash silt : hydrated hydraulic lime (HHL) (2:1) to the scratched area.
4. Filled the graffiti with multiple thin layers of mortar and pressed it into the void with a piece of pumice. The rock compacted the mortar and gave it an uneven texture.

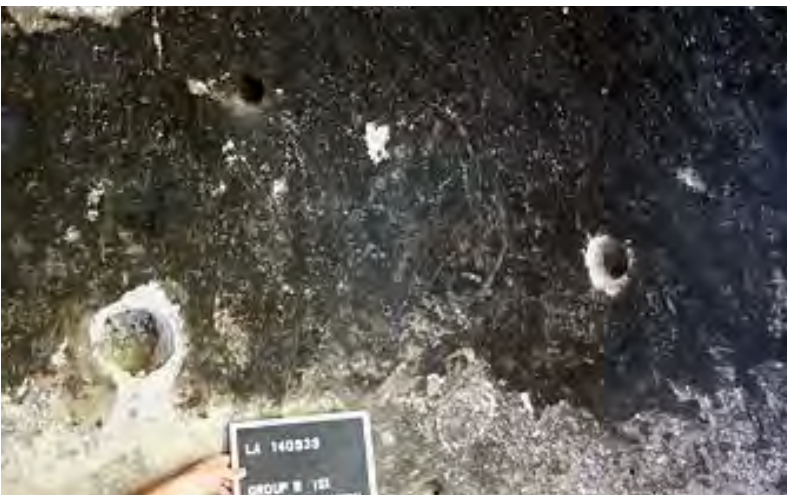
B151  
06/15

E WALL
