**VICKSBURG NATIONAL MILITARY PARK  
SHIRLEY HOUSE**

**HISTORIC STRUCTURE  
REPORT**

**Cultural Resources, Southeast Region  
National Park Service**

**2004**

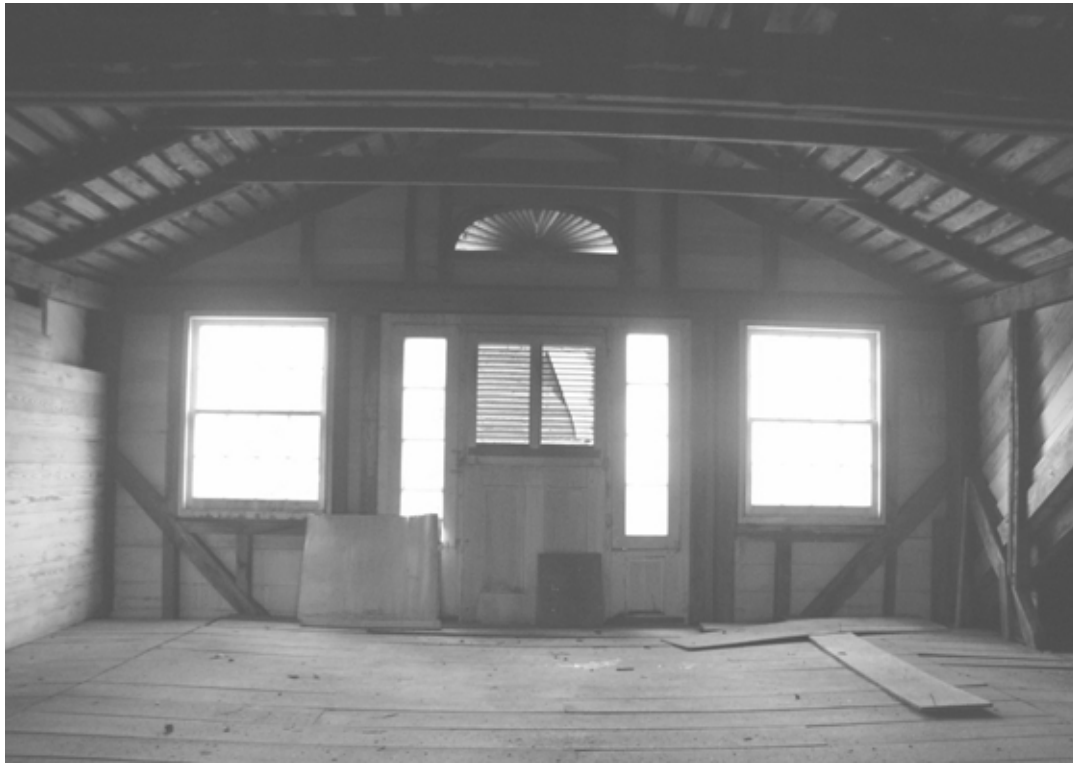
**Figure 67** View south in Room 200. NPS SERO 2001.

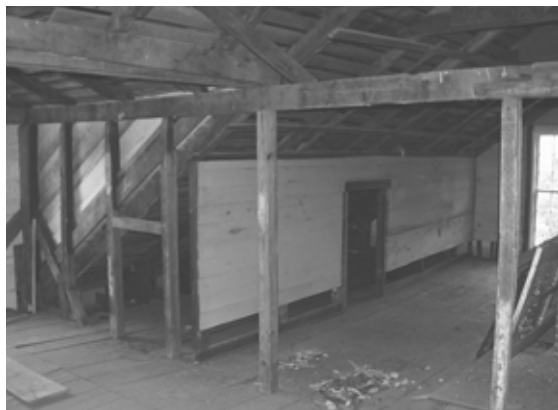
**Figure 68** View southwest in Room 200. NPS SERO 2001.

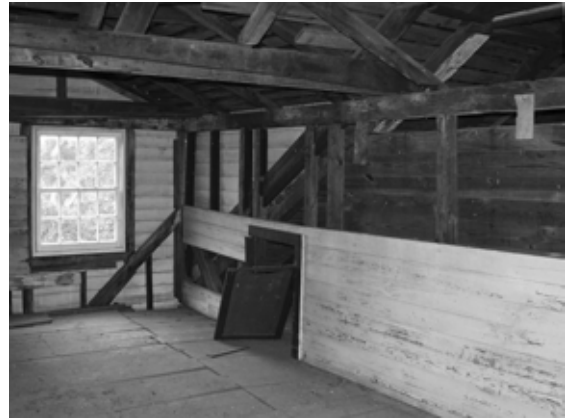
**Figure 69** View to northeast in Room 200. NPS SERO 2001.
