Fort Point National Historic Site  
Golden Gate National Recreation Area

## Abbreviated Fort Point Historic Structure Report

September 2006

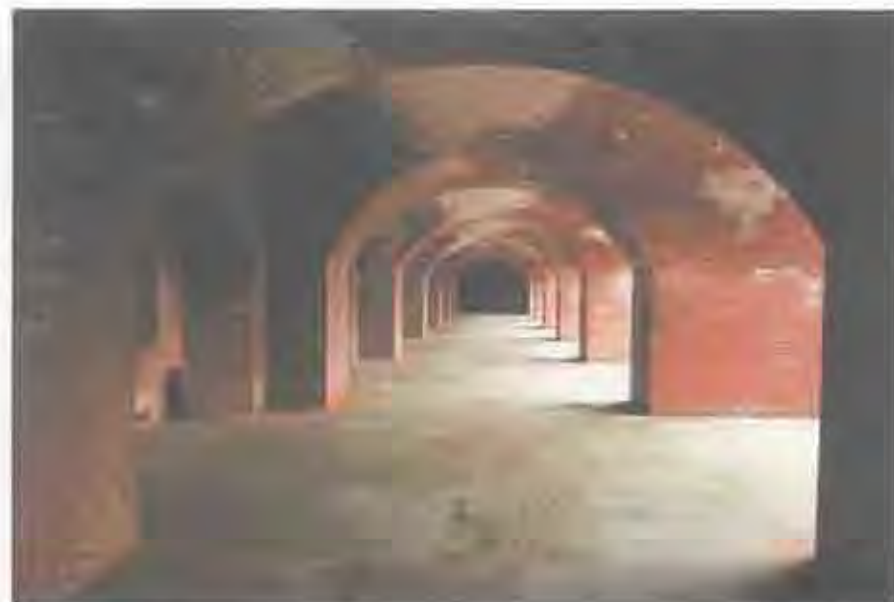
Each casemate has brick walls, laid in an English bond (alternating courses of headers and stretchers), and a brick barrel-vaulted ceiling. The mortar is deteriorated in many places; green algae and efflorescence is present as well. There is an arched opening from the parade into most of the casemates and all of the casemates have a cannon embrasure at the opposite end. The walls between the casemates on the 1st tier are constructed of 18" high granite blocks. Connecting each of the casemates is a 12 ft. wide arched opening with a brick arched header, 7'-6" high at the spring point and 9'-2" at the high point.

Typical brick casemates with arched ceilings and granite floors. (John Martini, 2005)

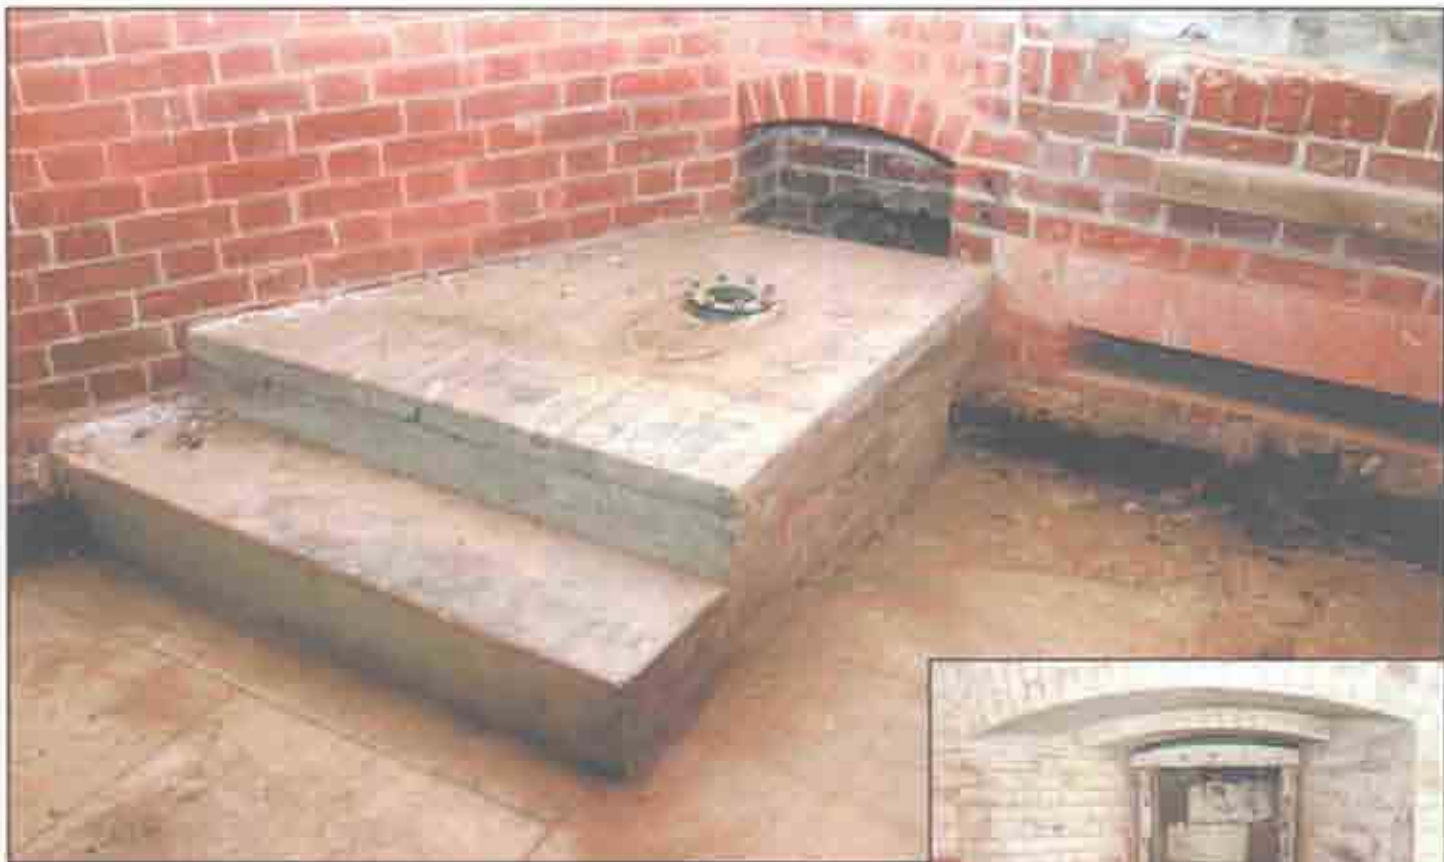
These concrete platforms for plumbing fixtures remain from the 1914 attempted remodel of the fort into a disciplinary barracks. (John Martini, 2005)

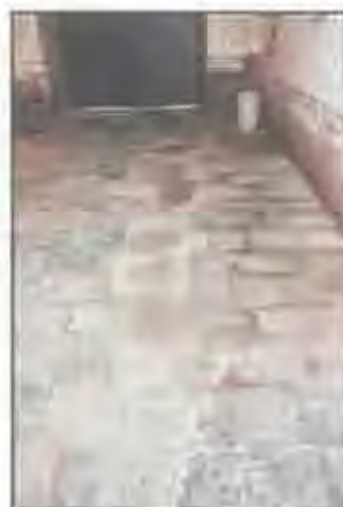
The original granite floors remain in good condition although a large concrete patch exists where a previous water line was installed. (John Martini, 2005)

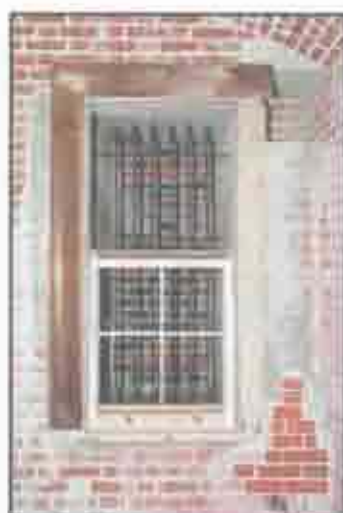
Rifle slit openings were enlarged and then bricked up leaving various building components. (John Martini, 2005)

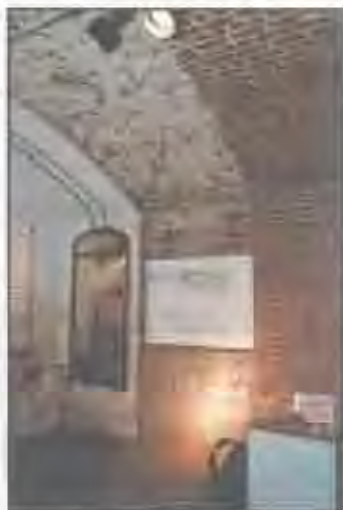
Walls were removed in the magazines during the conversion of the fort to a disciplinary barracks in 1914. Half of the 4-foot thick brick and rubble wall remains at right, while only the outline of a wall remains above. (John Martini, 2005)

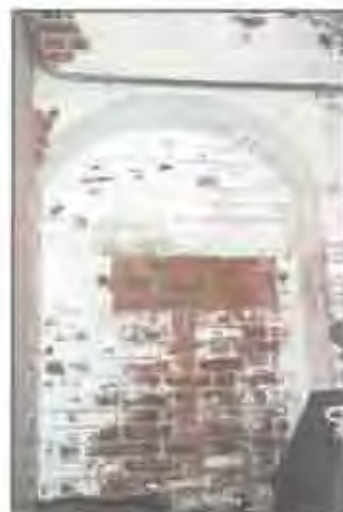
The rifle slit in the corridor of the jail area has been infilled with brick. (John Martini, 2005)

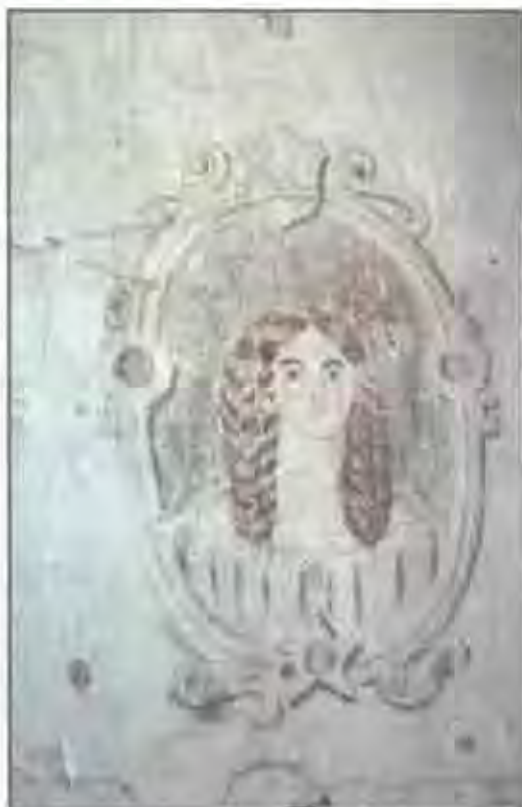
In the north jail cell, there is a drawing on the wall that was done by a prisoner in the 1860s. It is fair condition now, but should be preserved. The drawing depicts an oval portrait hung on a nail of a young woman with Victorian dress.

The drawing on the wall of one of the jail cells was done by a long ago prisoner. (John Martini, 2005)

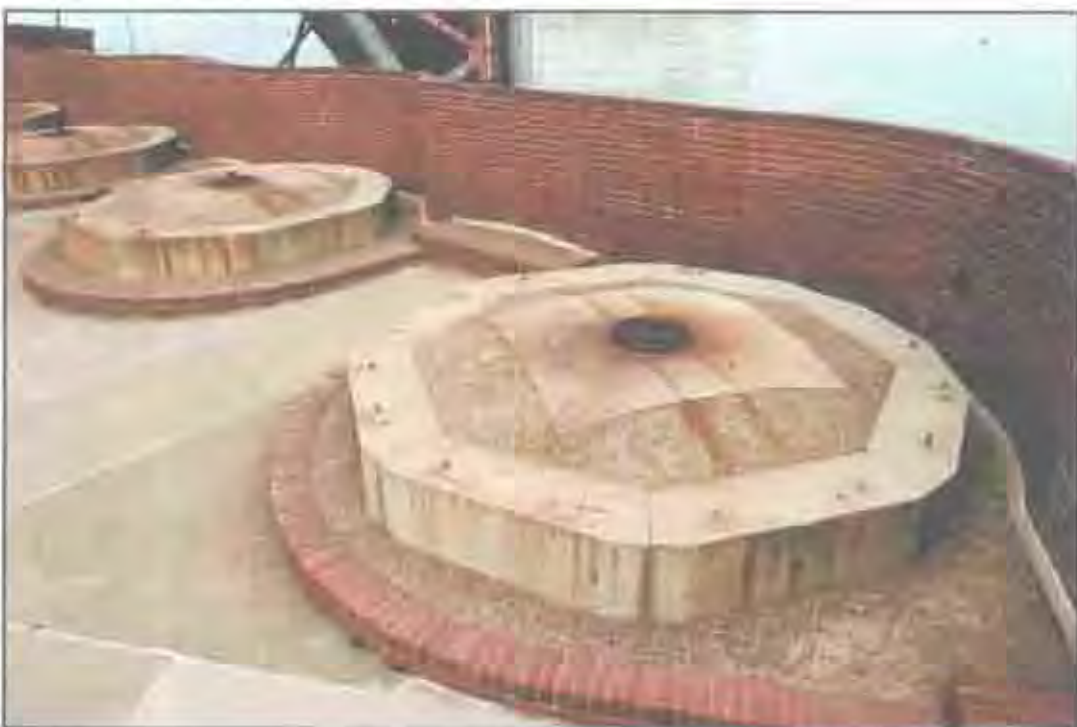
The top of the parapet wall in this area is concrete, but was originally grass. There are several dozen clay flue pipes projecting up through this concrete. There are 3 different styles of pipes, most likely related to the different time periods when they were installed. There are 1" diameter weep holes every 8 ft. in this wall. Although the top is concrete, moisture still appears to be coming from the weep holes, indicating that the concrete is leaking.

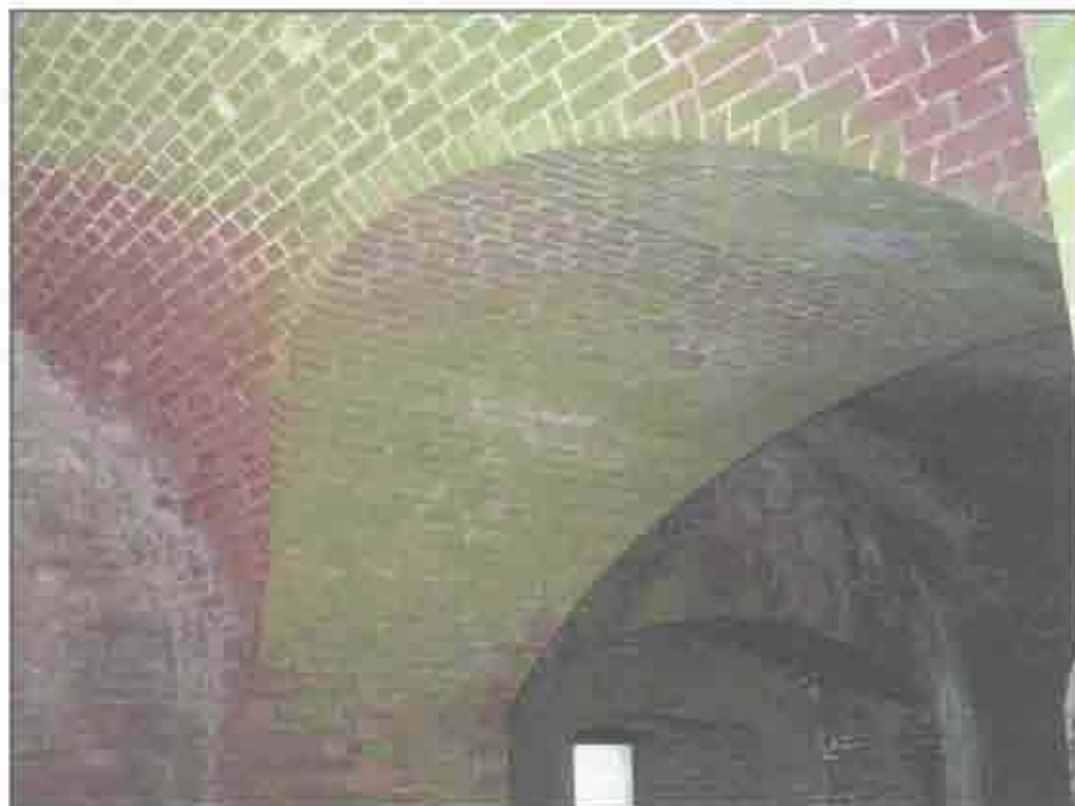
Condition Photo 2:  
Intersecting Arch of Casements  
98 and 99; Biological growth and  
efflorescence settle on masonry  
surfaces. (Courtesy of ARG, 2003)

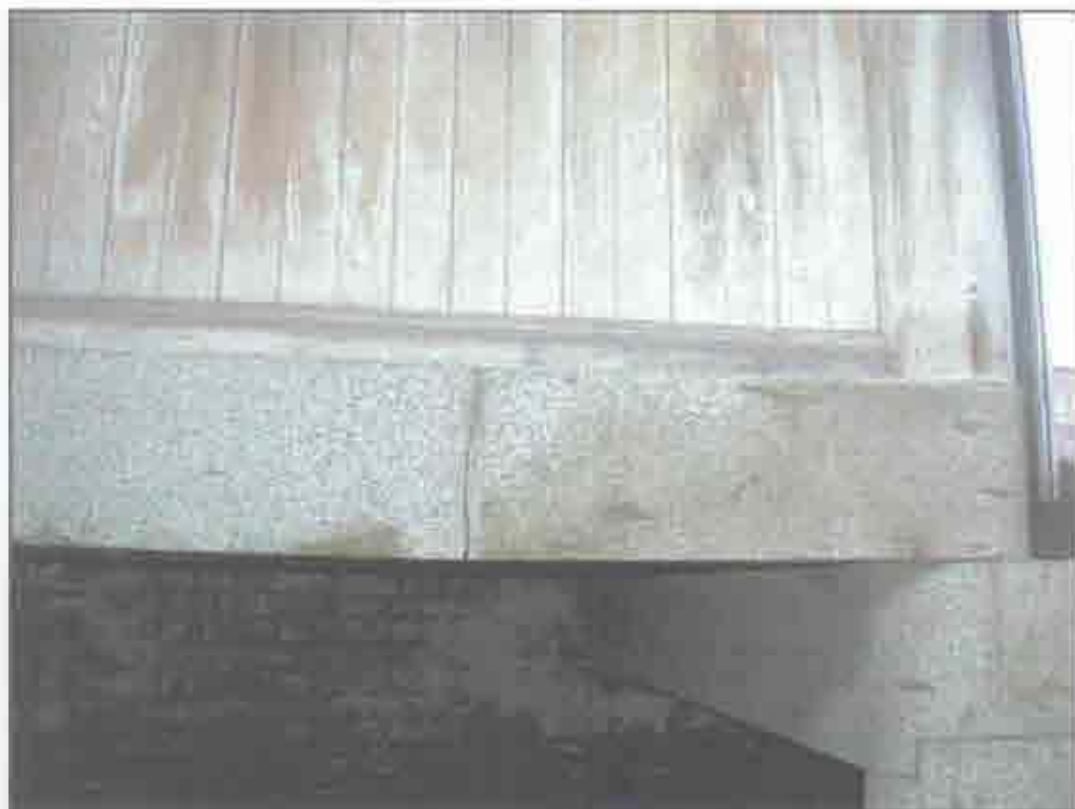
Condition Photo 6:  
Top Landing at Barbetta Tier; Crack  
in granite. (Courtesy of ARG, 2003)

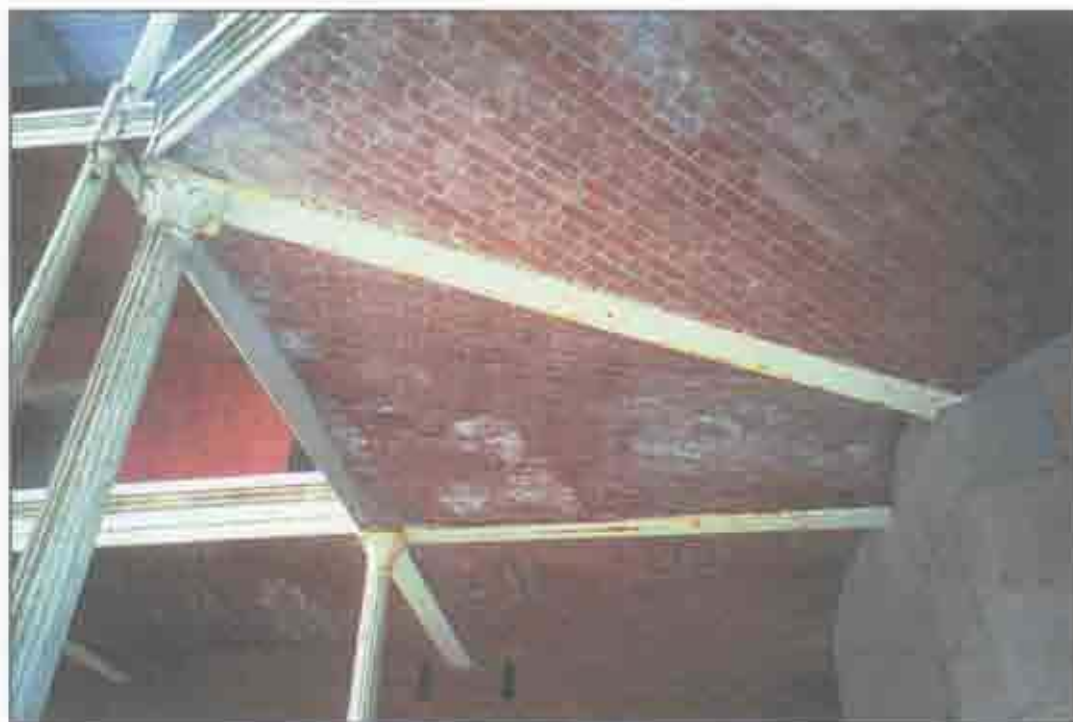
Condition Photo 9:  
Southeast Courtyard—Underside  
of Walkway at Tier One; Metal  
corrosion and staining of the granite  
walls. The brick facing is spalling.  
Efflorescence occurs on the brick and  
granite masonry.  
(Courtesy of ARG, 2003)

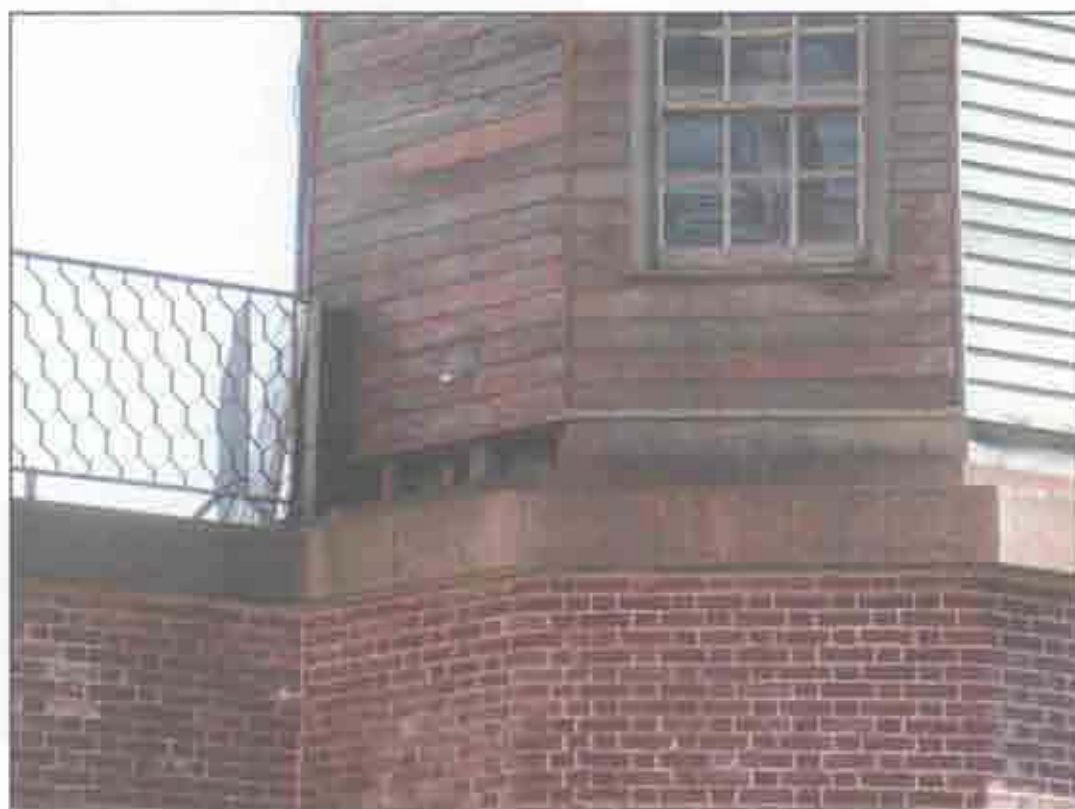
Condition Photo 13:  
Stair 3: Missing siding exposes the  
structural framing. (Courtesy of ARG,  
2003)

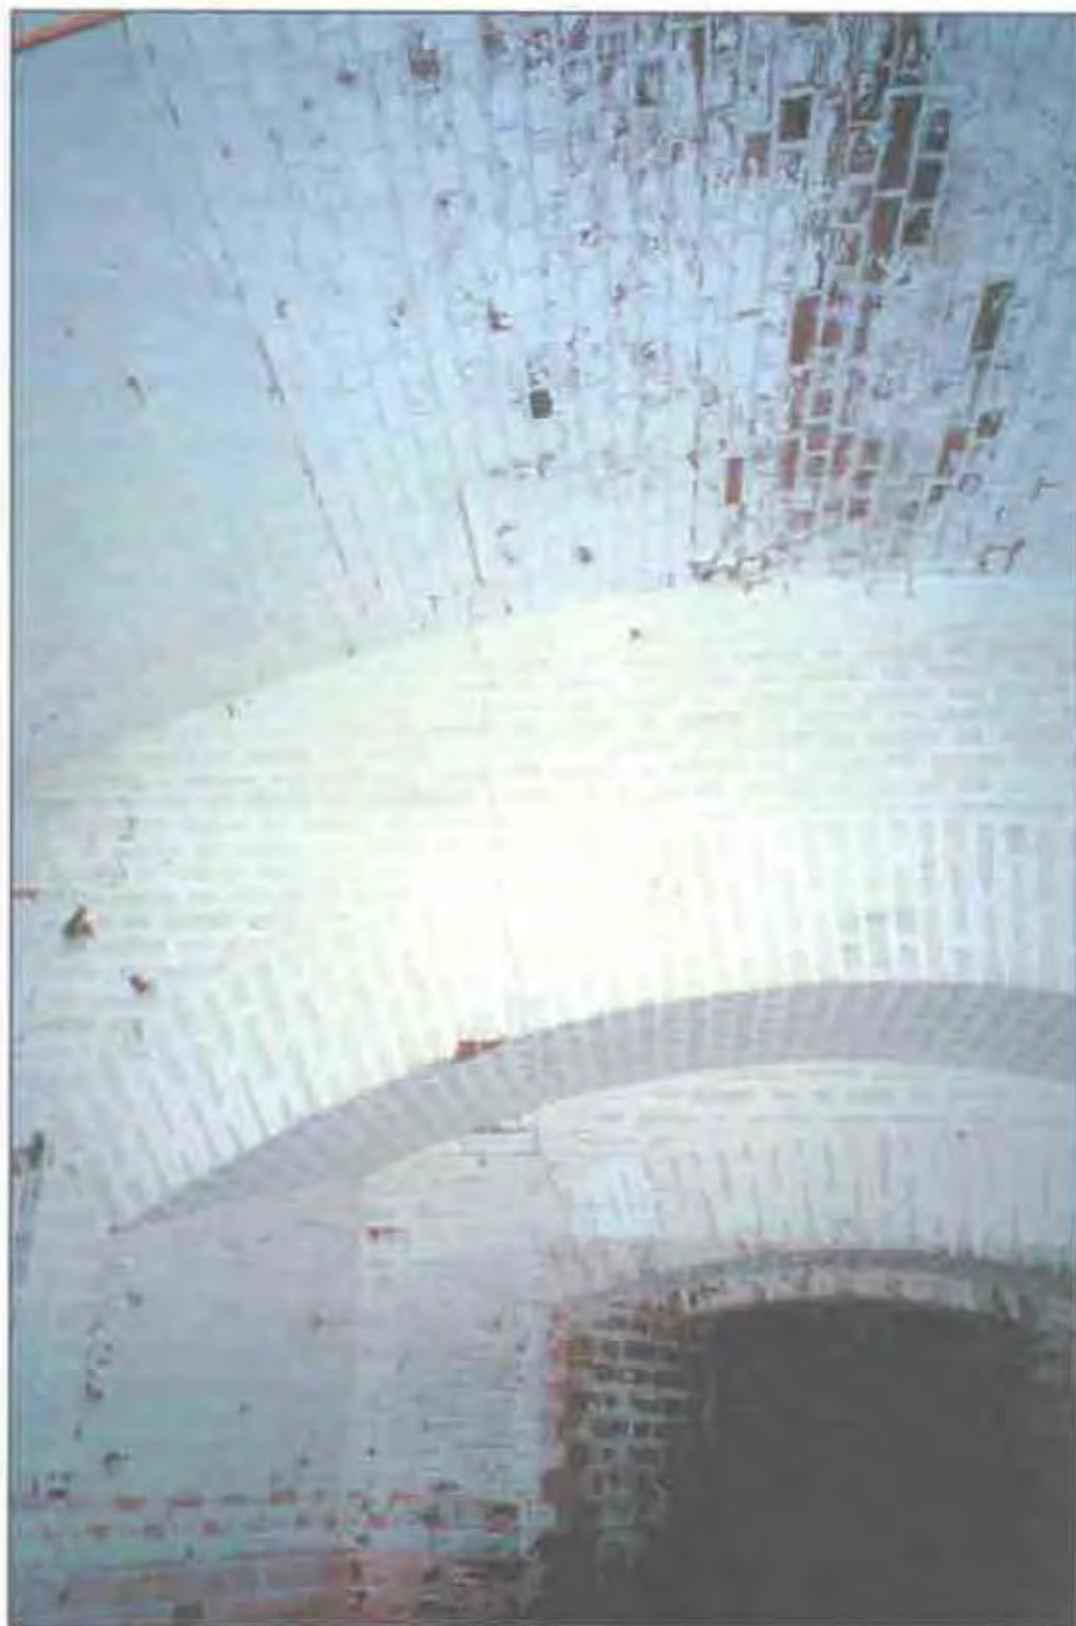
Condition Photo 15:  
Casemate 19: Cracks in brick masonry  
and joints have failed. The heavily  
flaking paint is typical in casemats.  
(Courtesy of ARG, 2003)

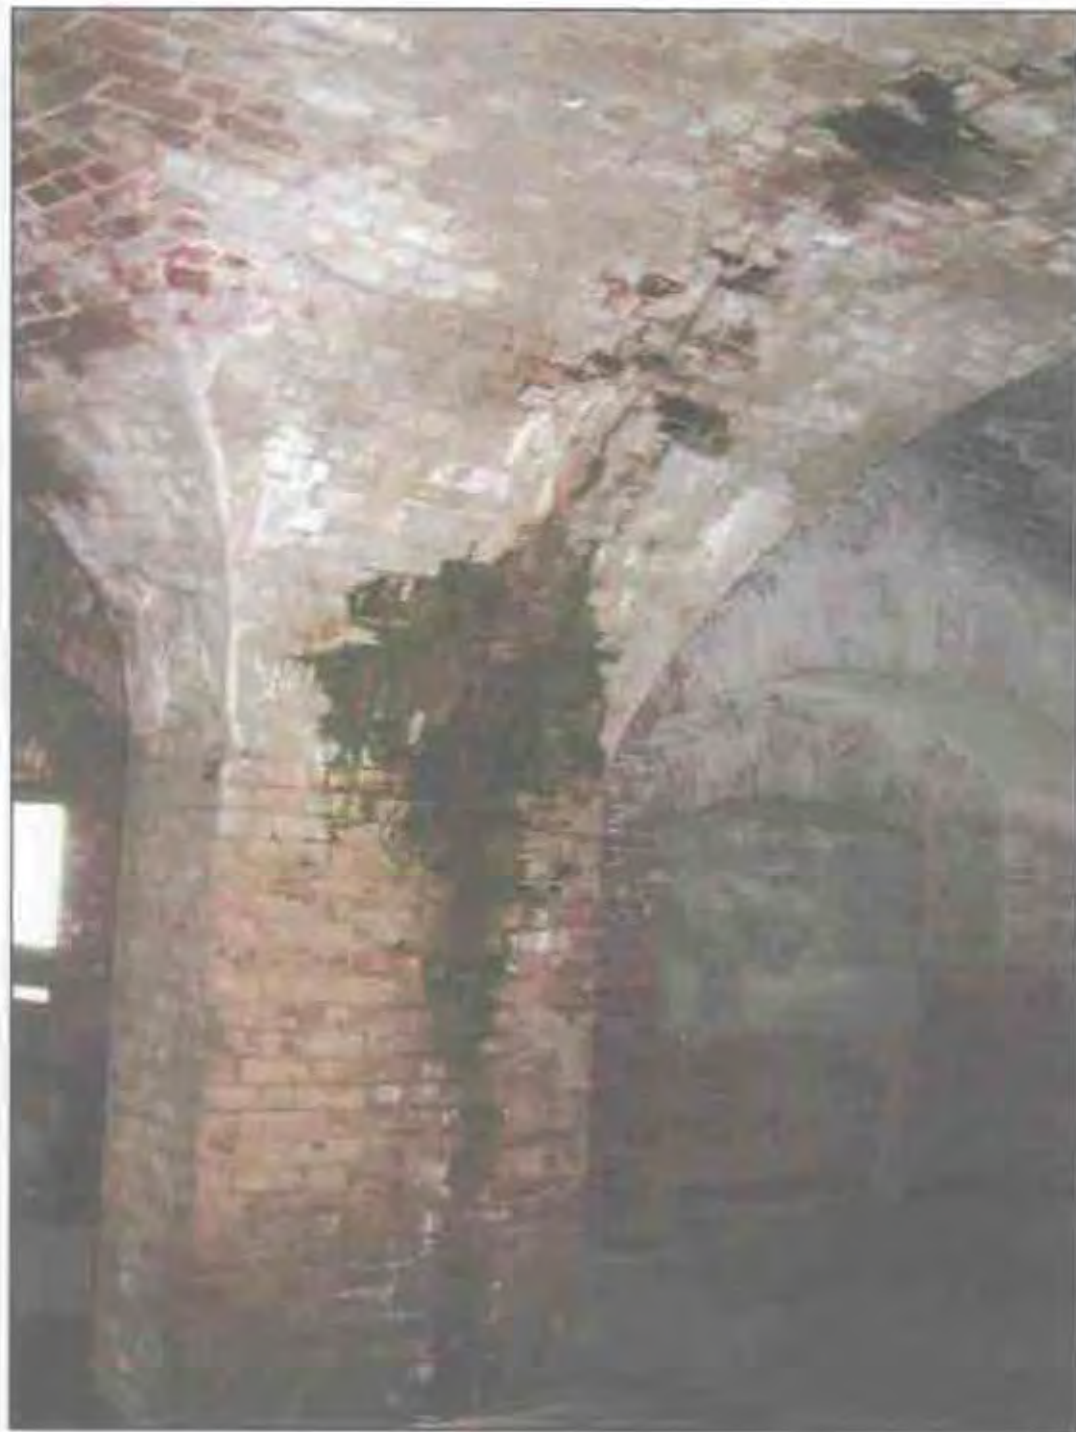
Condition Photo 17:  
Casemate 68A- Third Tier; Crack  
spanning the arch of a casemate,  
typical at the intersection of the east  
barrion and arch of the adjacent  
walkway. Extensive water damage,  
biological growth and efflorescence  
of masonry. (Courtesy of ARG, 2003)

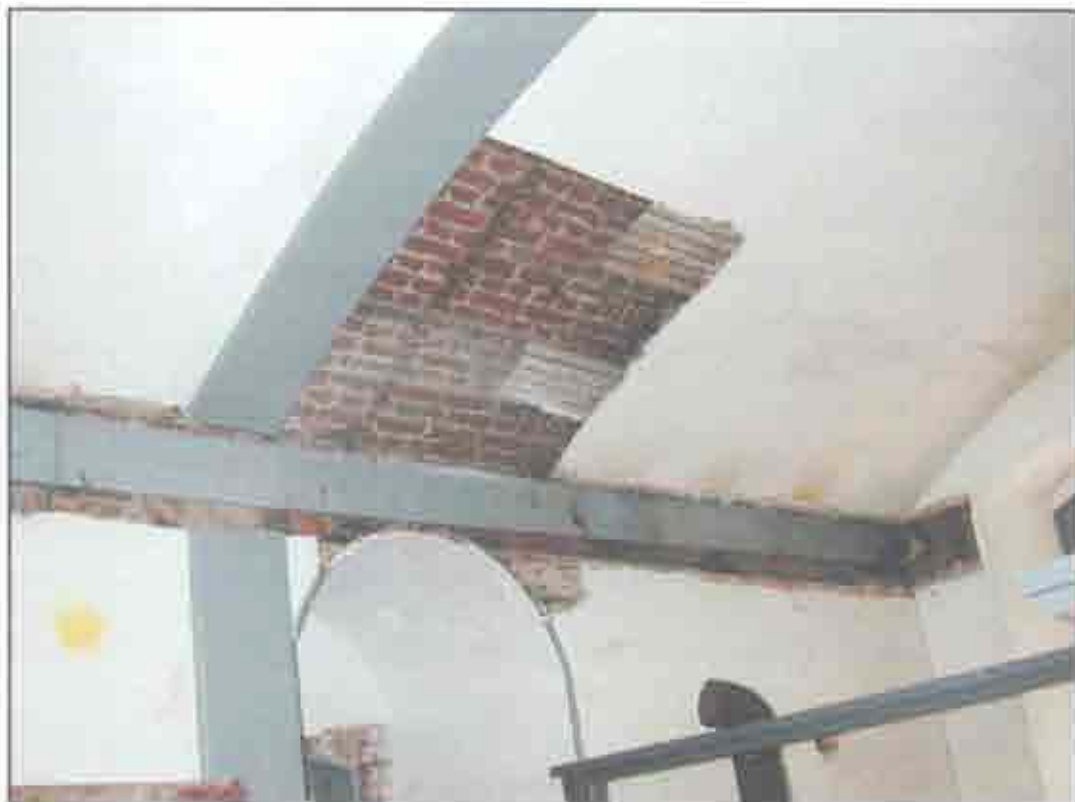
Condition Photo 20:  
Photo shows interior plaster  
patching at 2<sup>nd</sup> tier.  
(Courtesy of ARG, 2003)

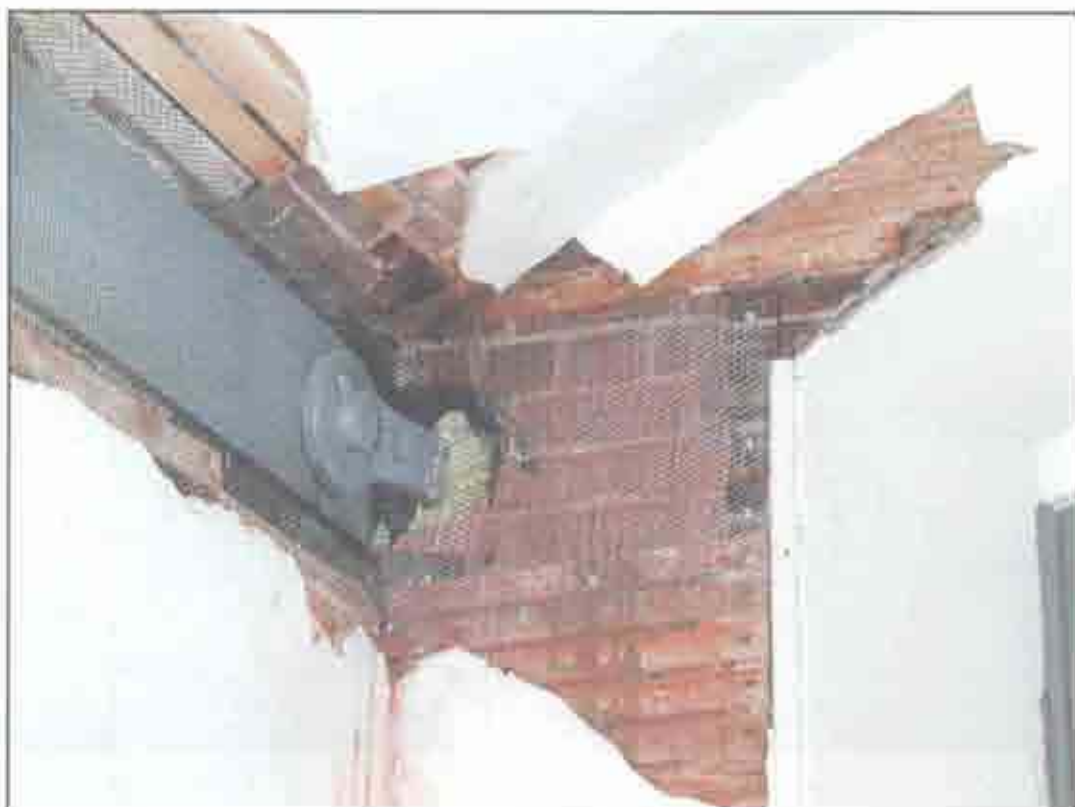
Condition Photo 21:  
Detail of brick lath, wire mesh, and  
plaster layers. (Courtesy of ARG,  
2003)
