Memorandum

Subject: Hydrology of the Ramp 49 area, Cape Hatteras National Seashore

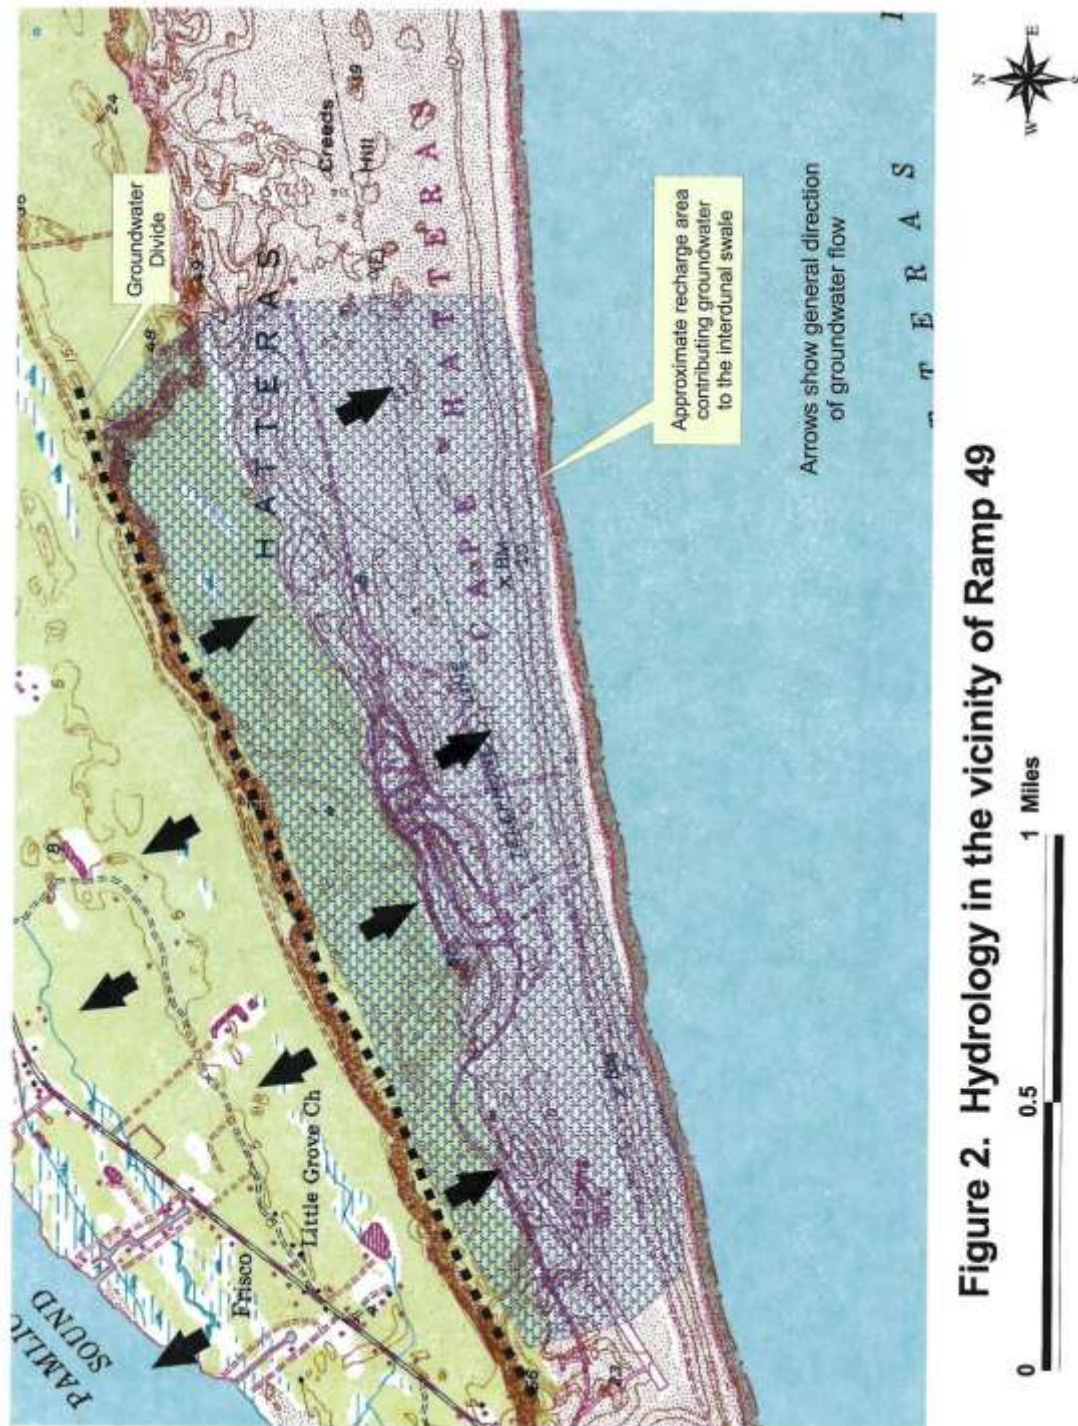
The area contributing groundwater to the interdunal swale is from the center of the island (approximately coinciding with the park boundary north of the campground) southward to the ocean. The east and west boundaries of the area contributing groundwater to the swale are determined by the east-west extent of the flooded interdunal swale area. Figure 2 shows the approximate extent of the area contributing groundwater to the swale. Most of the area contributing groundwater flow to the interdunal swale area is undeveloped NPS land. To the southwest the Frisco airstrip provides a buffer to activities and hydrologic perturbations in the Frisco area. To the north, NPS property extends to the approximate location of the groundwater divide at the center of the island. The only NPS development in the area is the campground, which has no effect on the quantity or direction of groundwater flow. To the east, undeveloped NPS land extends for several miles.

There is no inflow of surface water into the interdunal area in the vicinity of Ramp 49. There are no ditches that would import extra water into the area. There are no land uses or recent land use changes in the surrounding areas that could cause an increase in groundwater flow to the area. Therefore, the cause of increased frequency and duration of flooding on the interdunal road can only be above average precipitation which causes above average water table elevations.

**Figure 2. Hydrology in the vicinity of Ramp 49**
