## **Water Supply Wells At Park Headquarters, Organ Pipe Cactus National Park**

Subject: Repair/Rehab of wells in Headquarters Area

## ORPI – SOUTH WELL

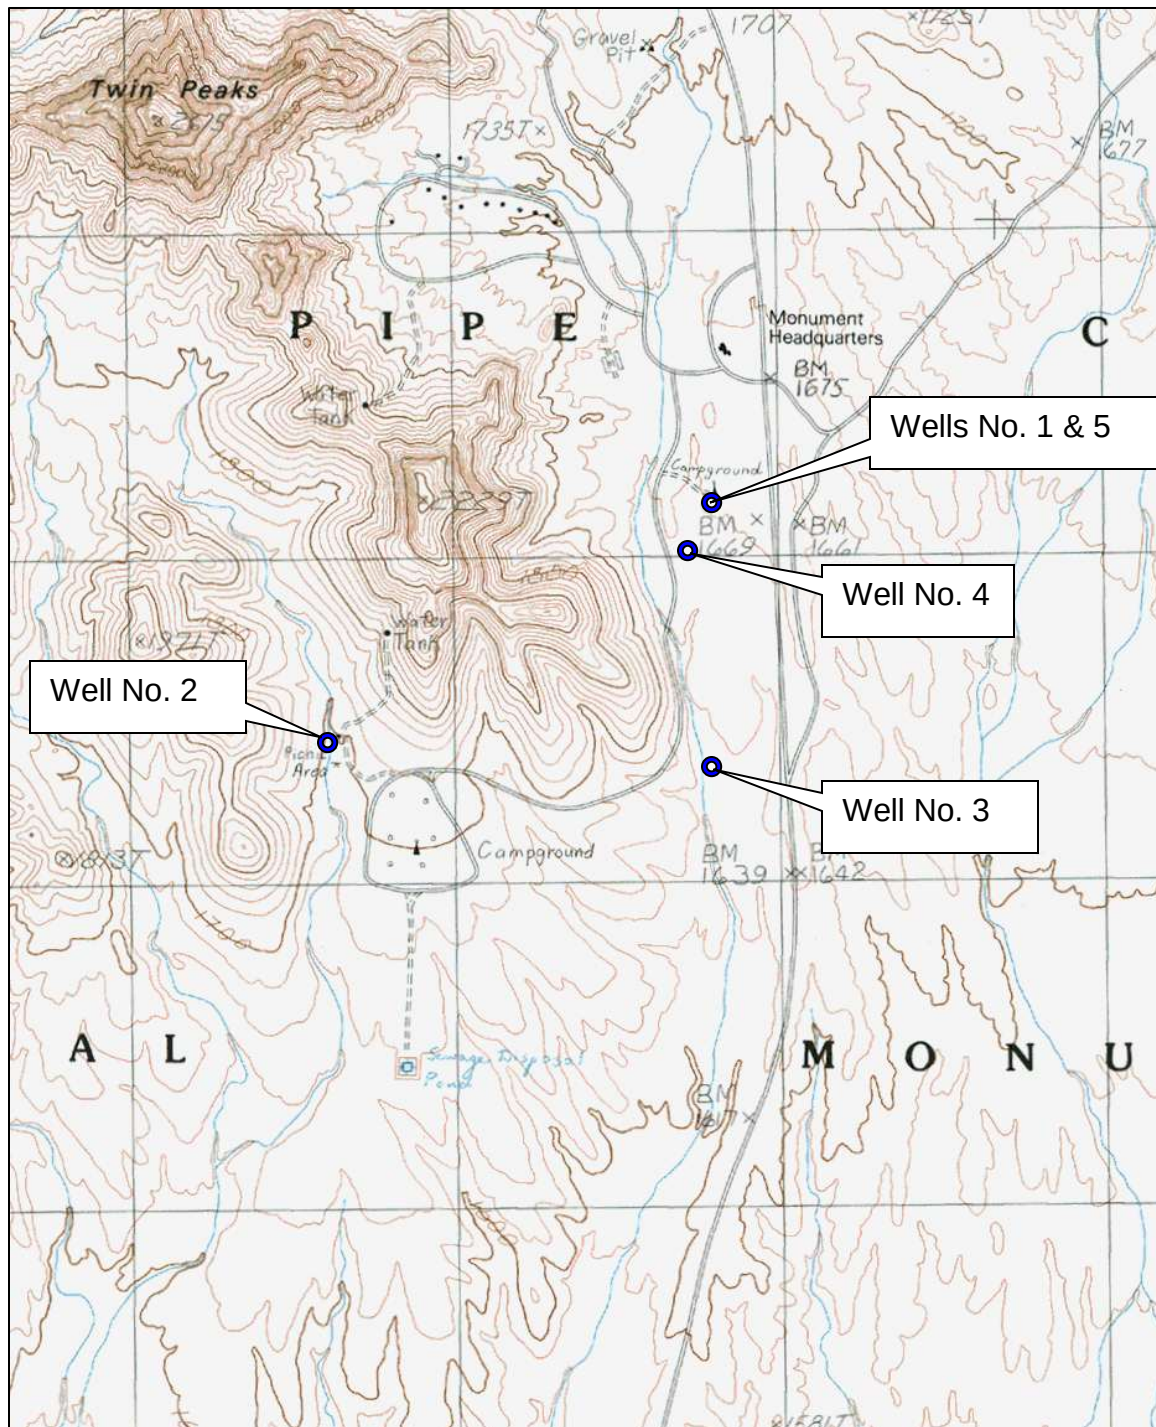
Approximate locations of Wells in the Headquarters area at  
Organ Pipe Cactus National Park

Well No. 5 is the “**North Well**”. Well No. 4 is the “**South Well**”. Well No. 3 was apparently never used for water supplies. Well No. 2 was dry and was backfilled and abandoned immediately after drilling. Well No. 1 was replaced by Well No. 5 in 1974.

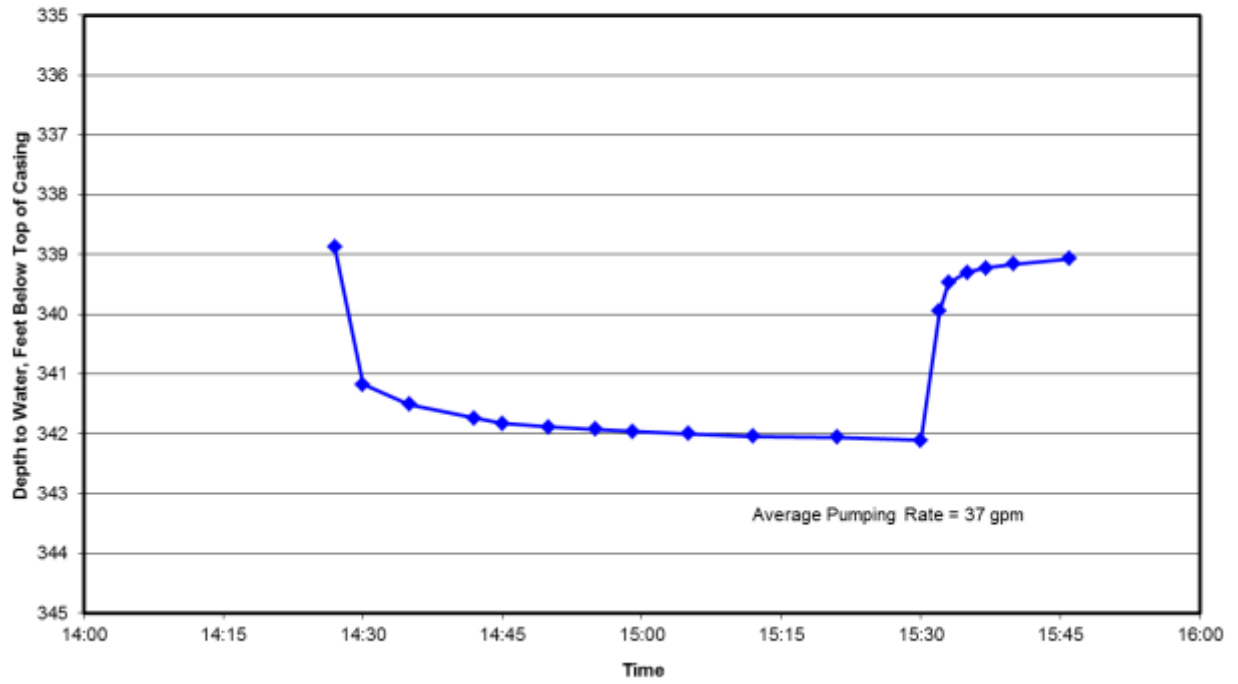
Organ Pipe Cactus National Park  
North Well, aka Well No. 5  
January 26, 2004

The drop pipe from above the water table was in good shape, both inside and out. The pipe from below the water table had a lot of encrustation on the outside. The pump intake was nearly plugged with rust particles and fragments of green electrical tape. The worn ring and hole in the nipple above the pump was thought to be caused by vibration and rubbing of the attachment of the pump shroud at that location.

1. Remove the old pump. Assess the condition of the pump and motor.
2. Note whether there is evidence of degraded green electrical tape that might have been used to fasten the electrical cable to the drop pipe. If so, use another type of tape when installing the new pump.
3. Check the depth of the well and if necessary remove accumulated sediment by bailing, air lifting, jetting, or some combination of these.
4. Install a new pump, drop pipe, check valves, and a sand separator. (The existing pump and motor can be reused if they are still in good shape.)
5. Install new electrical cable if needed.
6. Install polyethylene tubing to facilitate water level measurements.
7. Test pump the well until the water consistently runs clear.
8. Chlorinate the well and return it to service.
