# United States Department of the Interior

Subject: Trip Report to Drewry's Bluff Unit of Richmond National Battlefield Park  
September 13, 2011

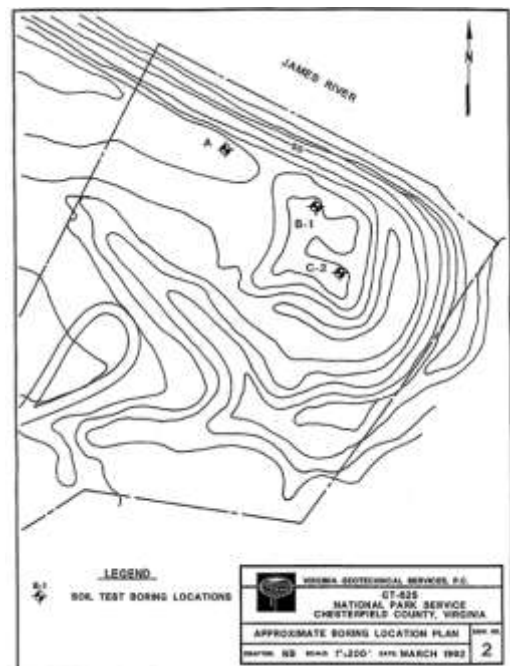
The 2011 request for technical assistance, which led to this trip, asked for assistance in installing monitoring wells and a rain gage to provide data to characterize groundwater response to storm events. Three borings were constructed at the site in December 1991 (Virginia Geotechnical Services, report dated March 1992). The locations of the borings are shown on Figure 1. Depth to water was noted at 57-61 feet below ground surface in these borings. The occurrence of the water table at that depth places it a few feet above the clay layer observed in the outcrop near the base of the bluff. Groundwater seeps from sand or gravel lenses at various locations higher up on the face of the bluff are temporary, perched groundwater lenses resulting from infiltration of precipitation. These features would not register in monitoring wells screened below the water table, more than 60 feet below ground surface.
