# **Canoa Ranch at the Santa Cruz River Photo Monitoring**

**Neva Connolly  
Pima County Office of Conservation Science  
March 29, 2011**

Report by Neva Connolly, Frank Postillion, and Julia Fonseca

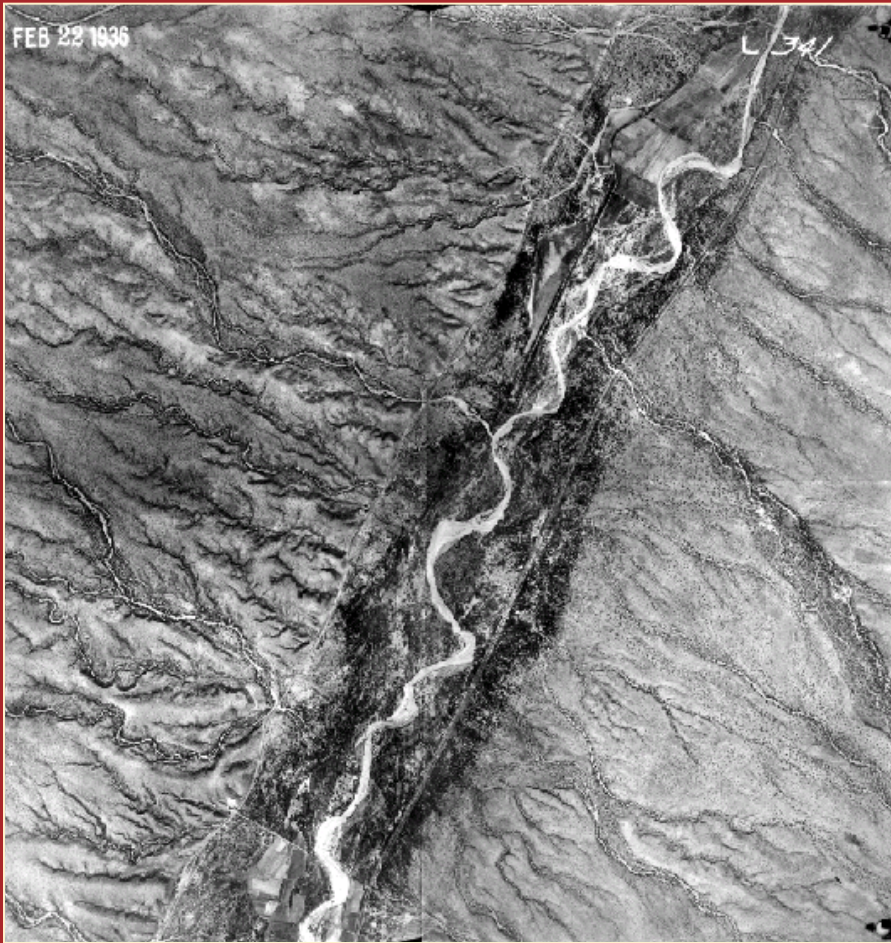
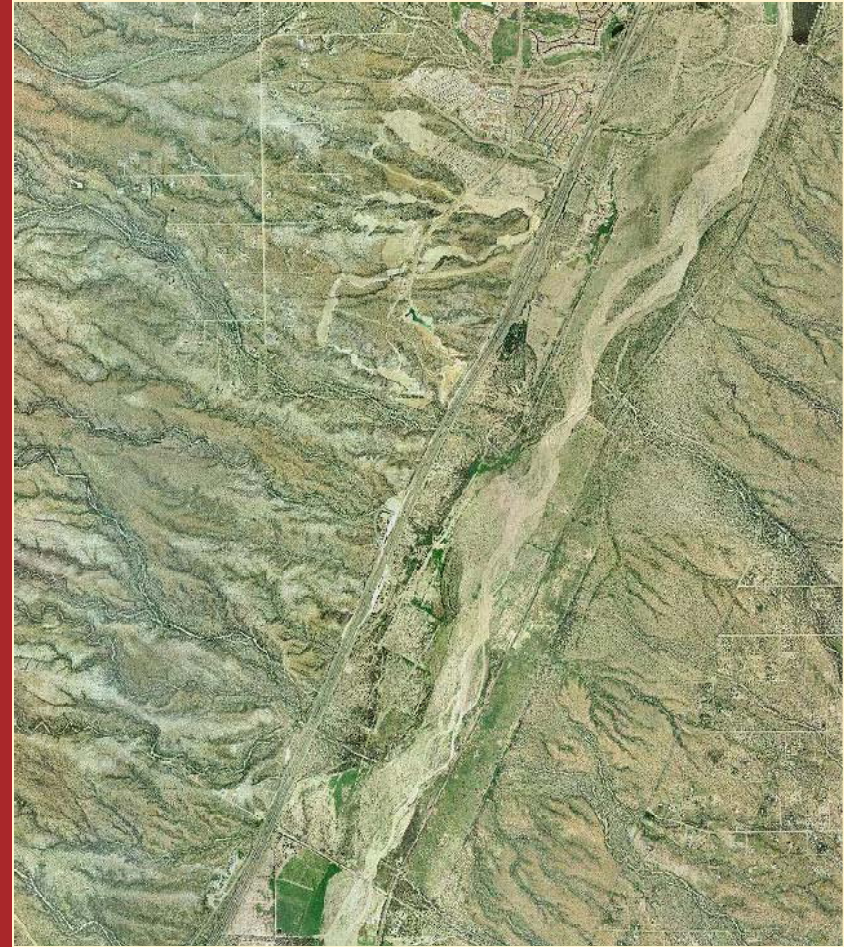
# Aerial comparison: 1936-2002

- Distance to bank measurements were not effective in determining channel bank change.
- Regional aerial photography available every 2-3 years.
- Can be used to determine channel changes.
- When used with photo monitoring, can tell a more complete story.
