# Weather Station Maintenance in Southwest Alaska Network Parks

## *Summary for the 2014 Hydrologic Year*

Natural Resource Data Series NPS/SWAN/NRDS—2014/725

October 2014

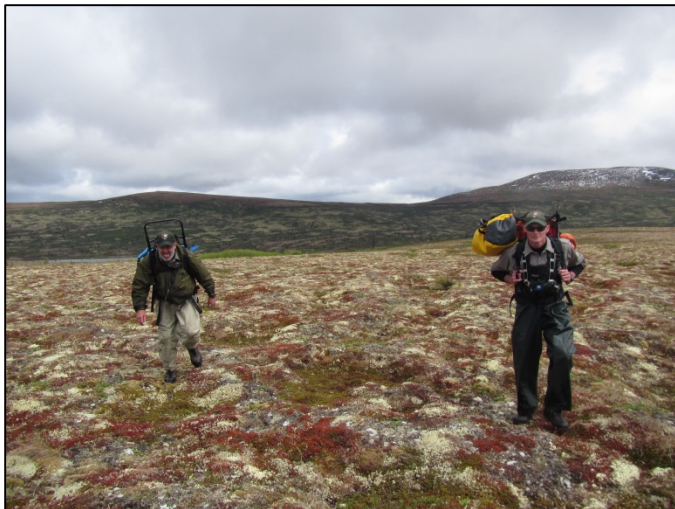
**Figure 9.** Coville RAWS – NPS rangers each carrying 70-pound batteries.

Access to the Coville weather station was by NPS float plane from King Salmon. NPS rangers helped carry two 70-pound batteries to the weather stations (Figure 9). The station was in good condition. The two 100 Ah batteries that power the station were replaced after six years of service. The AT-RH sensor, WS sensor, WD sensor, SR sensor, and rain gauge tipping bucket were replaced. A WD sensor direction test was done. The rain count for the tipping bucket was zeroed, and a tipping bucket test was done. All data in the data logger were downloaded to send to the WRCC in order to update the archive. The SD sensor was replaced with a Campbell Scientific SR50A SD sensor, which was rehabbed with new transducer plates and desiccant. Data logger program COVI\_DLP\_SR50A.prg was edited to zero the SD sensor. Snow depth was zeroed to an average reading of -0.5 inches to account for fluctuation without reporting misleading snow depth readings. All bolts on the station were checked and tightened if loose and all cables were zip-tied. Station observations and GOES transmission quality were checked before departure. Observations and transmissions were verified from the WFMI website and relayed by satellite phone. Before departure the station was photographed from eight directions (every 45°, Figure 10) and the inside of the instrument enclosure (Figure 11) was also photographed. An unused 10 W solar panel remains mounted to the station (Figure 12). This solar panel originally charged a separate battery used for the Campbell Scientific camera described below.

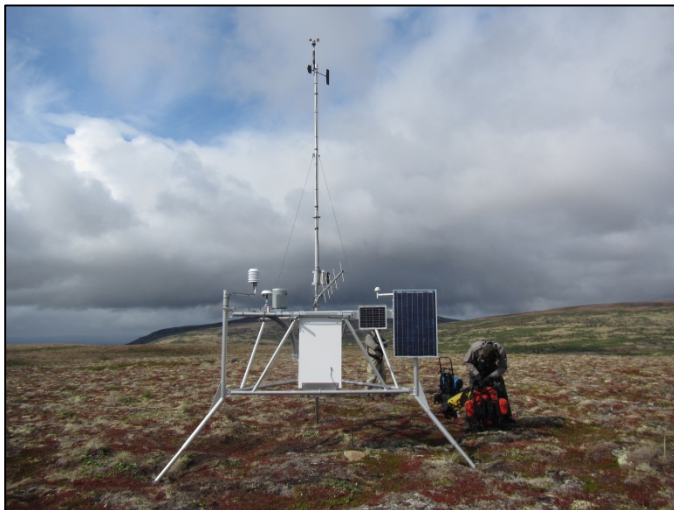
**Figure 12.** Coville RAWS – The small solar panel left of the larger one is not currently in use.

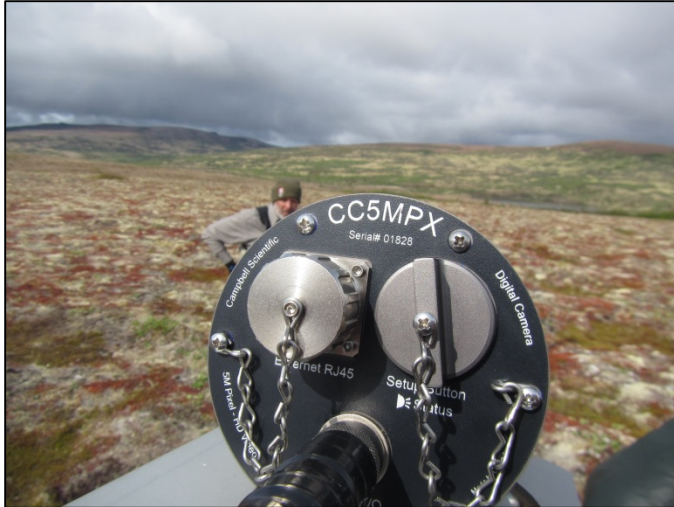
**Figure 13.** Coville RAWS phenocam – The Campbell Scientific time lapse camera was replaced with this updated version of the same equipment.

The existing Campbell Scientific time lapse camera (S/N 01123) was removed for return to Campbell Scientific (RMA# 19871) for a necessary hardware modification to fix the power consumption problem experienced in 2012-13. The camera did operate correctly during 2013-14 after it was powered directly off the weather station batteries (two 100 Ah batteries). The camera collected 13 JPG-format photos/day between June 25, 2013 and June 2, 2014. A new Campbell Scientific time lapse camera (S/N 01828) was installed with updated firmware (version 1.22; Figure 13). New desiccant and an empty 16 GB SD card were installed.

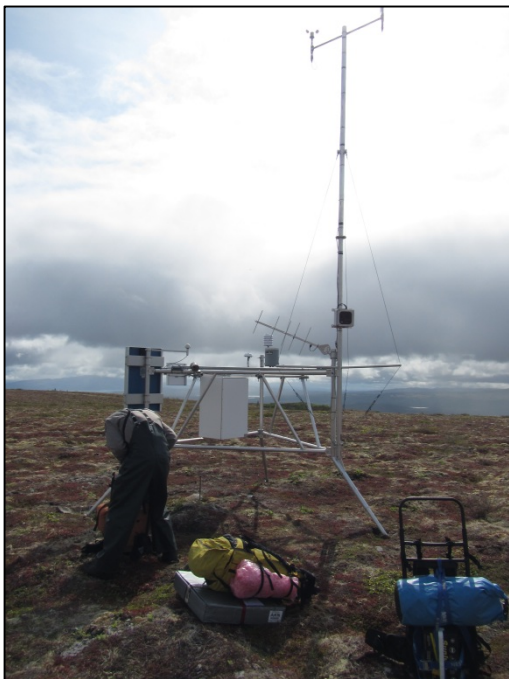
**Figure 14.** Coville RAWS phenocam – The Harbortronics time lapse camera is mounted to the mast.

The Harbortronics time lapse camera was maintained (Figure 14). The 32 GB SD card was exchanged for an empty one and the desiccant packs were replaced. The camera collected four RAW-format photos/day between June 25, 2013 and June 2, 2014. The intervalometer was reprogrammed because the weather station batteries were replaced. The same specifications as before were used. Before departure a thin film of silicone grease was applied to the gasket on the housing door with an irrigation syringe to help maintain a weather-tight seal.

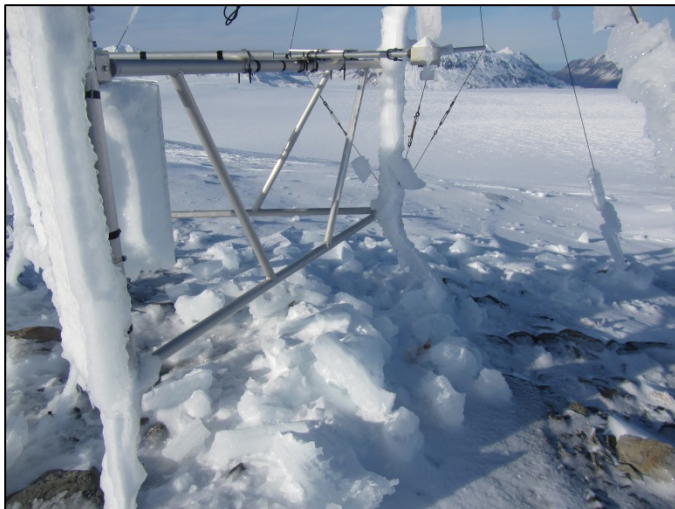
The solar radiation sensor was replaced. It failed on September 1, 2013. This was unscheduled maintenance supported by helicopter availability for glacier monitoring field work. The station was heavily iced (Figures 20 and 21) and the tip had fallen off of the wind direction sensor (Figure 22). Wind direction seemed to be accurate.

**Figure 21.** Harding Icefield RAWS – Ice chunks that had fallen off the station.

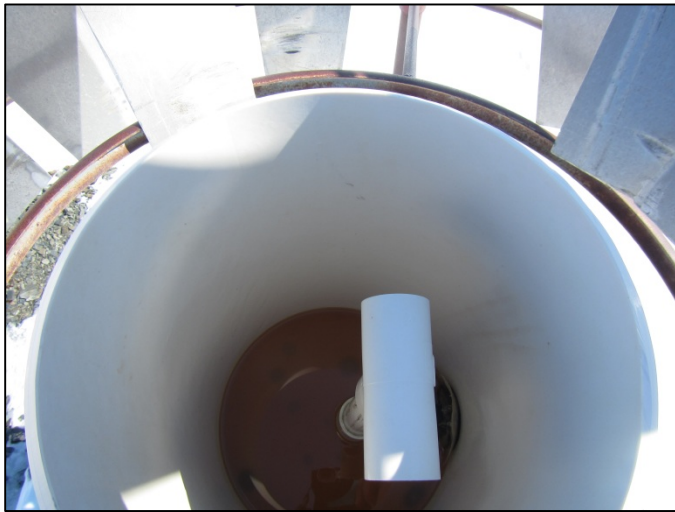
**Figure 26.** Harding Icefield RAWS – View down precipitation gauge. No ice was present.

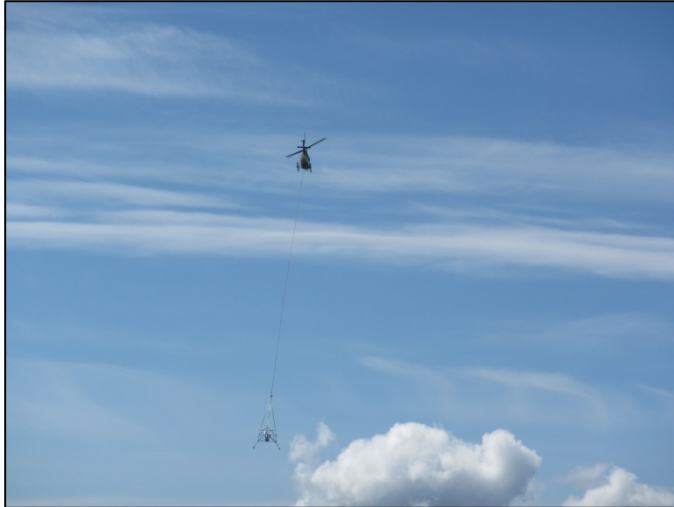
**Figure 31.** Hickerson Lake RAWs – Helicopter sling load of Hickerson Lake weather station frame.

The weather station was disassembled and transported by helicopter sling load to the NPS cabin at Chinitna Bay. All sensors were removed from the station, tow straps were attached to the frame and a 100 ft long line with a remote hook was used to sling the station (Figure 31). No trace of the weather station remains on-site (Figure 32). The weather station components will be stored for future use at the NPS warehouse in Anchorage. Some sensors will need to be replaced before use because they will be out of calibration.

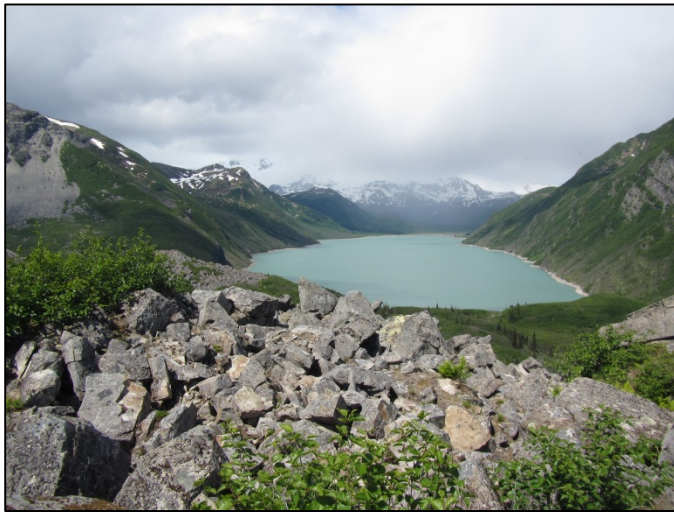
**Figure 32.** Hickerson Lake RAWs – Weather station site after removal.

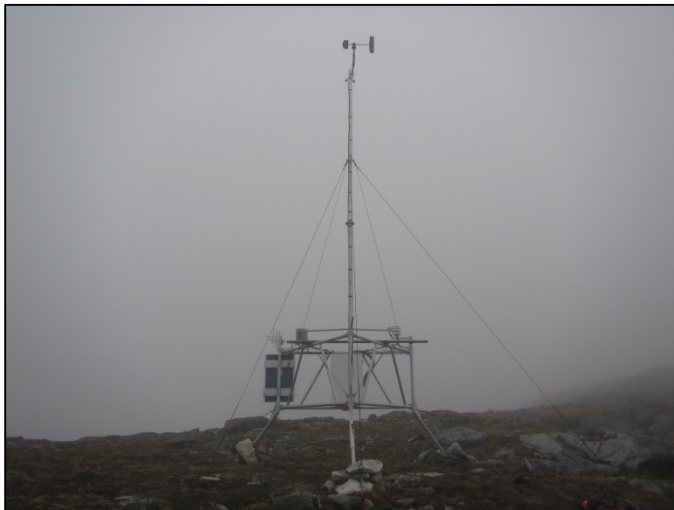
**Figure 38.** McArthur Pass RAWS – Station viewed from north after maintenance.

Low clouds prevented landing the helicopter at the weather station so a landing zone (Figure 36) located about 300 ft below the weather station on the lee (north) side of the ridge was used. Hiking time to the weather station from this helistop was about 20 minutes. During the hike up, an old AT-RH sensor and a different WD sensor fletching were found and recovered. The wind direction sensor was replaced (Figure 37). Deteriorating weather conditions prevented any further maintenance tasks from being completed, but the station looked like it was in good condition (Figure 38).

A round-trip helicopter flight was made from Homer to replace the wind direction sensor, which had failed on June 17 during a storm that had peak wind speeds of 93 mph. The fletching (tail) had fallen off the wind speed sensor, so wind directions for this period are off by 180 degrees.

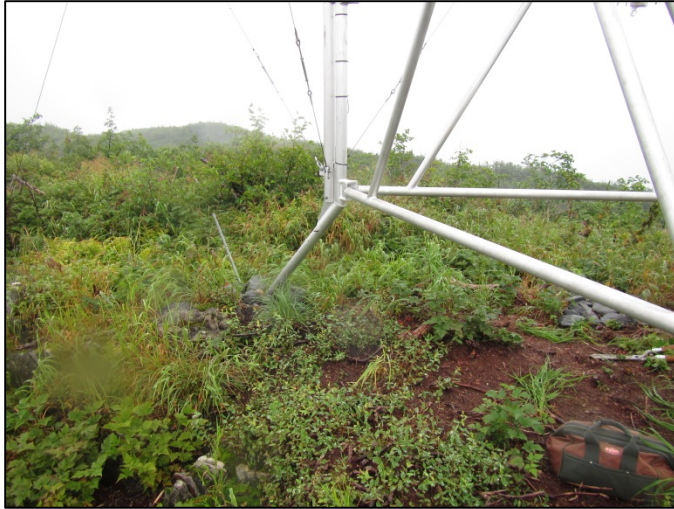
**Figure 40.** Pedersen Lagoon RAWS – Abundant vegetation grows around the weather station each summer. Plant growth is incidentally documented by the snow depth sensor which recorded a growth spurt beginning around June 9.

Access to the Pedersen Lagoon weather station was by M/V Serac (NPS boat from Seward) and foot (from Alaska Wildland Adventure's Kenai Fjords Glacier Lodge). It rained, with almost two inches of precipitation falling on the same day that maintenance was completed. Vegetation beneath and around station had grown significantly (Figure 40) but not as much as in previous years. This vegetation was trimmed using garden shears. The weather station was in good condition. To date, there has been no damage caused by wildlife. This is surprising given the abundance of bear (black bear) sign around the weather station. The AT-RH sensor, WS sensor, WD sensor, SR sensor, and rain gauge tipping bucket were all replaced. A WD sensor direction test was done. The rain count for the tipping bucket was zeroed and a tipping bucket test was done. All data from the data logger were downloaded to send to the WRCC in order to update the data archive. The SD sensor was replaced with a Judd Communications SD sensor that had been rehabbed with a new transducer plate and desiccant. The data logger configuration file PELA\_F6config\_Judd.xml was modified to zero snow depth to an average reading of -0.5 inches to account for fluctuation without reporting misleading snow depth readings. All bolts on the station were checked and tightened if loose and cables were zip-tied. Station observations and GOES transmission quality were checked before departure. Observations and transmissions were verified from the WFMI website and relayed by satellite phone. Before departure, the station was photographed from eight directions (every 45°; Figure 40) and the inside of the instrument enclosure (Figure 42) was also photographed.

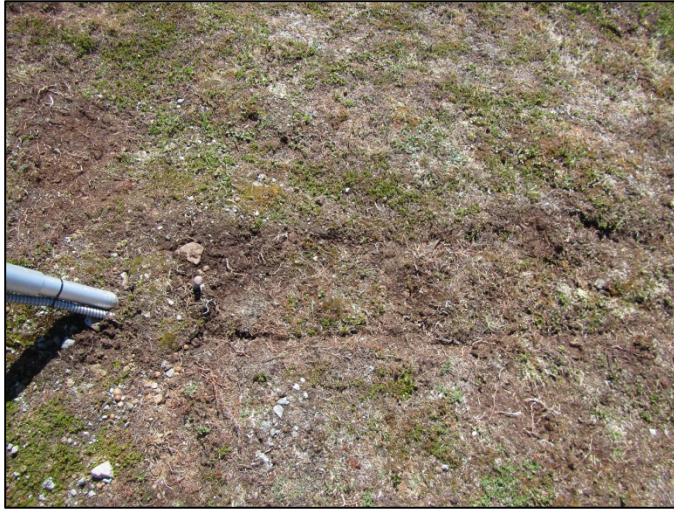
Access to the Pfaff Mine weather station was by NPS wheel plane. The station was in good condition but the soil temperature sensors were acting up. This has been a persistent problem at this station. The first (10 cm) soil temperature sensor stopped working in early March 2014. The AT-RH sensor, WS sensor, WD sensor, and SR sensor were replaced. A wind direction test was done. The rain count was zeroed, and a tipping bucket test was done. The SD sensor was replaced with a Campbell Scientific SR50A SD sensor, which had been rehabbed with new transducer plates and desiccant. Note that this station can only accommodate the SR50A sensor when soil temperature probes are also in use. The dual soil temperature probes were replaced at the same location and depth of 10 and 50 cm (Figure 43). The SDI-AM module was also replaced (Figure 44) in case it was the cause of the failed soil temperature sensor. Both 100 Ah batteries were replaced. Data logger program PFMI\_DLP\_SR50A\_SoilTemp.prg was edited to zero snow depth and operate the soil temperature sensors (transmitted element No. 17 corresponds to Temp1 in the data logger program and this is the soil temperature at 10 cm depth. Transmitted element No. 18 corresponds to Temp2 in the data logger program and this is the soil temperature at 50 cm depth). SD was zeroed to an average reading of -0.5 inches to account for fluctuation without reporting misleading snow depth readings. All data were downloaded to send to the WRCC in order to update the archive. A large rock was placed in the rain gauge tipping bucket in order to mitigate excessive tipping that occurs during strong wind events (Figure 45). This has now been done for the last three years. Station observations and GOES transmission quality were checked before departure. Observations and transmissions were verified from the WFMI website and relayed by satellite phone. All bolts on the station were checked and tightened if loose and cables were zip-tied. Before departure the station was photographed from eight directions (every 45°, Figure 46) and the inside of the instrument enclosure (Figure 47) was also photographed.

**Figure 43.** Pfaff Mine RAWs – Soil temperature probes are located 1 m from the base of the SW corner of the weather station at 10 and 50 cm depth.

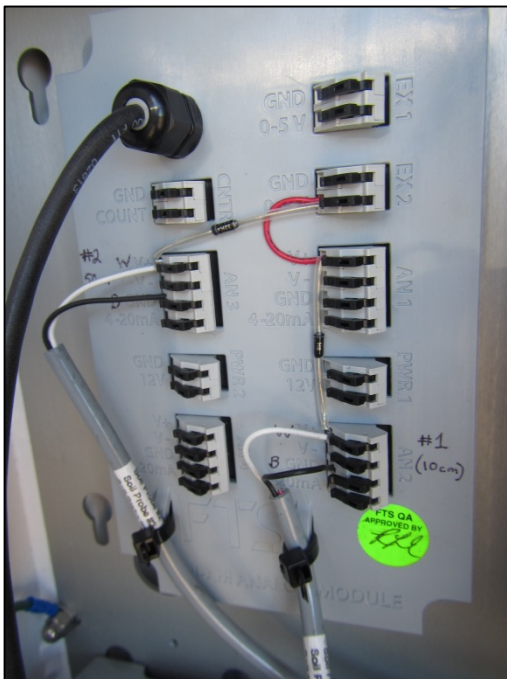
**Figure 44.** Pfaff Mine RAWs – Wiring configuration used on the replacement analog/digital convertor that accommodates dual soil temperature sensors through SDI.

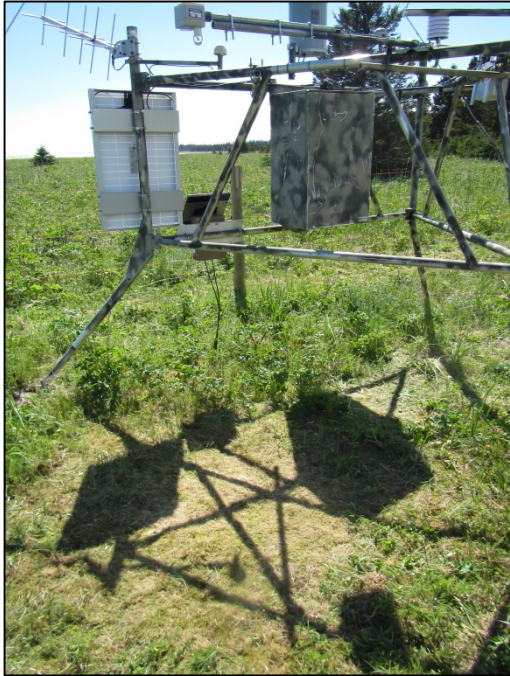
**Figure 51.** Silver Salmon Lakes RAWS – Judd snow depth sensor and snow depth target cleared of vegetation.

The station was in great condition. Vegetation beneath and around the station had grown significantly (Figure 50). This vegetation was trimmed using a hand-held weed whip and by hand pulling. The electric fence was operational and in good condition. The AT-RH sensor was replaced. The rain count was zeroed, and a tipping bucket test was done. The SD sensor was replaced with a Judd Communications SD sensor (Figure 51), which was rehabbed with new transducer plates and desiccant. Snow depth was zeroed to an average reading of -0.5 inches to account for fluctuation without reporting misleading snow depth readings. All data in the data logger were downloaded to send to the WRCC in order to update the archive. All bolts on the station were checked and tightened if loose and all cables were zip-tied. Station observations and GOES transmission quality were checked before departure. Observations and transmissions were verified from the WFMI website and relayed by satellite phone. Before departure the station was photographed from eight directions (every 45°, Figure 52) and the inside of the instrument enclosure (Figure 53) was also photographed.
