## Hydrogeologic Assessment of the water-supply well at Kamloops Island Campground Lake Roosevelt National Recreation Area

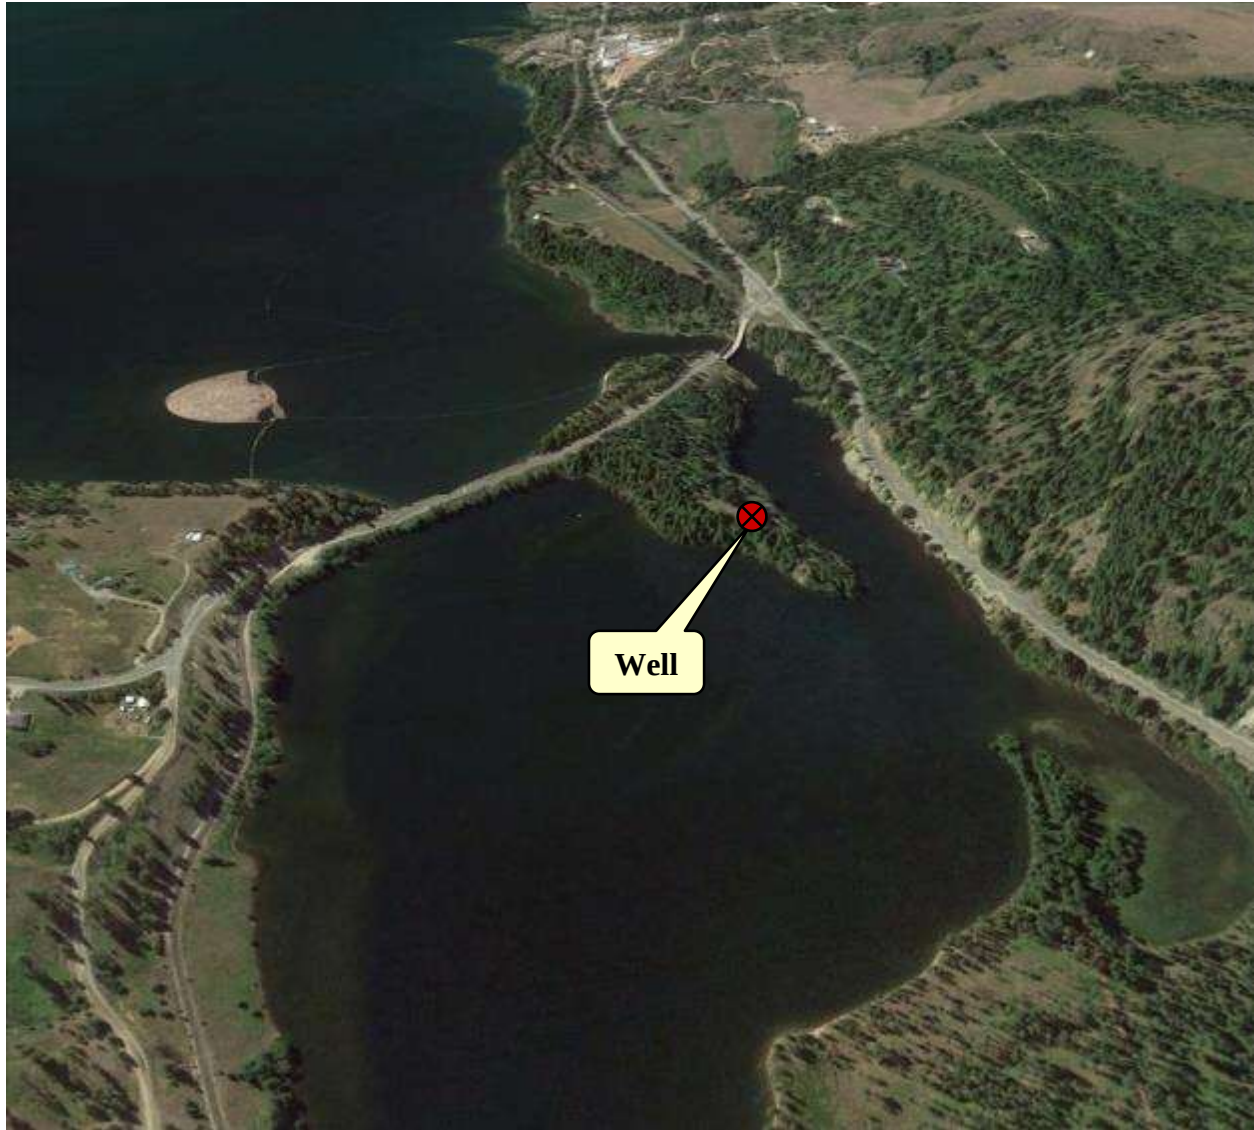
Figure 3. Google Earth view of the Kamloops Island area. View is to the south.

Kamloops Island Campground is located at the mouth of the Kettle River arm of Lake Roosevelt. It is 7 miles north of Kettle Falls (Figure 1). The campground has 17 sites and is open all year long, but the water system is only available seasonally from June to September. The campground does not have flush toilets. The only source of water is from the hand pump on the well. Water from the well is piped through an iodine treatment system into an underground tank to provide some contact time. Water from the tank is piped back to the discharge spout of the hand pump. It is about 110 feet from the well to the normal full-pool shoreline (Figures 2 and 3).

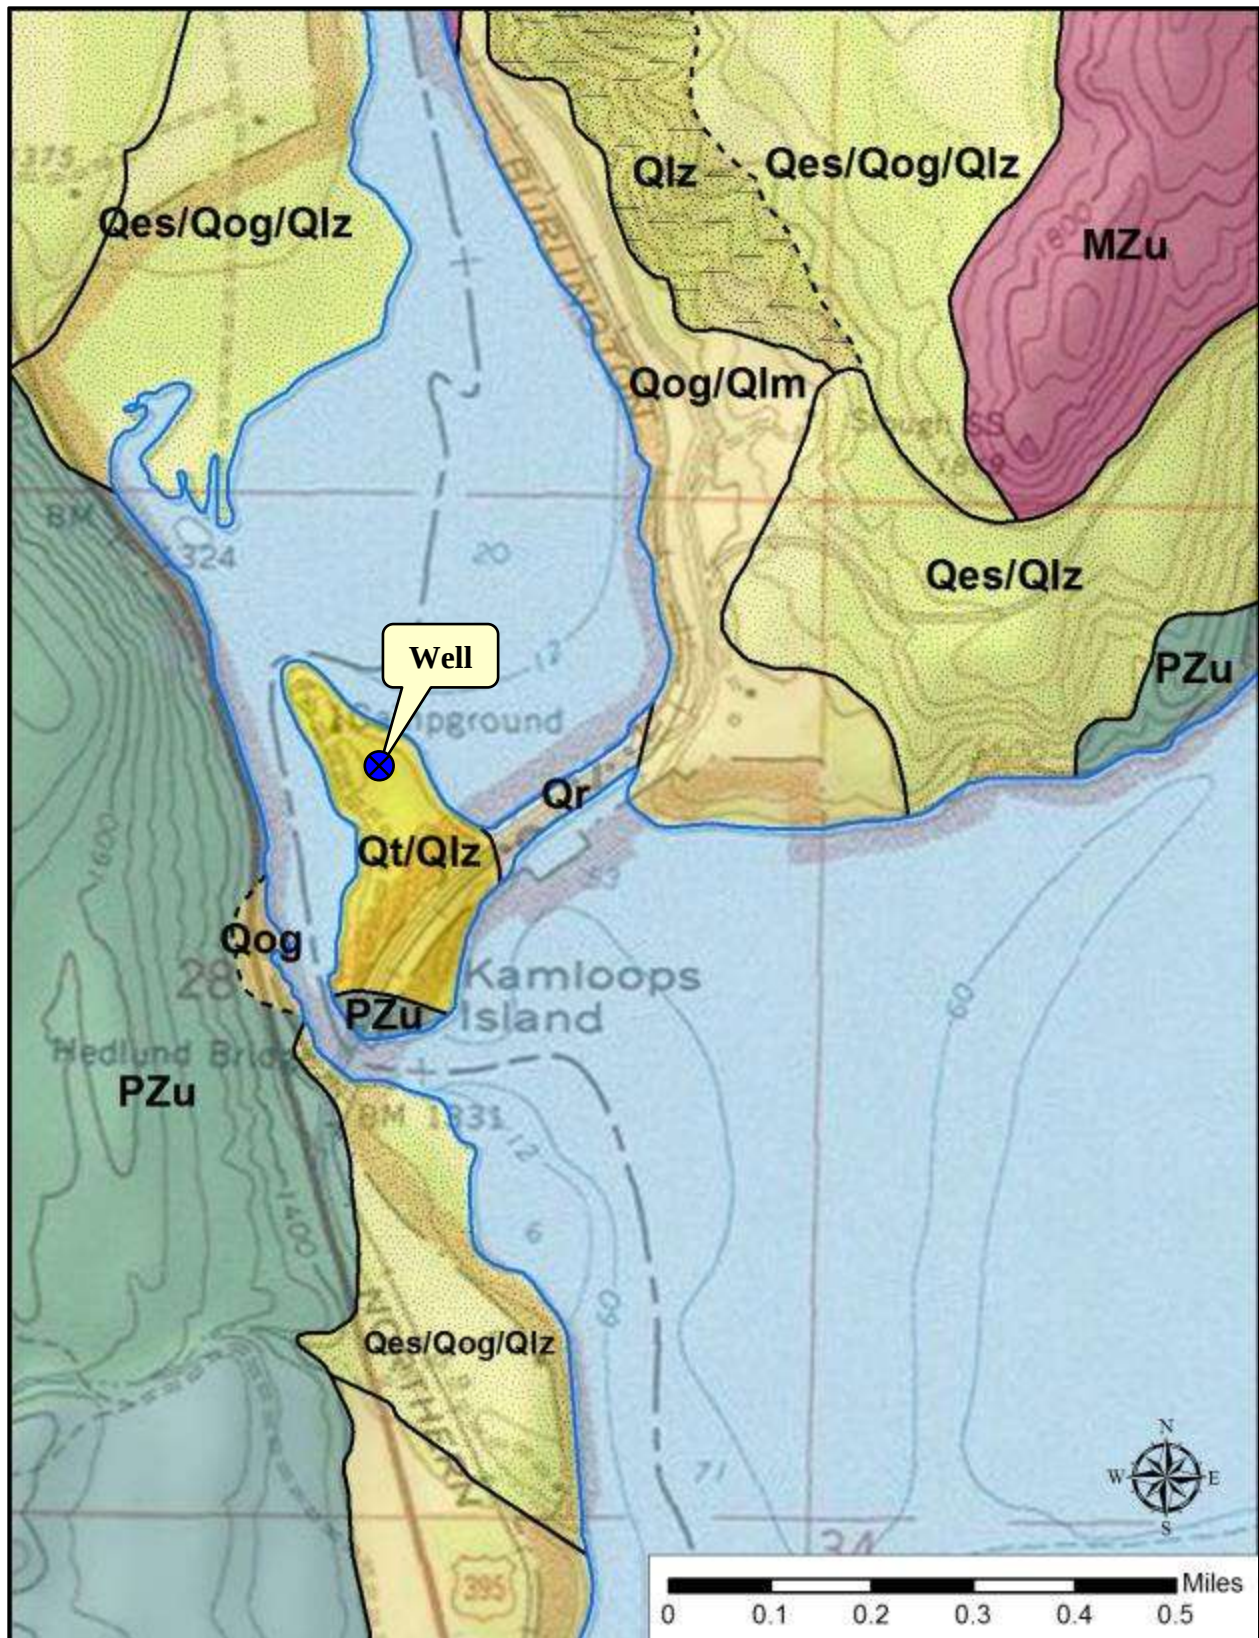
Bedrock is exposed along the west and southwest shore of Kamloops Island. It is overlain by sand and gravel outwash deposits interbedded with glacial-lake clay.

Figure 4. Surficial geology in the vicinity of Kamloops Island campground,  
From NPS Geologic Resources Inventory Program. (2009).
