# Las Conchas Post-Fire Response Plan

Bandelier National Monument

AUGUST 2, 2011

**PREPARED BY:** National Park Service Las Conchas BAER Team

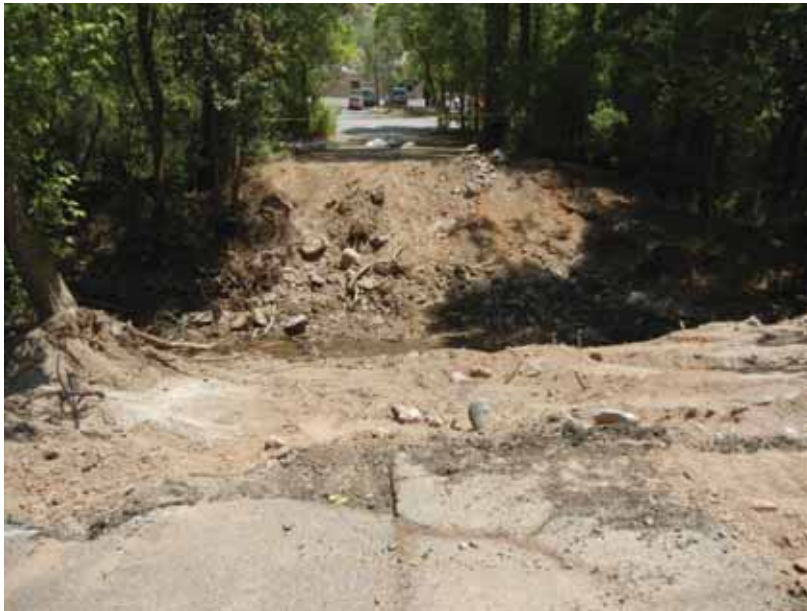
**Site of removed motor car bridge.**

An emergency consultation was initiated with the New Mexico State Historic Preservation Officer on July 3, 2011 requesting concurrence with a proposal to demolish the crossing structures. Concurrence with that proposal was received on July 4, 2011. Within the following week, seven (7) pedestrian bridges and one motor car bridge were demolished (two by park staff and five by a contractor.) Additionally, floatable debris within the Rito de Frijoles vicinity, consisting primarily of dead and down woody material, were removed. Down mature trees in the channel adjacent to the parking lot and a woody debris dam near the streamflow gaging station are still in place and should be removed. Concrete and other deconstruction debris should also be removed from near the channel. With these preparations, agency managers acted to assure that free flows within the creek were restored and flash flood events were unlikely to exceed the highest levels identified in the Delineation of Floodplains memo, and that the exposure of the archeological sites in the canyon to flood damage was at a low level.

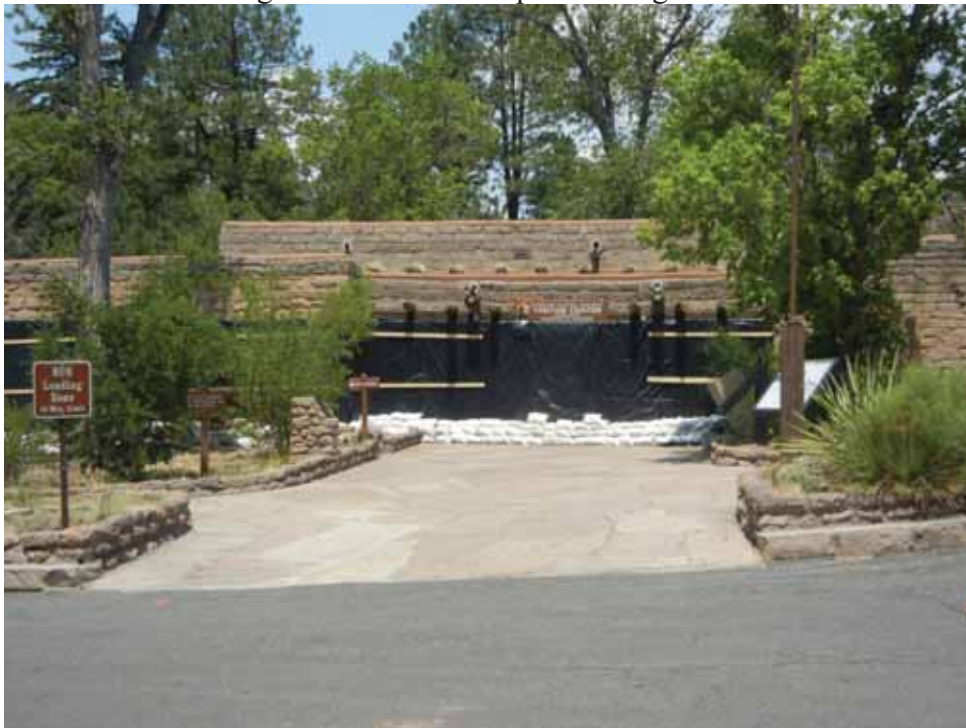
**Plywood, plastic sheeting, and sandbags protecting Visitor Center.**

Agency managers then turned their attention to point protection of structures at risk from flash floods at the anticipated level of 3,000 to 4,000 cfs. These structures consist of both modern and historic portions of the Visitor Center, the sewer lift station, and other infrastructure such as valve boxes and manhole openings. Following removal of museum objects from the Visitor Center, the building was protected by a plywood/sheet plastic/sandbag protection layer. The lower lying areas along the Rito de Frijoles were armored with diversion structures consisting of “K” rail and sandbag assemblies in two parallel alignments.

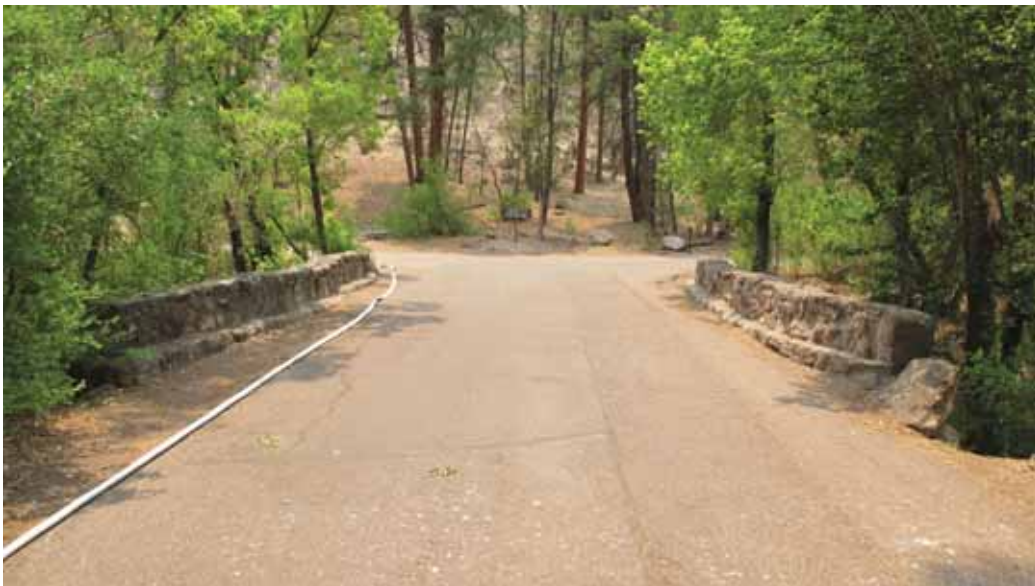
View 2 – Motor car bridge as viewed from the roadbed, crossing Rito de Frijoles.

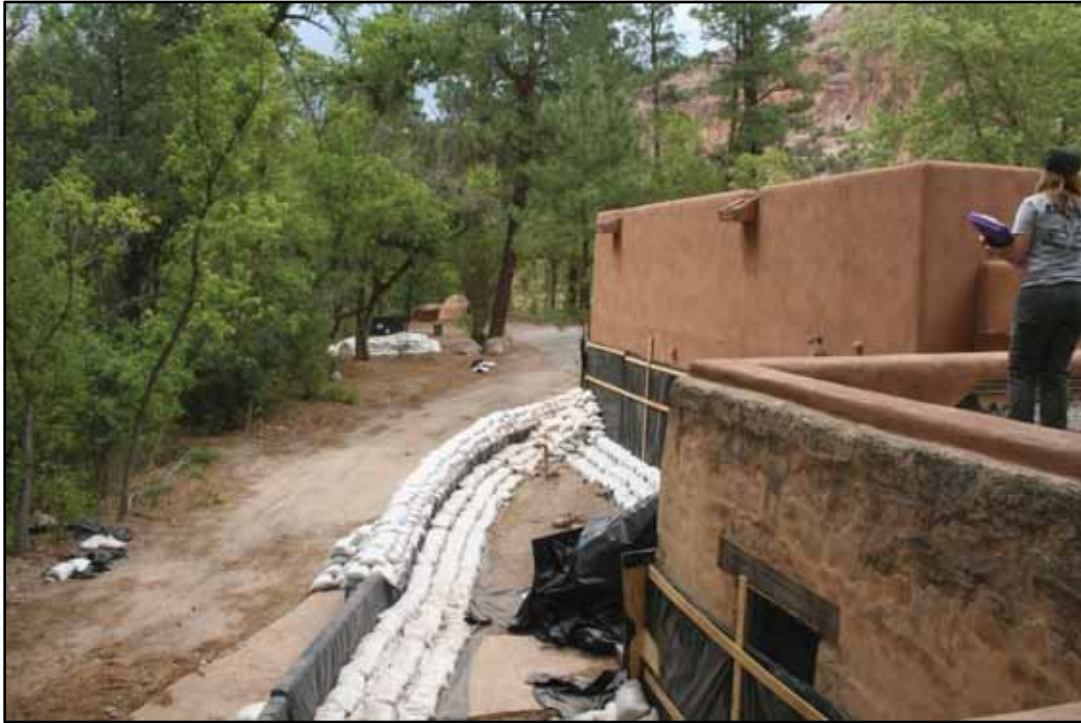
Figure 1. Looking Northwest showing sandbagging and armoring.

After each flood event a comprehensive inspection of the structure should be conducted. Any areas where the new addition is attached to the historic structures should be inspected, looking for any signs of separation indicating the new addition is moving, which may affect the stability of the historic structures. Any separation greater than ¼ inch visible on the surface may indicate that the new addition is beginning to separate from and damage the original historic structure it is attached to. At that point a determination needs to be made whether to try to repair or sever the connections. Foundations and lower wall areas need to be inspected for erosion and degradation as well.

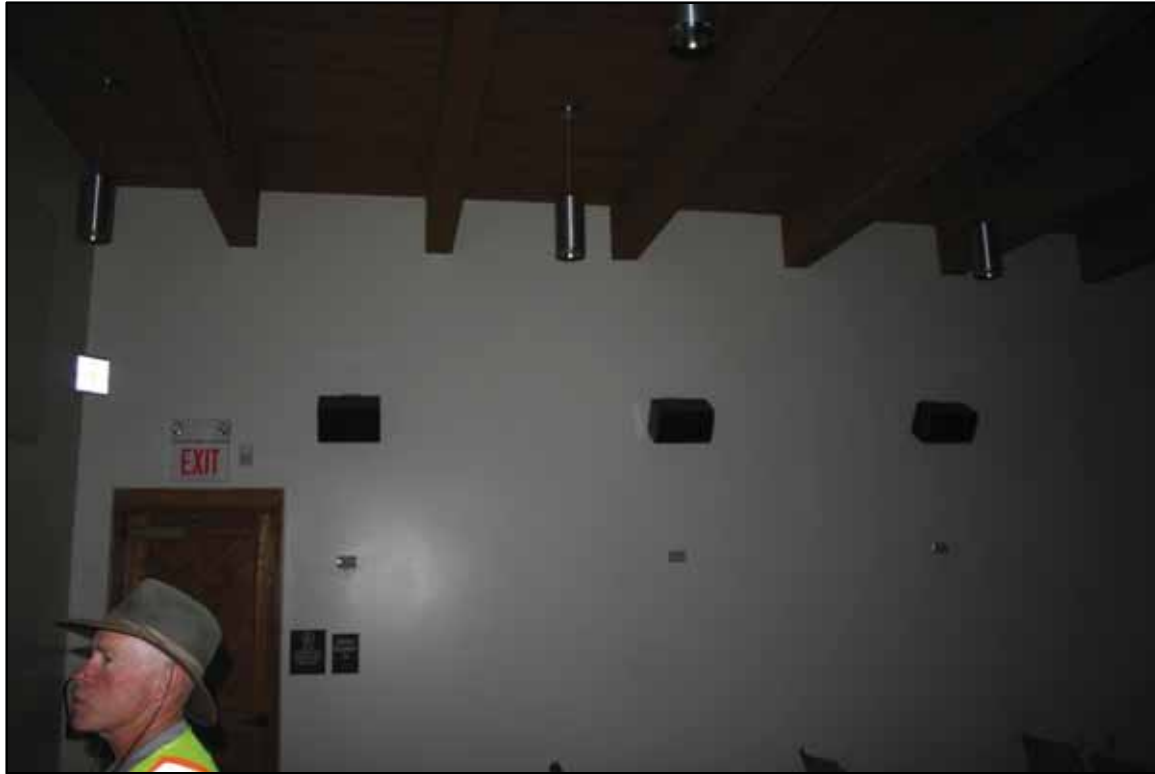
Figure 10. Southeast end of southwest wall of theater addition.

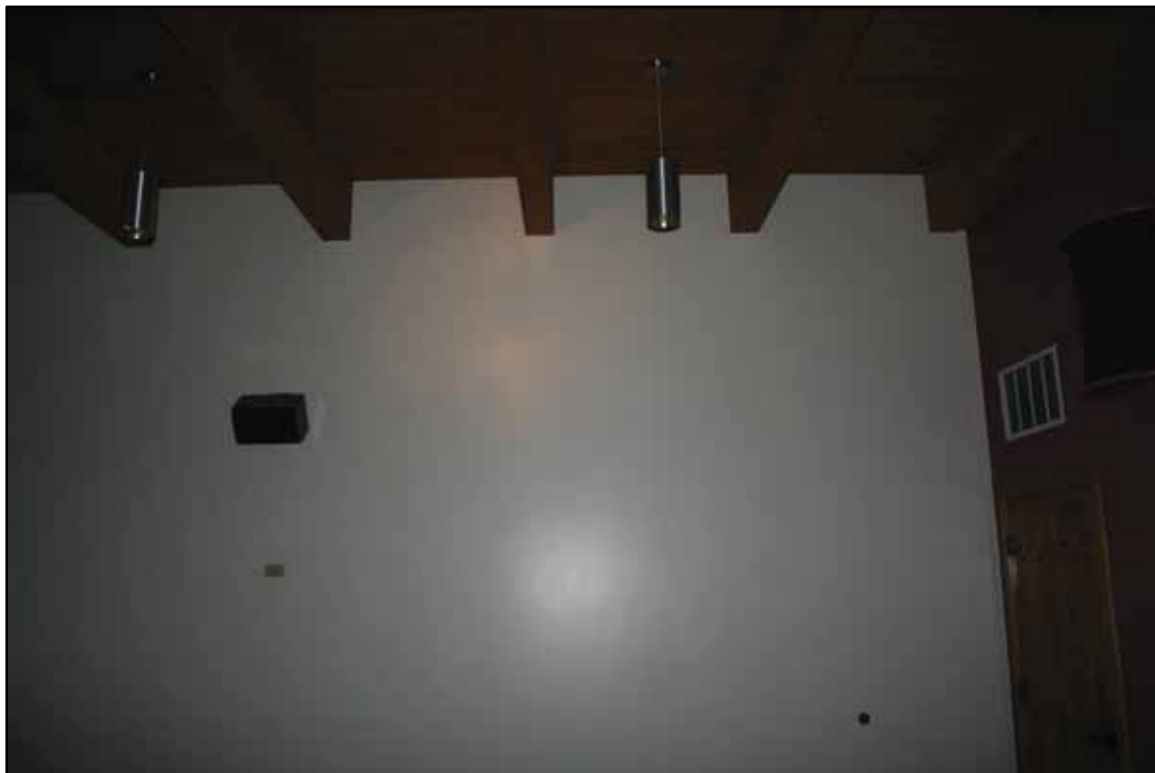
Figure 11. Northwest end of southwest wall of theater addition.

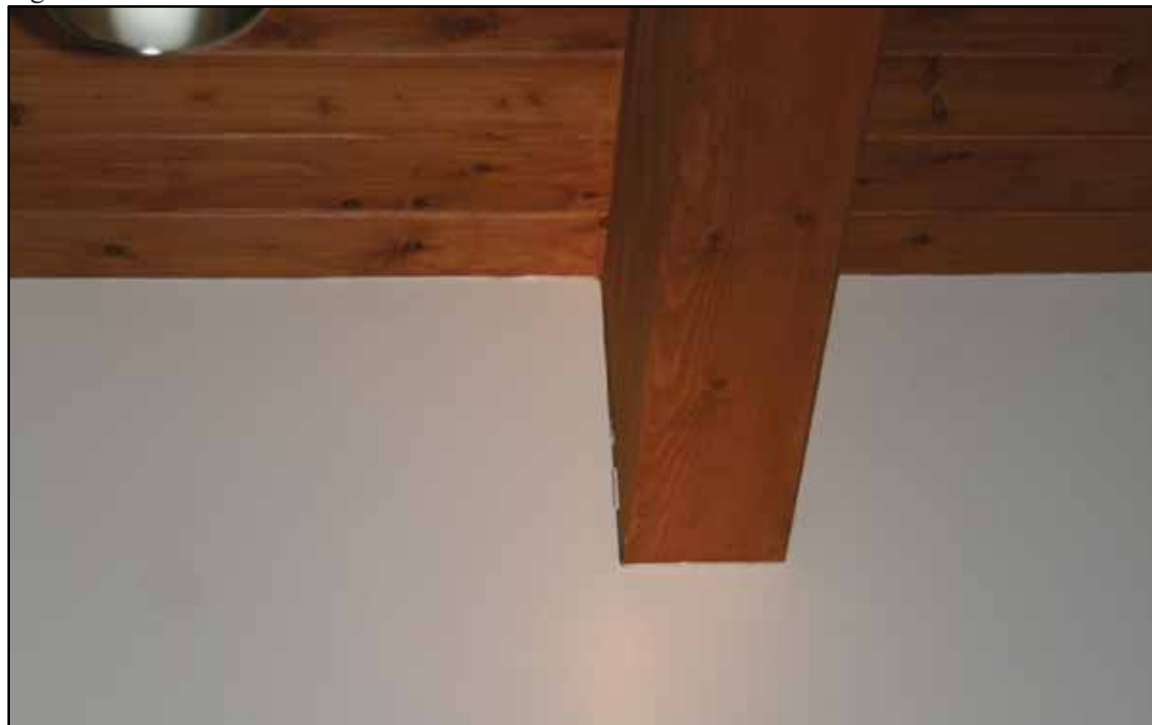
Figure 12. Closeup of wall and the beam closets to the southeast end of the southwest wall of the theater addition.

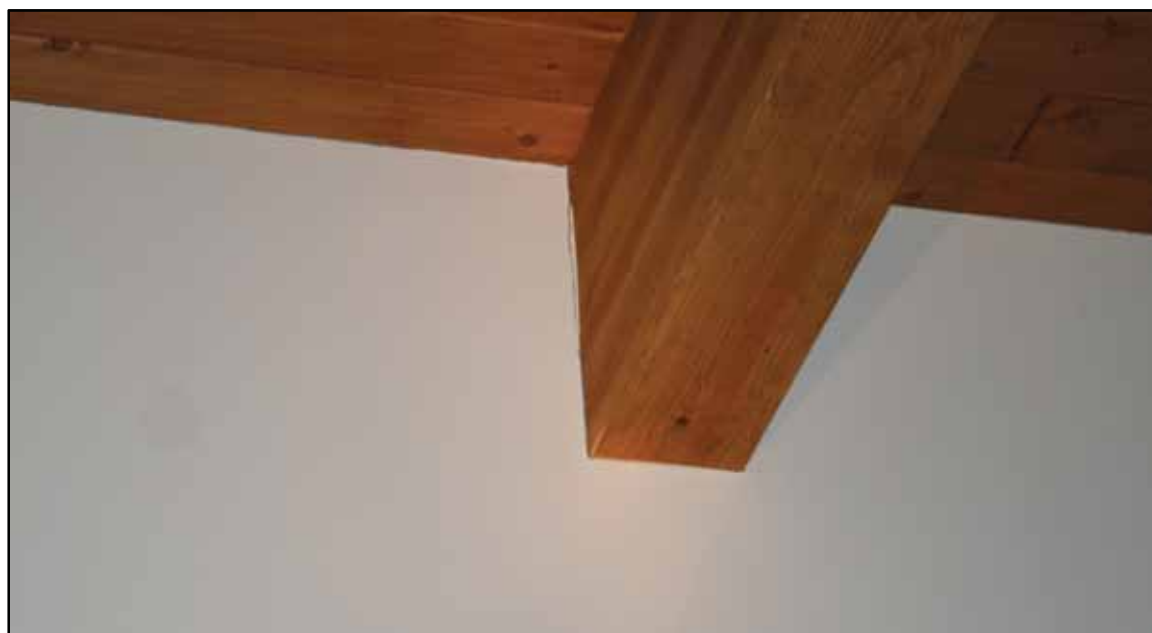
Figure 13. Closeup of wall and the 2<sup>nd</sup> beam from the southeast end of the southwest wall of the theater addition.
