# **Elkmont Historic District**

## **Great Smoky Mountains National Park**

## **Finishes Analysis Report**

March 31, 2016

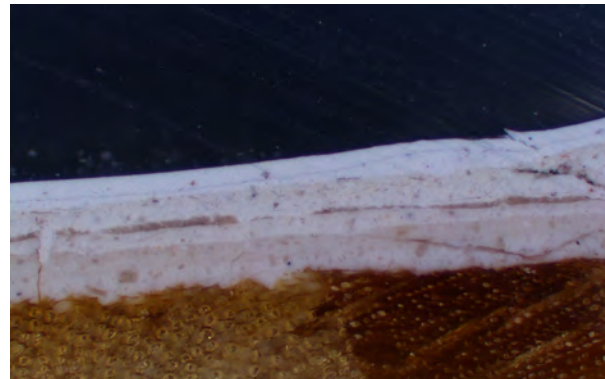
Figure 5: Sample ELK.1.2, 40x magnification, visible light (above) and UV light (below). All of the layers of this door surround are white.

The samples removed from the door surround and windowsill are similar when viewed in cross-section. Both contain approximately five campaigns of whites. While the wood surfaces appear slightly uneven, it is not clearly stripped or worn (fig. 5).

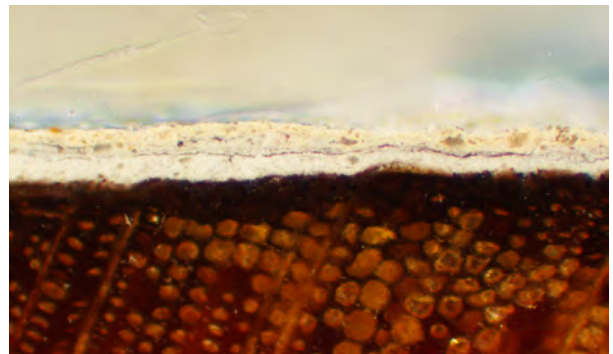
The sample removed from the front door (ELK.3.1) contains several layers of white/off white. The paint layers appear separated from the wood substrate (fig. 10), and there may be an

Figure 10: Sample ELK.3.1, 40x magnification, visible light (above), UV light (below). The paint has separated from the wood at some locations (black arrows), but it appears as if the first layer may be a brown followed by several layers of off-white.

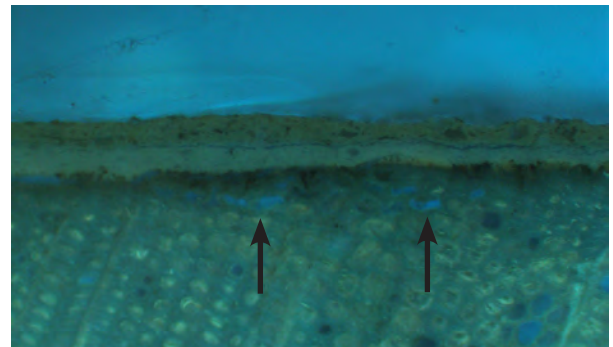
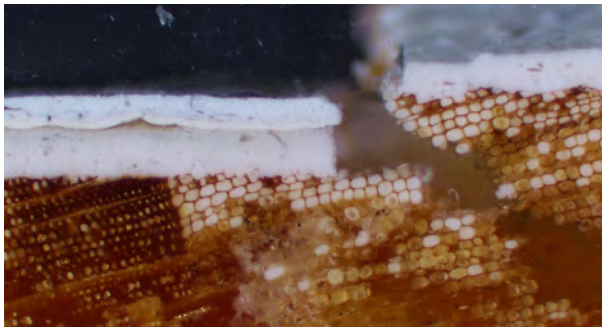
**Figure 11:** Sample ELK.3.5, 40x magnification (above) and ELK.3.6, 100x magnification (below). The paint history of these two samples is similar, although ELK.3.6 has more recent paint layers.

Samples ELK.3.5 and 3.6 contain similar paint histories (fig. 11). The earliest layer on both is a somewhat translucent white and the next layer is an opaque off-white. Sample ELK.3.6 contains more paint layers overall, but all are white.

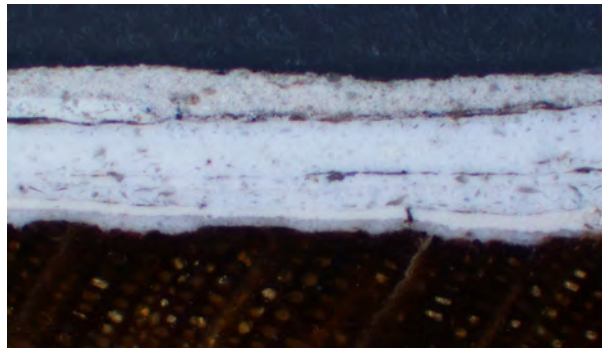
**Figure 12:** Sample ELK.3.4, 40x magnification, visible light (above) and UV light (below). The surface of this sample is rough and darkened. The green paints do not auto-fluoresce.

The substrate of sample 3.4, removed from the siding, is highly rough and discolored at the surface (fig. 12). The first layer is a damaged layer of olive green paint followed by a lighter green. The unevenness and discoloration of the wood substrate suggests that it was exposed for a period of time.

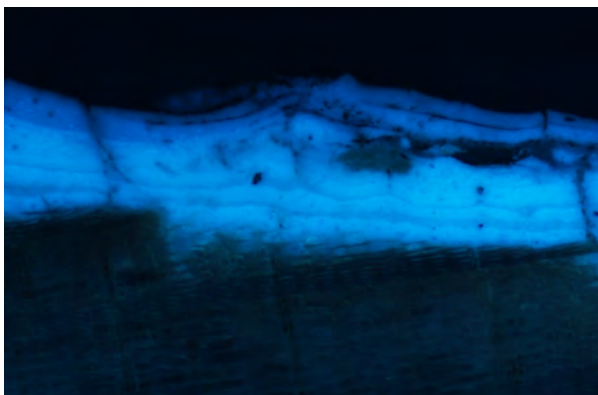
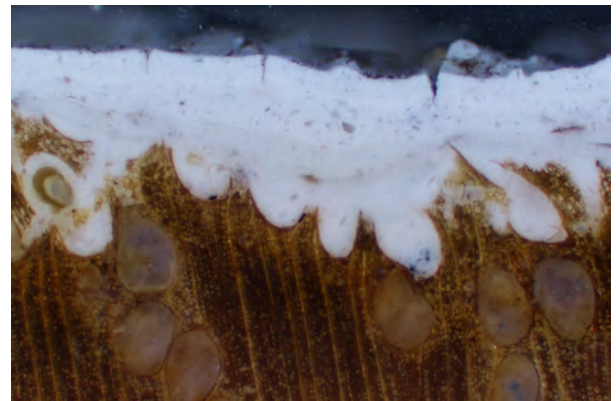
**Figure 15:** Sample ELK.5.4, 40x magnification, visible light (above) and UV light (below). The wood of this sample is different than the other samples.

combined with a small number of paint layers, may suggest lost earlier paint finishes. The substrate of sample 5.4 is a hardwood, while the other samples are softwoods (fig. 15). According to the HSR, this wall was added in the 1970s when the rear porch was extended so it is possible a different type of wood was used. However, it appears as if the white paint scheme was maintained.

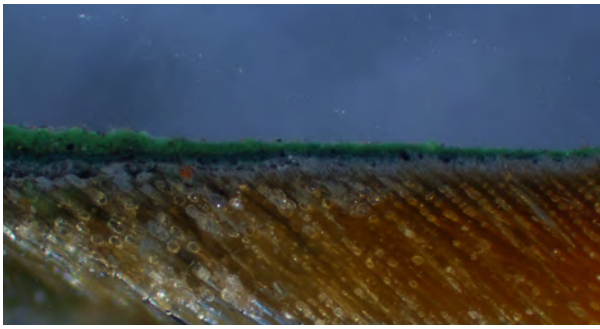
**Figure 16:** Sample ELK.5.5, 40x magnification, visible light (above) and UV light (below). Early layers are gray-green, later layers dark green.

Sample ELK.5.5 is the only sample from the Addicks cabin to contain a green paint. The sample contains three layers overall, the first a grayish blue-green, second a dark blue-green and the current a dark green (fig. 16).

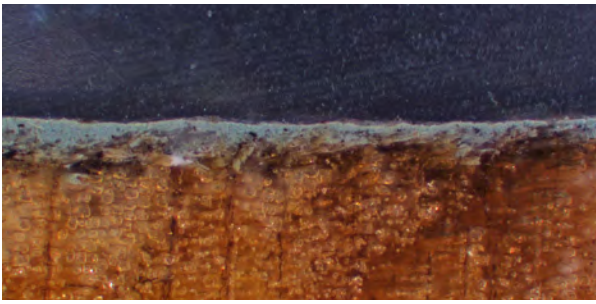
**Figure 18:** Sample ELK.6.3, 40x magnification, visible light (above) and UV light (below).

All samples contain somewhat rough wood surfaces, and three of the four contain highly soiled or discolored surfaces. All contain blue-green or green paint finishes; however, the greens appear slightly different from one another. The window sash (ELK.6.3) contains one or two thin layers of a grayish green on a rough or stripped surface (fig. 18). Samples ELK.6.1 and 6.4 both contain a brighter blue-green on a rough and discolored surface. Sample ELK.6.5 contains a green on a highly rough and discolored surface (fig. 19). It is possible that the three different paints were applied at different times and were meant to imitate each other but are slightly different. The window sash may have been stripped, as historic images of the Creekmore Cabin show the window sash as white, while no white paint was found in the cross-section (fig. 20). In addition, while it is difficult to tell if the siding is stained, unpainted or just worn in the historic photographs, it does not appear as if there is an opaque paint finish on the siding.

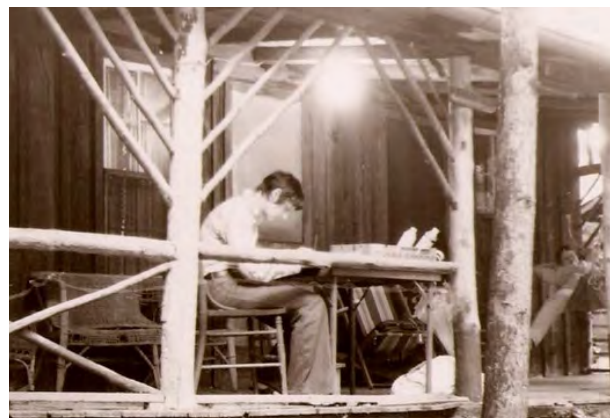
**Figure 20:** Creekmore Cabin, 1967. Note that the window sash and front door are white. The siding and window and door surrounds are dark, although it is not clear if they are painted or unpainted. (Joseph K. Oppermann—Architect, P.A., Creekmore Cabin HSR).

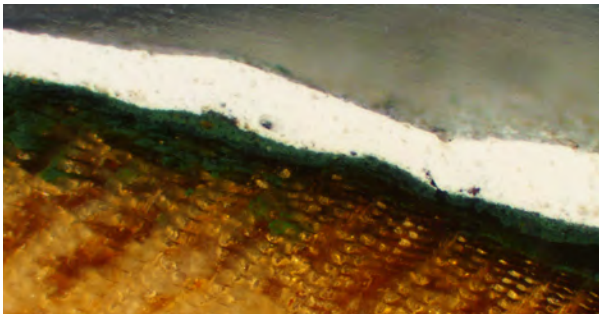
**Figure 25:** Sample ELK.7B.3, 40x magnification, visible light (above) and UV light (below). The earliest color is green, followed by the current white.

west (front) elevation (ELK.7B.1); the front door (ELK.7B.2); the board and batten siding on the east (rear) elevation (ELK.7B.4); and a window surround on the west elevation (ELK.7B.3). Sample ELK.7B.1, 7B.2, and 7B.4 all contain only white paint (image 25). The earliest existing paint layers on all three is an off-white, although only traces of it exist in ELK.7B.4, and the layer is damaged in ELK.7B.1 and 7B.2. It is possible that the siding of this cabin was originally white, as the wood surfaces do not appear as rough and darkened as in other samples, similar to the Mayo Cabin. The window surround, however, contains an early dark green paint. The surface of the wood appears slightly worn and the paint is soaked into the wood, but there is no evidence of an early white paint as was found on the siding and door. Given the evidence visible in cross-section, it seems like the Mayo Servants' Quarters was painted in the same colors as the main Mayo Cabin.

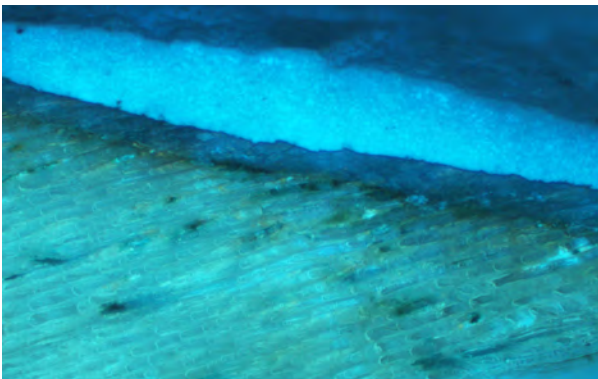
**Figure 28:** Sample ELK.8.5, 40x magnification, visible light (above) and UV light (below). The brown layer (arrow) is autofluorescent and may represent a resinous finish.

The front door contains evidence of several paint colors (fig. 28). The first color is a green, but it is only seen in traces in the pores of the wood, so it is unclear if it is an intentional paint layer. Following the green is a brown that is very thin and damaged. The layer may be a resinous finish as it is autofluorescent. After the brown is a red, also thin, followed by the current sea foam green, also thin. The surface of the wood appears somewhat worn but is not discolored.

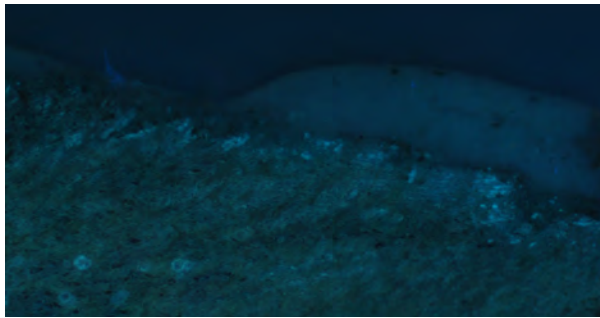
The two samples removed from the southwest addition both contain wood that is not as worn and discolored as the samples removed from the east elevation, nor is the early green paint soaked in a deeply (fig. 29). However, the green is thin and uneven, particularly on the siding. In addition,

**Figure 29:** Sample ELK.8.7, 40x magnification, visible light (above) and UV light (below). The worn wood surface contains evidence of a green paint.

the substrate of the siding looks more like a stripped wood surface than is found on the other elements—the wood surface is feathered, without a distinct edge. The green on the siding appears different in cross-section than the current green paint on the east elevation, and is similar to the earlier paint. This could suggest that it was applied concurrent with or within the same era as the early green paint on the east elevation. The siding from the southwest addition also contains a later white, which appears similar to the later white applied to the window elements on the east elevation.

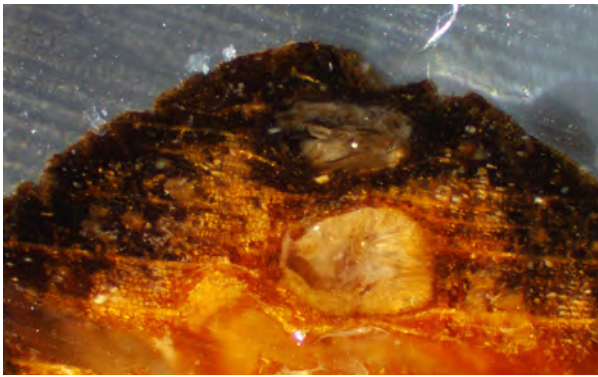
**Figure 31:** Sample ELK.9.1, 40x magnification, visible light (above) and UV light (below).

The three samples from the siding all contain one layer of red-brown paint. The wood surfaces of all three samples are worn and rough, and sample ELK.9.1 is particularly darkened (fig. 31). It is possible that the woods of these three samples are not the same as some two appear to be hardwoods and one appears to be a softwood, suggesting different dates of installation.

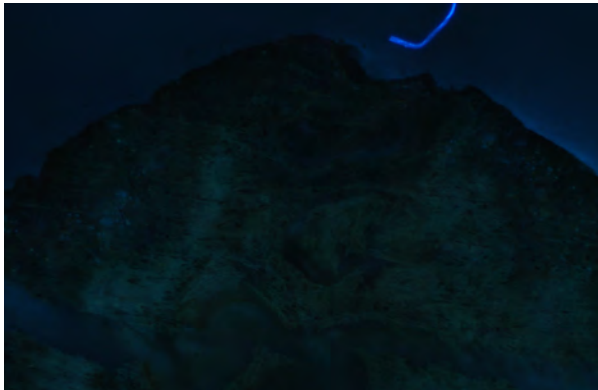
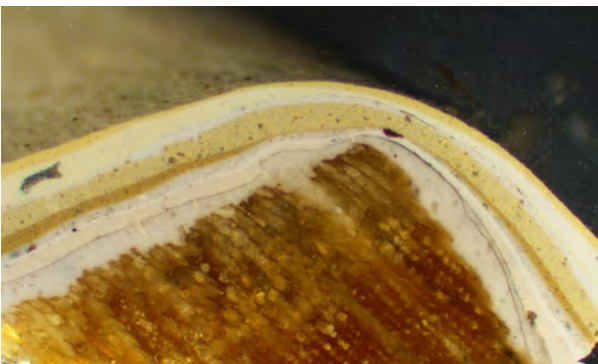
**Figure 32:** Sample ELK.9.7, 40x magnification, visible light (above) and UV light (below). The earliest layer is white and later layers yellows.

The sample from the front door surround (ELK.9.7) contains ten layers of paint—more layers than in typically found on most of the cabins (fig. 32). However, the wood substrate also appears somewhat uneven, suggesting exposure or possibly stripping. The earliest existing paint layer is a white with a soiled surface, followed by a partial layer of a similar white. The next layer is a cream. Following the cream is a very thin white and a thicker off-white. After this, the colors turn to yellow, including a yellow-tan, yellow, light yellow, and current yellow. The sample from the front door, in contrast, only contains four to five layers. These layers appear similar in cross-section to the last five layers of the surround. The substrate of ELK.9.6 does not appear particularly worn, although the surface is somewhat darkened, possibly soiled.

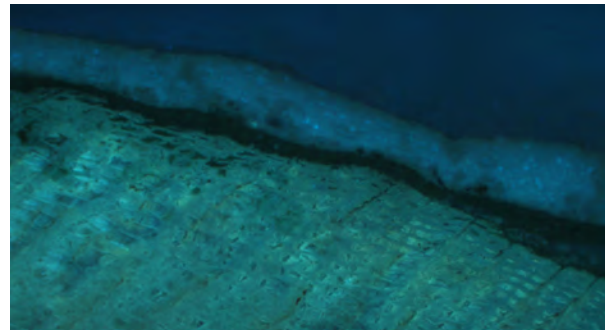
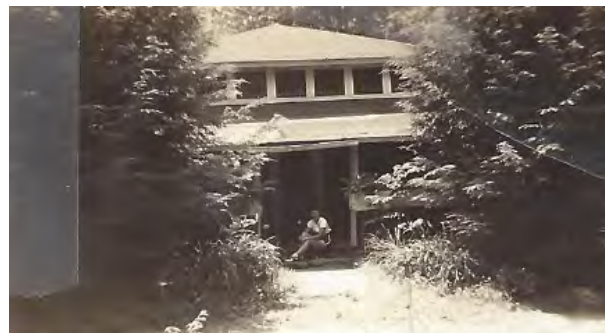
Both samples exhibit a worn wood surface and disturbed early paint layer. Sample ELK.10.1 shows a darkened and uneven wood surface typical of many board and batten siding samples, with dark green paint seeped into the wood (fig. 34). The layer is thin and damaged. Sample ELK.10.2 contains traces of a dark green paint, some of it encapsulated within the later white paint layers. Again, the surface is worn or stripped, but not as darkened as sample ELK.10.1.

**Figure 34:** Sample ELK.10.1, 40x magnification, visible light (above) and UV light (below). The sample has an uneven and darkened surface with a dark blue-green paint.

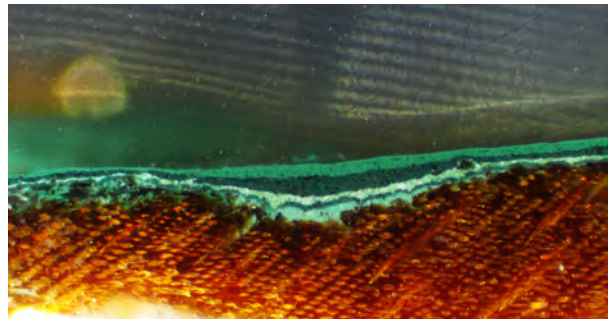
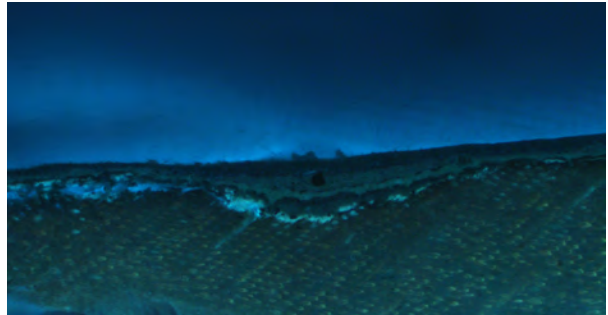
**Figure 39:** Sample ELK.11.4, 40x magnification, visible light (above) and UV light (below). The wood is uneven.

The screen door (ELK 11.4) contains several paint layers, mostly green (fig. 39). The surface of the wood is somewhat worn, possibly stripped. There may be a partial early brown paint or resinous layer on the surface, but is unclear in cross section—the surface of the sample appears to auto-fluoresce but it may be that the paint is separating from the substrate. Following the possible brown is a light green and a worn dark green. A thin white is on top of the dark green, and then two other greens.

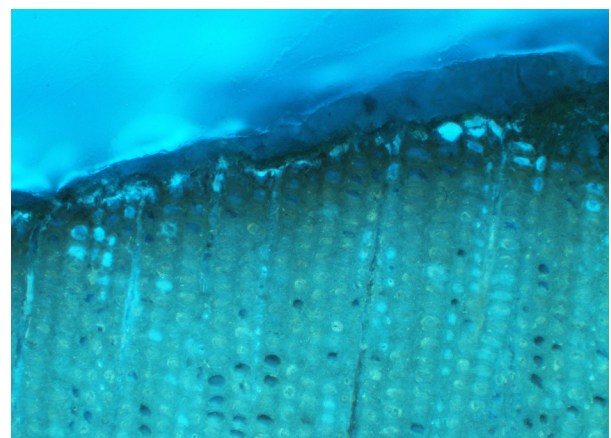
**Figure 42:** Sample 13.5, 40x, magnification, visible light (above) and UV light (below). The surface of the wood appears uneven.

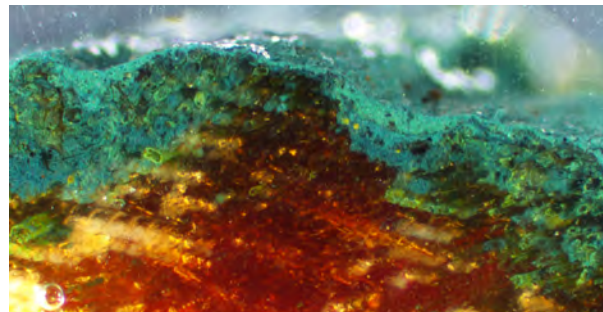
The sample removed from the siding contains what appears to be two green-blue paints on a darkened and partially weathered surface. The first is a green paint is seeped into the wood surface at a damaged area, with a thin layer of blue green on top. The blue-green paint appears more like a continuous thin coating where the wood is not damaged (fig. 42). This sample was removed from a protected location at the top of the wall under the porch roof, and it doesn't appear as rough as some other samples.

**Figure 44:** Sample ELK.15.1 (above) and 15.2 (below). 15.1 contains several different greens, while 15.2 contains one green.

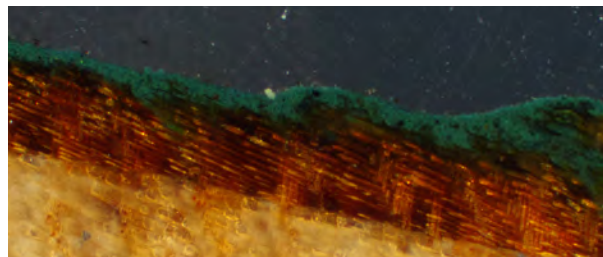
**Figure 45:** The substrate of ELK.15.3 is very rough, and the paint is soaked into the wood.

The two samples removed from the west and south elevations appeared similar when examined in cross section. Both contained rough, weathered wood surfaces that are darkened, with paint seeped deep into the wood. The campaigns are difficult to decipher as the layers are not continuous, but the two samples do both appear to share a deep blue green and a yellow-green paint (fig. 44). The current color of ELK.15.1 is a blue-green, while the current color of ELK.15.3 is a bright blue. The sample removed from the interior also shows a somewhat rough and discolored wood surface. The only paint is the current dark green (fig. 45).

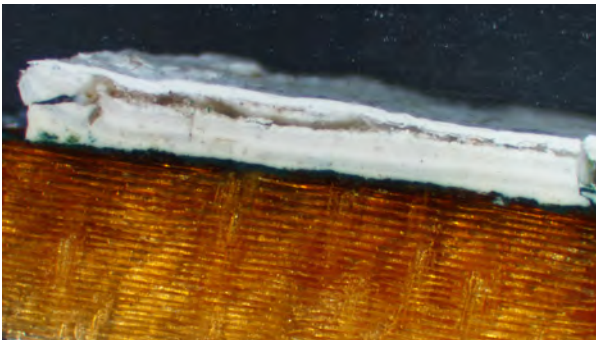
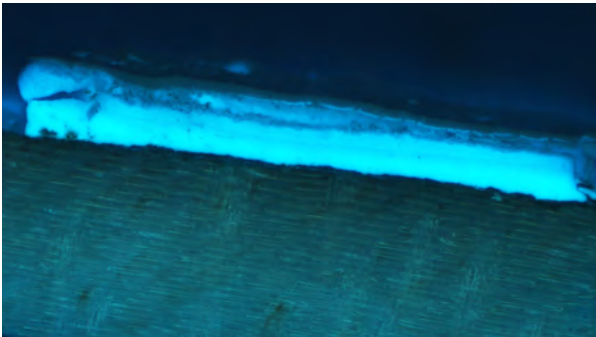
**Figure 46:** Sample ELK.15.4, 40x magnification, visible light (above) and UV light (below). The wood appears sound, with an early dark green.

The samples removed from the window and door were similar in cross-section. The window contains approximately five layers, with the earliest a dark green. The dark green is thin, uneven and seeped into the rough wood surface. The green is followed by a light blue/white, then another one or two whites. The door also contains a dark green first layer, but the wood surface appears generally intact and not weathered (fig. 46). Following the dark green is a light blue/white, and then five whites/light grays. The current color on both elements is white.

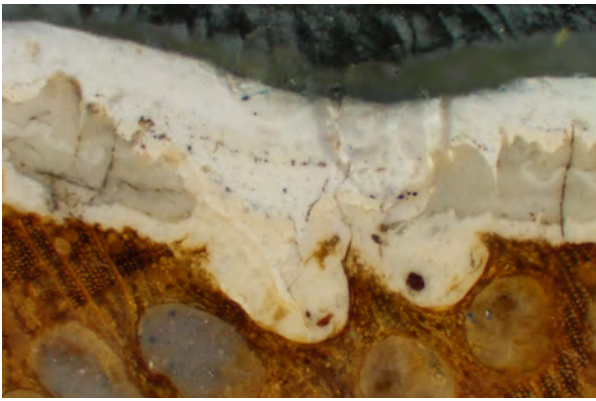
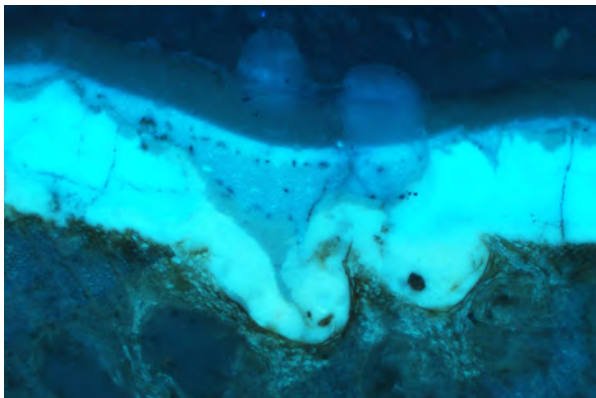
The sample removed from the front door surround shows a hardwood painted in a cream/off-white followed by a light gray and several whites (fig. 49).

**Figure 49:** Sample ELK.38.3, 40x magnification, visible light (above) and UV light (below). This sample from the door surround contains all whites/creams.

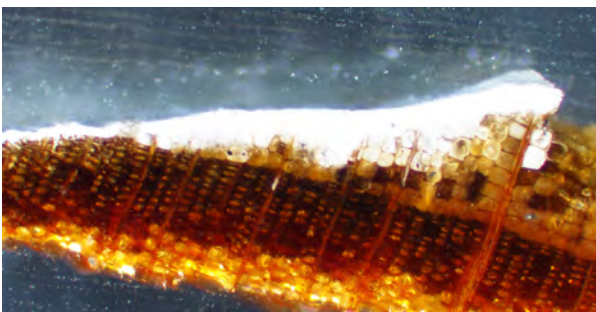
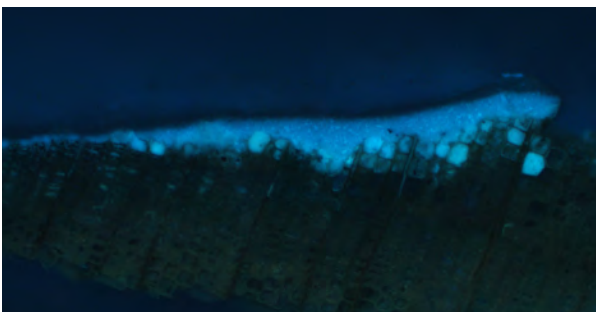
**Figure 50:** Sample ELK.38.4, 40x magnification, visible light (above) and UV light (below). This sample from the window sash contains only the current paint.

The surface of the wood is generally sound, and the cream/off-white likely represents an original finish. In comparison, the window sash sample consists of only one or two paint layers, both cream/white on a worn or stripped surface (fig. 50). The sample removed from the siding contains several green or yellow-green paints, but there is no clear layering structure, and none of the samples auto-fluoresce (fig. 51). The wood substrate appears worn and discolored, as if it was exposed, and there is no evidence of a clear coating. The sleeping porch posts contain only one layer of a blue-green—similar to one of the paints in the siding sample—on a somewhat worn surface.

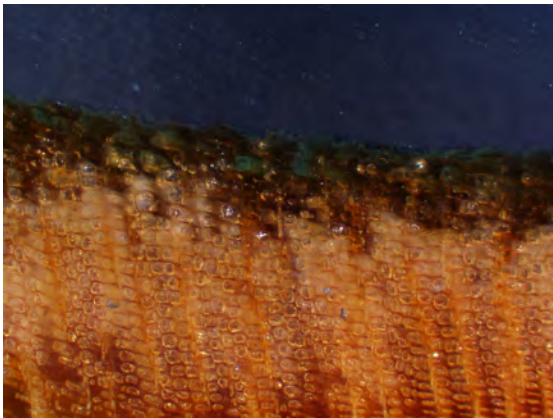
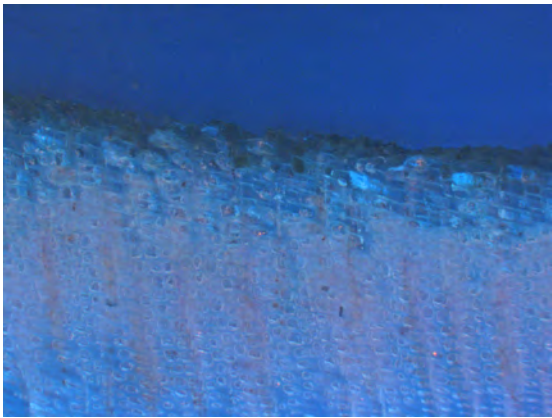
**SAMPLE NO:** ELK.2.1  
**CABIN:** Smith  
**LOCATION:** South elevation, siding, rear (SW) porch, under window

| LAYER | REFLECTED LIGHT | UV LIGHT | NOTES |
|---|---|---|---|
| Wood | | | uneven - worn/stripped |
| 2 | Green | dark | seeped into pores |

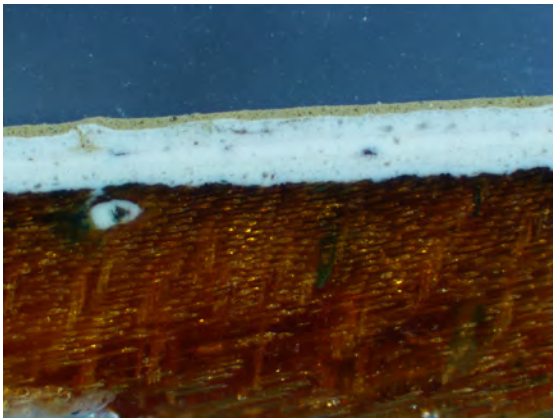
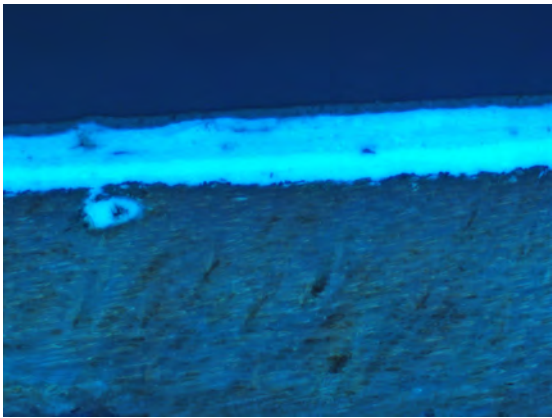
Figure 16

**SAMPLE NO:** ELK.2.5  
**CABIN:** Smith  
**LOCATION:** East elevation, door surround,  
south door

| LAYER | REFLECTED LIGHT | UV LIGHT | NOTES |
|---|---|---|---|
| 5 | off white | grayish | cracked |
| 6 | off white | grayish | cracked |
| 7 | white? | | very thin; cracked |

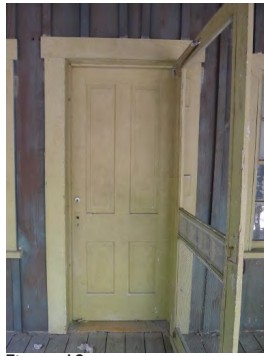
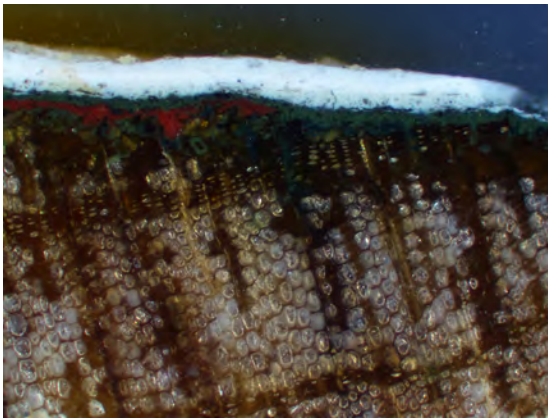
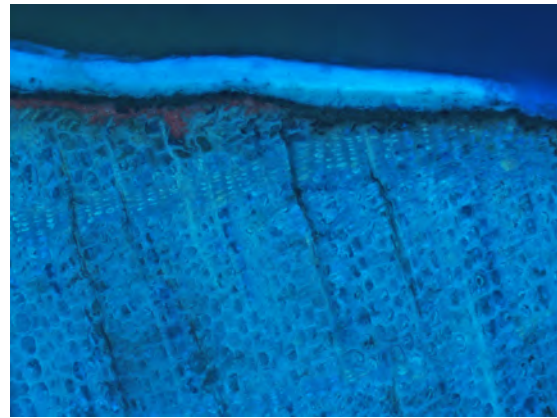
Figure 19

**SAMPLE NO: ELK.2.6**

**LOCATION:** East elevation, main door, middle rail, south door

| LAYER | REFLECTED LIGHT | UV LIGHT | NOTES |
|---|---|---|---|
| 1 | dark green | | in pores - leakdown from above? |
| dirt/ | worn | | |
| 8 | yellow | | leaked down to green |

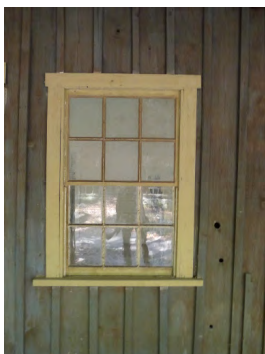
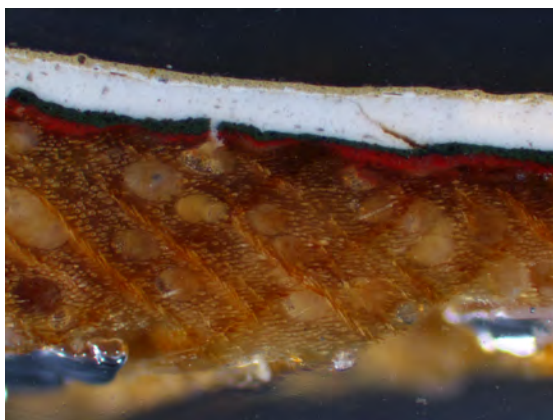
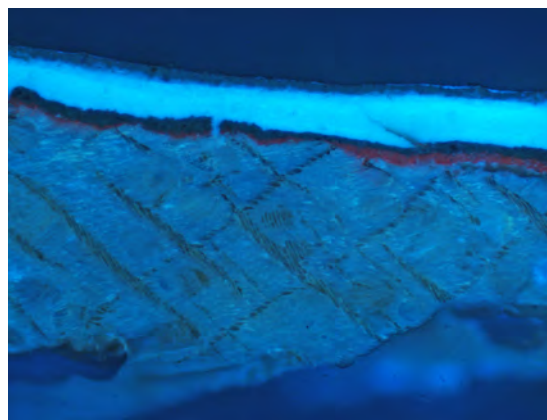
Figure 22

**SAMPLE NO:** ELK.2.7

**LOCATION:** East elevation, window sash, south window

| LAYER | REFLECTED LIGHT | UV LIGHT | NOTES |
|---|---|---|---|
| 2 | Red | none | cracked |
| 3 | Green | none | cracked/worn surface |
| 6 | Yellow | none | |

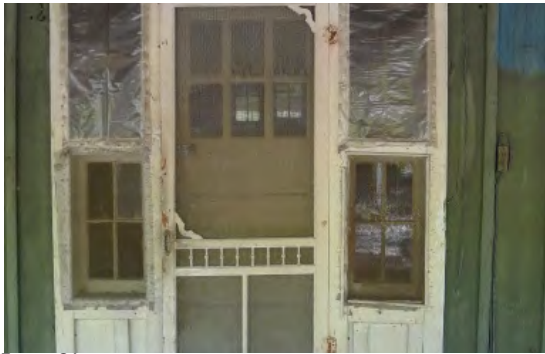
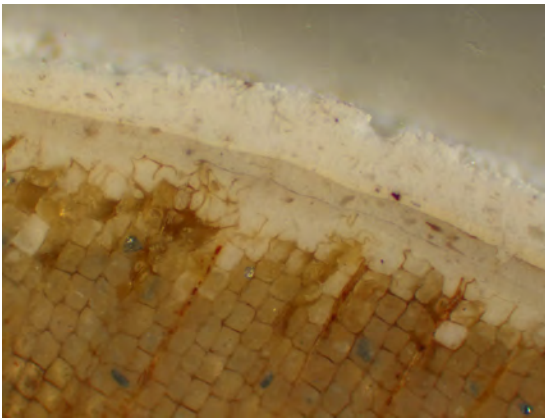
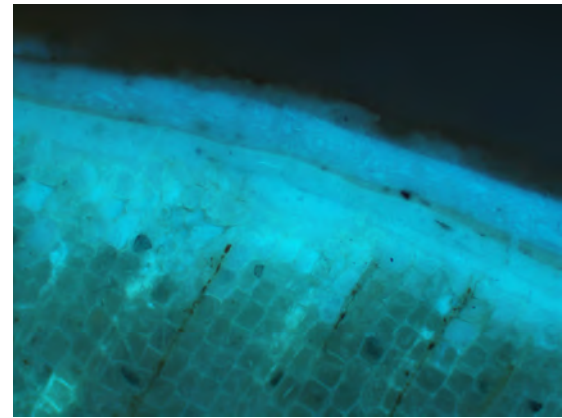
Figure 31

**SAMPLE NO:** ELK.3.2

**LOCATION:** West elevation, front door, surround, rail at south side under light

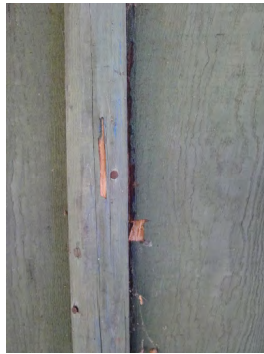
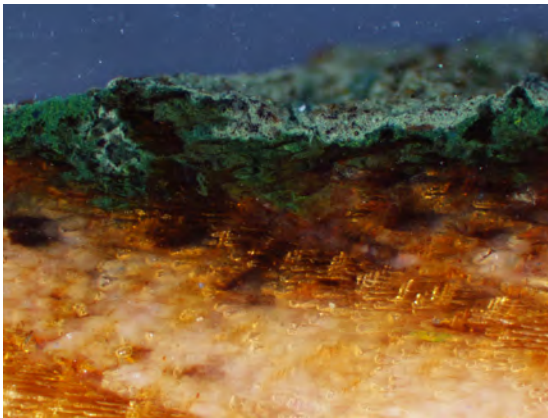
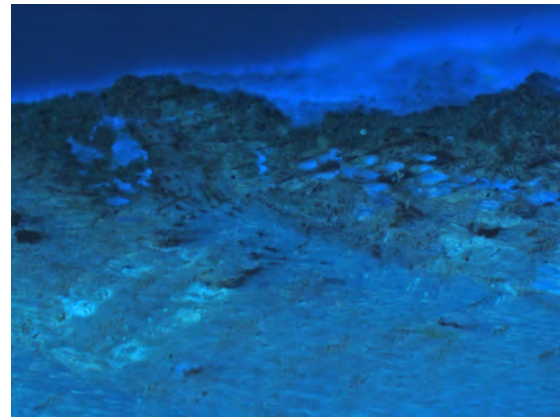
Figure 34

**SAMPLE NO: ELK.3.4**

**LOCATION:** West elevation, siding at south side, adjacent to batten

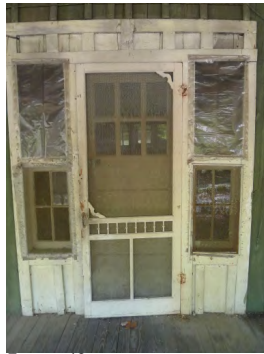
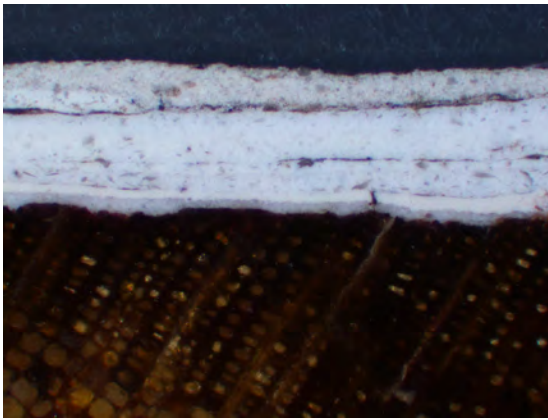
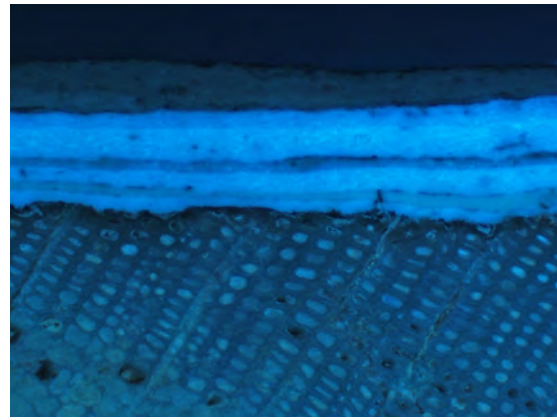
Figure 40

**SAMPLE NO: ELK.3.6**

**LOCATION:** West elevation, screen door

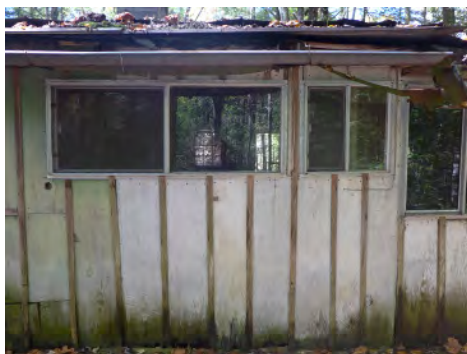
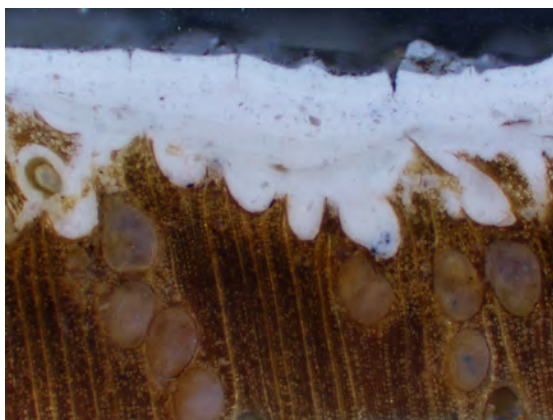
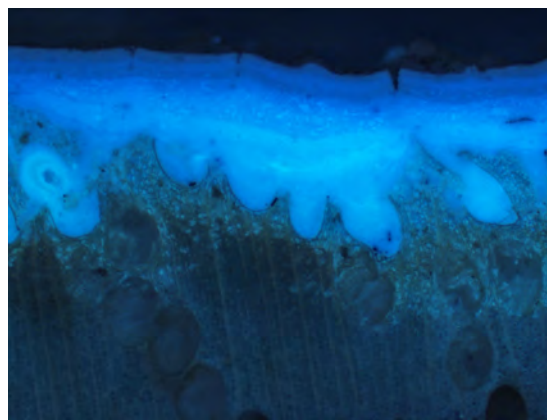
Figure 52

**SAMPLE NO:** ELK.5.4

**LOCATION:** East (rear) elevation, center, vertical board and batten siding (exterior of room 107), under aluminum window

| LAYER | REFLECTED LIGHT | UV LIGHT | NOTES |
|---|---|---|---|
| 6 | White | grayish | |

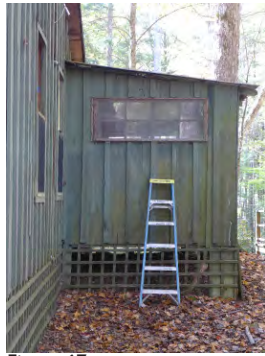
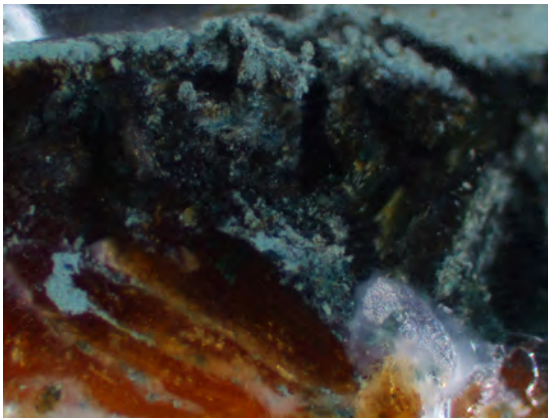
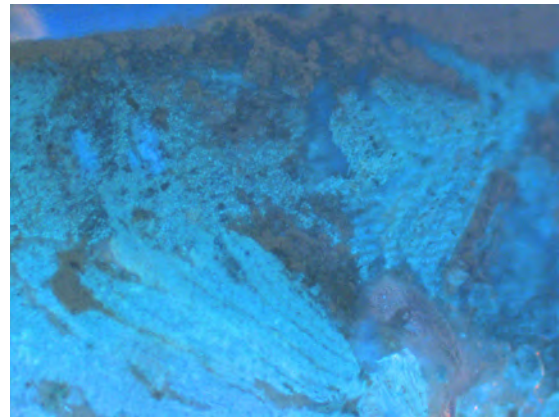
Figure 67

**SAMPLE NO:** ELK.6.5

**CABIN:** Creekmore

**LOCATION:** East elevation, front elevation of last addition (on north side of building), from board of board and batten siding

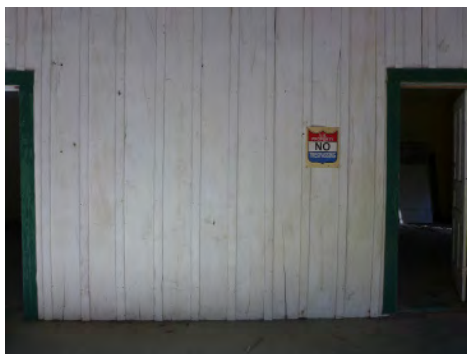
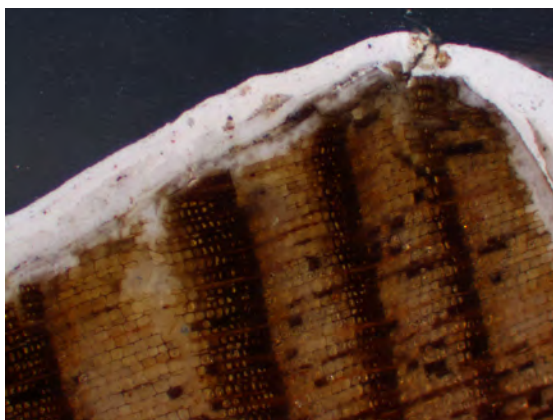
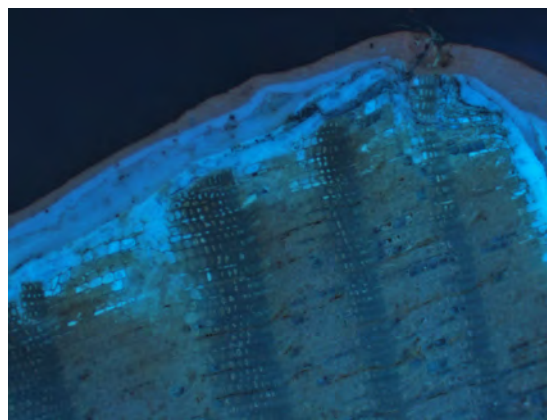
Figure 70

**SAMPLE NO:** ELK.7.1

**CABIN:** Mayo

**LOCATION:** West (front) elevation, board and batten siding, from a batten between door to rooms 101 and 102

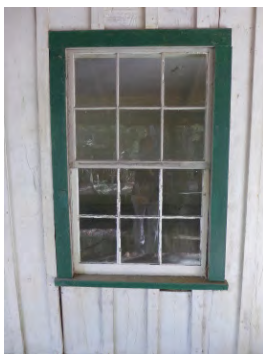
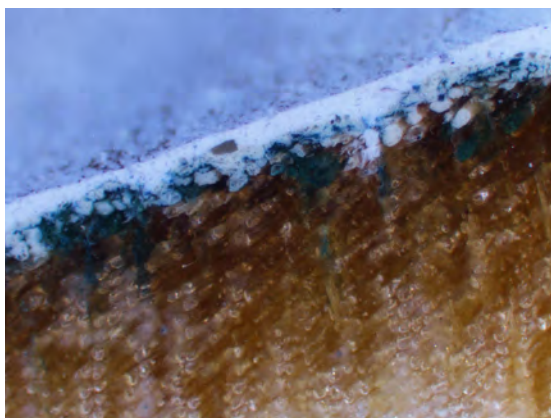
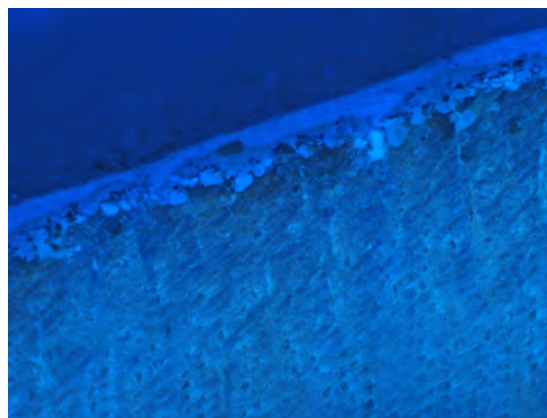
Figure 72

**SAMPLE NO:** ELK.7.2

**CABIN:** Mayo

**LOCATION:** West (front) elevation, north window of room 102, lower sash, south stile

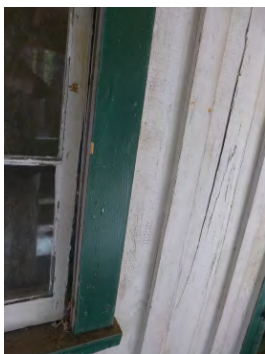
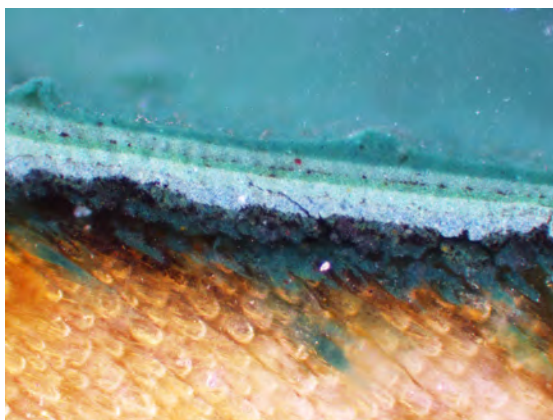
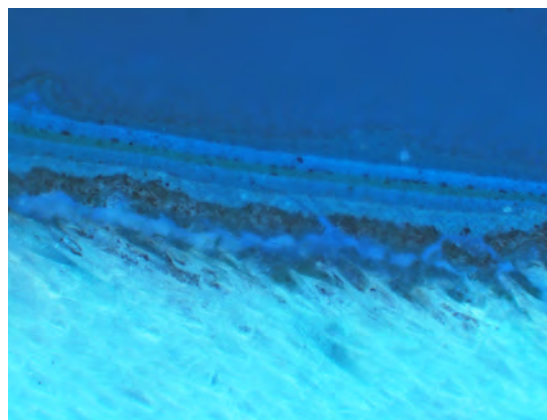
Figure 75

**SAMPLE NO:** ELK.7.3

**CABIN:** Mayo

**LOCATION:** West (front) elevation, north window, south surround

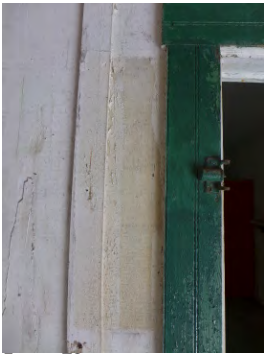
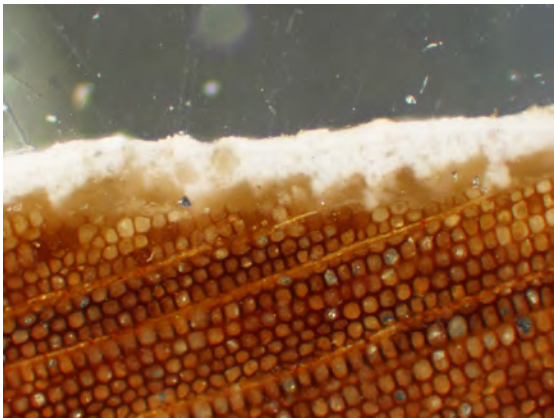
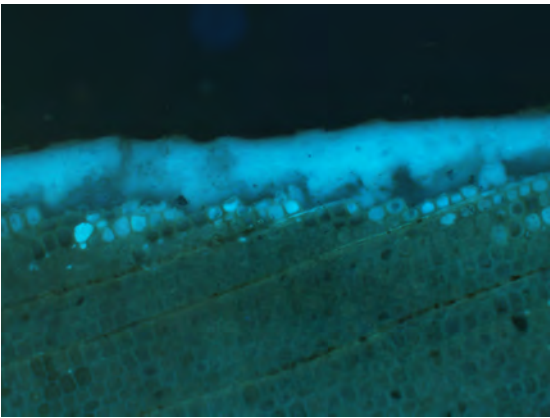
Figure 78

**SAMPLE NO:** ELK.7.4  
**CABIN:** Mayo  
**LOCATION:** West (front) elevation, siding,  
area of graffiti, which dates paint to before 1950

| LAYER | REFLECTED LIGHT | UV LIGHT | NOTES |
|---|---|---|---|
| 1 | white | | looks broken at wood surface |

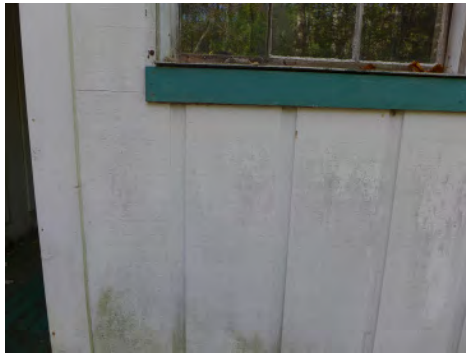
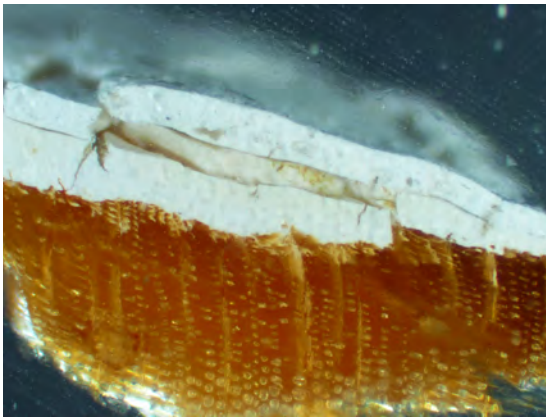
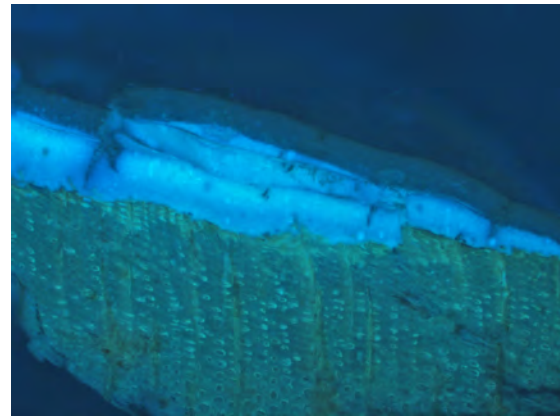
Figure 81

**SAMPLE NO:ELK.7.5**

**CABIN:** Mayo

**LOCATION:** East (rear) elevation, reverse board and batten siding of enclosed porch addition, from north of door to room 103

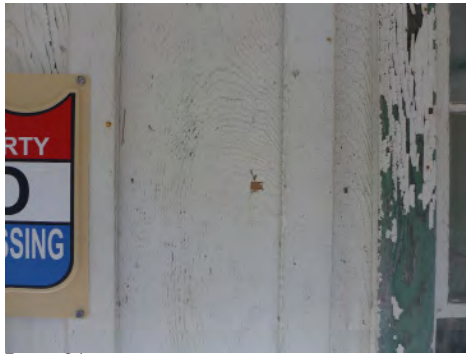
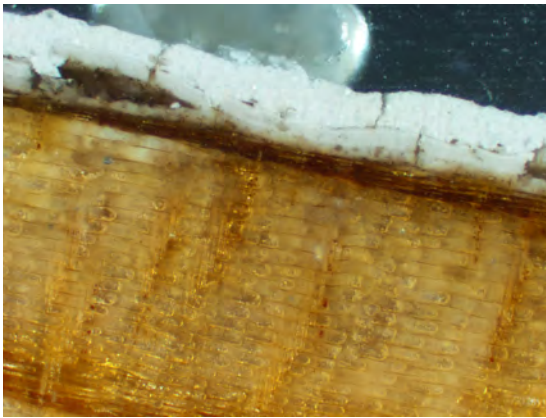
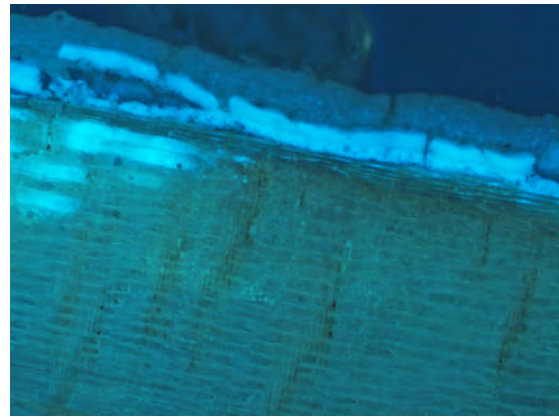
Figure 84

**SAMPLE NO: ELK.7B.1**

### **CABIN:** Mayo Servants' Quarters

**LOCATION:** West (front) elevation, board and batten siding between front door and window

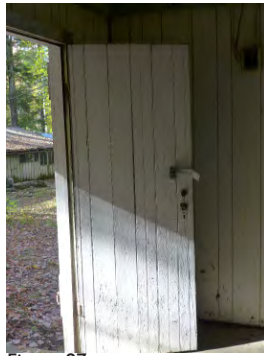
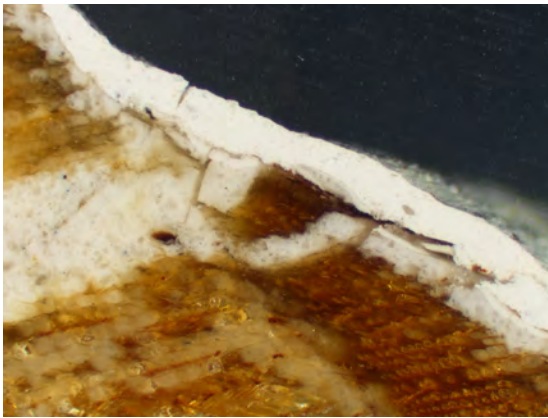
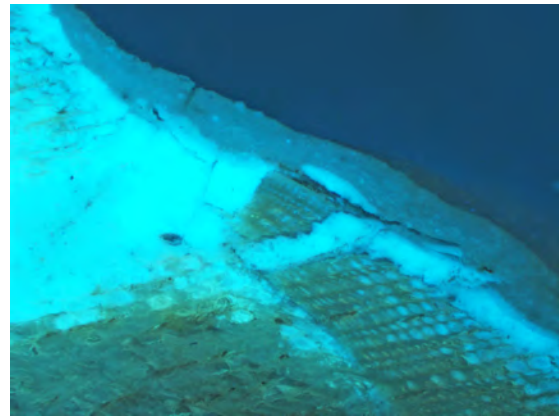
Figure 87

**SAMPLE NO: ELK.7B.2**

### **CABIN:** Mayo Servants' Quarters

**LOCATION:** West (front) elevation, front door, tongue and groove board near hinges

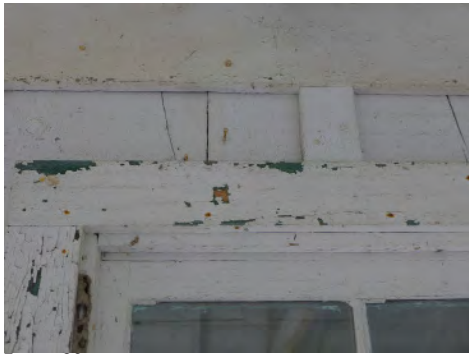
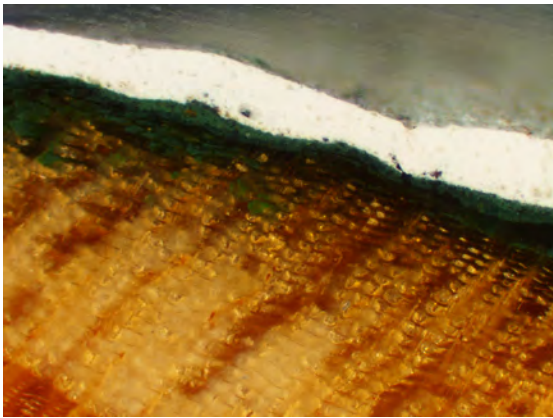
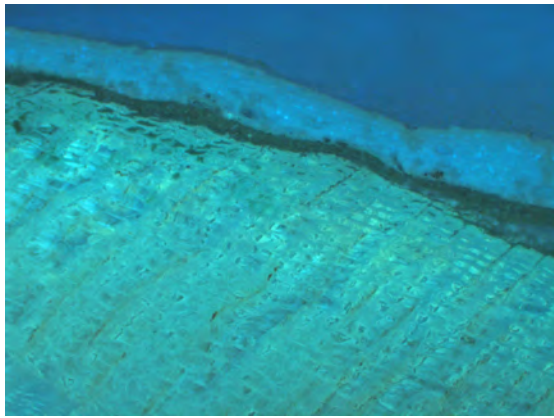
Figure 90

**SAMPLE NO:** ELK.7B.3  
**CABIN:** Mayo Servants' Quarters  
**LOCATION:** West (front) elevation, window surround, top

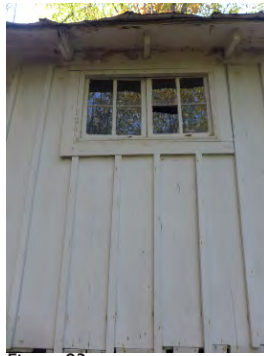
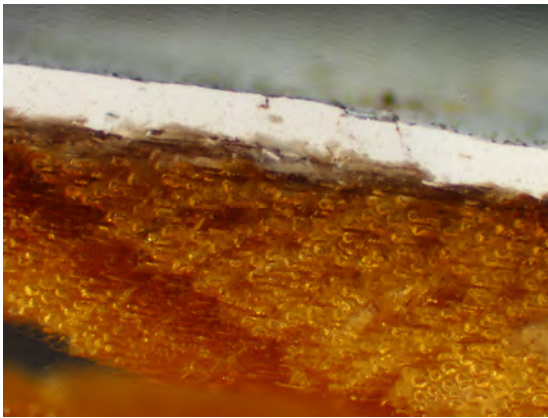
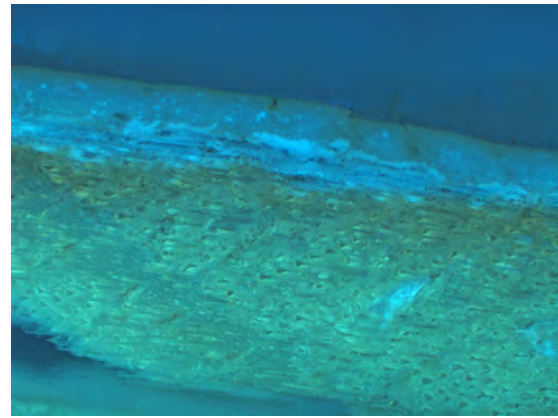
Figure 93

**SAMPLE NO: ELK.7B.4**

### **CABIN:** Mayo Servants' Quarters

**LOCATION:** East (rear) elevation addition, board and batten siding, from board below window

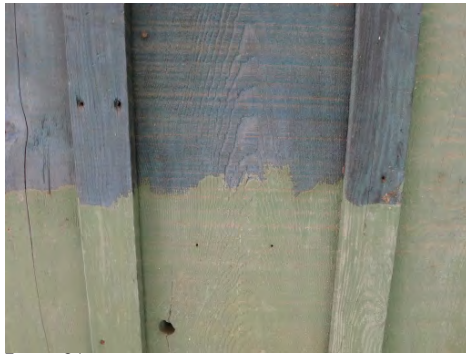
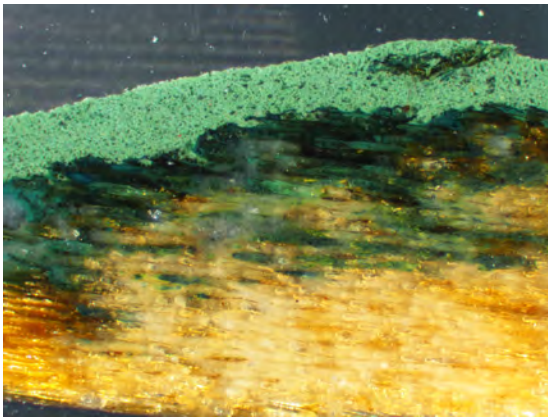
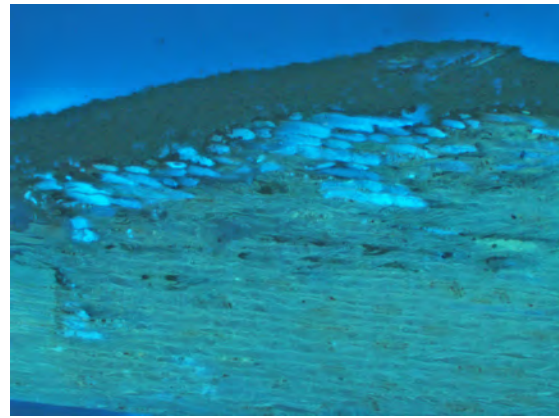
Figure 96

While no binder medium was clearly identified in any sample, evidence of a natural binding medium, such as oil or resin, was found in three of the four samples (ELK.8.1, 13.4, and 38.5). Sample ELK.38.5 showed two paint layers in SEM-EDS, but the earlier layer could not be adequately isolated for GC-MS. However, the GC-MS did include markers for a drying oil. FTIR was run on both paint layers, which identified the presence of an acrylic binder, commonly referred to as latex paint. It is assumed that the latex paint relates to the most recent paint layer, and the oil/resin from the GC-MS to the earlier layer. This is consistent with samples ELK.13.4 and 8.1. Sample ELK.8.7 was so thin, the wood fibers tended to overwhelm the spectra and the FTIR was unable to detect the presence of any binding medium.

**SAMPLE NO: ELK.8.1**

**CABIN:** Cain

**LOCATION:** East elevation, siding at location of missing later paint, between two windows under porch

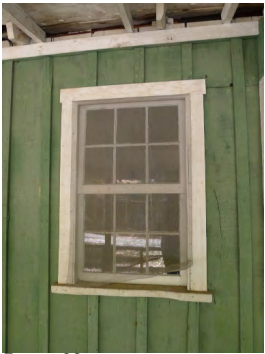
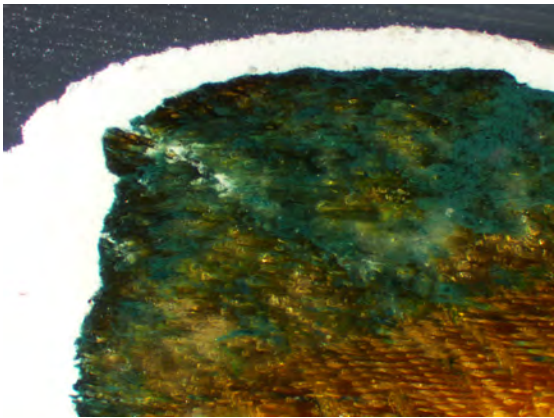
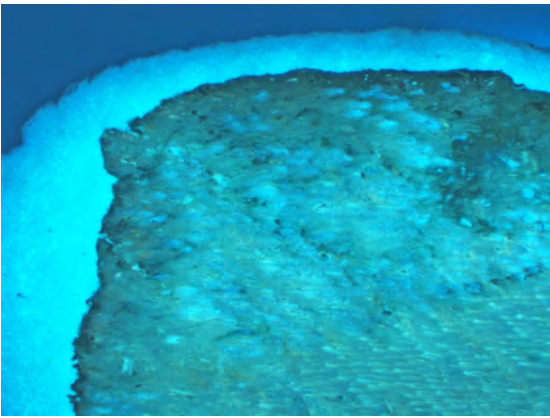
Figure 99

**SAMPLE NO:** ELK.8.3  
**CABIN:** Cain  
**LOCATION:** East elevation, window surround, north window under porch, stile
