# **Elkmont Historic District**

## **Great Smoky Mountains National Park**

## **Finishes Analysis Report**

March 31, 2016

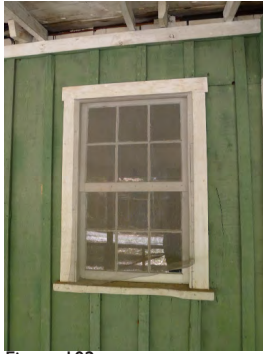
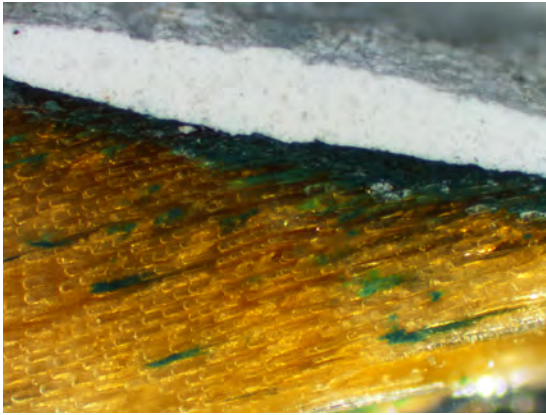
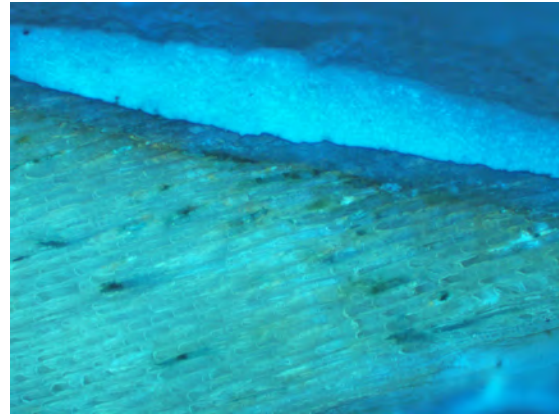
Figure 102

**SAMPLE NO: ELK.8.4**

**CABIN:** Cain

**LOCATION:** East elevation, window sash, north window, under porch, bottom rail of bottom sash

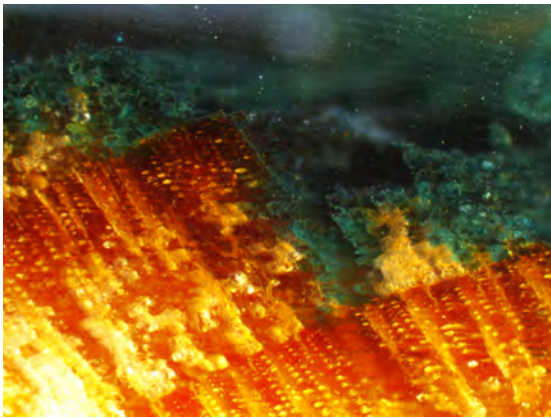
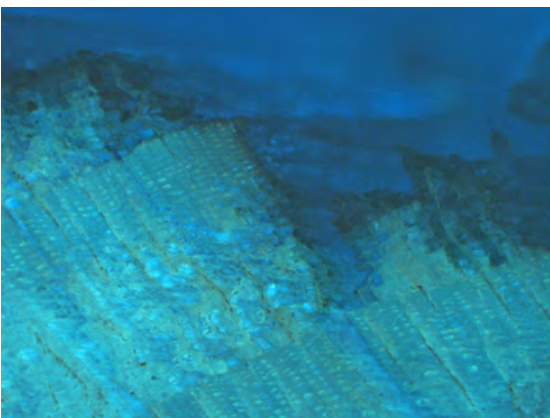
**SAMPLE NO:** ELK.11.2  
**CABIN:** Scruggs-Briscoe  
**LOCATION:** West elevation, siding of house, under porch

| LAYER | REFLECTED LIGHT | UV LIGHT | NOTES |
|---|---|---|---|
| 1 | Dark green | none | |

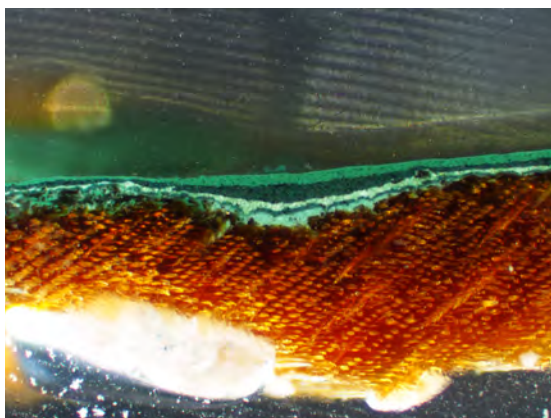
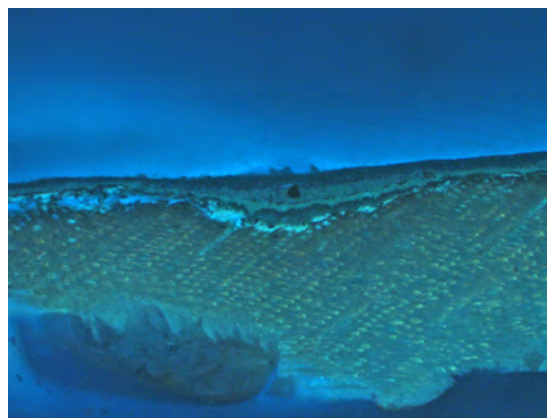
**SAMPLE NO:** ELK.11.4

| LAYER | REFLECTED LIGHT | UV LIGHT | NOTES |
|---|---|---|---|
| 1 | Brown? | bright blue-green | partial, damaged? |

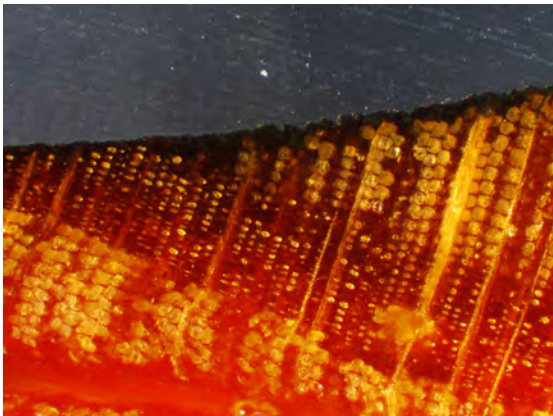
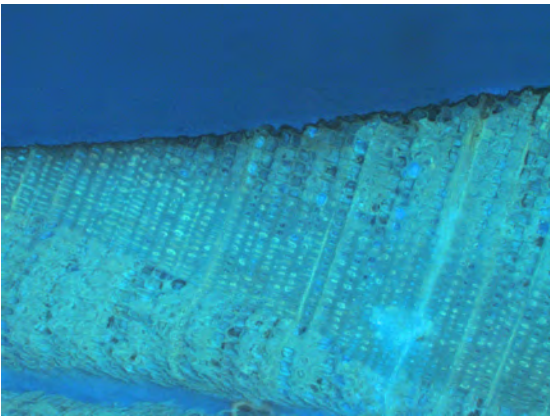
**SAMPLE NO:** ELK.11.6  
**CABIN:** Scruggs-Briscoe  
**LOCATION:** Window sash, bottom rail, south window on porch

| LAYER | REFLECTED LIGHT | UV LIGHT | NOTES |
|---|---|---|---|
| 1 | Brown | none | very thin |

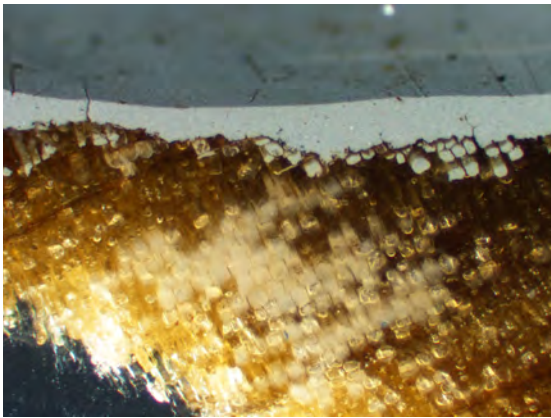
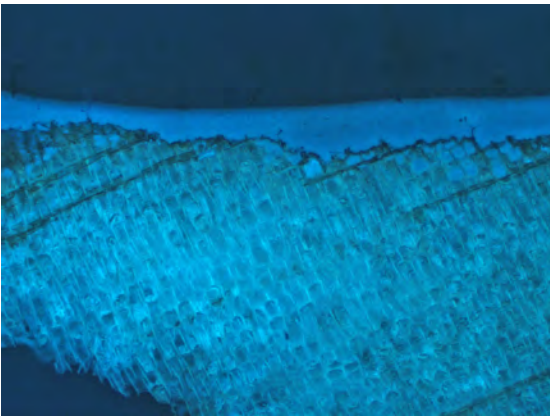
**SAMPLE NO:** ELK.13.6  
**CABIN:** Cook  
**LOCATION:** Porch floor

| LAYER | REFLECTED LIGHT | UV LIGHT | NOTES |
|---|---|---|---|
| 1 | Light gray | | in pores and on surface |

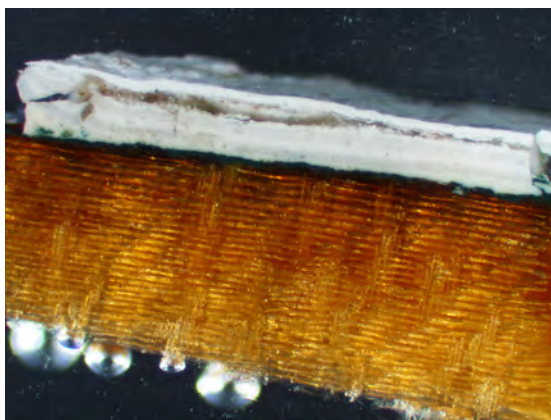
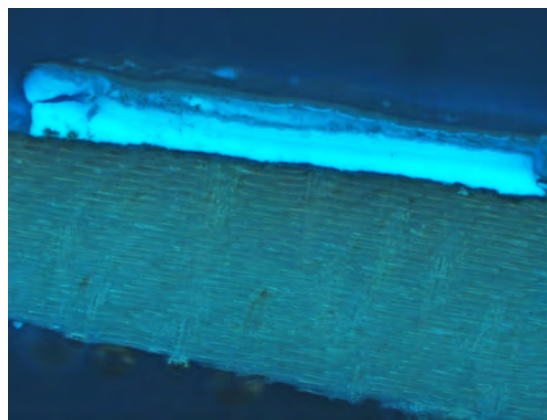
Figure 190: Reflected Light, 40x

**LOCATION:** West (front) elevation, south door, middle rail at hinge stile

| LAYER | REFLECTED LIGHT | UV LIGHT | NOTES |
|---|---|---|---|
| 6 | white | | damaged |

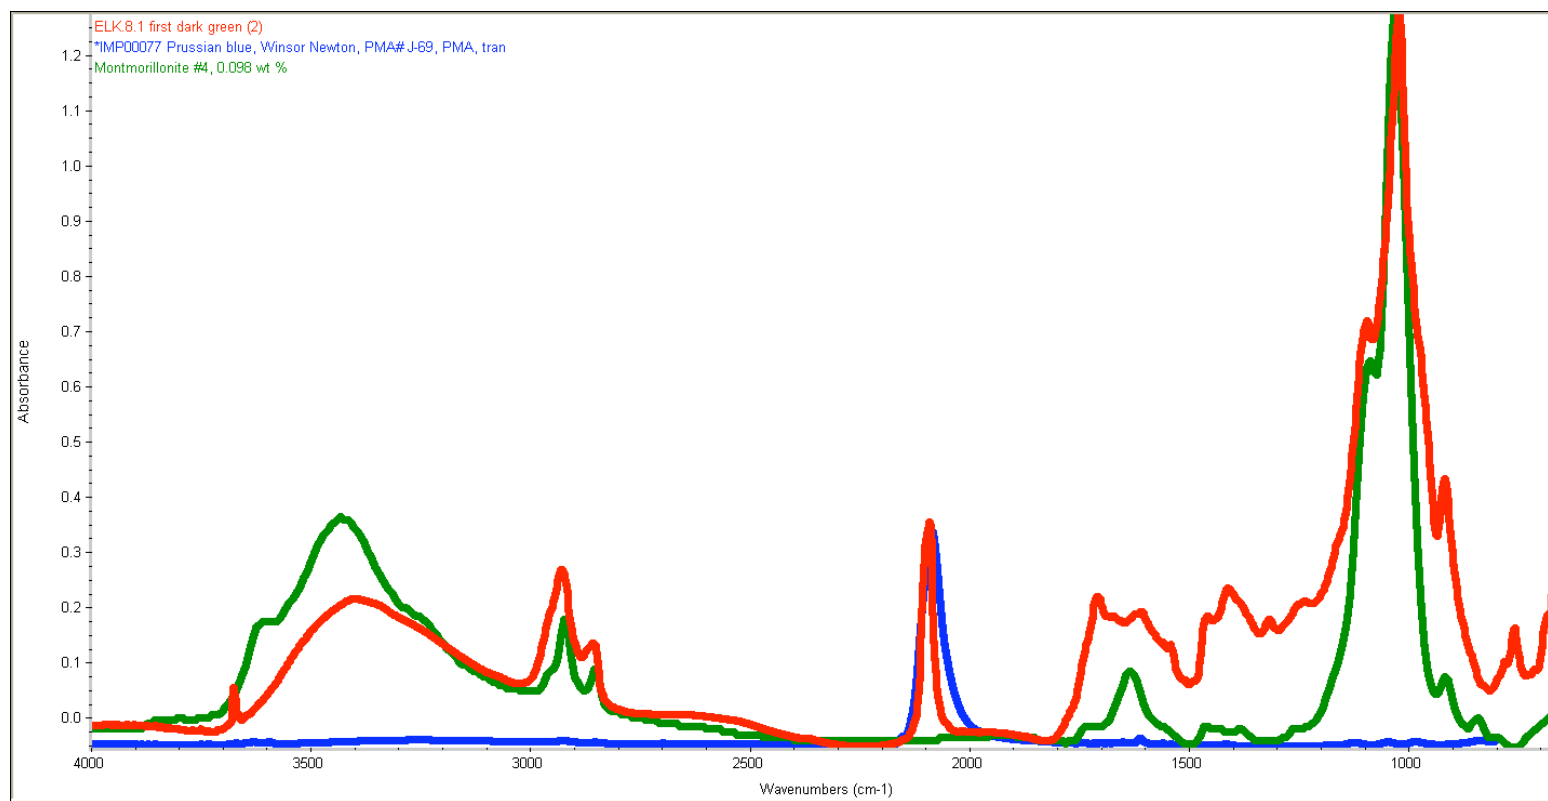
Figure 2 Elkmont

The dark green finish of this sample is applied directly to the wood substrate and is extremely thin. Wood fibers is the main component in the FTIR spectrum of this sample due to the difficulty of isolating the thin green finish (Figure 2). A stretch at approximately 2100cm<sup>-1</sup> indicates the presence of Prussian blue pigment in the finish.

Sample ELK.8.1 first dark green finish layer (red spectrum) overlaid with reference spectra for Prussian blue pigment (blue spectrum) and montmorillonite ((Na,Ca)<sub>0.33</sub>(Al,Mg)<sub>2</sub>(Si<sub>4</sub>O<sub>10</sub>)) (green spectrum)

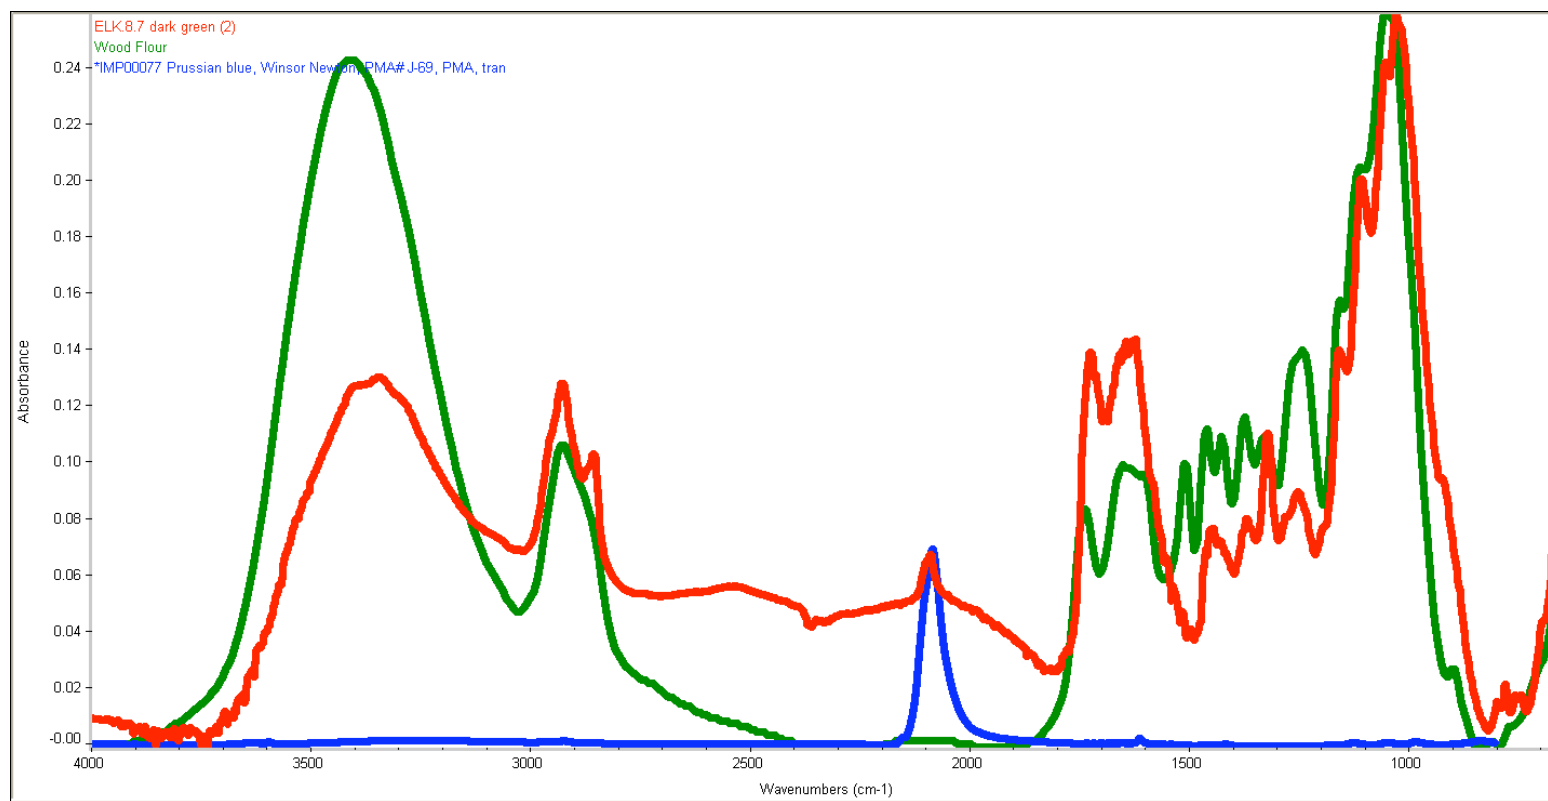
Figure 3 Elkmont

Sample ELK.8.7 dark green finish layer (red spectrum) overlaid with reference spectra for Prussian blue pigment (blue spectrum) and wood flour (i.e. wood fibers) (green spectrum)

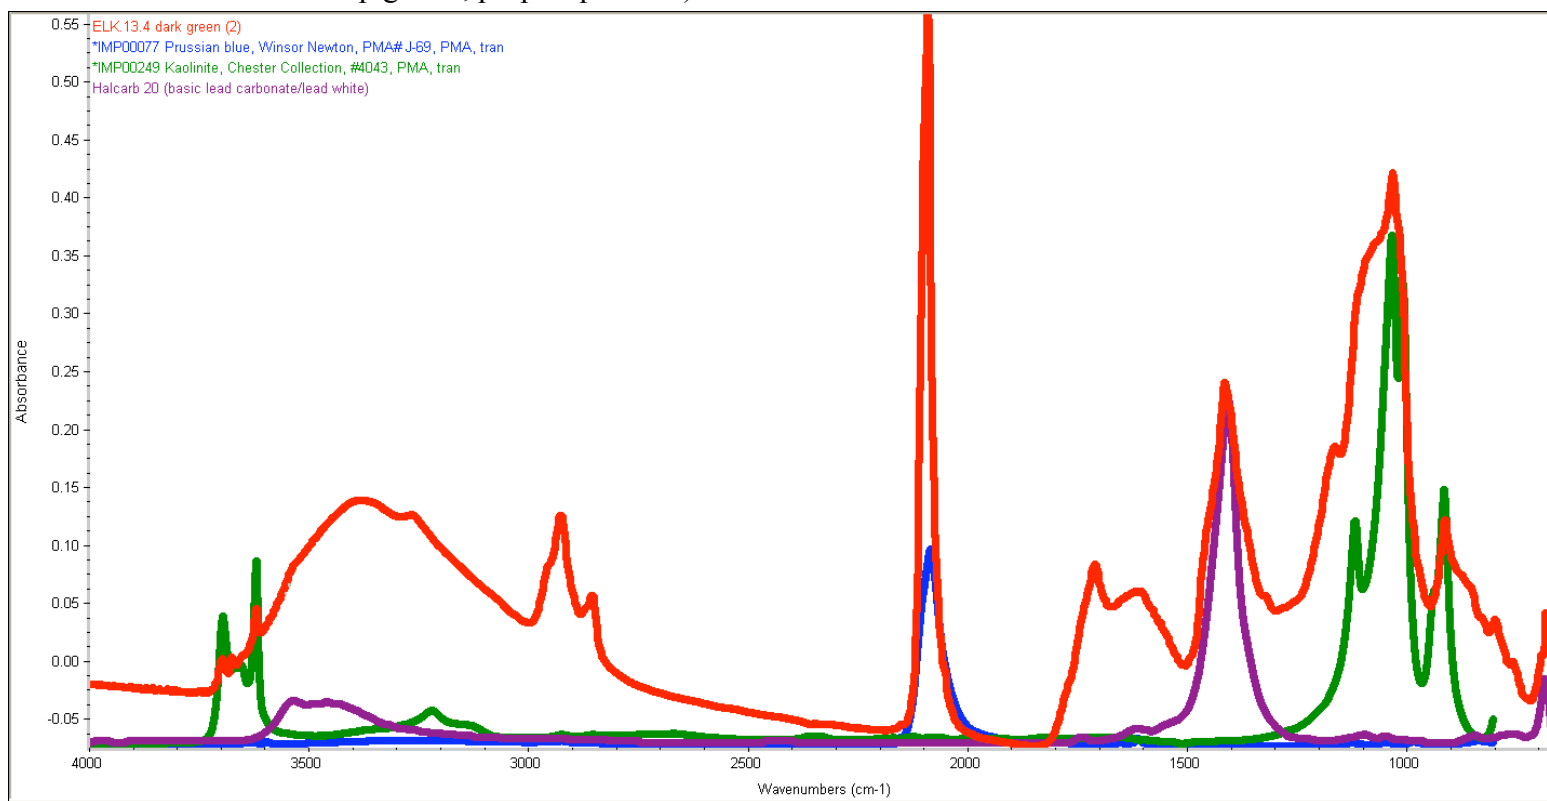
Figure 4 Elkmont

As with Samples ELK.8.1 and ELK.8.7, Prussian blue pigment is detected in the green finish of sample ELK.13.4 (Figure 3). Clay is also detected with Si-O stretches detected around 1000cm<sup>-1</sup> and water of hydration O-H stretches detected around 3700-3600cm<sup>-1</sup>; a reference spectrum for kaolinite (Al<sub>2</sub>Si<sub>2</sub>O<sub>5</sub>(OH)<sub>4</sub>) is provided. The stretch between 1500-1300cm<sup>-1</sup> is characteristic of a carbonate (CO<sub>3</sub><sup>2-</sup>), either from lead white (2PbCO<sub>3</sub>·Pb(OH)<sub>2</sub>) or calcium carbonate (CaCO<sub>3</sub>).

Sample ELK.13.4 dark green finish layer (red spectrum) overlaid with reference spectra for Prussian blue pigment (blue spectrum), kaolinite clay ( $\text{Al}_2\text{Si}_2\text{O}_5(\text{OH})_4$ , green spectrum) and Halcarb 20 (i.e. basic lead carbonate/lead white pigment, purple spectrum)

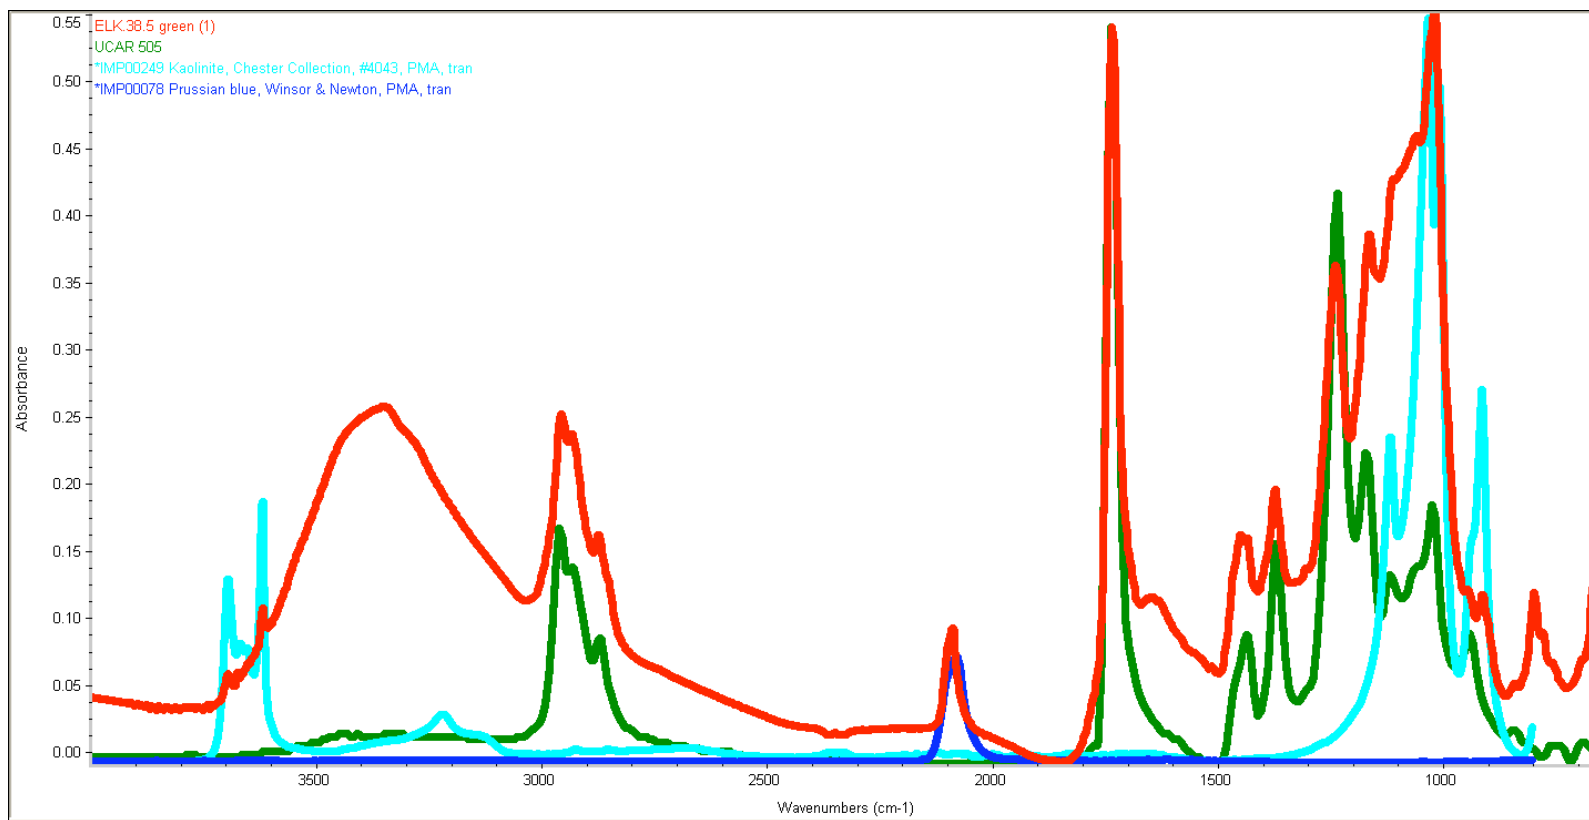
Figure 5 Elkmont  
Gas chromatography – mass spectrometry (GCMS)  
Sample ELK.38.5 green finish layer

Though the SEM-EDS analysis suggests there are two green finish layers in this sample, the two finishes could not be separated and isolated for GC-MS analysis. FTIR analysis of the two green finishes/paints shows the presence of an acrylic binding medium, clay (a reference spectrum for kaolinite is provided) and Prussian blue pigment. Acrylic paint binding media is known commercially, and for architecture, as latex paint. Gas chromatography of the two green finishes detects an overwhelming amount of wood products because the paints could not be cleanly isolated from the substrate either (Figure 5). However, three marker compounds indicative of a drying oil are detected: azelaic acid dimethyl ester (at 14.300minutes), palmitic acid methyl ester (at 18.411minutes) and stearic acid methyl ester (at 20.325minutes). It is assumed the drying oil is present in the first green finish applied to the wood substrate. The binding medium of the second green paint layer is an acrylic as determined by FTIR and based on examination of the bulk sample. Acrylic media is not detectable with GC-MS and so one can deduce that the oil component is coming from the first green finish layer; the monomer units of acrylics are only detectable with pyrolysis-GC-MS.

Sample ELK.38.5 green finish layer (red spectrum) overlaid with reference spectra for UCAR 506, an acrylic (green spectrum), kaolinite clay ( $\text{Al}_2\text{Si}_2\text{O}_5(\text{OH})_4$ , turquoise spectrum) and Prussian blue pigment (blue spectrum)

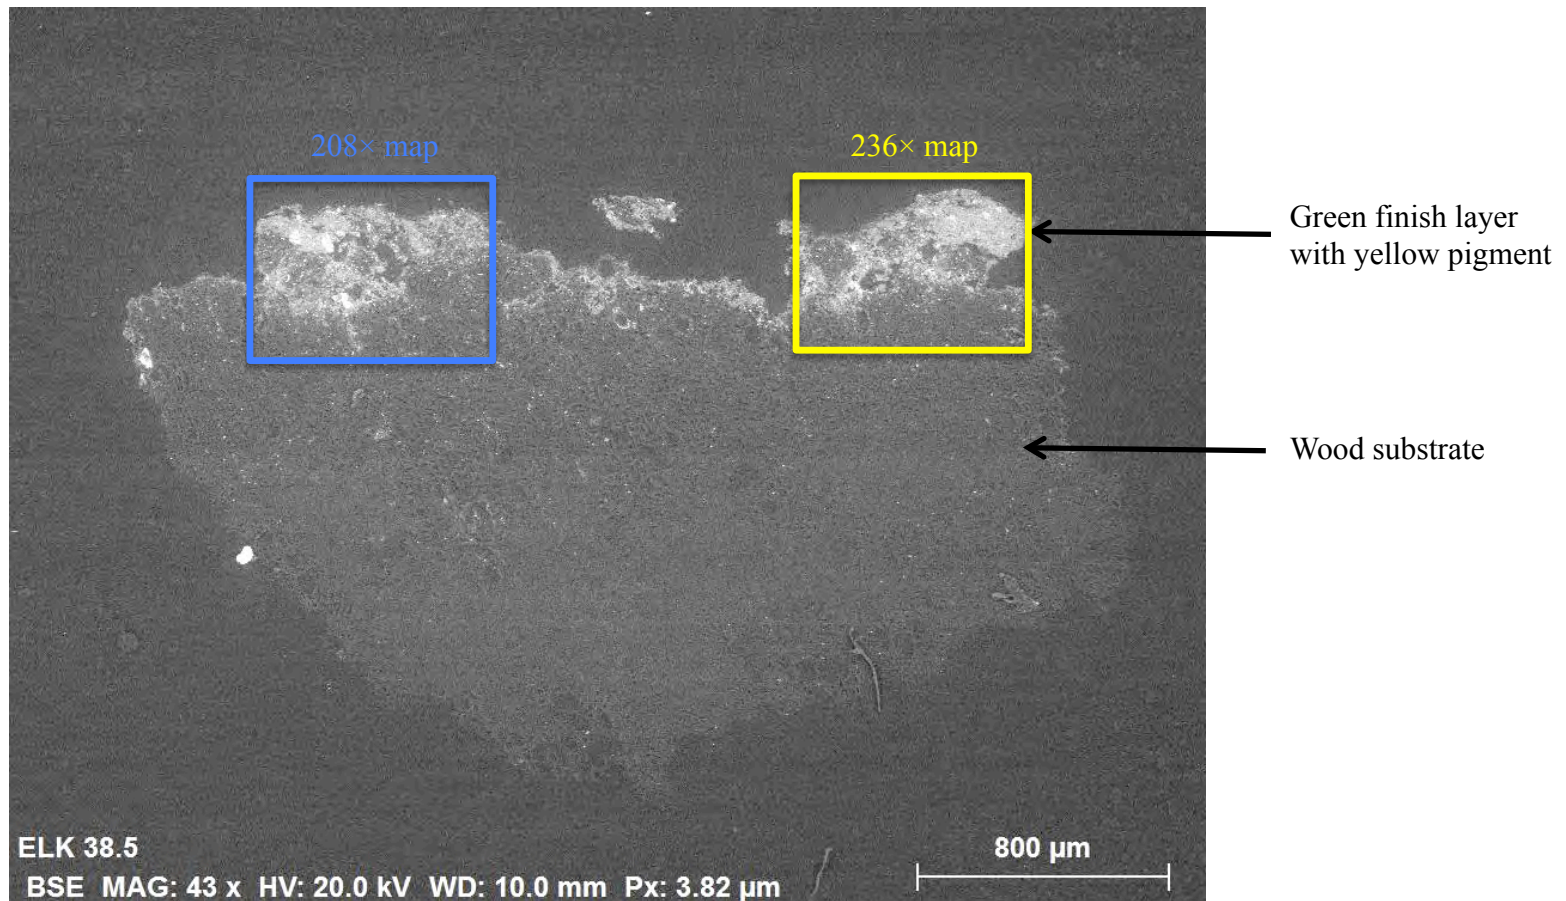
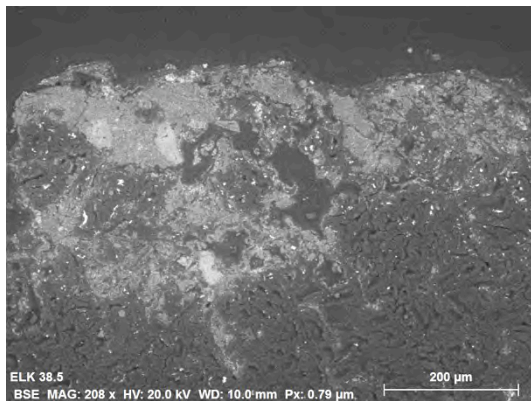
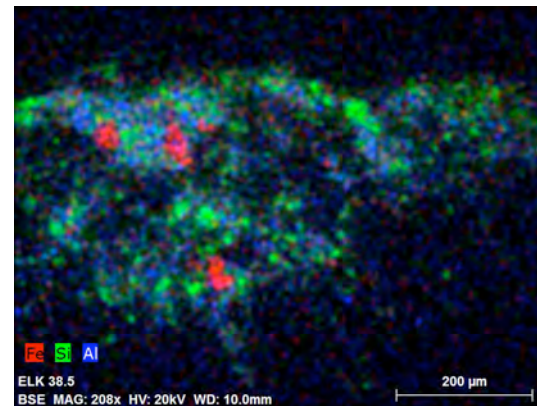
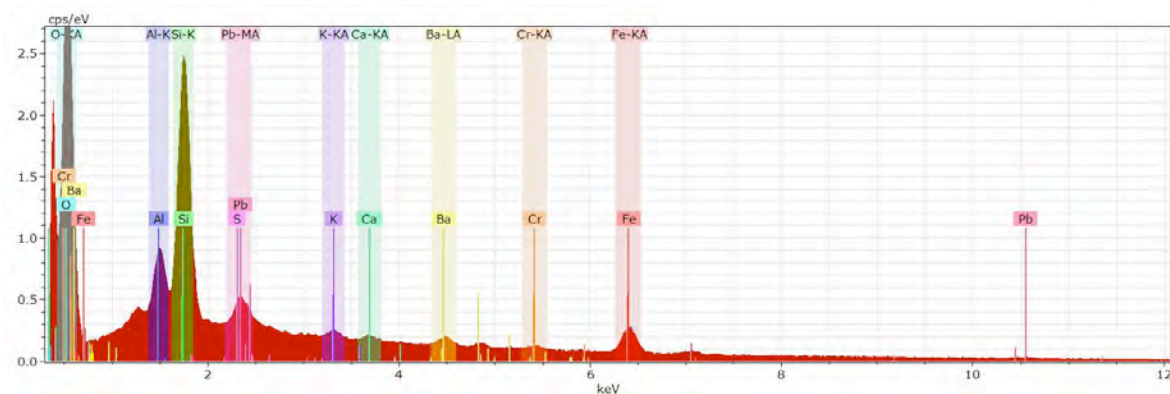
Figure 7 Elkmont  
Scanning Electron Microscopy – Energy Dispersive Spectroscopy (SEM-EDS)  
Sample ELK.38.5

The primary elements detected with SEM-EDS analysis of this sample are silicon, aluminum and iron (Figures 7 and 8). This elemental profile suggests a similar composition of aluminosilicate clays and Prussian blue detected in sample ELK.8.1 and ELK.13.4. Though the elements do not map well, the EDS spectra from both maps (208× and 236× magnifications) detect weak amounts of lead (Pb), barium (Ba) and chromium (Cr). These elements suggest the low concentration of the pigments lead white, barium white (BaSO<sub>4</sub>) and yellow lead chromate
