National Park Service  
Cultural Landscapes Inventory  
2010

Boca Chita  
Biscayne National Park

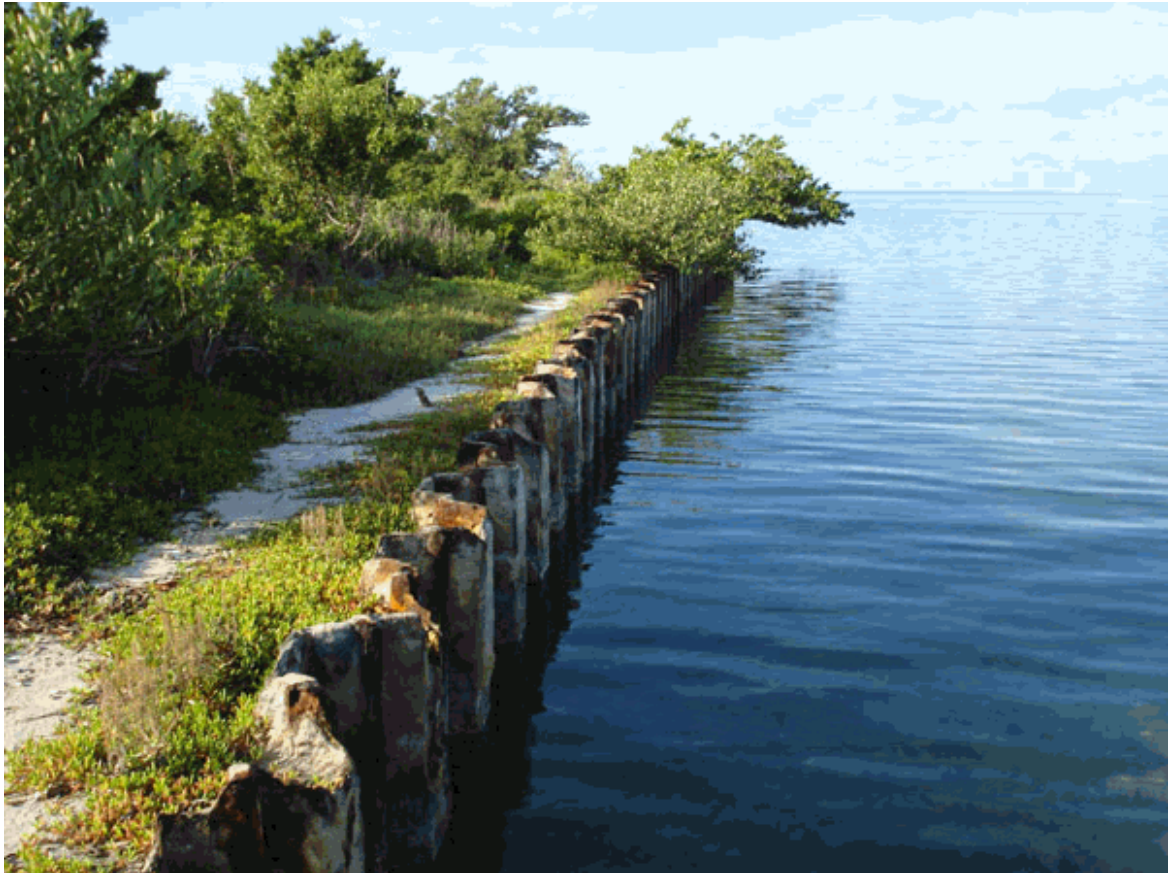
*Graphic 52: Harrison's bulkhead*

Within the historic district, Harrison's bulkhead is obscured by a new steel bulkhead and concrete cap built in 1994. The new bulkhead was constructed to repair damage to Harrison's bulkhead by Hurricane Andrew. South of the historic district, the original bulkhead is still defines the western edge of the island. The bulkhead does not retain sufficient historic integrity to be a contributing resource.

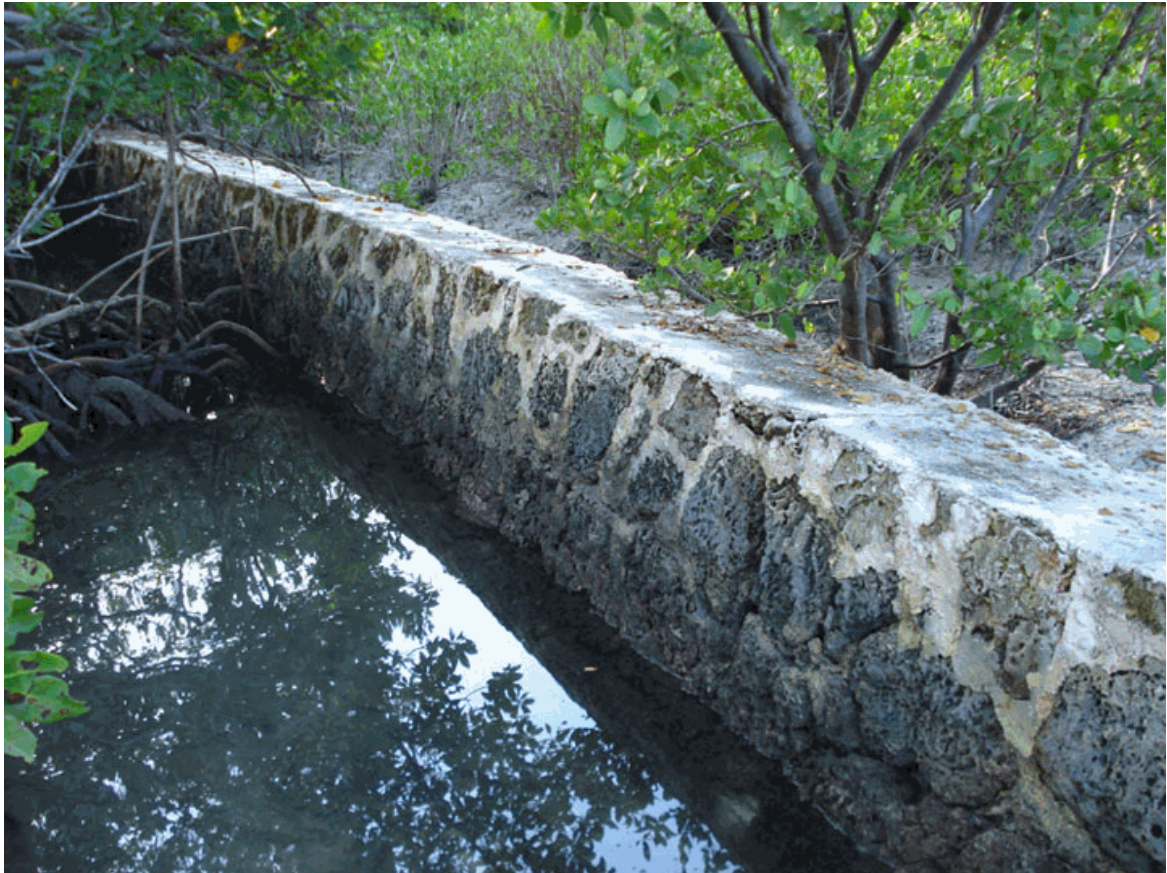
*Graphic 55: Drainage canal*

This drainage canal is visible from the nature trail just south of the historic district. A small portion of limestone wall associated with the original construction of the canal remains. The stone wall is leaning and appears to have recently been repaired. Due to a substantial loss of material this feature is considered a non-contributing resource.

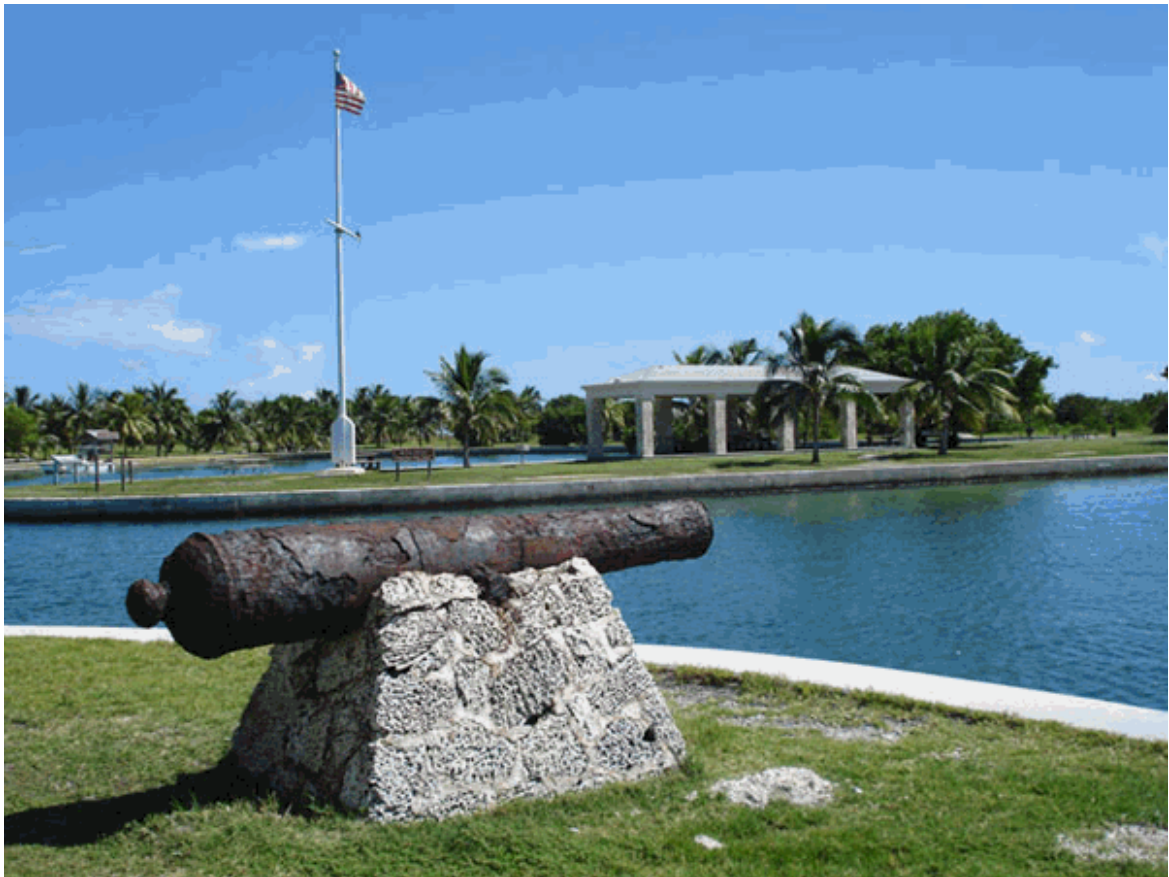
*Graphic 56: Boca Chita Cannon*

The cannon is located near the base of the lighthouse at the mouth of the harbor. An oolitic limestone base supports the cannon. The cannon is badly corroded, while the stone base is in good condition.

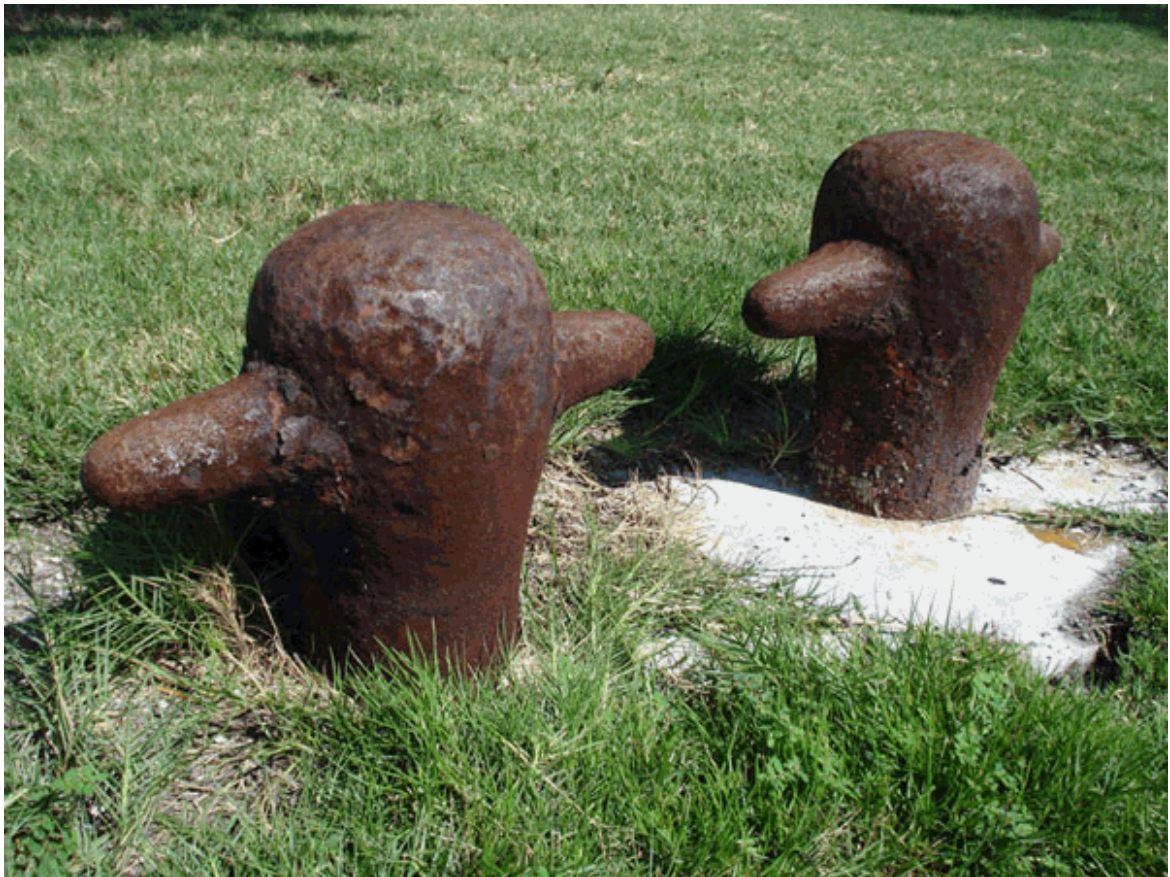
*Graphic 57: Steel bollards*

A pair of bollards is located at the north end of the harbor at the terminus of the boardwalk. A second pair is located on the east side of the harbor along the boardwalk. Both pairs of steel bollards are located in the same positions that were recorded in the 1994 survey of the property but appear to have been reset in new concrete bases. The bollards are badly corroded.
