# **Facilitating migration of coastal landforms and habitats by removing shore protection structures**

## *An adaptation strategy for Northeast Region units of the National Park Service*

Natural Resource Report NPS/NER/NRR—2016/1240

June 2016

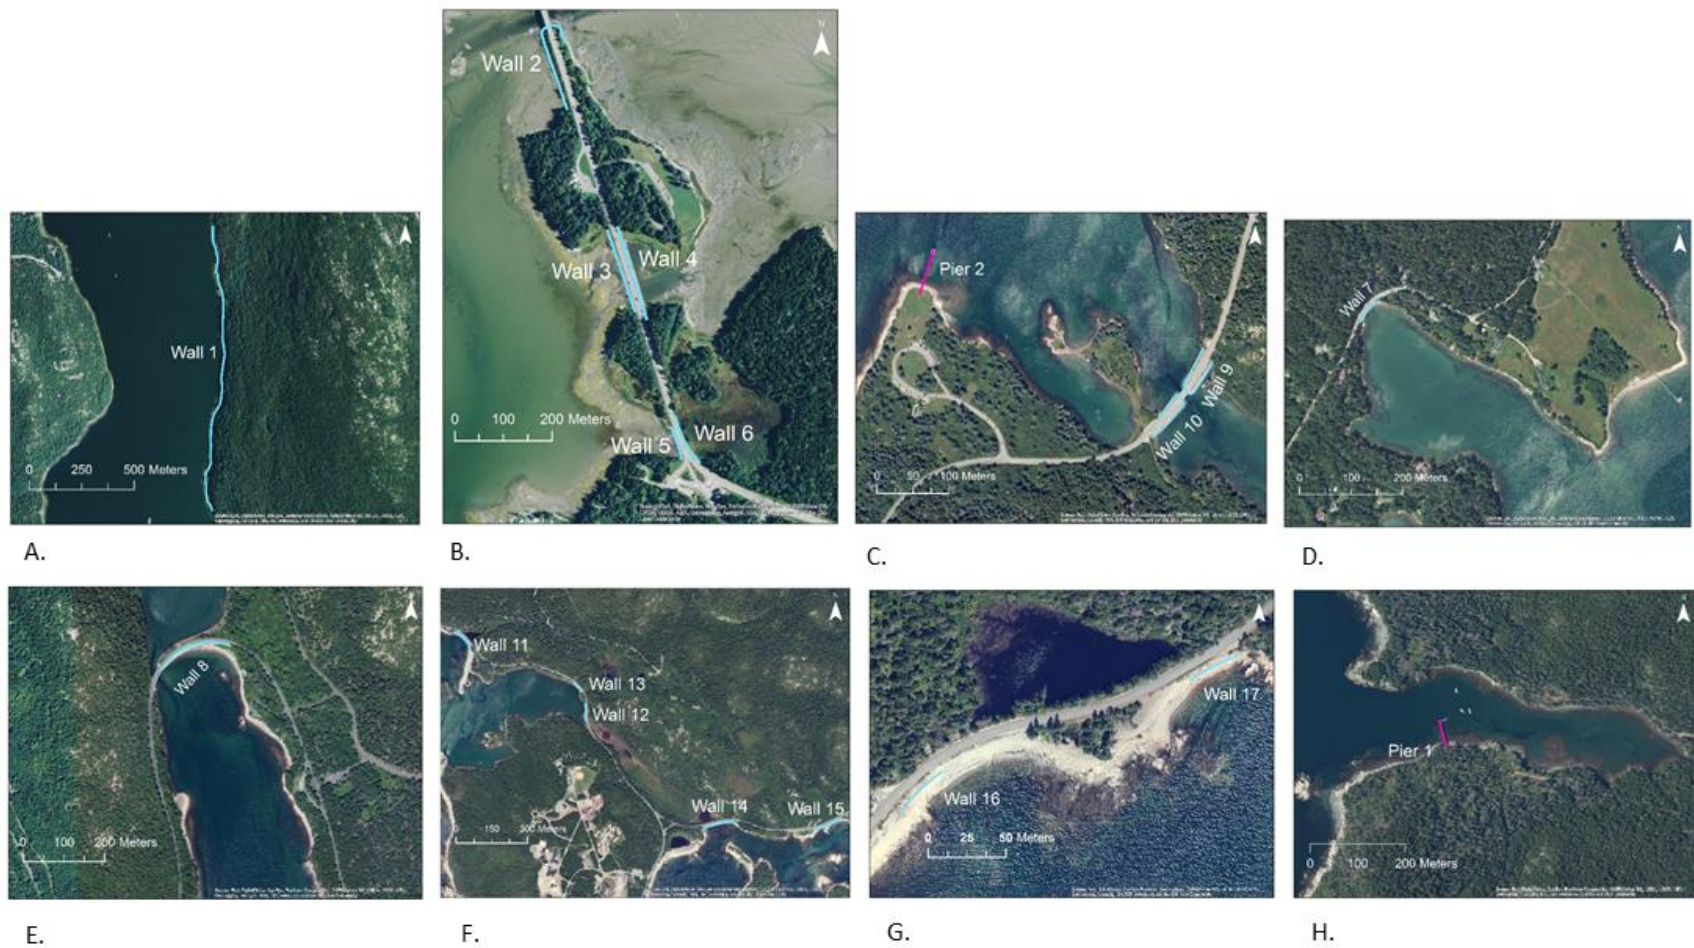
**Figure 5.** Setting of structures at Acadia National Park.

Key geologic aspects of Acadia National Park (Figure 4) include its high local relief and exposure of wave-planed and glacially-scoured igneous and metamorphic rocks (granite, schist). The human imprint is less conspicuous than in many coastal parks, except near the shoreline, where access roads provide vistas of the water. The high local relief results in great local diversity of habitats. These habitats transition from maritime to mountain summit within only a few kilometers (Harris et al. 2012). The complexity of the shoreline and presence of offshore islands result in great local differences in exposure to ocean and locally-generated waves. Some sites protected by structures are fully exposed to ocean waves; other sites are in bays where fetch distances are less than 1 km (Figure 5). The large amount of bedrock in the coastal formations results in creation of gravel beaches in some locations and bedrock outcrops at the waterline in others. Sandy beaches are confined to small isolated pockets, except at Sand Beach (Figure 6, left panel). Most of the protection structures in the park (Appendix A, Table 1) were built to protect roadways that are still used, in contrast to many coastal parks, where remnant structures protect infrastructure that does not perform its original function. Loop roads on the southeast side of Mount Desert Island and the southern portion of Schoodic Peninsula are close to the shoreline and low, resulting in a threat from wave overwash, with deposition of boulders and cobbles on their surfaces during storms. Some of the roads function as barriers to landward migration of the gravel beaches seaward of them (background of Figure 6 right panel).

Many protection structures appear to be non-engineered dumped rip-rap. This rip-rap has a chemical composition similar to the naturally-forming gravel beaches, but the blocks are larger, more angular, with less sand and pebbles within the boulder/cobble matrix (Figure 6 right panel). Engineered walls, with fitted quarry rock, occur where roads on bridges or filled causeways cross bays. The rock used to build protection structures in the park is less intrusive visually and environmentally than the rip-rap used to protect sandy environments in most other coastal parks. Some of the roads and rip-rap placed across bays prevent tidal exchanges between ocean and bay; other protected roads have culverts that allow for tidal exchanges but at restricted rates of flow. Most of the bays are small and steep-sided, so the areas of existing and potential saltwater wetland that would be affected by removal of protection structures are small. Some bays are relatively large, such as at the road at the Natural Seawall site (Figure 4).

Rising sea levels will increase the potential for onshore migration of gravel beaches, erosion of unconsolidated (e.g. soil covered) portions of the upland, and flooding of locations formerly above the influence of the sea. If no new rip-rap is emplaced, sediment in gravel barriers will be transported across the roads, and the substrate of the roads will be eroded by storm waves, resulting in undermining and structural failure. The steeply sloping coast and bedrock foundation will limit the area affected by shoreline retreat but make construction of new roads difficult. Relocation of threatened coastal roads is not as easy to accomplish as in coastal parks that are on low-lying sandy formations. Protecting the roads by traditional structural methods would require placing new rip-rap where it has not been needed before and increasing the height of rip-rap where it already exists. This would keep the sediment that is in the gravel beaches seaward of the rip-rap rather than being transported across roads.

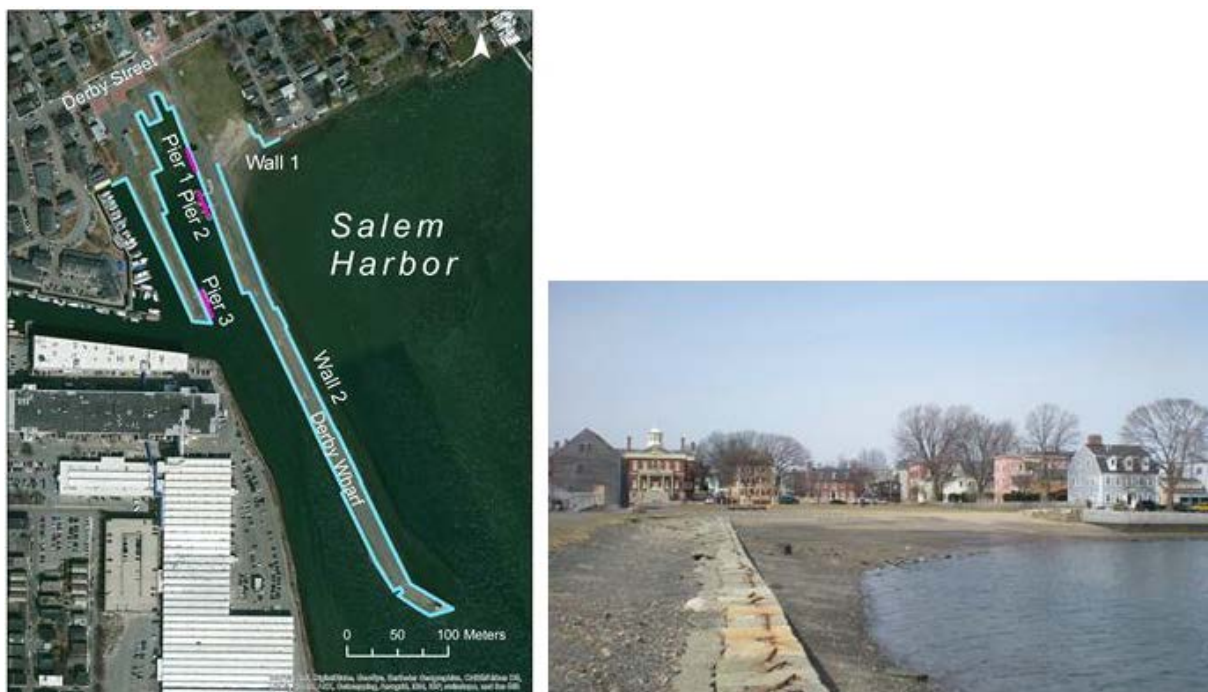
The park occupies a small parcel of land within the town of Salem and on the shore of Salem Harbor (Figures 7, 8). The park is subject to flooding from storm surges generated in the Atlantic Ocean, ocean-generated waves entering the harbor from the northeast, and waves generated within the harbor across fetch distances up to 1.9 km. The park consists of several historic buildings, three wharfs, intervening land between the historic buildings and wharfs that is landscaped using lawn grass, and a beach located on the bayward side of the largest extent of lawn. The wharfs and the short length of upland between them are protected by bulkheads. The longest wharf, Derby Wharf (Figure 8), extends 505 m into the harbor. The bulkhead segments along the wharf (Appendix A, Table 2) are constructed alternatively of wood or rectangular uniformly placed rocks. The center of Derby Wharf is managed as a walkway. Wave splash over the bulkhead on Derby Wharf has eroded portions of the fill along much of its length (Figure 8, right panel) and, in the bayward portions, the pedestrian pathway on top of the fill.

Derby Wharf is the oldest extant historic resource in the park. The wharf is a fundamental landscape element of the park and provides access to the bay for views of the harbor as well as protection to private holdings to the west outside park boundaries (Figure 8). The only portion of park shoreline not protected by a bulkhead is occupied by the 50 m long beach. This beach is the only landform or habitat in the park that is allowed to evolve by natural coastal processes unconstrained by shore protection structures. Beaches in urbanized estuaries are opportunistic landforms that occur in areas of remaining unconsolidated upland formations or where shore perpendicular structures trap the limited amounts of sediment moving alongshore. These two conditions have contributed to maintenance of the beach here. The beach sediments are poorly sorted and poorly graded across the shore, which are diagnostic characteristics of low wave energy. The accumulation of angular quarry gravel that has fallen from the fill within the wharf gives the beach an unnatural appearance. This quarry gravel and the poor grading and sorting of the rest of the beach sediment reduce the aesthetic value of the beach. Nevertheless, the beach is evolving by natural processes, including overwash onto the grassy area landward. Beaches like this were common locations for boat launching in the past, so the beach has cultural relevance as well as natural value.

**Figure 8.** Salem Maritime National Historical Park. Left panel shows structures evaluated in text and Appendix A, Table 2. Right panel shows Derby Wharf (on the left side) and the beach and historic buildings in the background.

Removing the wall around Derby Wharf would have little value in creating natural habitat because the fill landward of it is artificial and of limited volume. As an intertidal feature, it would not mimic any natural feature that would have occurred there in the past. Removal of the wall would eventually allow waves to break on the wall fronting the private developments to the west (Figure 8, left panel). Leaving the wall in place, allowing more of the fill to erode from within, would retain the historical context of the wharf but restrict or prevent its present use as a pedestrian walkway. The walls around the remnant wharfs would be visible most tidal stages and could be marked to identify their locations during high water levels. The NPS will likely consider bolstering the wharf to protect the landscape and visitor use and provide a more sustainable walking path, because of the overriding historic and protective value.

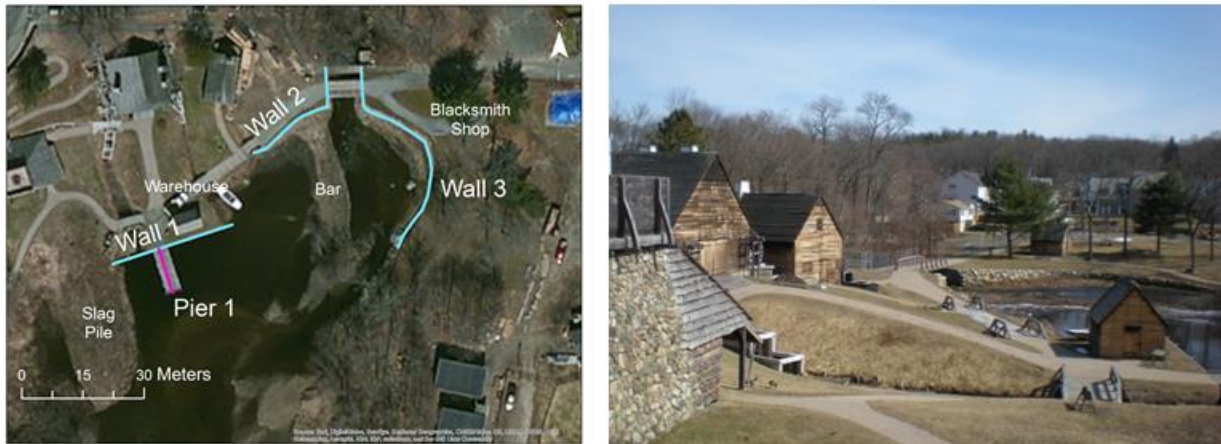
The park (Figure 9) is on the margin of Saugus River and surrounded by suburban development. Most of the buildings in the park are close to the water. Several are above flood levels likely to occur in the next few decades, but two (Waterfront Warehouse and Blacksmith Shop, Figure 9) are presently flooded at their bases during extreme events, as are portions of the grassy area, walkways, bridges and pier. These locations are protected from wave erosion by low walls (Appendix A, Table 3). The fetch distance for wave generation across the river basin to the south is only 310 m even when the basin is flooded, and the shallow bottom would restrict wave generation. In 2007-08 a major waterfront and river corridor restoration project was implemented that re-established the open water “turning basin” south of Pier 1 (Figure 9) and tidal mudflats. Wave energies are too low to prevent colonization of the unprotected shore of the basin by vegetation. Wave erosion may not be a critical issue where vegetation protects the banks in the basin, but the expected higher flood levels associated with sea level rise, combined with stream currents, have the potential for inundating and scouring a narrow portion of the grassy margin of the developed area, particularly at the base of the upland where the Saugus River empties into the wider basin. The bar there (Figure 9 left panel) directs the current toward the east bank. The rock retaining wall emplaced there prevents critical bank erosion, but susceptibility to future erosion is evident in scour of the surface of the upland just landward of the wall. Farther south, the flat intertidal gradient and vegetation growth on the margin of the basin indicate that the upland is not subject to erosion away from the channel. Trees growing in low portions of the slope landward of the tidal flat and marsh may become increasingly inundated with future increased water levels, converting portions of the woods into marsh, but the steep upland will confine the marsh to a narrow fringe. Sea level rise should not markedly change the dimensions of the basin due to steep slopes. Thus, the energy of locally generated waves is not expected to increase appreciably in the next several decades. Raised water levels and increases in rainfall and stream discharge may increase the susceptibility of the lower buildings to inundation.

**Figure 9.** Saugus Iron Works National Historic Site. Ground view, looking east, shows the high ground to the north (left) and the low elevations at the river outfall, Iron Warehouse, Blacksmith Shop, paths and bridges in the right background.

The slag pile (Figure 9, left panel) is protected at the base by a ring of cobbles. It is susceptible to leaching during rain and may be susceptible to sloughing above the line of cobbles when inundated by sea level rise. The pile is known to contain priority pollutant metals (PPM) and polycyclic aromatic hydrocarbons (PAH), and the Massachusetts Department of Environmental Protection has placed an Activity and Use Limitation on the property, which prohibits public access as well as any digging. The slag pile is also a key remaining archaeological feature, so removal may not be a viable option. The substrate would not make suitable habitat if allowed to erode, because of pollutant levels within it. It is likely that these cultural byproducts were left to interact with shore processes in the distant past, but modern practice would argue against allowing this traditional practice to occur in the future, and increasing the size of the wall around the slag pile in the future may be appropriate.

The three bridges along the path over the Saugus River and the pier are low and are likely to be inundated by higher water levels in the future. Structural damage to the bridges by waves is not likely but ice damage is possible. Consideration could be given to relocating the path, the bridges and the Waterfront Warehouse and Blacksmith Shop. Protecting the structures with higher walls is incompatible with natural accommodation strategies, although the minimal amount of natural habitat that would be created by reverting to natural processes may justify protecting the structures in place. The absence of erosion scarps at the beach/upland contact within most of the basin implies that shoreline retreat is not presently critical.

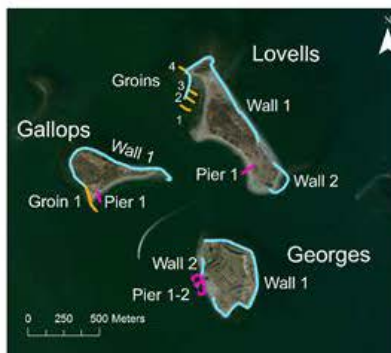
C. Lovells, Gallops and Georges Islands

Lovells Island is exposed to relatively high wave energies at the mouth of the harbor, but it also provides partial shelter to several islands within the bay (Figure 11). The island is now managed, in part, to protect natural resources, such as a Least Tern nest colony, although the characteristics of the shore and its evolution are not natural. The wall on the central ocean-facing portion of the island (Lovells Island Wall 1 Appendix A, Table 4) protects Fort Standish, an abandoned fort built about 1900 and now unused and overgrown (Figure 12, left panel). The portion of the same wall just north of Fort Standish (Figure 12, right panel) now functions as a barrier to wave uprush during small storms but not high surges. Removal of the wall here on the eastern shore of the island would result in increased wave attack of the base of the central bluff, with delivery of more sediment to the beach. The structures at Fort Standish would eventually be exposed on the beach and function as a temporary groin and then as a short revetment until the shoreline migrated landward of it. More frequent overwash would occur into the marsh on the northwest side of the island (landward of the beach in Figure 12 right panel). These changes would occur even if the wall were not removed, although at a much slower rate since the wall would remain as a sill, initially embedded within the landward migrating foreshore and eventually ending in the nearshore.

**Figure 12.** Riprap of Lovells Island Wall 1, protecting the east-central portion of the island (Figure 11C). Fort Standish is buried behind the high ground to the left on the left panel. The right panel shows the portion of wall north of Fort Standish. The wall here separates the foreshore from the storm beach and restricts overwash landward.

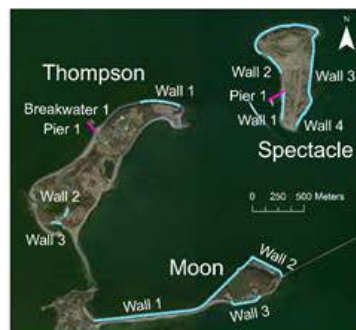
E. Thompson, Spectacle and Moon Islands

**Figure 13.** Thompson Wall 1 (Figure 11E), showing greater erosion on the unprotected bluff on the south (right) side of the wall than on the bluff landward of the wall.

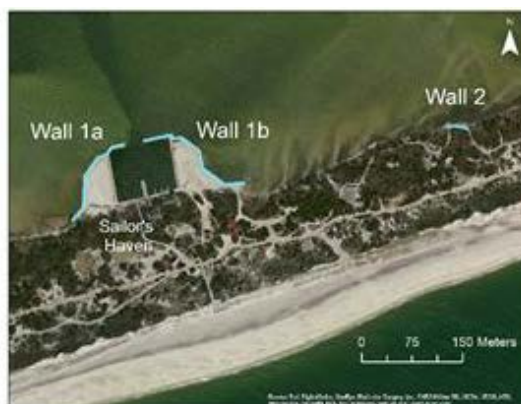
B. Sailors Haven

If marinas cannot be rebuilt to be more compatible with sediment transfers alongshore, mitigating action can be taken by using material dredged from the navigation channels to nourish adjacent beaches. The project to establish a feeder upland at Sailors Haven Marina (Nordstrom et al. 2010) is an example of a way to compensate for marina construction while helping overcome the bayside sediment deficit caused by human actions on the ocean side.

**Figure 17.** Eroding shore east of Sailors Haven Marina Wall 1b, Figure 16B, showing beach transgressing the marsh (far right) and undermined trees falling onto beach (center background).

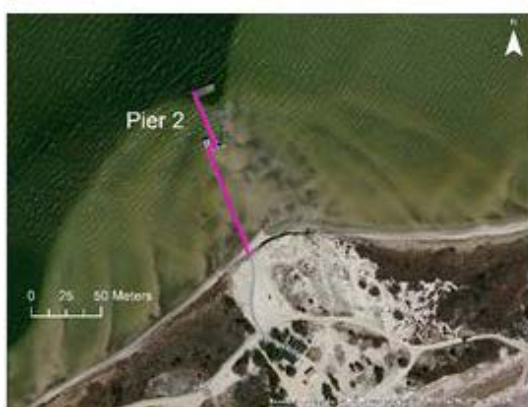
C. Talisman

The advantages of diminishing the environmental footprint of marinas are apparent at Talisman. The pier there (Pier 2, Figure 16C) is a replacement for a former marina that projected 125 m into the bay and was protected by a bulkhead that created a barrier to longshore transport. The new pier is on pilings and allows for alongshore sediment transport on the beach. The bulkhead at the old marina extended 90 m alongshore. The sediment that was sequestered landward of it has been allowed to erode since construction of the new pier, and has moved alongshore to partially nourish adjacent beaches. The pier is more compatible with natural dynamics than a marina protected by a bulkhead and provides a good example of a way of accommodating natural processes while maintaining access. Piers do not eliminate the need for dredging to maintain depths for deep-draft vessels, so their use for accommodating large boats is not totally benign. Provision of a pier may also lead to demands for provision of support facilities. Piers are not necessary to accommodate use of small boats.

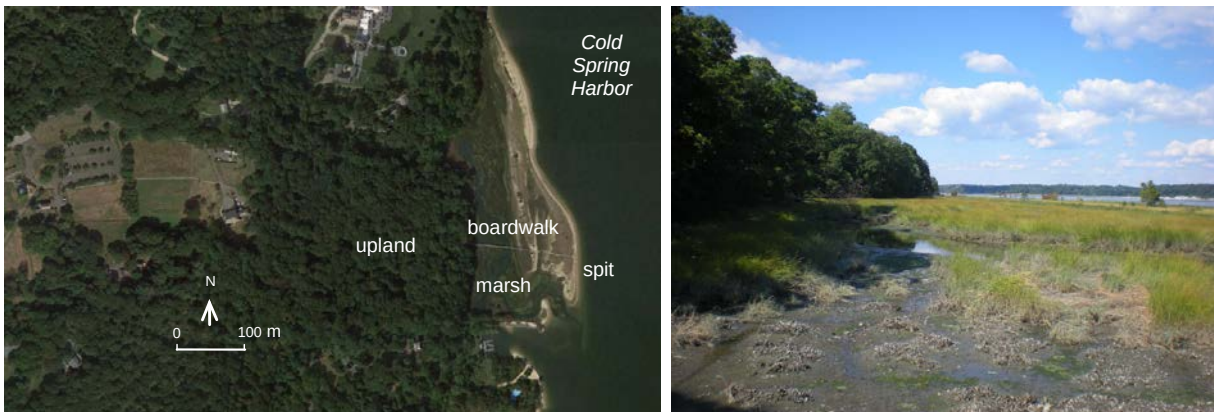
wave generation potential from the north but still favors sediment transport to the south. Southerly transport of sand and gravel has created a 35-70 m-wide spit on the east side of the park (Figure 18 left panel). A 65-140 m-wide marsh separates the upland from the spit. The only structure near the water is a boardwalk over the marsh. Wave energies within Cold Spring Harbor are low, and the spit and marsh provide adequate protection against erosion of the upland. The energy of locally generated waves is not expected to increase appreciably in the next several decades. Increased inundation of the marsh may occur in the future.

**Figure 18.** Sagamore Hill National Historic site, showing the relatively great distance of fixed infrastructure from the shore (left panel) and the lack of erosion of the upland landward of the spit and marsh (right panel).

The lack of evidence of active erosion of the shore landward of the marsh (Figure 18 right panel) implies that there is no immediate threat from shoreline retreat during small storms. Periodic flooding during high intensity storms would not penetrate more than a few meters into the steep upland. The visitor center and other buildings are at least 450 m from the seaward edge of the spit and are located on high land. They are not threatened by erosion or flooding in the near or distant future. The boardwalk is on pilings. This method of construction allows for passage of water and sediment and thus does not interfere with evolution of the marsh. The lack of historical infrastructure or visitor facilities other than the boardwalk implies that there is no need for structural protection if future sea level rise or interference with the longshore sediment budget by human actions to the north result in beach retreat.

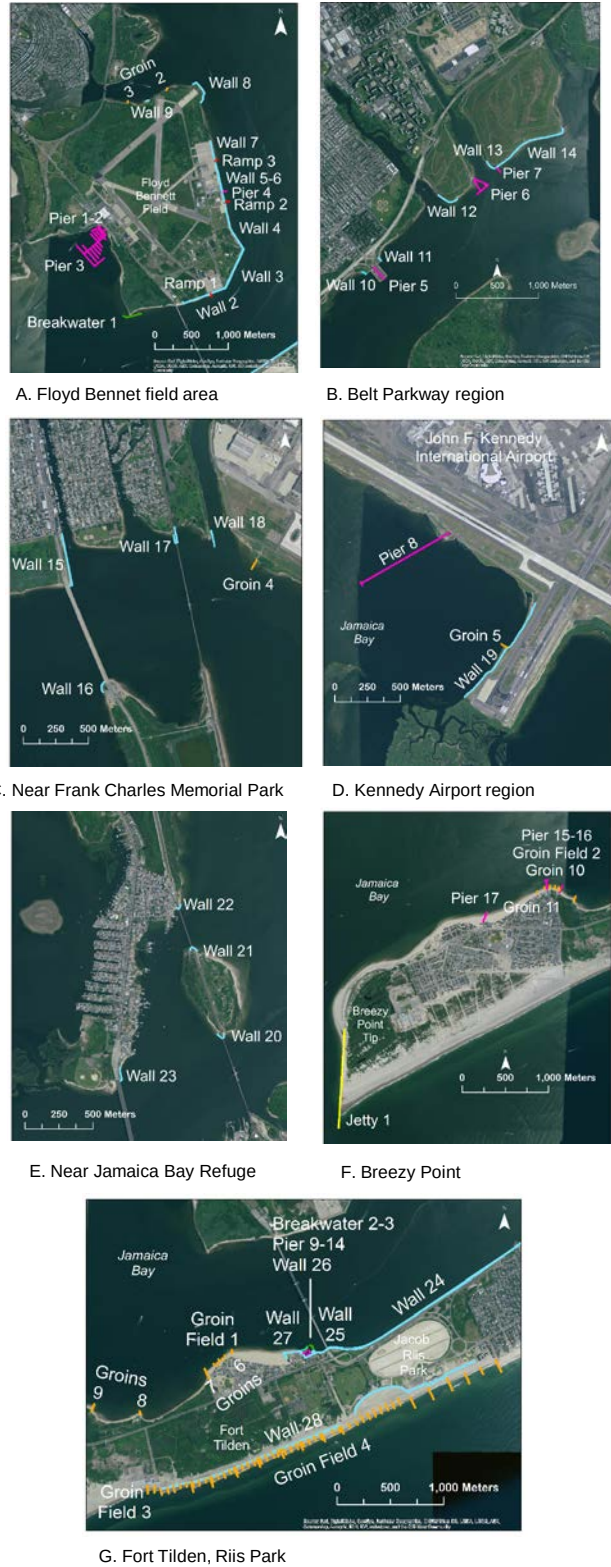
**Figure 20.** Structures evaluated at the Jamaica Bay Unit, Gateway National Recreation Area. Sites identified and drawn based on Dallas et al. (2013b) but number designations of structures and type of structures may differ (see Appendix A, Table 7 for differences).

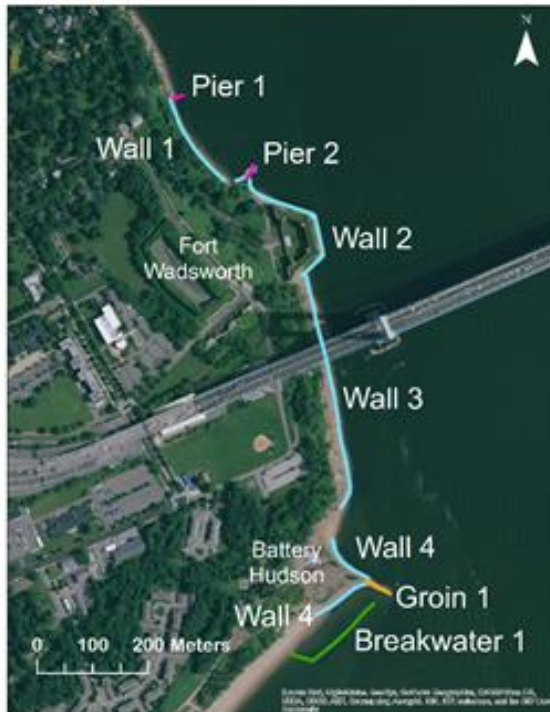
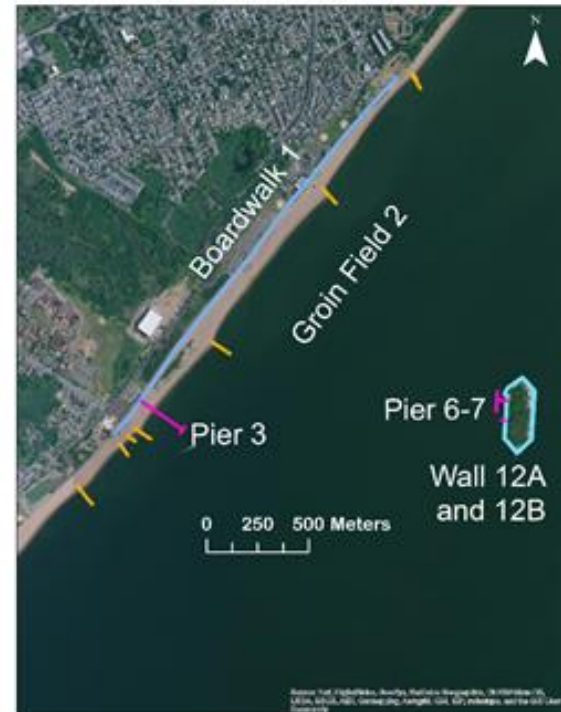
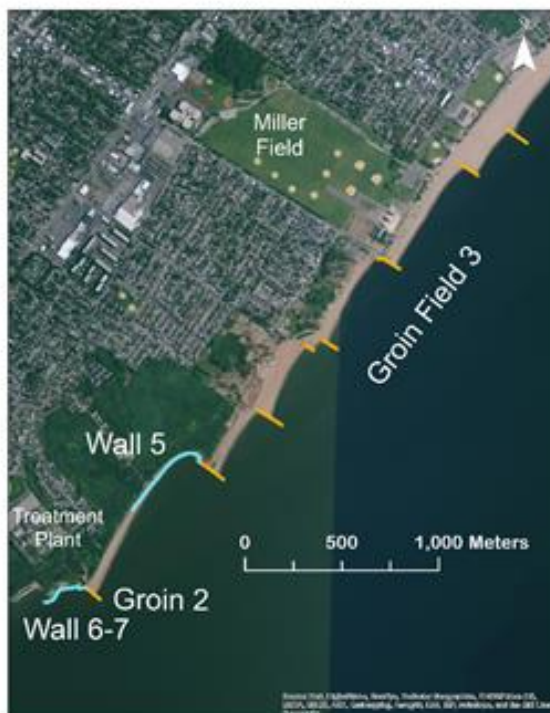
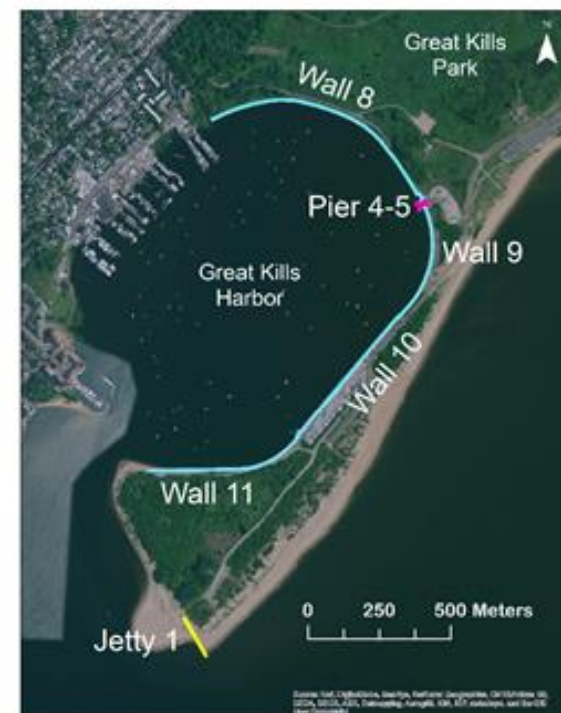
**Figure 22.** Structures evaluated at the Staten Island Unit, Gateway National Recreation Area. Sites identified and drawn based on Dallas et al. (2013b) but number designations of structures and type of structures may differ (see Appendix A, Table 8 for differences).

Natural landforms are already beginning to become reestablished landward of weak points at Wall 6 (Figure 22C). Wall 7, which extends the effect of Wall 6 southward, would have little use if Wall 6 degrades further. Removal of these structures is not suggested because of the proximity of the Oakwood Beach Wastewater Treatment Plant landward of them. Allowing these two walls to remain while they deteriorate would provide some erosion protection, even as the shoreline evolves to more natural conditions. The bulkhead at Wall 8 (Figure 22D) could be removed because there are no key features landward of it. This site and a site on the eroding bluff shoreline in the northern portion of the park (at Battery Hudson) are singled out as case studies to provide perspective on the issues involved in restricting the future use of structures or removing structures in the Staten Island unit.

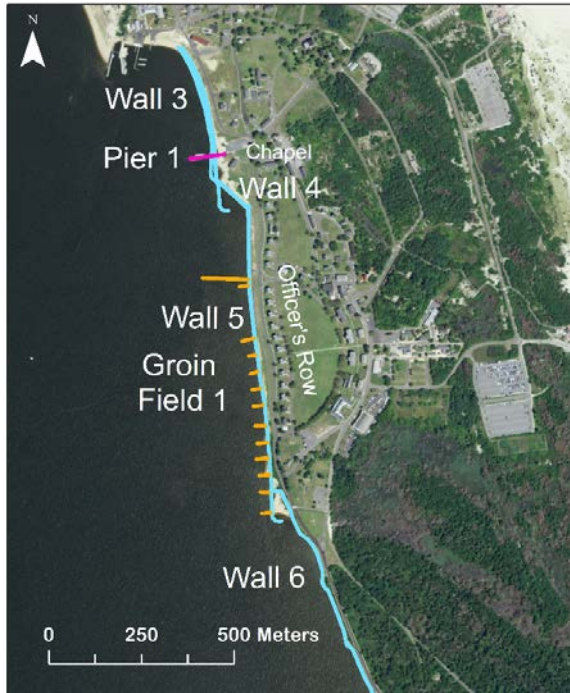
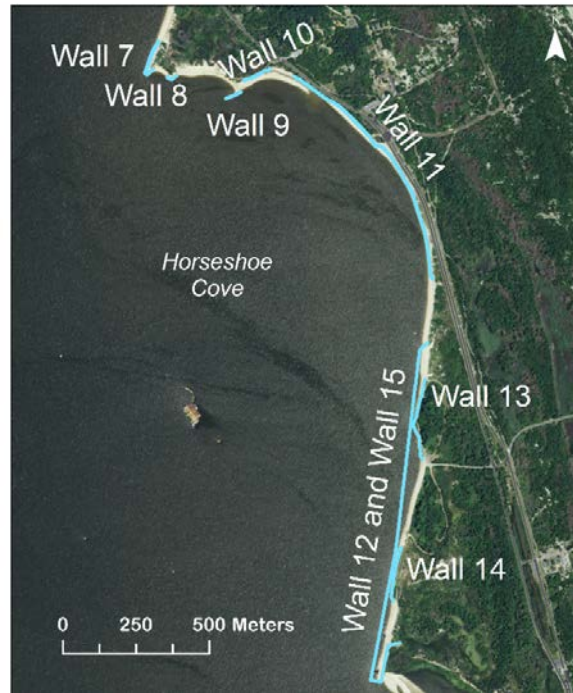
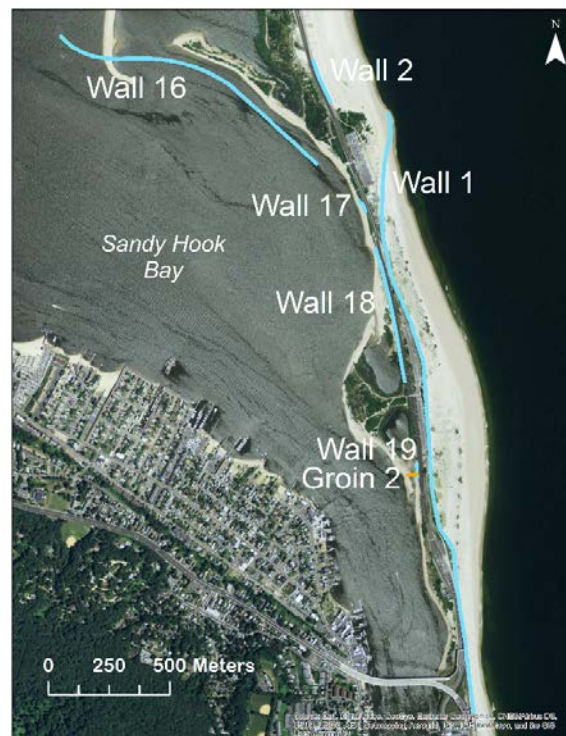
**Figure 25.** Structures evaluated at the Sandy Hook Unit, Gateway National Recreation Area. Sites identified and drawn based on Dallas et al. (2013b) but number designations of structures and type of structures may differ (see Appendix A, Table 9 for differences).

Nineteen of the structures in the twenty-two locations on NPS land (Figure 25) are shore-parallel walls. All but two of the walls represent initially well designed structures. Wall 8 (Figure 25B) is a building that eroded in place, with its concrete remnants now functioning as a revetment. Wall 14 is dumped concrete and asphalt rubble. The quarry stone seawalls are in good condition except for a few spots where settling has lowered the top elevation slightly. Most of the seawalls have a top elevation corresponding roughly to the elevation of the land behind them. Five of the six wooden bulkheads on the bay shore have deteriorated and have little present effect on shoreline change, as revealed in formation of beaches or erosion scarps in the upland landward of them. Two locations have groins fronting seawalls. The groins at Groin Field 1 (Figure 25A) have negligible amounts of sand within them. Groin 2 (Figure 25B) is a single structure that acts as a training wall for tidal currents and sediment entering an embayment. Pier 1 (Figure 25A) is elevated on pilings and has negligible impact on shoreline change. Eight more structures (two breakwaters, two walls, three piers and one groin) are located on Coast Guard property on the bay side of the spit north of Pier 1 and are not evaluated here.

Battery Kingman, landward of Wall 13, is a massive structure and is difficult to remove. It makes little sense to remove Wall 13 and allow the narrow strip of upland to erode if the battery will then act as a barrier to natural processes as has occurred at the structure that now functions as Wall 8 (Figure 25B).

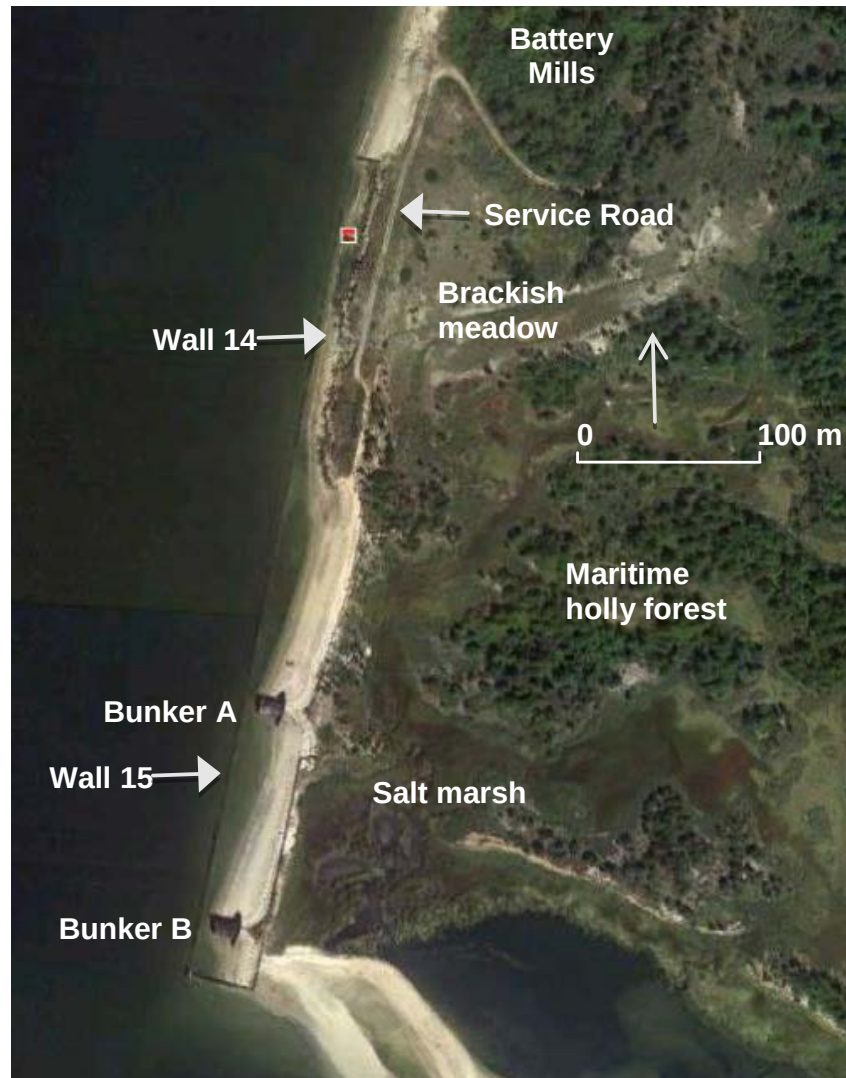
This portion of Sandy Hook had been stabilized by a long wooden bulkhead in the past, but the bulkhead has deteriorated and remains as Walls 12 and 15 on Figure 25. The portion of Wall 15 facing the saltmarsh to the east is intact (Figure 26) but the portion facing west has deteriorated, and the beach behind it is now more mobile than in the past. No clearly demarcated public access to the shore exists in the vicinity of Walls 12 to 15. Battery Mills is 25 m from the seaward edge of the eroding headland. No functional shore protection structures are directly bayward of Battery Mills, but a short groin-like extension at the northern end of Wall 14 helps retain sediment bayward of the battery. Wall 14 is dumped concrete and asphalt riprap, placed to protect the service road that provided access between the batteries and the bunkers. The debris is only partially effective in providing protection to the upland landward of it because it is too small to withstand wave attack, and bluff erosion is occurring in places. The asphalt blocks could be removed because they can have potentially adverse effects on biota. The concrete blocks are chemically benign, but they would introduce an exotic habitat in a naturally functioning nearshore.

The two ammunition bunkers in the sand-starved segment south of Wall 14 are no longer protected by the west side of Wall 15 and are exposed on the beach (Figure 26). The eastern intact portion of Wall 15 still prevents overwash from the bay onto the marsh landward of it. Some sediment has passed beyond the south end of the bulkhead, but the volume is not sufficient to prevent onshore migration of the spit that formed there (bottom of Figure 26). The southern portion of the bulkhead now forms a salient that functions as a hinge point in the shore. Eventual natural destruction of the bulkhead will eliminate this stabilizing effect but leave remnants stranded offshore. Pilings remaining as remnants of the deteriorated western portion of Wall 15 are likely to exist in place for decades, as will the concrete in the bunkers. Little reason exists to retain Wall 15 as a structural headland with no historic or human-use value. If removal of the bulkhead and bunkers are desired options, this should be done soon, while vehicular access still exists via the beach (Nordstrom and Jackson 2013).

**Figure 26.** Structures and environmental resources at Walls 14 and 15, north of Spermacetti Cove, Sandy Hook Unit (modified from Nordstrom and Jackson (2014)).

Removal of Wall 15 would result in overwash into the marsh at its southern end and replace a resistant artificial headland with an eroding headland in other places, contributing to an increase in the amount of sediment delivered to the spit southeast of the present terminus of the wall. The low elevation of the beach landward of Wall 15 indicates that overwash onto the marsh would occur as soon as the wall is removed. The upland just landward of Wall 14 is too high for overwash to occur into the brackish meadow landward of it (Figure 26). The lowland there may experience flooding with sea level rise because the stream that runs through the marsh provides a conduit for bay water. The newly inundated land will be close to existing marsh, facilitating natural colonization by marsh plants. Extension of the marsh inland via stream flooding may partially compensate for loss by inundation of lower portions of the marsh because of sea level rise and burial of bayward portions of the marsh by overwash deposits.

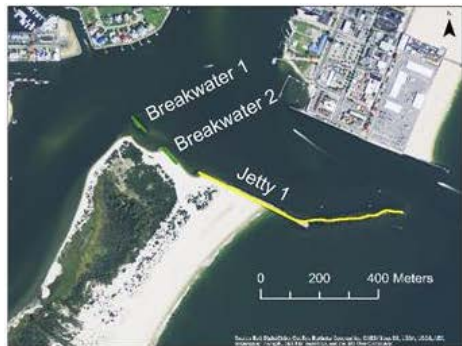
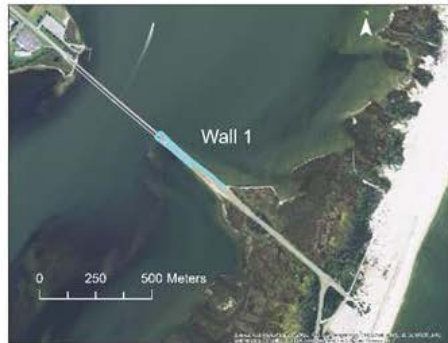
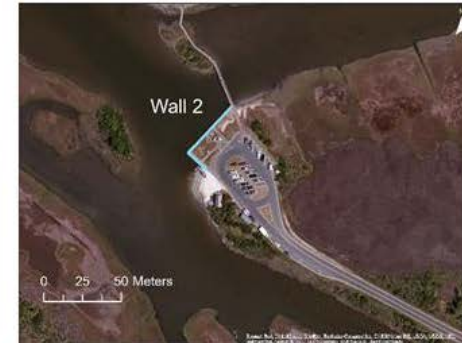
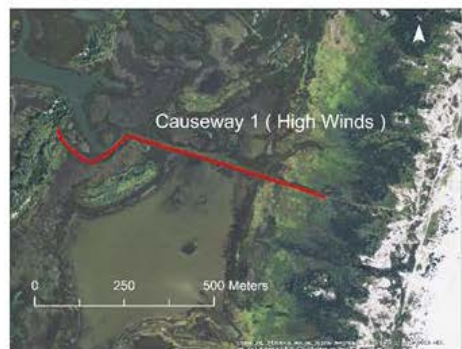
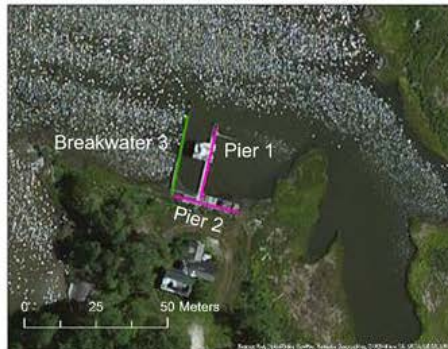
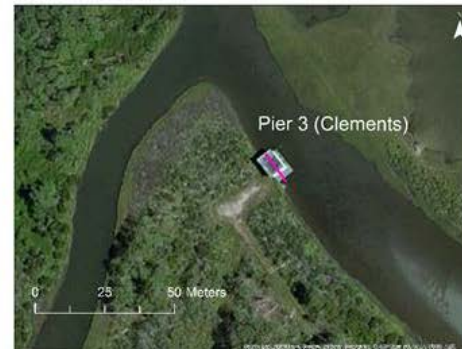
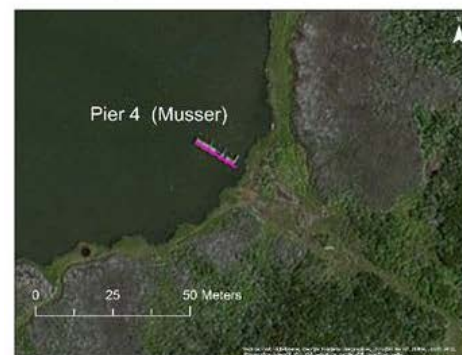
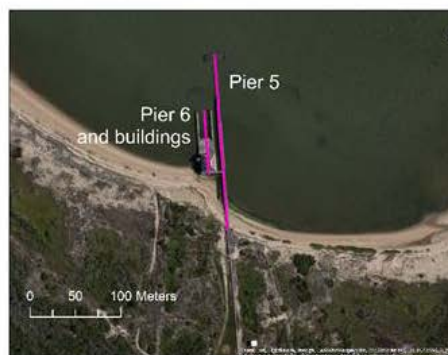
Thirteen structures are identified as complete or partial barriers to shoreline migration (Figure 28, Appendix A, Table 10). Jetty 1 and Breakwaters 1 and 2 are important in maintaining Ocean City Inlet (Figure 28A). Wall 1 (Figure 28B) protects the main access road and bridge to the island, and Wall 2 (Figure 28C) protects a parking lot and interpretive facility at Old Ferry Landing. Little appears to be gained by removing these five structures under current conditions. Piers 1-6 (Figure 28E-H) were associated with past uses and have deteriorated. Piers 5-6 are associated with the US Coast Guard Station boathouse in Virginia. This structure is located within an NPS cultural landscape and is eligible for listing on the National Register. Pier 5 serves as a breakwater and clearly has a localized impact to sediment distribution and shoreline position. Pier 1 and 2 and Breakwater 3 remain as safety concerns and non-sandy exotic habitat although they cause little interference with natural processes. They could be removed or allowed to deteriorate further.

**Figure 28.** Structures evaluated at Assateague Island National Seashore.

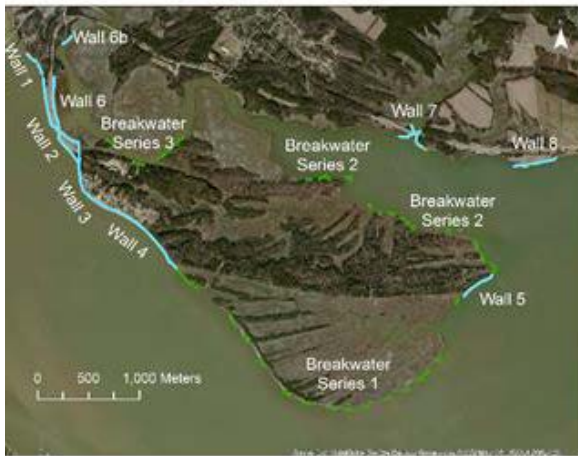
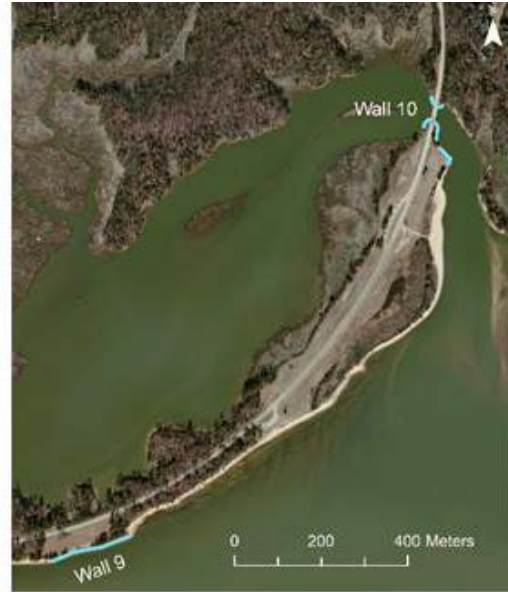
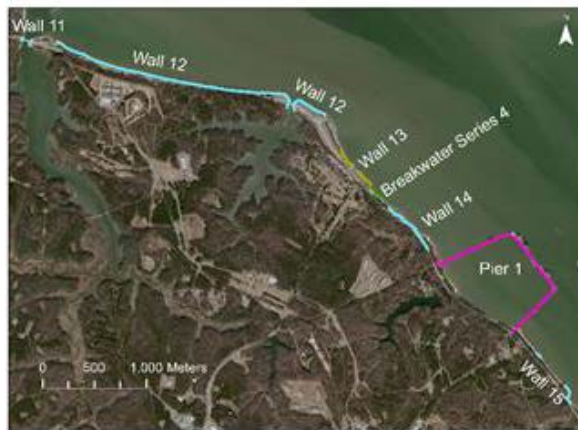
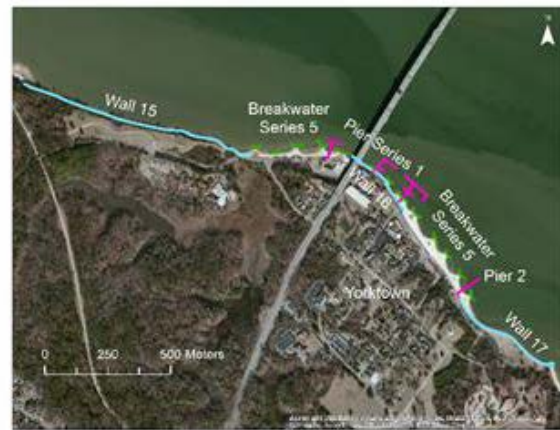
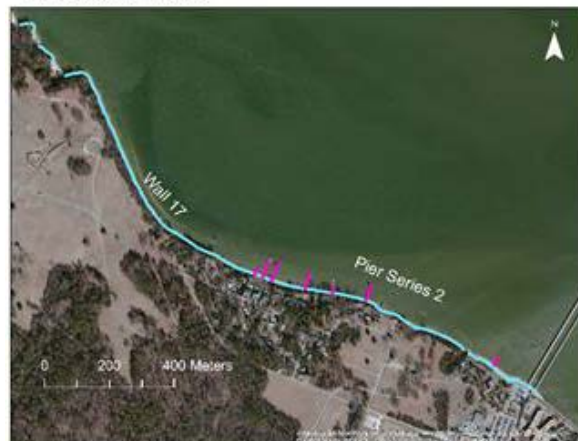
The shore protection structures at Colonial are primarily riprap revetments and offshore segmented breakwaters (Figure 35, Appendix A, Table 12). Future protection strategies for the York River side include constructing or increasing the dimensions of these structures and building new ones in

**Figure 35.** Locations of shore protection structures at Colonial National Historical Park. Sites identified and drawn based on Dallas et al. (2013a) but number designations of structures and type of structures may differ (see Appendix A, Table 12 for differences).

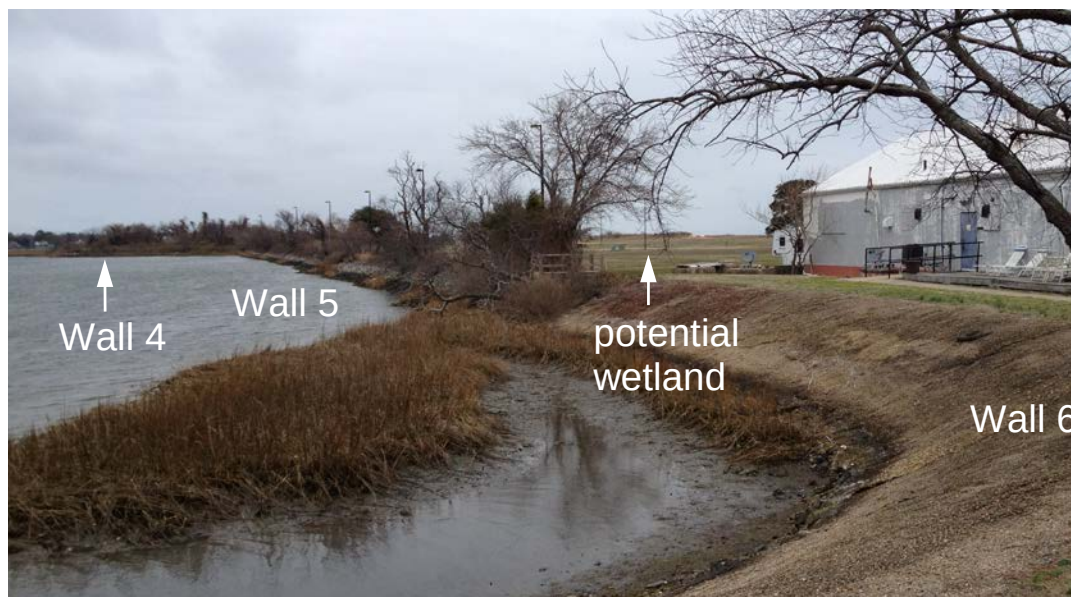
The presence of vegetation along the creek shoreline north of the recreational vehicle (RV) park facilities (Figure 3) implies that shoreline retreat is not presently critical there, although portions of the interior of the spit are subject to flooding. Removal of Walls 1-4 is expected to have little effect on shore processes and evolution of habitats, and the concrete blocks used to construct the walls could remain in place.

**Figure 3.** North end of Wall 6, looking north.

Removal of Wall 5 and the berm landward of it is likely to convert grassland (Figure 3) to more diverse wetland habitat and thus should be considered a future option. This location would make a good demonstration area for evaluating the advantages and disadvantages of removing structures that are still functional but have lost their original rationale. Maintaining so many areas of lawn does not appear necessary for recreation, and lawns have little habitat value relative to wetland. Large expanses of lawn would still exist elsewhere on the spit for future uses. If flooding of the facilities at the RV park becomes an issue, a ring levee could be built around them. A simple earth structure would provide enough protection because wave erosion would not be an issue in this portion of the creek shore.
