Summary Report  
Watershed Rehabilitation Unit 03-01  
LB500, AA2, and PT1 Road Complexes

Ingrid Corson  
Redwood National and State Parks  
December 2003

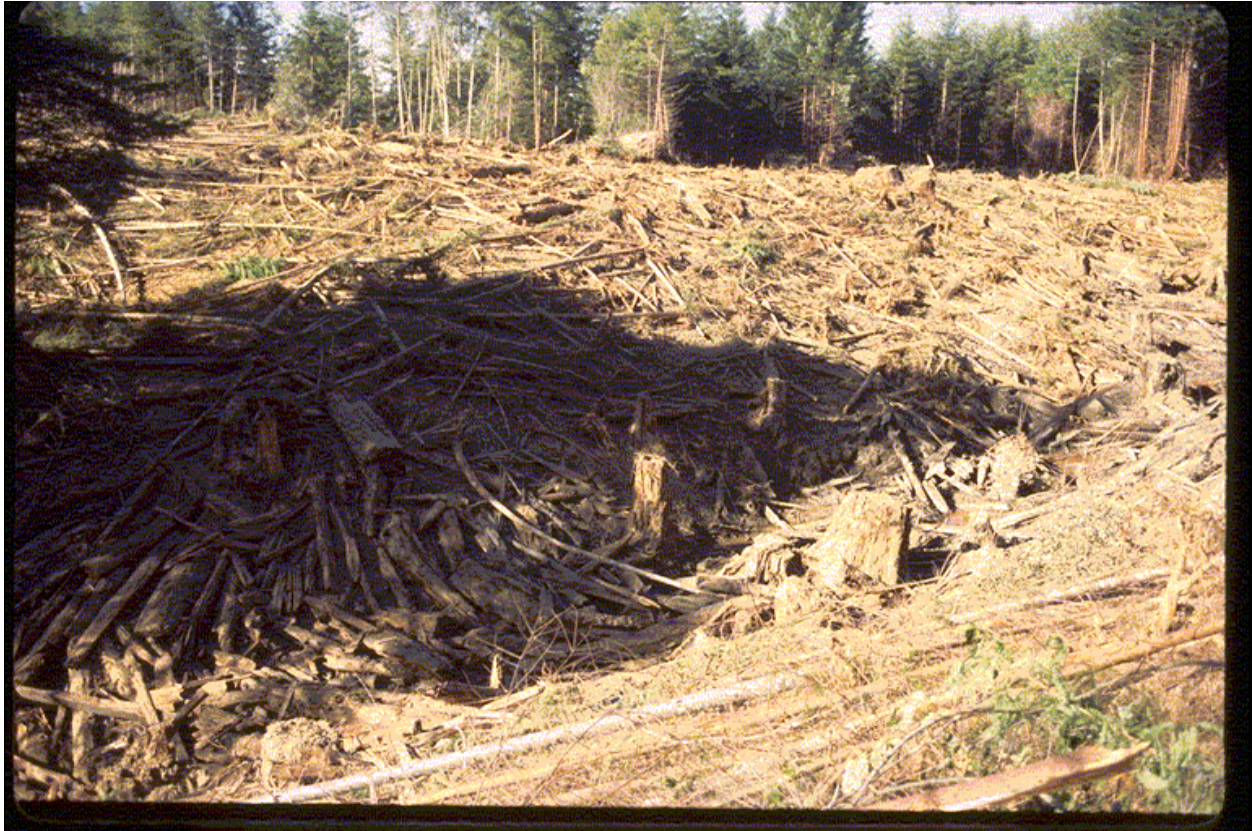
**Figure 3.** Vegetative debris mulching on excavation sideslopes provides for control of surface and fluvial erosion (this depicts a heavy rate of mulch application). Note the excavated stream channel with large woody debris placement in the foreground.

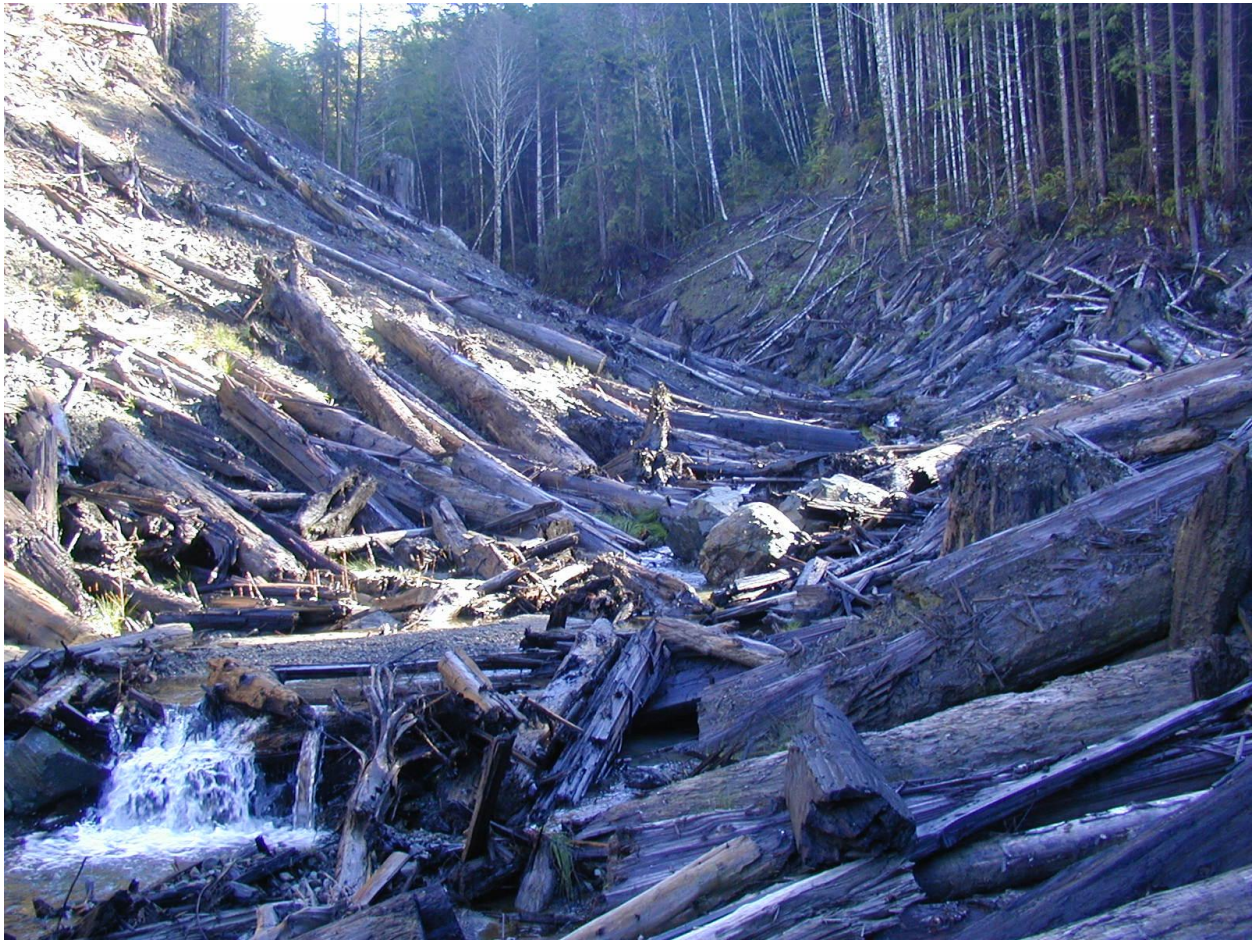
**Figure 4.** A stream crossing excavation with extensive woody debris placement. This photo was taken after the first winter following excavation.
