# Summary Report

## Watershed Restoration Project 08-03:

- Upper B500 – 0803a
- A111 – 0803b
- A112 – 0803c
- A350 – 0803d
- A200 – 0803e
- A100 north – 0803f

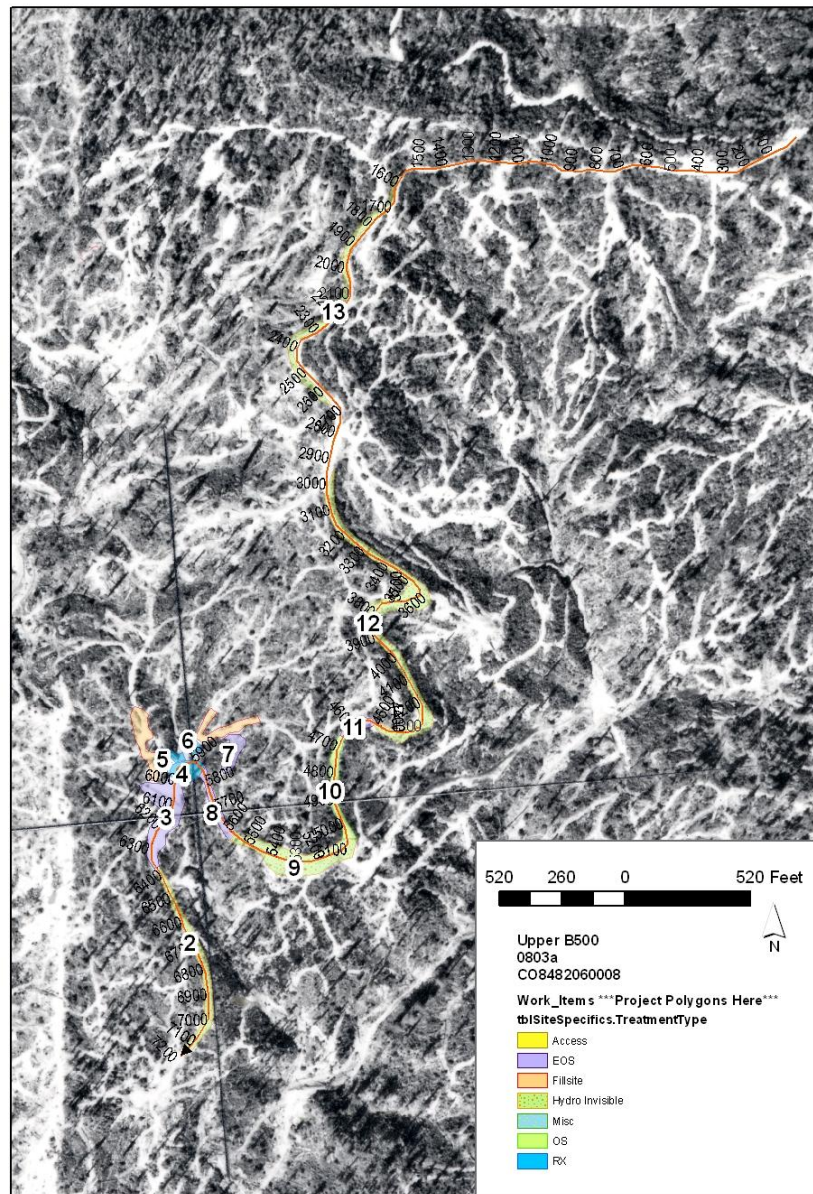
Upper B500, 0803A  
June 16 to July 17

The Upper B500 was constructed in the headwaters of the North Branch of the North Fork of Lost Man Creek. The terminal landing at the end of the Upper B500 was treated in 2007 as a fillsite for the North

Branch North Fork landing (0703b, Work Item 2). The 2008 work focused on 5000 feet of the remaining 7000 feet of road. Most of the road features along the treated portion of the B500 were perched road fills above stream channels. Three small stream crossings and three swales were restored in this phase of the project. A total of 29,278 cubic yards of road fill was excavated in the combined treatments. Additionally, approximately 1500 cubic yards of road surface rock was end hauled off site (approximately 2000 linear feet, 2 feet deep by 14 feet wide). The rock was removed due to its inconsistency and relative volume with the native soils. The material was stockpiled off site for reuse in future road maintenance work.

The first couple of work items addressed a series of swales and springs along a slope above the north branch of the north fork. Work item A4 addressed a stream crossing on the main haul road, while items A5 through A7 treated a series on smaller crossings above Work Item A4. Work item A8 focused on a steep slope with a spring where road fill was perched above the left bank, downstream of the crossing excavation at work item A4. The remaining treatments (work items A9 to A13) focused on removing pockets of perched fill above seasonal tributaries to the north branch of the north fork from station 55+00 to station 15+00. The remaining 1500 feet of the Upper B500 was left to re-vegetate without treatment due to the low potential for erosion and sediment delivery.

During the excavation of the early work items, a heavy layer of surface rock, not native to the area was encountered. For the removal of the later road reaches, the surface rock layer was end hauled to an off site location to allow for enhanced re-integration of the outsloped soils.

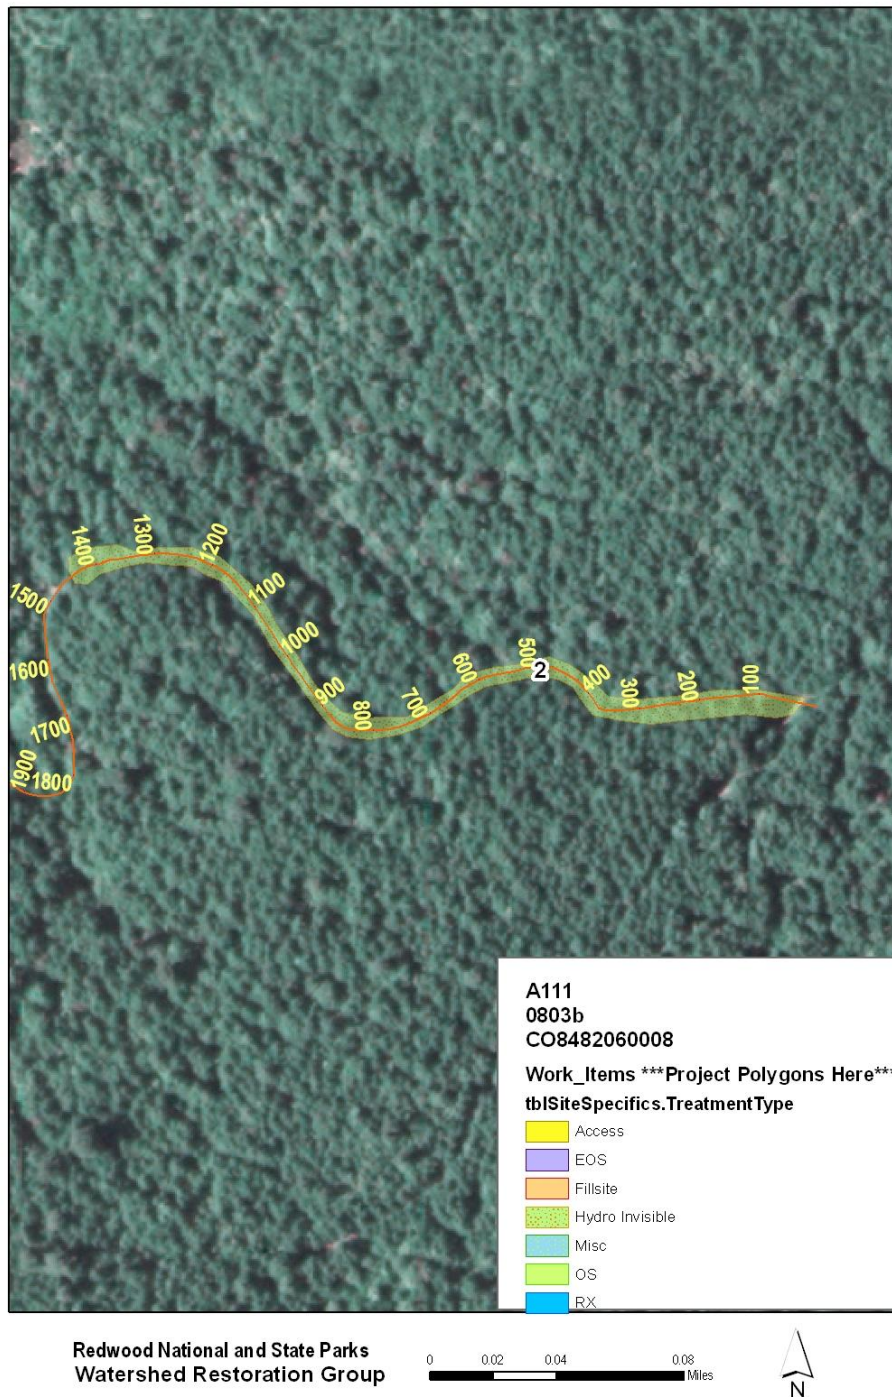
A111  
July 18 to July 23

The A111 portion of project 0803 treated the remaining segment of the road where work had been suspended in 2007. This reach of road consisted of moderate to minor outslowing treatment to address perched fill and re-establish hydrologic connectivity above a tributary to the middle fork.

The treatment for the remaining reach of the A111 consisted of a single outslope prescription, work item B2. The reach was just over 1400 feet in length from Holter Ridge road to the termination of the project 0701 work. A ridge landing at station 14+00 had some steep, perched fill with a high threat of failure into a tributary that was being treated by the A112 removal effort. Otherwise, the majority of the A111 removal simply restored hydrologic integrity to the headwater slopes.

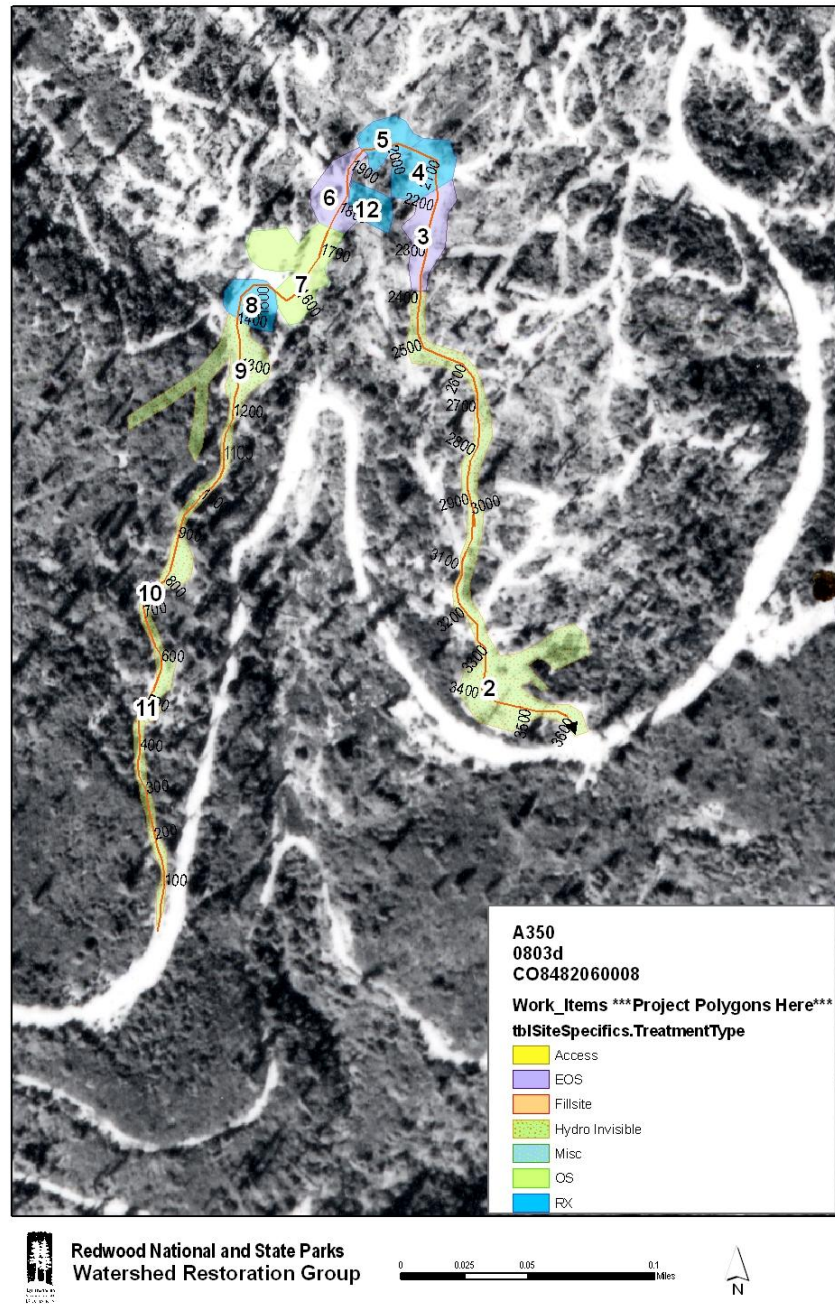
0803D: A350

The A350 was a rock haul road to station 17+00. Major skid roads fed the area up station of the terminal landing. These skid roads crossed several headwater drainages. A series of skid roads were re-connected

to provide end hauling for the road removal project to a small landing at station 34+00. The original project plan was to only haul material from a seepy spring at work item 3. The road was brushed open in mid September exposing much more surface moisture than had been hoped for that point in the season. Additional hauling was required, increasing the final cost of this part of the project.

The pre-season plan for the A350 was to tie a skid road network together along the east side of the drainage to access a small landing that would be used as a fillsite for a very wet swale (Work Item D3). The swale contained 2444 yd<sup>3</sup>s of saturated fill. Off highway trucks were anticipated for the haul. As the road was being brushed open for access, additional springs and surface moisture were encountered. The presence of this late season moisture prohibited using some of the planned fillsites and equipment, requiring additional end hauling for several of the work items (D4, D5, D6 & D12). The additional end hauling added approximately 16% to the final cost of the A350 removal.

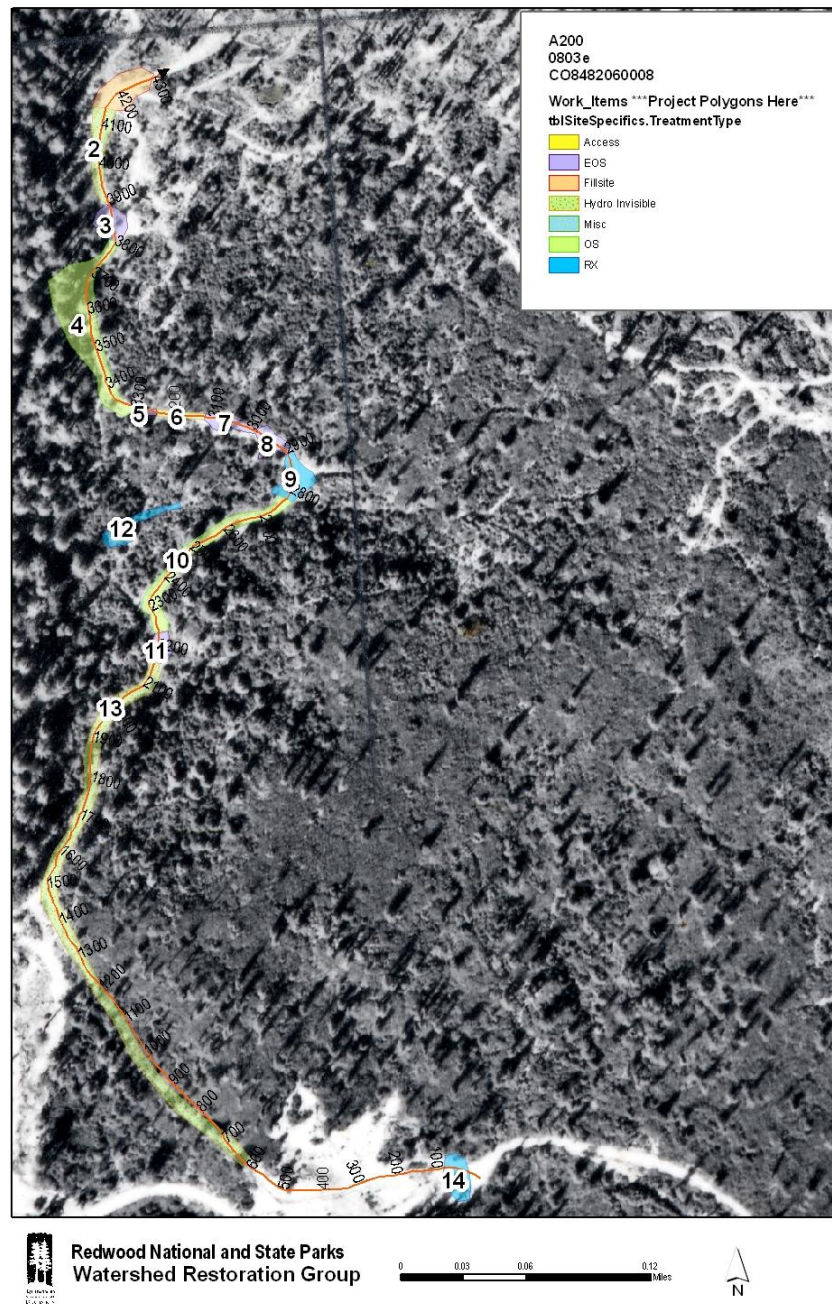
0803E: A200

The A200 road removal treatments picked up where work ended in the 2000 season. Several swales, two stream crossings and many reaches of steep slopes were treated. An old rock pit near the beginning of the road was utilized for spoiling excavated crossing fill from a major swale at the junction with the Geneva

road (a permanent road / bicycle trail). Sluff rock from the abandoned pit was removed prior to backfilling the site. The salvaged rock was utilized to hard surface some soft spots on Geneva road.

A portion of the Geneva road had to re-routed for a 12,000 yd<sup>3</sup>s channel excavation. The portion of Geneva had shown signs of failure over the recent decade. In 2006, during a culvert replacement, some of the fill had been relocated with the intention of lessening the resource threat from the site. The re-aligned segment of Geneva now crosses the channel with a small rock ford.

The rock pit near the A200 and Geneva junction was left accessible as a future sluff rock resource. The original plan was to close out the pit with fill from re-route excavation. There ended up being more storage space than needed, so the fillsite was graded in a manner that would retain access to a portion of the rock face that had the potential for continued sluffing.

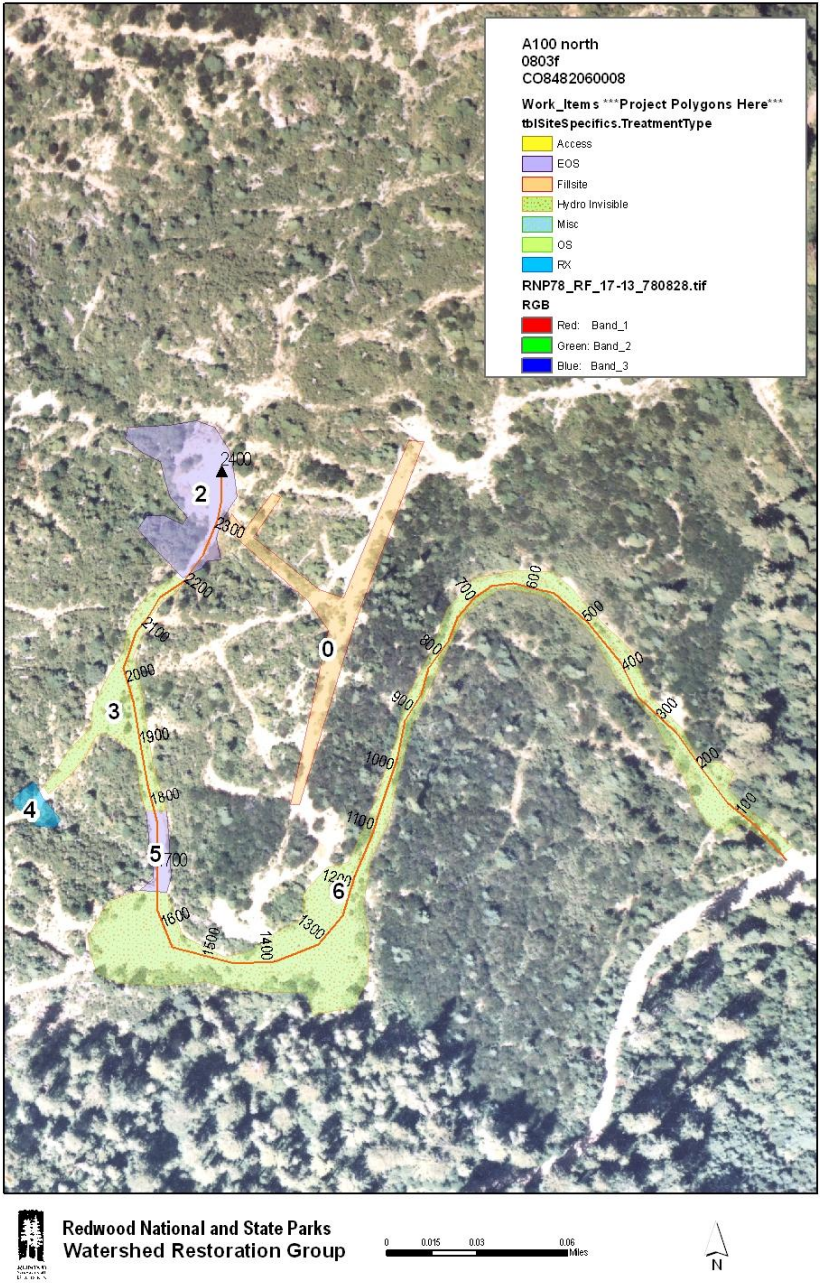
0803F: A100 north

The A100 north was a short haul road that accessed a portion of the ridge below the A200 and above the B550 unit. The predominate resource threats existed in the north fork portion of the cut block at work items F2 and F4
