SKUNK CABBAGE CREEK:  
An Evaluation of 1980 Rehabilitation  
Training Sites and Techniques

Annette M. Parsons  
Robert B. Rohde

Redwood Community Development Council  
Forest Improvement Center  
Eureka, California  
April, 1981

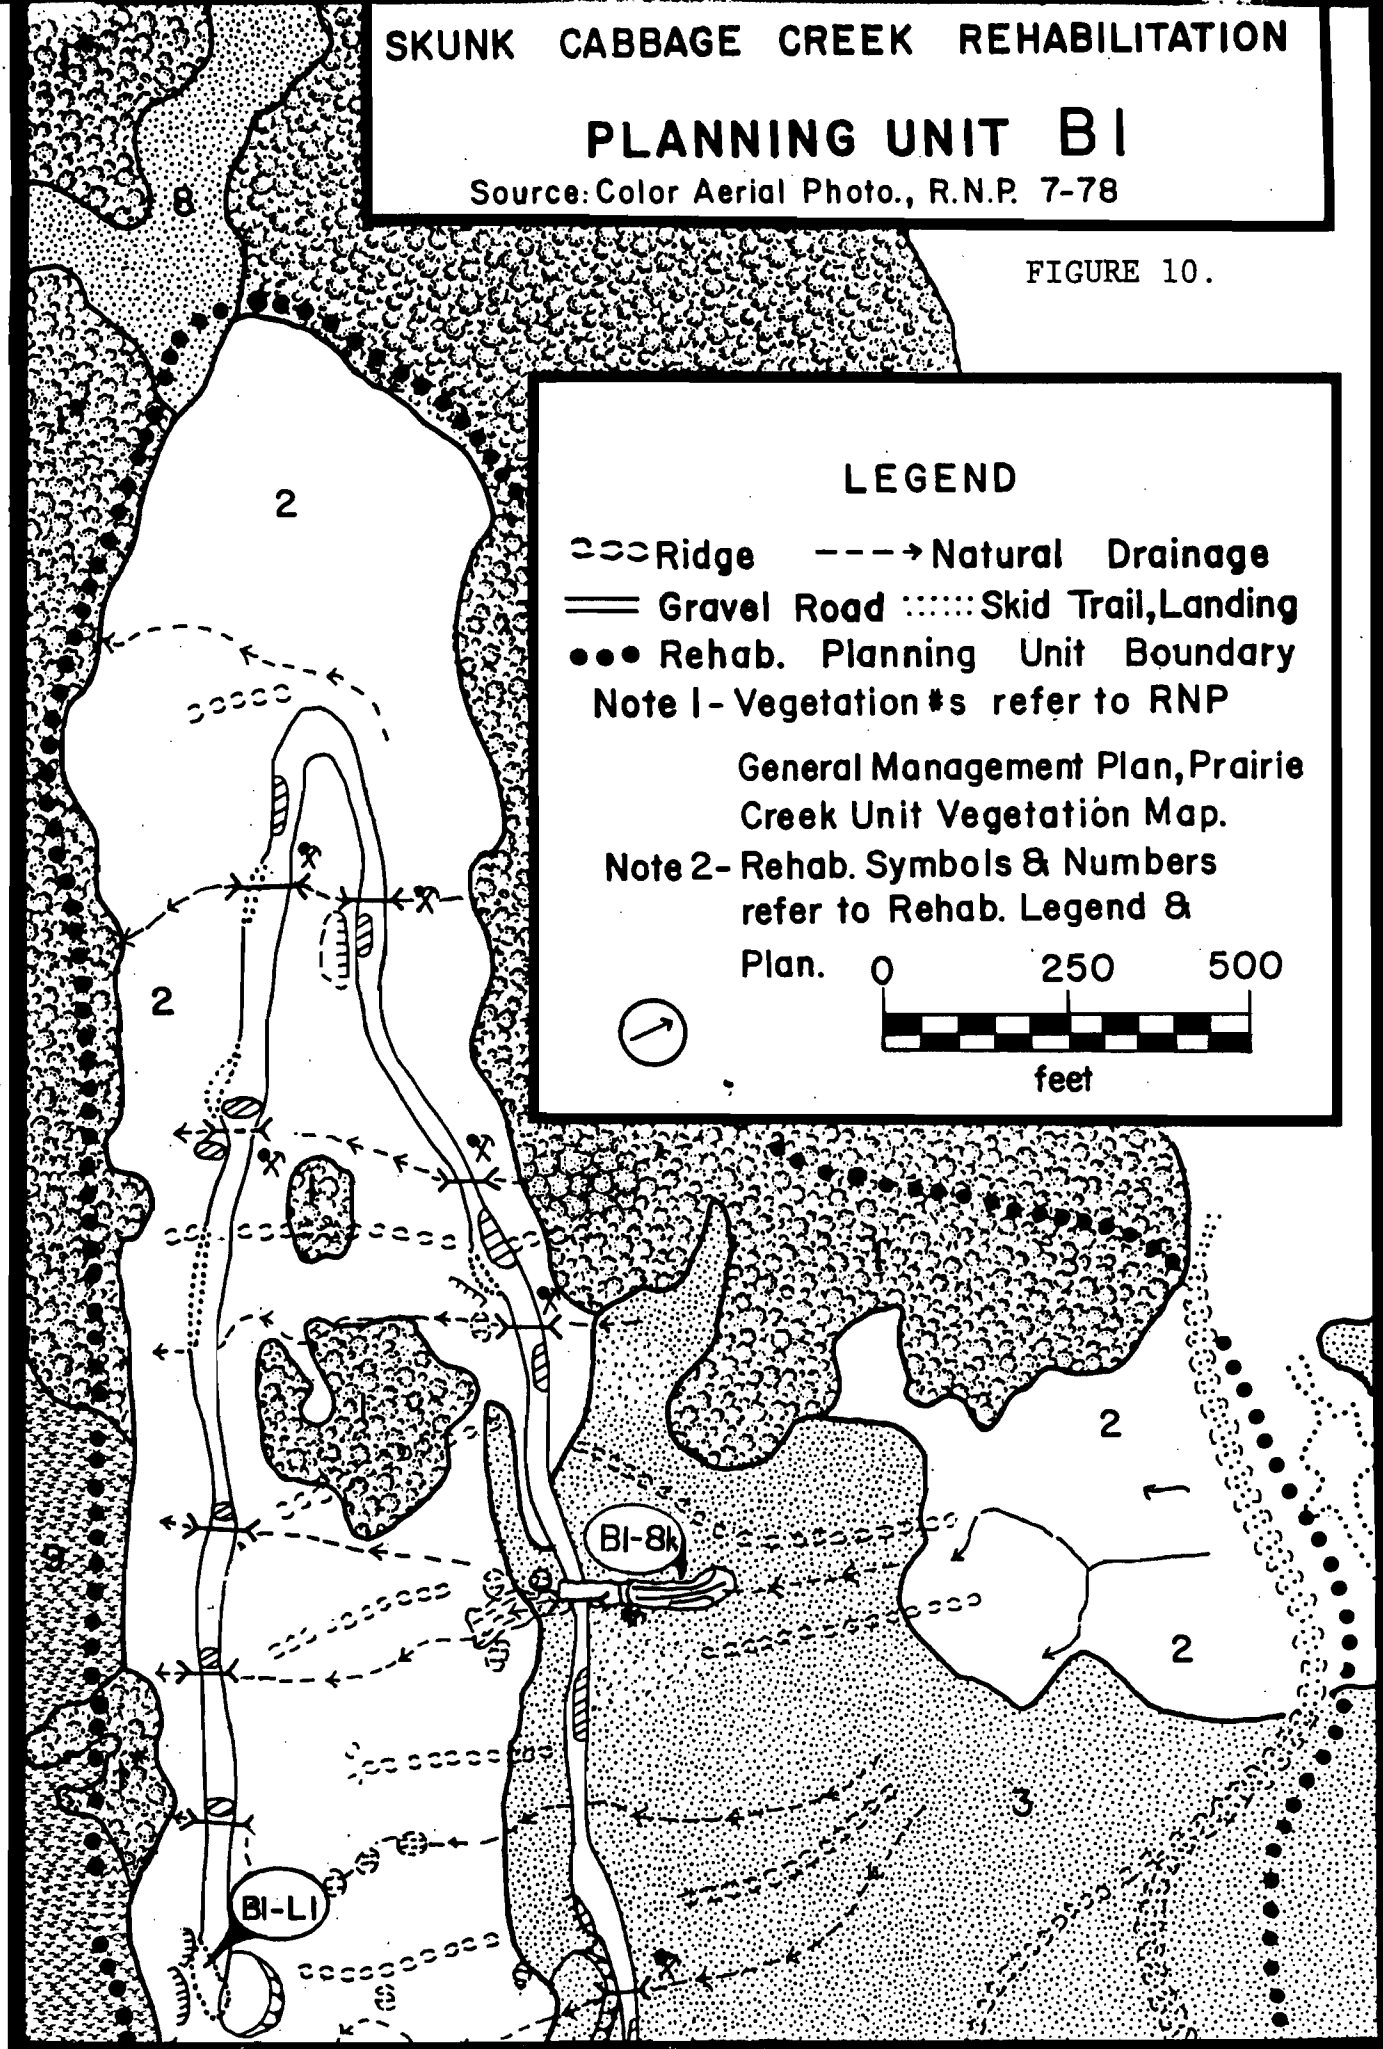
FIGURE 10.

Revegetation in the Unit is good. The primary erosion problems in this Unit are due to alteration of drainage patterns by roads and to mass slope failures. A landslide occurred in a drainage channel (Site B1-8k) in this Unit during the mapping phase of site investigation (March, 1980) (Figures 10 and 11). The slide was probably triggered by ground saturation resulting from water ponding behind tractor-constructed fill crossings. As the mass of soil and debris slid down the channel, it scoured the channel bed and banks severely. The bulk of the material came to rest on and below the main haul road. This completely blocked the road and created potential for road failure and continued movement of the material downslope.

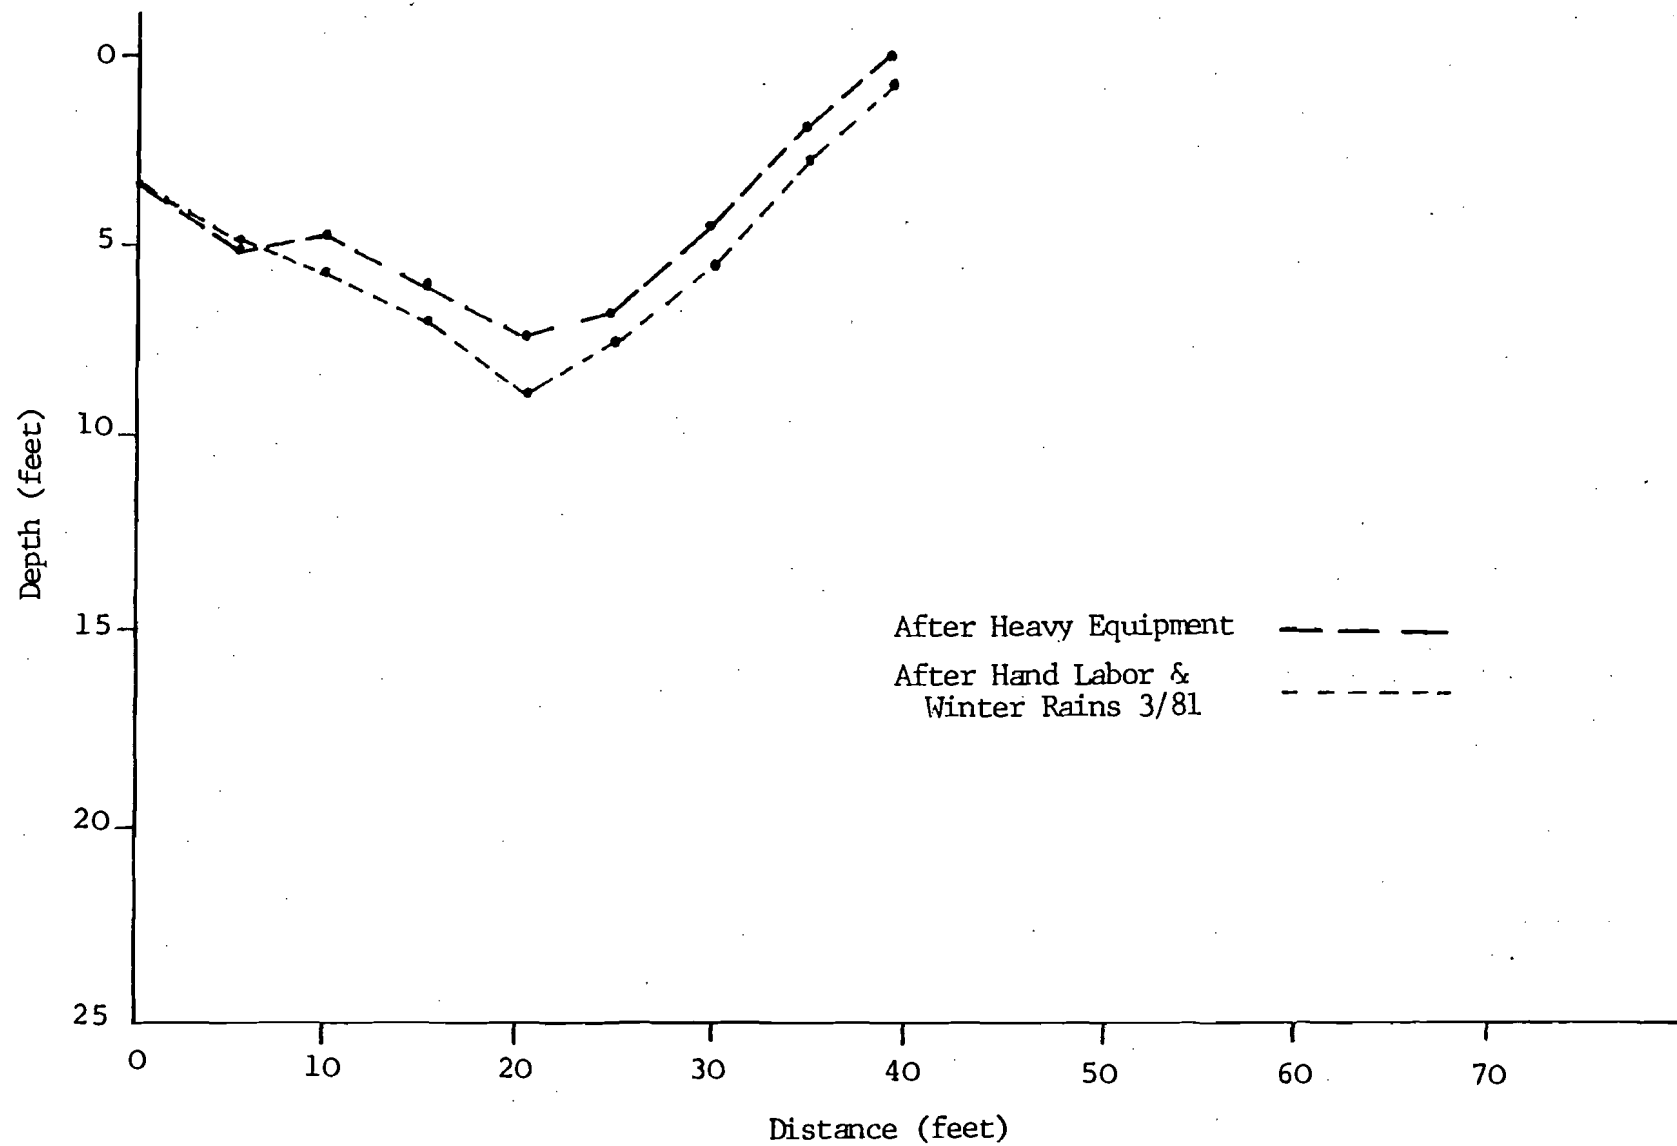
Figure 13. Channel Cross-Section, Sites 1 & 2.

At Site 2, where heavy equipment was unable to completely excavate to the original channel level, a slug of approximately 3200 cubic yards of material remained in the channel. This created a potential flow barrier and/or potentially unstable mass which would be likely to fail in the future, endangering downstream structures. A riffle box about six feet in length was installed to conduct flow over a 5-foot drop-off and prevent downcutting at this point. The check dam at the head of the riffle box has filled with sediment and

no sidecutting has occurred. The riffle box is effectively conducting flow and slowing water velocity with no significant leakage, but at the base of the energy dissipator below the riffle box, a plunge pool has developed. This is undermining the stakes which secure the rocks, and eventual failure is inevitable unless maintenance takes place. Some overall channel downcutting has occurred.

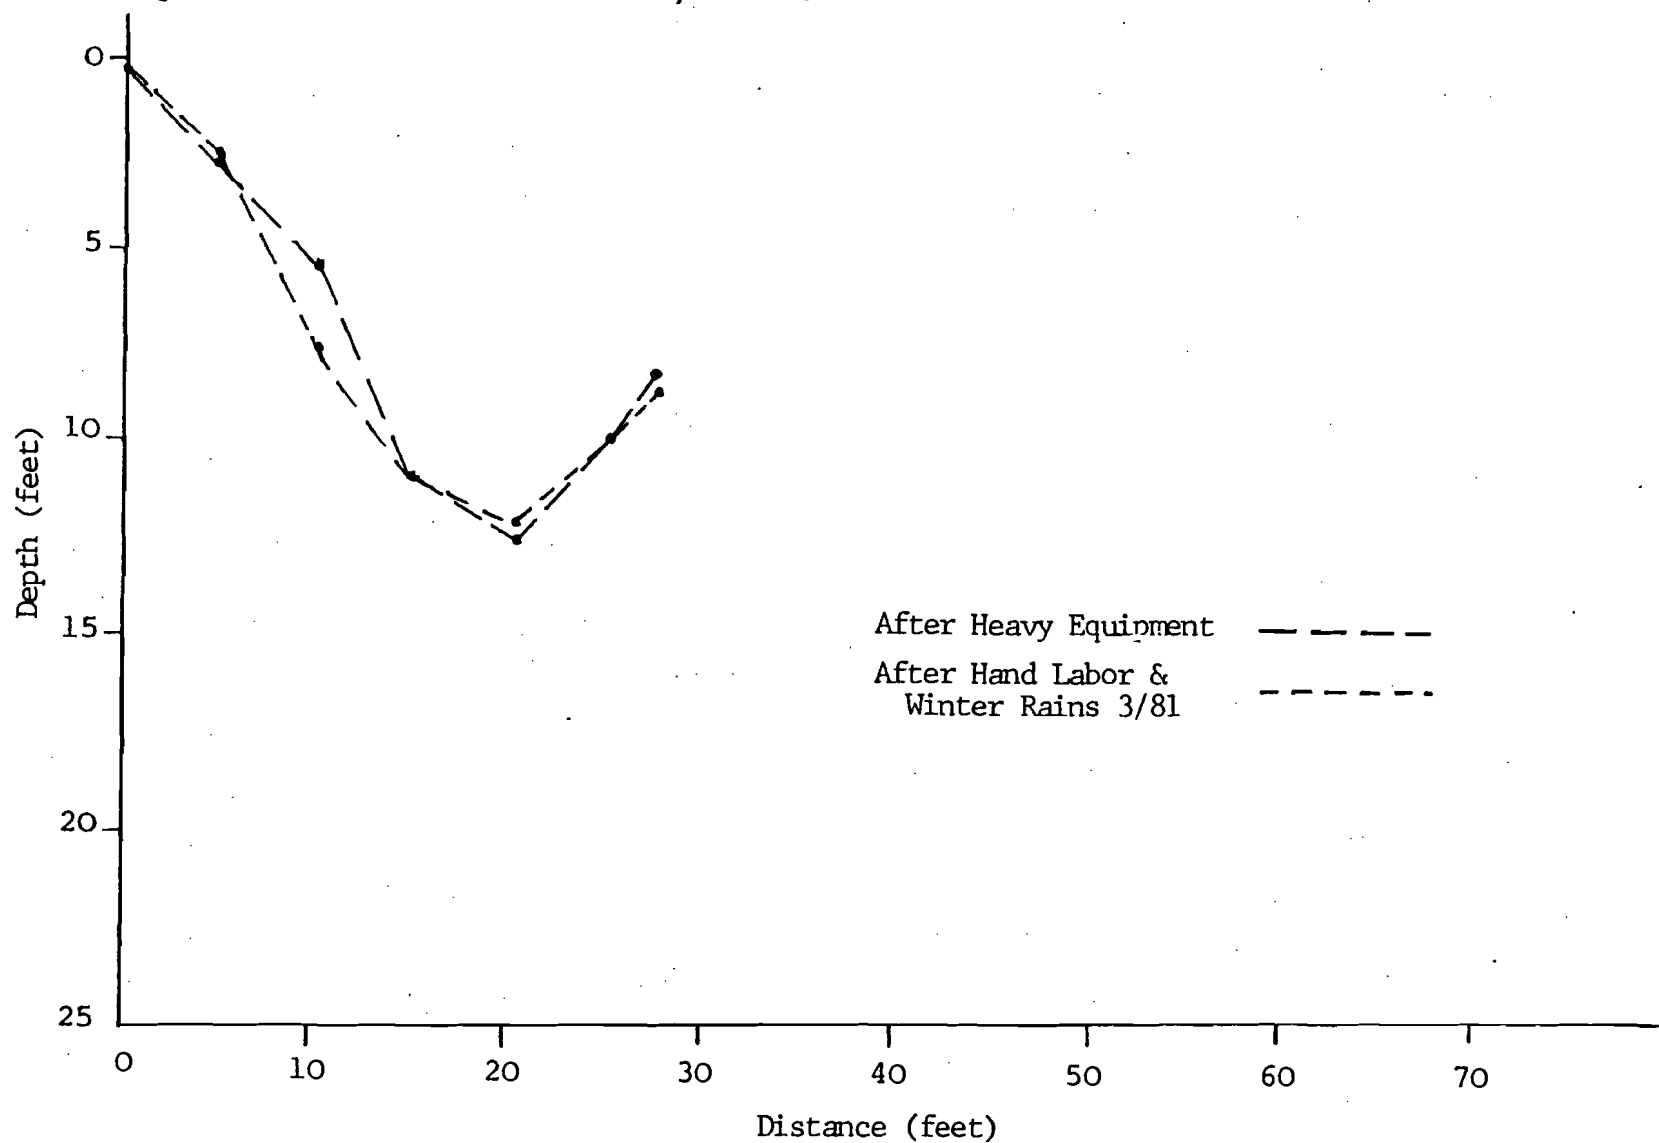
Figure 22. Channel Cross-Section, Site 4.

Large pieces of logging debris prevented complete excavation of the stream channel at Site 4. After as much of the fill material as possible was removed, streamflow went underground into a hole in the remaining fill. This created potential for instability due to soil piping and subsurface saturation. The structures built at this site were designed to keep streamflow above ground to minimize this hazard. The uppermost structure is a riffle box approximately eight feet long. The slabs which support this and other riffle boxes and water ladders are expected to act as check dams. These dams act as a foundation for the other structures. In case of significant leakage beneath the structures, a V-notch has been cut into these slabs to discharge any water that may build up behind them (Figure 19).

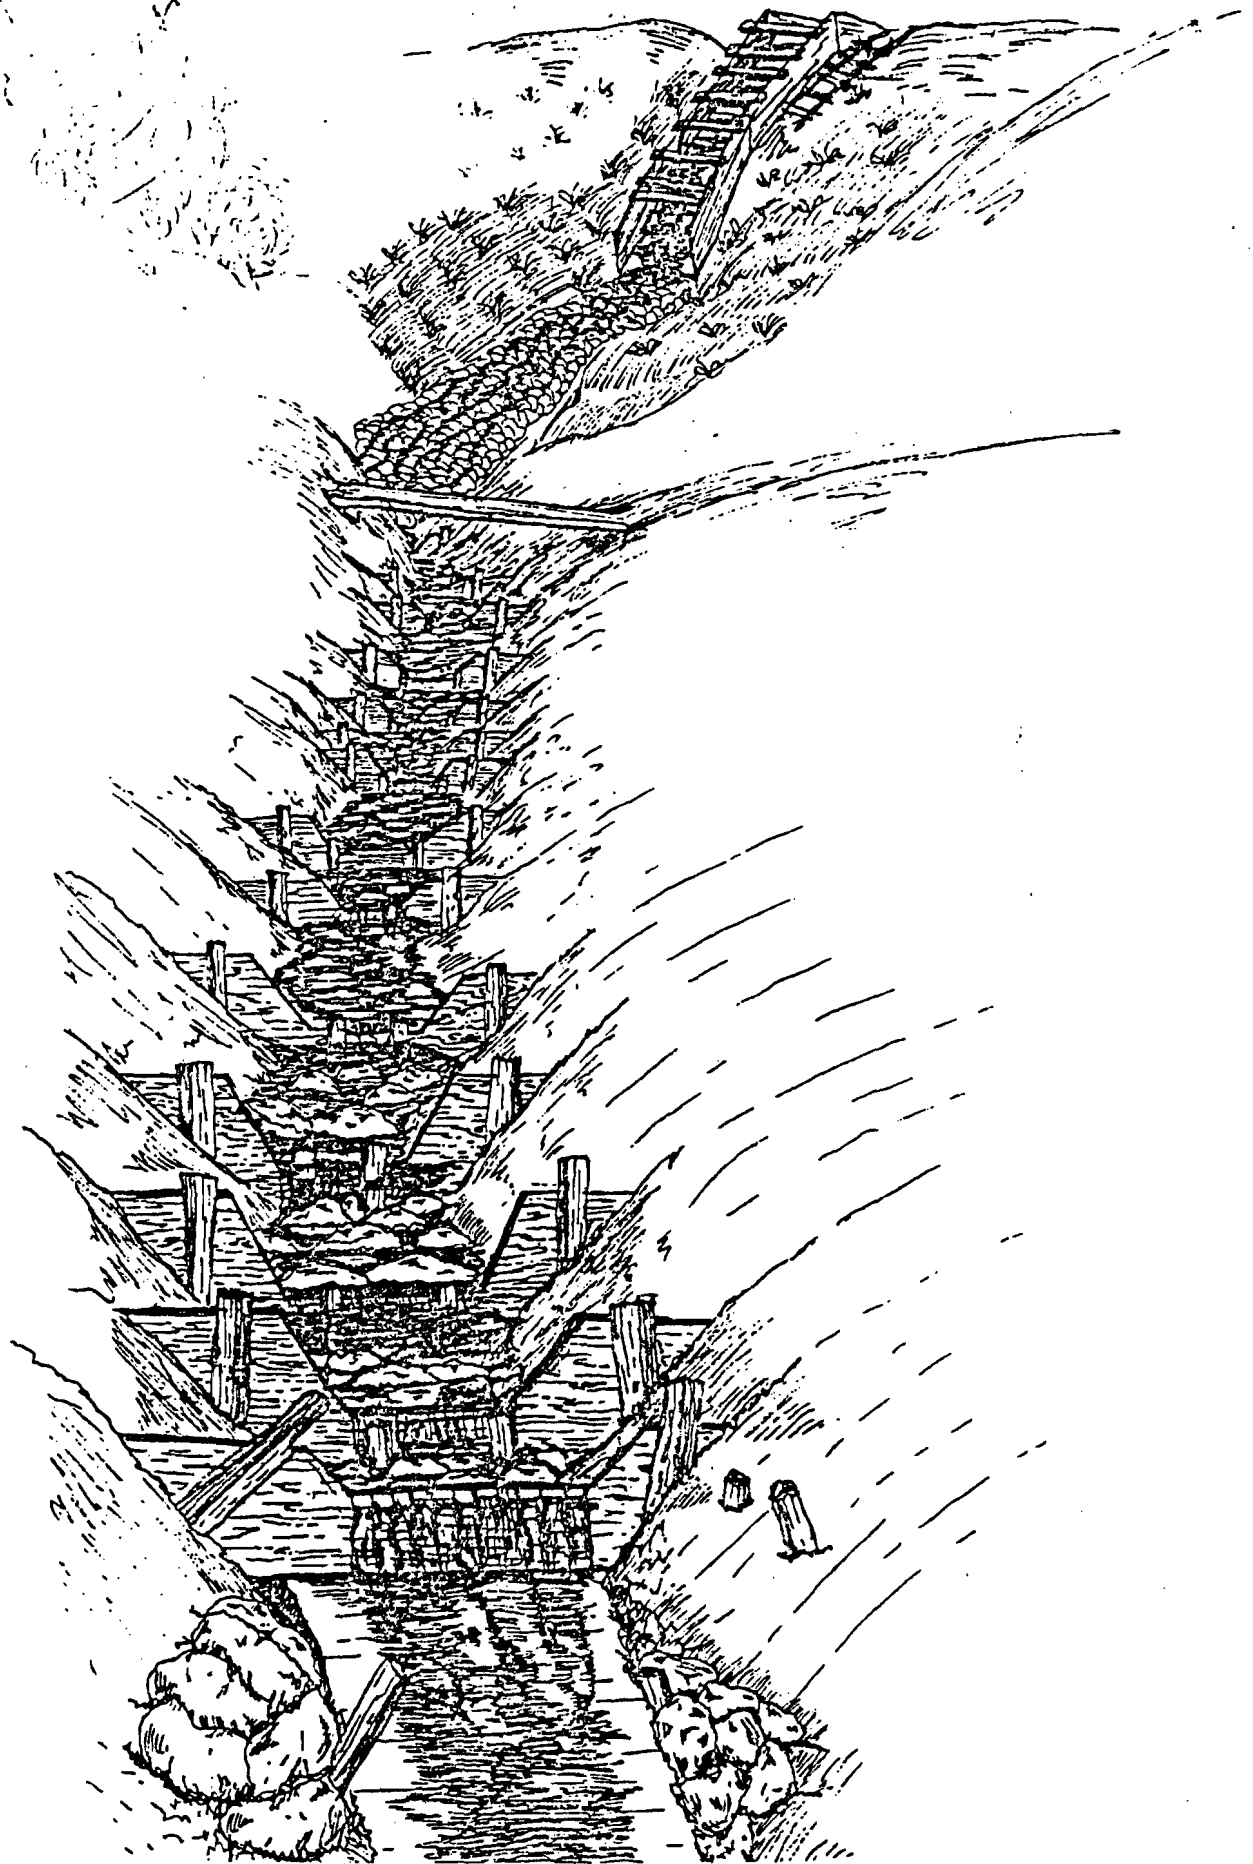
FIGURE 32. Erosion control techniques  
at Sites 5 and 6.

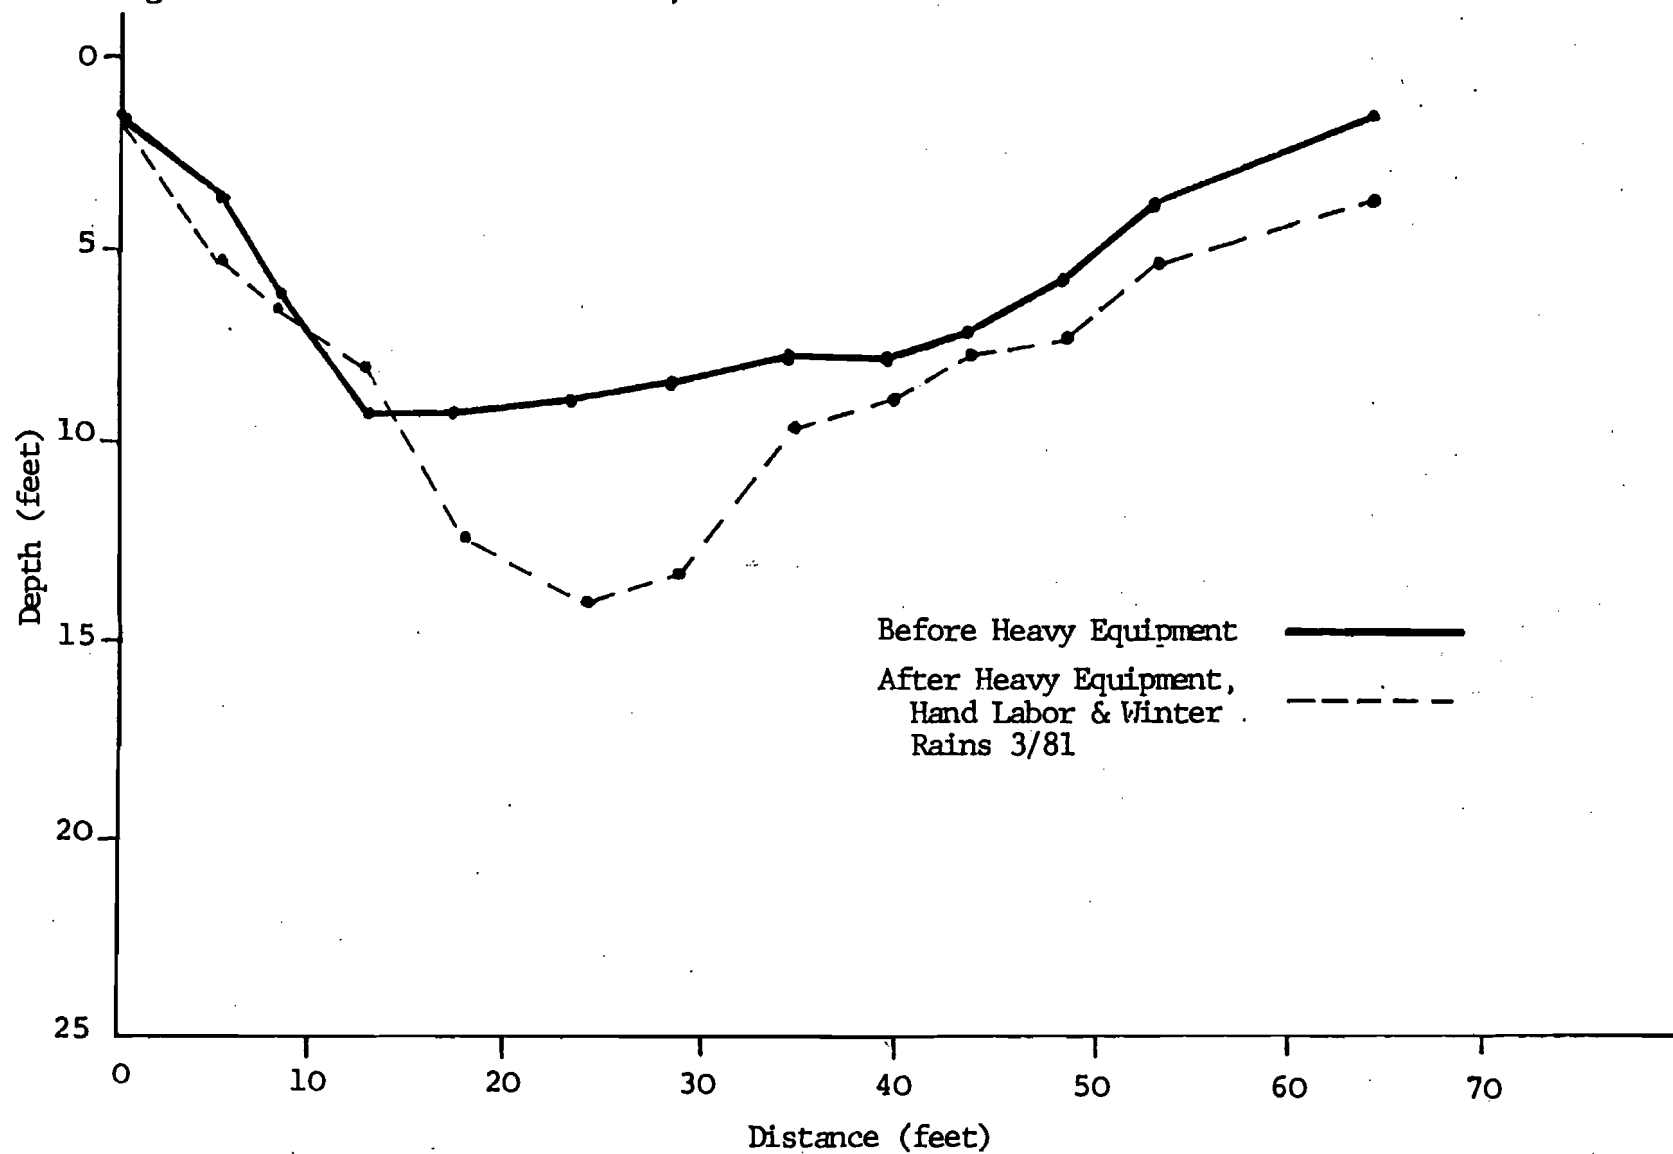
Figure 36. Channel Cross-Section, Site 8.

Figure 36 diagrams changes in channel cross-section before and after treatment.

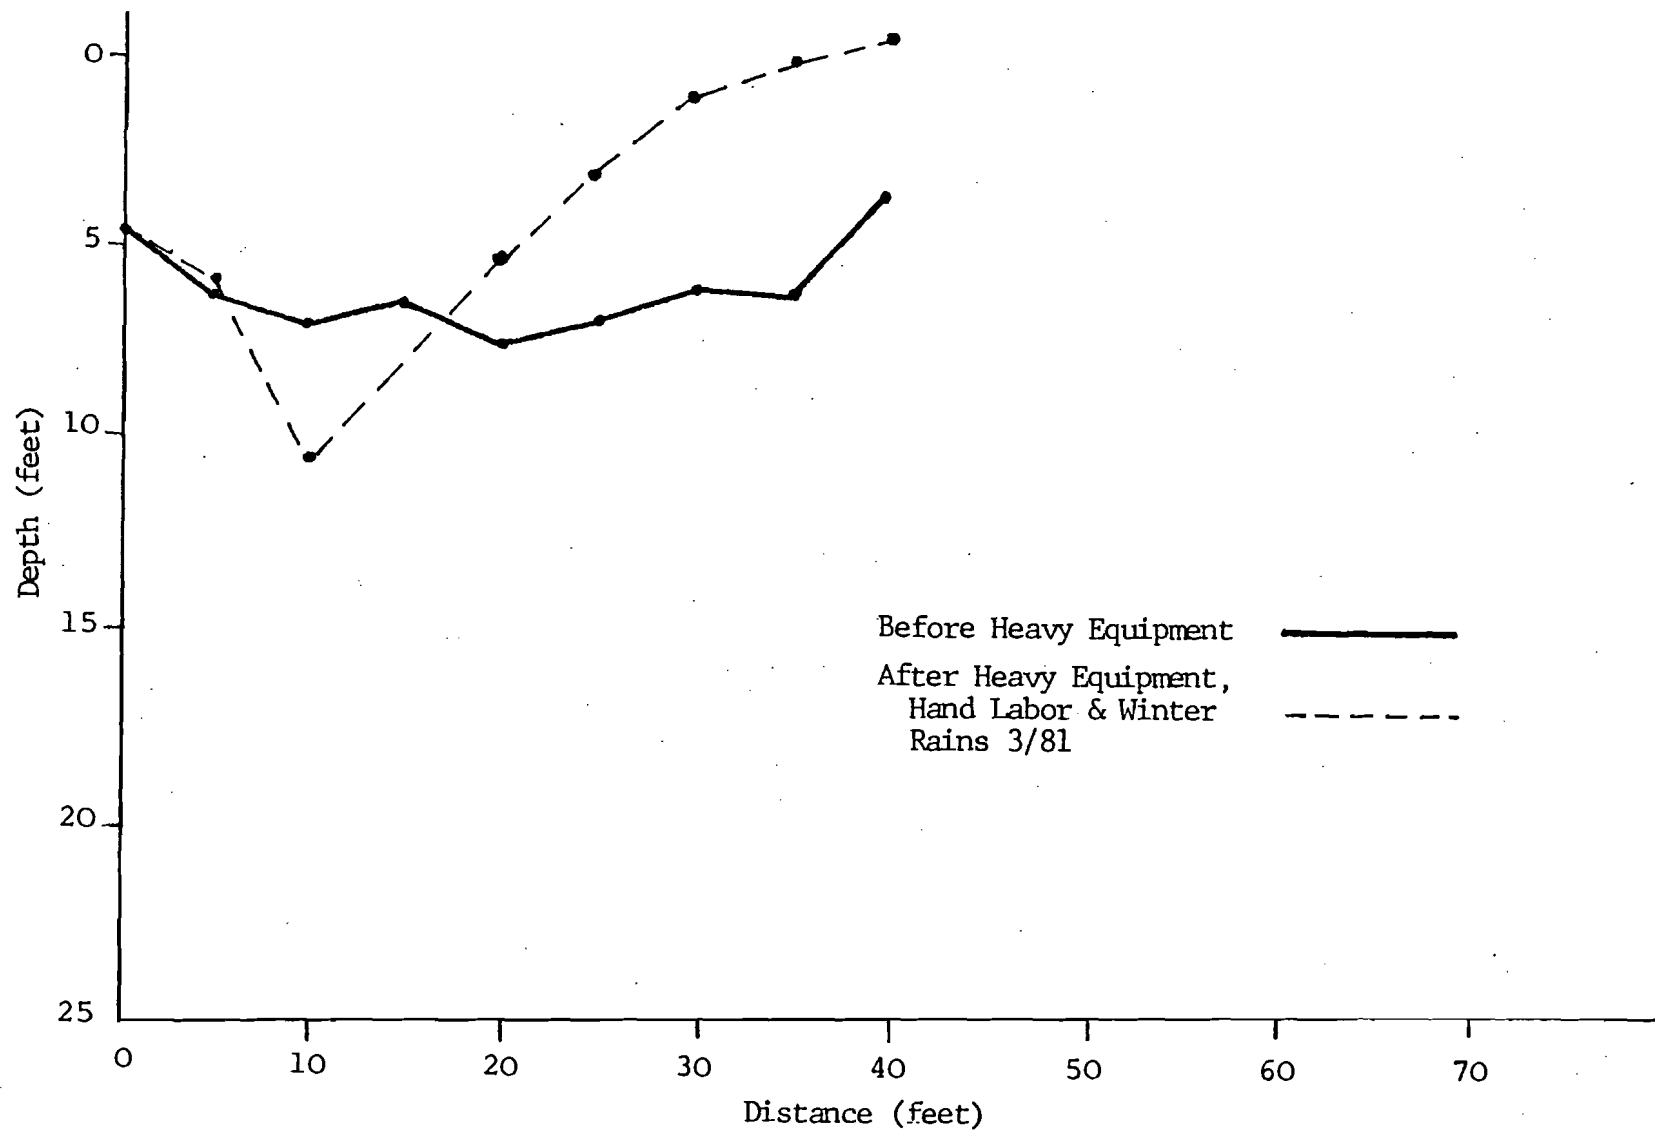
Figure 39. Channel Cross-Section, Sites 9 & 10.

At Site 10, a riffle box about 15 feet in length conducts flow over a steepened channel reach. The only apparent problem is a slight plunge pool developing at its base. A submerged spillway which was intended to

halt development of a nick point has been severely undercut, threatening the structure and adjacent channel banks. From this point on down, no further channel structures were built. The stream flows onto bedrock, to a drop of about 15 feet. The contour terraces constructed on raw exposed slopes at this site were constructed of shorter poles, and are not continuous across a terrace level. Rills and gullies are developing where gaps in a terrace occur. These terraces need some repair, and perhaps should be replaced with longer poles to form a continuous terrace at each level. Planted seedlings look good, and horsetails (Equisetum sp.) are returning to the slopes in abundance.
