# **Fort Matanzas National Monument**

## **Structural Condition Assessment Report**

**October 2016**

Structural Engineers:  
Faisant Associates  
810 Light Street  
Baltimore, Maryland 21230

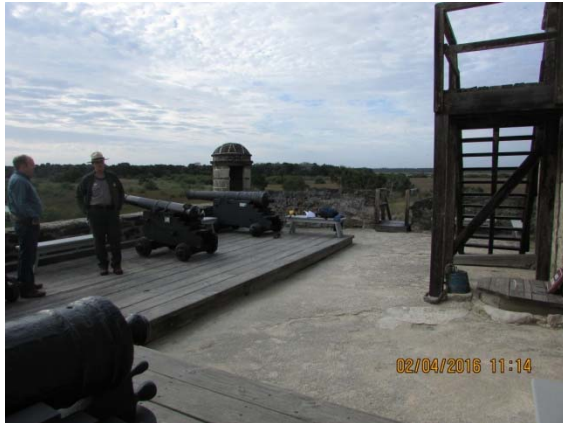
**Photo B-1:** Terreplein, looking southwest (2016, Faisant Associates).

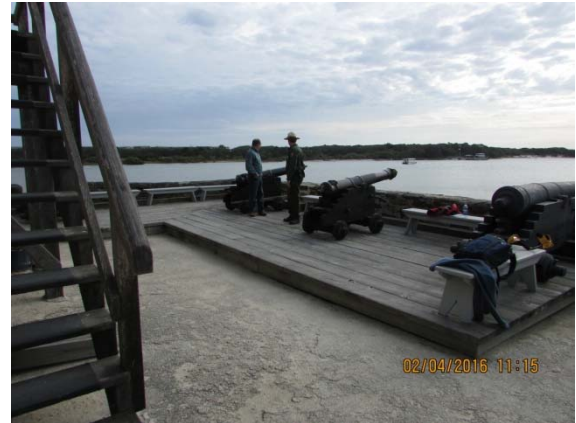
**Photo B-2:** Terreplein, looking southwest (2016, Faisant Associates).

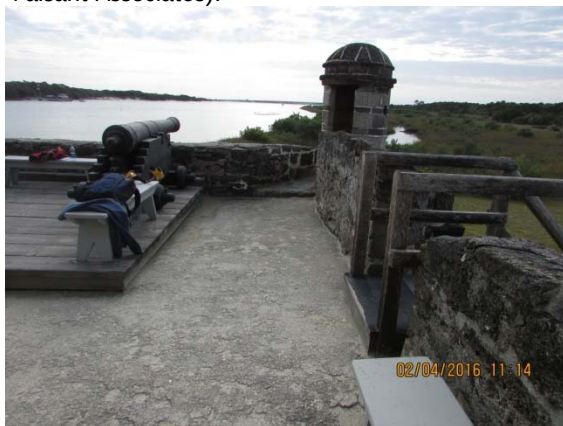
**Photo B-3:** Terreplein, looking south (2016, Faisant Associates).

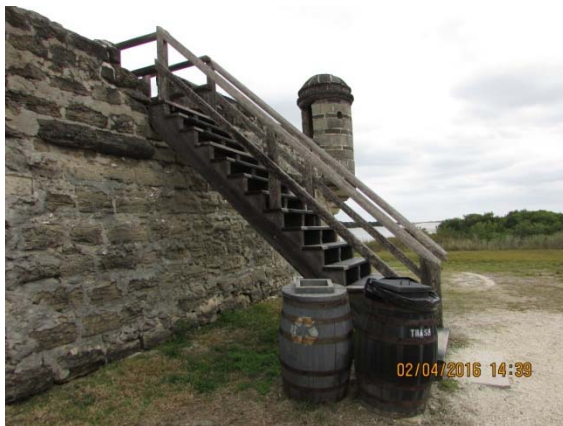
- d. The stairs leading from grade to the terreplein elevation (constructed in 2001), and from the terreplein to the second floor (constructed in 1998) are of wood construction. Though no signs of rotting or insect damage were noted, advanced weathering and biological growth were observed (*photos B-7 and B-8*).

**Photo B-7:** Stair at Fort entrance (2016, Faisant Associates).

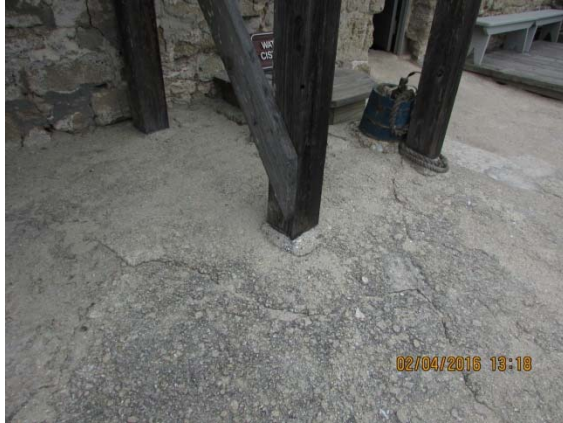
**Photo B-10:** Stair posts at terreplein deck support (2016, Faisant Associates).

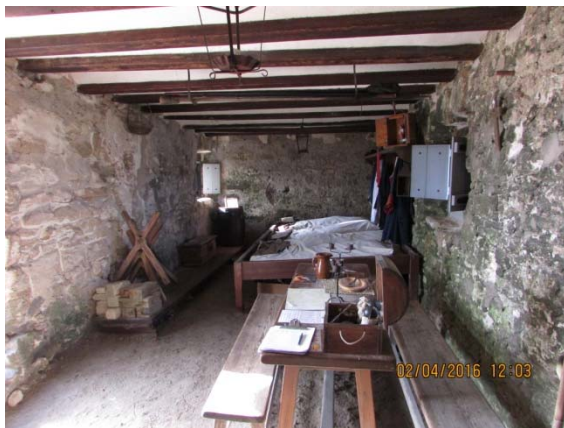
**Photo C-1:** First floor room, looking west (2016, Faisant Associates).

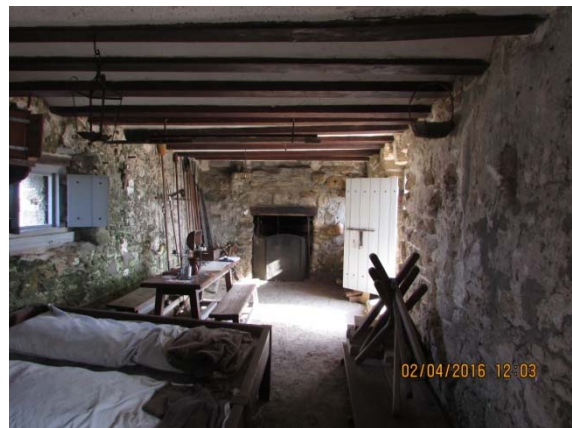
**Photo C-2:** First floor room, looking east (2016, Faisant Associates).

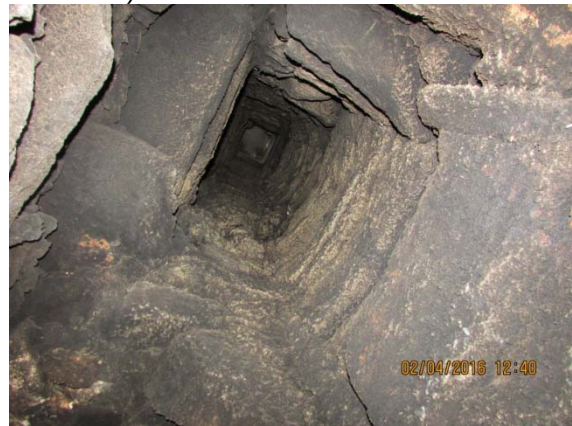
- f. The hearth shows evidence of recent reconstruction; however, the chimney flue is in poor condition, exhibiting deteriorated stones, open mortar joints, and moderate soot buildup (*photo C-6*). A wood lintel supports the fireplace opening, which is not in compliance with IBC 2015 section 2111.8 stating that "masonry over a fireplace opening shall be supported by a lintel of noncombustible material."

**Photo C-6:** Chimney flue (2016, Faisant Associates).

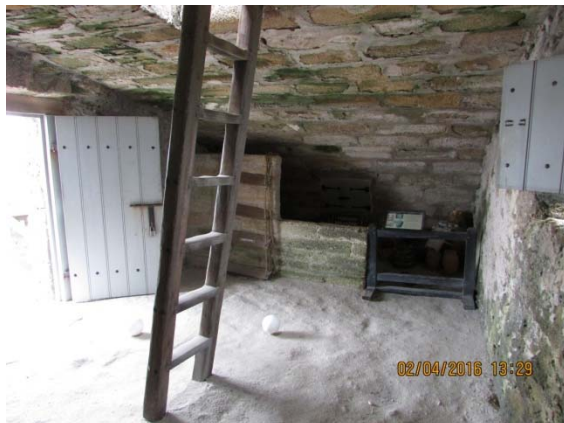
**Photo E-1:** Second floor room, looking west (2016, Faisant Associates).

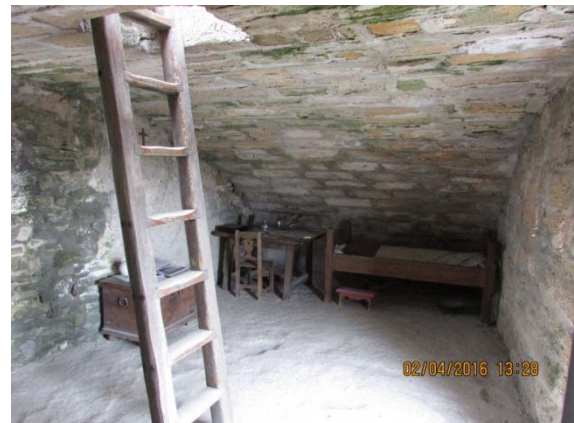
**Photo E-2:** Second floor room, looking east (2016, Faisant Associates).

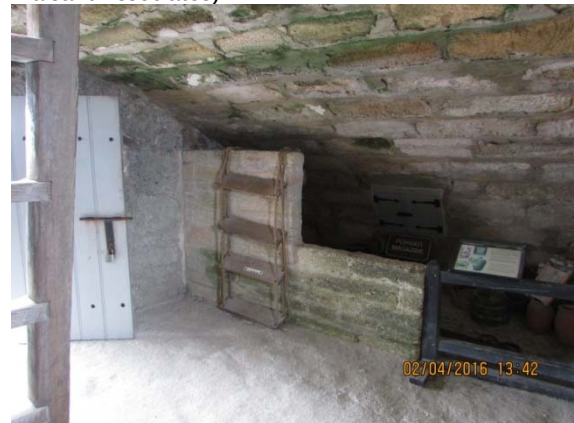
**Photo E-6:** Coquina partition wall (2016, Faisant Associates).
