# FORMER SULLIVAN OPERA HOUSE

252-254 Main Street, McGregor, Iowa  
Predevelopment Project

**MARCH 2015**

**DOUGLAS J. STEINMETZ**  
**A R C H I T E C T**

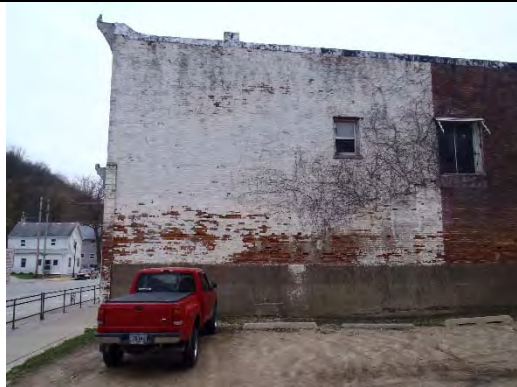
PHOTO 4: PARTIAL EAST FACADE.

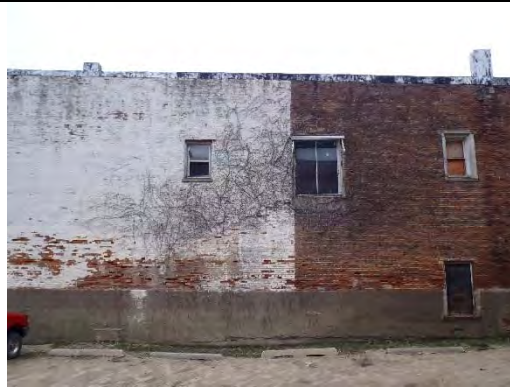
PHOTO 5: PARTIAL EAST FACADE

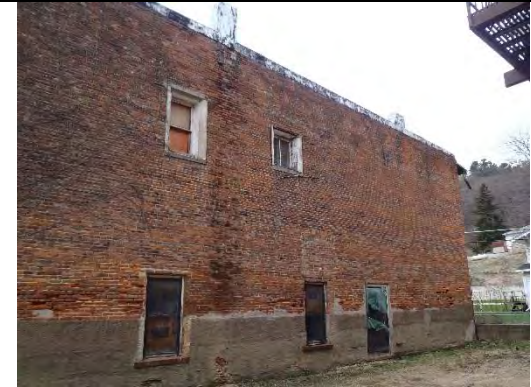
PHOTO 6: PARTIAL EAST FACADE

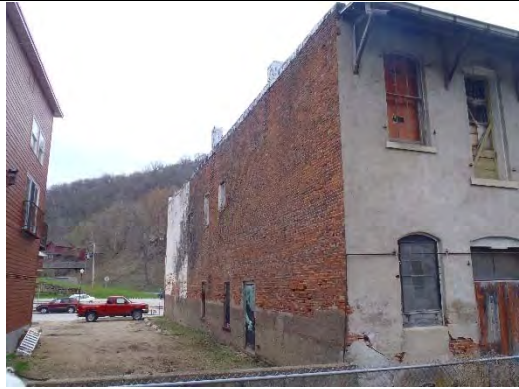
PHOTO 7: LOT EAST OF BUILDING

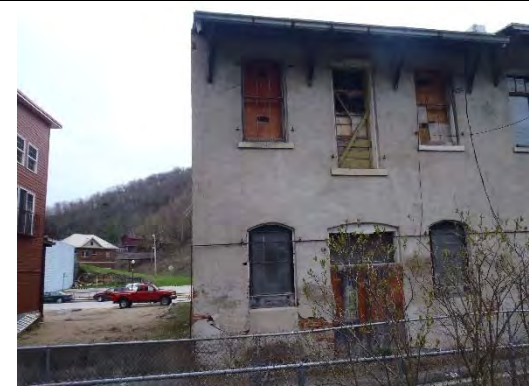
PHOTO 9: PARTIAL NORTH FAÇADE

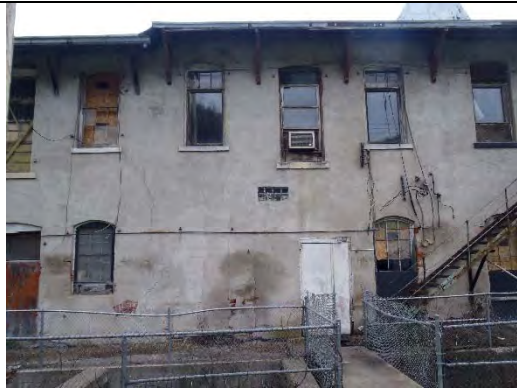
PHOTO 10: PARTIAL NORTH FAÇADE

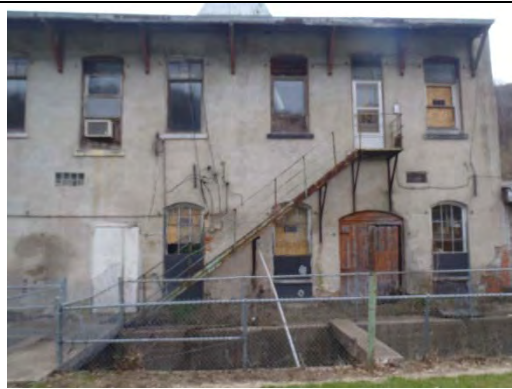
PHOTO 11: PARTIAL NORTH FAÇADE

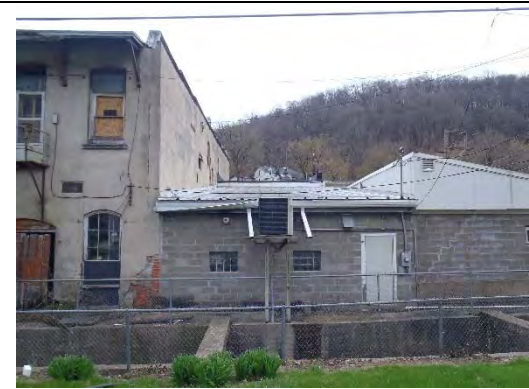
PHOTO 12: NORTH FAÇADE-  
NEIGHBORING BUILDINGS

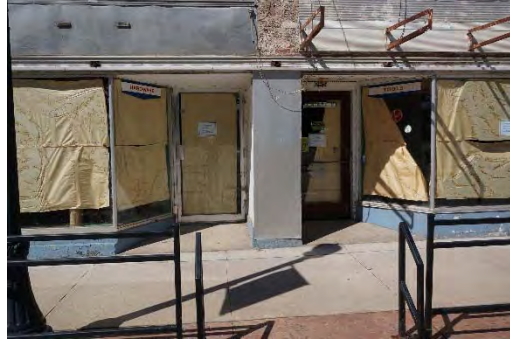
PHOTO 26: DETAIL OF STOREFRONT

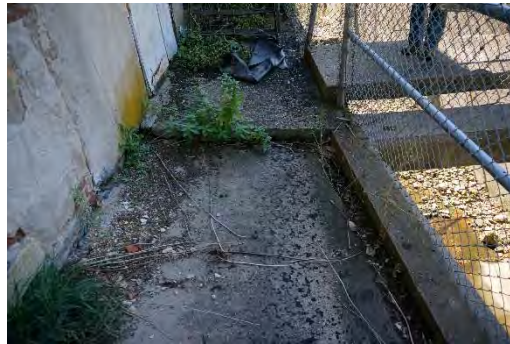
PHOTO 29: WALKWAY BETWEEN BUILDING AND STORM SEWER IN NORTH YARD

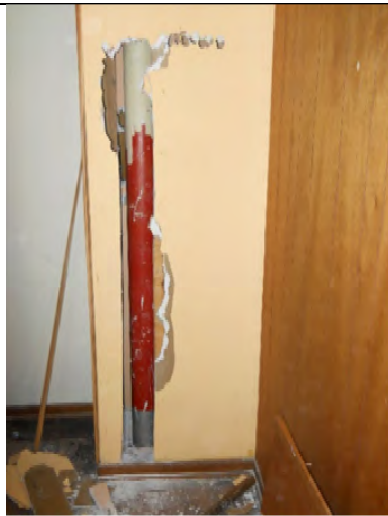
PHOTO 40: COLUMN DISCOVERED IN APT PARTITION IN FORMER BALLROOM

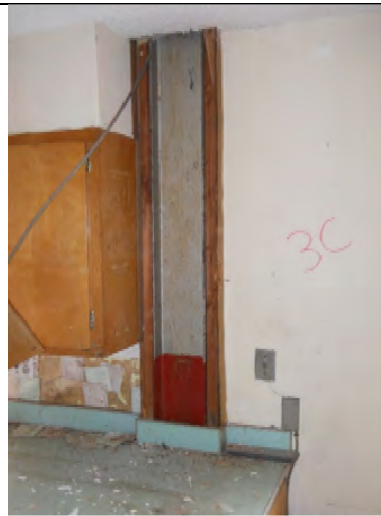
PHOTO 41: GREY AND RED STEEL COL AT NORTH WALL OF SECOND FLOOR

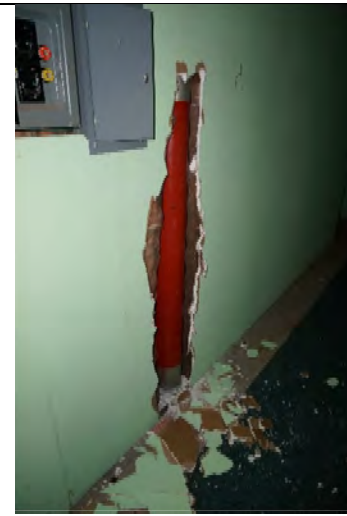
PHOTO 42: COLUMN DISCOVERED IN APT PARTITION IN FORMER BALLROOM

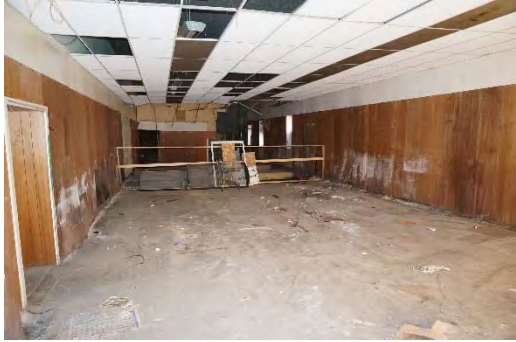
PHOTO 43: FIRST FLOOR AFTER DEBRIS REMOVAL

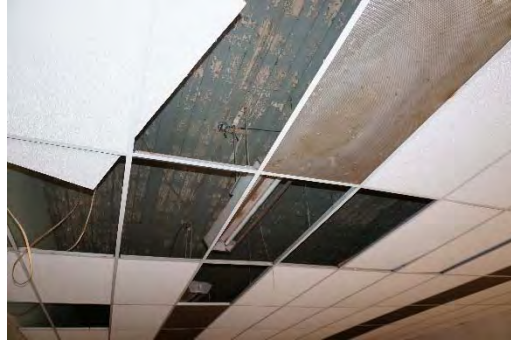
PHOTO 44: WOOD CEILING OF FIRST FLOOR SPACES

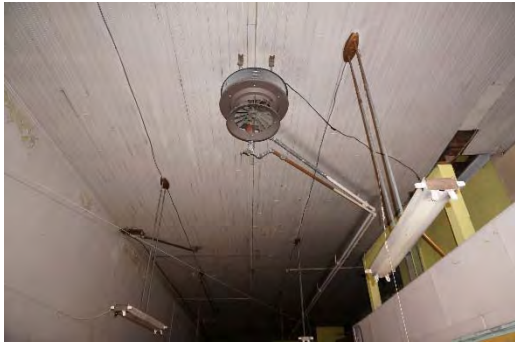
PHOTO 46: WOOD CEILING OF FIRST FLOOR SPACES

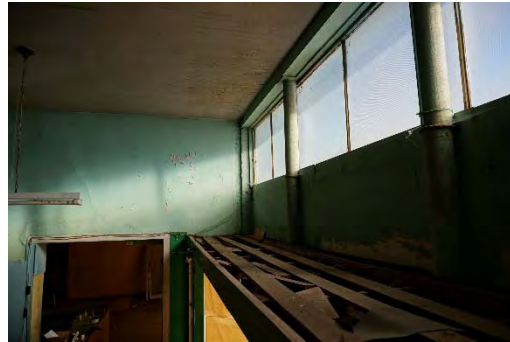
PHOTO 47: INTERIOR OF EXISTING STOREFRONT

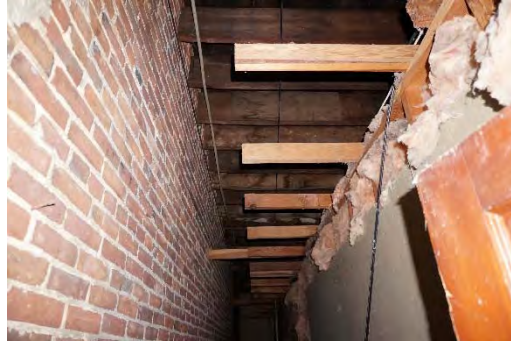
PHOTO 50: SECOND FLOOR APT CEILINGS  
FRAMED LOWER THAN HISTORIC CEILING

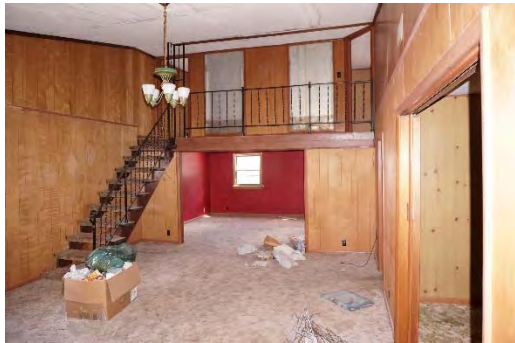
PHOTO 52: TYPICAL SECOND FLOOR  
APARTMENT FINISHES

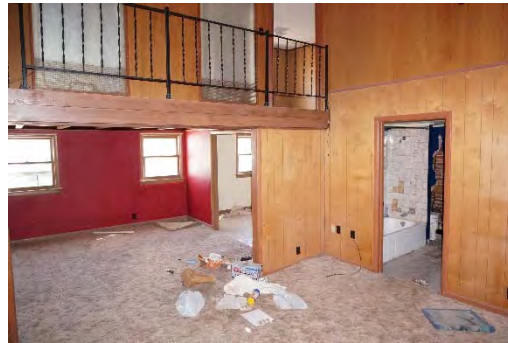
PHOTO 53: TYPICAL SECOND FLOOR  
APARTMENT FINISHES

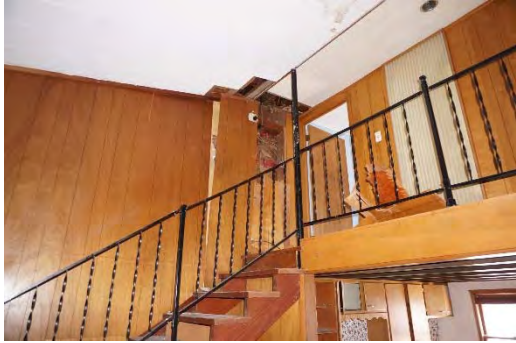
PHOTO 55: TYPICAL SECOND FLOOR  
APARTMENT FINISHES

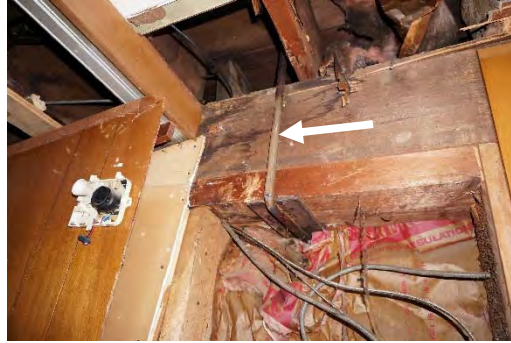
PHOTO 56: STRUCTURAL HANGER AT  
BUILDING CENTER BEAM

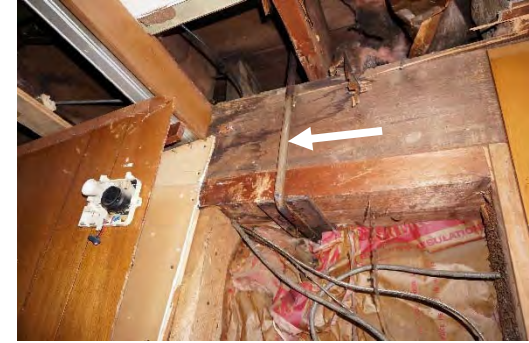
PHOTO 57: STRUCTURAL HANGER AT  
BUILDING CENTER BEAM

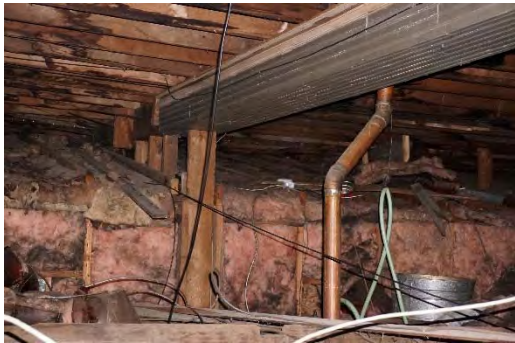
PHOTO 58: SPACE ABOVE APT CEILINGS  
IN FORMER BALLROOM

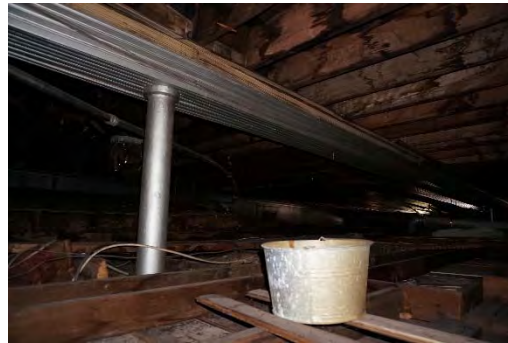
PHOTO 59: SPACE ABOVE APT CEILINGS  
IN FORMER BALLROOM

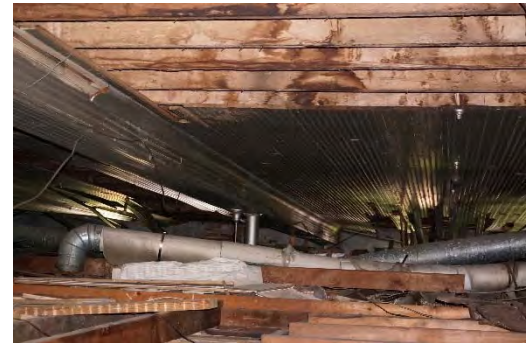
PHOTO 60: SPACE ABOVE APT CEILINGS  
IN FORMER BALLROOM
