Geomorphological Assessment of Bank Erosion along the Missouri River near Fort Union Trading Post National Historic Site (FOUS) North Dakota – Update Report 2008.  
Fort Union Trading Post National Historic Site  
Lucy Ellis

**Geomorphological Assessment  
of Bank Erosion along the Missouri River  
near Fort Union Trading Post  
National Historic Site (FOUS)  
North Dakota – Update Report 2008**

Lucy Ellis

*February 2008*

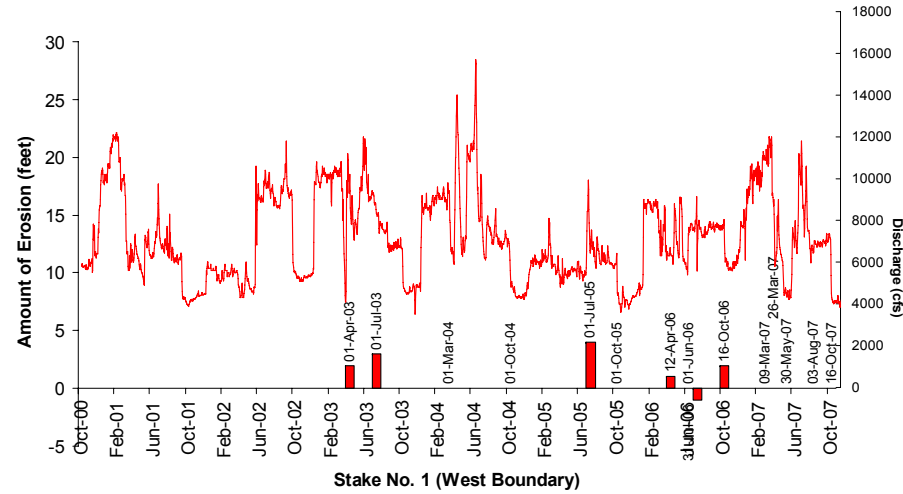
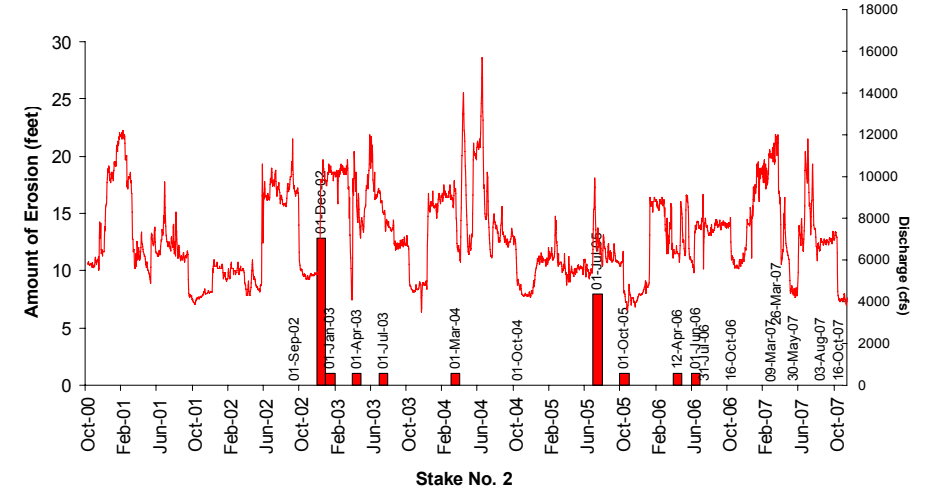
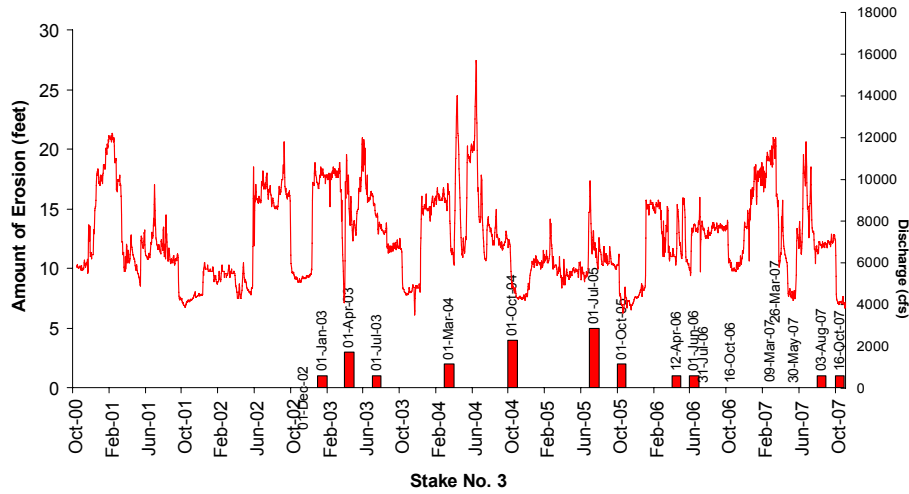
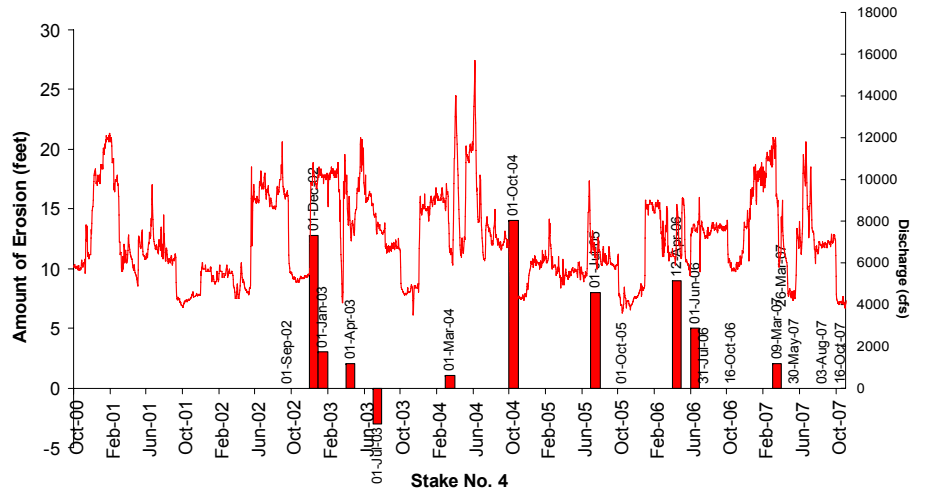
**Figure 3.3a Relationship Between Amount of Erosion Measured at Each Survey Stake (feet) and Mean Daily Discharge (cfs) for the Missouri River at Culbertson - Stakes 1-4**

The rate of bank erosion has been calculated from the newly provided measurements and is summarised in Figure 3.3a-c and Figure 3.4. Note Figure 3.4 represents the average monthly retreat, and is, therefore, somewhat dependent on the length of time between measurements.

- At stake 8, an unusually high amount of erosion, with a retreat of 28 ft, was recorded between Oct 2005 and April 2006. This may represent the failure of a discrete block of bank material, which would form an embayment in the bankline (as discussed in the 2006 update of the original 2005 report). There did not appear to be any trees or similar whose removal would result in this amount of localised erosion.

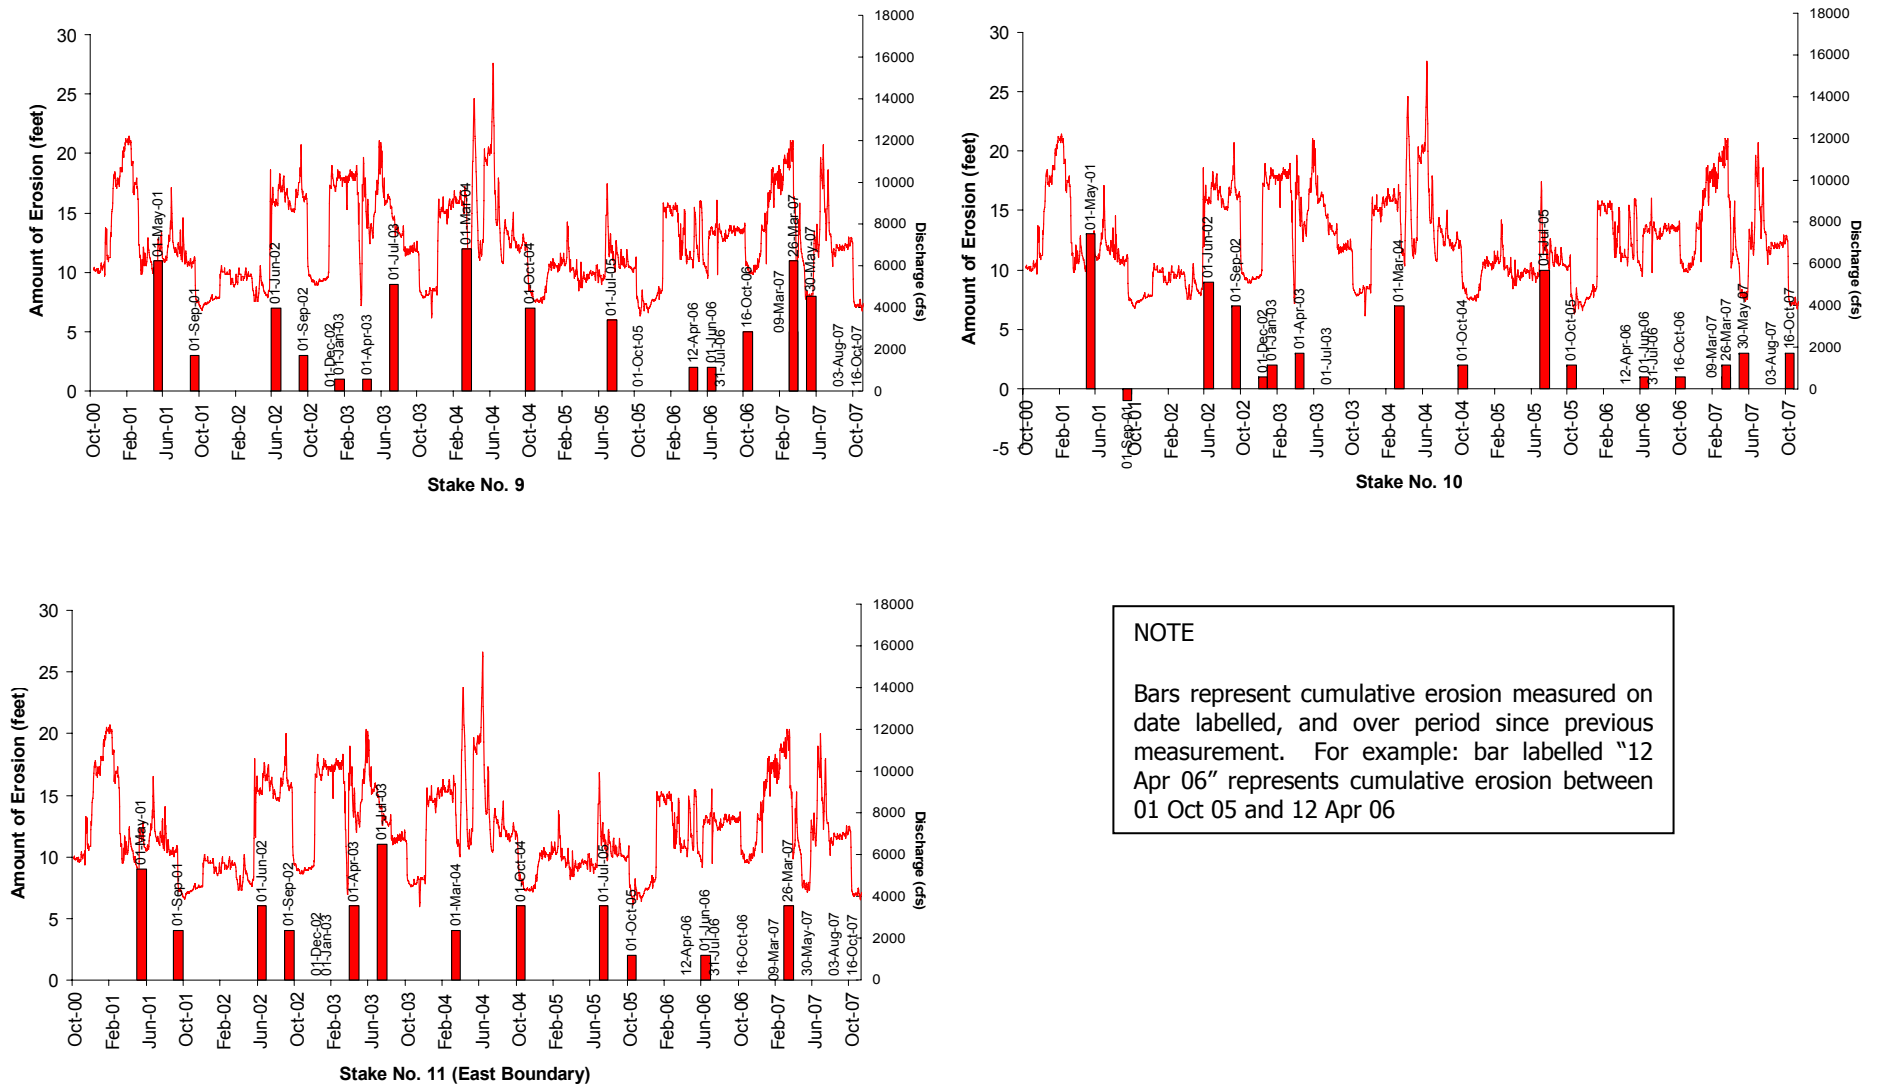
**Figure 3.3c Relationship Between Amount of Erosion Measured at Each Survey Stake (feet) and Mean Daily Discharge (cfs) for the Missouri River at Culbertson – Stakes 9-11**

- The irrigation ditch is now only approximately 130 ft from the downstream section of bankline. The average annual rate of erosion over the period of record for this section (marker posts 6 to 11) is approaching 20ft per year. This is in contrast to the upstream section, which averages only about 7 ft of erosion per year (a not inconsiderable amount). At this rate of erosion, the irrigation ditch adjacent to the downstream section of the study site would be reached within 7 years. This estimate is assuming no major change in planform (which is relatively unlikely, given the dynamicism of the Missouri River).
