# **Structural Condition Assessment**

**Center Theatre  
Franklin, Louisiana**

**City of Franklin  
Franklin Historic District**

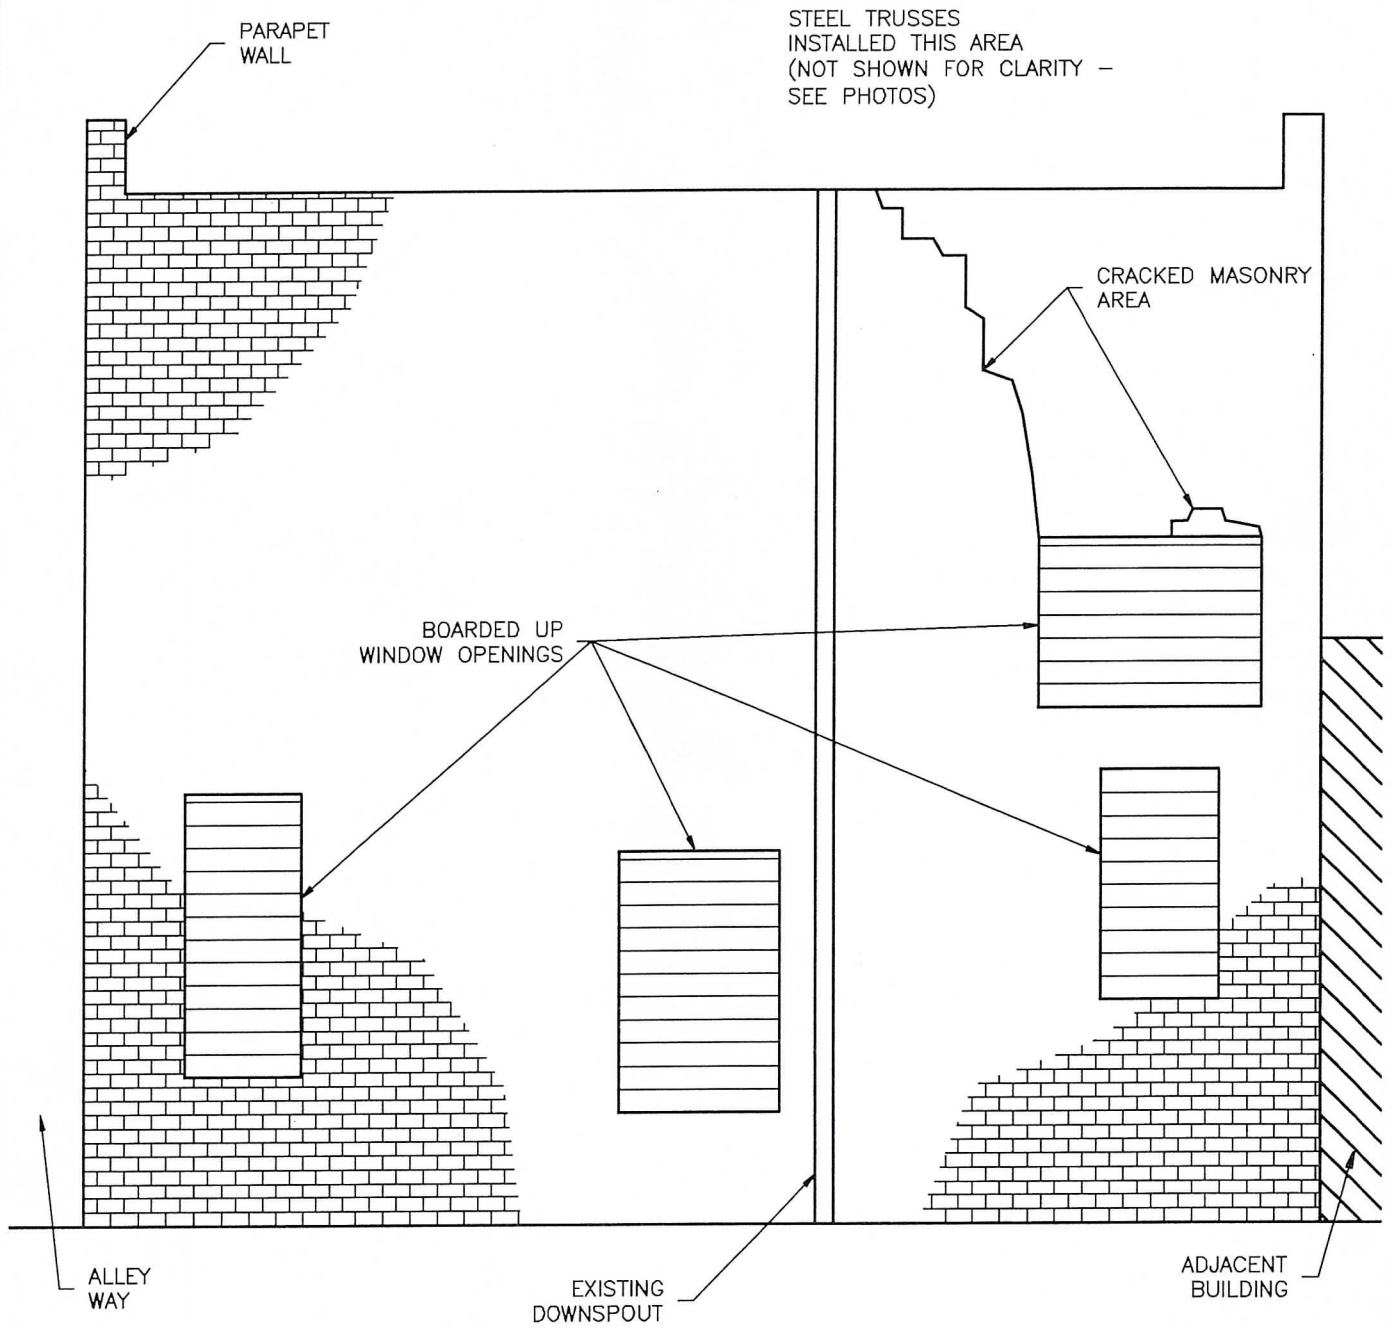
TITLE: **Structural Condition  
Assessment – Center Theatre  
Rear Elevation**

The brick masonry walls appear to be in good shape. Most of the masonry that could be examined in this investigation appeared to be intact with solid mortar joints. No significant deterioration of the masonry was observed. However, there was a significant crack in the rear masonry wall above the upper level window.

5.2.1. Additional investigation of the rear wall should be done to address the masonry wall cracking. The investigation should focus on possible settlement issues and other possible causes for the cracking. After fixing the root problem(s) for the wall cracking, the cracks should be sealed with cement mortar and/or flexible sealants will prevent additional water intrusion into the masonry wall.

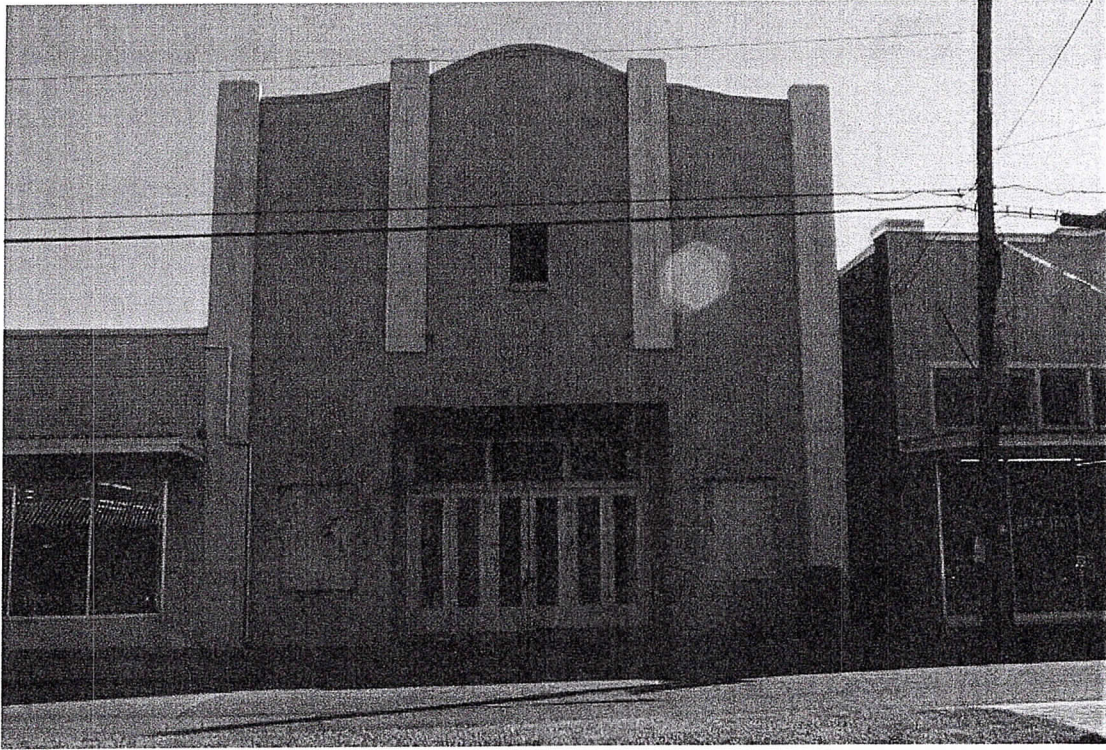
Front View (from Main Street)

The front façade of the building is finished with stucco and appears to be in good condition. Two openings on the front of the building have been boarded up. The exposed steel beam supporting the upper section of the façade wall is exhibiting significant corrosion from the weather. Also, the wood French doors at the front

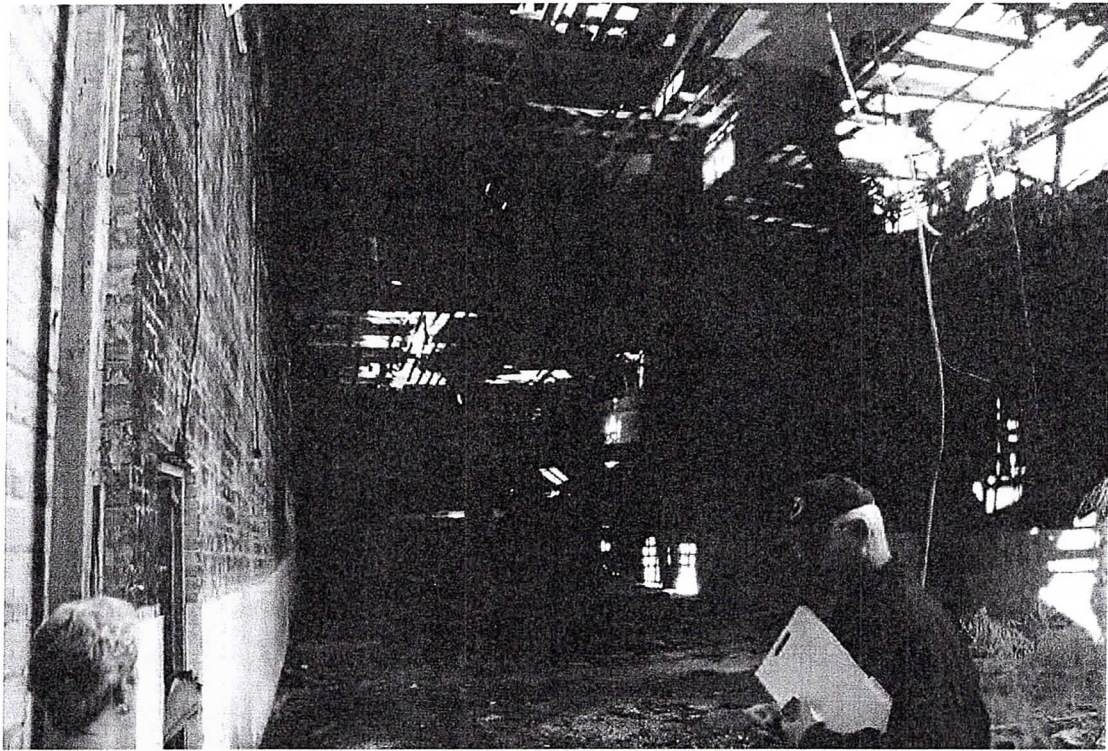
Overall view of interior from rear facing balcony area

- 4.2.2. General, Interior – The interior of the building is in an advanced stage of deterioration. The wood balcony structure has deteriorated due to water intrusion and general exposure to weather. The balcony also has a perimeter framing of steel beams that are also exhibiting severe corrosion from the water intrusion. The stairs leading up to the balcony and the floor structure appears to be unsafe to occupy.
