## Structural Assessment and Stabilization Plan for

# Gurski Homestead

26 Obtuse Hill Road  
Brookfield, CT

January 7, 2014

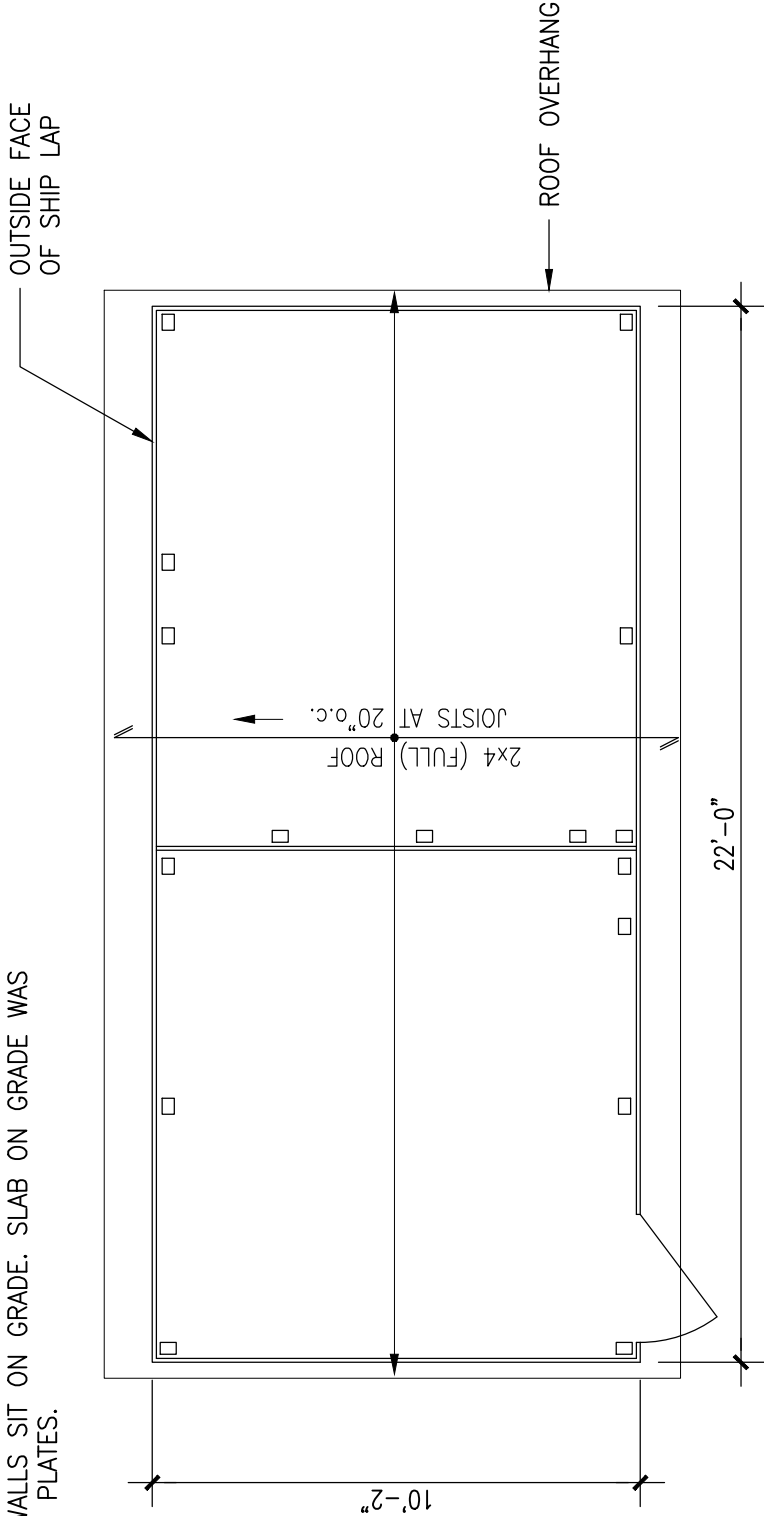
BUILDING #1 (SHED) PLAN

The post and beam wall framing for this building sits atop a sill plate set on grade. The concrete slab on grade floor was cast on grade using the perimeter sill plate as a form. Since the sill plate is exposed to earth on two sides and concrete on another, its exposure is extremely severe and its condition is poor as a result. The lack of a proper foundation for this building is a major inhibition to permanent stabilization since contact between wood and the ground or concrete promotes premature decay of the wood. The building is also not founded below the Code required frost depth and is therefore vulnerable to seasonal movement of the subgrade.

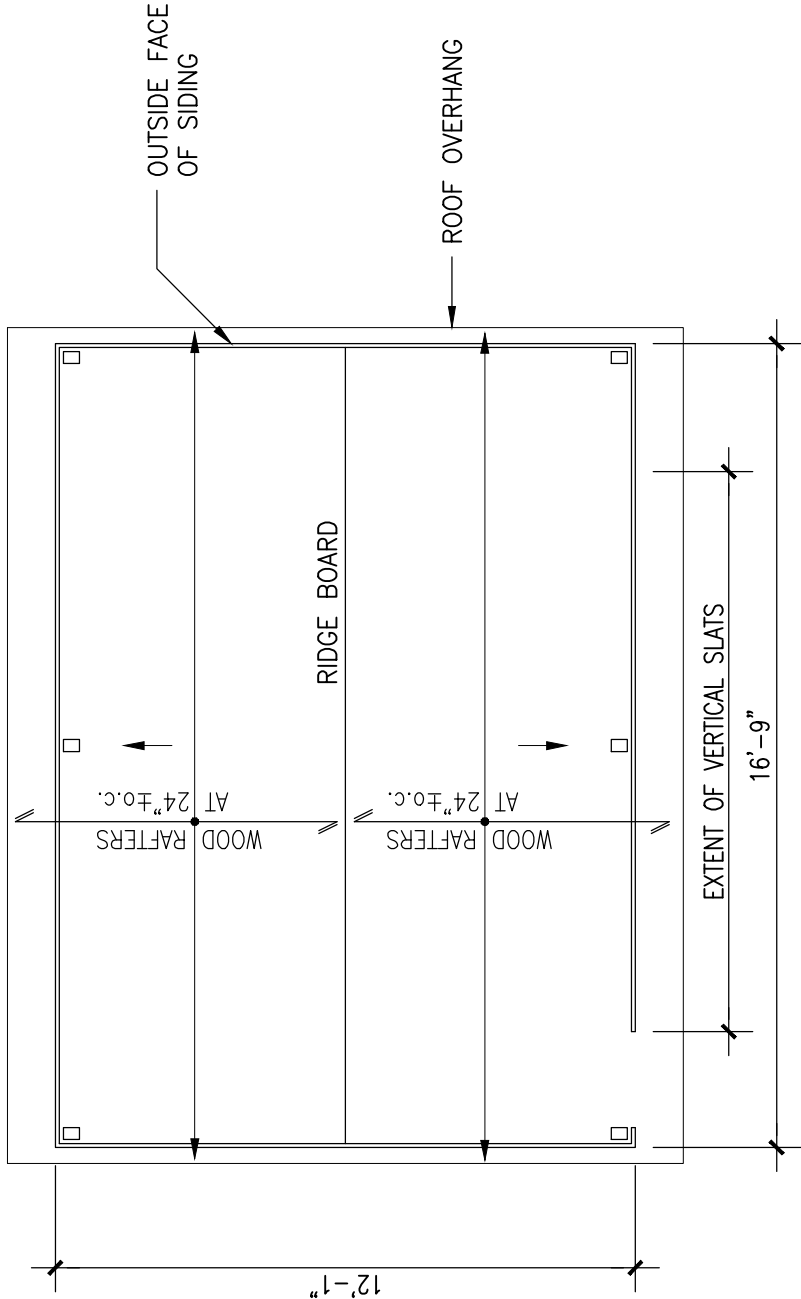
BUILDING #3 (CORN CRIB) PLAN

All framing for this building is severely deteriorated. Floor framing was concealed by debris along the building interior, but viewable sections are in poor condition. The roof is improperly framed, not having a ridge beam or ties at the ceiling level to hold it together. Its condition is also extremely poor and the center of the roof is severely deflected. Siding is severely deteriorated throughout, as are the roof boards and roll roofing material which was improperly used on a high slope roof. This structure cannot realistically be salvaged since the framing is deteriorated to the extent that it is hollowed out and unable to hold nails that would connect any repair pieces.

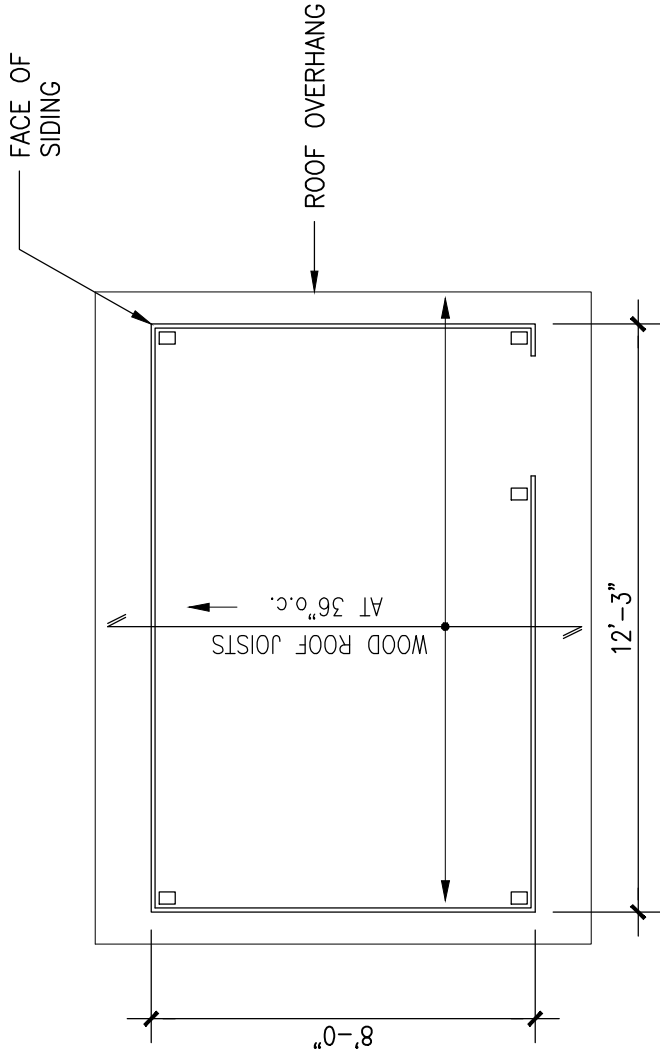
**BUILDING #5 (SHED) PLAN**

The post and beam wall framing for this building sits atop a sill plate set on grade. Since the sill plate is exposed to earth its exposure is extremely severe and its condition is poor as a result. The lack of a proper foundation for this building is a major inhibition to permanent stabilization since contact between wood and the ground promotes premature decay of the wood. The building is also not founded below the Code required frost depth and is therefore vulnerable to seasonal movement of the subgrade.

The roof is framed with rough sawn rafters with rafter tail extensions beyond the face of the walls. The rafters, and particularly the tails, are severely rotted from exposure. The fascias along the rafter tails are also rotted from exposure. The roof is improperly framed, not having a ridge beam or ties at the ceiling level to hold it together.

Siding condition is highly variable. Some boards are in fair condition, but many are in poor condition and require replacement.

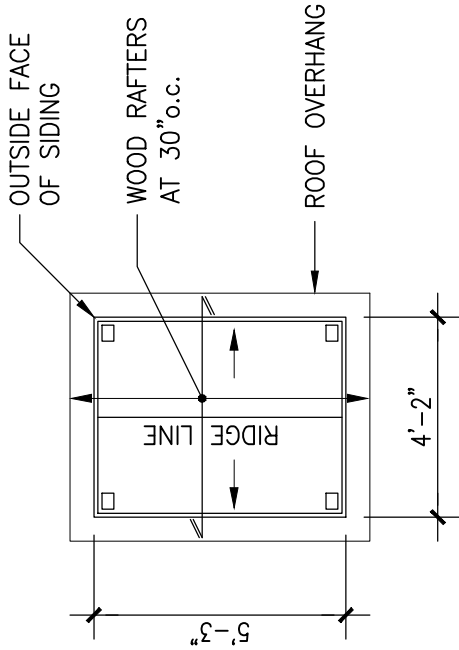
BUILDING #6 (PRIVY) PLAN

All framing for this building is severely deteriorated. The roof is in extremely poor condition and is partially collapsed. Siding and roof decking are severely deteriorated throughout, as is the roll roofing material which was improperly used on a high slope roof. This structure cannot realistically be salvaged since the framing is deteriorated to the extent that it is hollowed out and unable to hold nails that would connect any repair pieces.

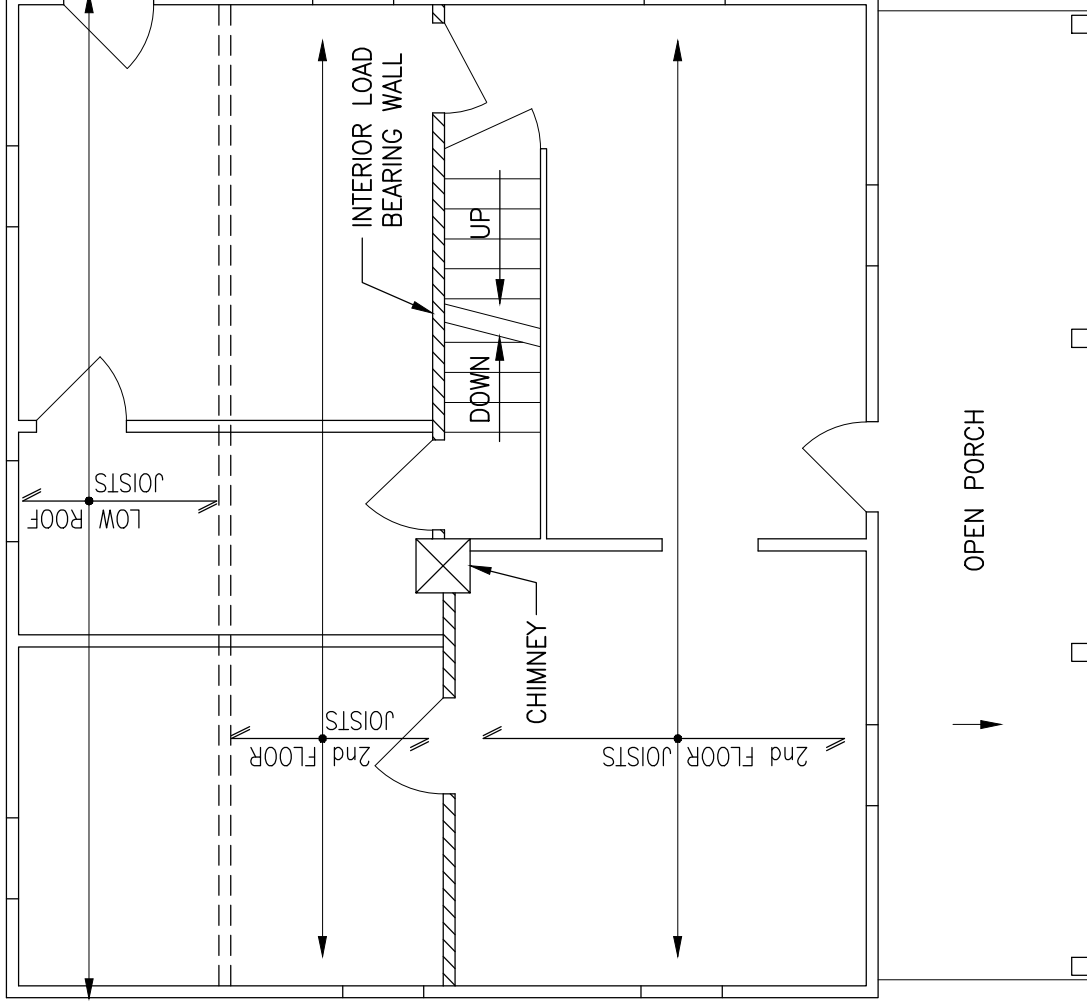
## FARM HOUSE FIRST FLOOR PLAN

The roof of the house is framed with rough sawn timbers spaced at four feet on center. There is a pronounced depression in the north side of the high roof. We observed the roof framing from a position on a ladder in the attic access hatch. There is one failed timber coinciding with the depression location and another failed timber along the framing around the chimney. The original roof decking is severely rotted, although it was previously covered with plywood and is no longer supporting the roofing materials. We could not verify the thickness or span rating for the newer plywood, although we note that the rafter spacing is much greater than plywood less than 3/4" can safely span.

The interior plaster walls and ceilings are in extremely poor condition. Plaster is cracked and bulged throughout, and several sections are loose and delaminating from the substrate.

The exterior finishes have been partially restored. The roof covering appears to be relatively new as do some trim boards. There are two layers of siding present. The outer layer is cedar shakes. The base layer, which is visible only near the east entrance, is wood clapboard siding. The cedar shakes are in poor condition throughout. Where clapboard is visible, it is also in poor condition.

The brick masonry chimney is exposed above the roof for about four feet. Mortar joints are deteriorated throughout the exposed height of the chimney.

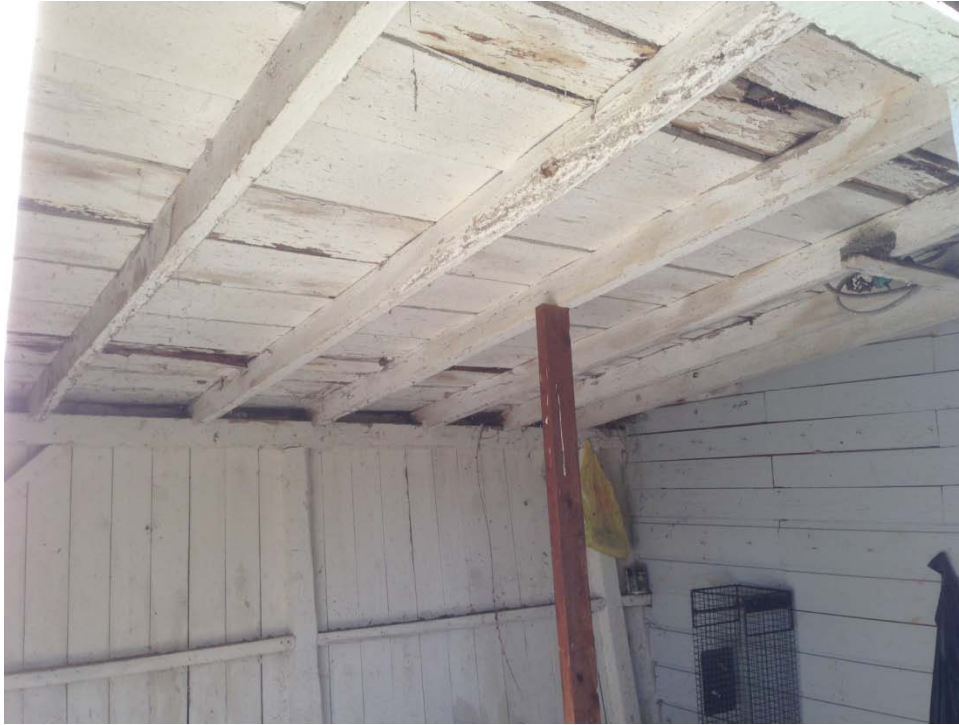
Building 1

Typical Interior View

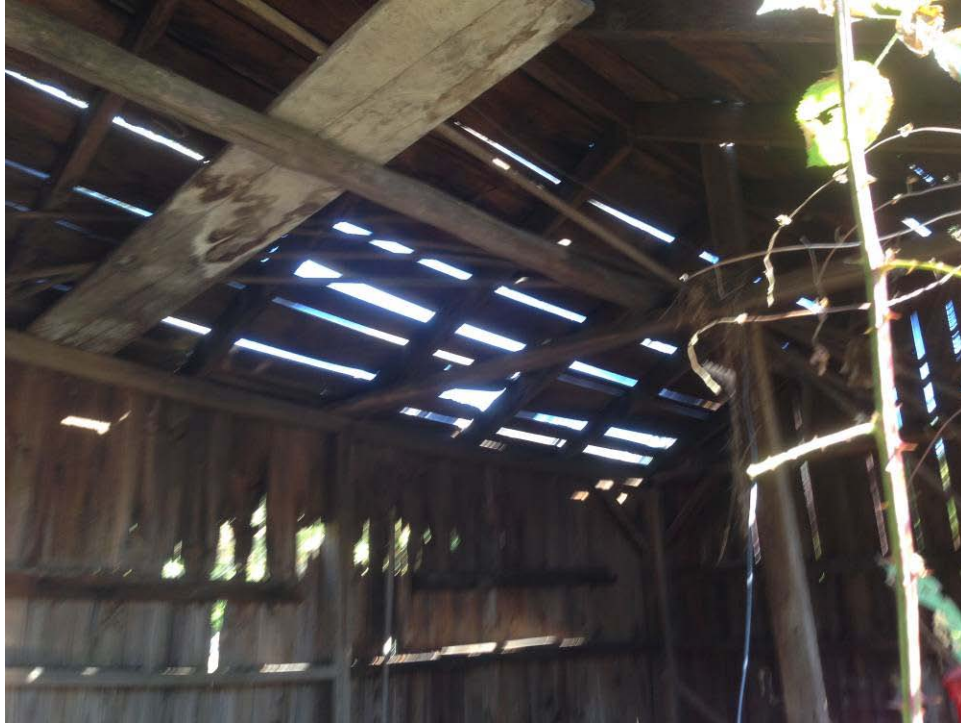
Building 3

Typical Interior View

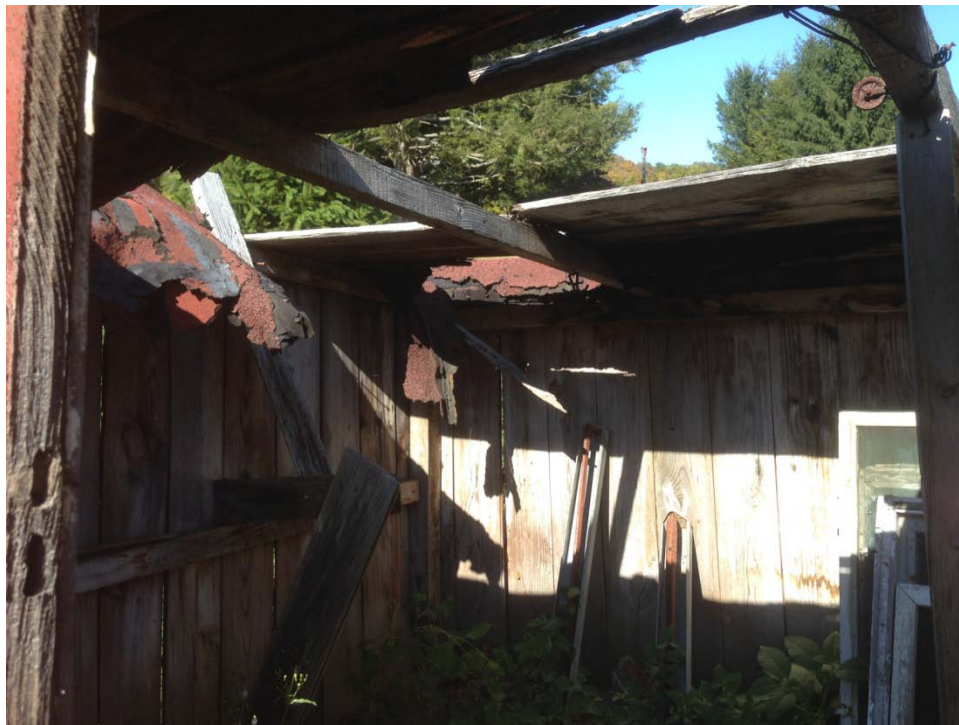
Building 5

Typical Interior View
