December 15, 2014

**Re:   Wichita-Sedgwick Historical Museum Building Condition Assessment and  
Maintenance Plan  
CASE Project No. 2439001**

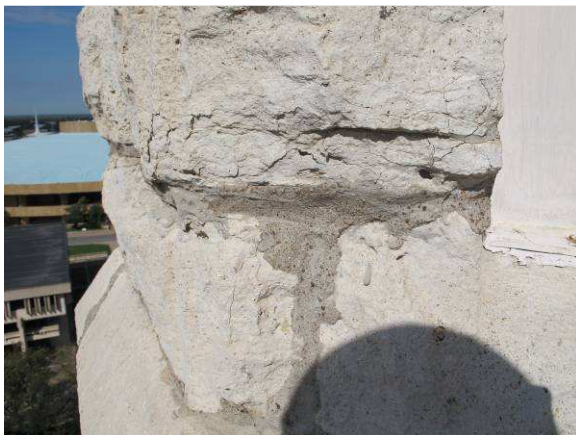
**Poorly installed mortar and deteriorated limestone**

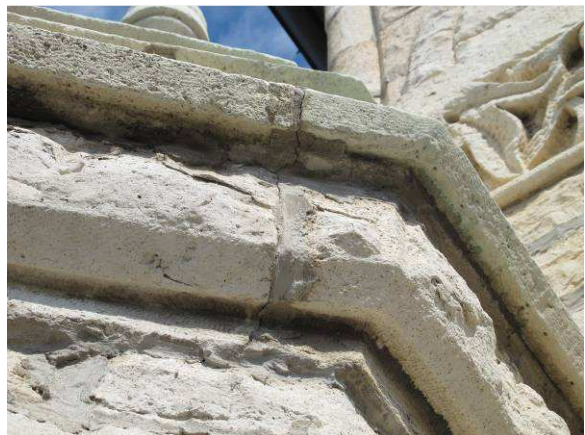
**Separation at mortar joint**

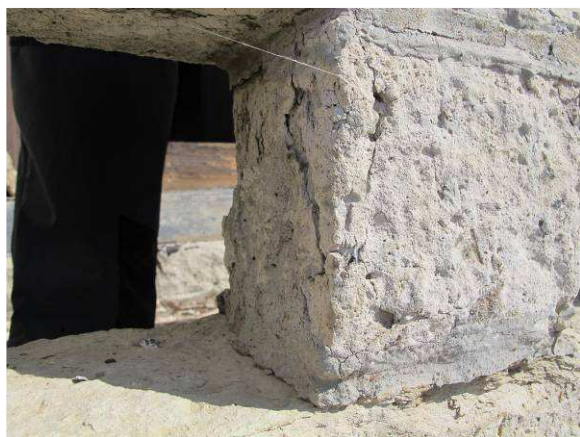
**Deteriorating limestone at balcony rail**

| <b>2015 -<br/>2017</b> | Repair main entry balcony | |

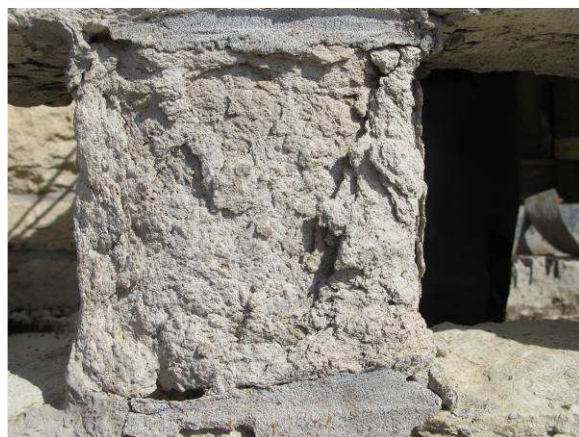
**Deteriorating limestone at balcony rail**

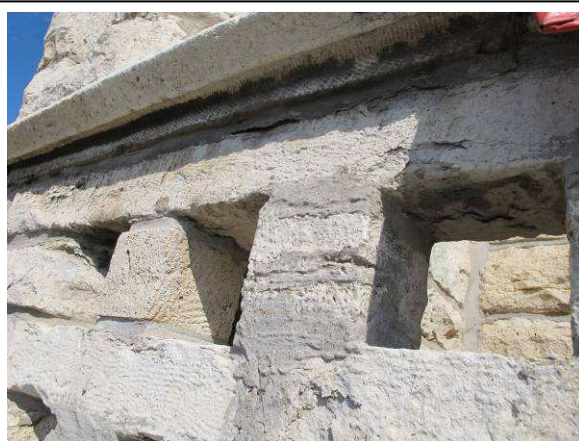
**Poor quality repair at balcony rail**

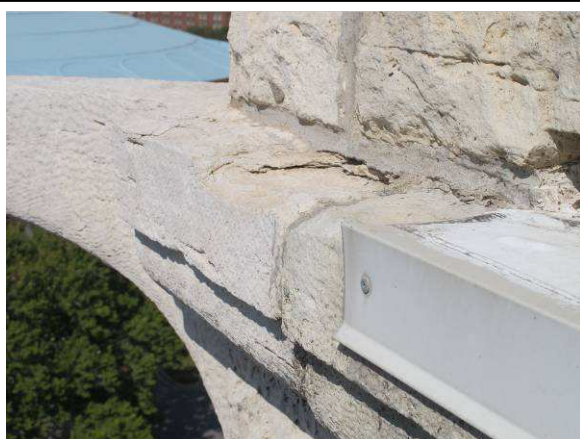
**Deterioration at top of stone**

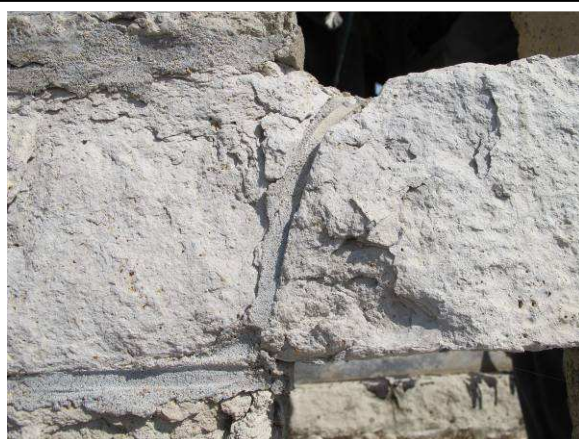
**Poor repairs at balcony rail**

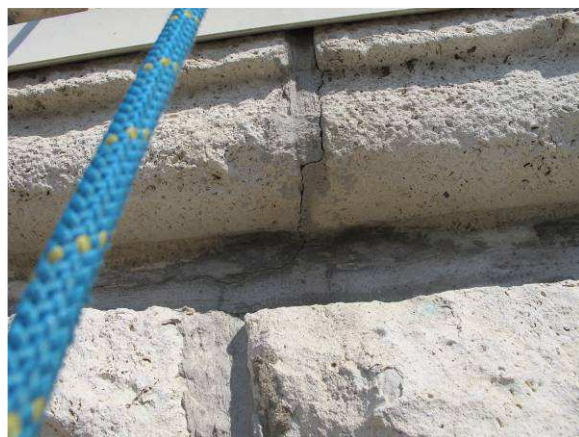
**Mortar separation above arch**

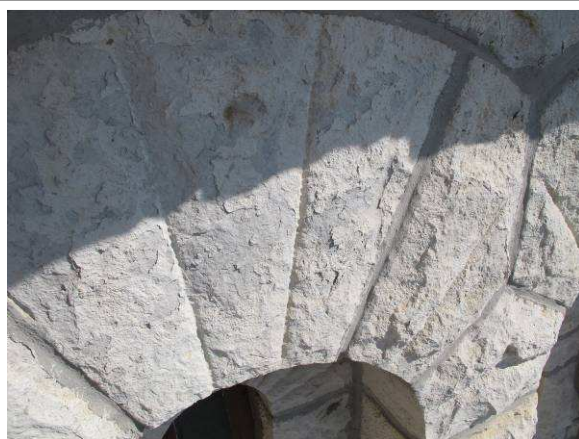
**Loss of surface detail at arch**

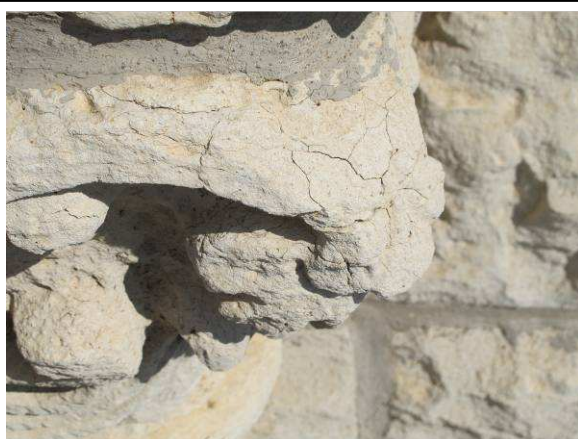
**Deteriorating carved detail**

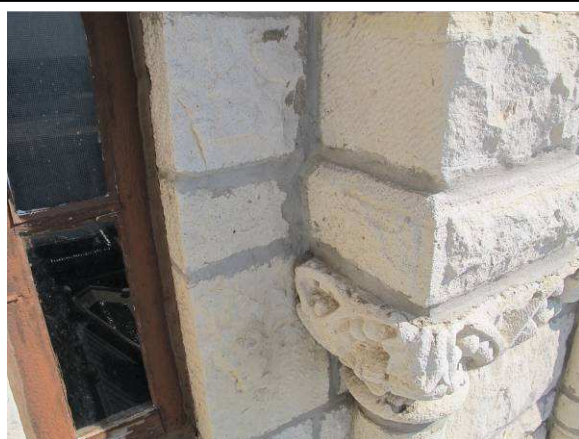
**Poor mortar installation and decaying wood**

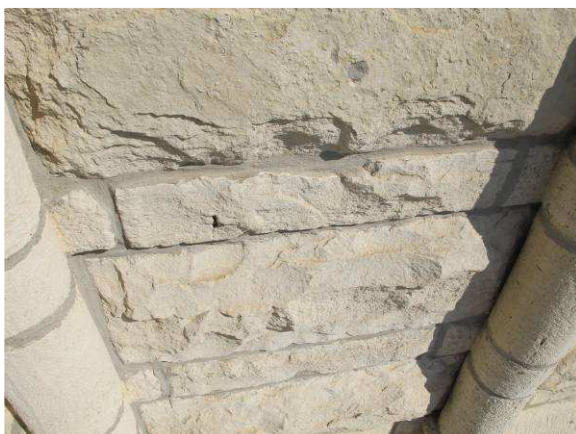
**Deteriorated mortar and spalling stone**

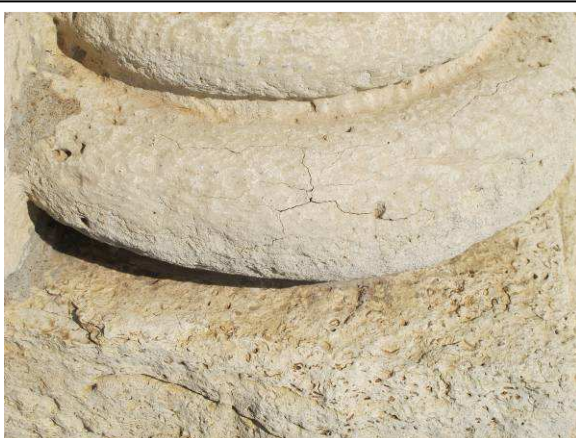
**Deteriorating stone at column base**

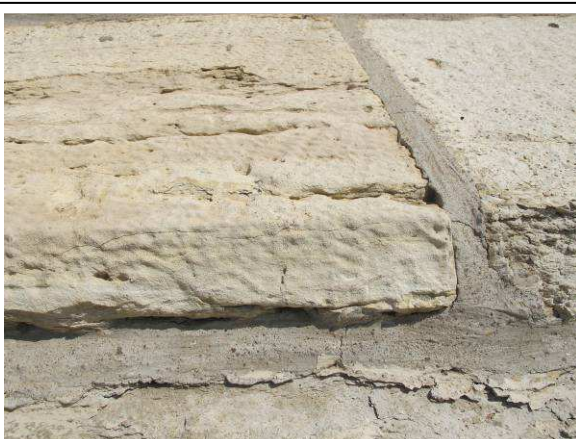
**Deteriorating mortar and limestone**

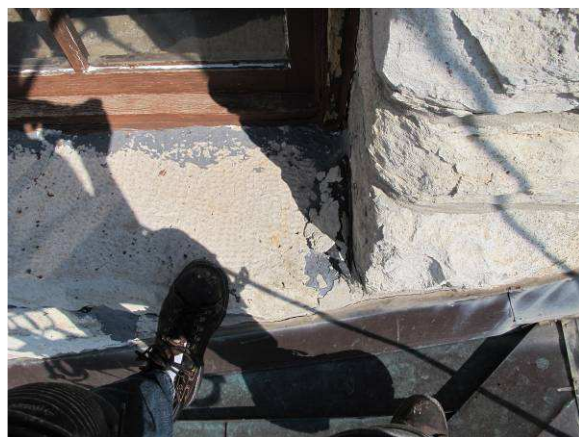
**Wood window and ledge in need of treatment**

| <b>2018 -<br/>2020</b> | Restore remaining wooden windows and doors (including removal and replacement as necessary) | |

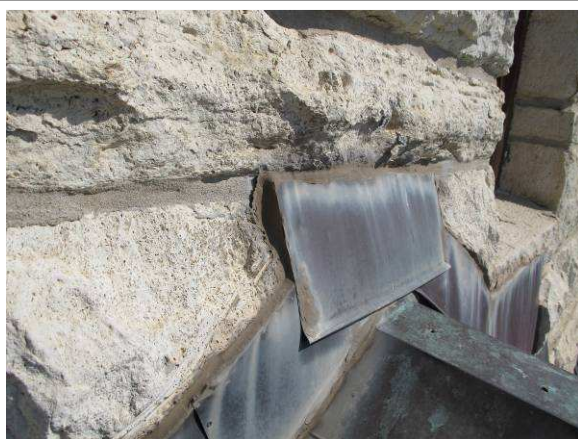
**Questionable flashing detail**

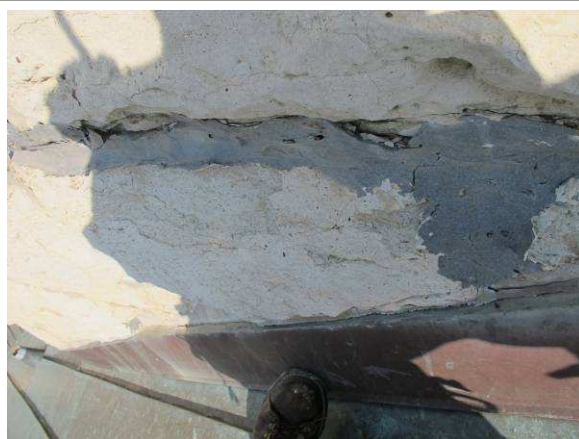
**Deteriorating mortar near flashing**

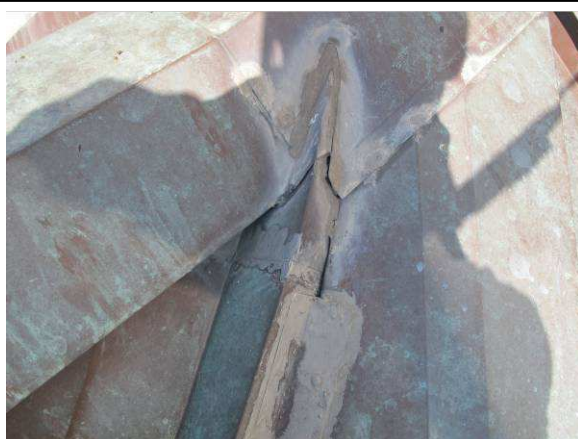
**Poor flashing detail**

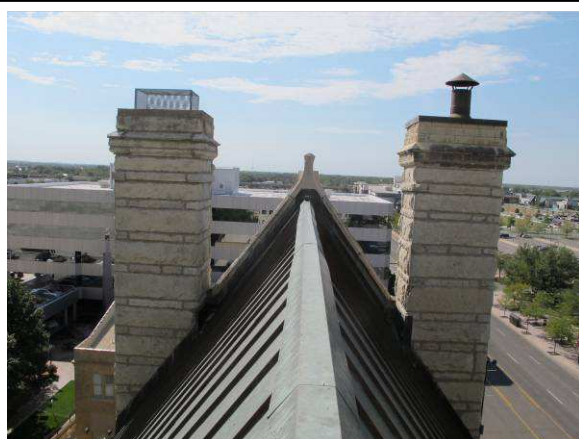
**Back of south side chimneys**

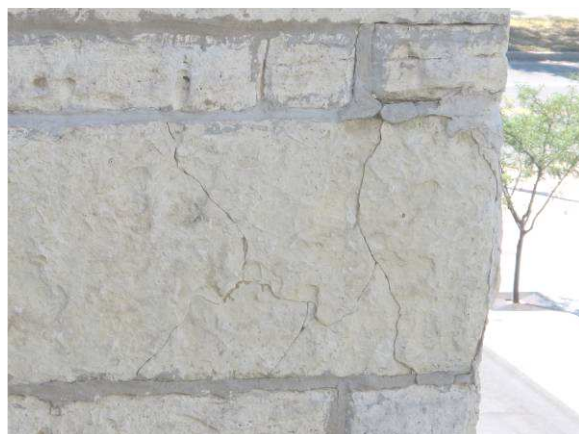
**Close up of deteriorated stone**

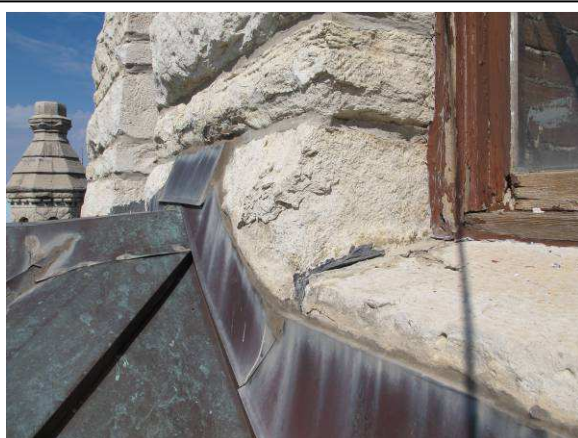
**Deteriorating window, limestone and mortar**

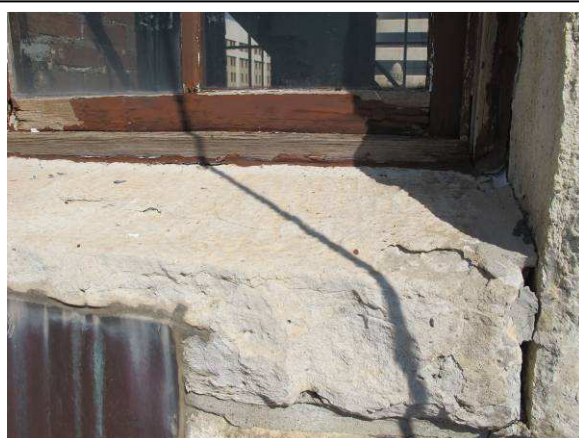
**Deteriorating window, limestone and mortar**

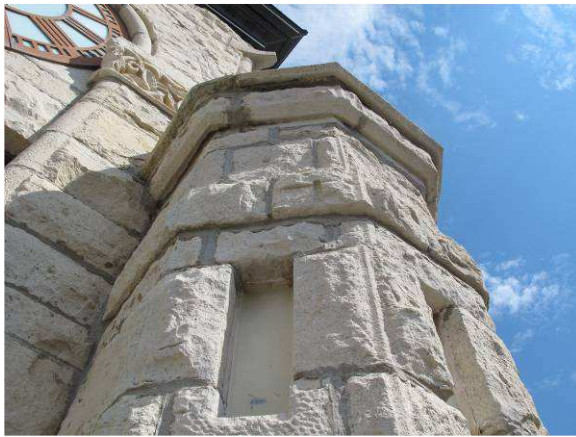
**Poor mortar installation**

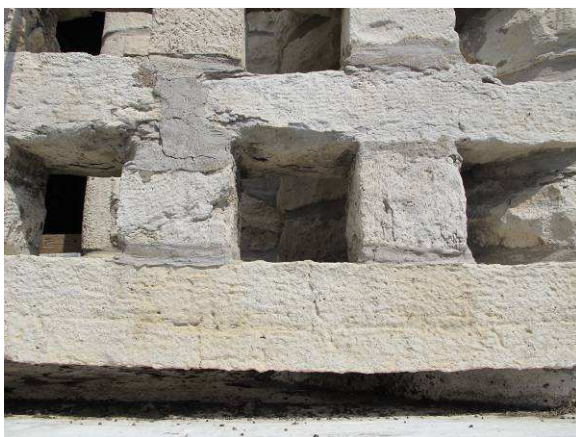
**Poor repairs and deteriorating stone at balcony**

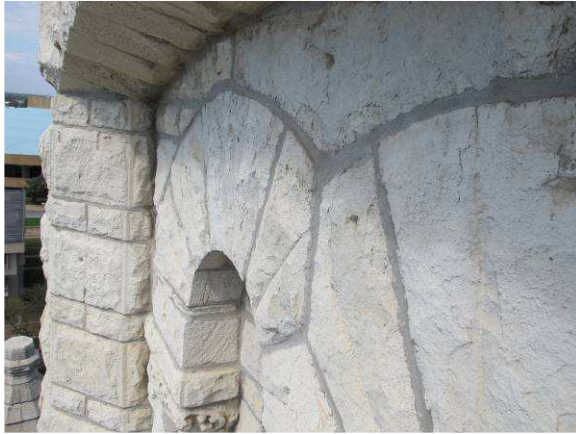
**Loss of detail at arch**

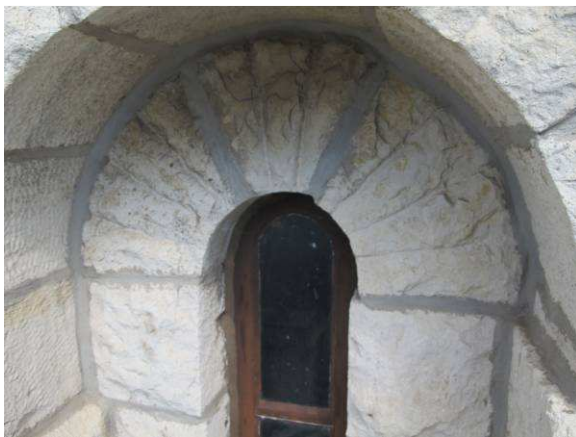
**Poor mortar installation at arch**

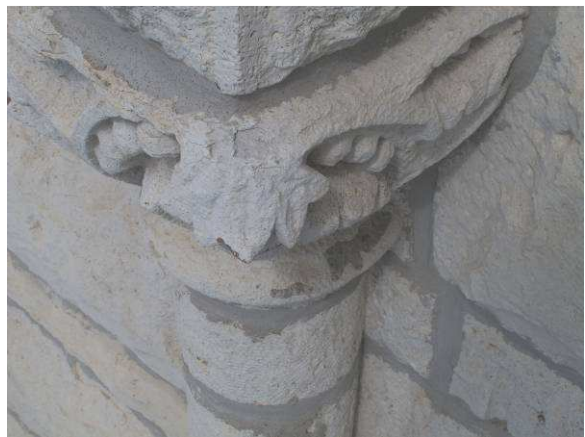
**Poor mortar installation**

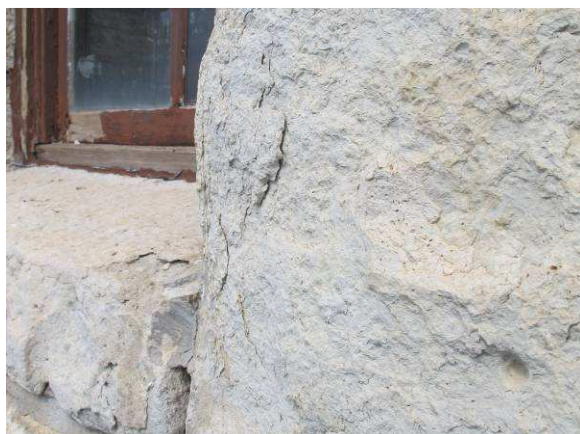
**Deteriorating stone and wood window frame**

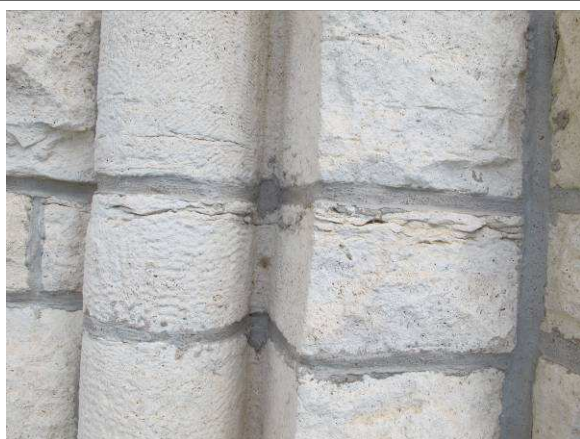
**Delaminating naturally bedded stone**

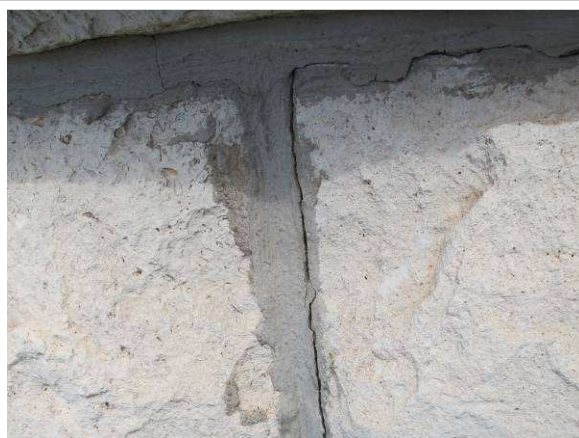
**Separation at mortar joint**

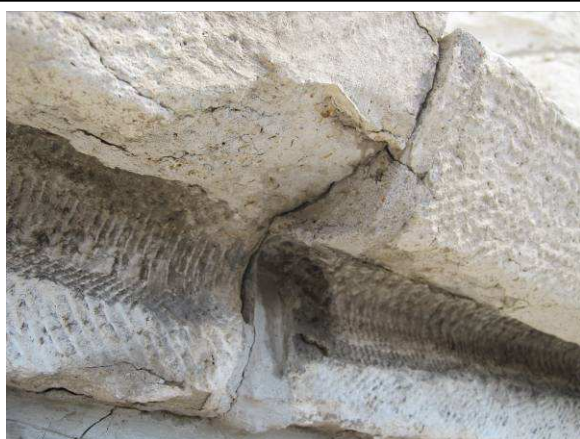
**Mortar loss and stone deterioration**

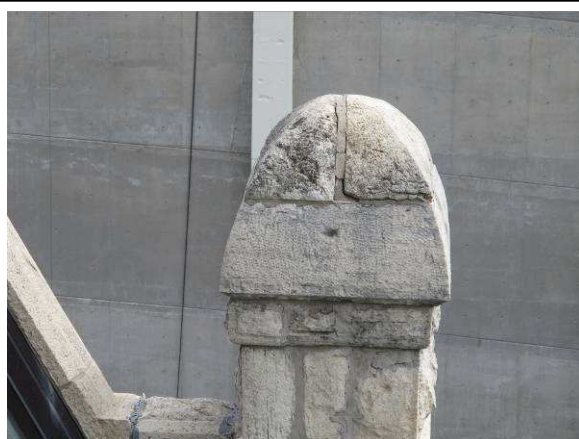
**Failing mortar at roof edge spire**

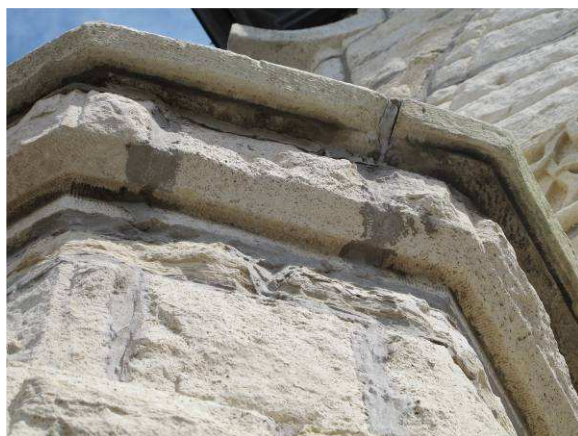
**Separating mortar joint**

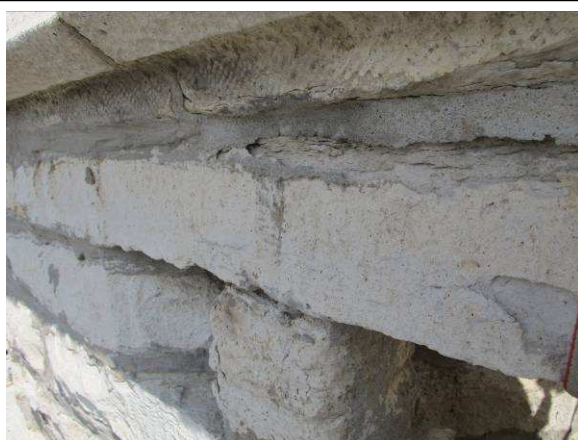
**Deteriorated stone and mortar at balcony**

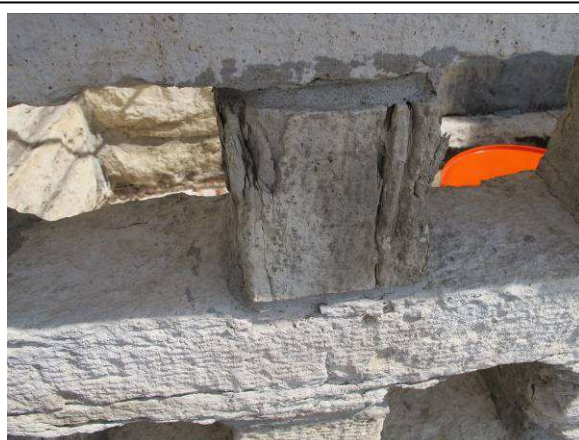
**Failing stone at balcony**

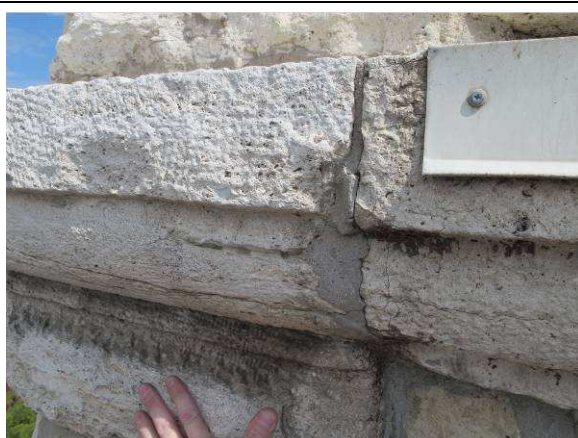
**Deteriorated mortar joint**

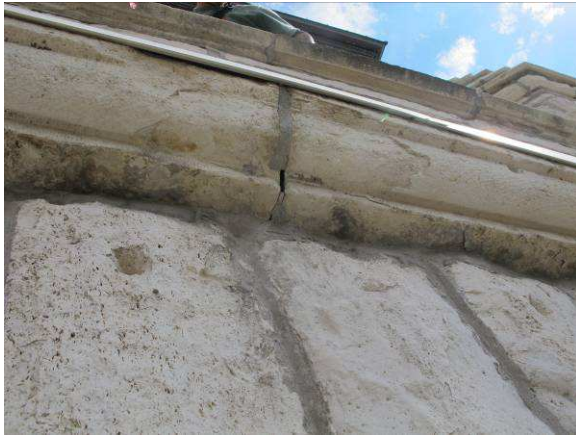
**Open mortar joint and spalling stone**

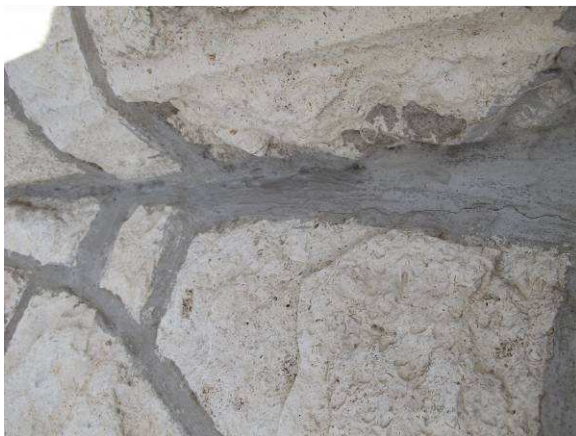
**Poor mortar installation**

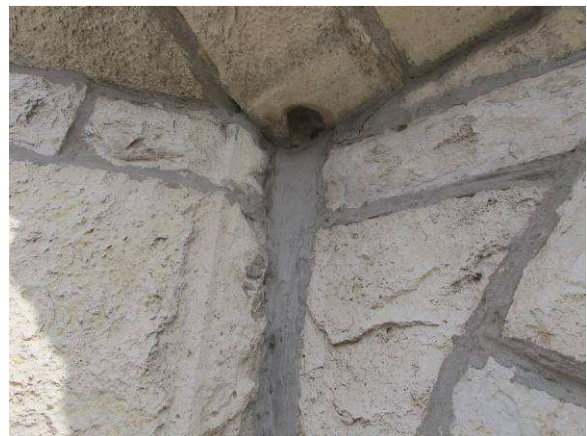
**Poor mortar installation**

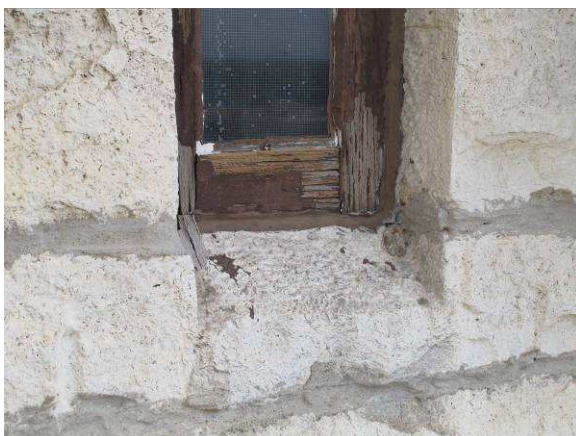
**Deteriorating wooden window and ledge**

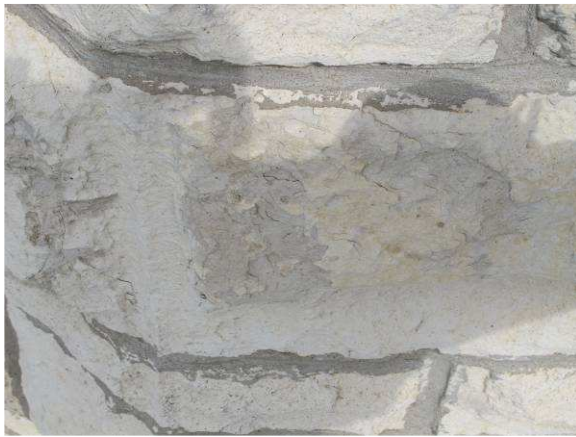
**Spalled face of stone**

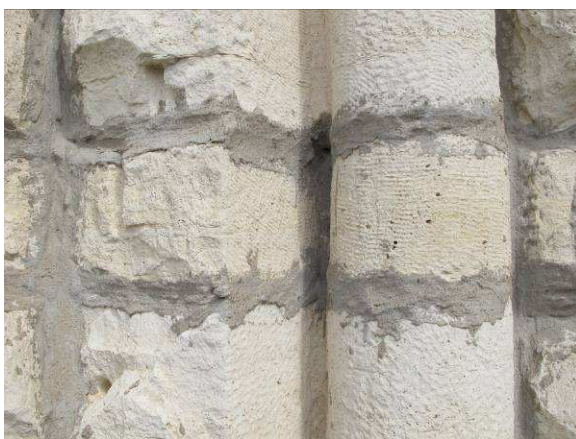
**Poor mortar installation**

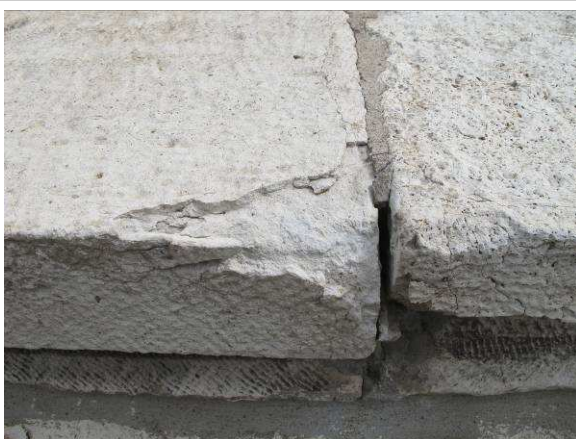
**Failed mortar joint and spalled stone**

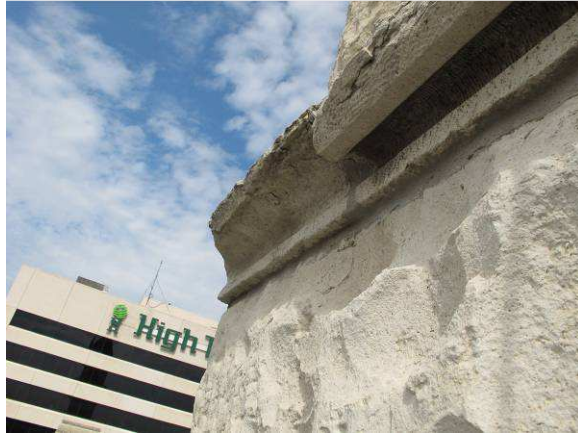
**Spalled and delaminating stone**

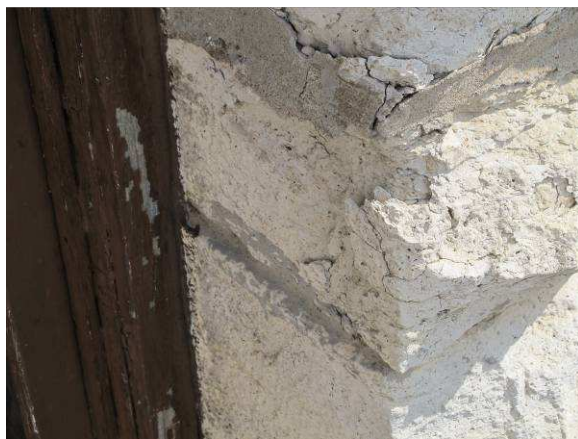
**Deteriorating stone and mortar**

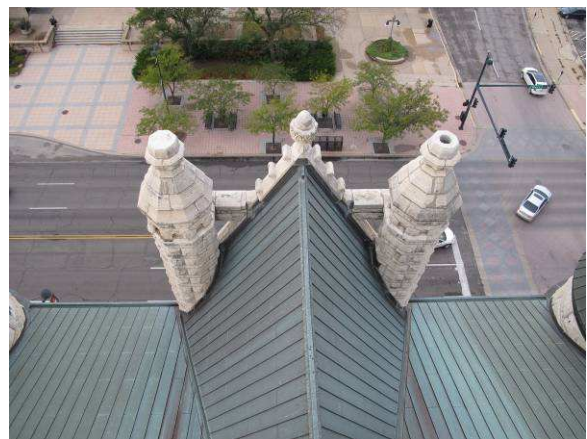
**View of back of perimeter stone**

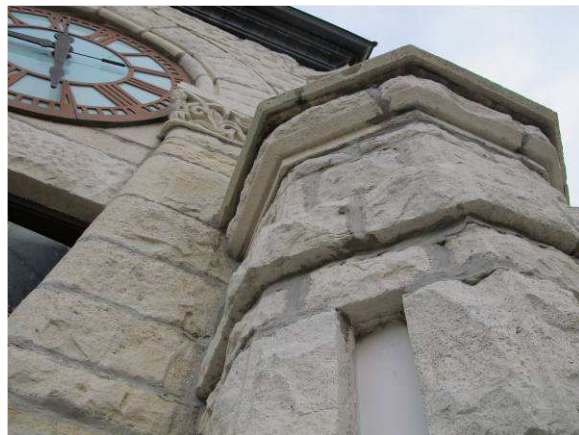
**Poor mortar installation**

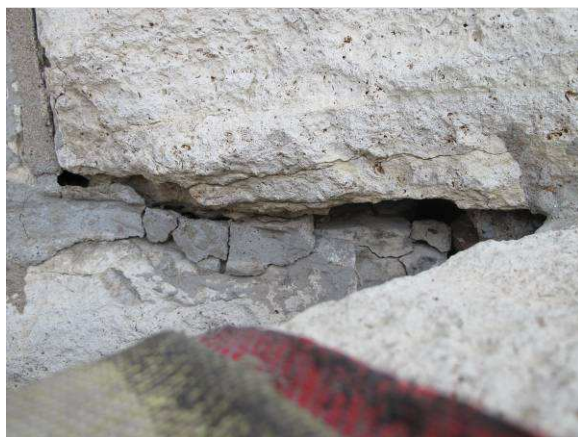
**Broken mortar in joint**

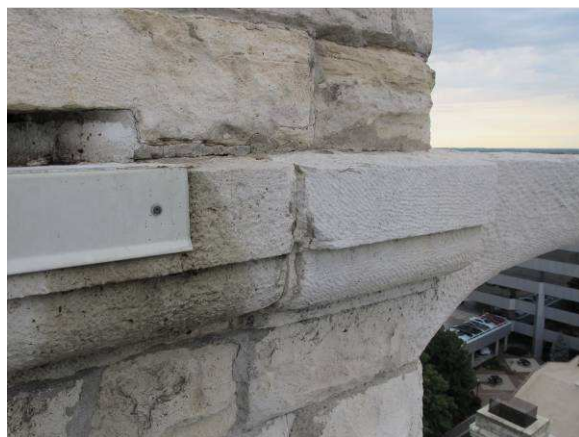
**Deteriorating stone and mortar**

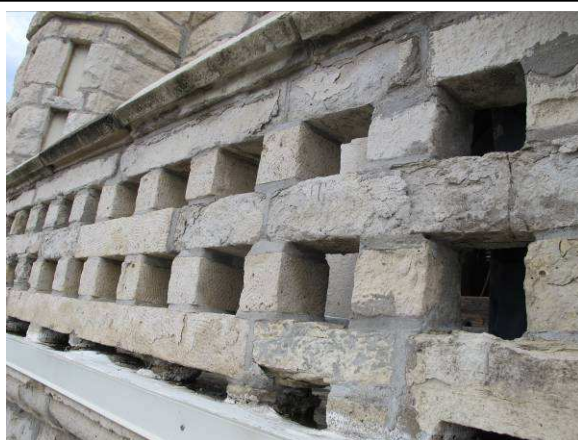
**Delaminating stone at balcony**

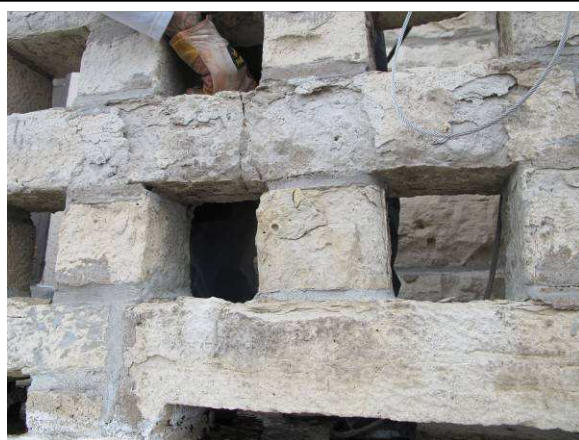
**Delaminating stone at balcony**

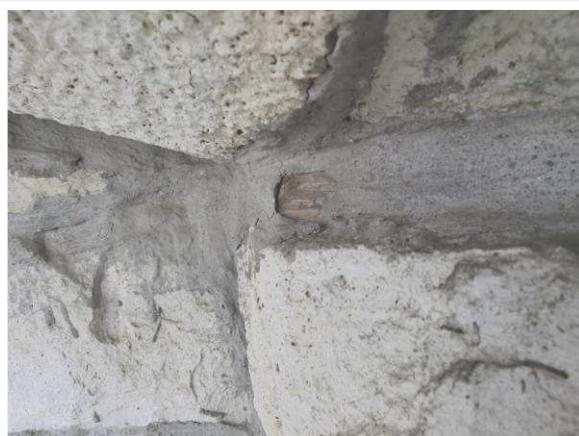
**Failing mortar joint**

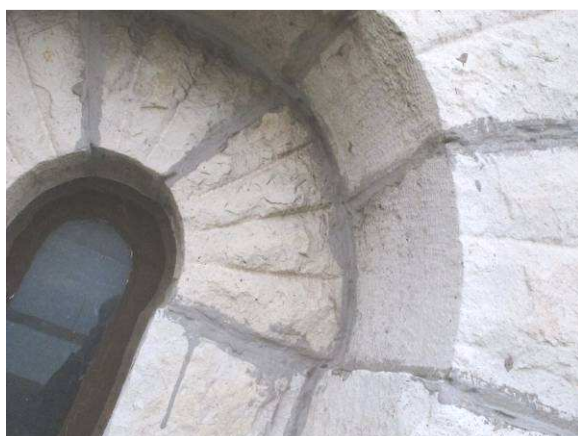
**Poor workmanship and failing joints**

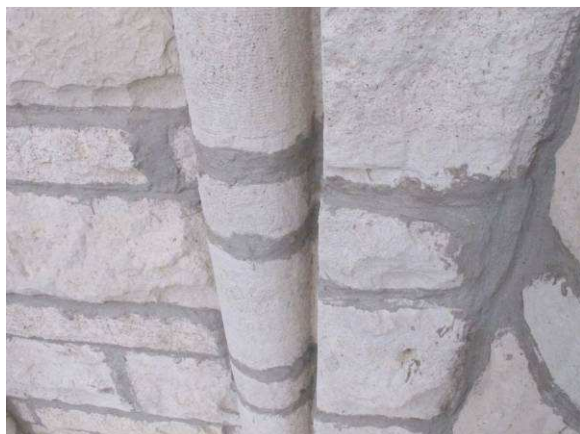
**Poor mortar installation**

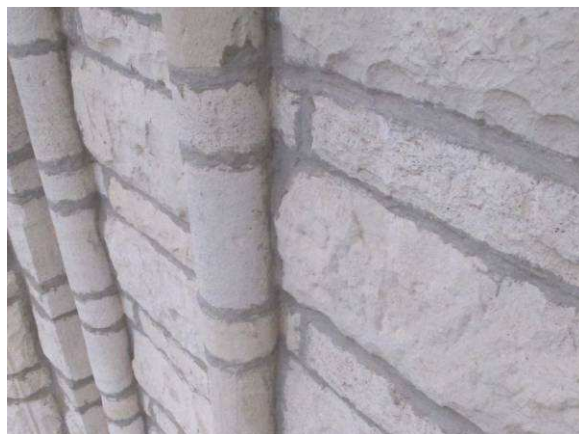
**Poor mortar installation**

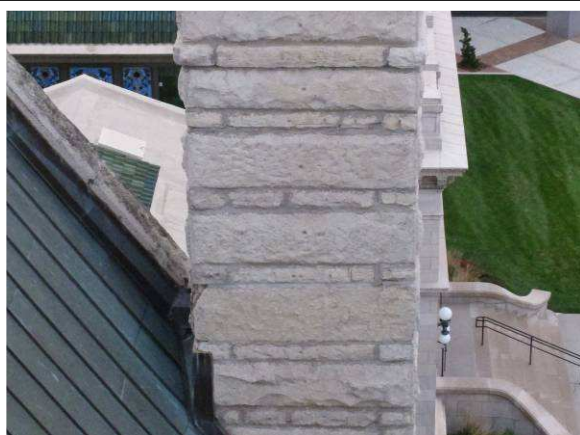
**Backside of chimney at south end of bldg**

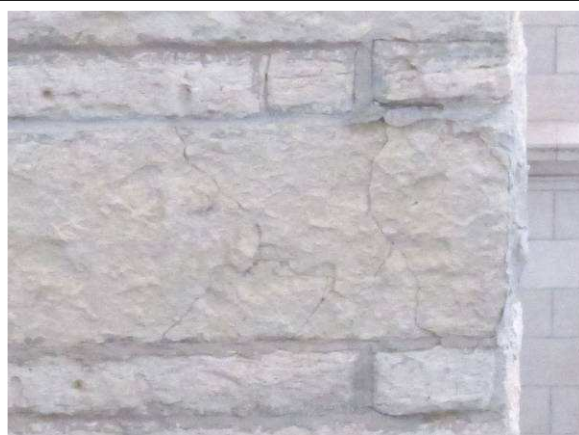
**Deteriorated stone in chimney**

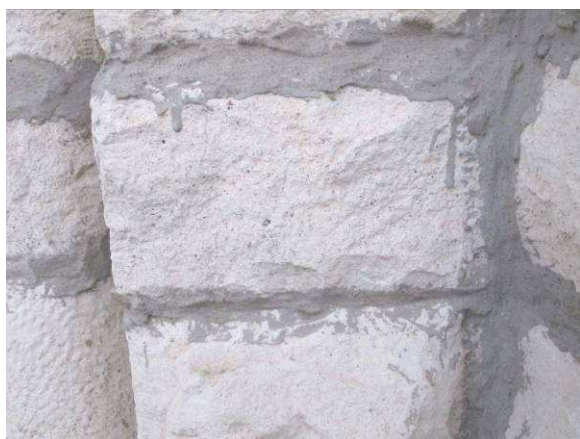
**Poor mortar installation**

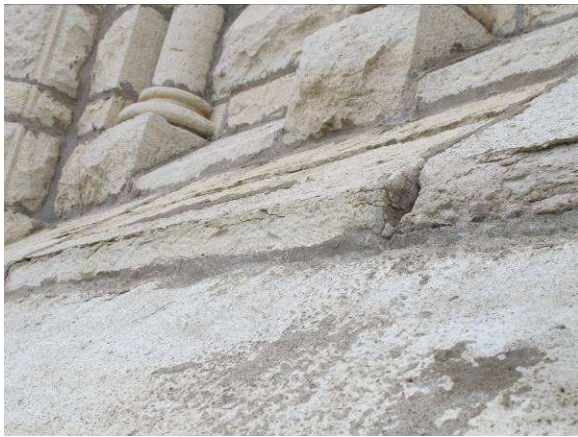
**Failing mortar below columns**

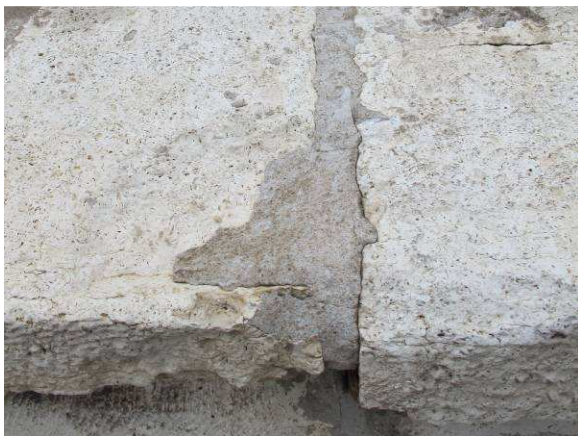
**Separated mortar joint**

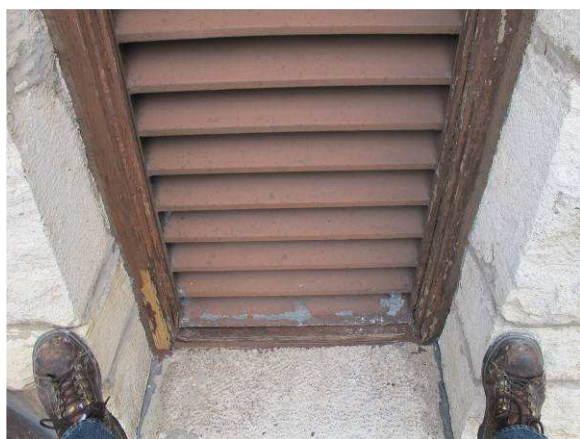
**Deteriorating wood window and caulking**

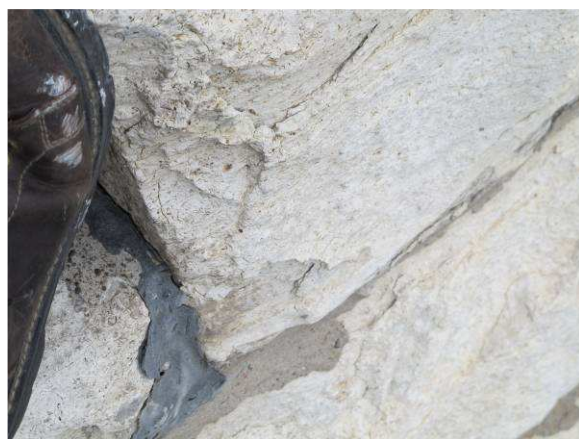
**Deteriorated caulking and stone**

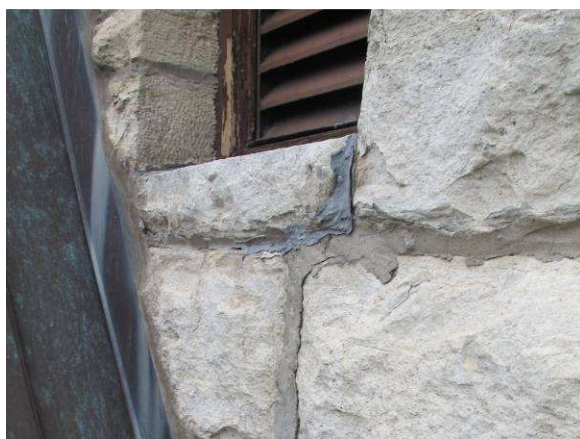
**Failed caulking and separated mortar**

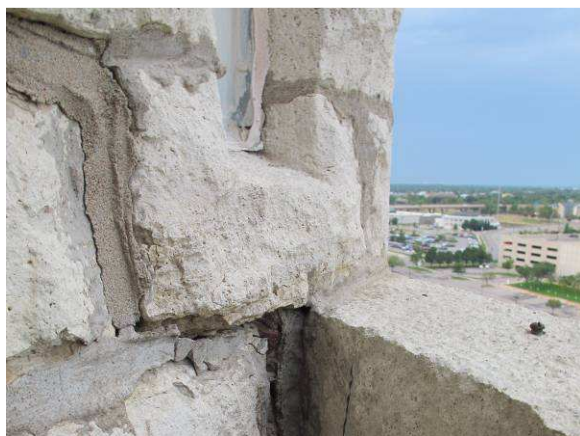
**Failing mortar at balcony**

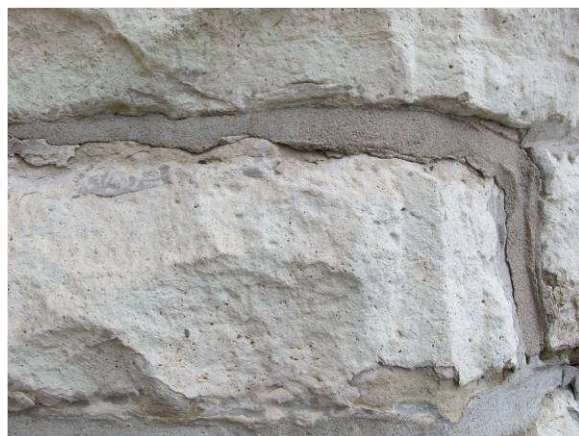
**Failing mortar at balcony**

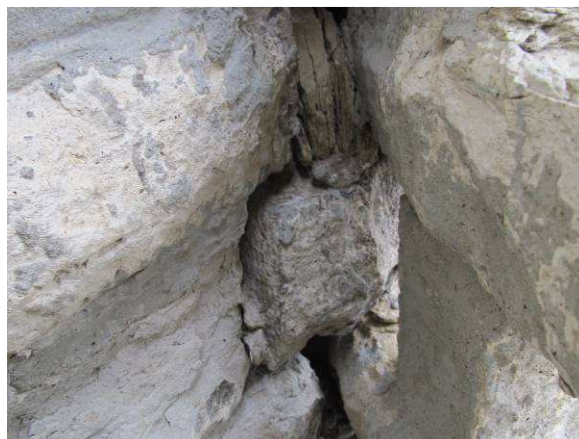
**Deteriorating stone at balcony corner**

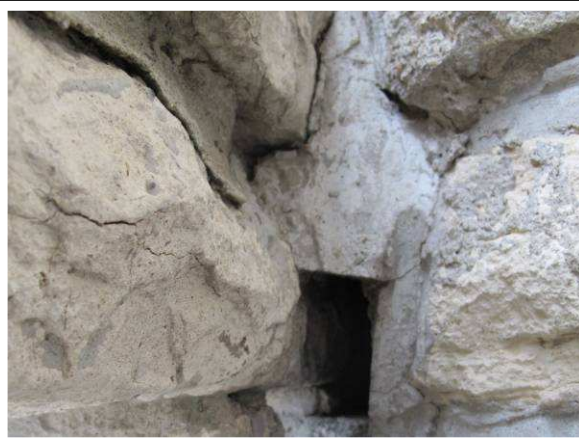
**Missing brick at balcony corner**

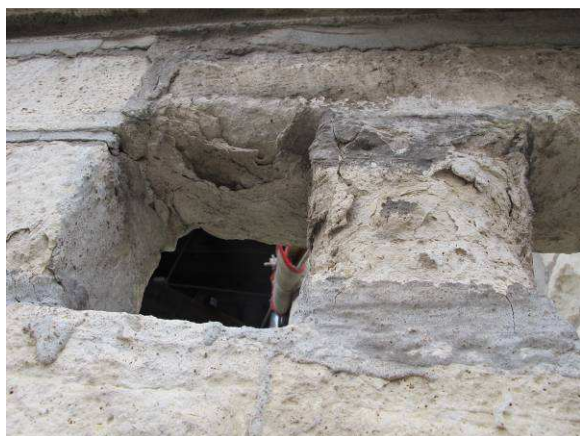
**Deteriorated limestone at balcony**

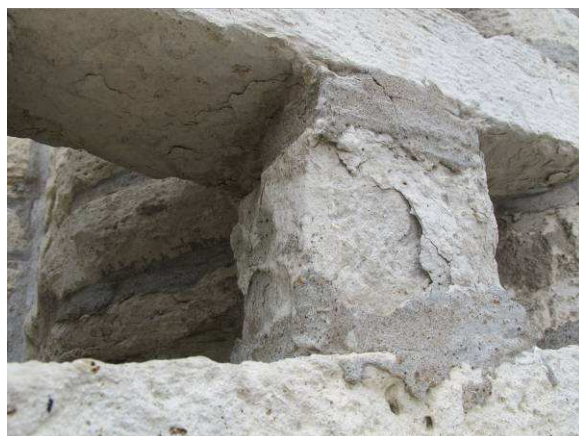
**Deteriorated limestone at balcony**

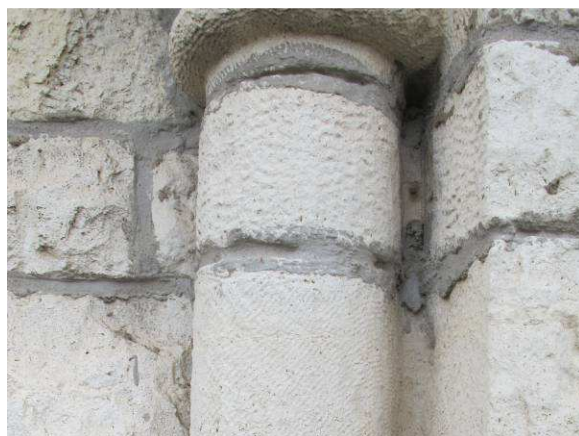
**Poor mortar installation**

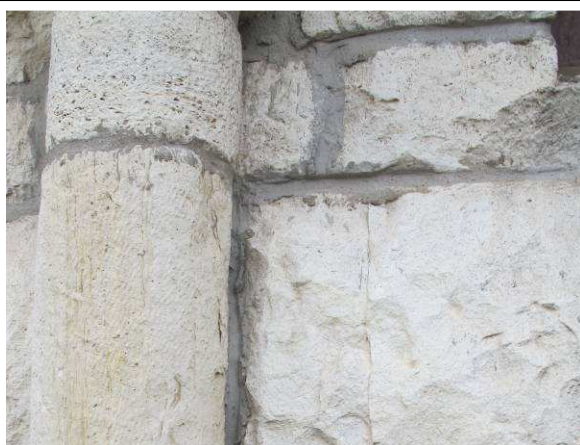
**Poor mortar installation**

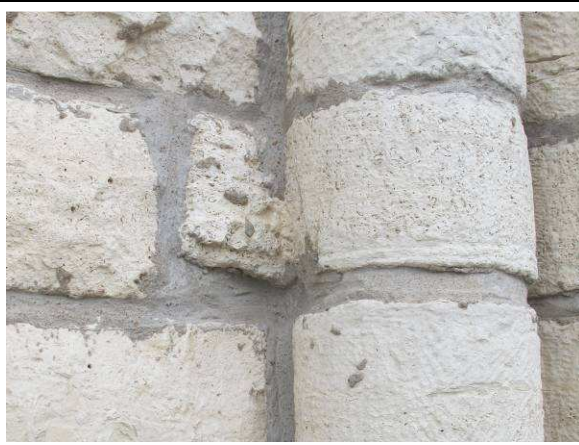
**Poor mortar installation**

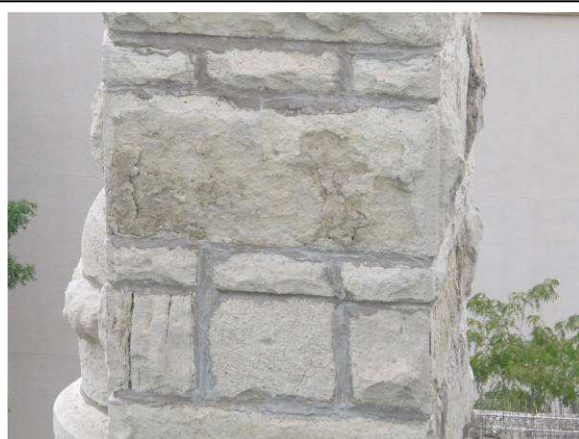
**Deteriorating stone at chimney**

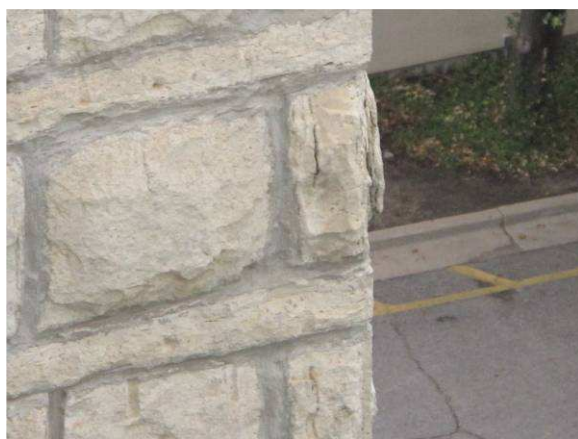
**Spalling stone on opposite side of chimney**

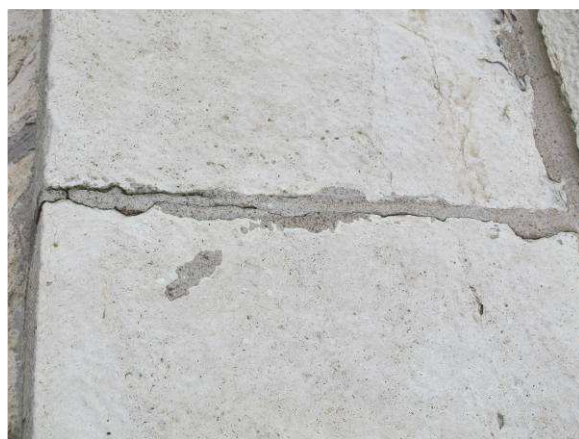
**Separated mortar joint**

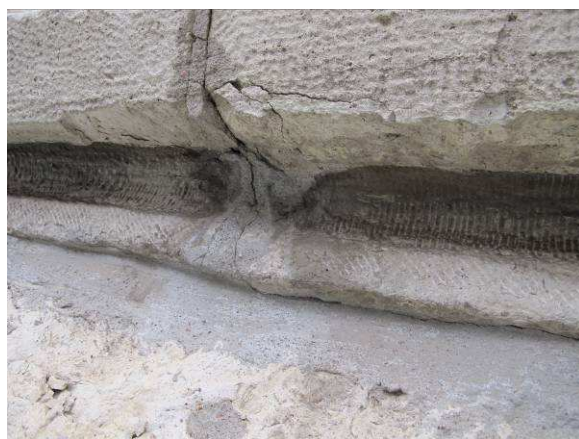
**Failed mortar joint and deteriorated stone**

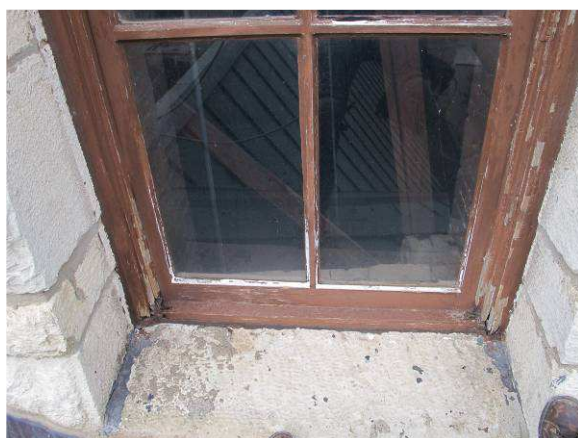
**Decaying wood window**

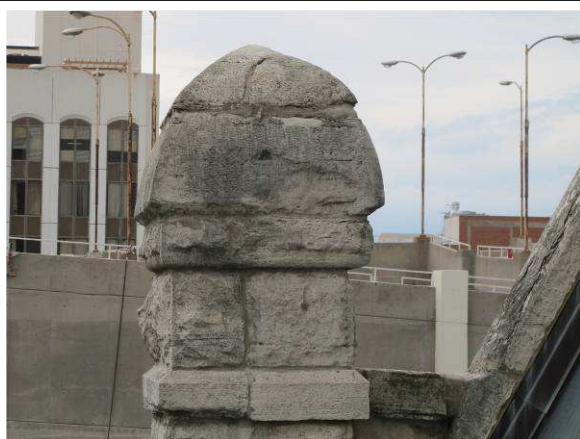
**Mortar failing at spire**

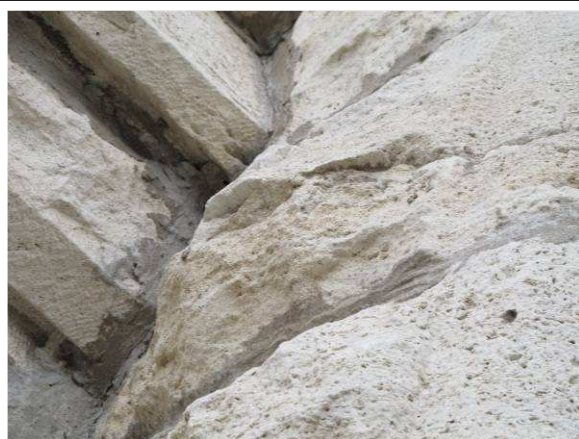
**Poor mortar and failing stone**

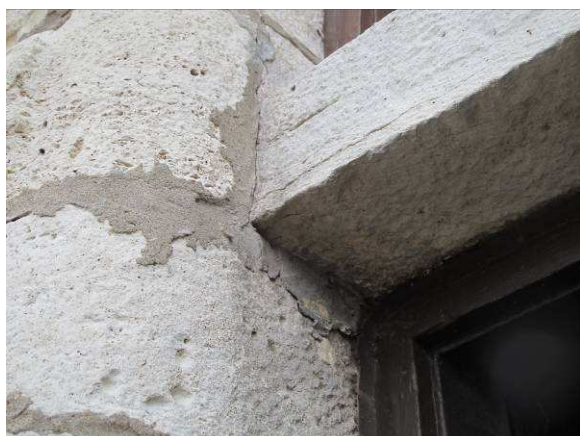
**Poor mortar installation**

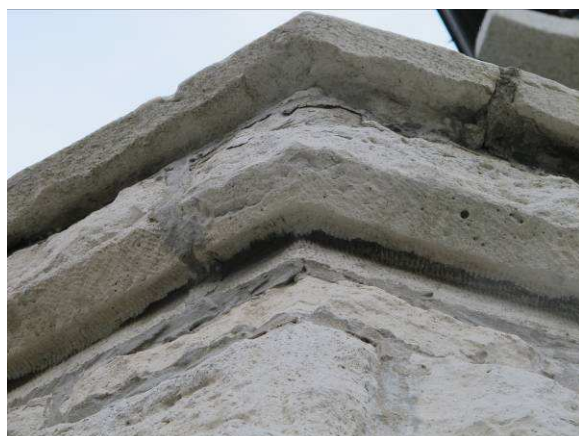
**Poor mortar installation**

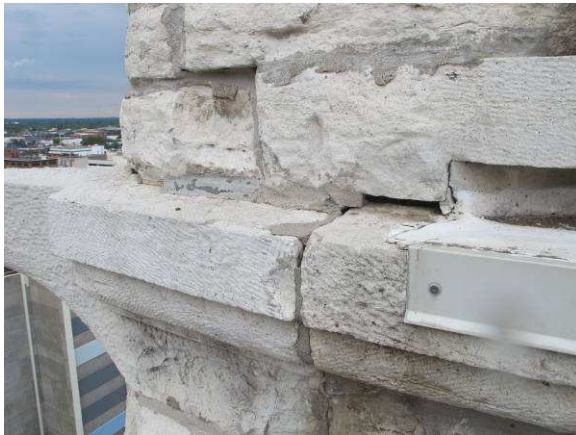
**Failed mortar and deteriorating stone**

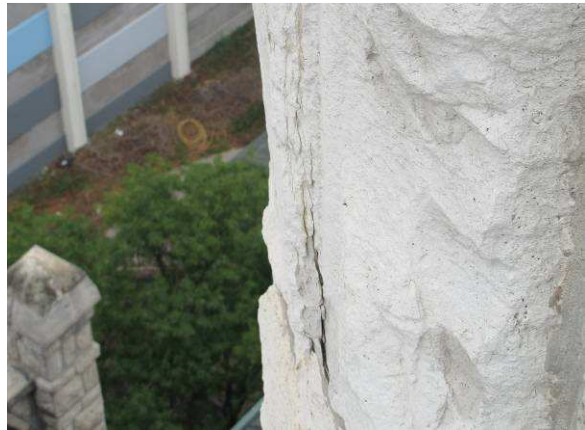
**Spalling stone at NE corner of tower**

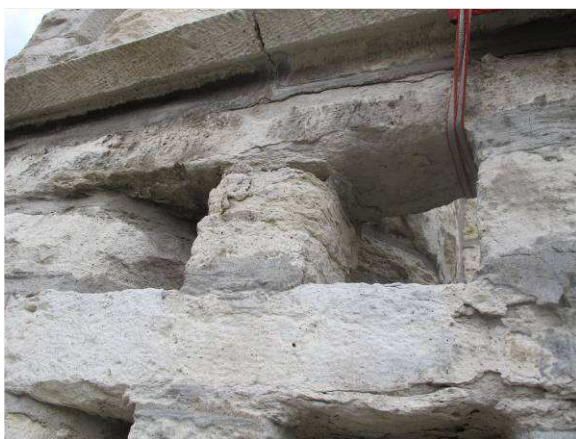
**Deteriorating limestone at balcony**

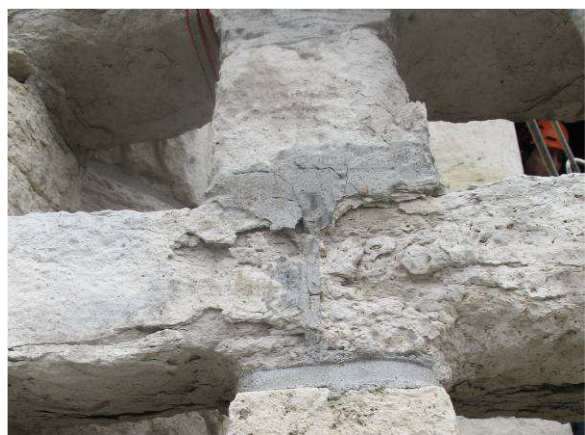
**Failed mortar and damaged stone**

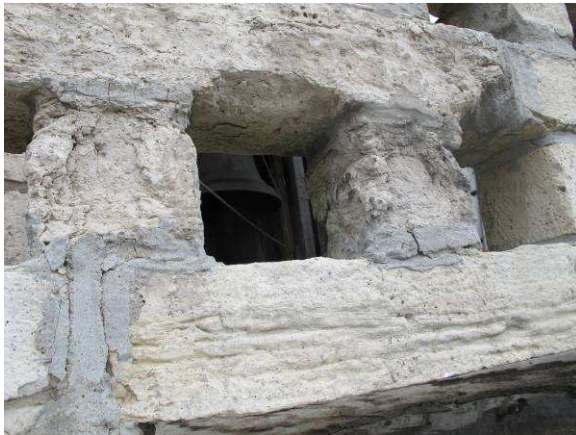
**Deteriorating stone and poor mortar installation**

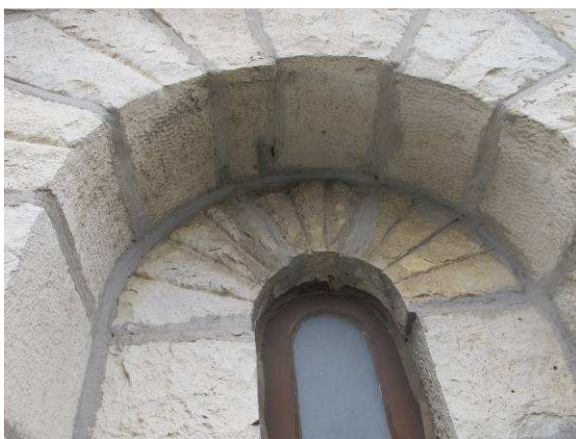
**Poor mortar and stone damage at arch**

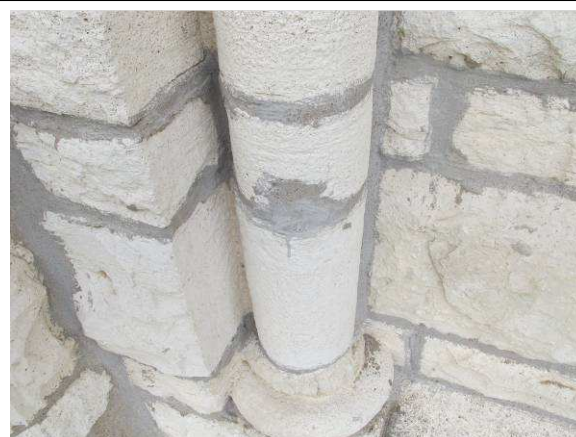
**Poor mortar installation**
