December 15, 2014

**Re:   Wichita-Sedgwick Historical Museum Building Condition Assessment and  
Maintenance Plan  
CASE Project No. 2439001**

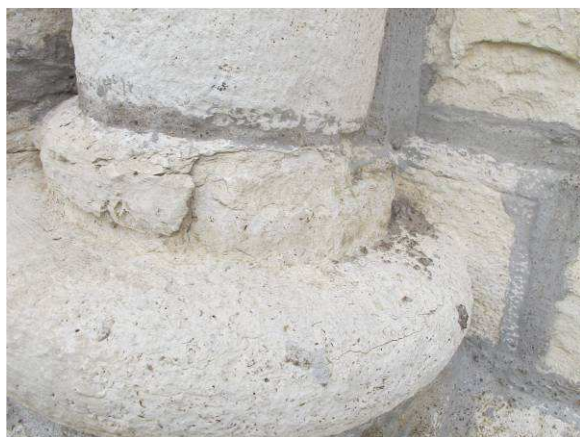
**Deteriorating column base**

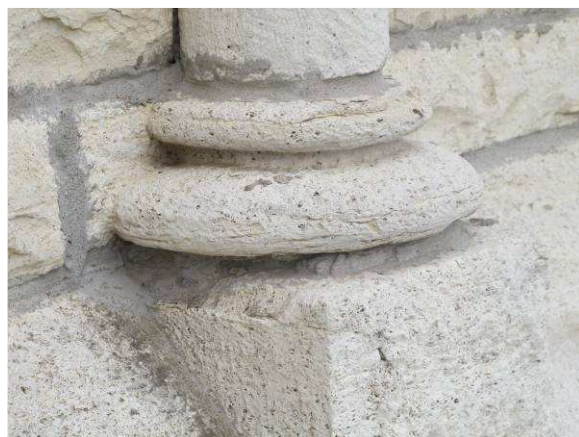
**Loss of mortar at column base**

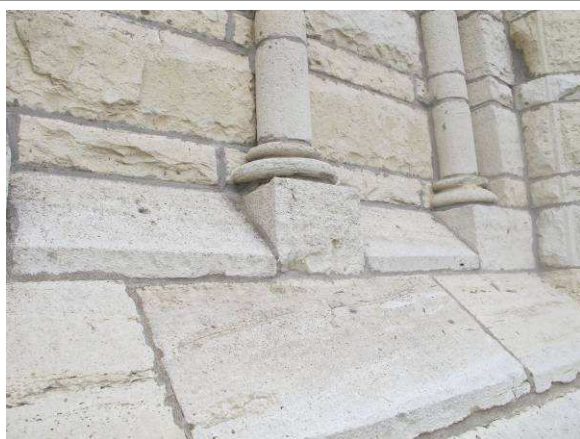
**Deteriorating stone below columns**

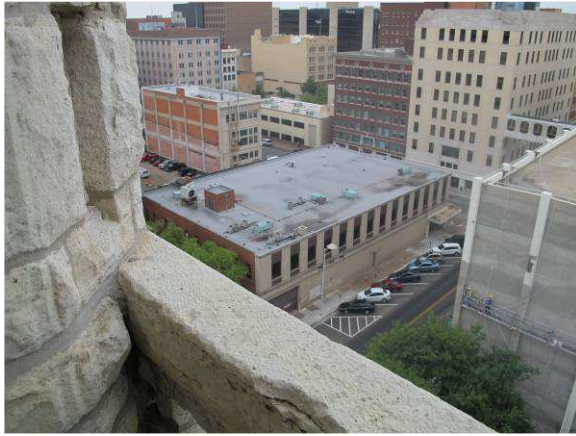
**Damaged balcony rail**

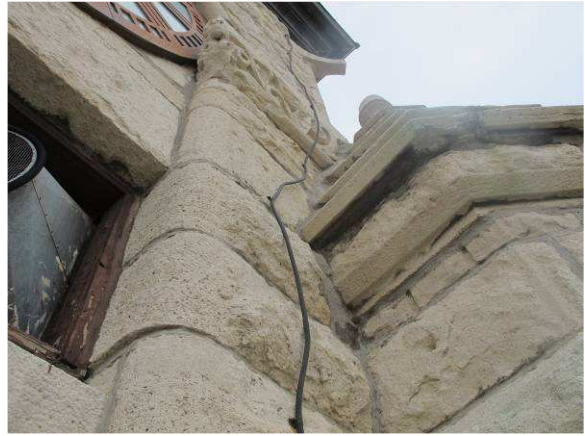
**Decaying wood and missing mortar**

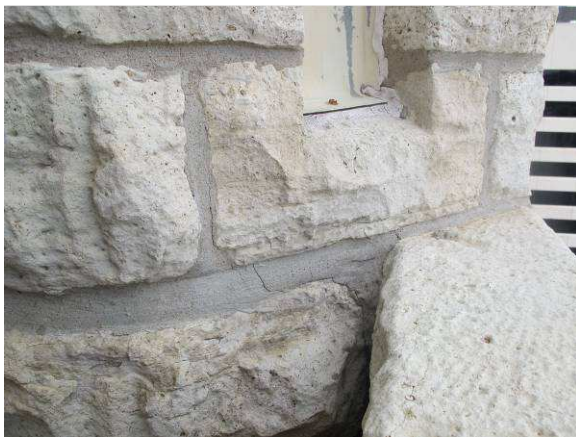
**Vertical crack in mortar joints**

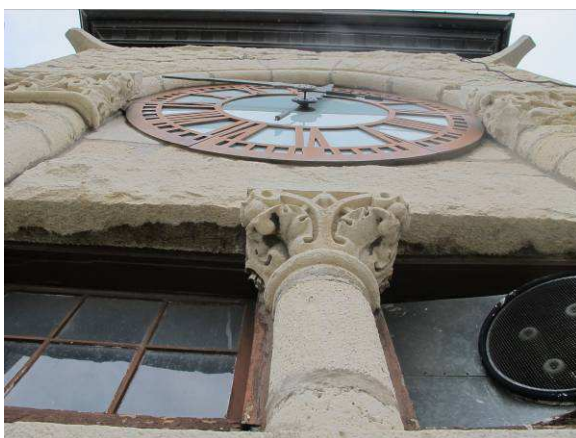
**Water evidence at window headers**

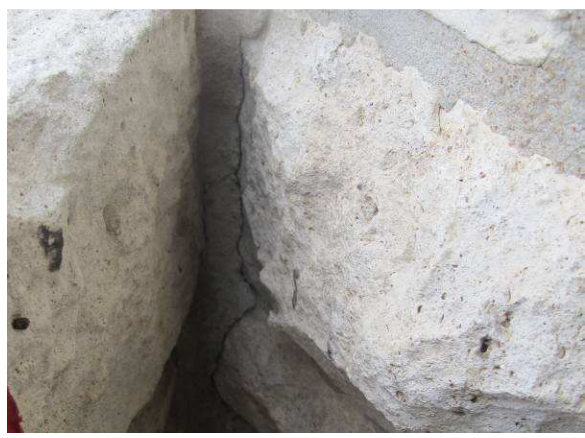
**Separating mortar at corner of balcony**

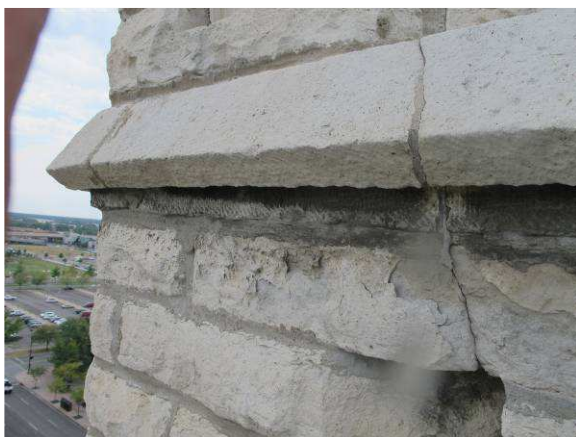
**Vertical mortar separation and crack in stone**

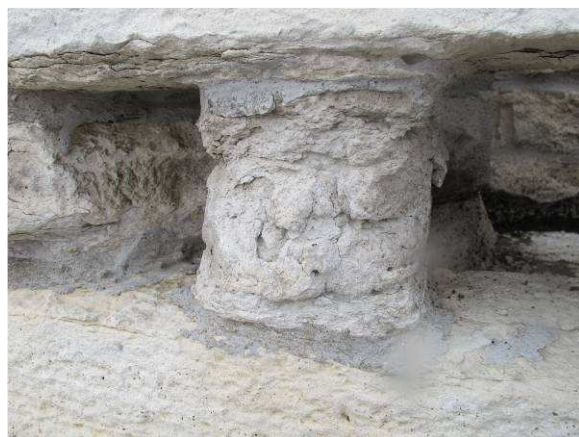
**Deteriorating stone at balcony**

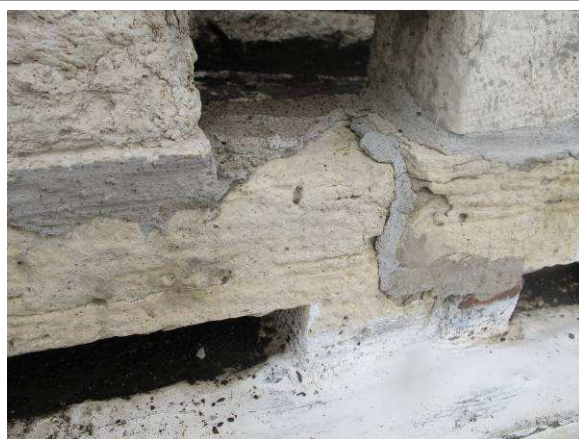
**Deteriorated limestone**

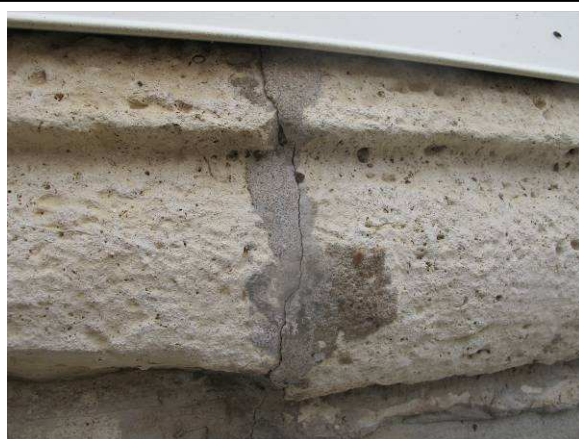
**Missing mortar**

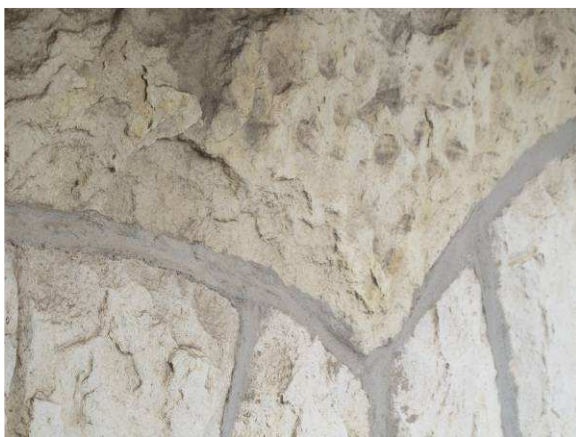
**Crack in mortar joint**

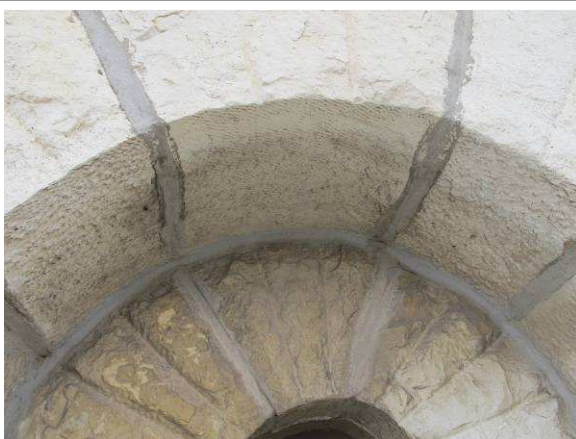
**Deteriorated stone at arch**

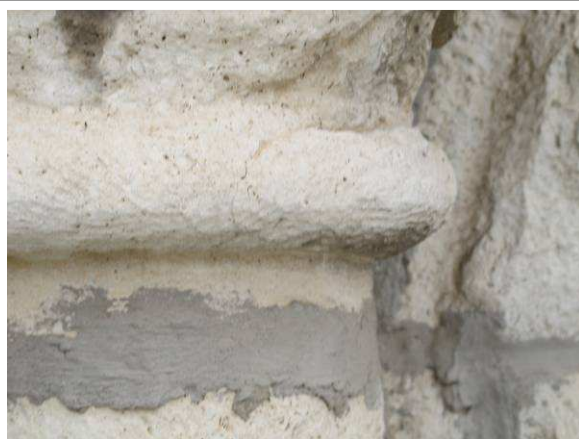
**Failed mortar and stone loss at arch**

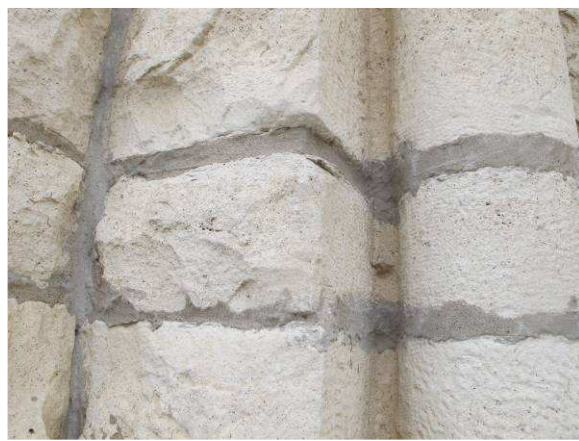
**Poor stone patch**

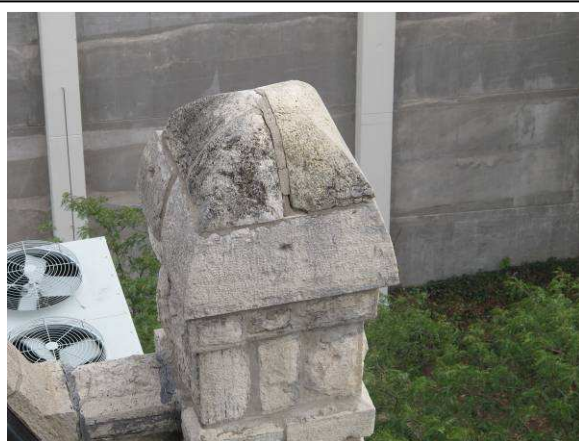
**Poor mortar installation and deteriorating stone**

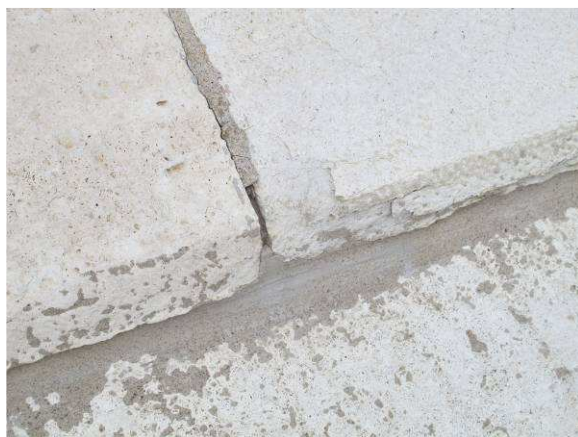
**Deteriorating stone**

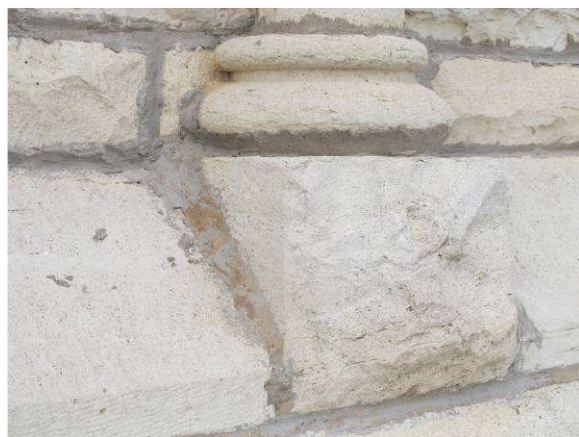
**Missing mortar and stone**

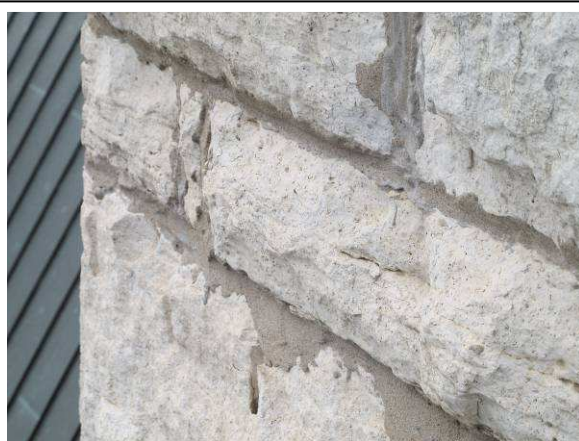
**Spalled limestone**

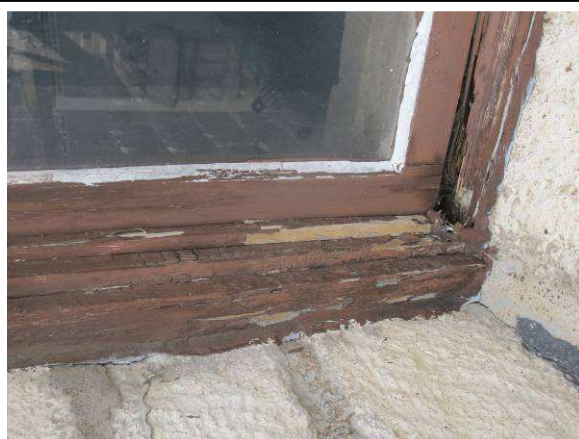
**Deteriorating wood window and stone ledge**

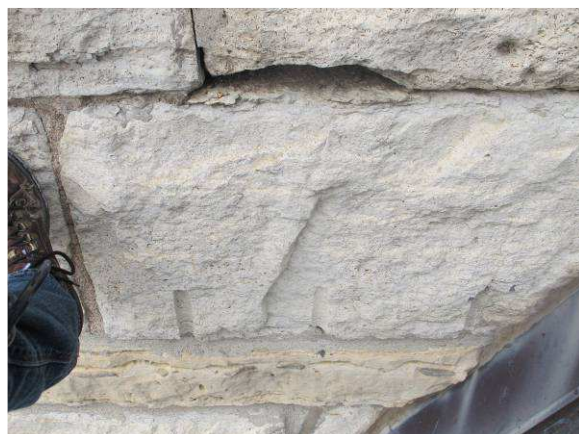
**Poor mortar installation**

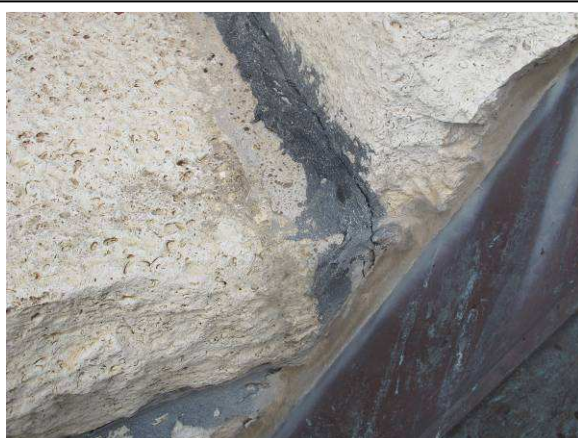
**Missing mortar above flashing**

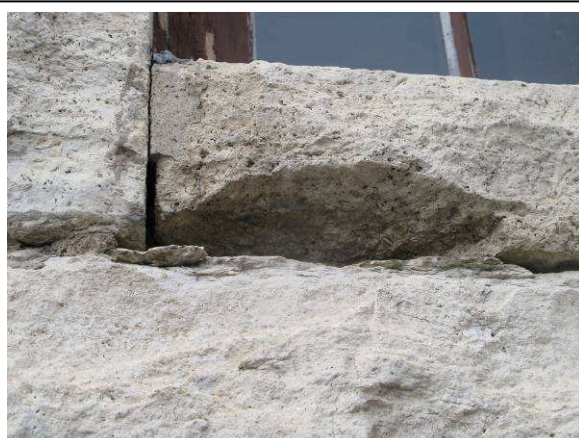
**Failed caulking above flashing**

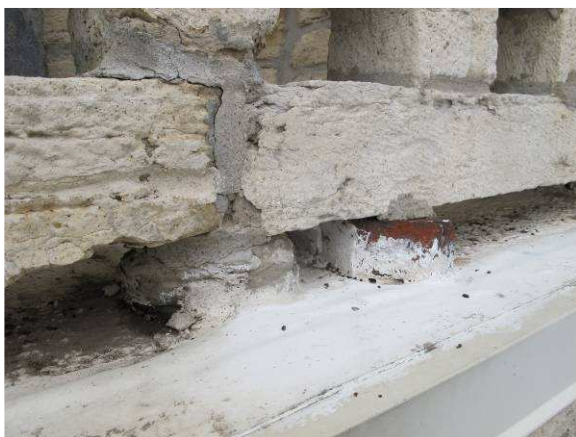
**Failed sealant**

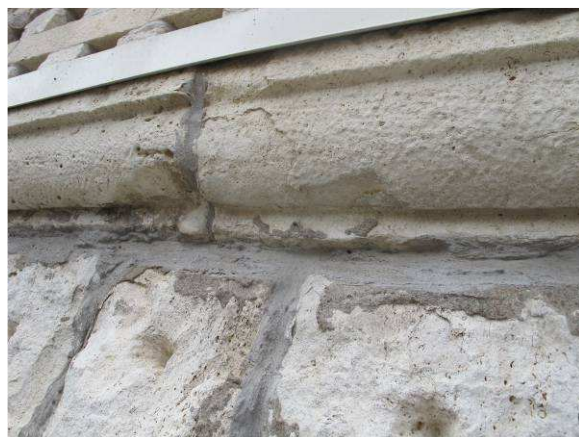
**Missing stone and deteriorated mortar**

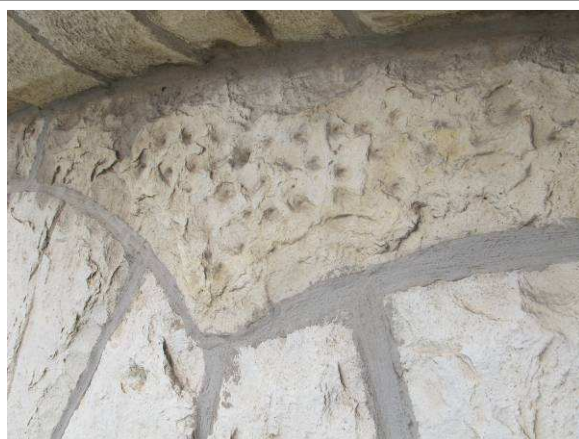
**Exfoliating stone**

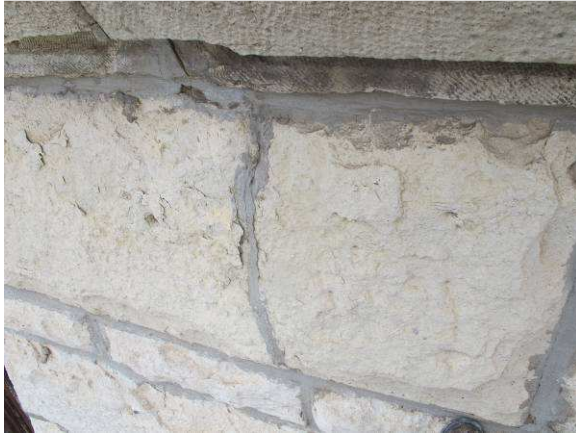
**Missing mortar**

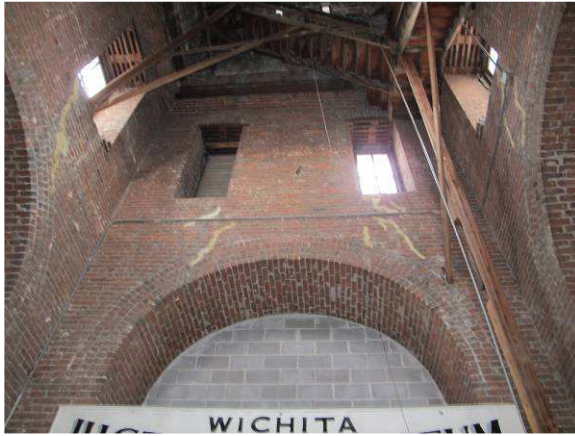
**APPENDIX B**  
**- Inside tower -**

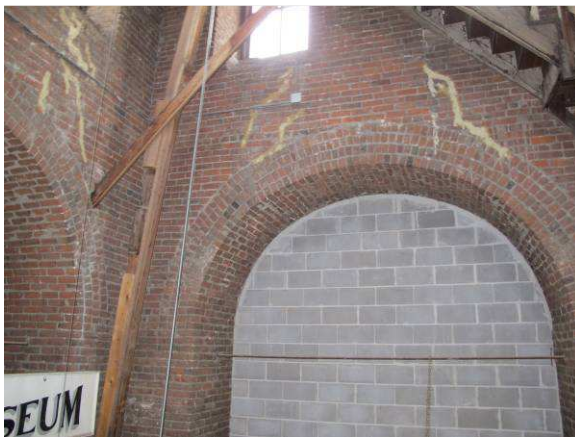
**Repaired cracks above arch**

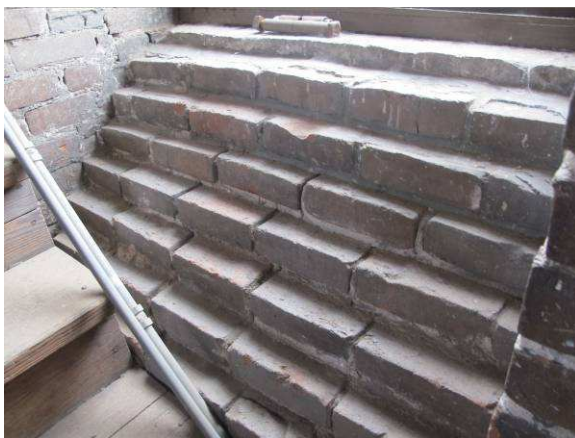
**Close up of repaired crack**

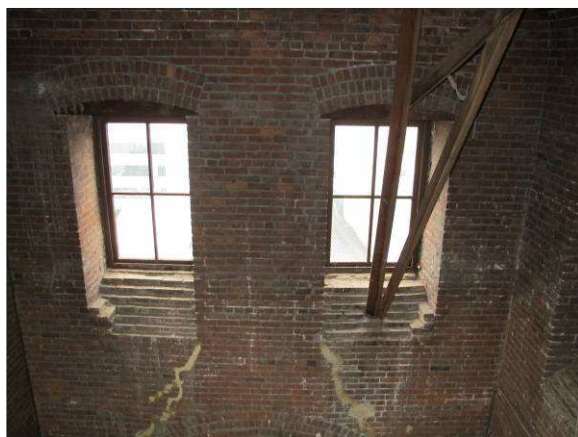
**Repaired crack below window**

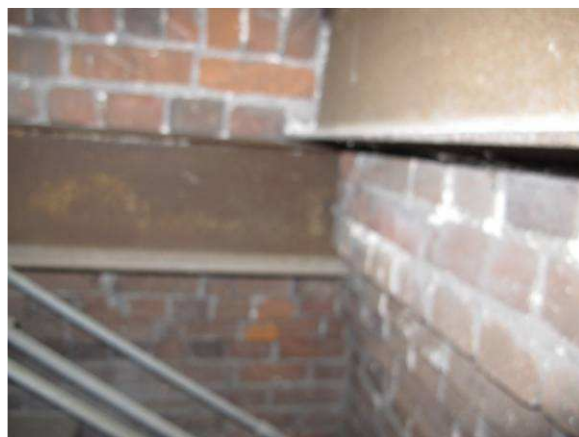
Repaired cracks from above

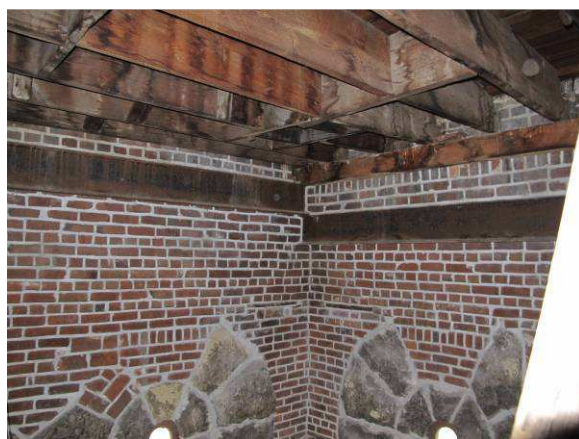
Mix of brick and stone evidence of smoke damage

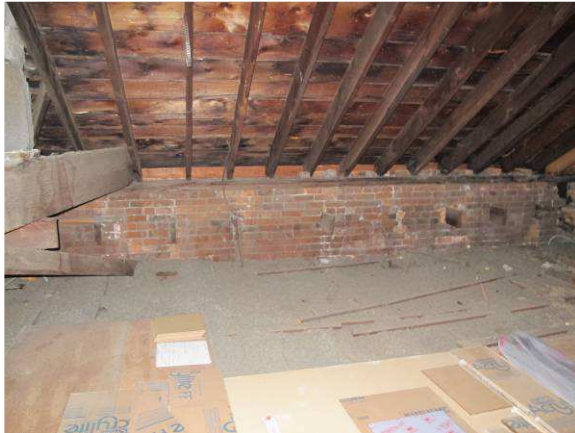
**Interior brick wythes and seated ceiling rafters**

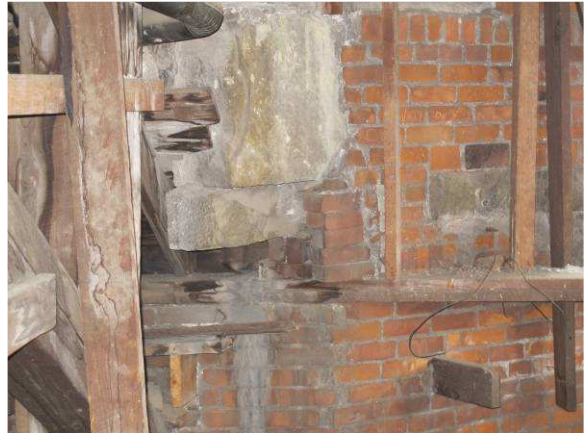
**Uncoursed mix of brick and limestone**

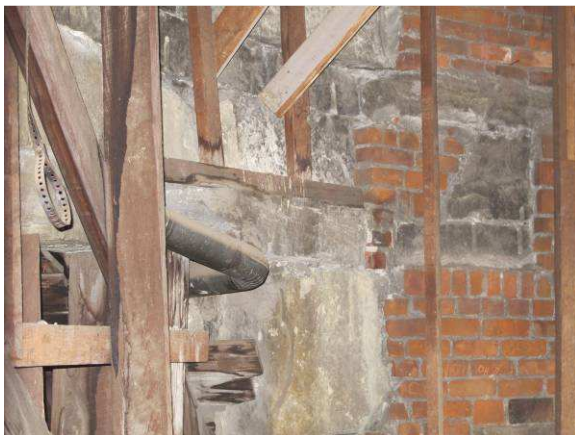
**Evidence of smoke damage**

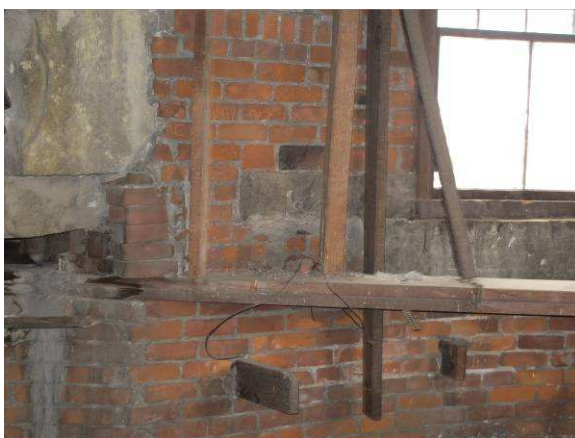
**Uncoursed brick and stone**

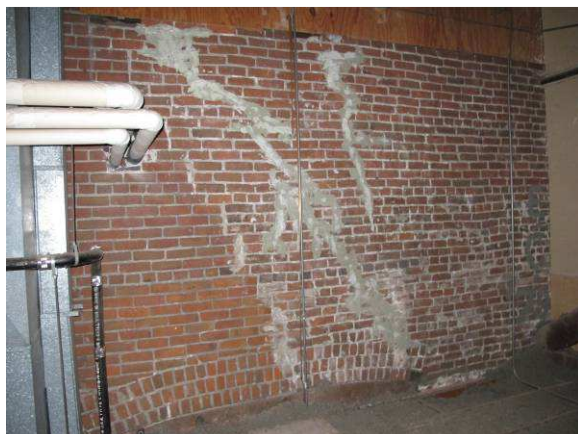
Brick repairs at north end roof

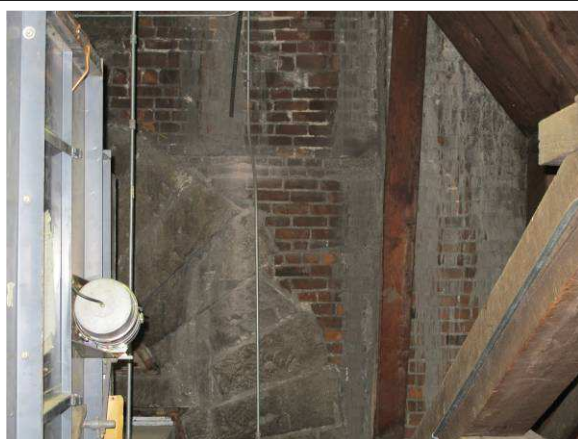
Smoke damage evident on stone

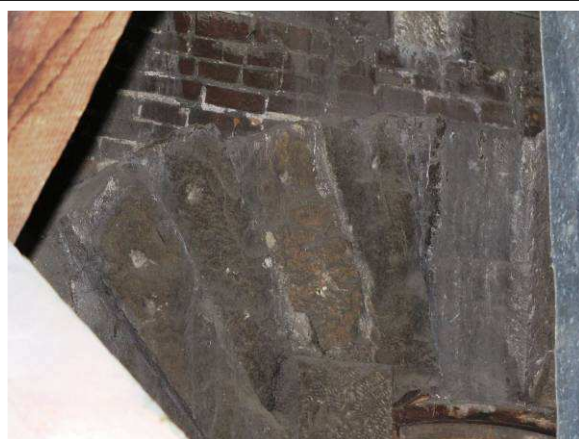
Smoke damage on interior stone arch

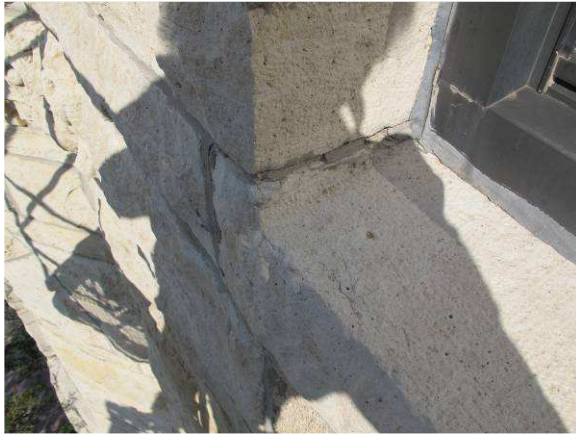
**Failed mortar and sealant at window**

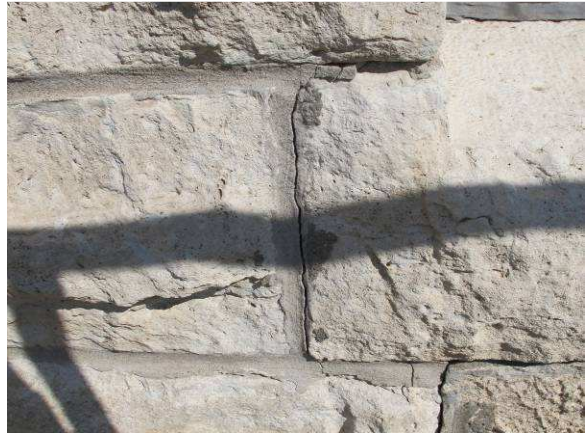
**Debonded mortar joint and failed mortar**

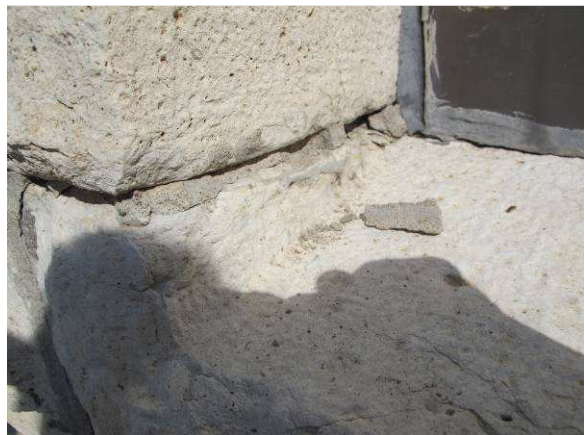
**Failed joint at window**

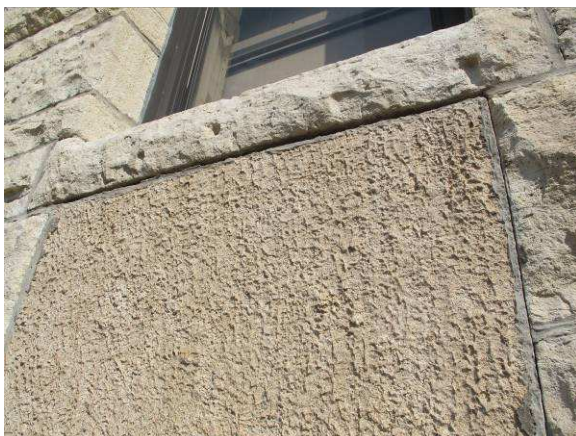
**Cement board infill at windows**

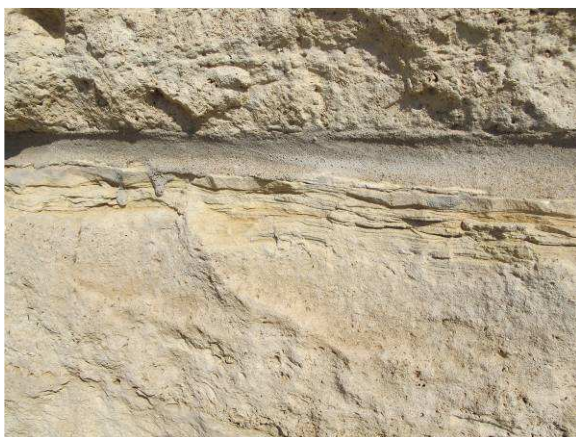
**Delaminating naturally bedded stone**

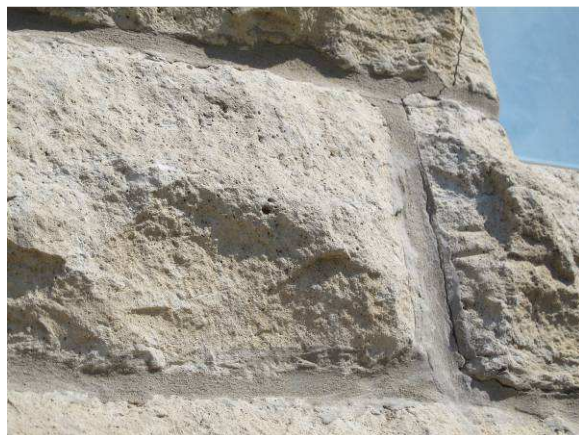
**Debonded mortar joint**

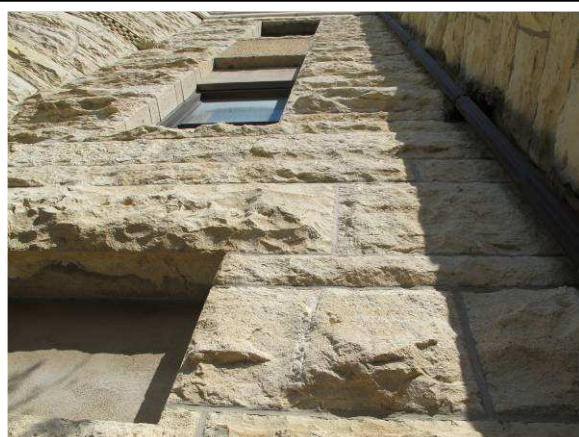
**Mix of infilled and glazed windows**

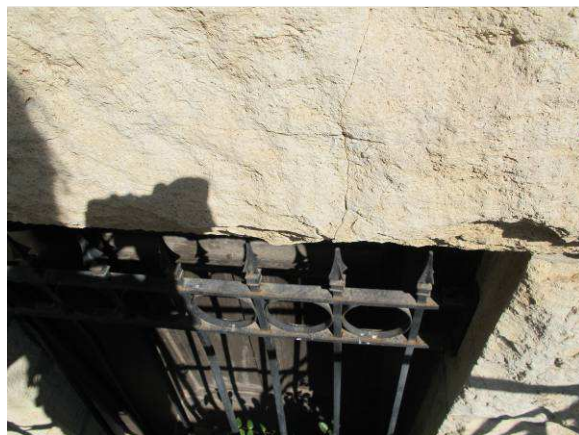
**Crack in stone above window**

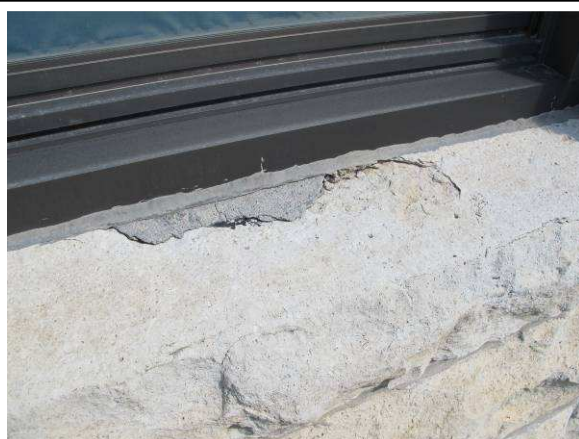
**Exfoliating window ledge and failed repair**

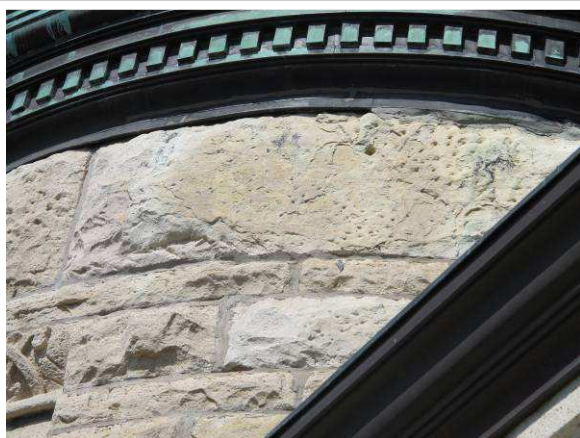
**Loss of stone detail**

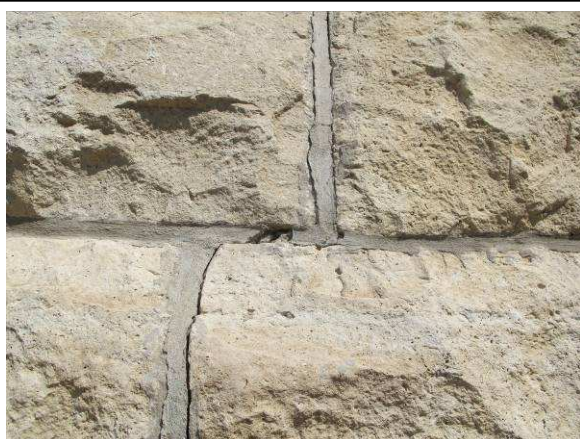
**Separated and missing mortar**

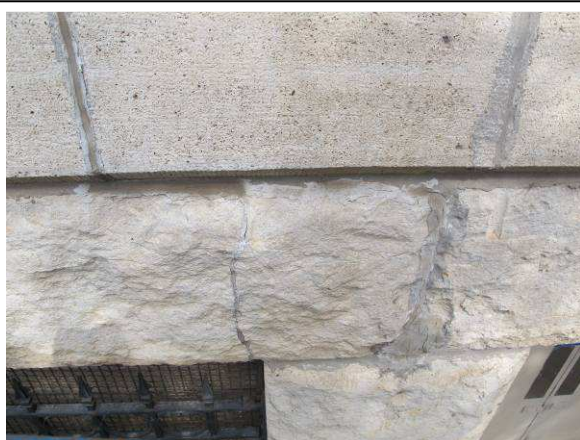
**Cracked stone at window opening**

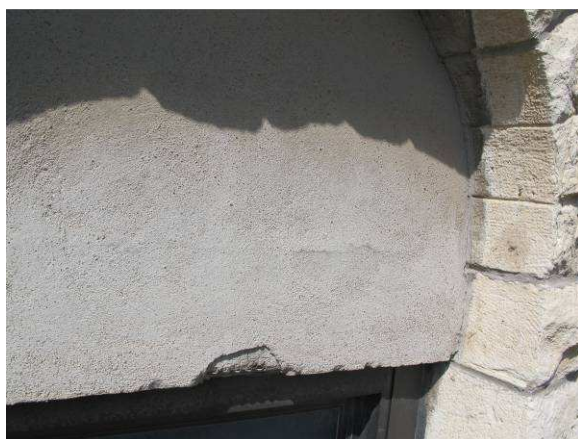
**Damaged cement board**

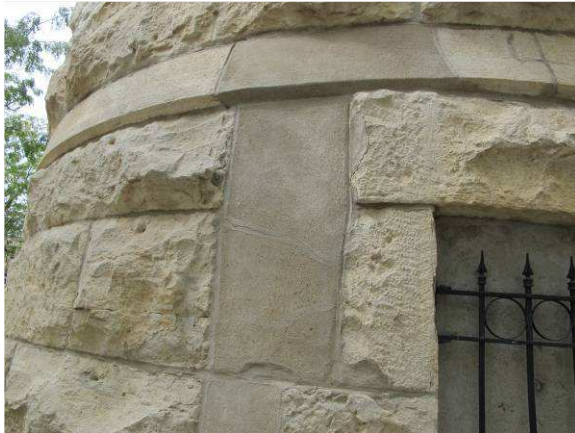
**Parging on limestone**

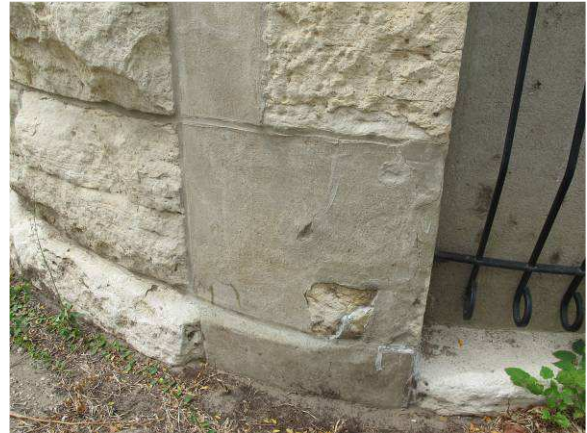
**Failed parging on limestone**

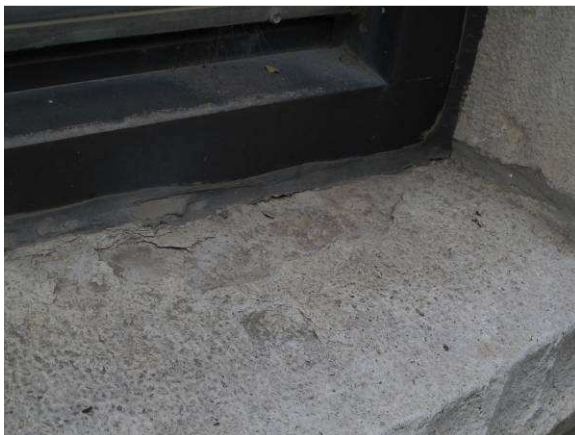
**Deteriorating window ledge**

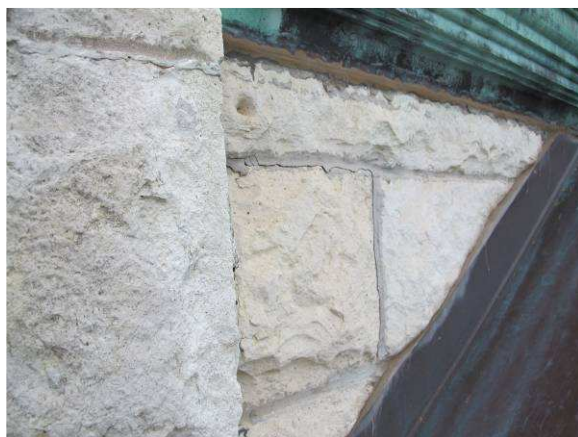
**Failing mortar joints near roof sealant**

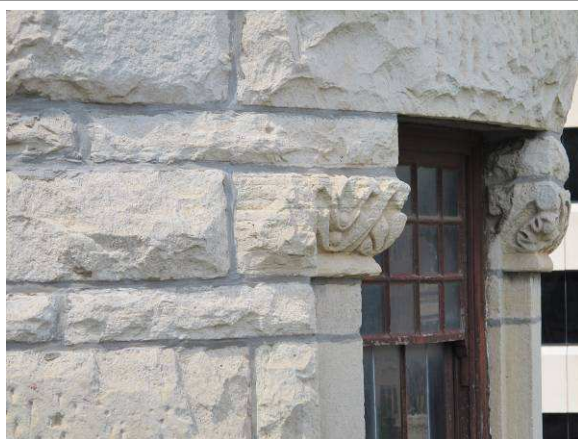
**Deteriorating wood window**

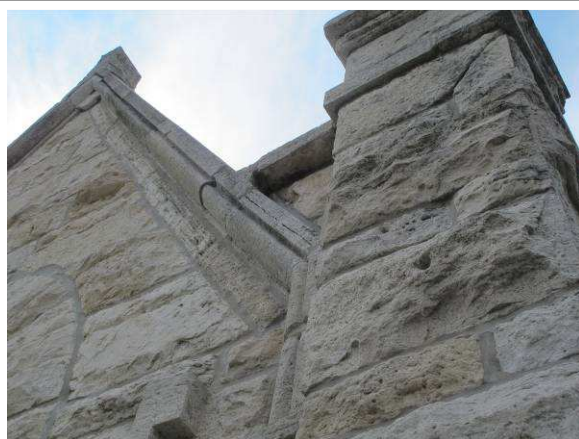
**Broken stone above addition**

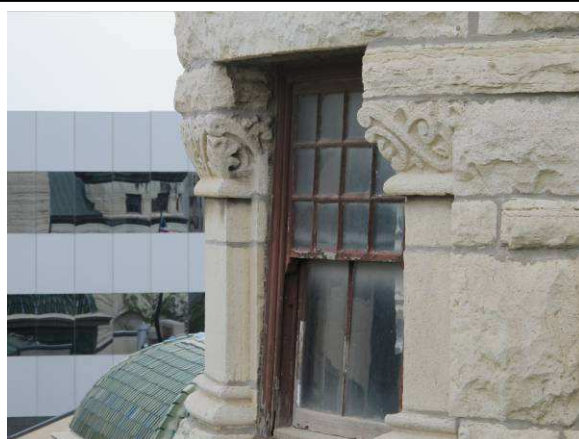
**Deteriorating wood window**

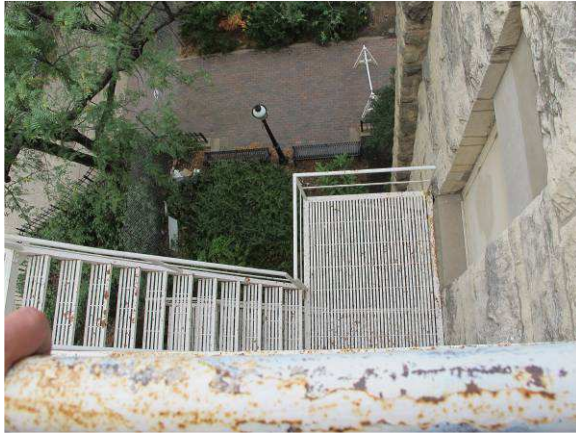
**Painting failing on exterior fire escape**

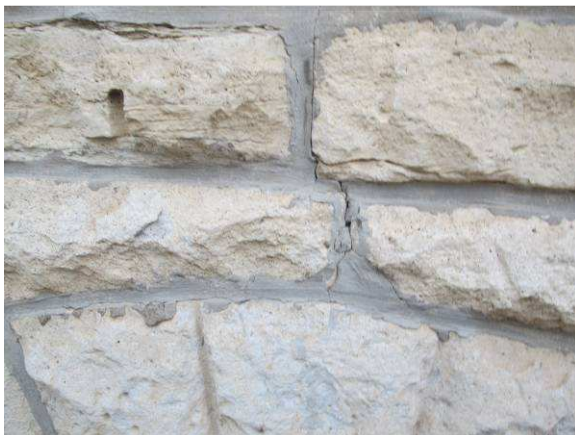
**Crack running through joints**

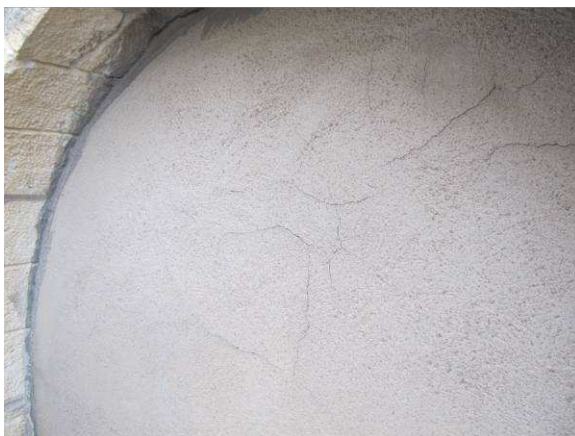
**Cracked cement board**

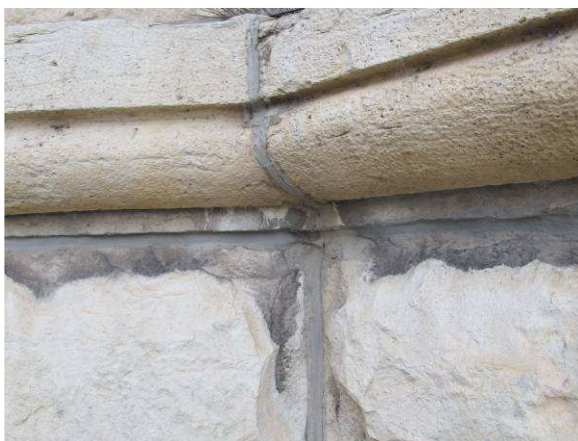
Poor mortar installation

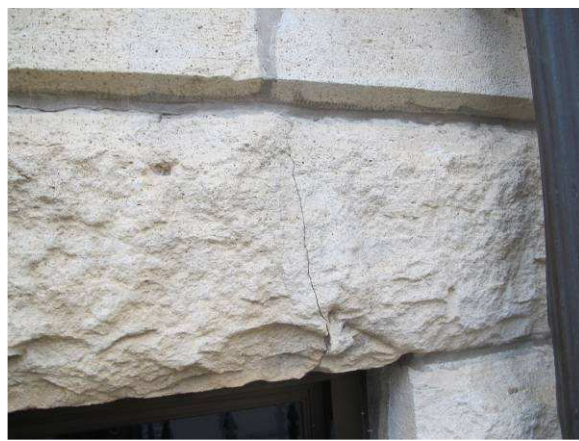
Cracked header stone

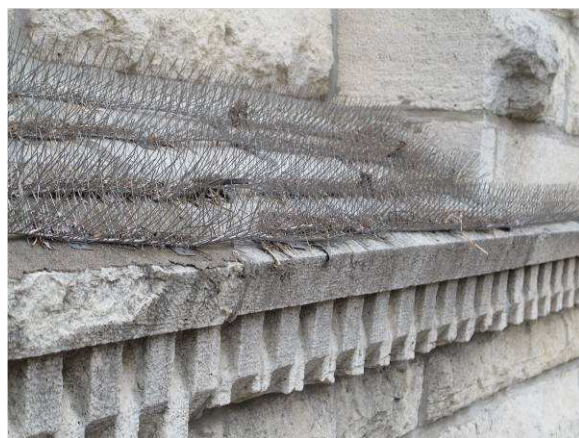
Spalled stone above dentil

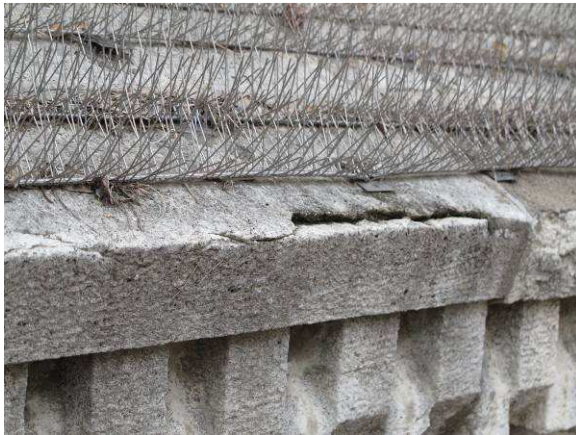
**Spalled stone above dentil**

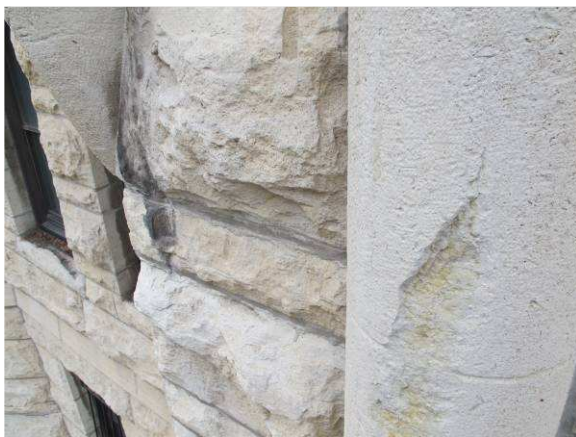
**Damaged stone column**

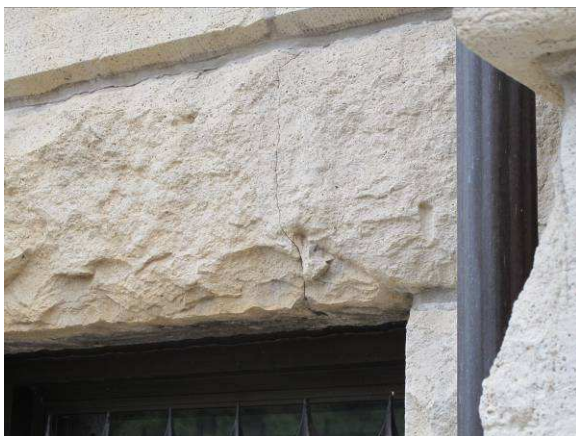
**Cracked header stone**

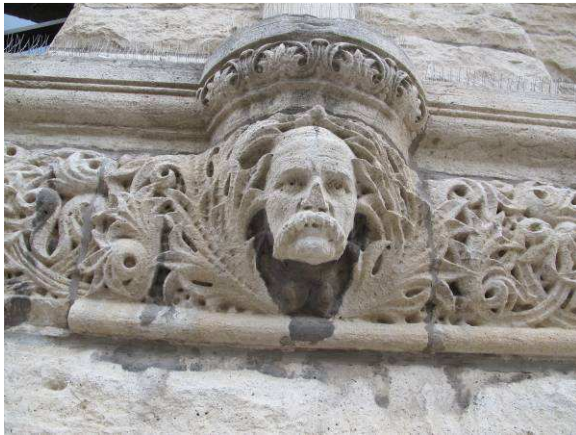
**Poor mortar installation**

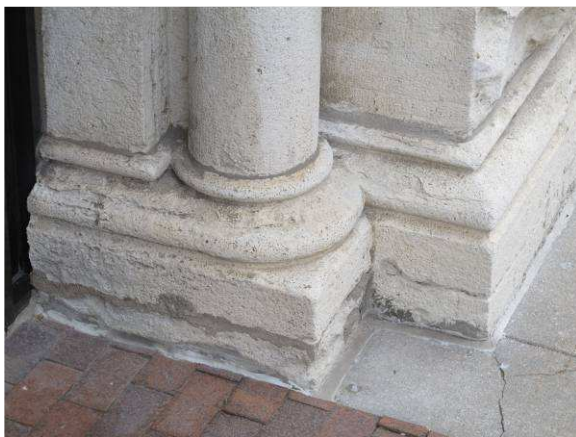
**Delaminating stone at grade**

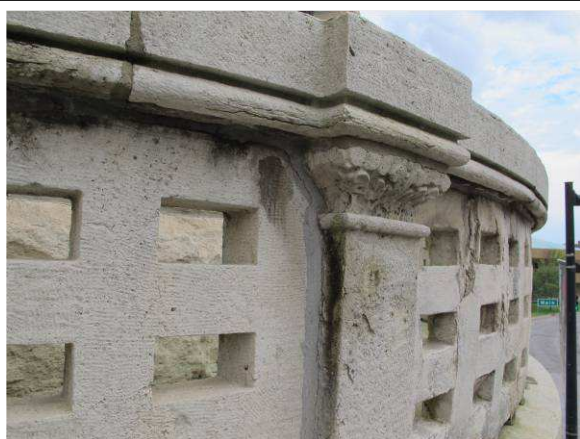
**Deteriorating balcony stone**

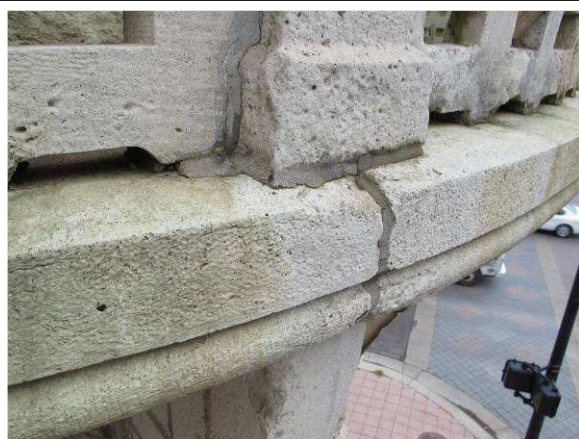
**Poor mortar installation**

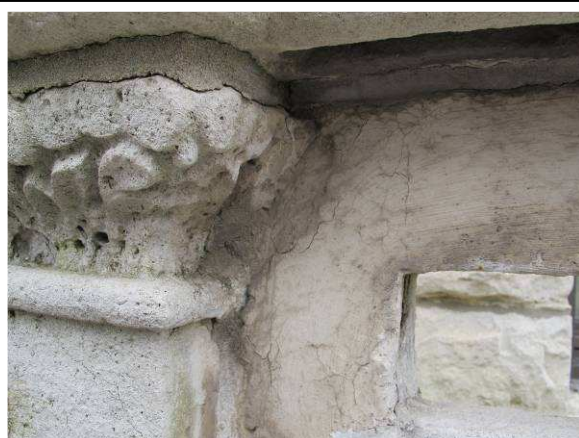
**Poor mortar installation**

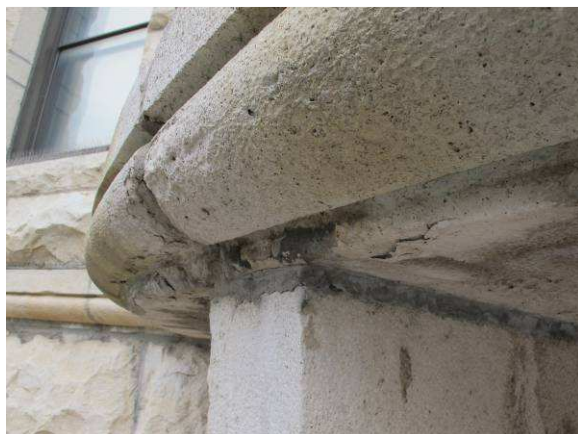
**Deteriorating stone on underside of balcony**

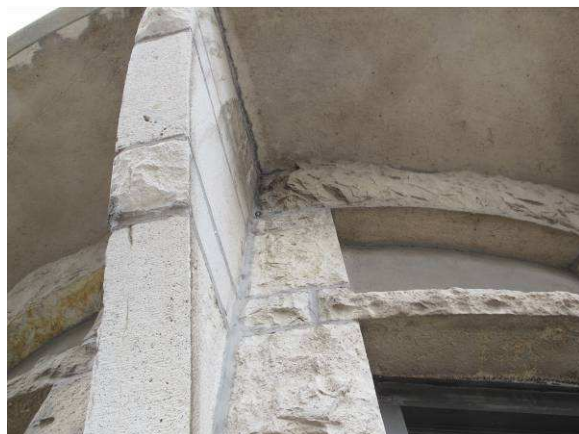
**Deteriorating stone on underside of balcony**

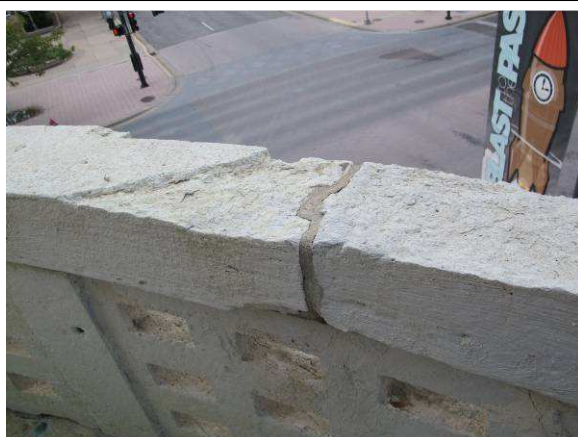
**Deteriorated balcony rail**

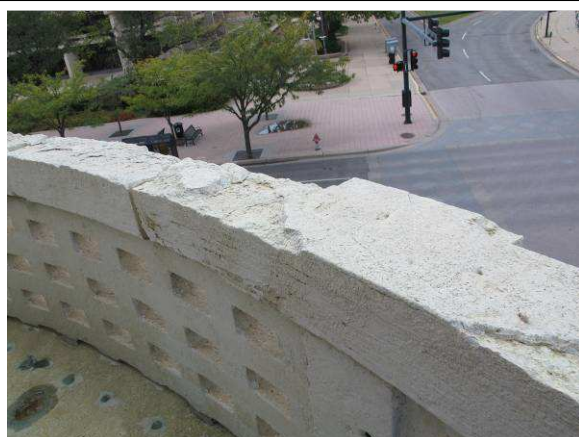
**Deteriorated balcony rail**

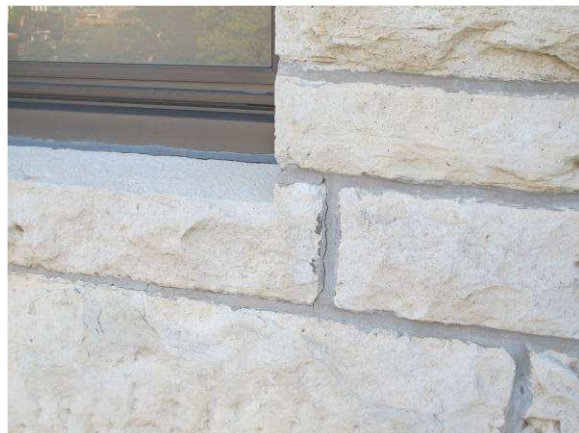
**Cracked mortar joint**

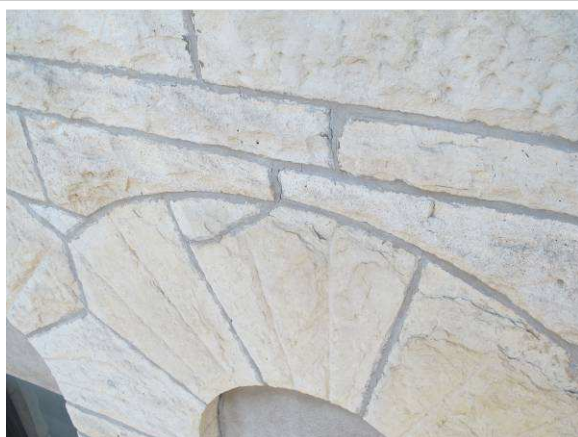
**Repaired cracked stone**

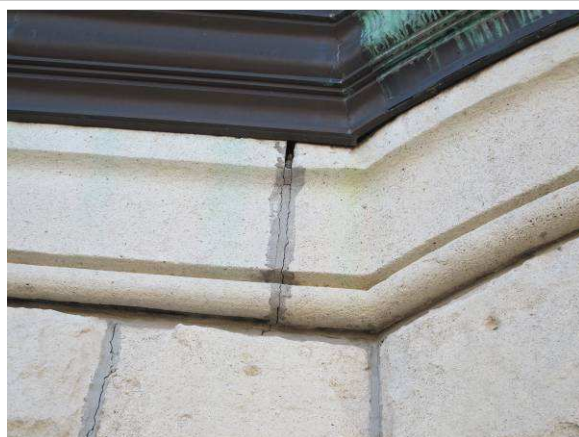
**Failed mortar joint**

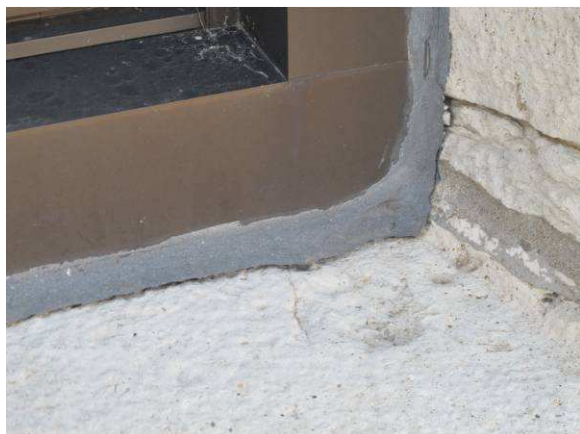
**Failed window sealant**

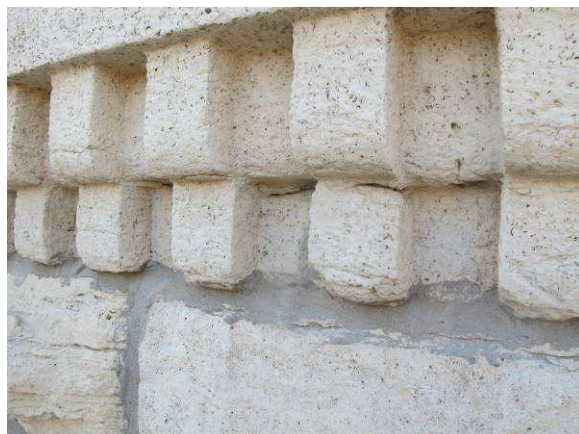
**Poor mortar installation**

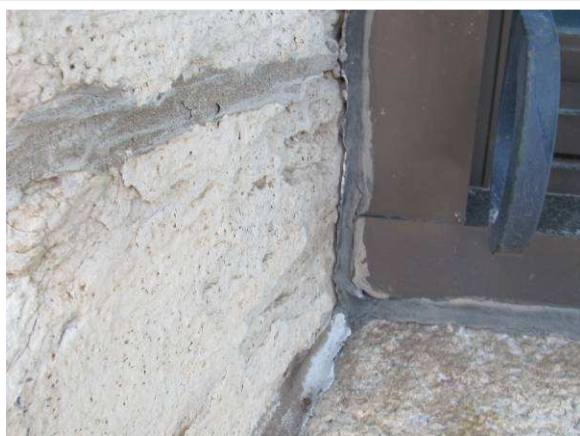
**Failed mortar and sealant**

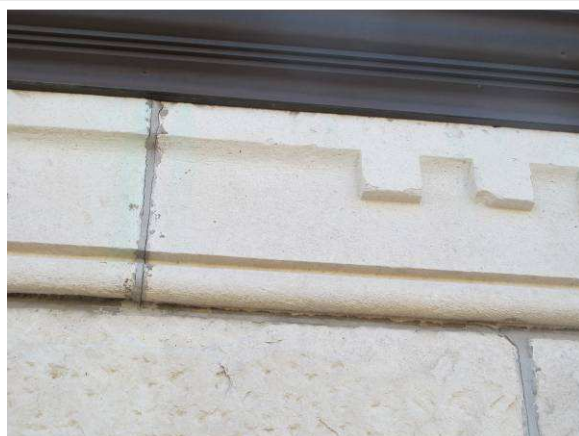
**Debonded vertical mortar joints**

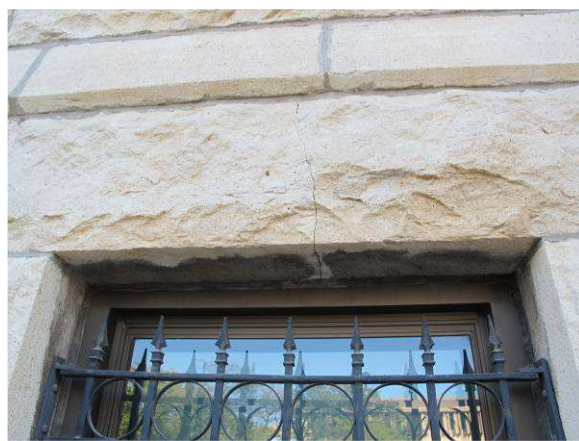
**Cracked header stone**

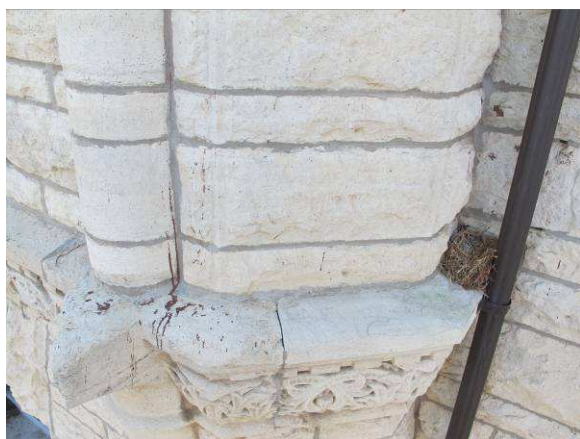
**Spalling stone above entry**

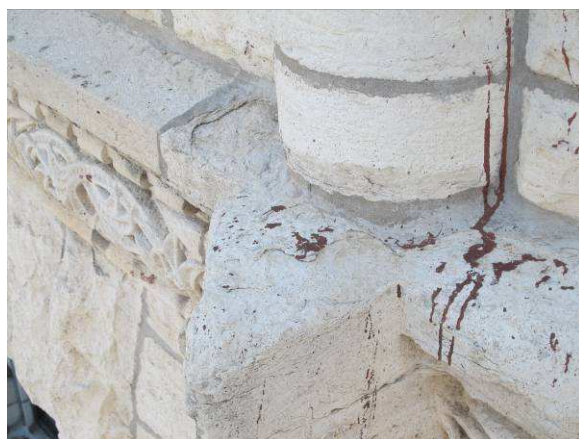
**Spalling stone above entry**
