December 15, 2014

**Re:   Wichita-Sedgwick Historical Museum Building Condition Assessment and  
Maintenance Plan  
CASE Project No. 2439001**

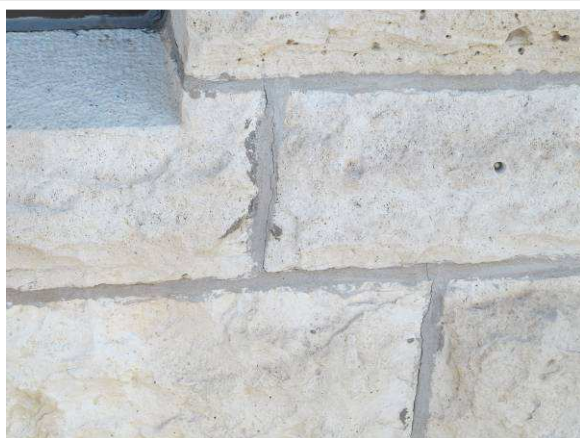
**Cracked vertical mortar joints**

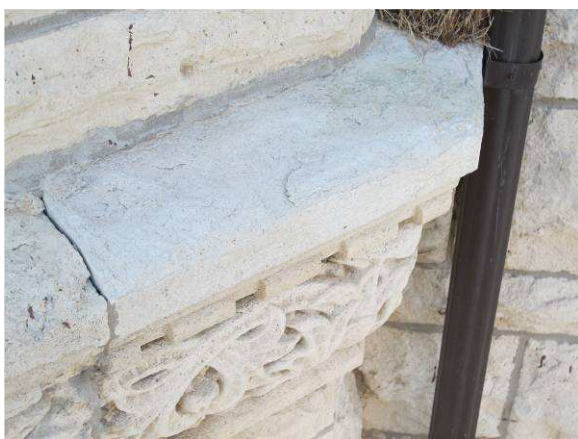
**Open skyfacing joint**

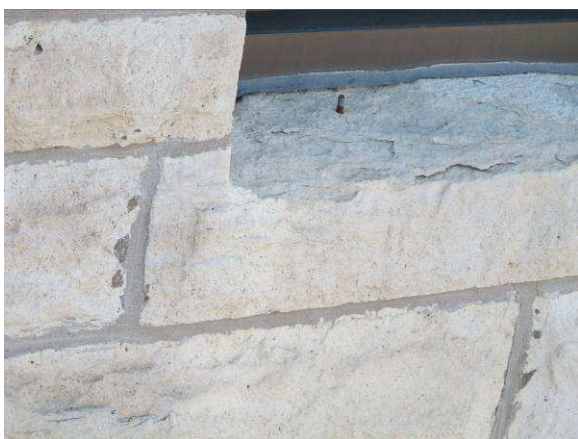
**Deteriorating stone ledge**

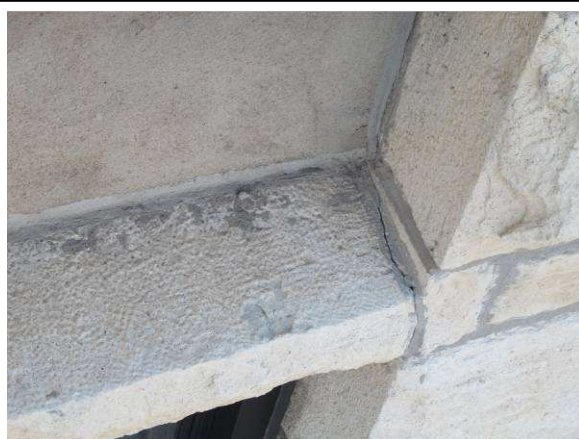
**Failed mortar joint at header**

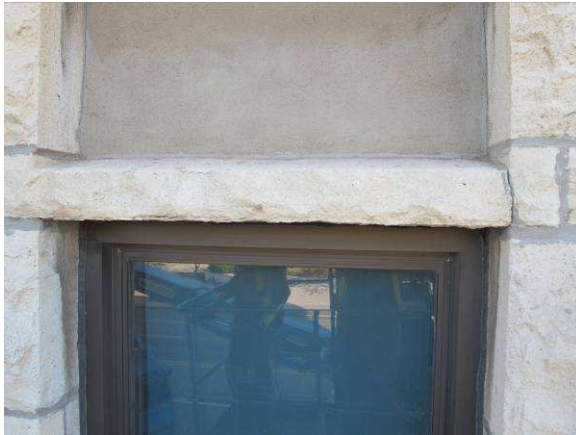
**Failed mortar joint at header**

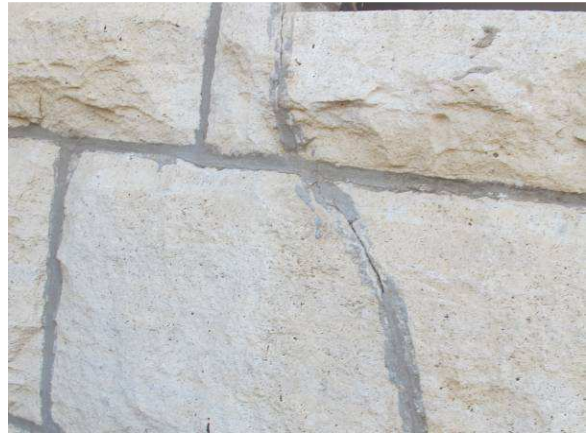
**Failed repair of cracked stone**

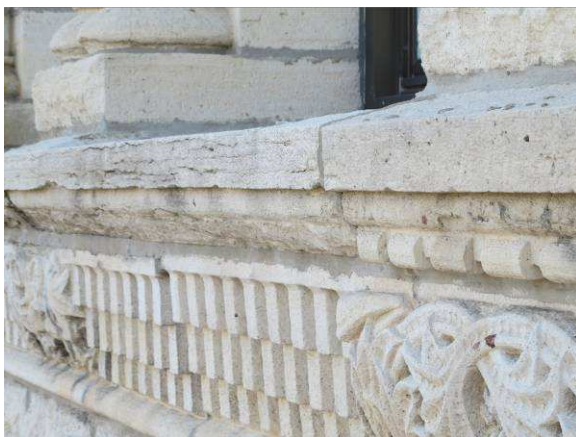
**Delaminating and exfoliating stone**

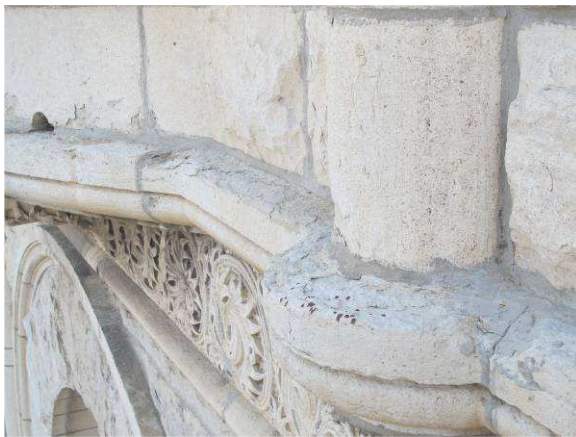
**Close up of deteriorating stone**

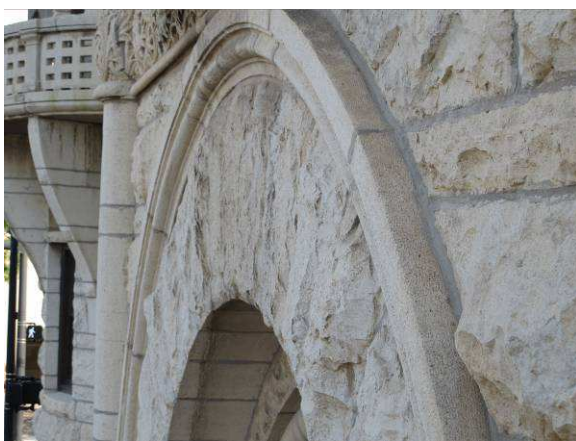
**Loss of stone detail above main entry**

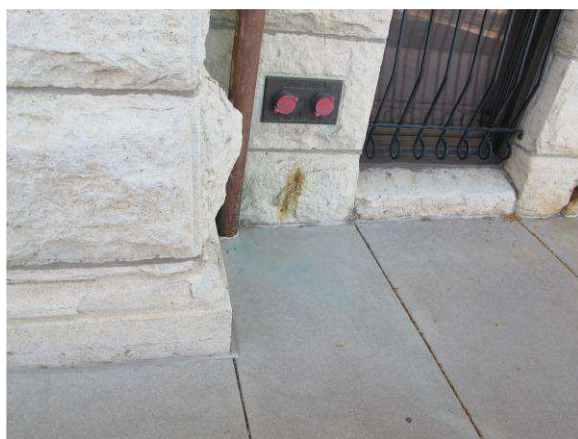
**Damaged stone at grade**

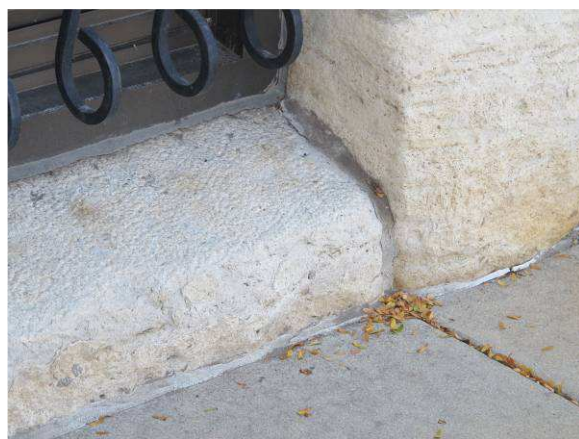
**Failed sealant at window and sidewalk**

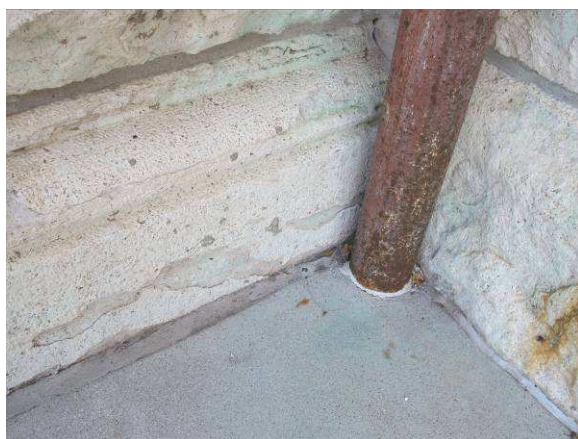
**Failed sealant and deteriorating stone**

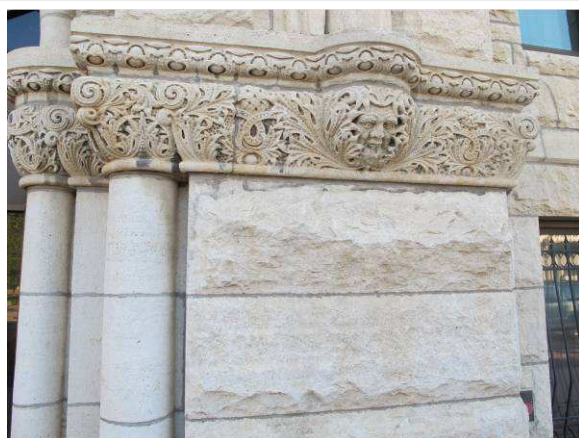
**Poor mortar installation below carving**

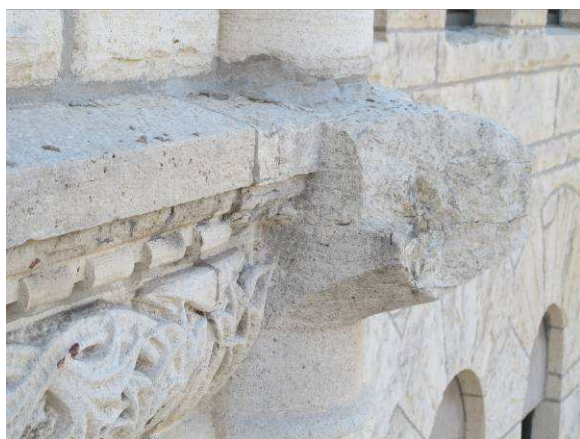
Damaged stone detail

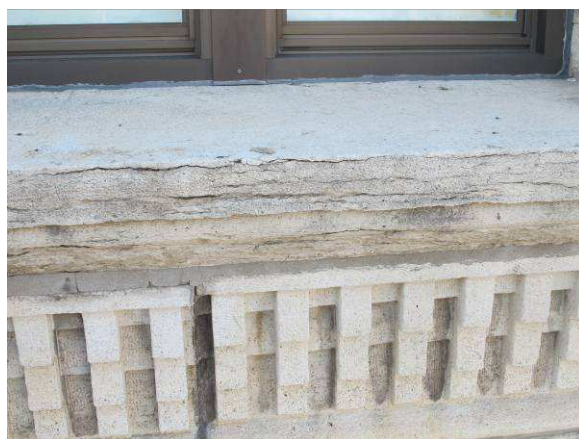
Delaminating stone ledge

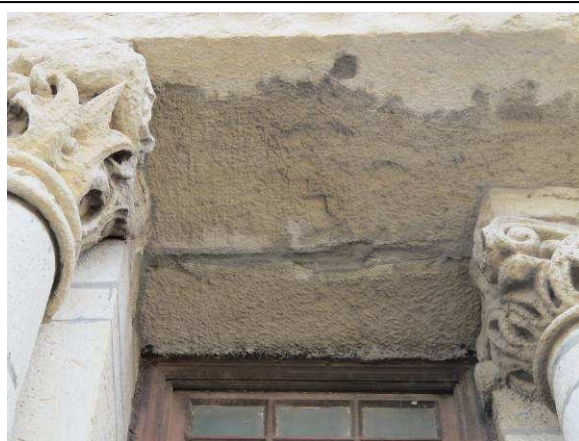
Deteriorating stone above columns

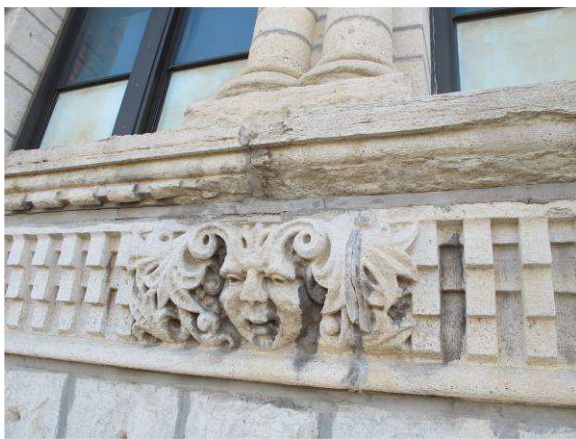
**Deteriorating stone and poor mortar installation**

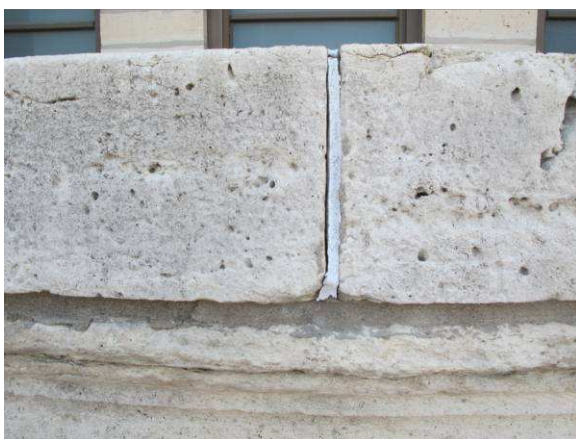
**Separated joint and deteriorated stone at balcony**

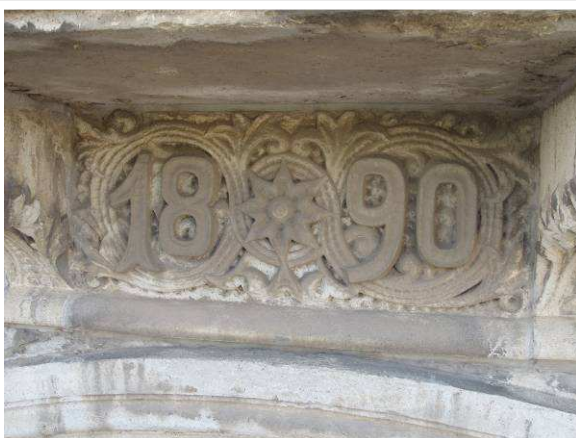
**Discolored carved date of construction**

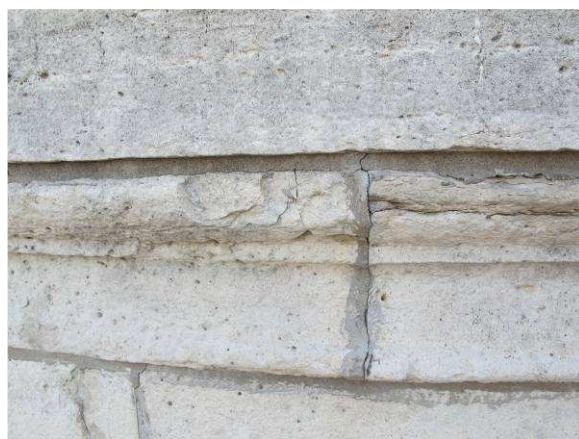
**Separated joint and deteriorating mortar**

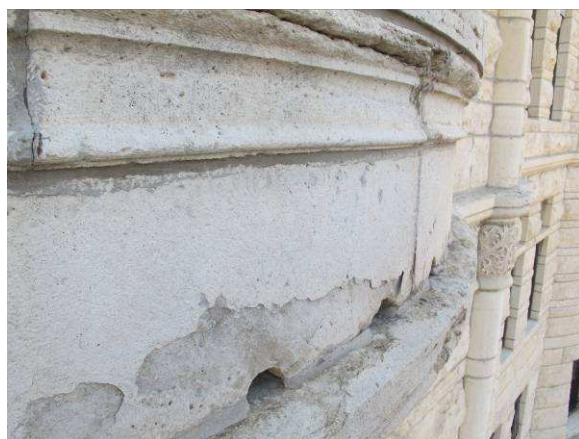
**Deteriorated stone at balcony face**

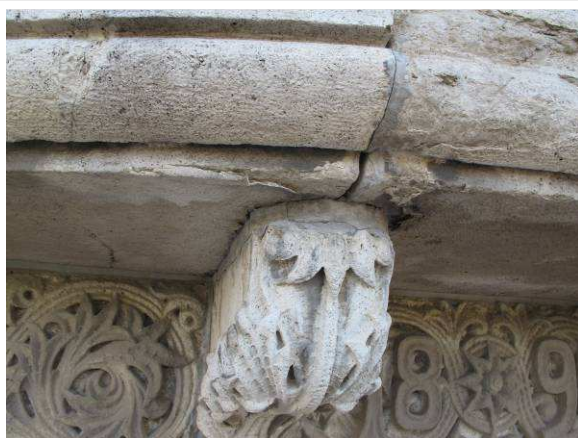
**Failed joint and damaged stone above support**

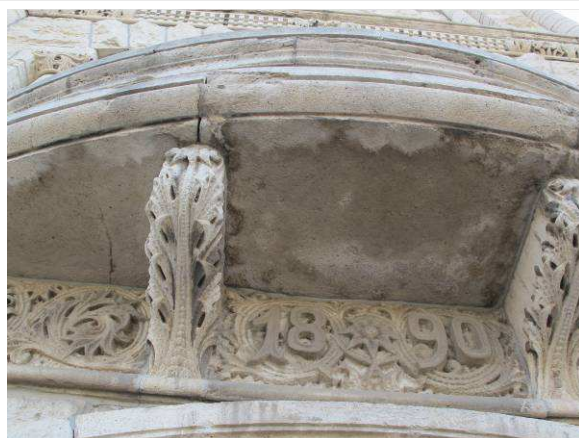
**Failed joint and damaged stone above support**

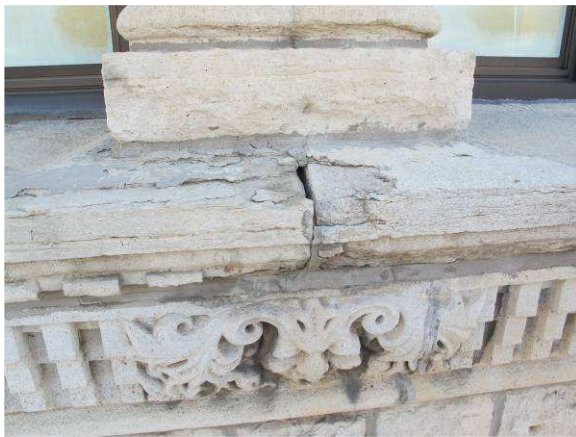
**Damaged stone and open skyfacing joint**

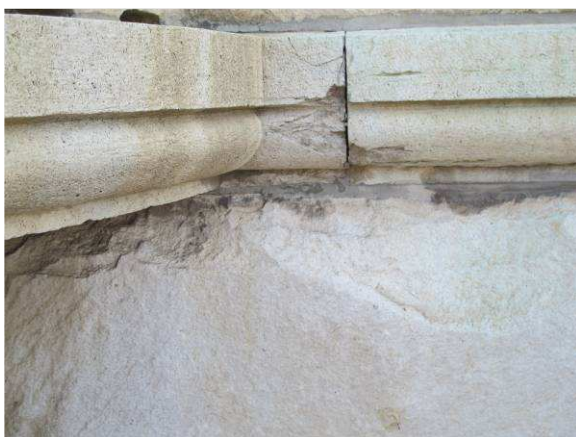
**Failed mortar and deteriorating stone**
