# Old Covington Fire Station Feasibility Study

RE: Old Covington Fire Station Feasibility Study

# **HISTORIC FIRE STATION BUILDING ASSESSMENT REPORT**

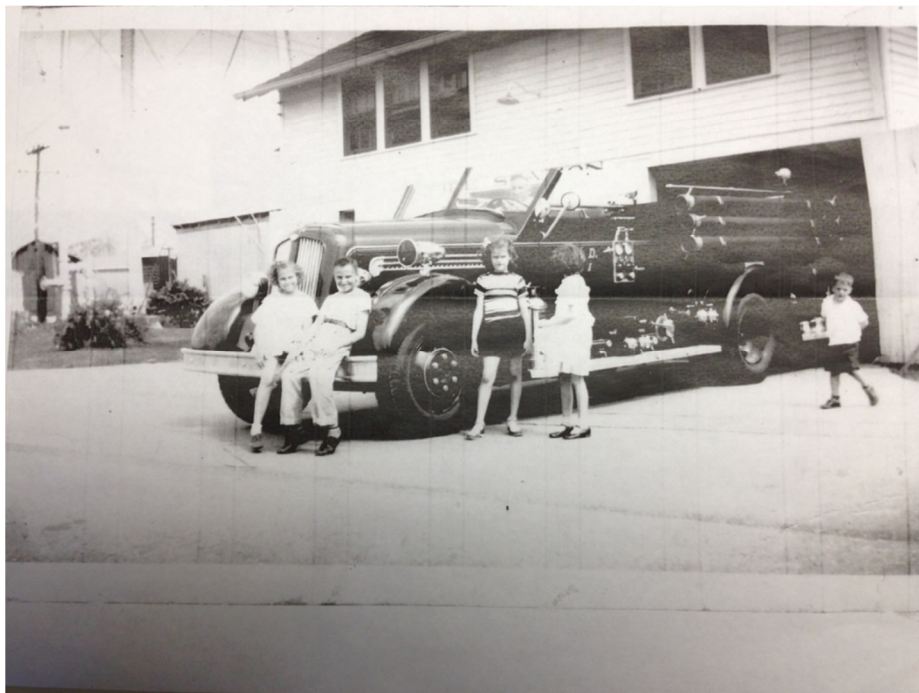
*Historical Photograph provided by Covington Fire Chief Richard Badon*
