# Historic Structure Report for Lincoln Hall

University of Nevada, Reno Historic District  
Reno, Nevada

Prepared for:  
The University of Nevada, Reno

August 2015

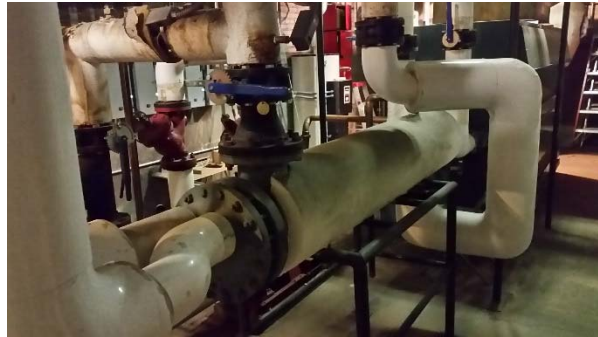
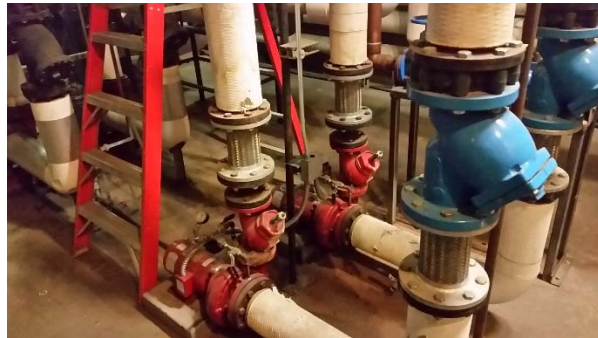
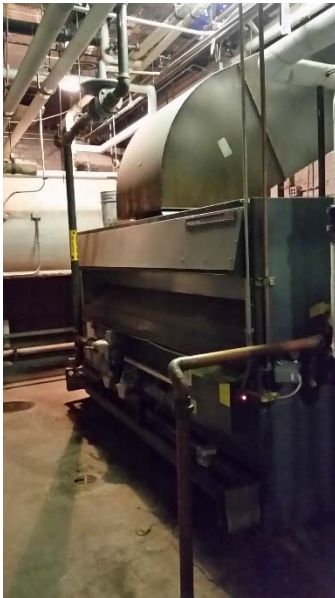
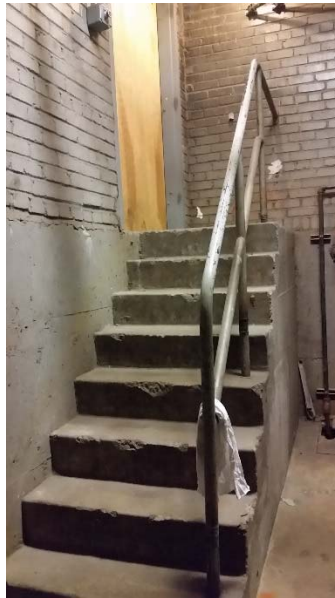
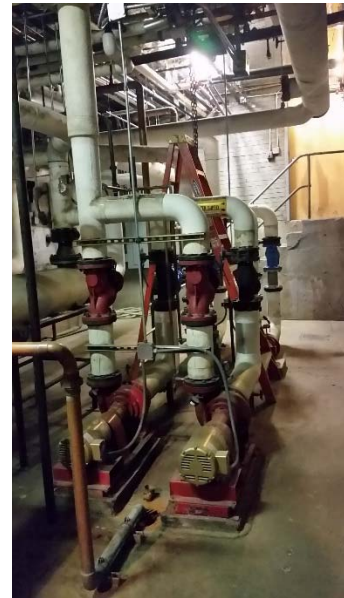
**Figure 6:** Hot water plant equipment – Room 7

The hot water heating plant serves hot water to the convectors located on all floors and the domestic hot water generator for Lincoln Hall. It also serves hot water to White Pine. The

high temperature to low temperature hot water heat exchanger is currently turned off. High temperature hot water to this heat exchanger is provided by the Central Heat Plant for the campus. Refer to [Figure 6](#) for illustrations of existing heating hot water plant equipment.

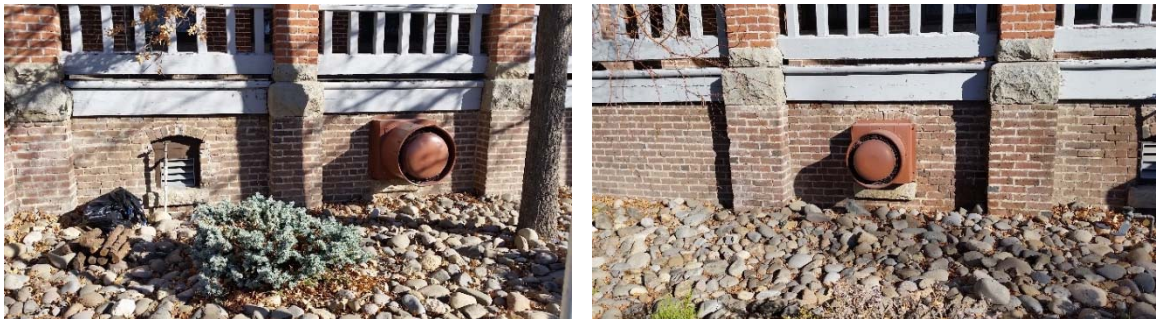
**Figure 8:** Basement Area General Exhaust Fans – South Side of Building.

Finned tube radiators can be found in some storage areas while in other areas, there is no means of heating or cooling. General exhaust fans and dryer exhaust serves the laundry room and laundry equipment. The elevator equipment room is not conditioned. The main electrical switchgear room is conditioned by an exhaust fan that is not operational.

Figure 8 shows the exhaust fans mounted on the front of building that serve the basement area general exhaust requirements.

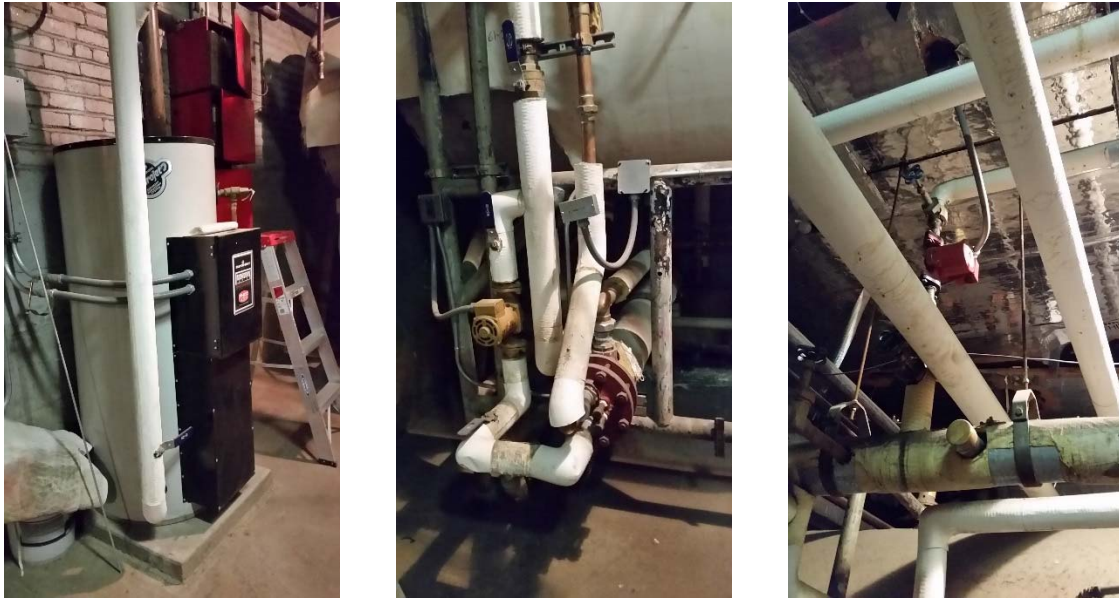
**Figure 13:** Domestic Water Heating – Room 7

A domestic hot water generator and water heater are located at the basement level in the mechanical room. The electrical water heater and the domestic hot water storage tank are connected together to provide hot water to the entire building. Circulation pumps recirculate hot water to the plumbing fixtures throughout the building. The electric water heater is not seismically strapped. The storage tank and hot water generator have reached the end of their useful life. The electric water heater could be re-used for the renovated building. Refer to [Figure 13](#) for the water heater installation.

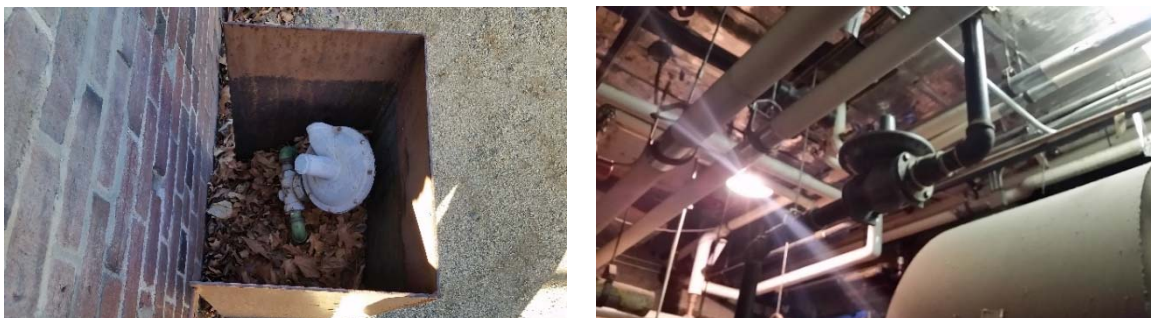
**Figure 16:** Natural Gas Piping – Generator and Boiler Room

The main natural gas piping service entrance is on the east side of the building. The gas meter is located at this entrance. A seismic gas valve is not installed on the main piping entering the building. The exterior piping is rusting and needs to be coated with a protective coating. The piping routes from the meter location into the boiler room. This gas service also appears to fuel a natural gas fired generator located to the north of the building. Refer to [Figure 15](#) and [Figure 16](#) for typical gas piping found in the building.

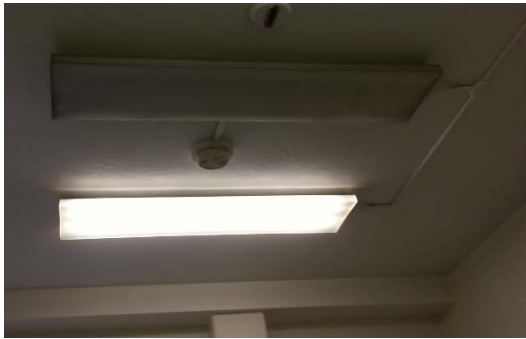
**Figure 17:** Typical dormitory lighting, originally one light was installed, but a surface raceway was used to install additional lighting in the space.

In other areas, such as the third floor dorm rooms, older fixtures are still in place, like surface mounted bowl type lamp holders as shown in [Figure 17](#).

These are most likely from the last large remodel, but are more likely to be what was in style at the time of construction. There are similar bowl type fixtures in some of the main corridor and lobby areas as well. The only lighting within the building that is more representative of the original lighting is the chandelier in the main entry way shown in [Figure 19](#). This style of light was close to the popular lighting design of the late 1800's and early 1900's, but none of the light fixtures are original fixtures.

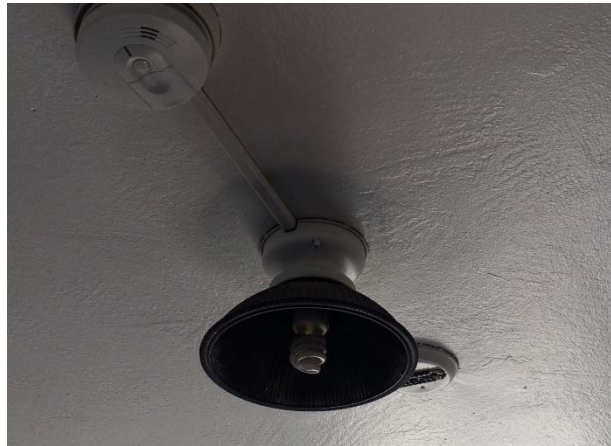
The light fixtures within the building are mostly vintage, 1990 linear acrylic wrapped fluorescent fixtures fed from surface raceways, as shown in [Figure 18](#). In other areas such as the restrooms, there are acrylic wrapped linear fluorescent fixtures that are surface mounted but have no surface raceway extending from them.

**Figure 18:** 3<sup>rd</sup> floor dormitory surface mounted light fixture with modern CFL lamp. Surface raceway used to service fire alarm device.

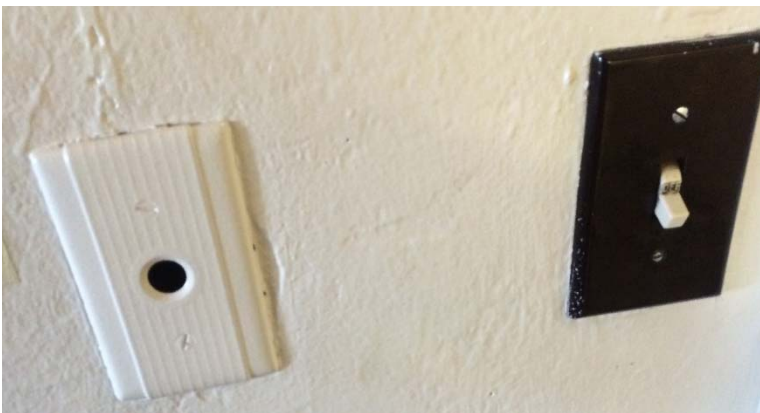
**Figure 21:** Typical lighting snap switch shown on the right with old pushbutton switch cover plate shown on the left.

Throughout the interior of the structure there are mostly snap switches common to any home from the last  $\frac{3}{4}$  century. There are references to push button switches being used in the initial design and construction of the building, but these were all replaced with modern switches as late as the 1952 remodel. There are still faceplates and positions for the snap switches as shown in [Figure 21](#), but these are not in service anymore and the pushbutton switch itself has been removed. The faceplate and junction box behind is all that remains.

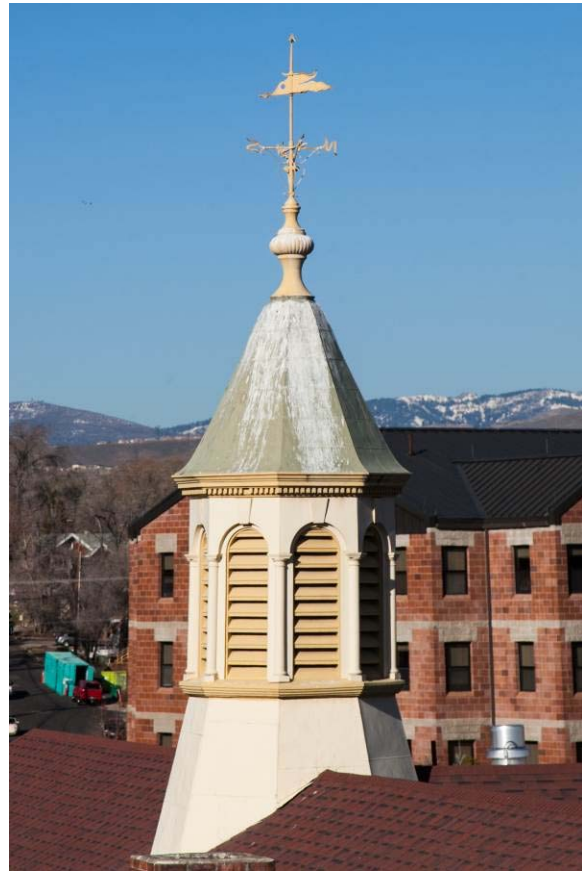
**Figure 29:** Cupola as it appeared in March 2015.  
Image Source: IS Architecture.

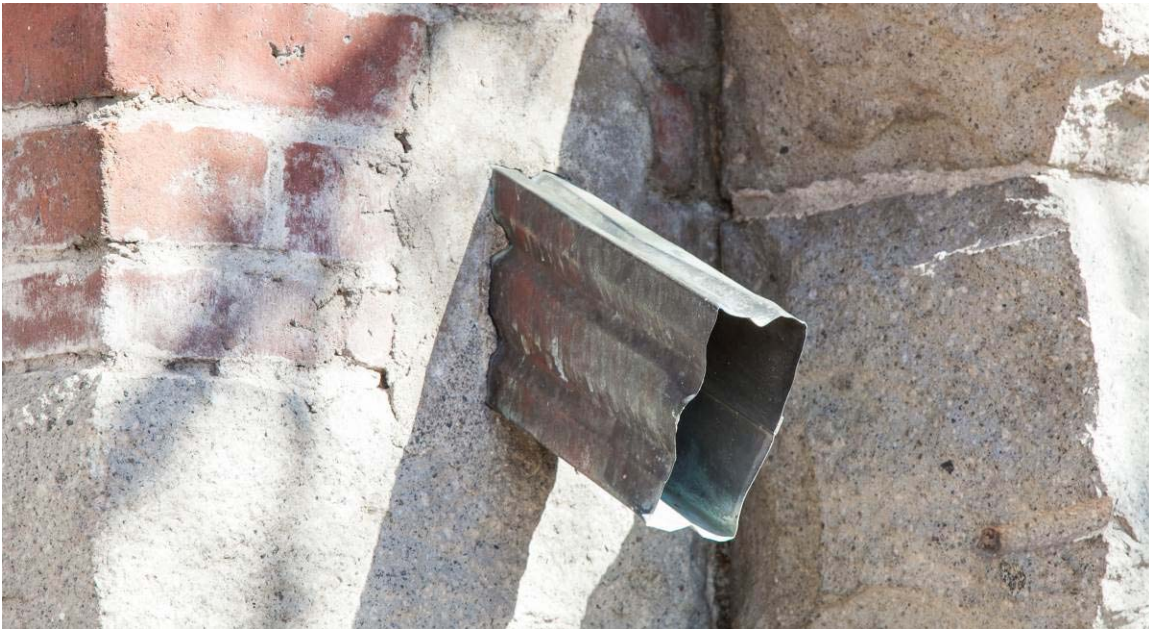
**Figure 33:** East wall of porch showing route of existing drainpipe, leader head and downspout. Note water damage to brick wall. **Figure 34:** Downspout outlet for the porch's east drainpipe. Image Source: IS Architecture, March 2015.

**Figure 35:** Detail view of downspout outlet. The west side of the porch has the same configuration. Image Source: IS Architecture, March 2015.

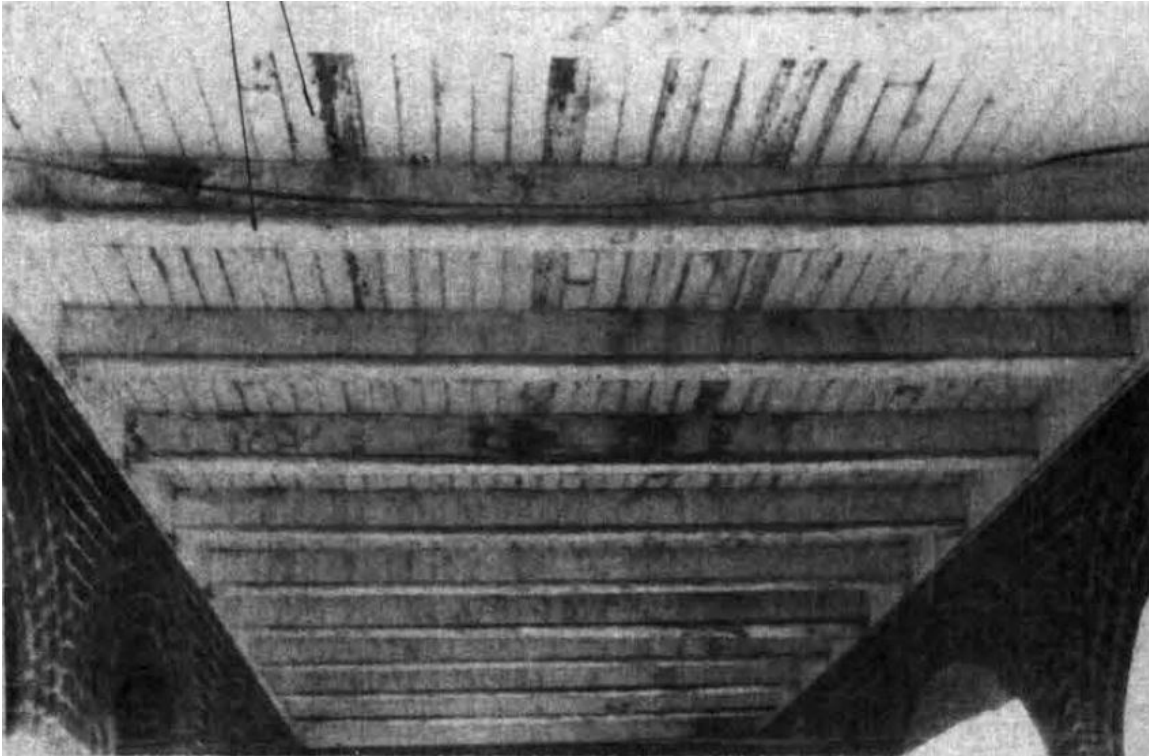
**Figure 37:** Photograph taken for inclusion in the 1989 “Lincoln Hall Reroof and Misc. Exterior Improvements.” The ceiling appears to be original from 1896. The 1989 drawing set called for “Existing paint to be removed off decking and box beams by hand scraping and hand sanding. Broken, cracked or badly warped box beam boards to be removed and replaced with matching material. All box beam boards to be re-nailed and all holes and joints to be caulked flush. Entire wood ceiling area shall be repainted.” Image Source: UNR Special Collections, February 24, 1989.

Refer to the images below and Appendix A: Photographs to recreate the ceiling assembly.

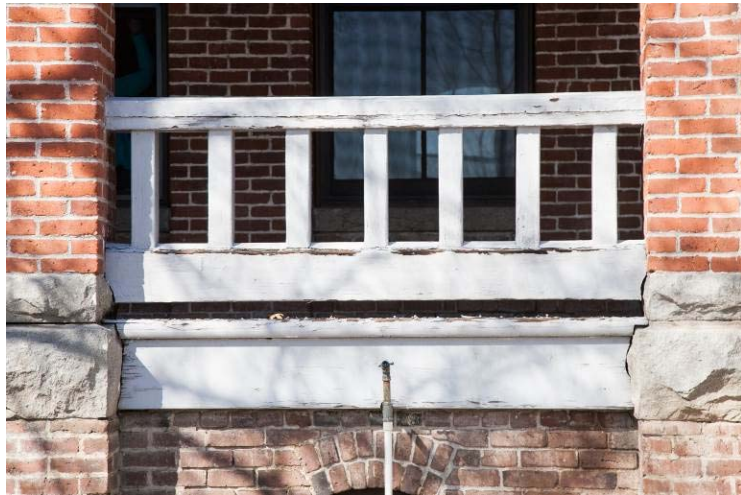
**Figure 40 (left):** c.1907 photograph showing railing assembly. Image Source: UNRA-P59-1. **Figure 41 (above):** Typical railing assembly as it appeared in March 2015. Image Source: IS Architecture, March 2015.

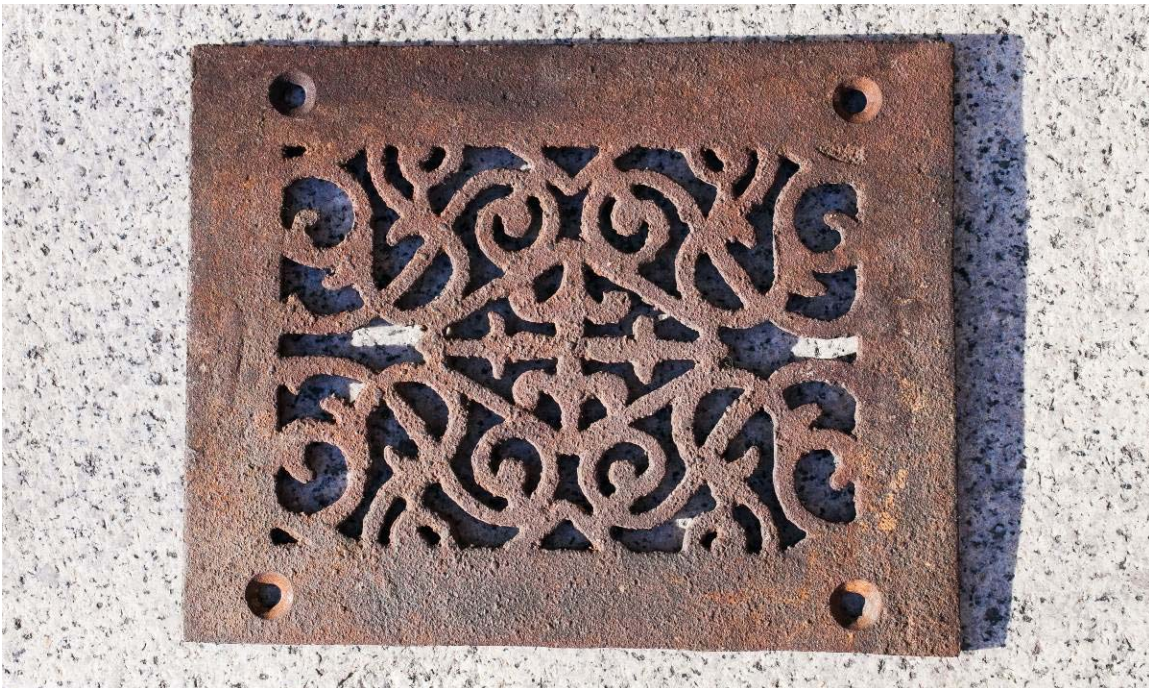
During our site visit, five decorative grilles were observed being stored in the west fireplace firebox. University staff was notified and a request was made for the grilles to be stored in a more secure location.

It can be speculated that if five grilles are being stored in the fireplace, that they, at some point, fell off the building or were possibly removed because they posed a hazard for pedestrians below. It is imperative all extant decorative grilles are inspected to insure they are securely fastened to the building. It is recommended grilles which are loose or are missing screws be reattached using masonry screws.

**Figure 45:** Detail view of removed decorative grille. Image Source: IS Architecture, March 2015.

It is recommended the five removed decorative grilles be reattached starting on the south façade, then the west, east and lastly the north façade.

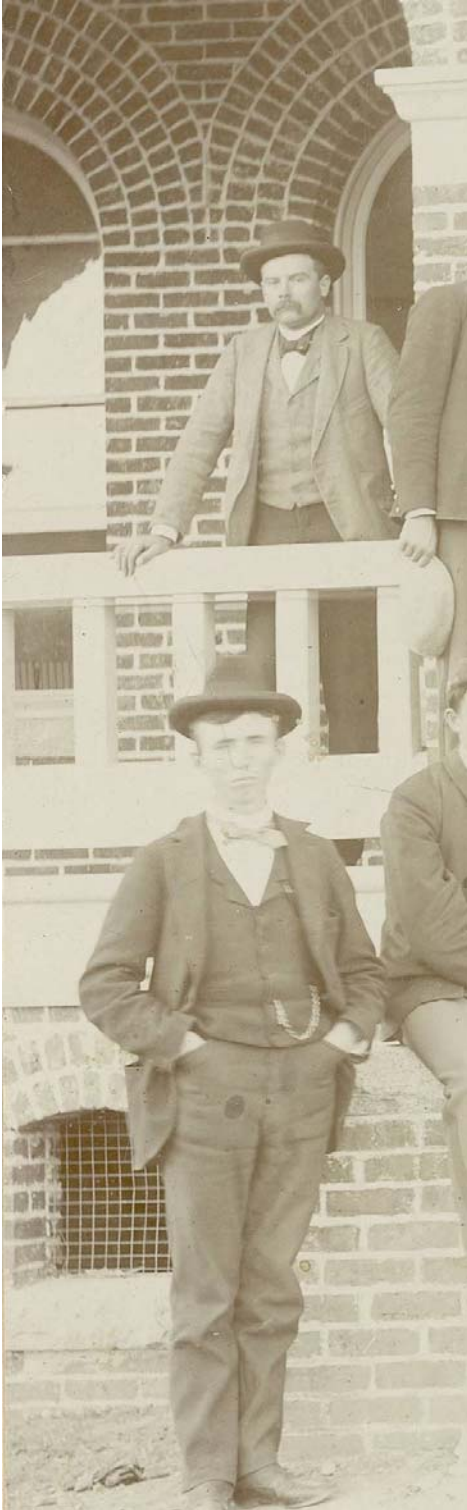
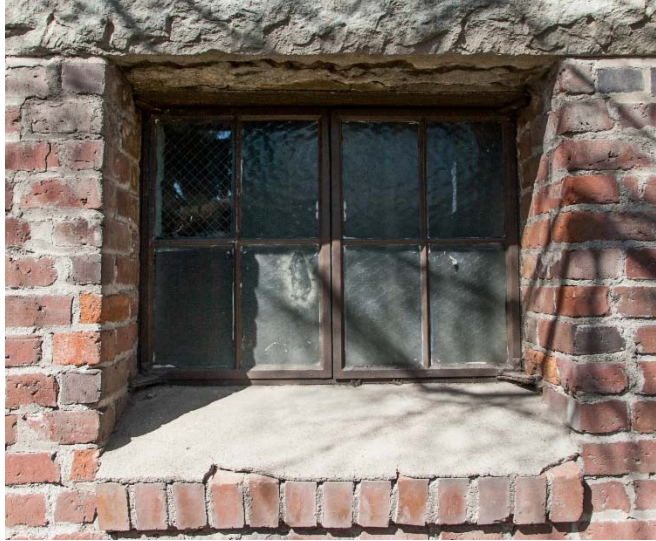
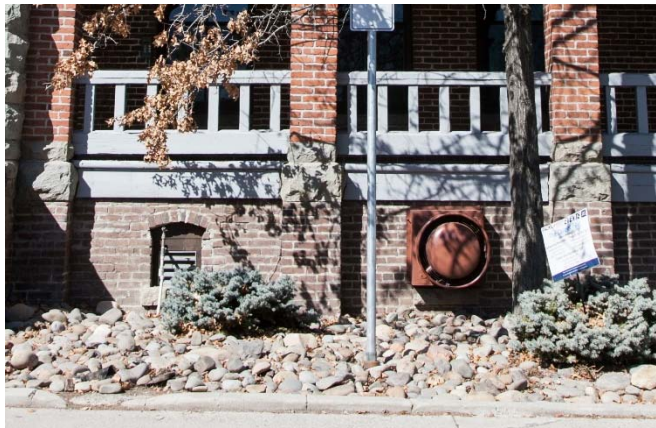
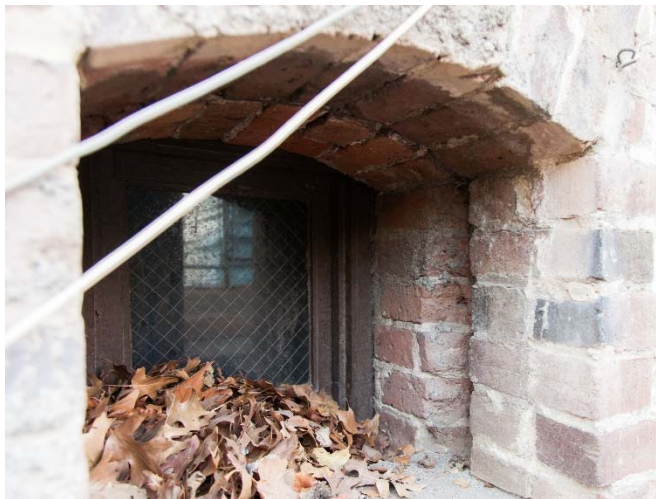
**Figure 46 (left):** Detail view of historic woven metal mesh at basement vent openings. Image Source: UNRA-P59-1, c.1907. **Figure 47 (top right):** Typical enlarged vent opening at west side of Lincoln Hall. **Figure 48 (middle right):** Vent openings on the south façade which have been modified. **Figure 49 (bottom right):** Vent opening on the north façade showing gap between wythes where woven metal mesh was once present. Image Source: IS Architecture, March 2015.

In basement rooms that do not require temperature regulation, the removal of infill windows should be considered. It is recommended woven metal mesh matching the historic design be installed into the original openings. Refer to figures below for an up close image of the original woven mesh material. Copper or stainless steel hardware cloth is an acceptable alternative.

Most infill wood casement windows are set flush to the interior wall. The historic metal woven mesh was designed to sit between the second and third wythe of brick from the exterior of the building. With wood casement windows left in place, reinstallation of woven metal mesh is desirable. This approach would only be feasible for basement vent openings that retain their historic shape. All other modified windows shall be left as-is so as to not create a false sense of history.

Lastly, it is desirable that the basement vent openings on the west side of Lincoln Hall which have been enlarged be scaled down to match the original design in size, shape and material. Woven metal mesh shall be installed to reflect the historic appearance of the feature.

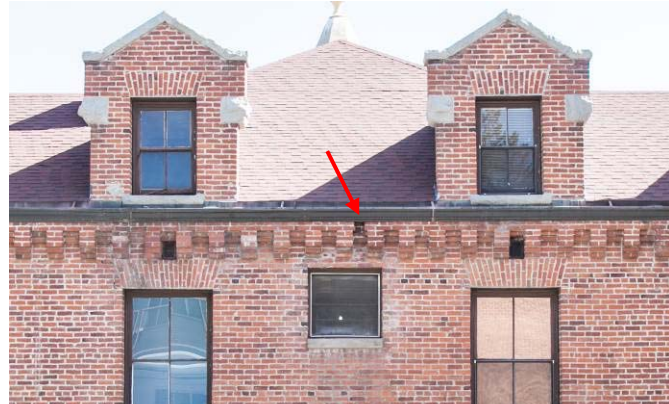
**Figure 51 (right):** Detail view of west façade showing past downspout location. Image Source: IS Architecture, March 2015.

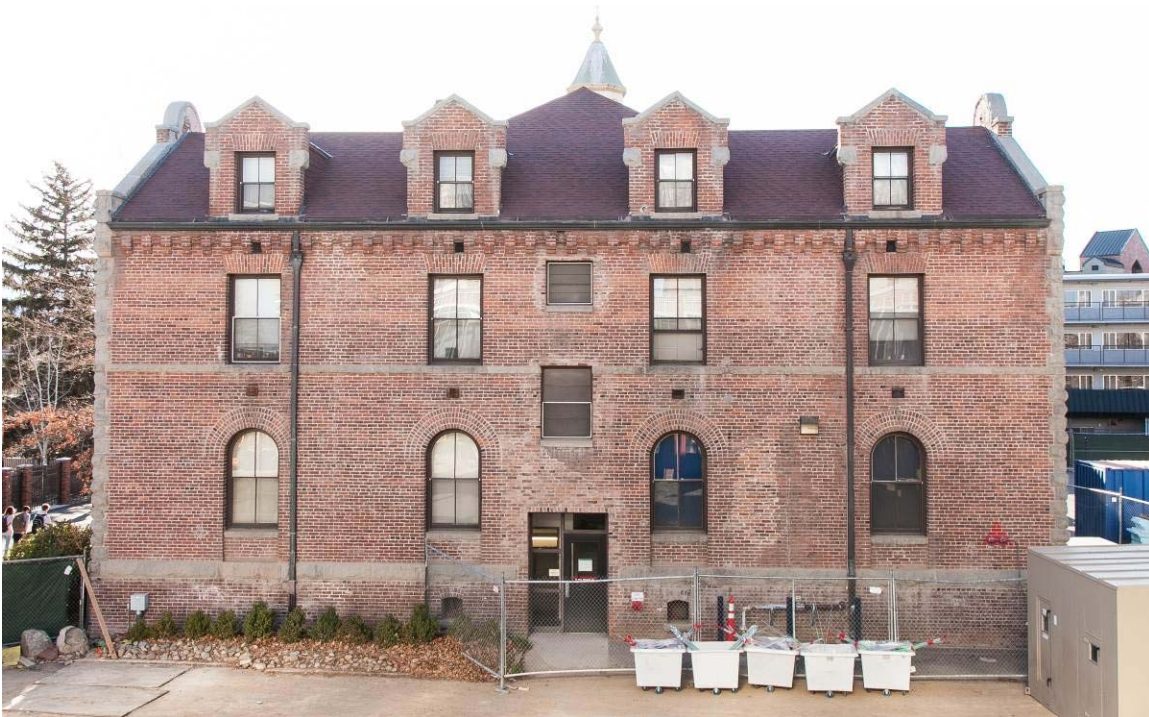
The majority of historic wood windows are extant and in good condition.

**Figure 61:** Overview of east facade showing typical historic first, second and third floor windows. Note: door and windows above are not original to Lincoln Hall. Image Source: IS Architecture, March 2015.

There are no immediate issues with the historic wood windows. They are in good working order. It is recommended weather stripping replacement and a sash pulley inspection is included in routine maintenance of Lincoln Hall.

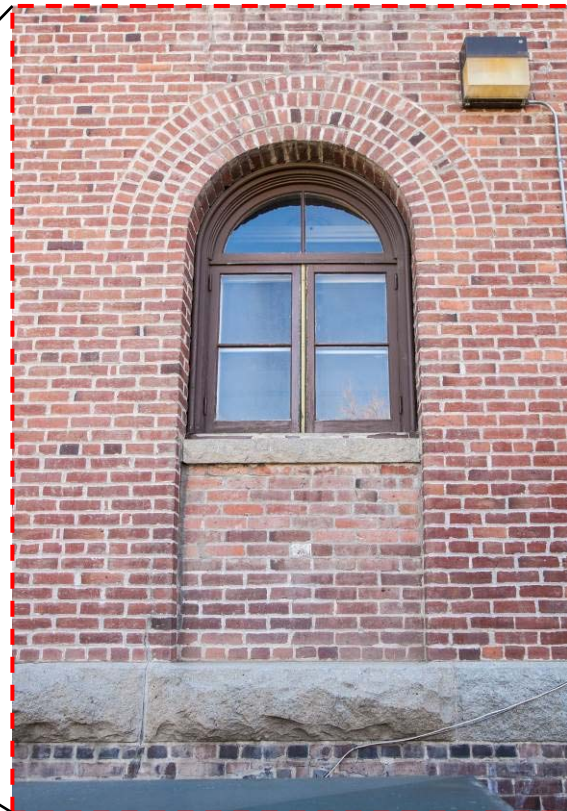
The north façade has undergone many changes that have adversely impacted the resource; primarily the infill or alteration of windows. In 1952, two small windows stacked one on top the other on the first and second floor were infilled when a large brick stack was constructed. Two other windows just east of the smaller brick stack were infilled sometime after 1999.<sup>74</sup> Also, in 1952, the two windows in Room 118 were replaced with casement windows and the four windows between the brick stacks were also replaced. The aforementioned windows that were replaced were either shifted upward, as was the case between the brick stacks, or were shortened in height by elevating the sill, as was the case in Room 118.

**Figure 64:** Detail view of Figure 63. Image Source: IS Architecture, March 2015.

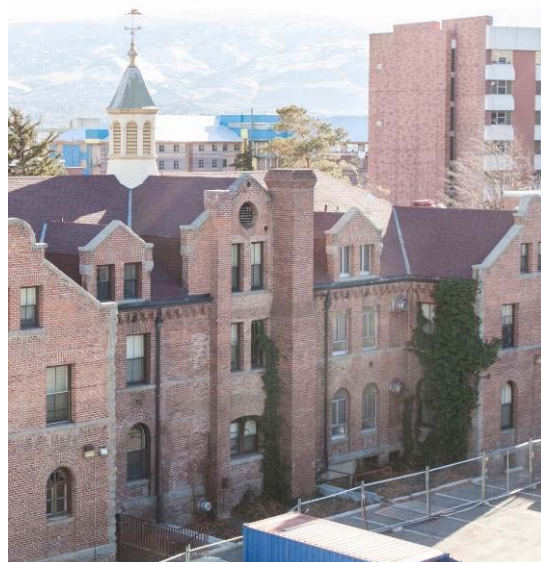
**Figure 67:** View of north facade showing newer brick mechanical stack in the background and shortened historic brick stack in the foreground. Image Source: IS Architecture, March 2015.

Consult a mechanical engineer to determine whether the non-historic west stack is currently being used. If the west stack is no longer needed, then it shall be removed. In its place, a new stack shall be reconstructed to match the historic east stack in height, size, shape and material. The intent of reconstructing this feature is to make the exterior of Lincoln Hall more closely reflect its historic appearance.

Consult a structural engineer who specializes in historic masonry to determine the feasibility of extending the height of both stacks to reflect their historic design. If feasible, the new brick shall match the historic in size, shape and material. Historic photographs show the tops of the stacks having one course of brick overhanging the exterior face of the stack. The overhang appears to be 2"-3".

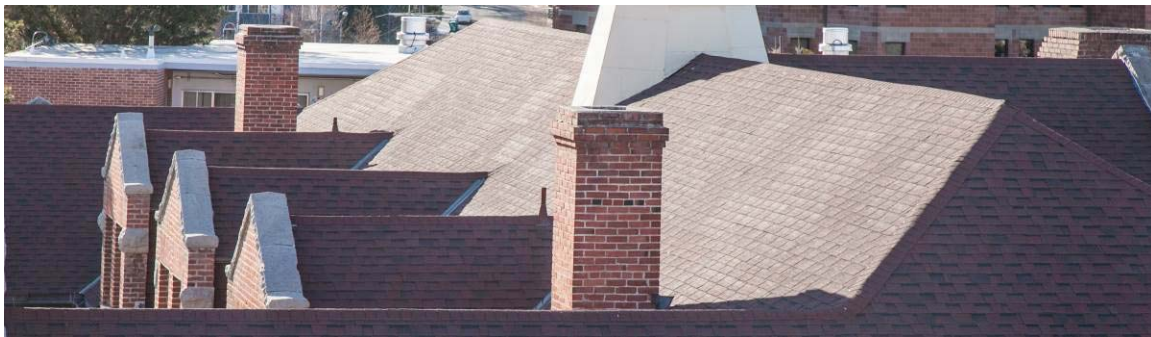
**Figure 71:** View west over roof line showing chimneys as they appeared in March 2015. Image Source: IS Architecture.

Consult a structural engineer to determine the feasibility of extending the chimneys to their historic height. If feasible, the new portion of chimney shall match the historic in size, height, material and overall appearance. The intent of reconstructing this feature is to make the exterior of Lincoln Hall more closely reflect its historic appearance.

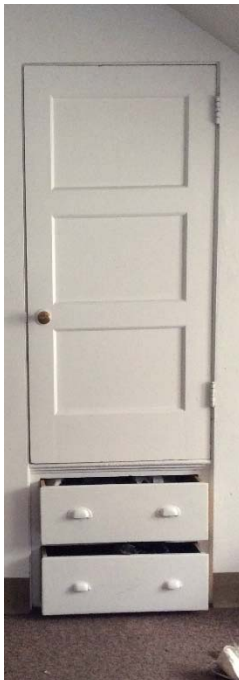
Paint samples were extracted from the middle wardrobe of Room 312. The 1952 construction document set for “New Stairs and Interior Alterations of Lincoln Hall” called for all wardrobe doors to be replaced. Paint analysis confirmed that the wardrobe door was not original; however, it did reveal that the jamb of the door was original. Most wardrobes are no longer in their original locations. Wardrobes in their original locations include Rooms 104, 105, 108, 109, 202, 203, 210, 211, 213, 214, 219, 220, and 302, the two westernmost wardrobes of Rooms 309 and 312 and lastly, 317.

**Figure 88 (left):** Middle wardrobe of Room 312. Image Source: IS Architecture, March 2015. **Figure 89 (top):** Typical interior elevation showing “Alterations to Existing Wardrobes” from the 1952 “New Stairs and Interior Alterations” construction set. Image Source: UNR Special Collections.

Wardrobes are a character-defining feature to Lincoln Hall. It is recommended wardrobes in their original location, as listed above, remain in place.

It is recommended any repairs be done in place and that any hardware missing be replaced in kind to match what is currently there.

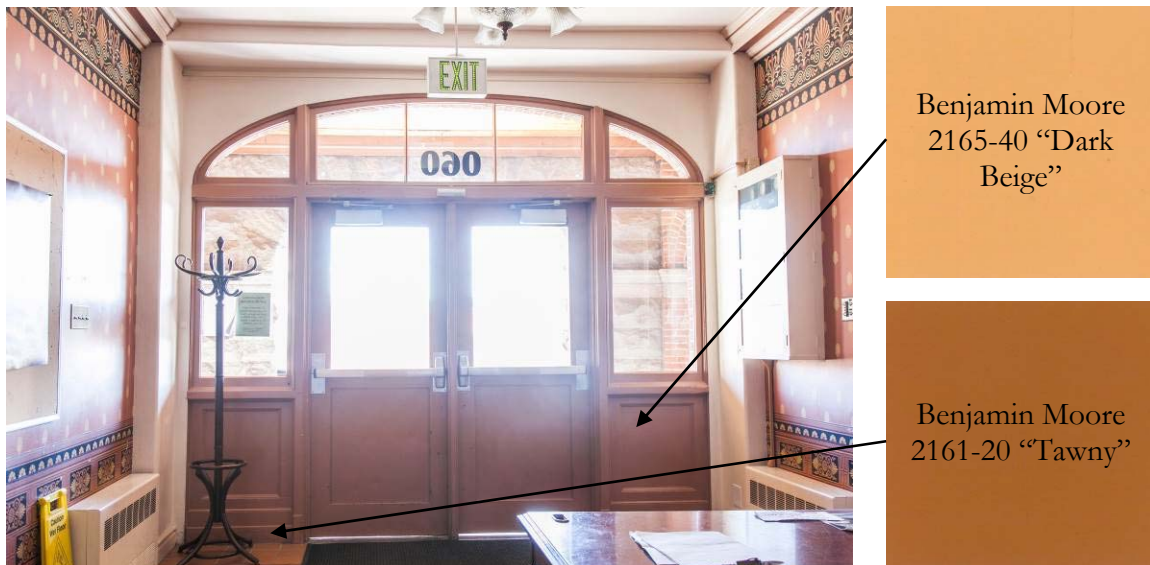
**Figure 90:** South wall of Entry. Paint analysis revealed the interior woodwork consisted of peach-beige (glossy) side panels (Benjamin Moore 2165-40 “Dark Beige”) and orange-brown baseboards (Benjamin Moore 2161-20 “Tawny”). Image Source: IS Architecture, March 2015.

Though not required, it is highly recommended interior wood features of Lincoln Hall be returned to their original paint color. Refer to Appendix E: Paint Analysis for current paint swatches that match the historic colors used at Lincoln Hall.<sup>77</sup> Rooms that did not receive paint analysis shall be painted in period appropriate colors that complement the known identified interior colors.

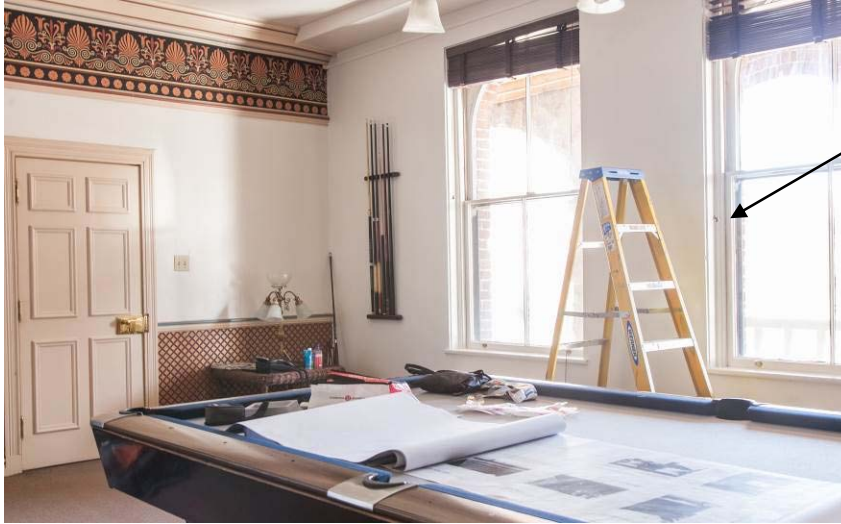
**Figure 91:** View southeast of Pool Room. Paint analysis revealed the interior window trim in the Reading Room (103) and Pool Room (107) was painted a red-brown (glossy) (Benjamin Moore 2097-10 "Toasted Brown"). Image Source: IS Architecture, March 2015.

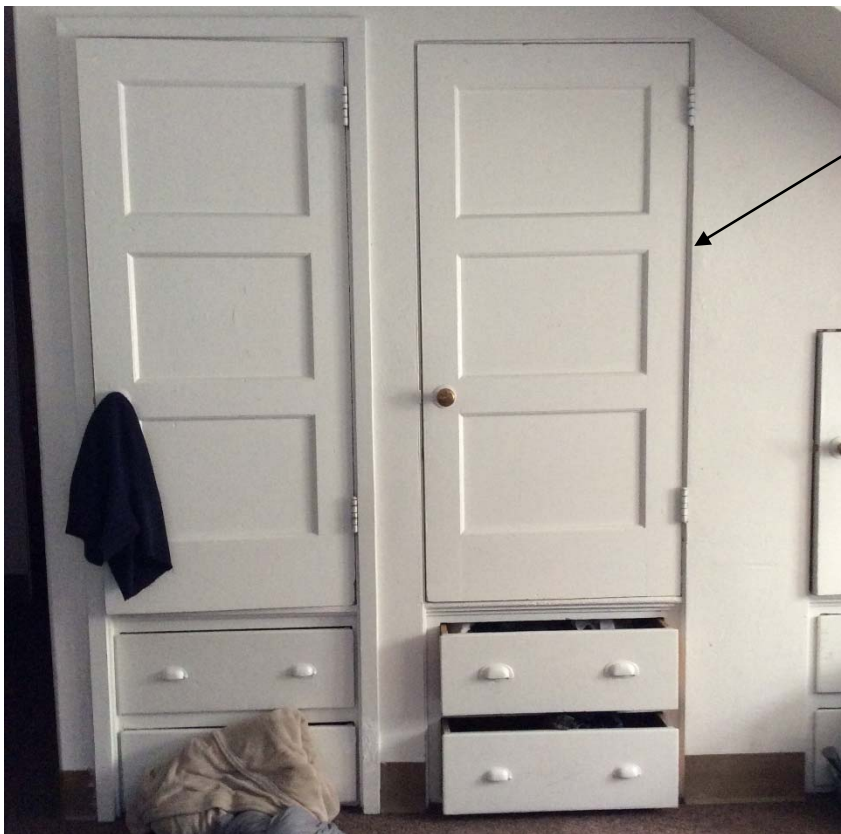
**Figure 92:** Photo elevation of Room 312 wardrobes. The wardrobe at the left of the frame was constructed in 1952 and is not historic. The jamb of the middle wardrobe is where the paint sample was taken and was found to be original. Paint analysis was inconclusive. The door jamb was painted with a yellow ochre paint, over which a very thin layer of red-brown paint was applied (the same red-brown used in rooms 103 and 107). Image Source: IS Architecture, March 2015.
