# HISTORIC PAINT FINISHES REPORT

THE MARYLAND BUILDING:

THE 1876 EXTERIOR FINISHES

### **The Maryland Building from the Centennial Exposition of 1876 Exterior finishes of 1876**

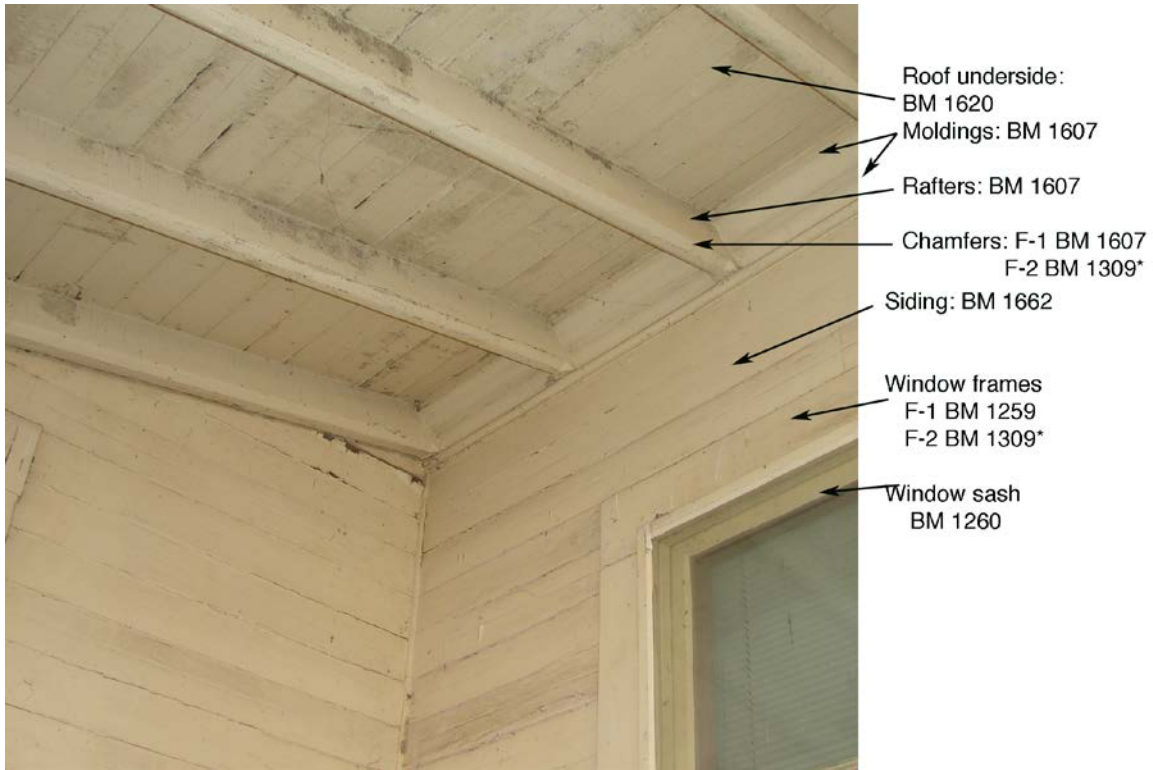
## Finish Schedule: Porch Construction details

The porch posts appear to have been painted entirely with BM 1259. This was based on surviving remnants of paint, which has stained the wood.

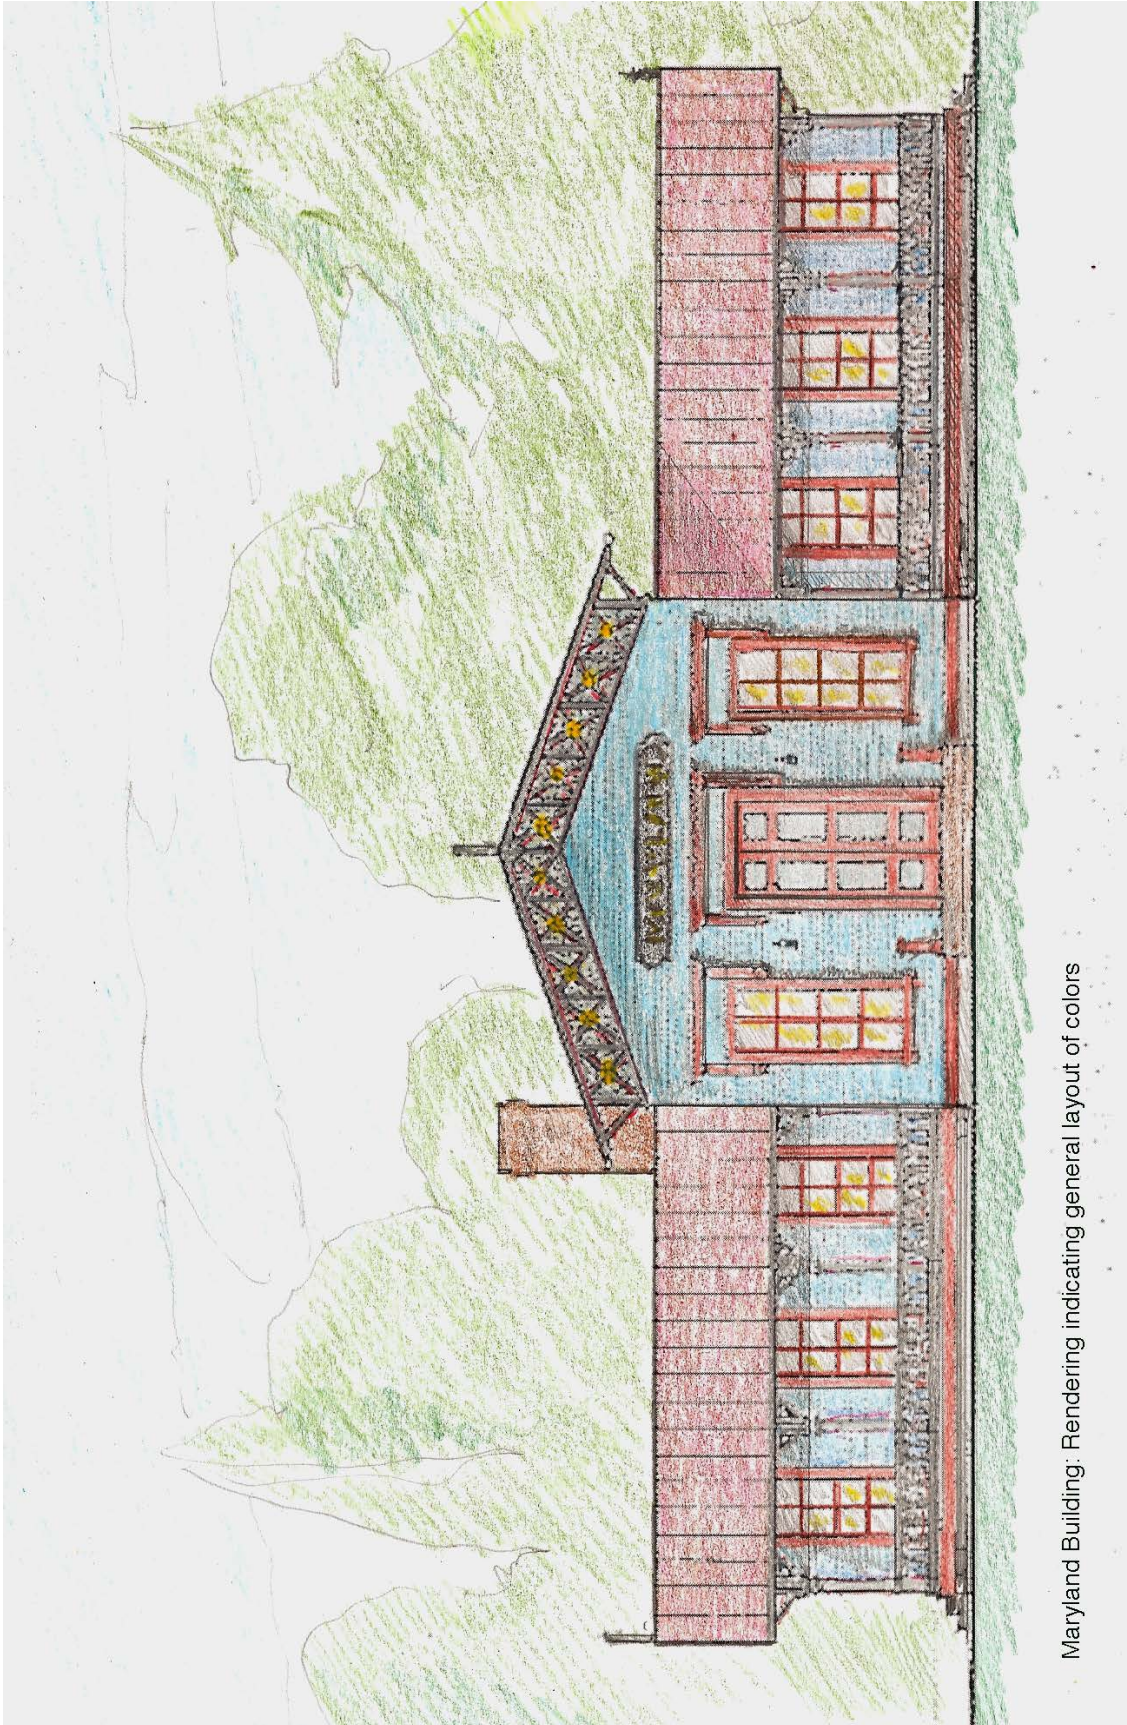
Maryland Building: Rendering indicating general layout of colors
