## **HISTORIC STRUCTURES REPORT**

# **Old Faithful Lodge Yellowstone National Park**

**NOVEMBER 1995**

Prepared By:  
**JAMES R. MCDONALD ARCHITECTS**  
**224 North Higgins Avenue**  
**P.O. Box 8163**  
**Missoula, Montana 59807**

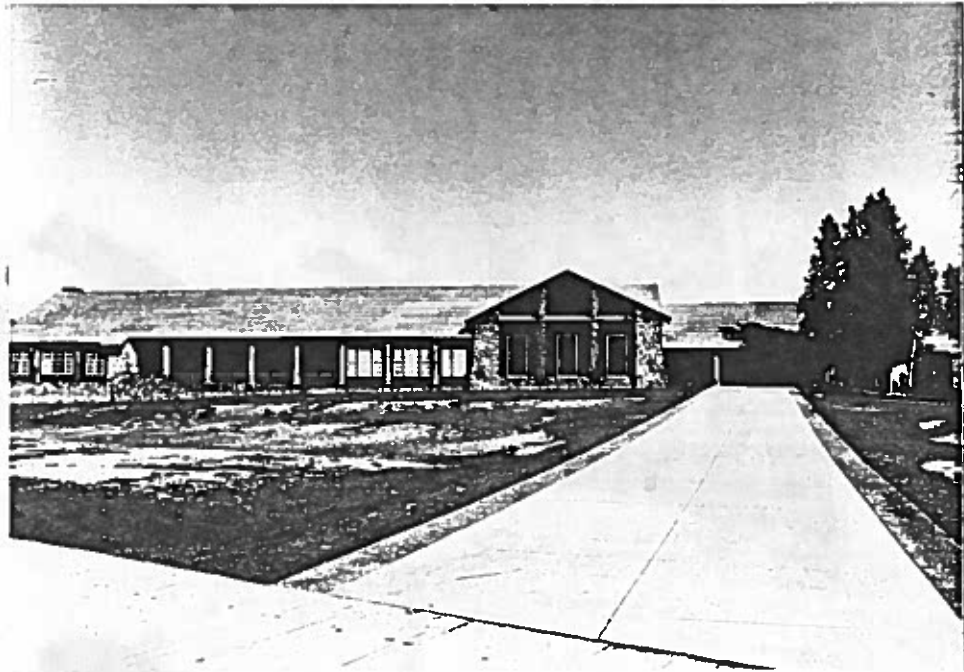
Figure 2: Looking east at the front of Old Faithful Lodge from the boardwalk at Old Faithful Geyser. Historically there was no vegetation on this side of the Lodge because of the Geyser.

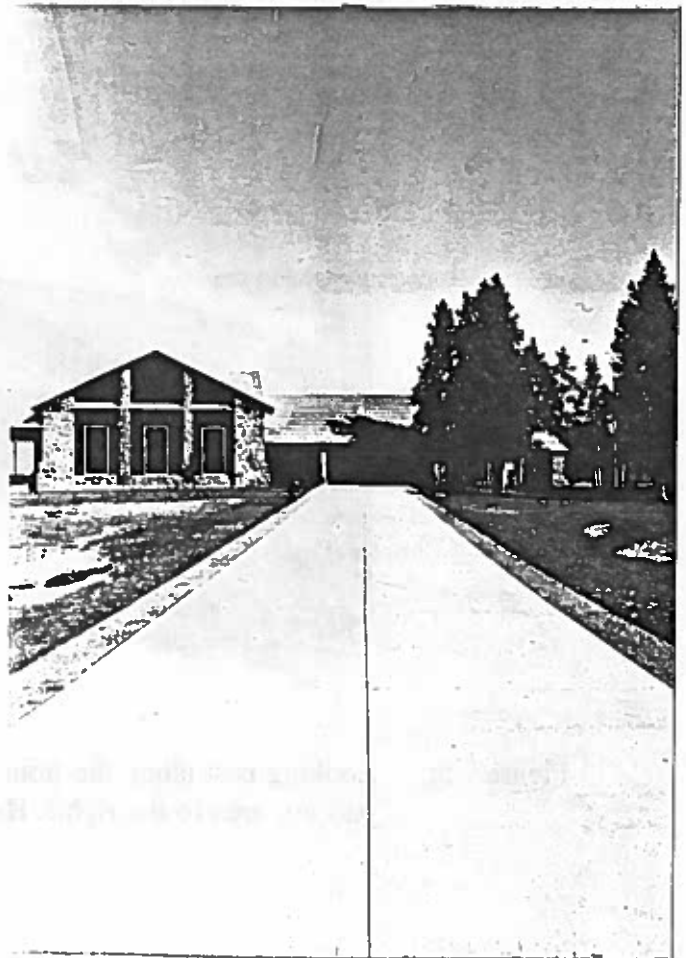
Figure 3: Looking east at the concrete walkway from the boardwalk leading up to the main entrance of Old Faithful Lodge. Note the area of trees to the right of the Lodge.

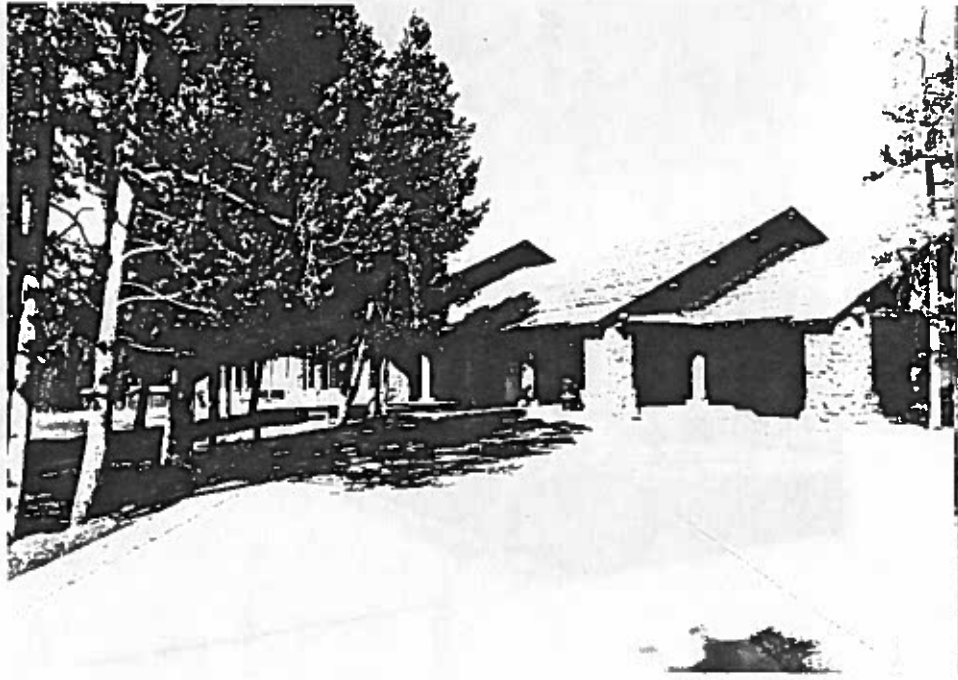
Figure 4: Looking northeast at the Old Faithful Lodge from the concrete walkway from the Visitors Center. Originally a log and post fence followed down along the walkway, from the Visitors Center to the Lodge.

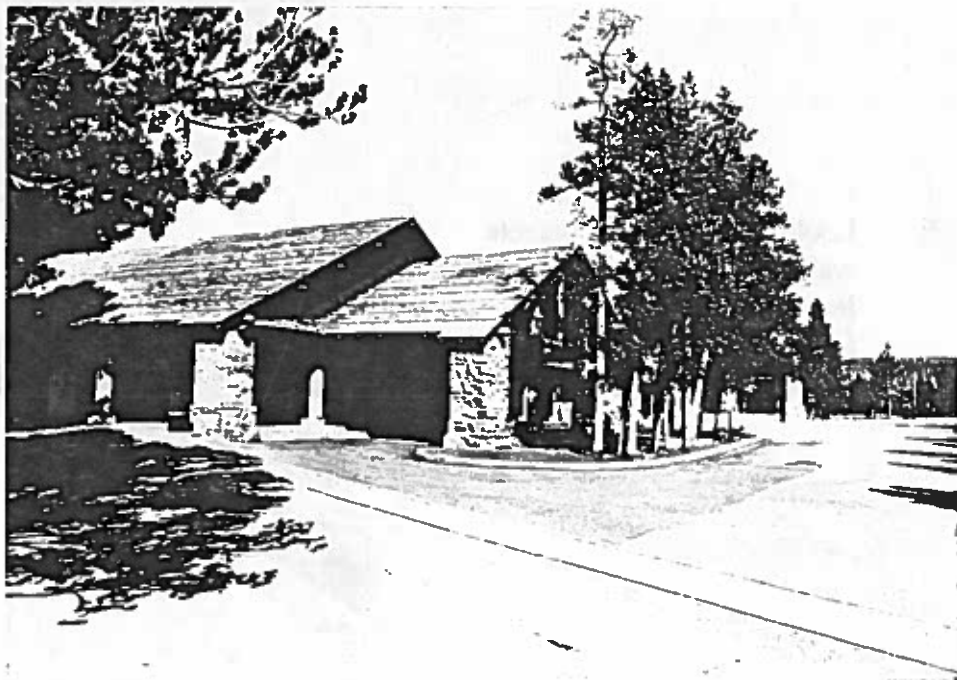
Figure 5: Looking east along the front of the Old Faithful Lodge porte-cochere and parking area to the right. Handicap accessible parking is located in this area.

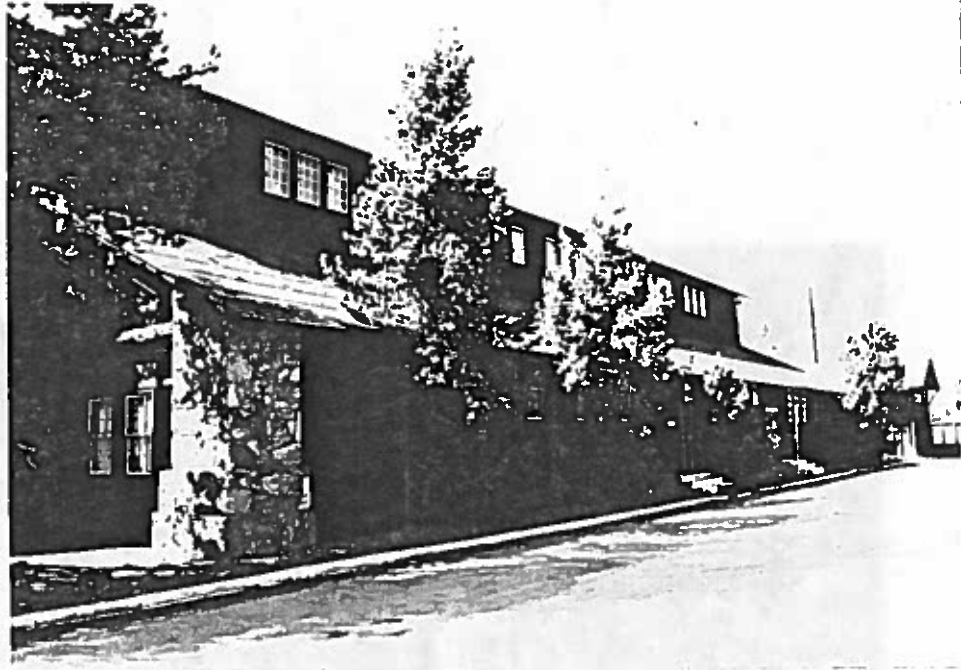
Figure 6: Looking northwest along Old Faithful Lodge on the east side. Note the roadway to the cabins and employee area along the east side.

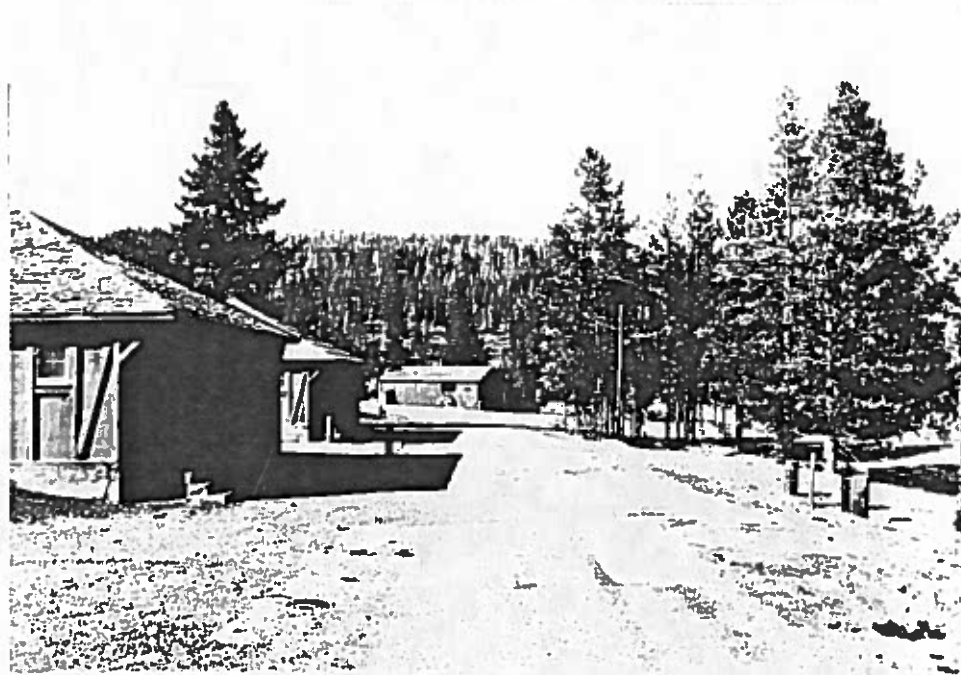
Figure 7: Looking north along the road to the cabin area on the east side of Old Faithful Lodge. The guest cabin area is to the left and the guest and employee cabins are to the right. The ground area around the cabins and to the right where cabins have been removed are very rough and there is little vegetation.

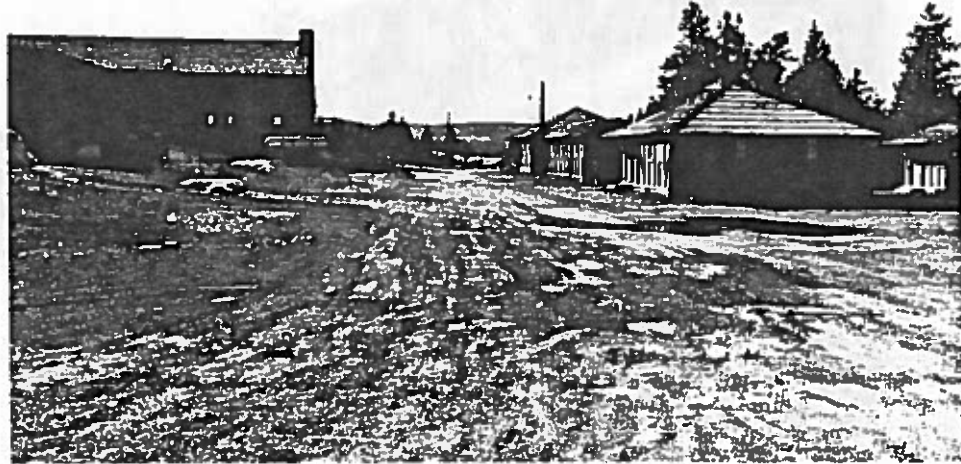
The Old Faithful Lodge Cabin complex site is threatened by loss of natural vegetation that was once prevalent. Excessive car and foot traffic between the lodge, cabin groupings and service/utility buildings have eroded the meadow grasses, shrubs and wildflowers. Lack of definition of parking and pedestrian walkways encourages visitors to use the shortest possible route to and from the lodge and their cars.

Figure 8: Looking west at the area between Old Faithful Lodge and the guest cabin area. Very little grass grows in this area because there is no designated driving area thus the cars travel all over this area.

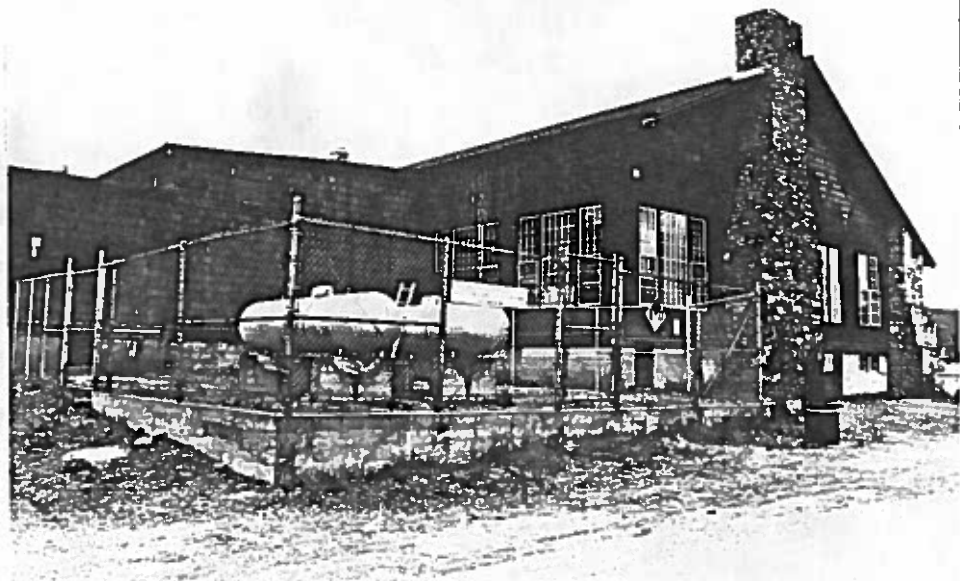
Figure 9: Looking west along the back side of the Old Faithful Lodge kitchen and employee dining area. Note the electrical transformers, and the propane tank area in the background. All of this faces the guest cabin area.

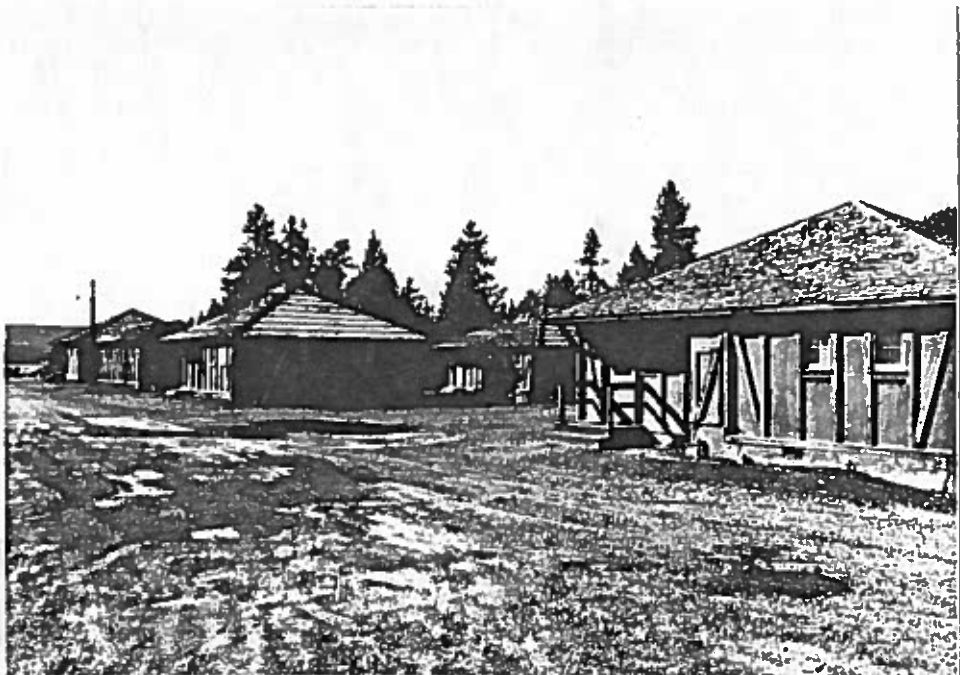
Figure 10: Looking southwest at the propane tank area with its chain link fence on the north side of the Lodge. The guest cabins look directly into this area.

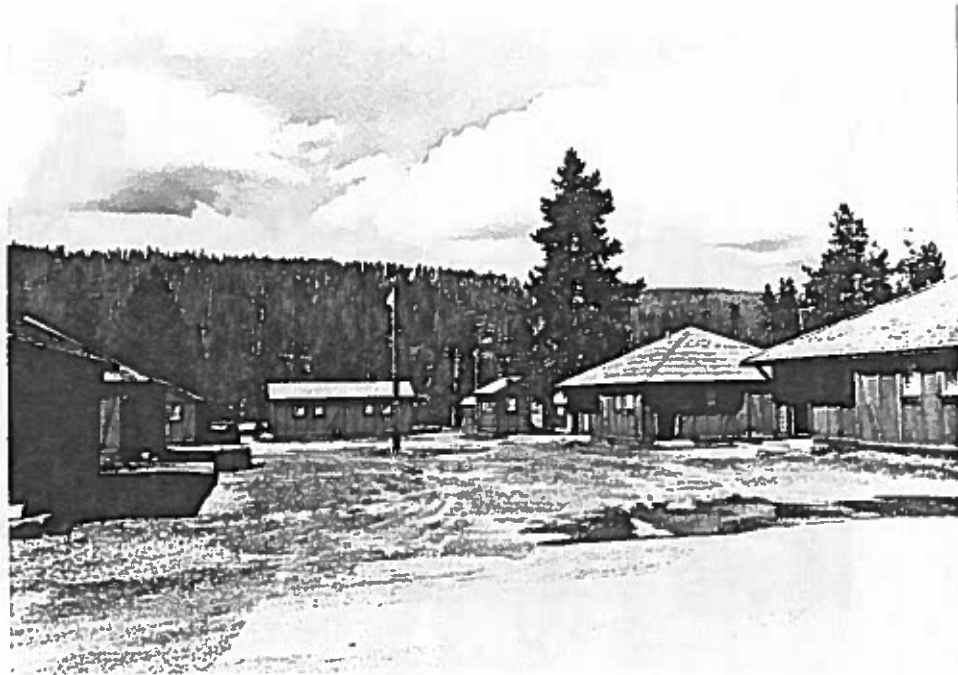
Figure 11: Looking northwest at the guest cabin area from the boiler building at Old Faithful Lodge. Note the little vegetation in this area.

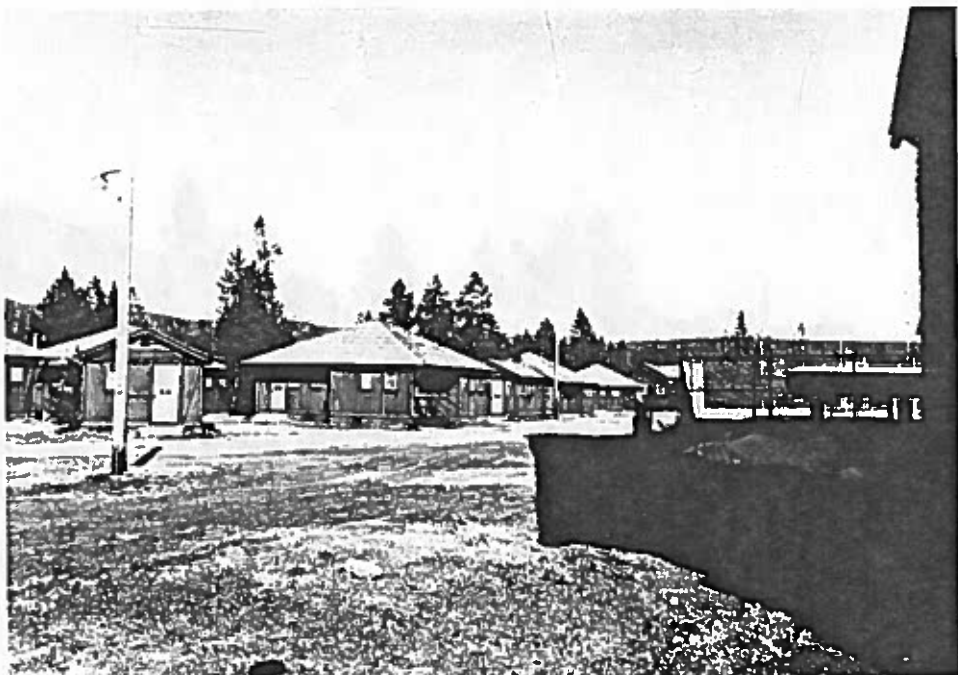
Figure 12: Looking north at an area in the guest cabin area on the north side of Old Faithful Lodge. Cabins have been removed so these areas tend to become driveways or parking areas thus little grass grows in this area.

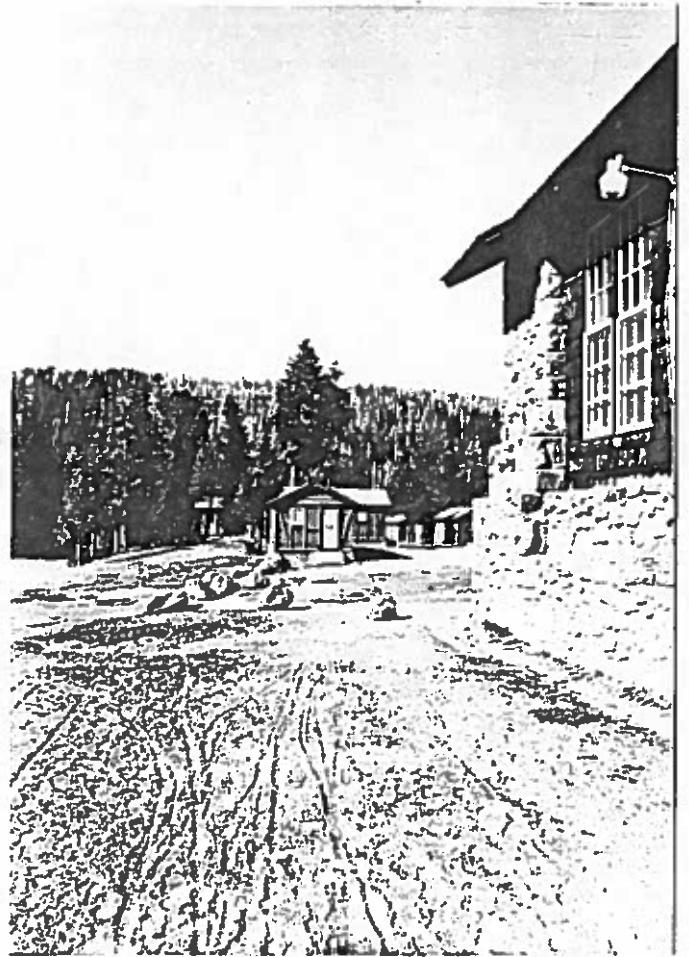
Figure 13: Looking east at the cabin area from the west end of Old Faithful Lodge. Note the street lights on the poles. This is also the view from the boardwalk of the geyser.

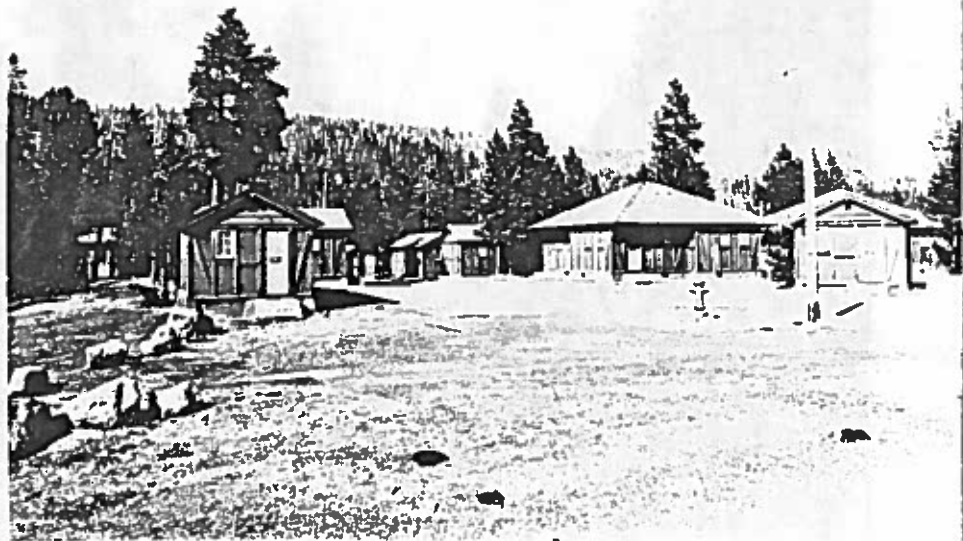
Figure 14: Looking north along the west side of Old Faithful Lodge towards the guest cabin area. Note the rocks that have been put out to discourage traffic along this side of the building. Also, note the wheel tracks from bicycles, and automobiles along this side of the building.

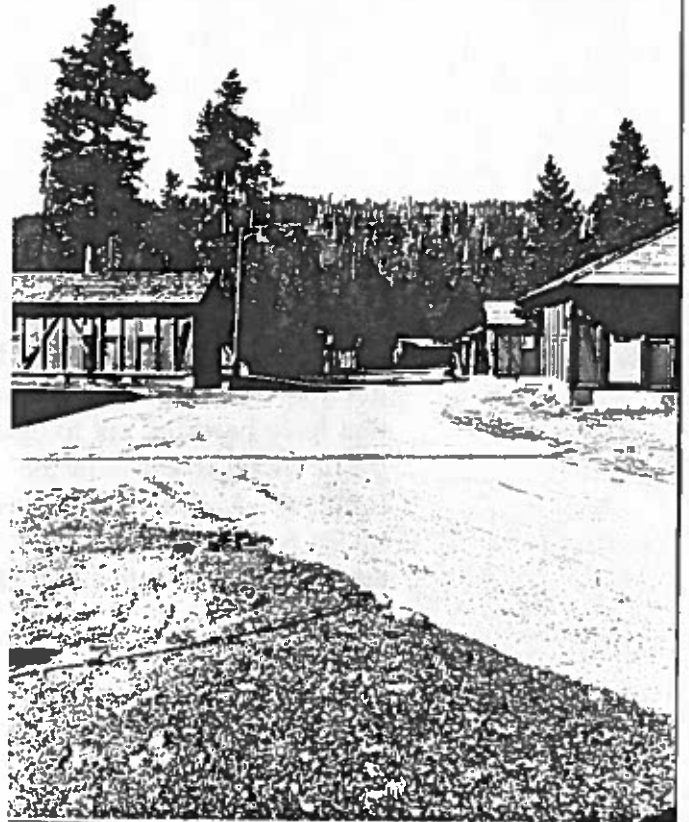
Figure 15: Looking north at the first row of guest cabins closest to the geyser behind Old Faithful Lodge. Most of the area is obsidian sand, with very little vegetation.

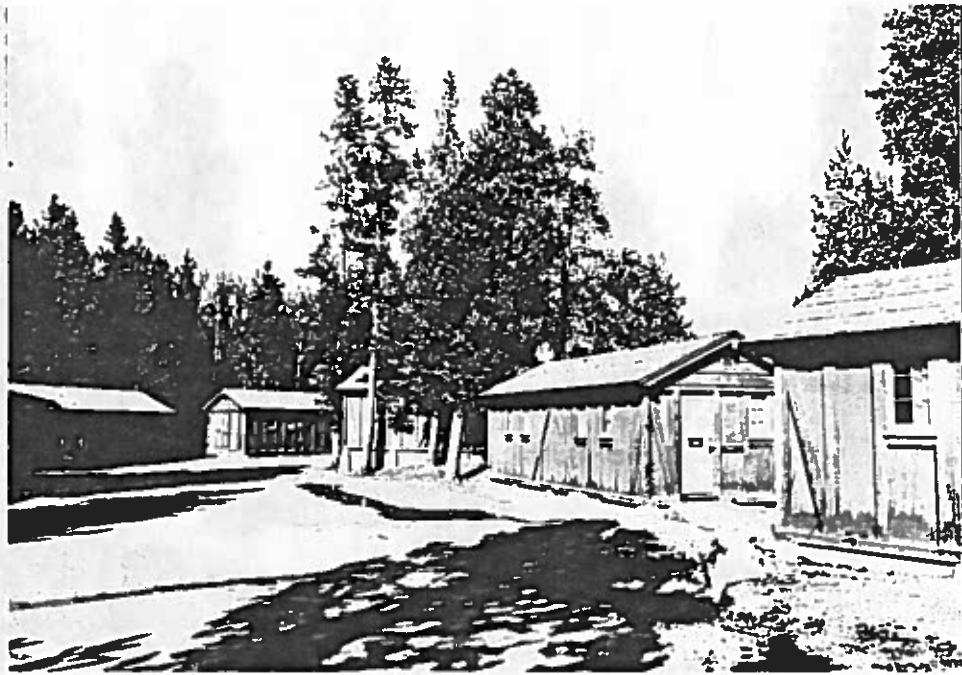
Figure 17: Looking east along the first row of guest cabins from the west road. Note the few trees which help to protect the area. There are no designated car spaces so there is little other vegetation.

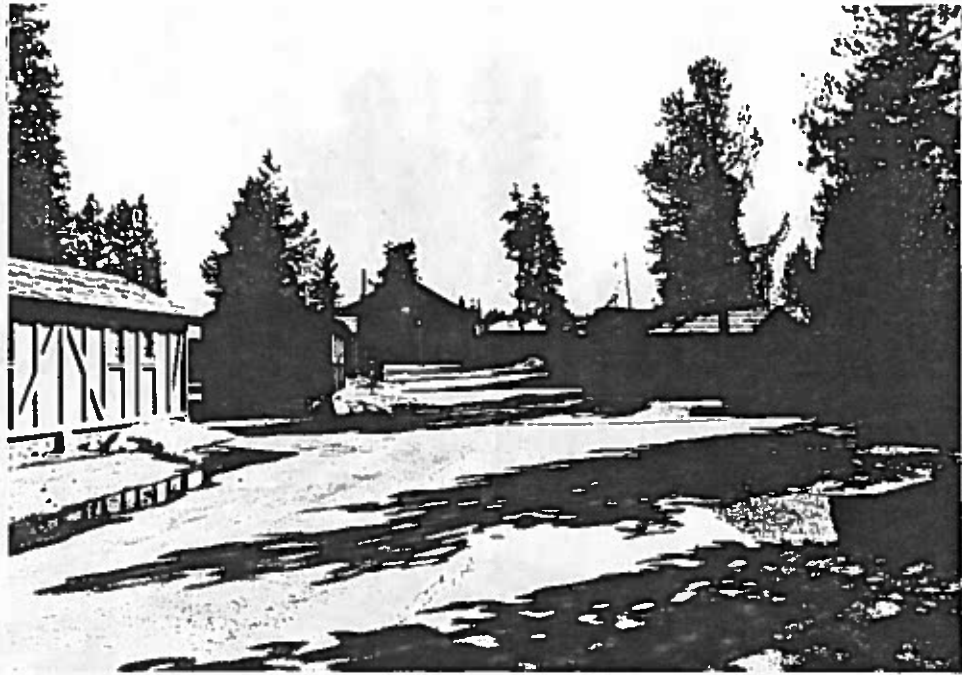
Figure 19: Looking east at the second row of guest cabins from the west road. There tends to be more trees and some grass as you proceed north through the cabin area.

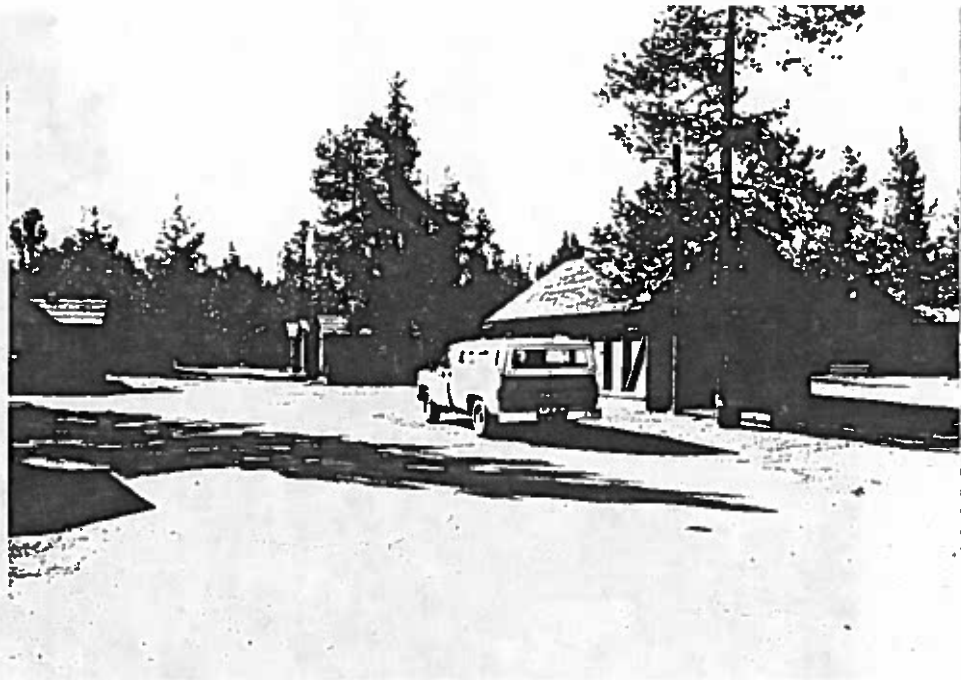
Figure 21: Looking east on the north end of the guest cabin area from the west road. Note the cabins on the right and the trees leading down to the Firehole River on the left. It is important to protect this area.

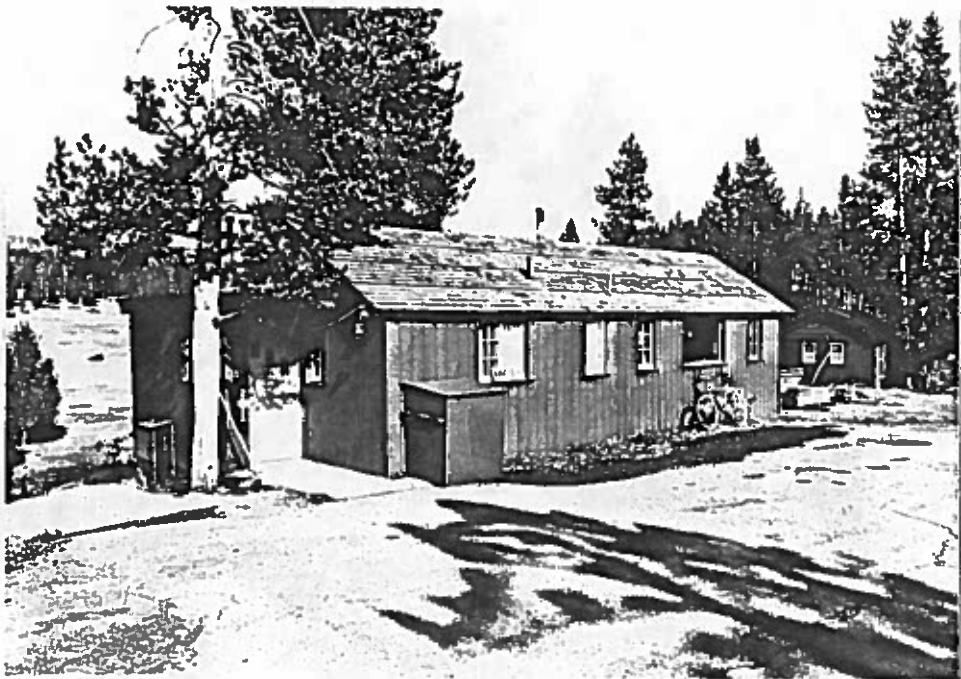
Figure 22: Looking west back along one of the roadways from the east road of the guest cabin area. Note the wide open spaces with little vegetation.

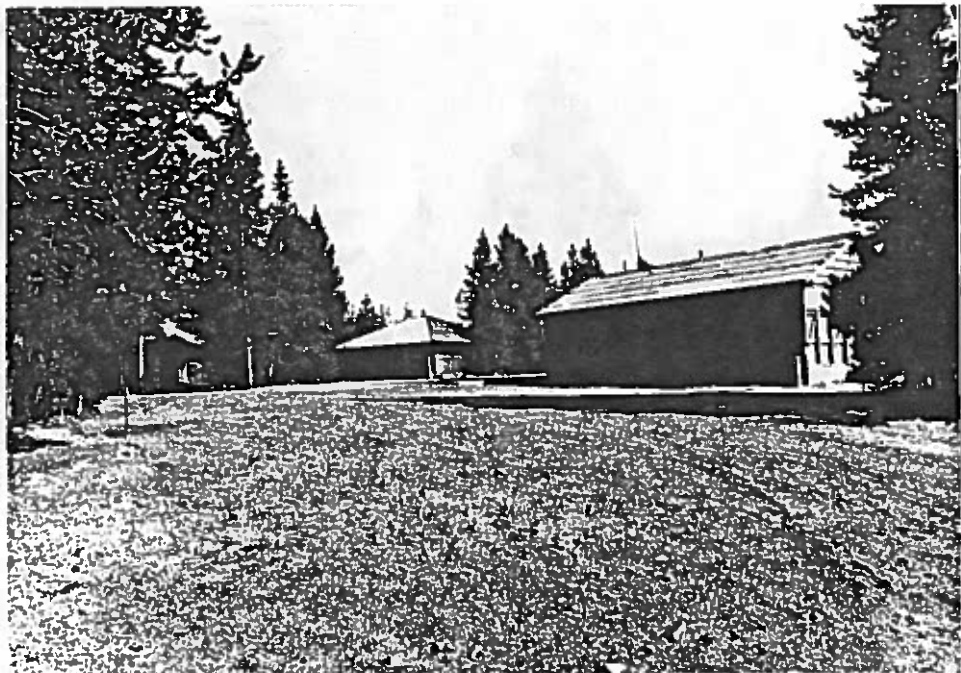
Figure 26: Looking west back towards the upper guest cabin area from the employee area to the east. Note the dormitory building with a large parking area on the left and employee cabins and parking on the right.

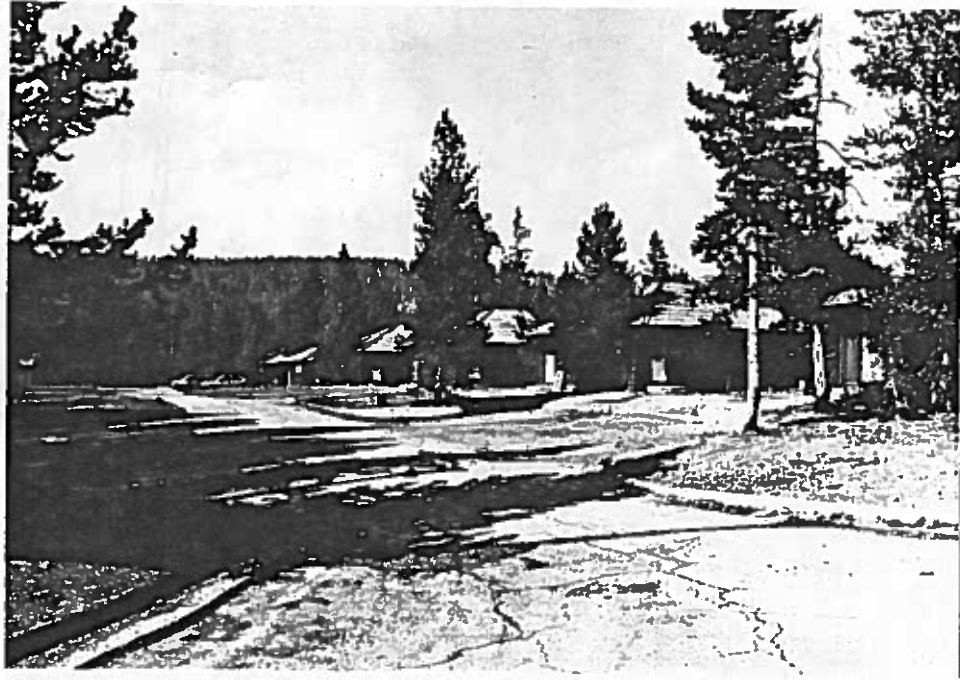
Figure 27: Looking southeast at the lower linen building towards some employee quad housing. Note the lack of vegetation and open space in this area.

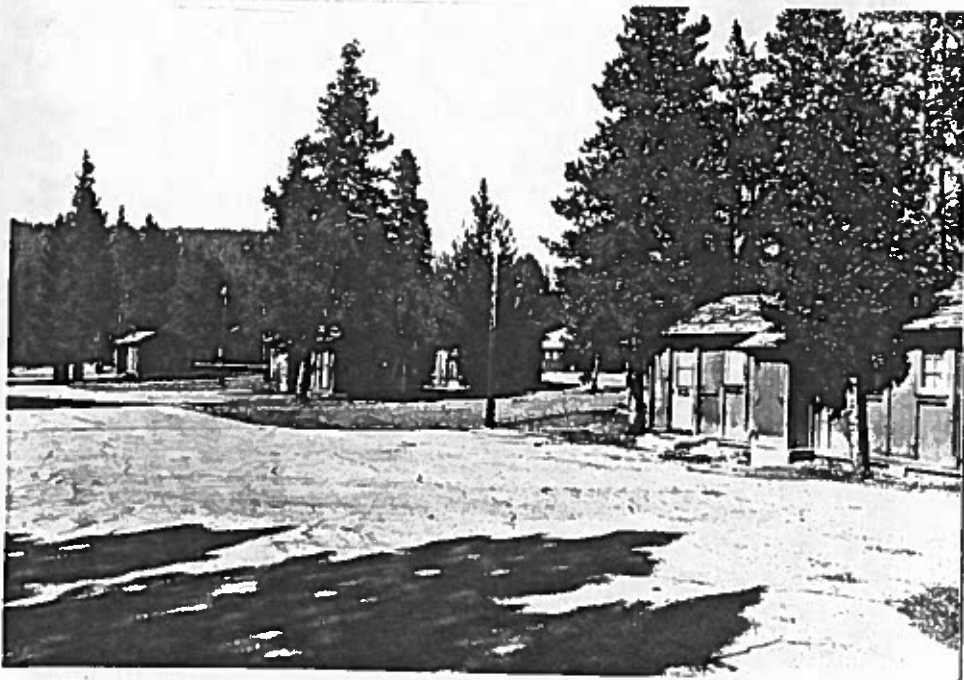
Figure 28: Looking north at the employee quad housing on the east side of the lower loop. This area has some curbs and designated parking which protects some of the fragile landscaped areas.

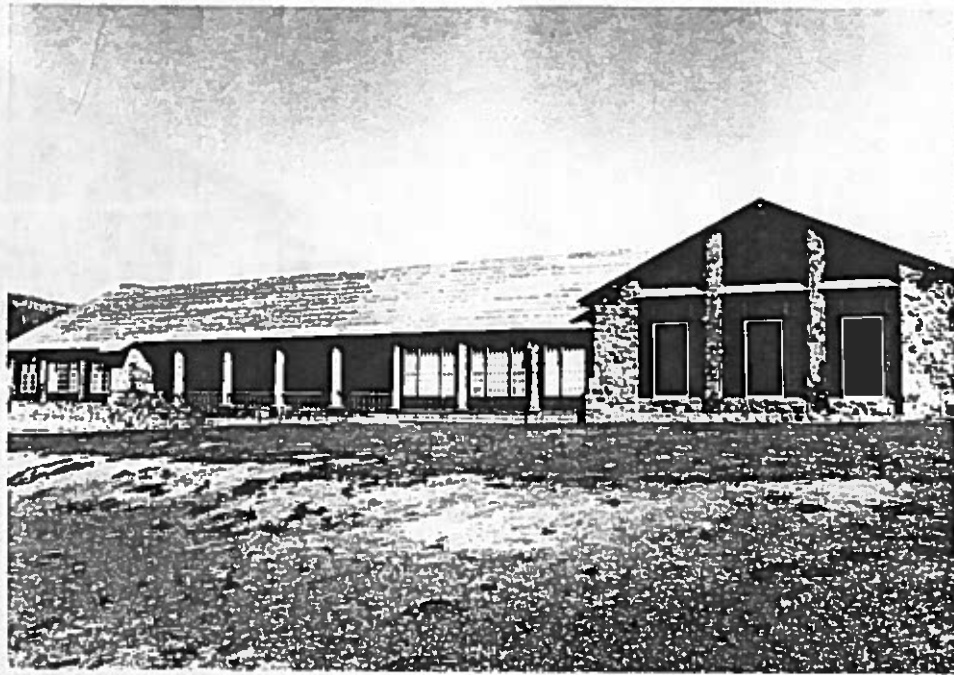
Figure 33: Looking east at the front of Old Faithful Lodge. The wood shingle roof appears to be in good condition.

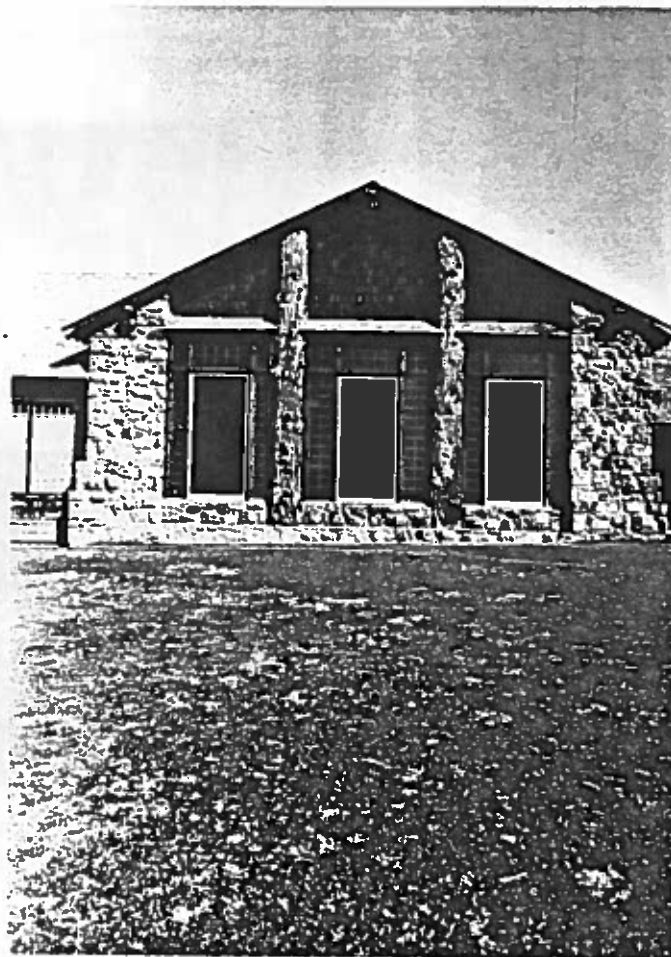
Figure 36: Looking east at the main windows in the Lodge. The sills and trim have weathered and checked and in some cases have opened up allowing water to flow into the sash. The glass has been coated with a calcium deposit from the geyser spray.

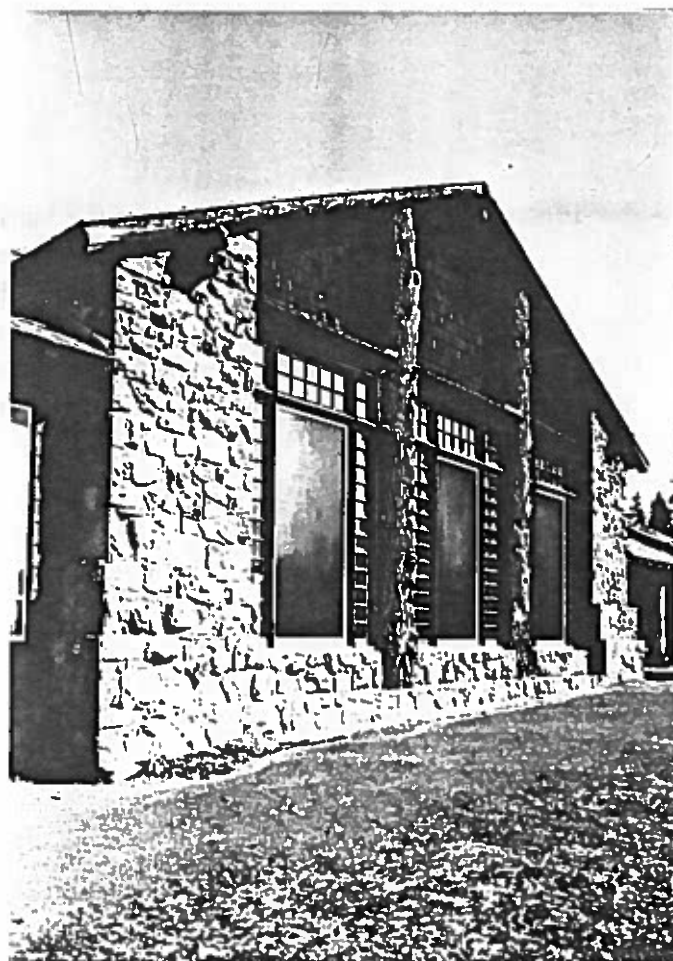
**Figure 39:** Looking southeast at a detail of the stonework by the main windows. Water flows into this corner of the building due to the ground not sloping away from the building.

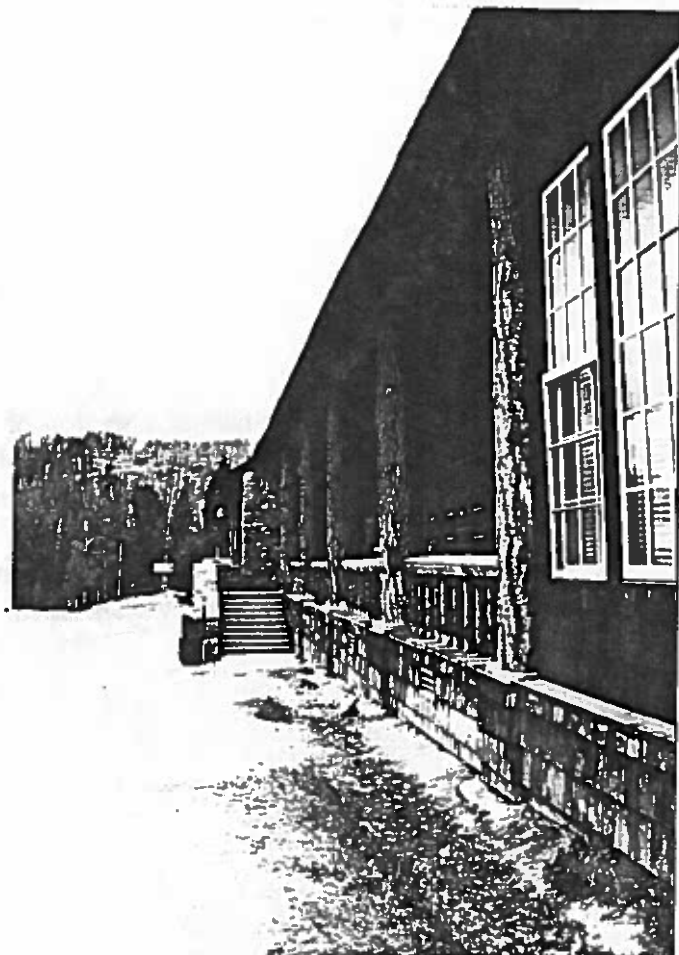
Figure 44: Looking east at the porch on the west side of the Lodge and adjacent to the cafeteria. Note the weathered wood railing.

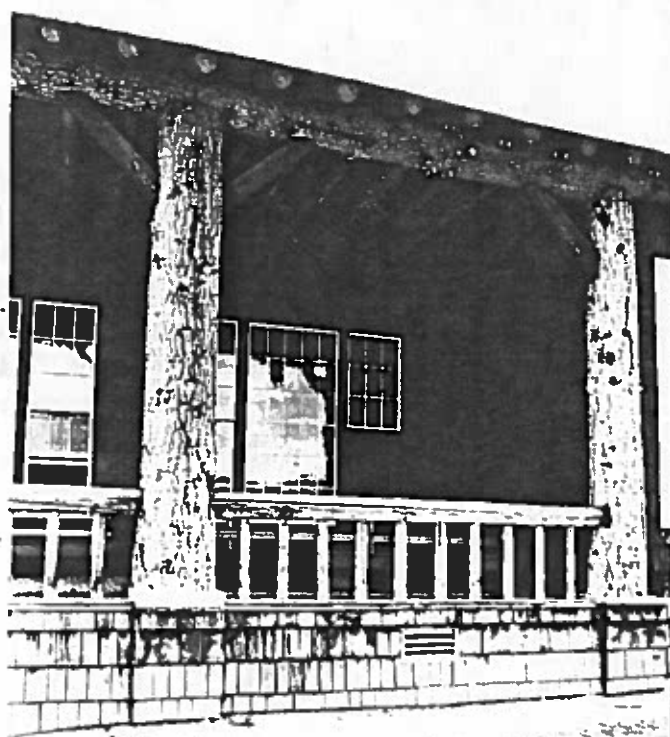
**Figure 45:** Looking northeast at a detail of the column and railing on the porch of Old Faithful Lodge. Note the weathered wood on the shingles, railing and balustrade. The concrete is undermined at this point.

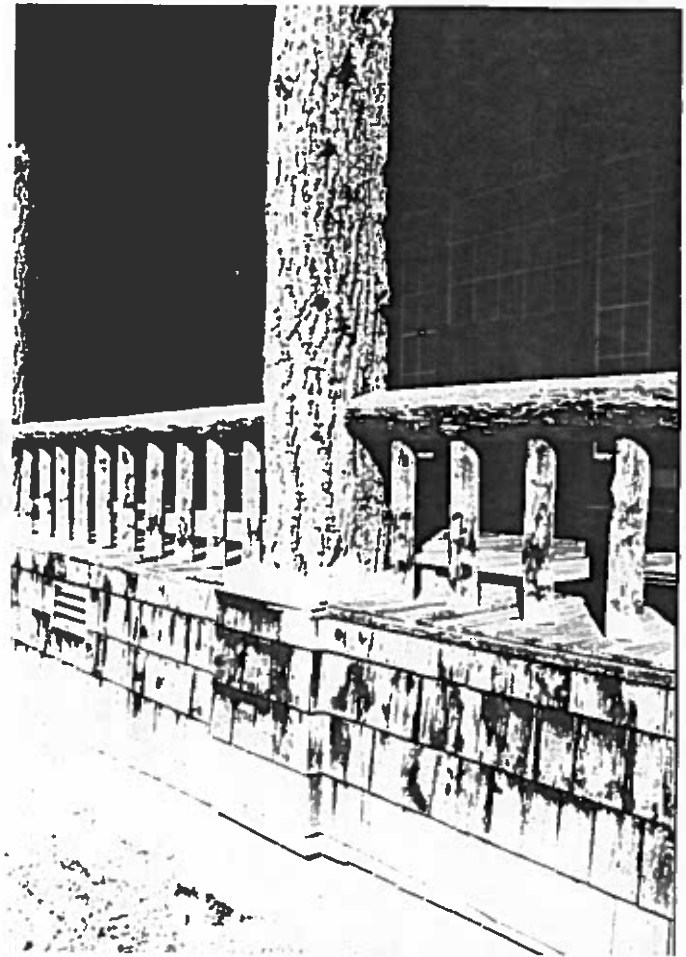
**Figure 46:** Looking north along the porch on the west side of the Lodge. Note the exposed concrete at the base of the columns. Water flows against the building at this point.

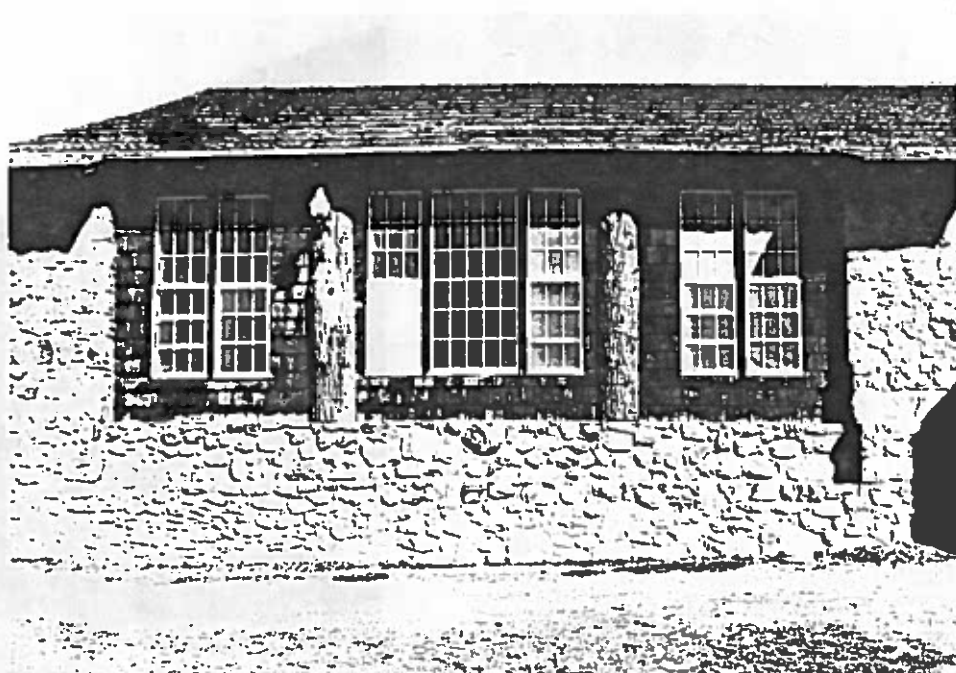
Figure 57: Looking east at the window bays on the north end of the west side of the Lodge. Some minor missing mortar occurs on this elevation. Note the lost bark on the column with the light fixture that allows water to penetrate into the bark area.

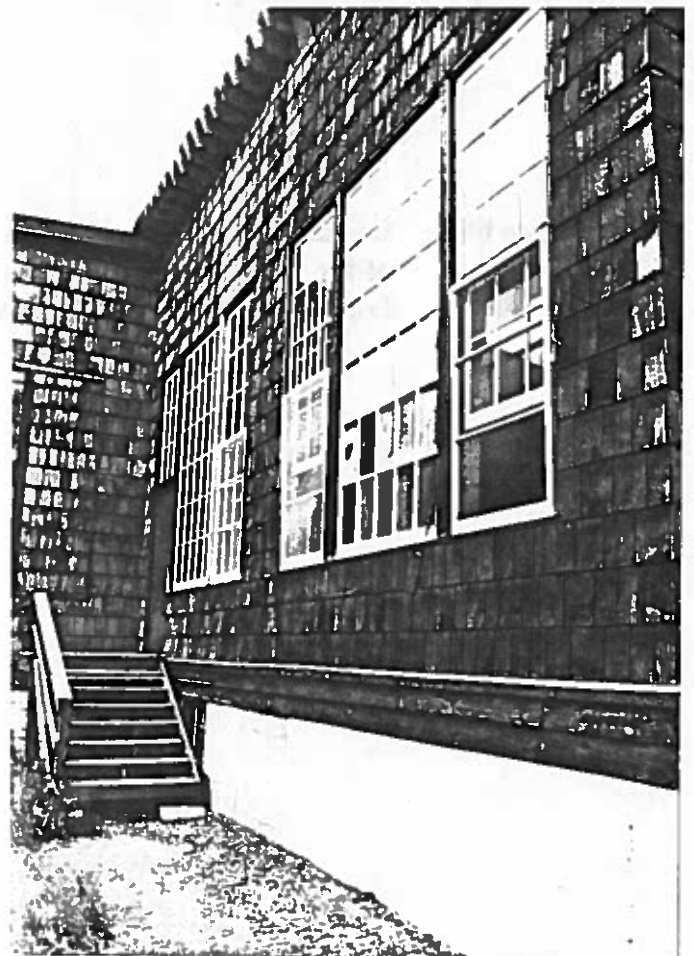
Figure 67: Looking south at the exterior wall of the kitchen and the employee ~~dining~~ room. Note the weathered wood shingles and the water table. The ~~windows~~ are also weathered.

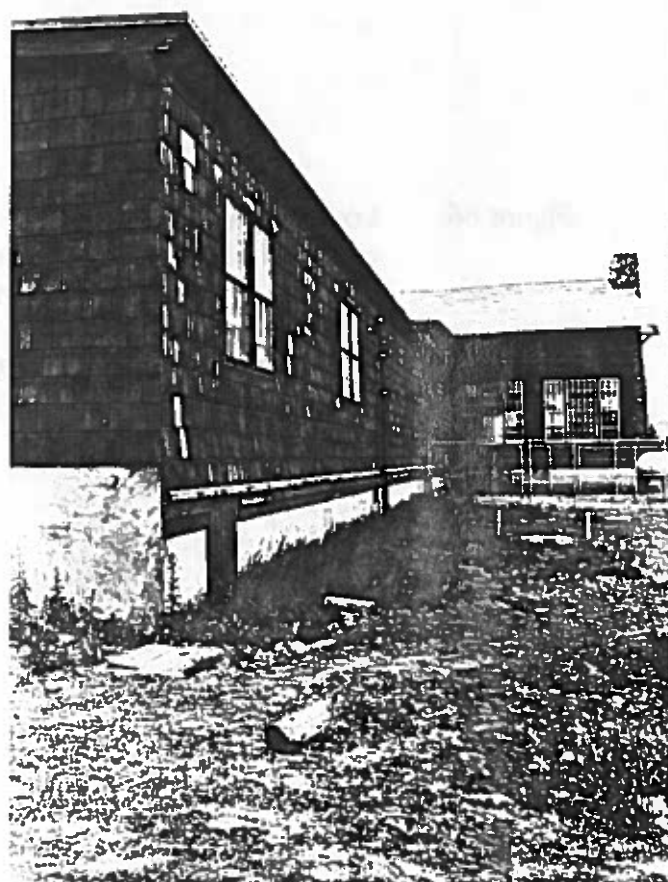
Figure 68: Looking west along the north wall of the kitchen/EDR section of the Lodge. Note the weathered wood.

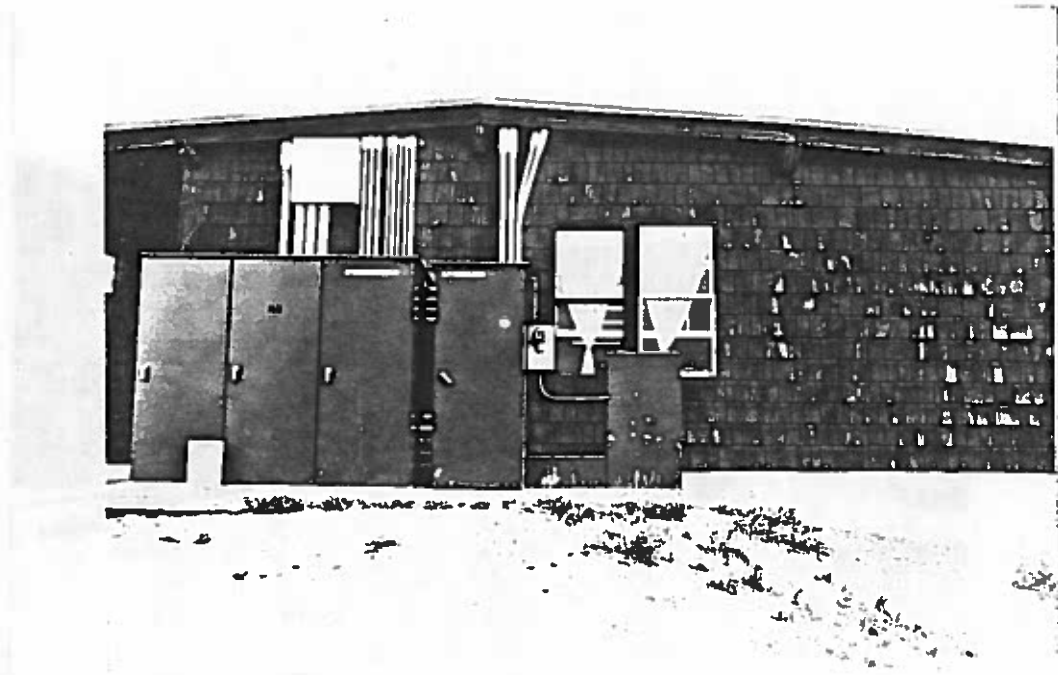
Figure 69: Looking west at the electrical transformers and disconnects on the east end of the EDR kitchen. Note the undermining of the concrete pad.

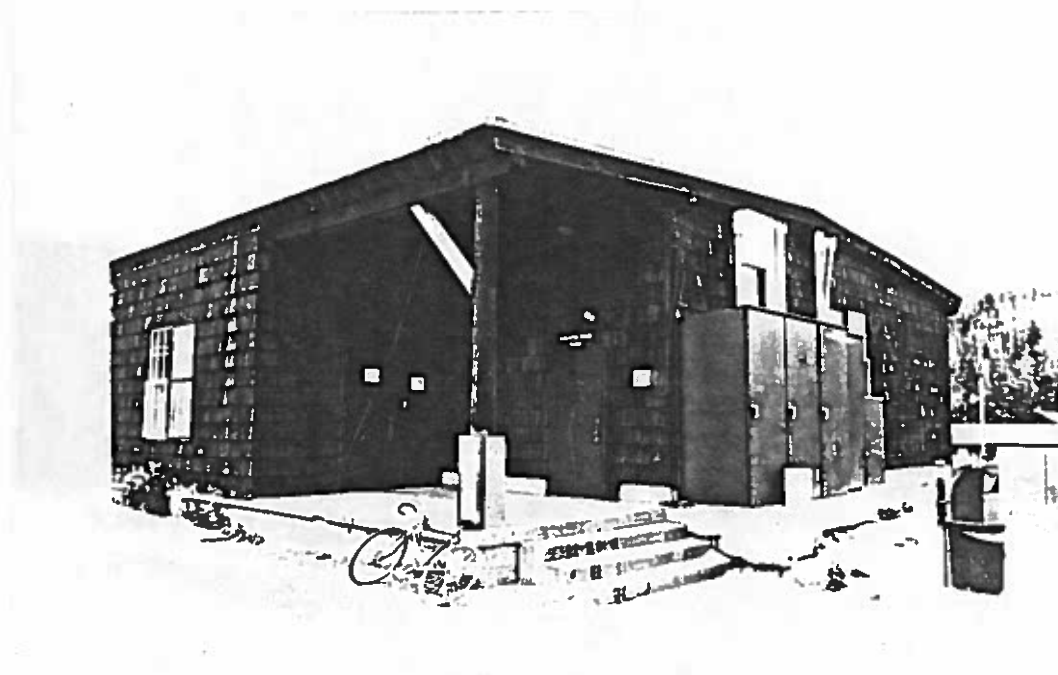
Figure 70: Looking northwest at the back entrance to the employee dining room. Note the wrapped base of the column that appears to be rotted out.

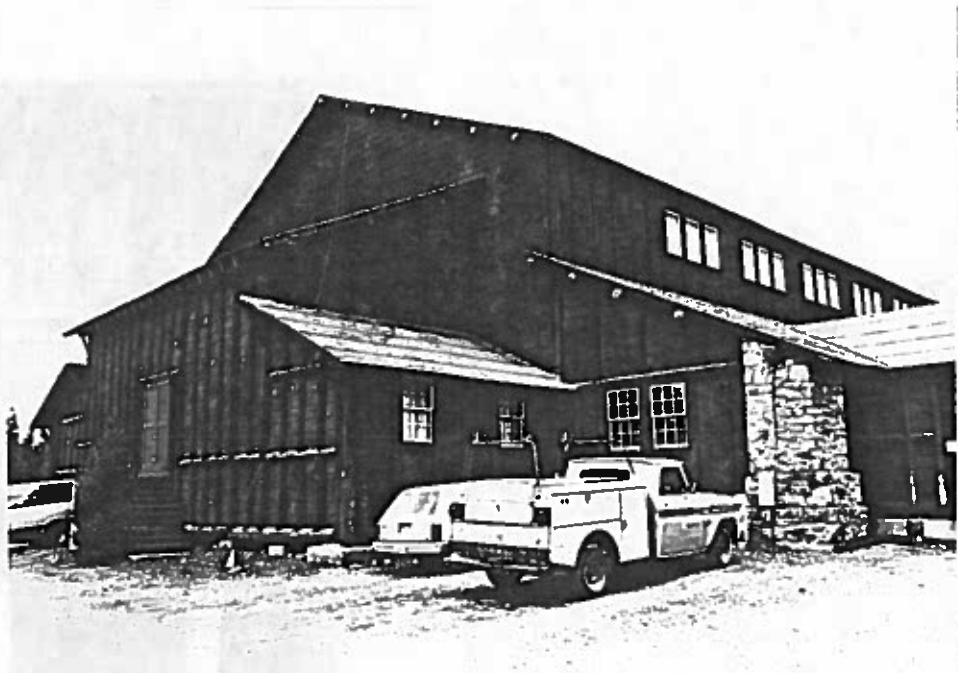
Figure 74: Looking southeast at the Rec Hall with the stage structure on the north end of the building. The log-out structure appears to be in good condition. There is minor rot and checks and weathered logs on the purlins, and in some of the sill logs.
