## **HISTORIC STRUCTURES REPORT**

# **Old Faithful Lodge Yellowstone National Park**

**NOVEMBER 1995**

Prepared By:  
**JAMES R. MCDONALD ARCHITECTS**  
**224 North Higgins Avenue**  
**P.O. Box 8163**  
**Missoula, Montana 59807**

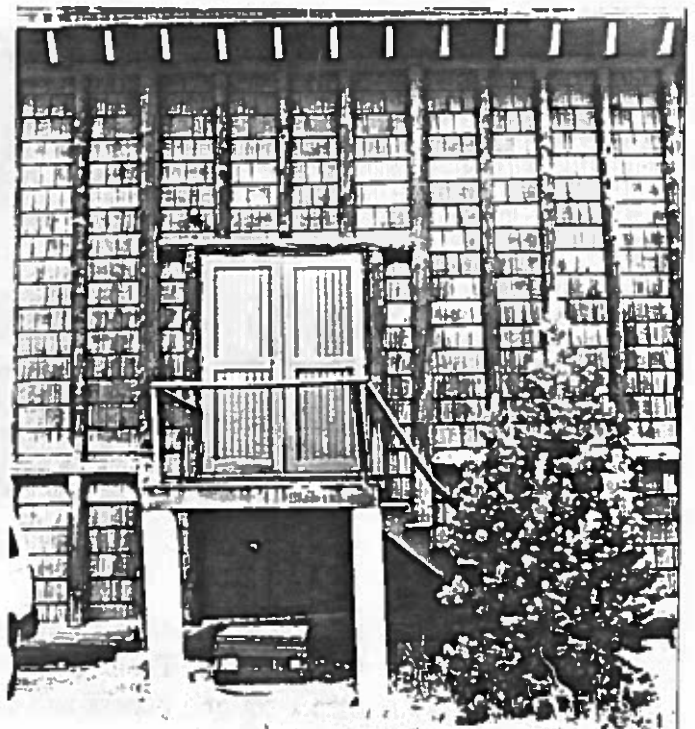
Figure 77: Looking southwest at the connection of the stage to the Rec Hall. All of the log roof rafters have been cut off at the eave line.

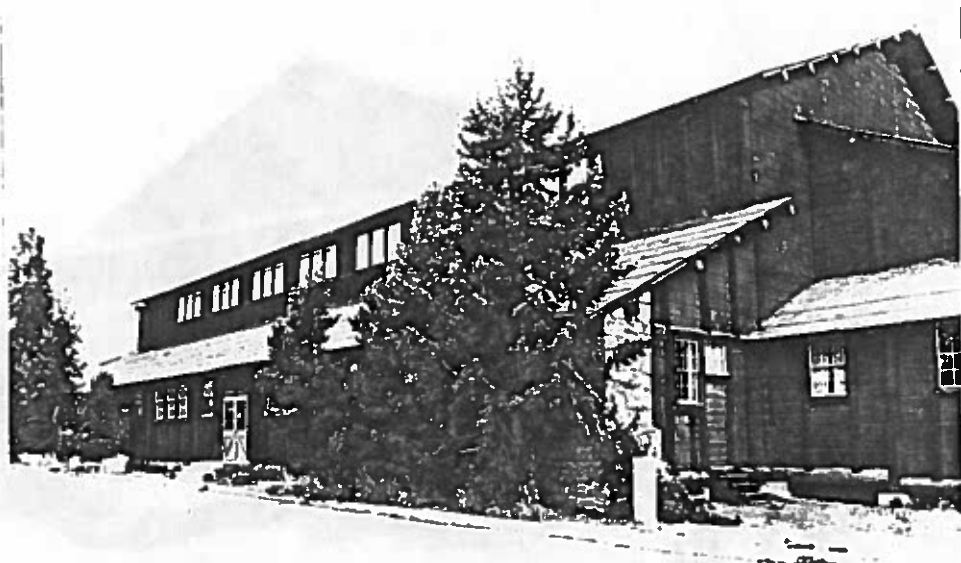
Figure 79: Looking southwest at the Recreation Hall at Old Faithful Lodge. Note the fir trees that are too close to the building causing problems of undermining the foundation and retaining moisture against the wood materials.

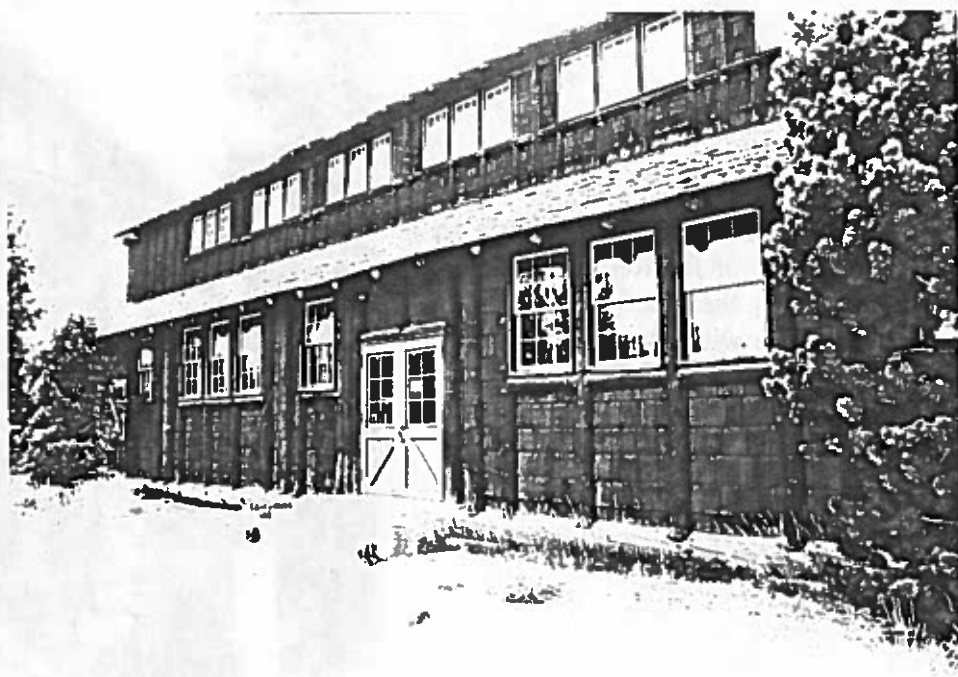
Figure 80: Looking southwest at the wall of the side aisles on the Rec Hall. The sill log and sills and trim around the windows and doors on this side of the building.

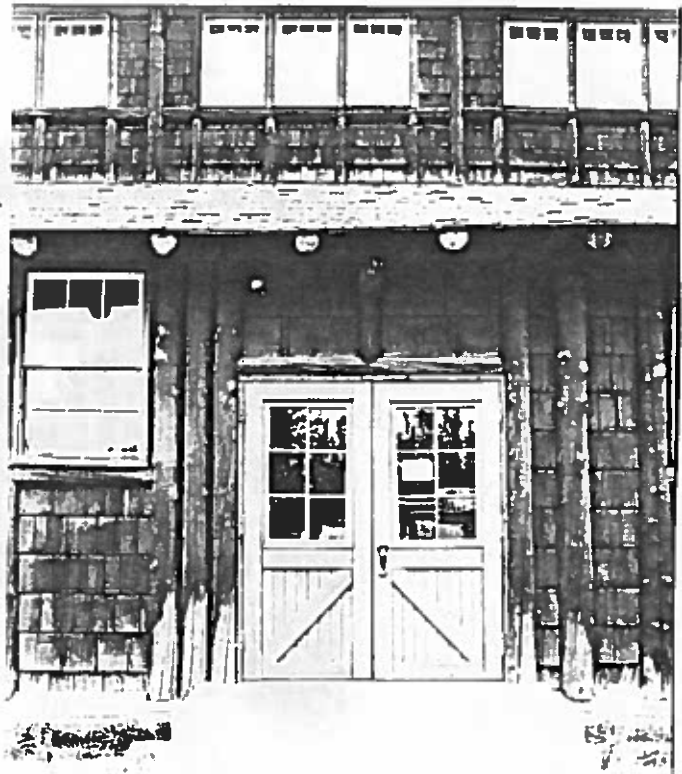
**Figure 82:** Looking west at a typical section of log-out wall on the east side of the Rec Hall. Note the weathered base log and sills and sash of the windows. Also the grade at this point allows water to flow under the building.

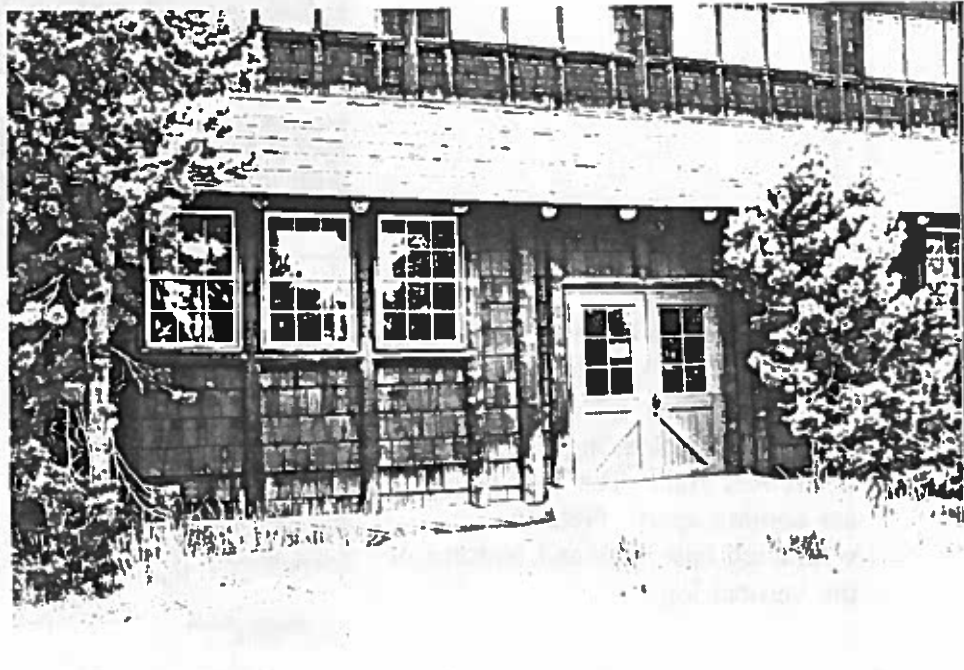
**Figure 83:** Looking west at a second set of doors on the east side of the Rec Hall. Note the weathered wood along the base and the close trees. The log rafter tips have been cut off on this side of the building also.

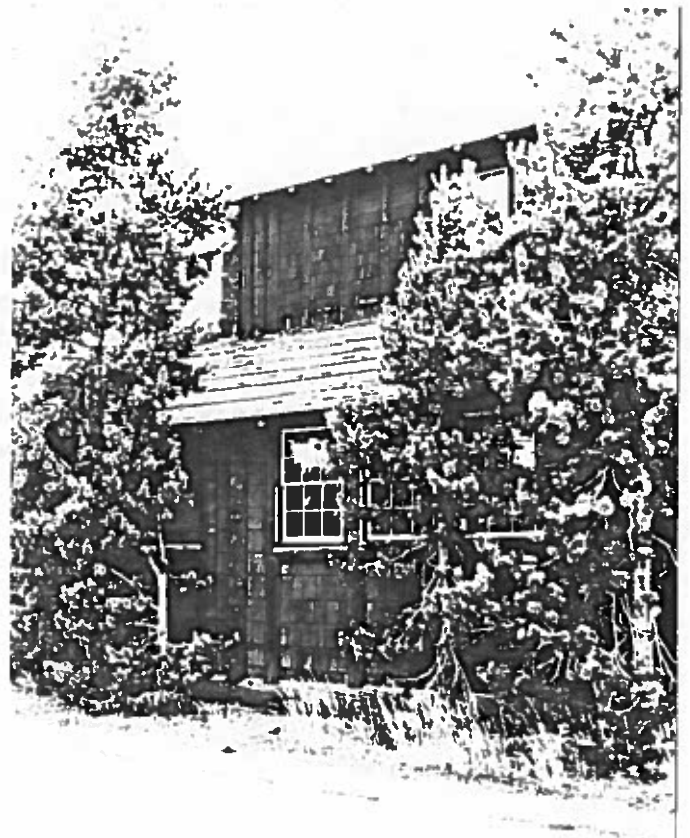
**Figure 84:** Looking west at the trees that are close to the east wall of the Rec Hall.

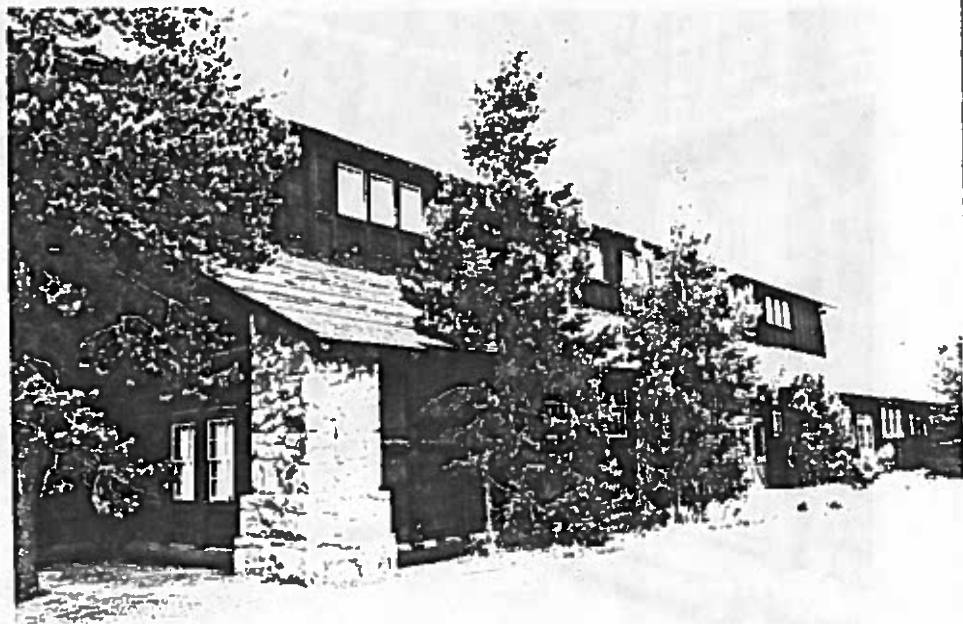
**Figure 85:** Looking northwest at the east side of the Recreation Hall. The upper windows have some weathered sills and there appears to be some open areas around the windows.

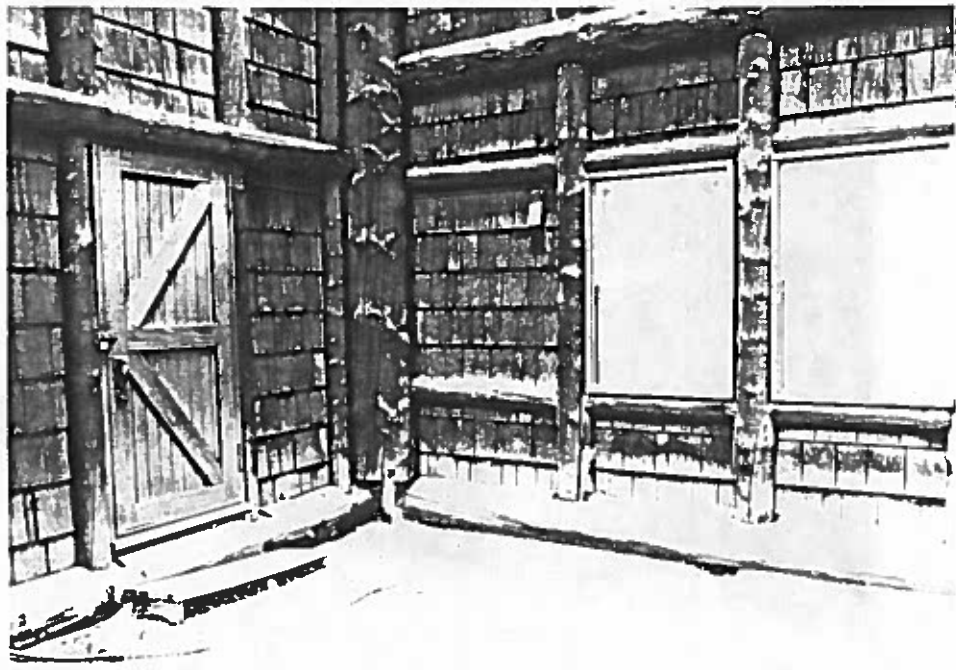
Figure 87: Looking northwest at a corner of the Rec Hall. Note the weathered base log and sills at the door and windows. The grade varies at this point allowing water to flow under the building.

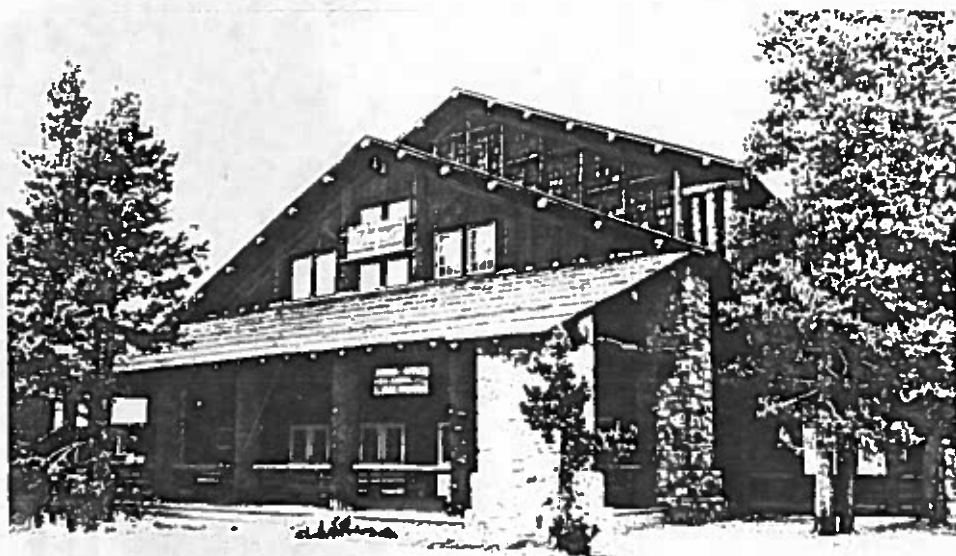
Figure 89: Looking northwest at a stone column detail on the south porch. Note the weathered base around the column and on the flooring.

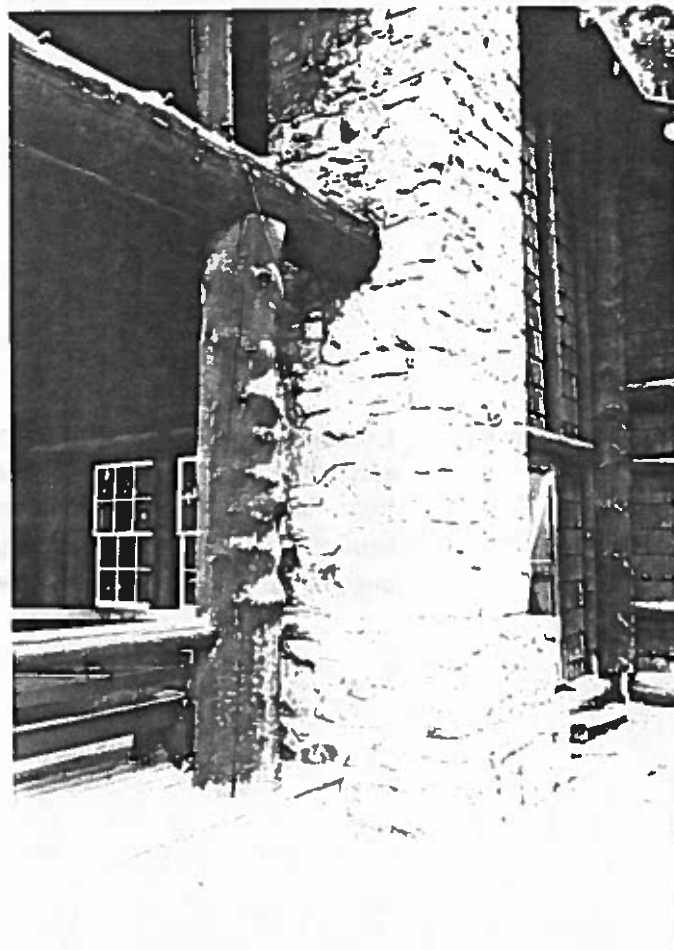
Figure 90: Looking northeast at the porch area on the south side of the Rec Hall. The materials with some exception of wear and tear appear to be in good condition.

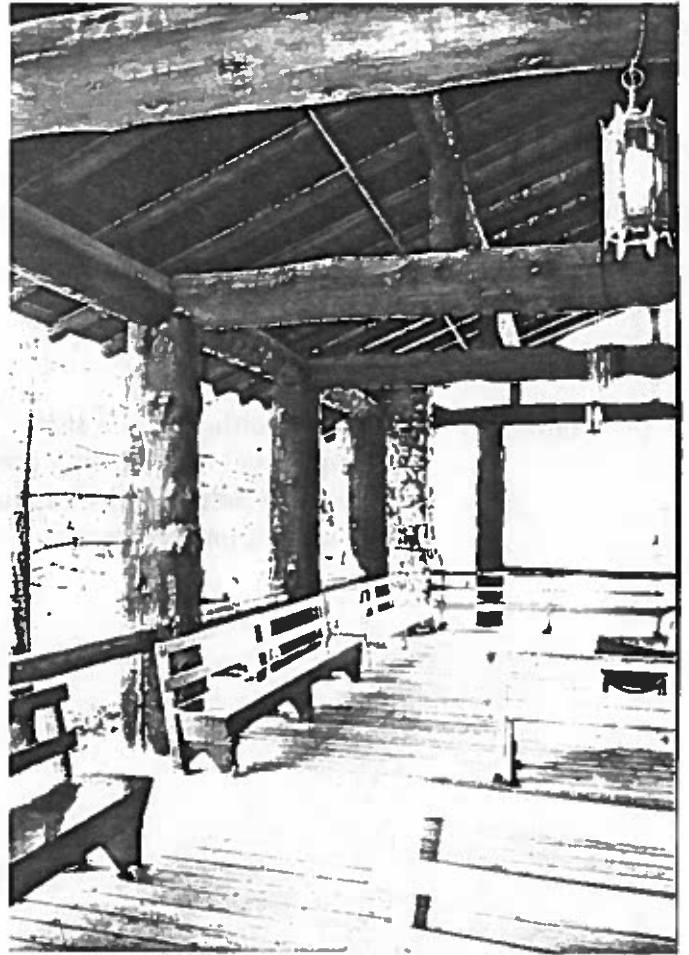
**Figure 92:** Looking northeast at some wood double-hung windows on the porch. The windows appear to be in good condition.

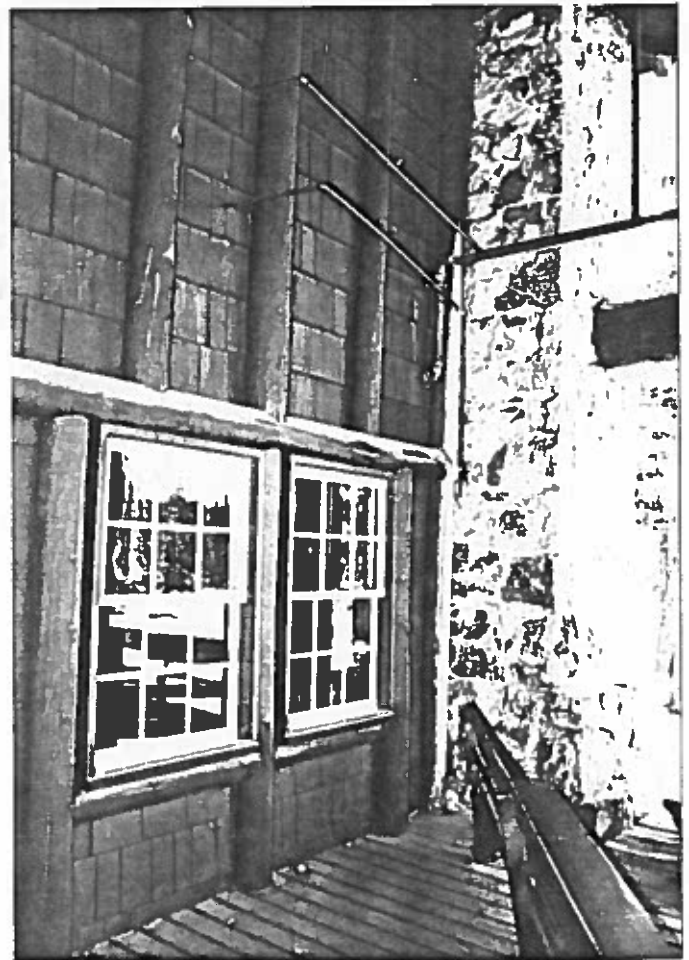
Figure 93: Looking north at the doors on the south porch. The doors also, appear to be in good condition.

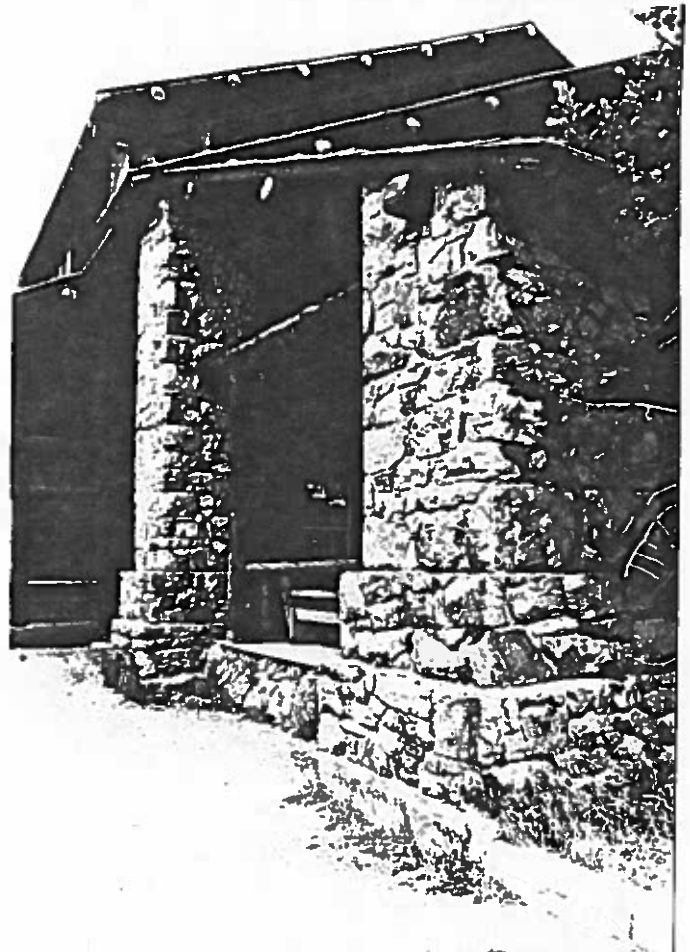
Figure 96: Looking north at the end wall of the side aisle on the south side.

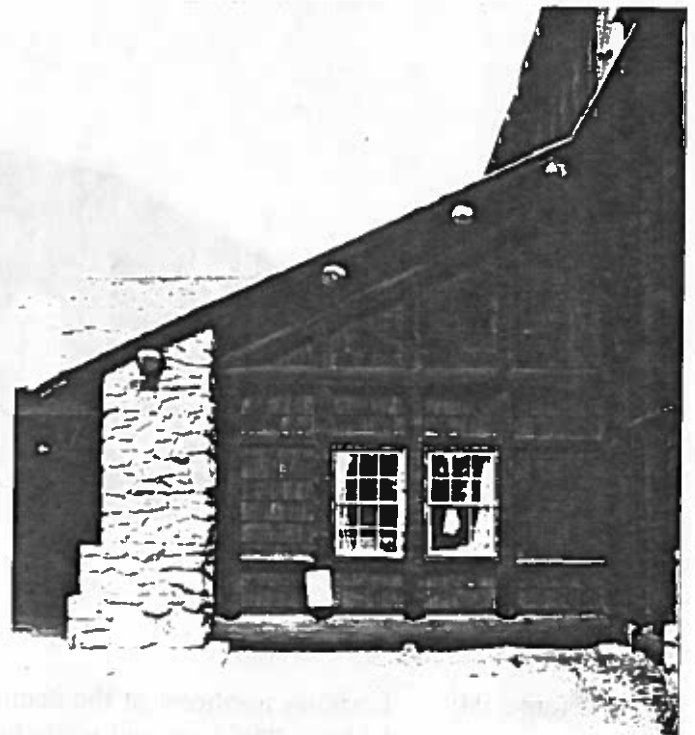
Figure 97: Looking north at the windows on the south wall of the Rec Hall. The windows are in very poor condition with rotted sash and sills, and wood trim.

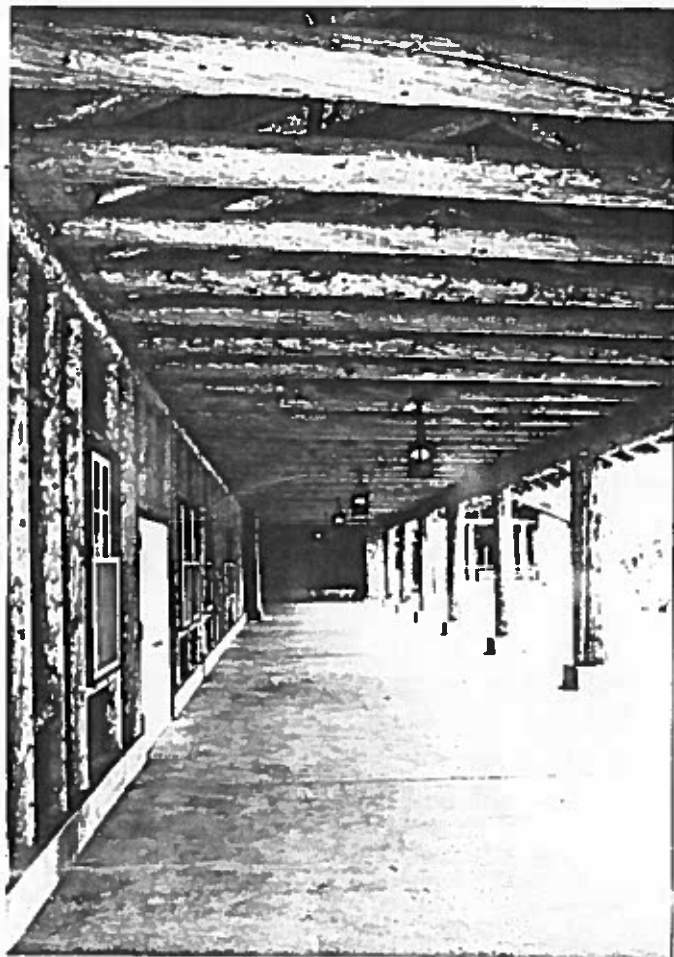
Figure 100: Looking east at the covered walkway on the south side of Old Faithful Lodge. Generally the logs and structure are in good condition. The concrete appears to be good.

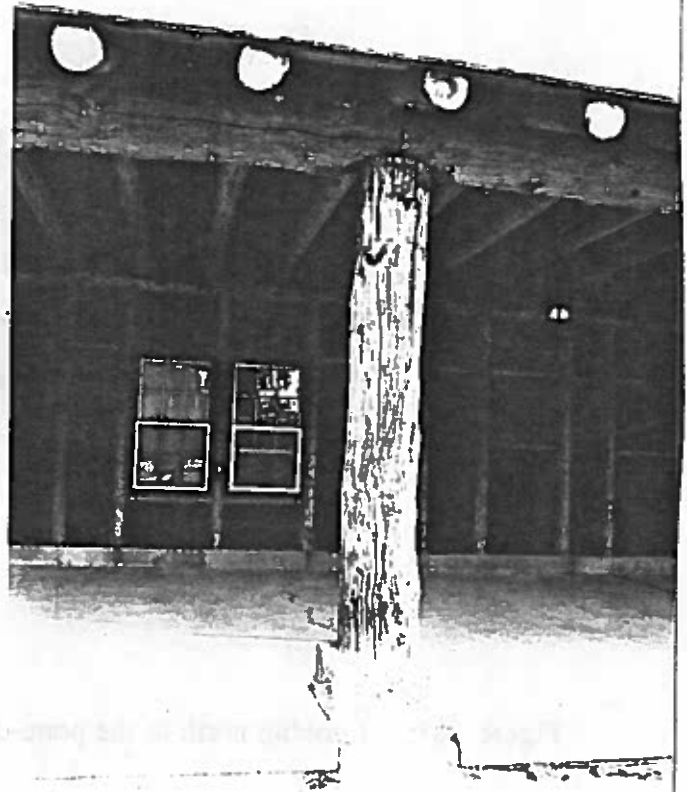
Figure 102: Looking north at one of the columns on the south side of the Lodge. The columns are weathered and there is some rot at the base. The concrete piers are also, breaking up.

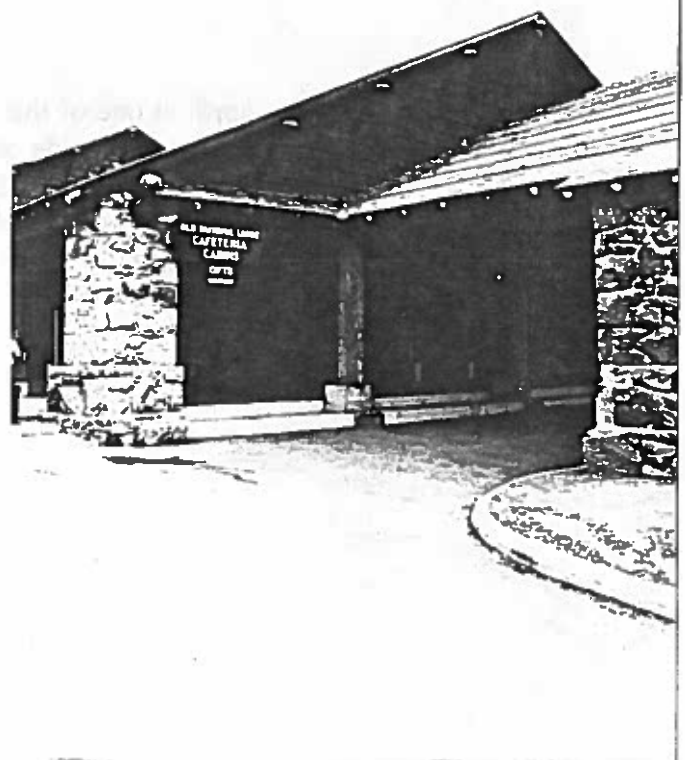
Figure 105: Looking east at the porte-cochere. The stonework is in good condition.

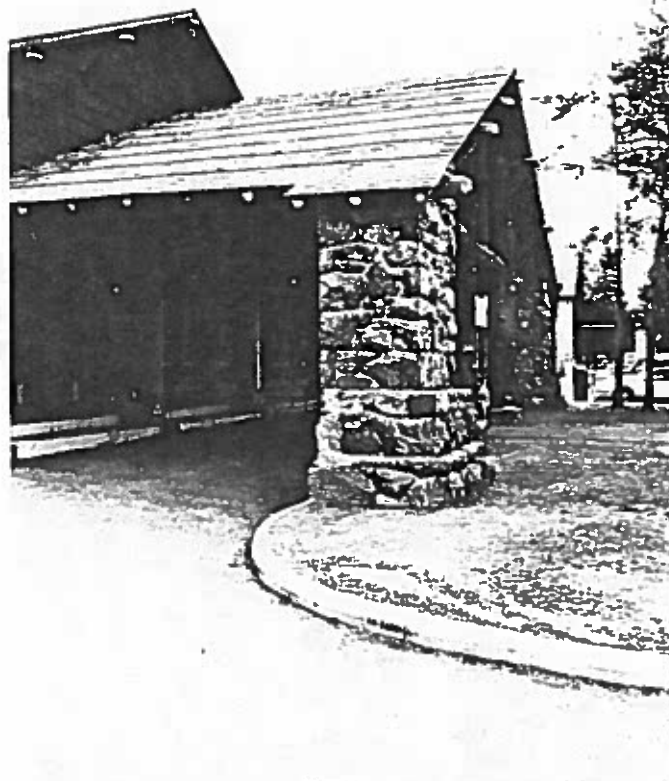
Figure 106: Looking east at the structure logwork of the porte-cochere. The logs are in good condition. There are original light fixtures up in the ridge.

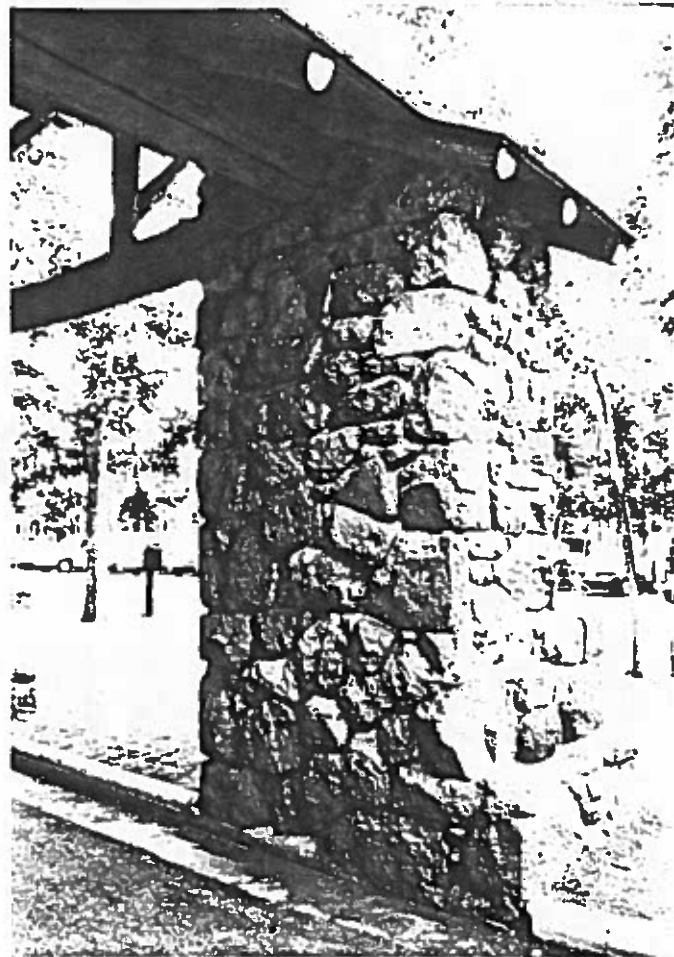
Figure 108: Looking at another stone pier on the southwest corner of the building and porch on the west side. The materials appear to be in good condition.

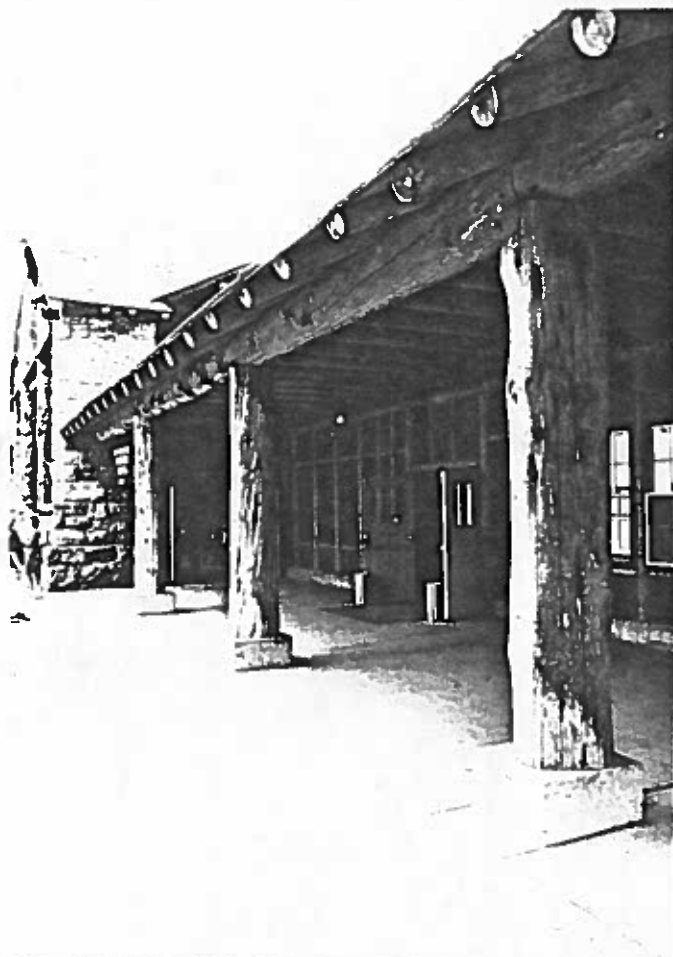
**Figure 110:** Looking north at the covered walkway along the west side of the building. Note the original light fixtures and wiring. The materials on this end of the building are in good condition.

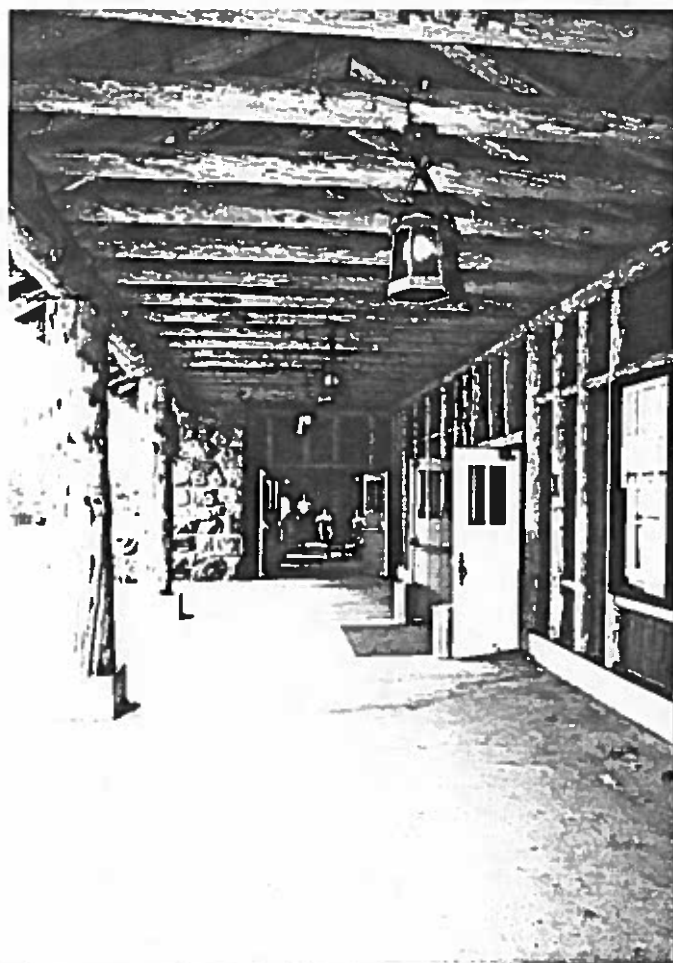
Figure 111: Looking north at the doors into the main public spaces of the Lodge. The doors with some minor wear and tear are in good condition.

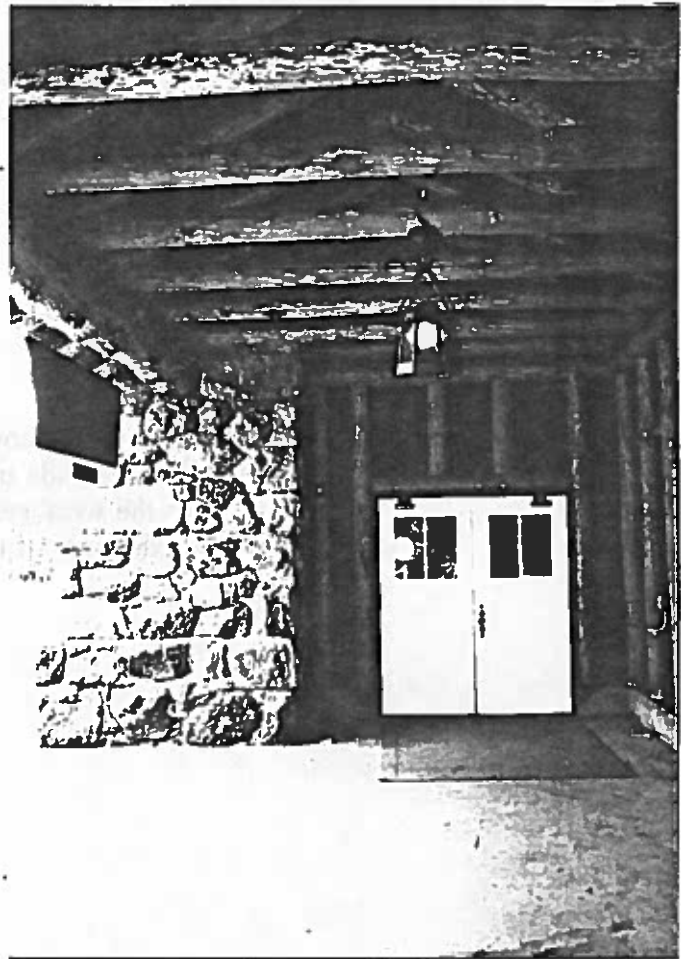
Figure 112: Looking south at the structure under the roof of the covered walkway. The structural logs are in good condition.

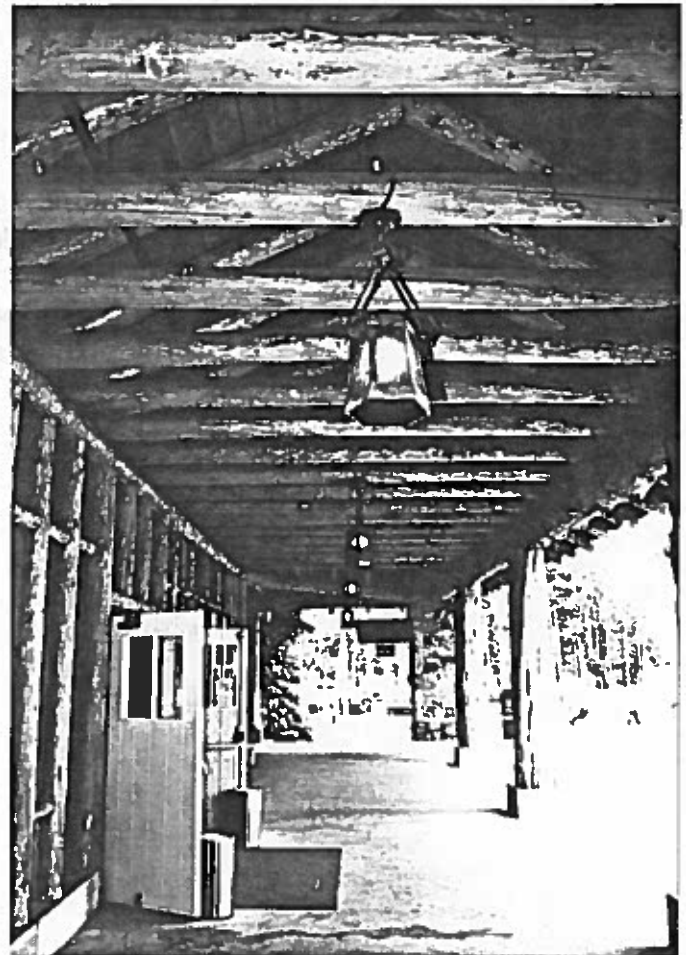
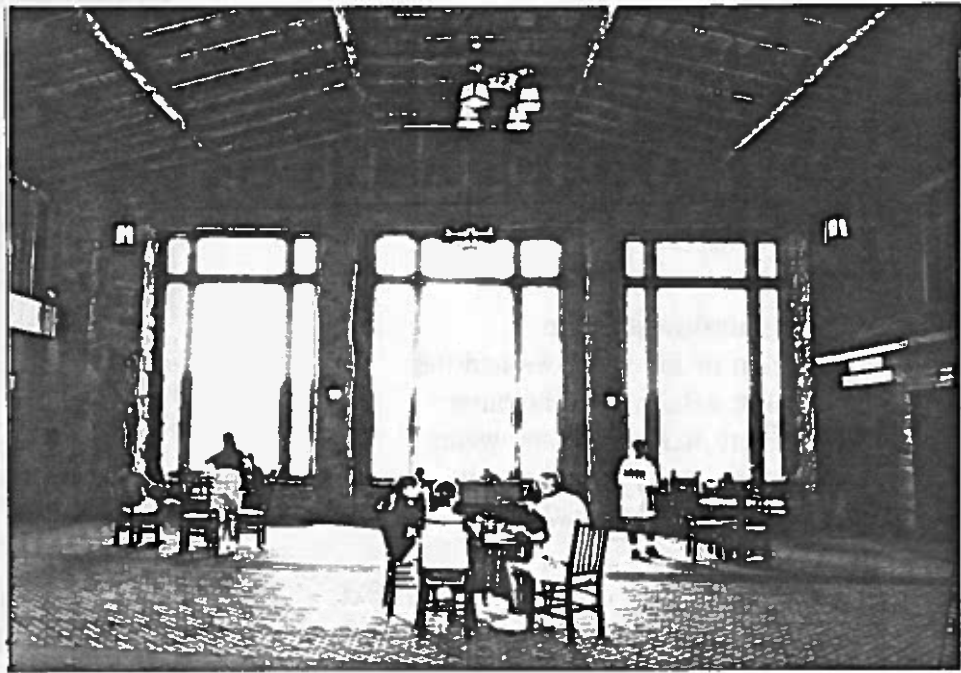
Figure 113: Looking west at the large windows in the main hall of Old Faithful Lodge. The structural system of the roof and walls over the windows appears to be in good condition.

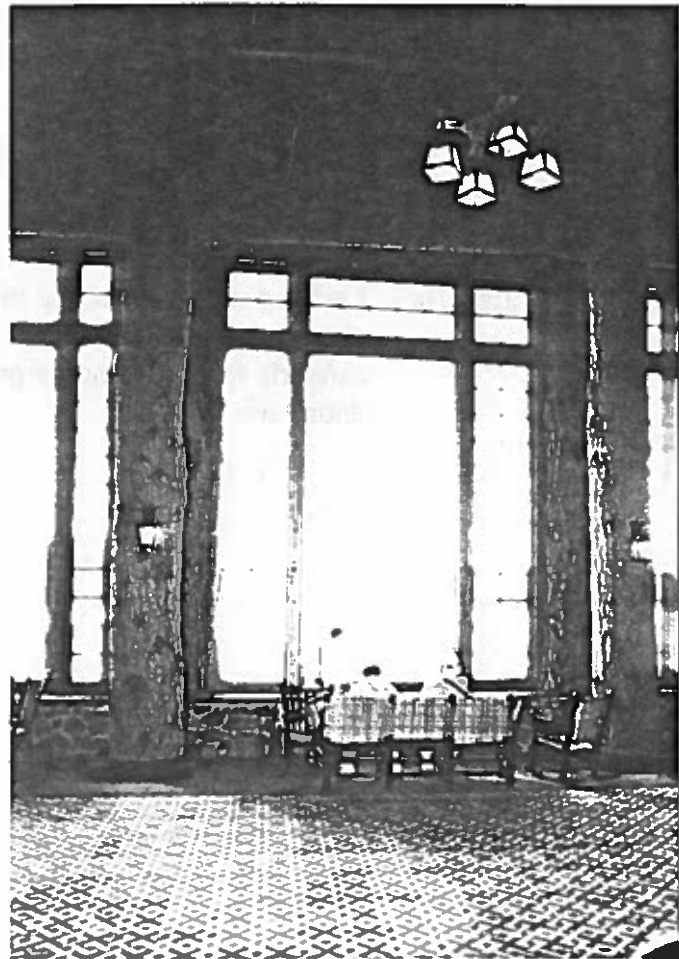
Figure 115: Looking northwest at the connection of the windows and the double log columns on the outer wall. There has been some water leaking into the flat surfaces and causing minor rot and staining.

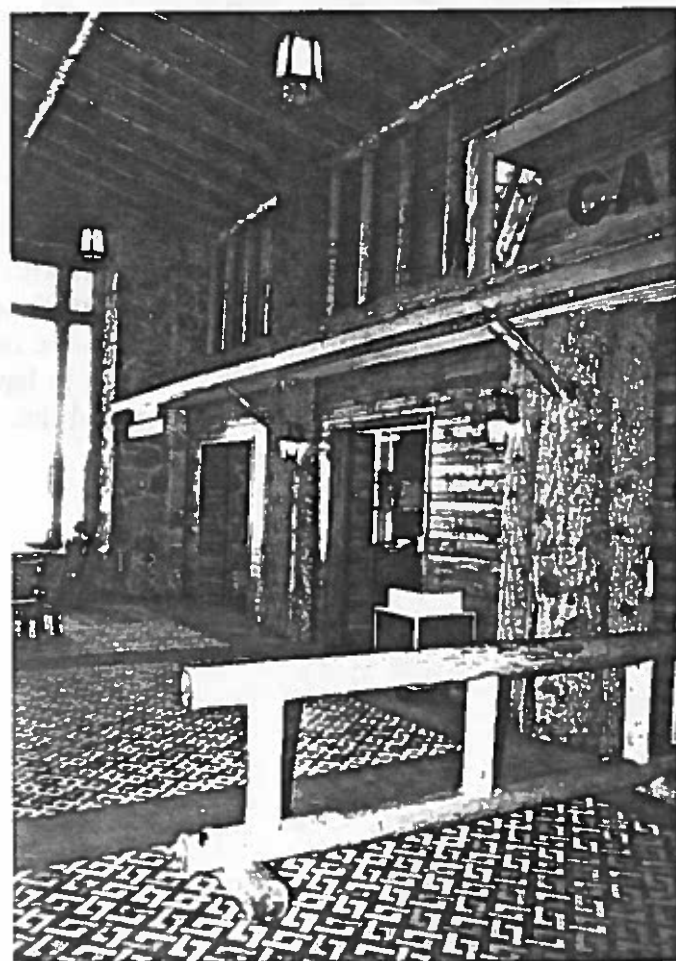
Figure 117: Looking north at the cafeteria entrance from the main hall of the Lodge. The materials and scale of the openings are not compatible with the historic character of the Lodge.

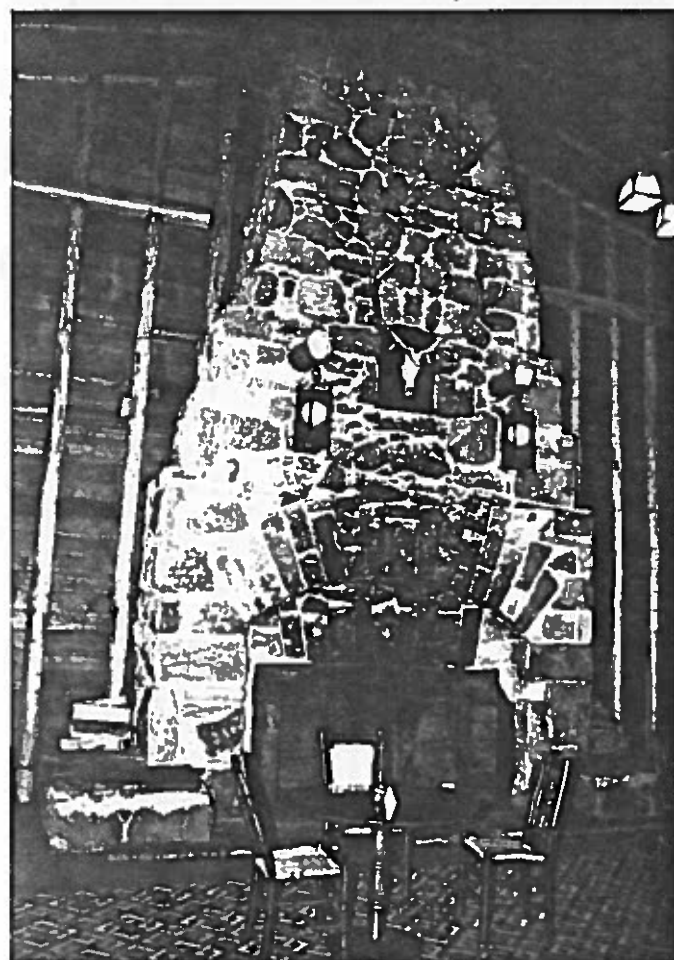
Figure 121: Looking northeast at a detail of the fireplace. The stonework with the exception of some mortar detailing is in good condition.

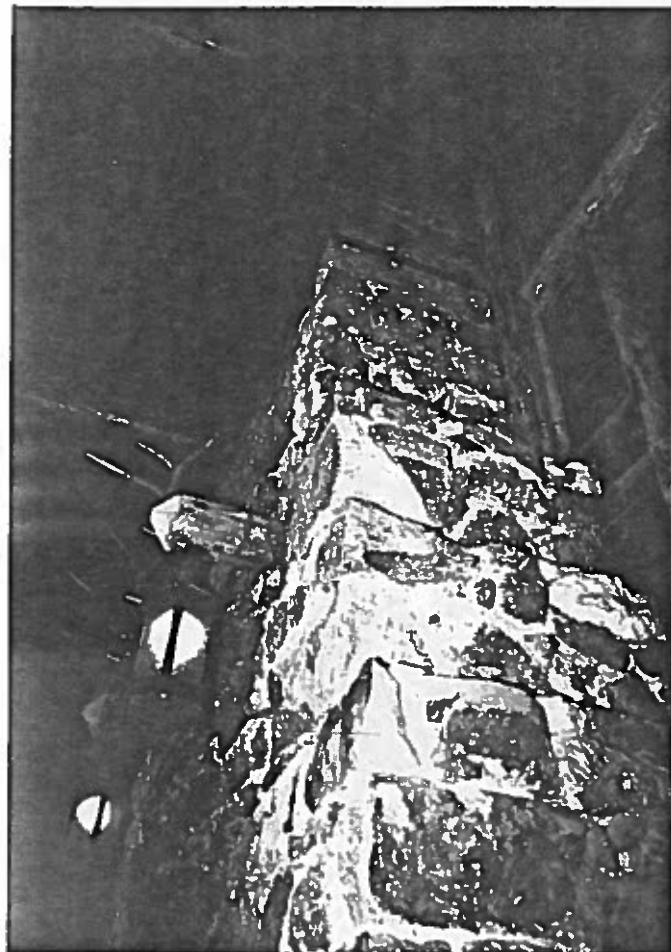
Figure 122: Looking east at the hearth of the fireplace. Note the soot on the face of the stone.

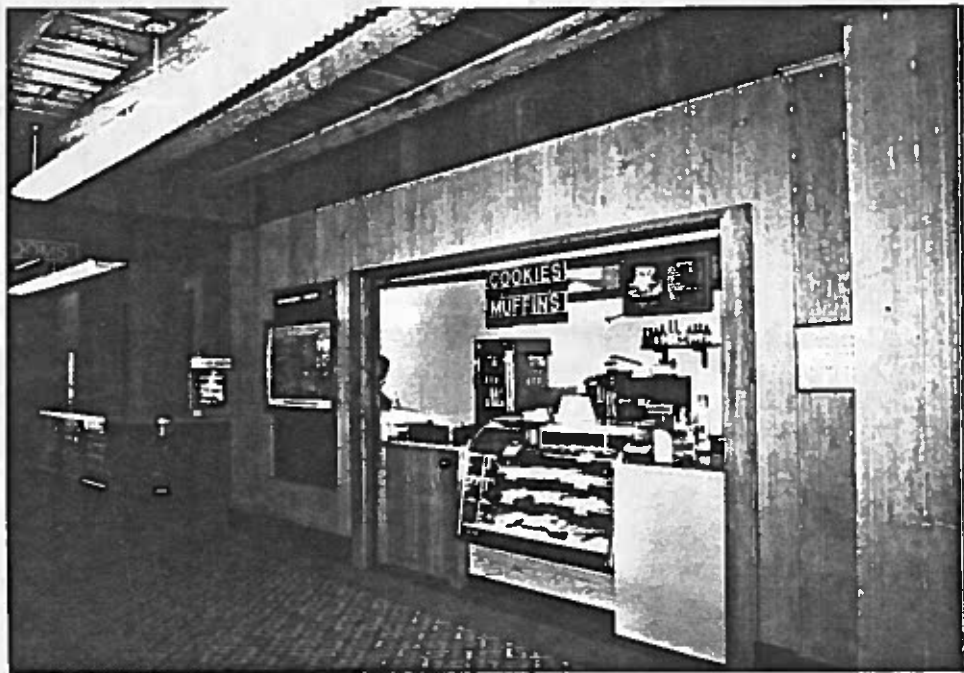
Figure 127: Looking southwest at the coffee shop in the hallway just off the main hall. Note the rough plywood around the walls surrounding the opening.

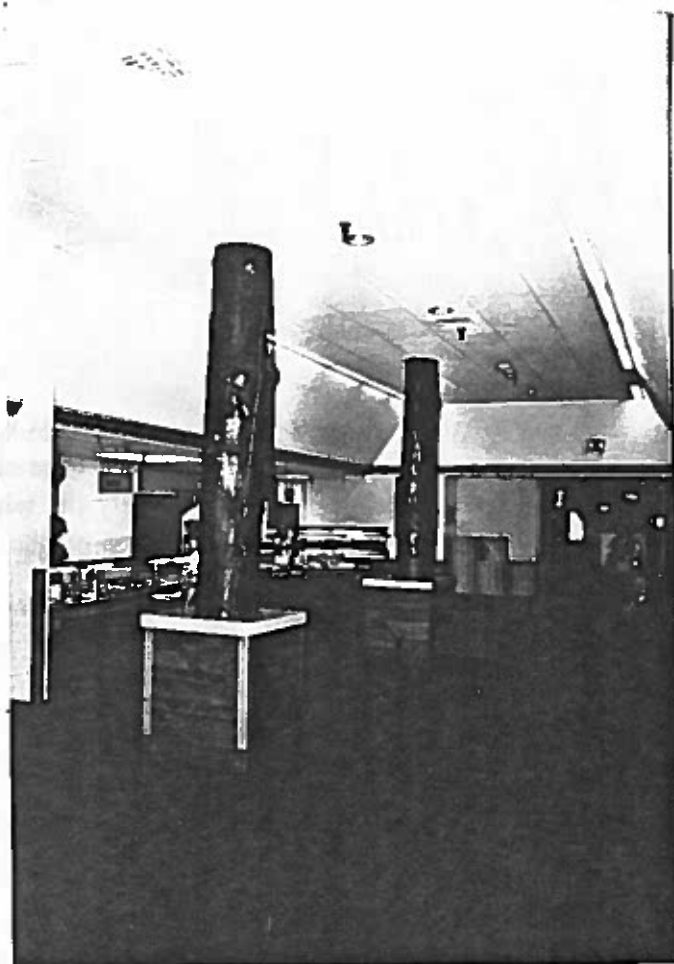
**Figure 134:** Looking south at the hallway along the west side of the building. Note the incompatible materials, especially the vinyl wall covering, doors and lighting fixtures.

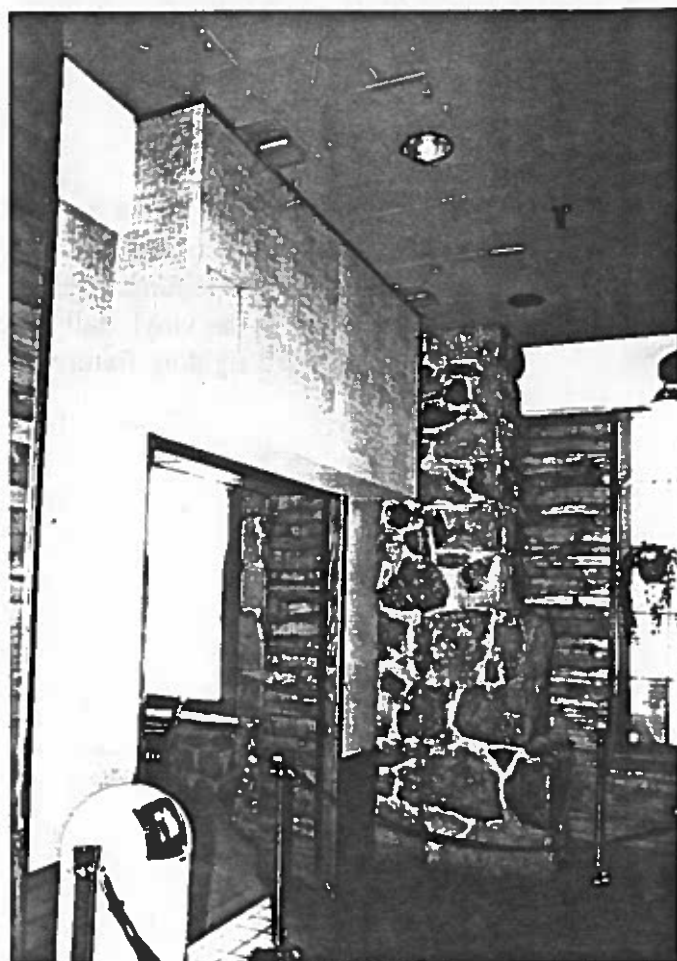
**Figure 137:** Looking west at the ice cream area with the incompatible materials.

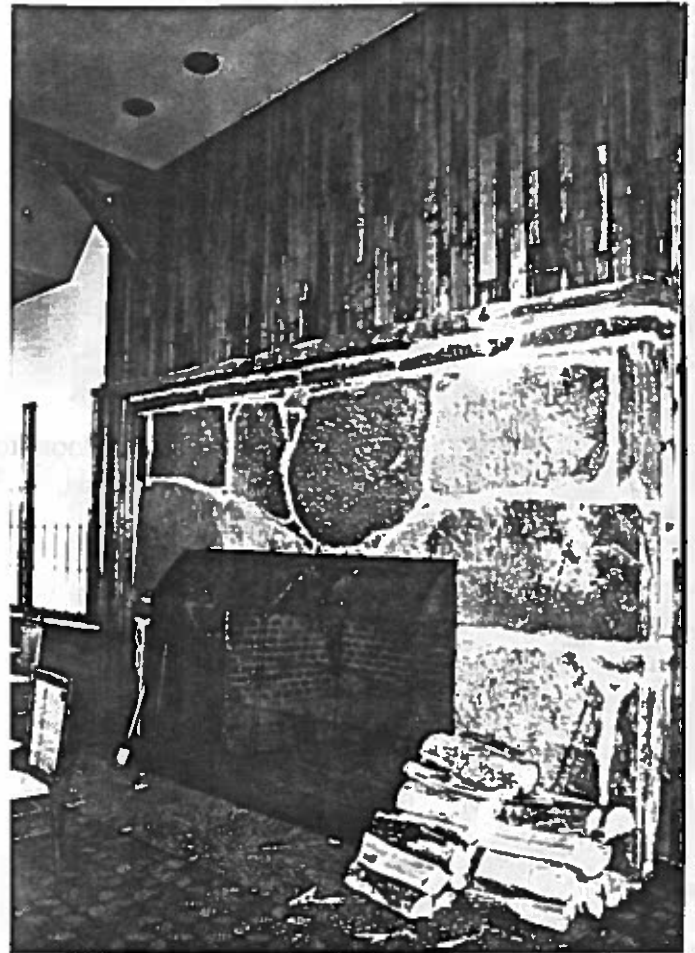
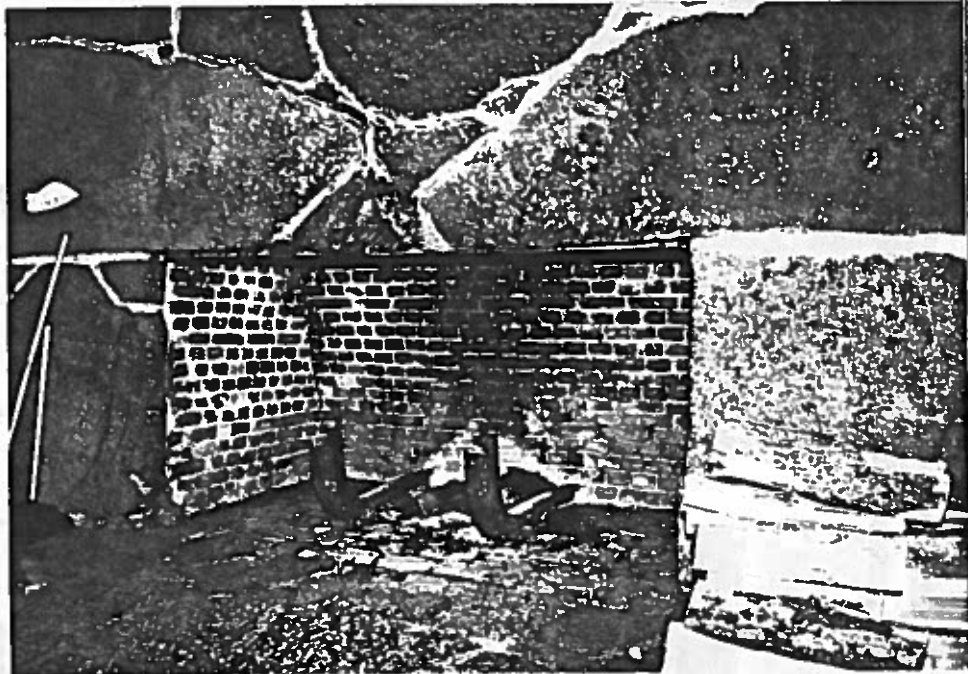
Figure 143: Looking northwest at the fireplace at the north end of the dining room. The mortar joints have been repointed with a wide lime mortar. The wood around and above the fireplace has been wet is cupped and rotted.

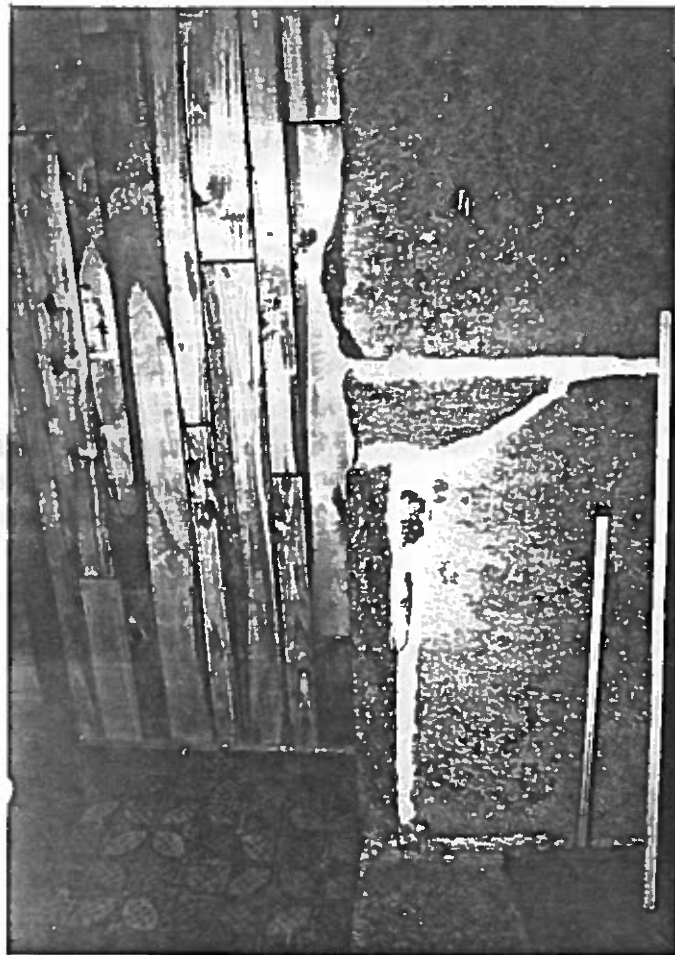
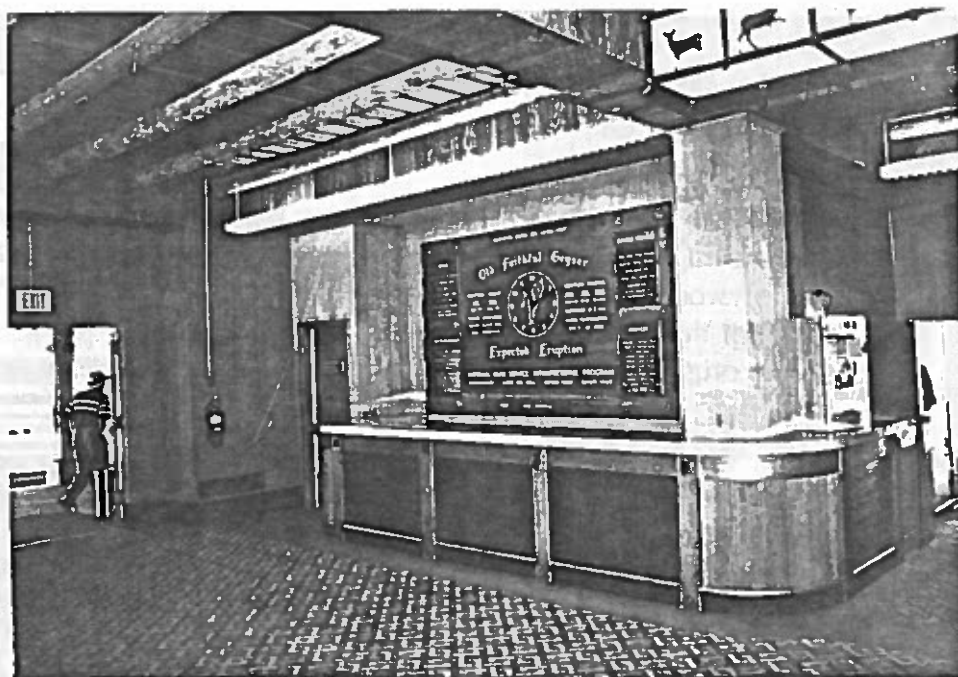
Figure 145: Looking at a detail of the stonework and wall at the fireplace. The mortar is not compatible with the historic character of the Lodge.

Figure 146: Looking west at the information desk. The cabinets are not compatible with the original building. The rough plywood has been added.
