## **HISTORIC STRUCTURES REPORT**

# **Old Faithful Lodge Yellowstone National Park**

**NOVEMBER 1995**

Prepared By:  
**JAMES R. MCDONALD ARCHITECTS**  
**224 North Higgins Avenue**  
**P.O. Box 8163**  
**Missoula, Montana 59807**

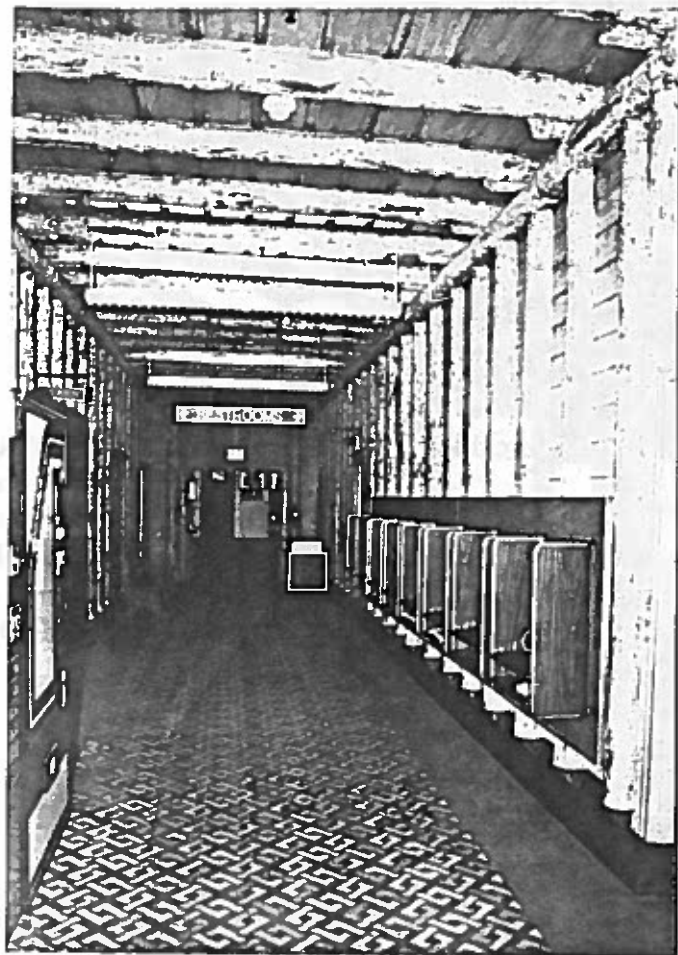
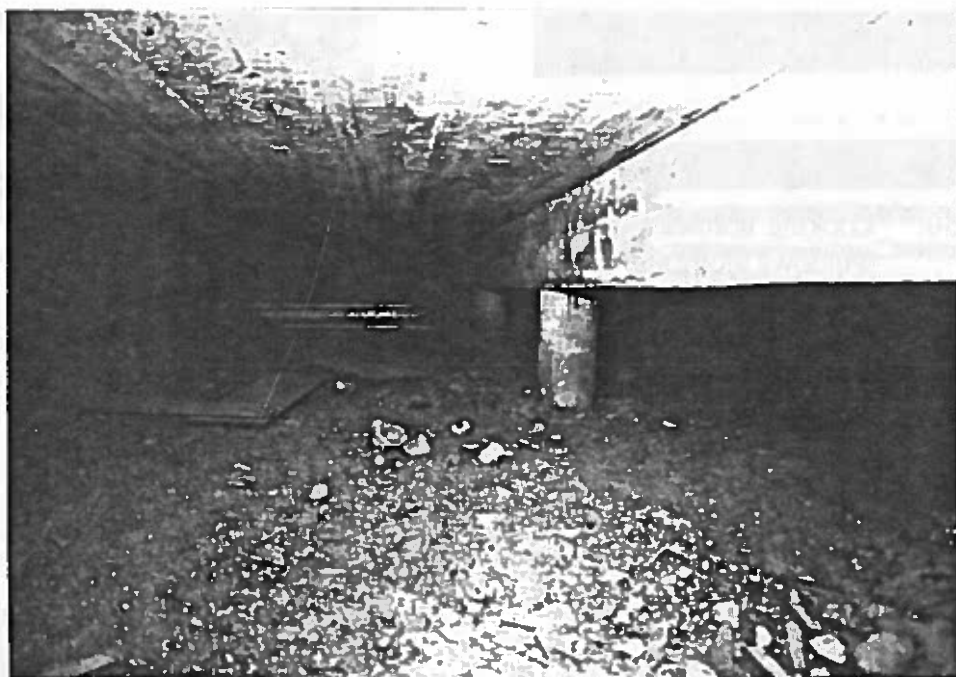
**Figure 151:** Looking east at the main corridor of the Lodge. Note the phone booths, trash cans, and vending machines around the bathroom/shower entrances.

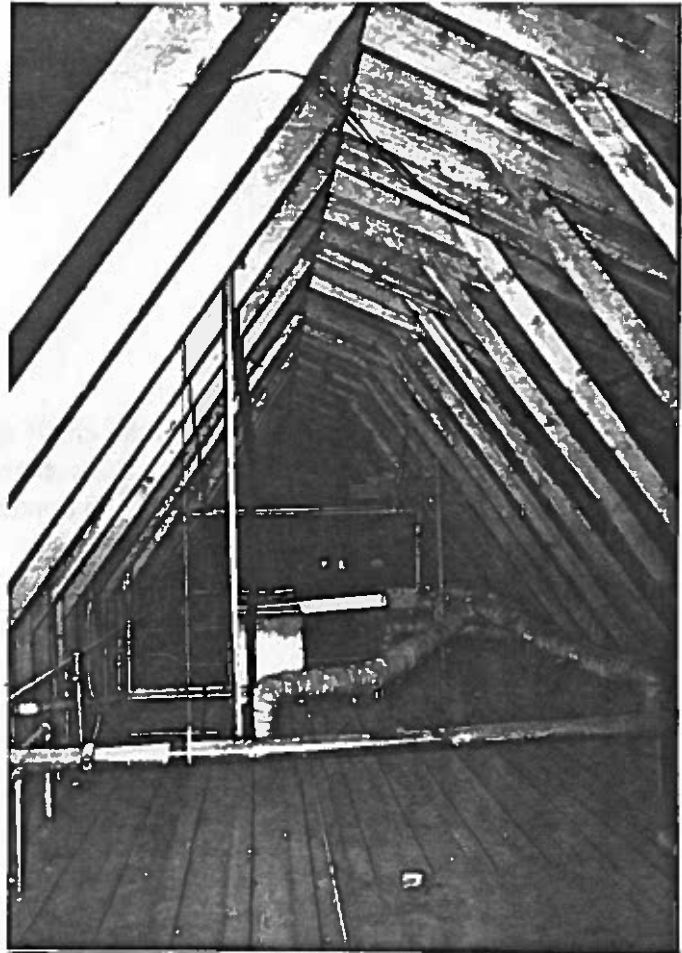
**Figure 156:** Looking northwest at the structure built up over the roof of an existing building when the Lodge was originally built. The area appears to be dry and in good condition.

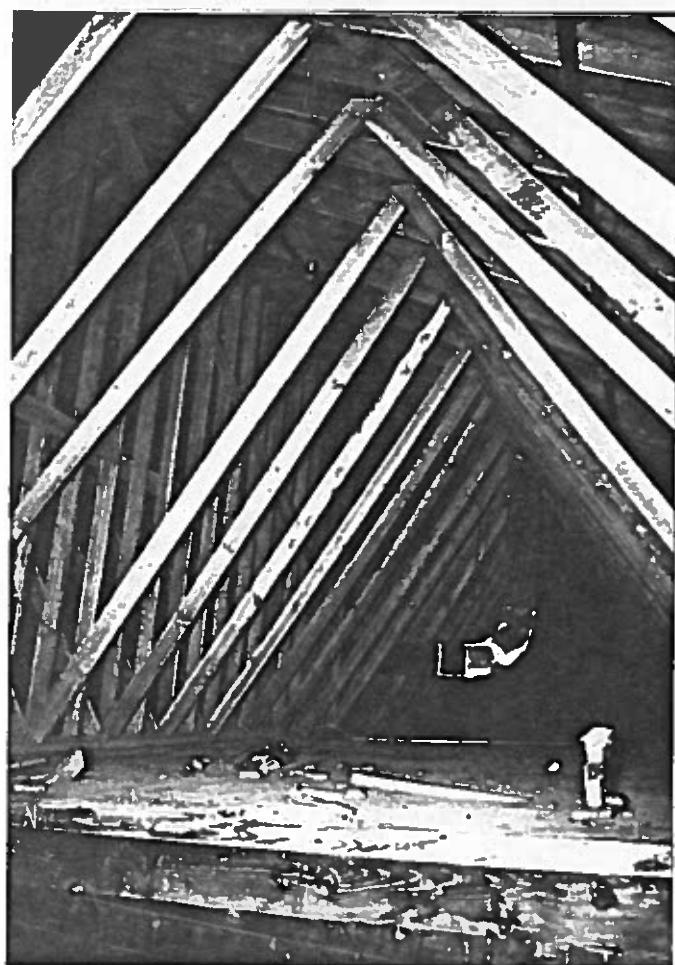
Figure 158: Looking north at the original open joist ceiling and trusses of the exposed ceiling in the dining room. A suspended ceiling has been added and the area is completely filled with ductwork.

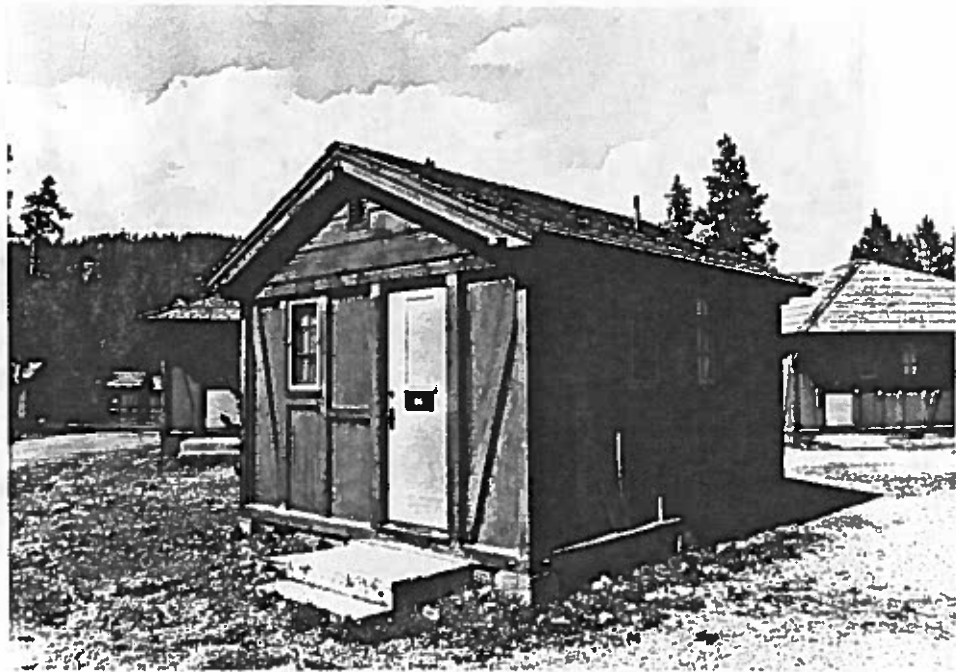
Figure 162: Looking north at a typical frame-out single cabin (#114). This building is in good condition with some minor rot on the sill plate. The siding and frame is dry and weathered.

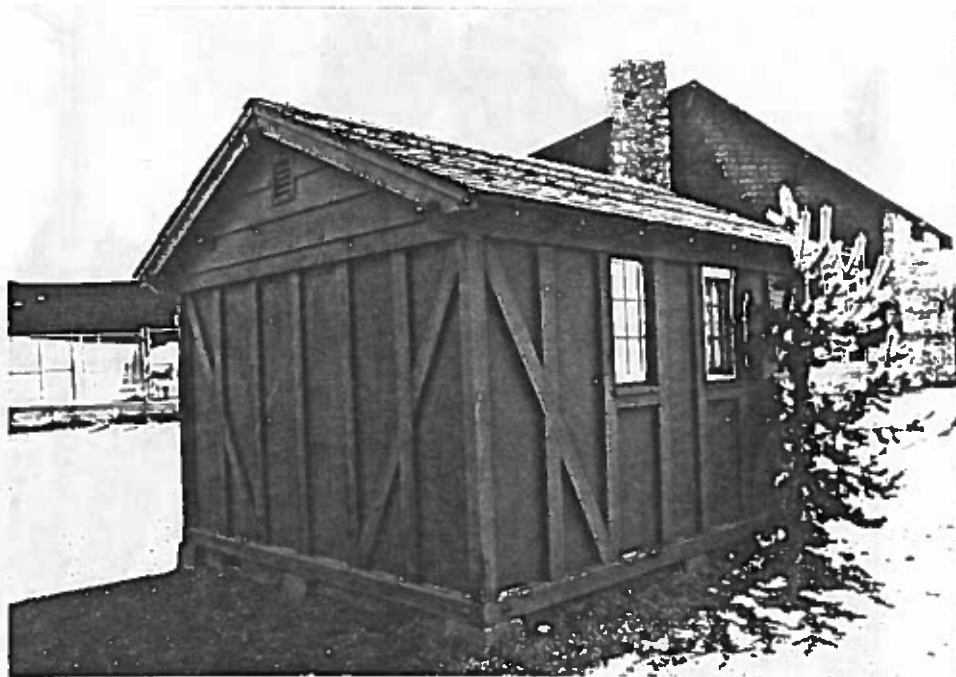
Figure 163: Looking south at a typical frame-out single cabin (#114). There is a missing screen on one of the windows and there is some weathering in the sill plate.

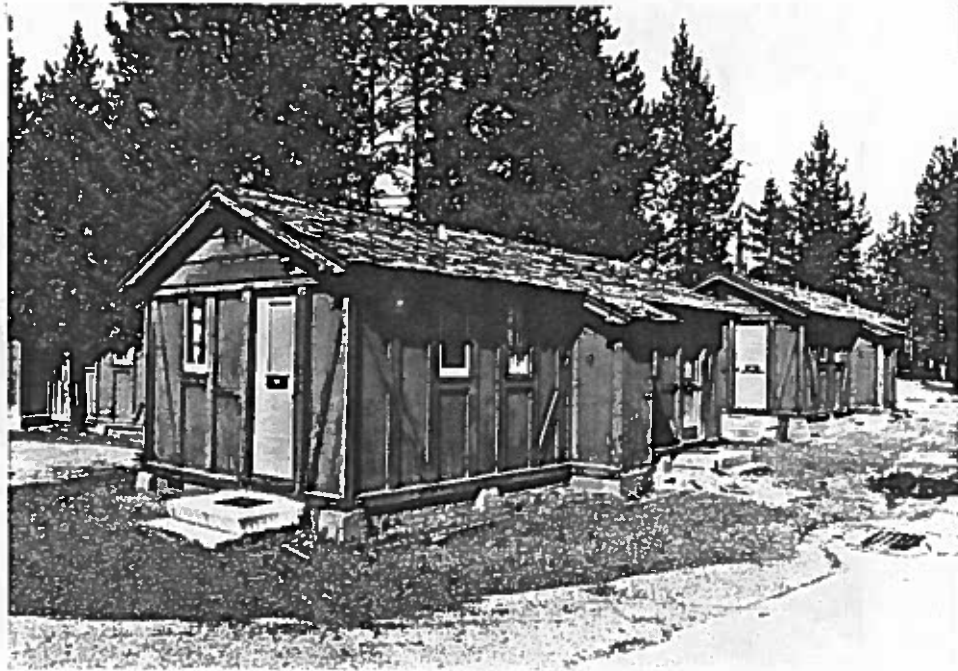
Figure 164: Looking northeast at a typical frame-out duplex cabin (#161-162). The roof is very poor on this cabin which is typical of about 60% of the cabins. Note the added bathroom.

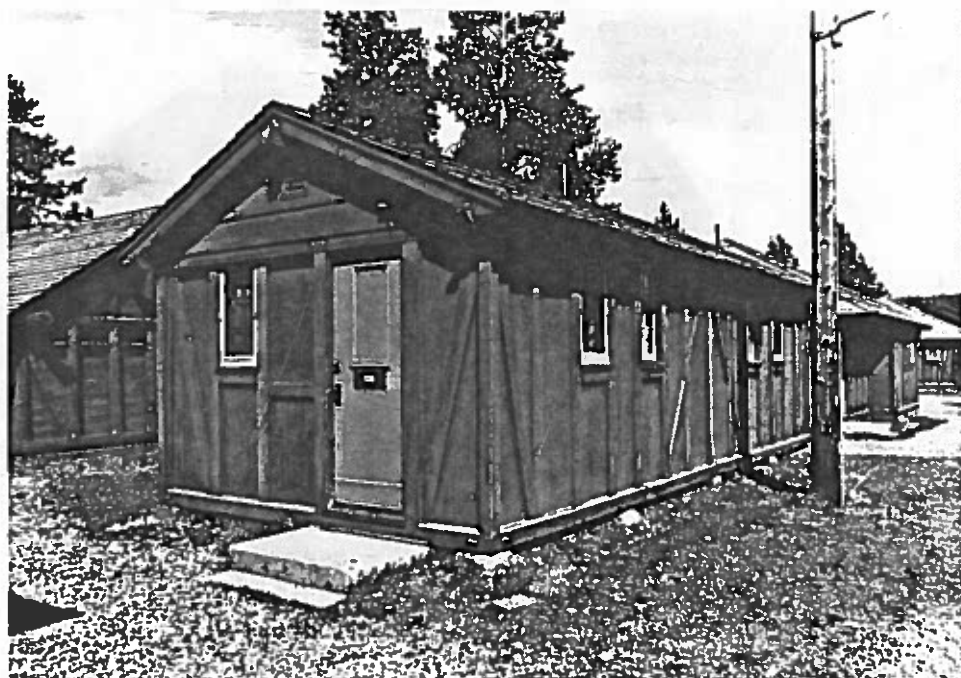
Figure 165: Looking northeast at a typical frame-out duplex cabin (#108-109). The cabin walls are dry and weathered.

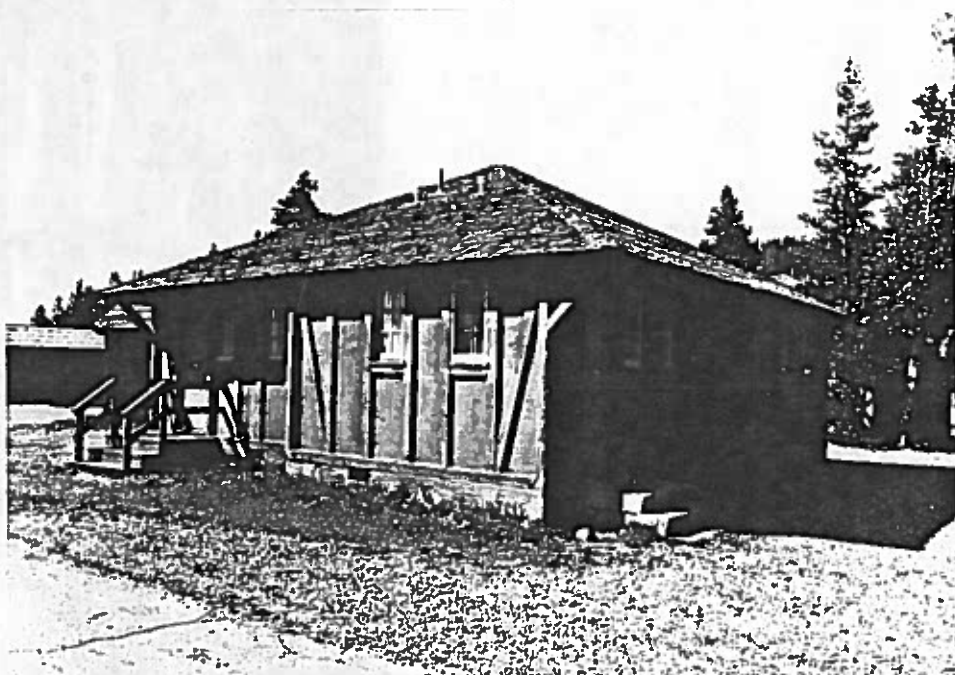
Figure 167: Looking northwest at a typical frame-out quad cabin (#110-113). Note the use of concrete and wood frame for the stoops. The roof on this structure has some bad areas.

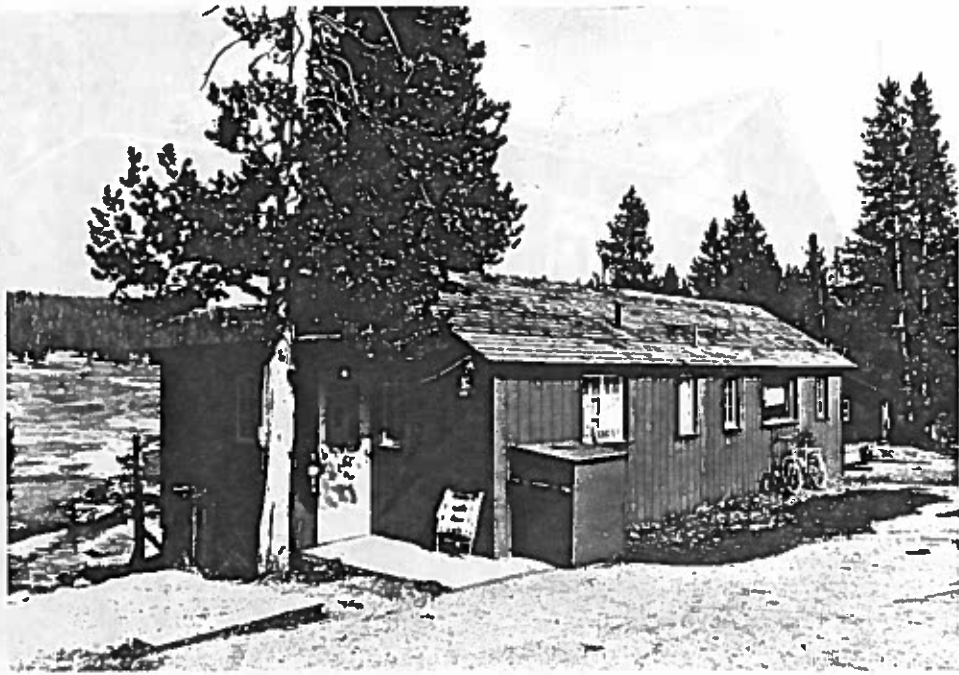
Figure 185: Looking east at the maintenance managers cabin. Note the texture 111 siding.

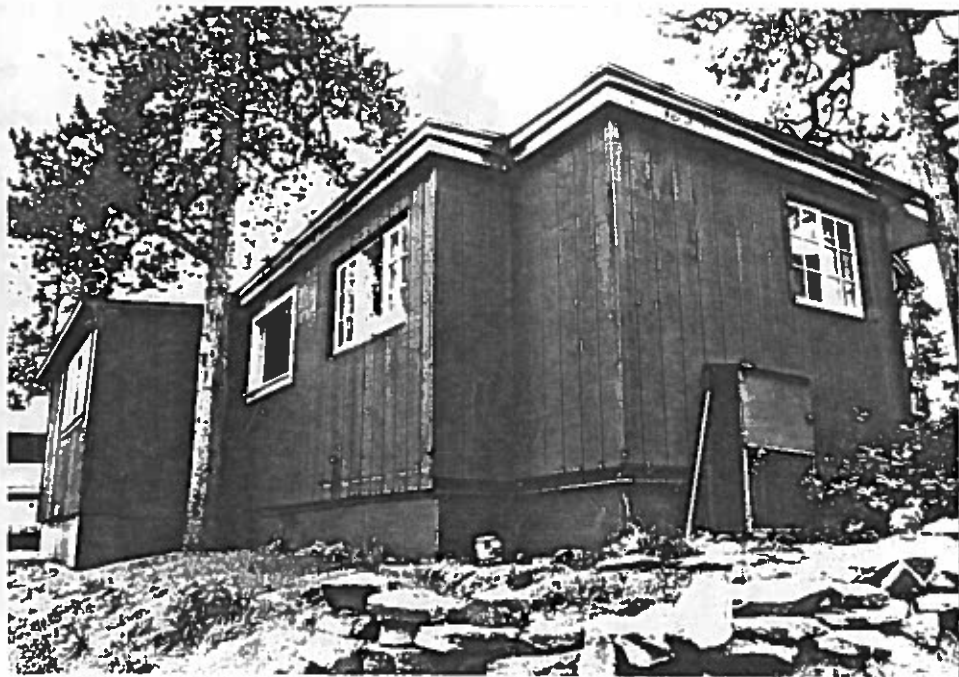
Figure 186: Looking south at the back of the maintenance managers cabin. Note the variety of windows and the shed roof additions.

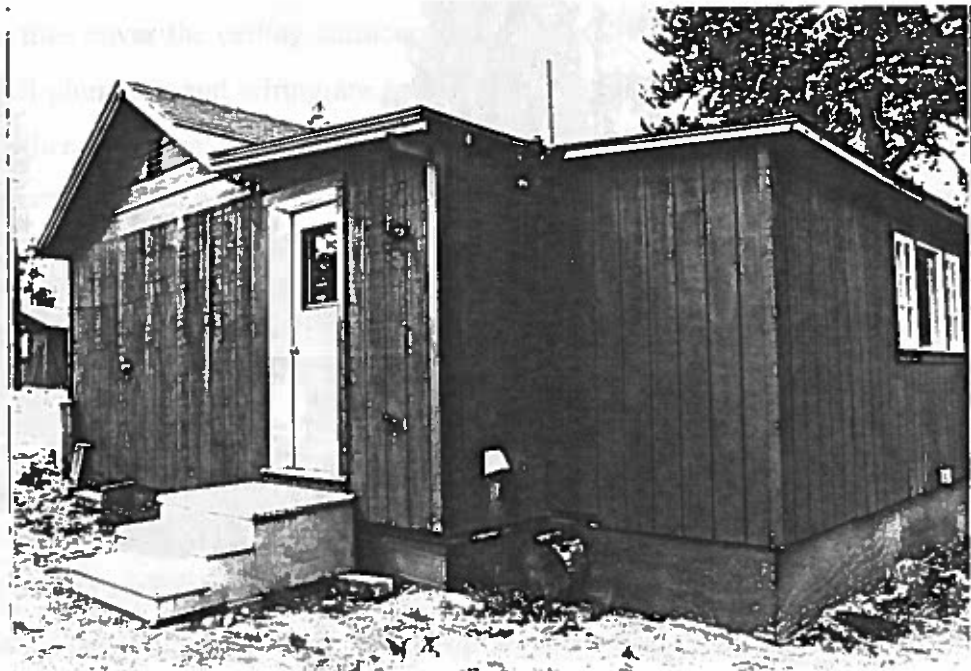
Figure 187: Looking west at the maintenance managers cabin. Note the various additions and the precast concrete stoop.

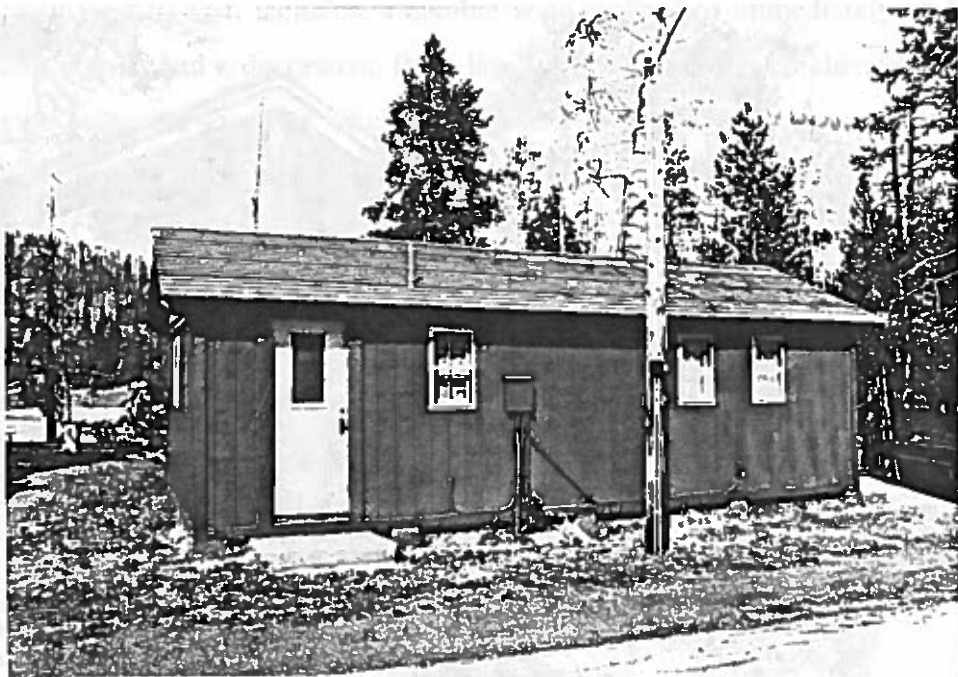
Figure 188: Looking north at a managers cabin. The texture 111 plywood paneling is starting to come apart (possible delamination) on the corners.

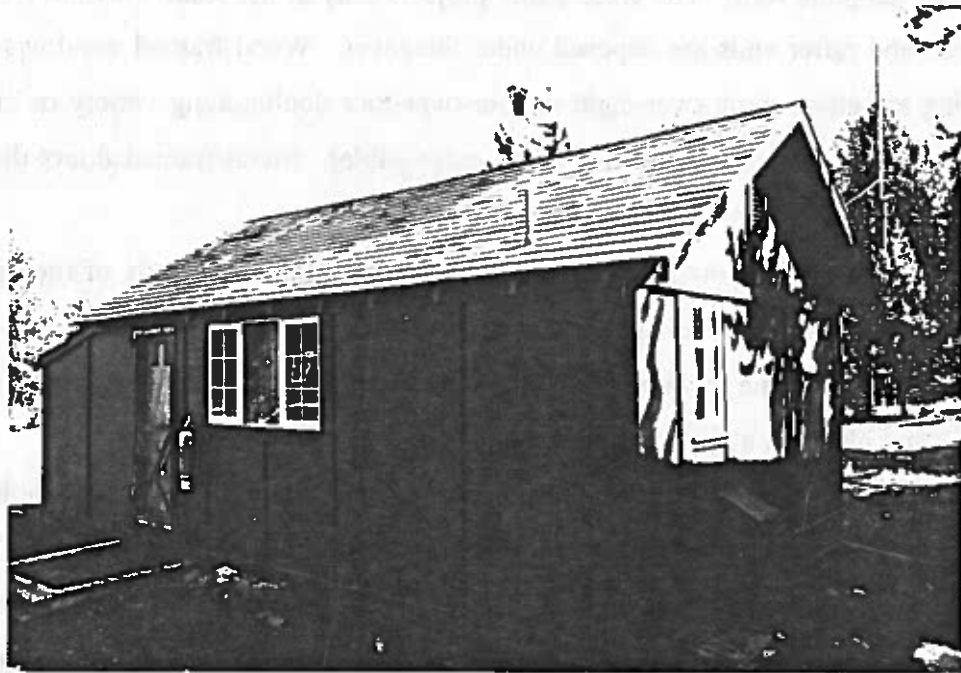
**Figure 189:** Looking south at the "love nest" cabin. The walls are plywood with battens over the joints. A bathroom has been added to the back.

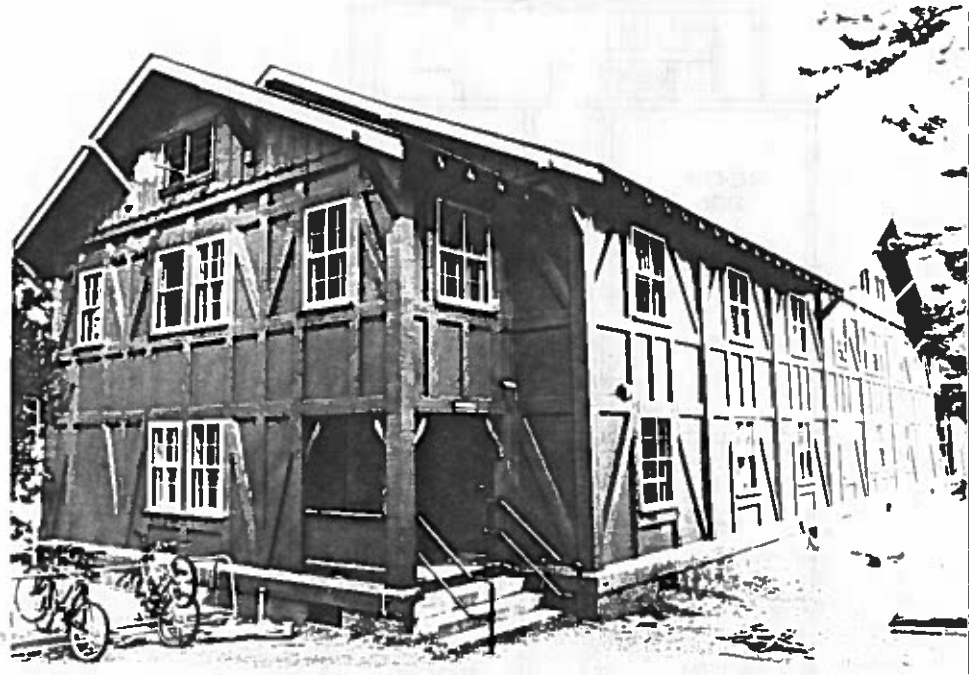
Figure 192: Looking northeast at the Dormitory building. This building is in good condition and appears to be well maintained.

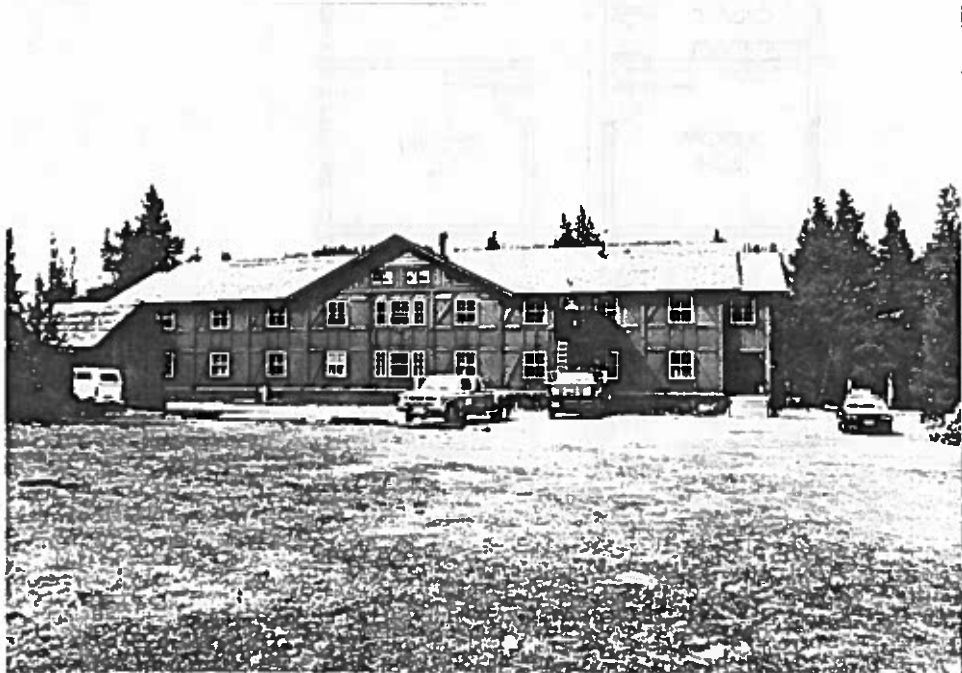
Figure 193: Looking north at the Dormitory building. The wood shingle roof is being replaced as this photo is taken.

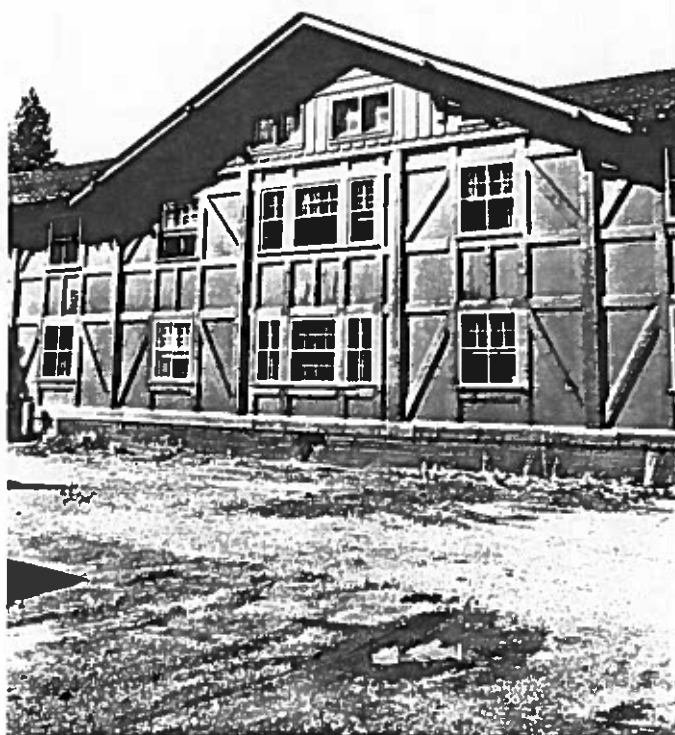
Figure 195: Looking northwest at the Dormitory building. The garbage cans and electrical on this side of the building are obtrusive to the details of the structure. Note the brackets under the eaves.

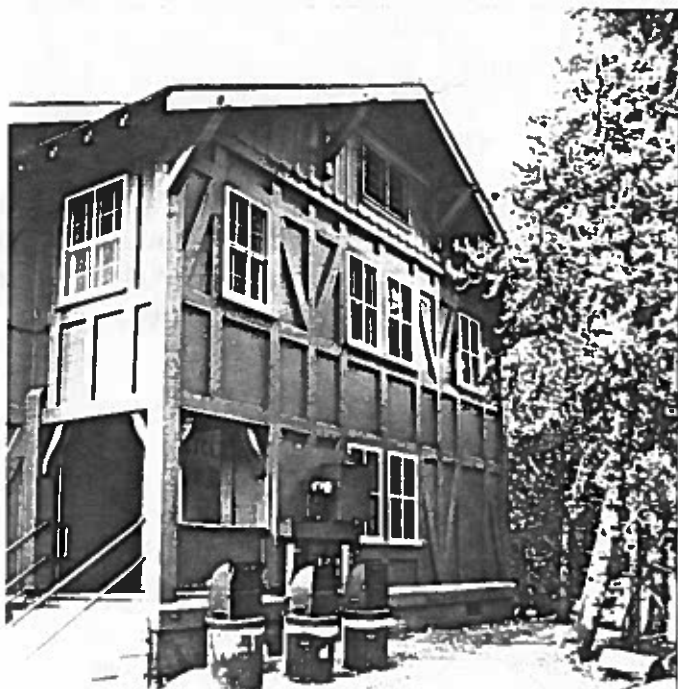
Figure 196: Looking southwest at the Dormitory building. The trees could become a problem because of the location next to the building.

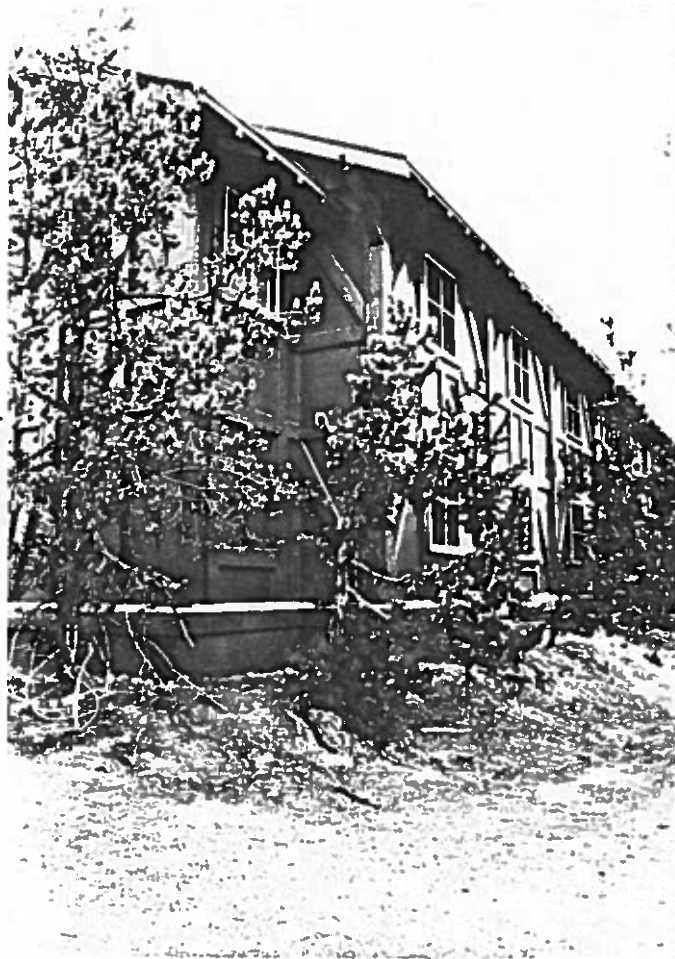
Figure 197: Looking south at a typical wall detail of the Dormitory building. Most of the wood elements are in very good condition.

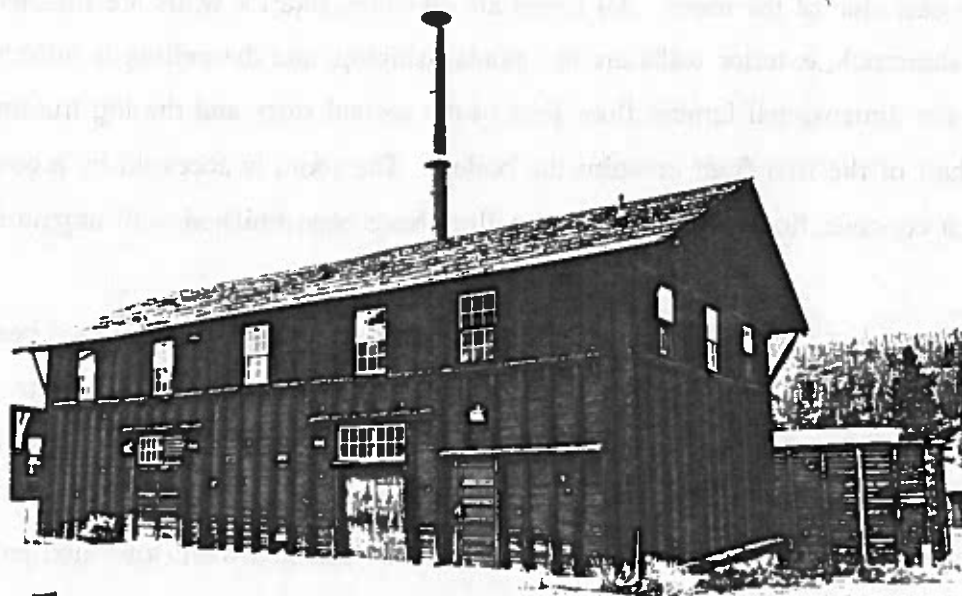
Figure 203: Looking northwest at the Boiler Plant building. The base wall boards and sill log are weathered and there is some rotted areas. The grade around this side of the building appears to be towards the building.

3. Some regrading of the site around buildings will have to be done in order to protect the buildings from further damage, although very minimal as compared to other areas. This will occur in all areas and is shown by the photographs in the site section as well as the building section.

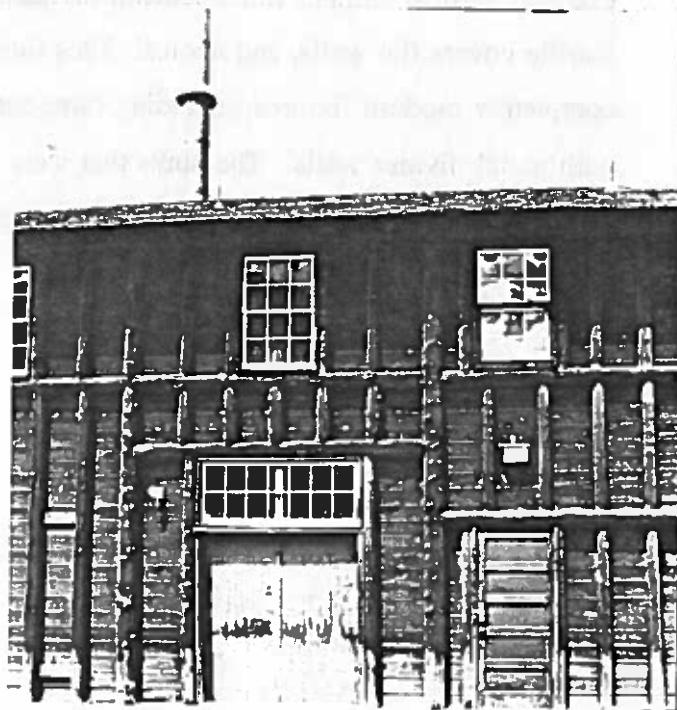
Figure 204: Looking north at the entries on the Boiler Plant building. Note the weathered wood and delamination of the plywood.

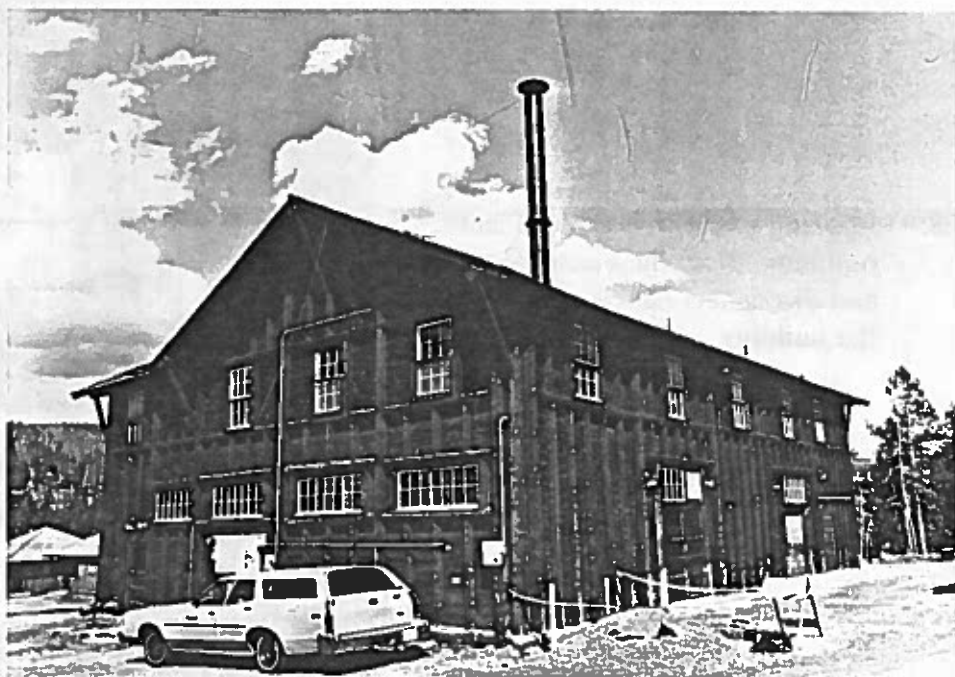
Figure 206: Looking northeast at the Boiler Plant building. The wall logs other than the bases appear to be in good condition.

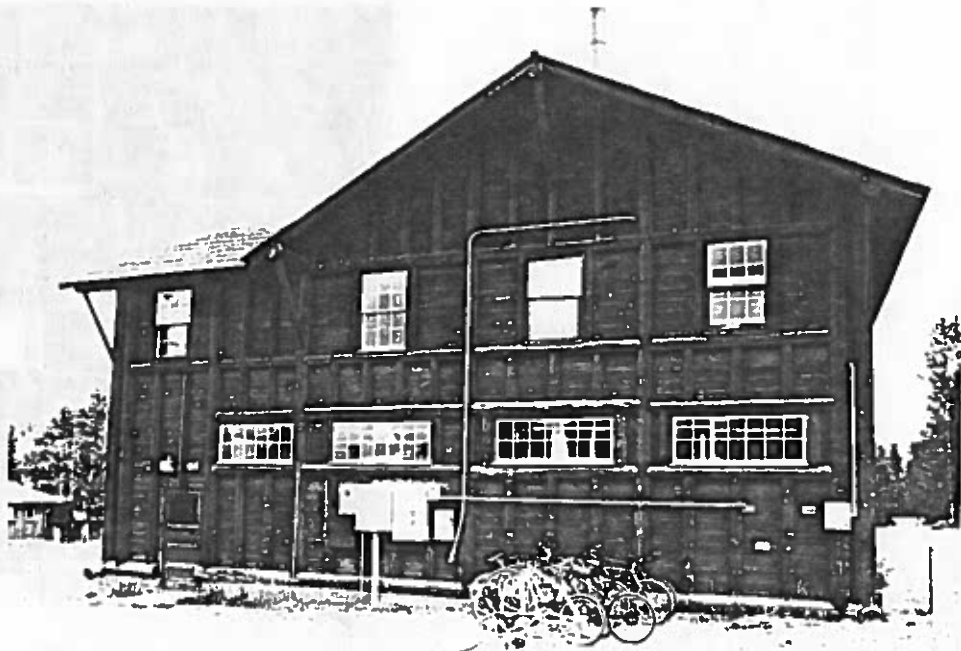
Figure 207: Looking east at the Boiler Plant building. The windows are in fairly good condition with some minor weathering of the sills and some sash.

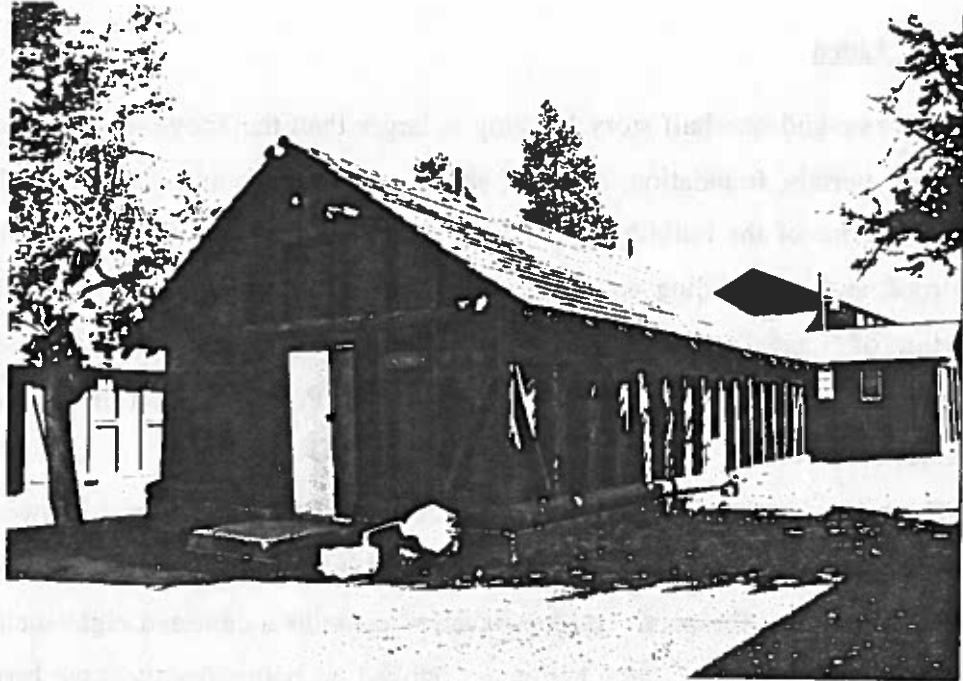
Figure 213: Looking southeast at the upper loop linen building. This log-out building has some rotted logs on the walls and base. Note the white flush wood door.

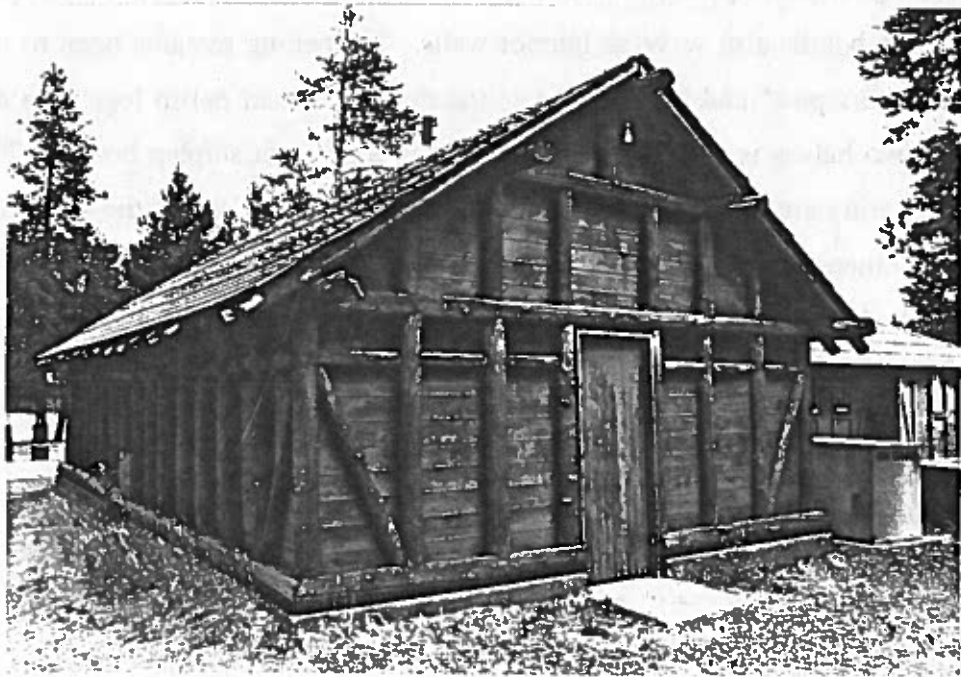
Figure 214: Looking northeast at the upper loop linen building. Note the rotted purlin tips. Also, there are some minor problems with the wood shingle roof.

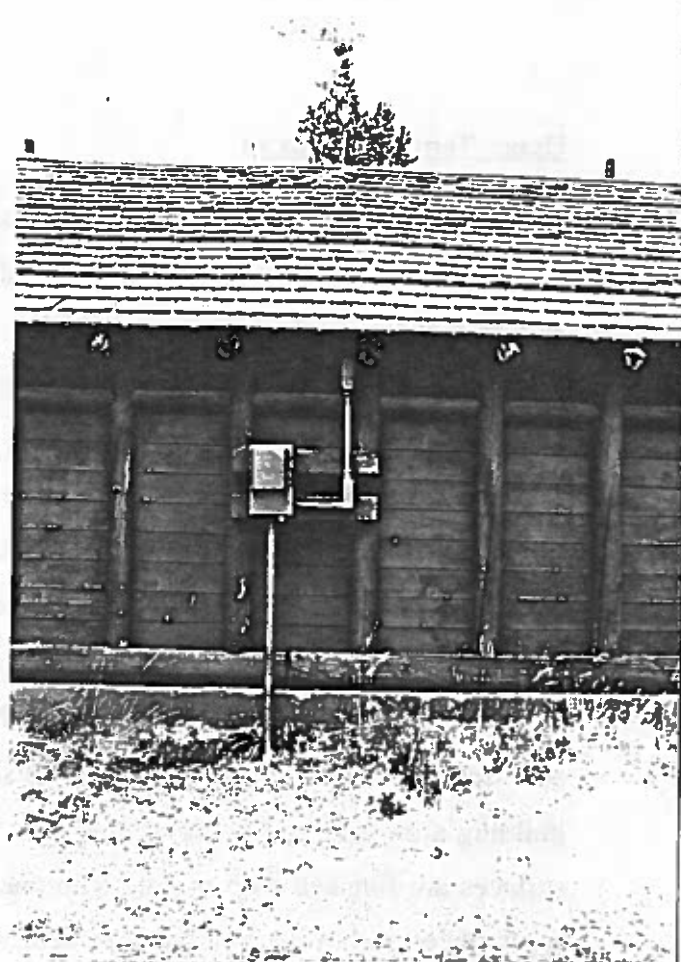
Figure 215: Looking west at the upper loop linen building. Note the rotted rafter tips and the curling of the roof shingles.

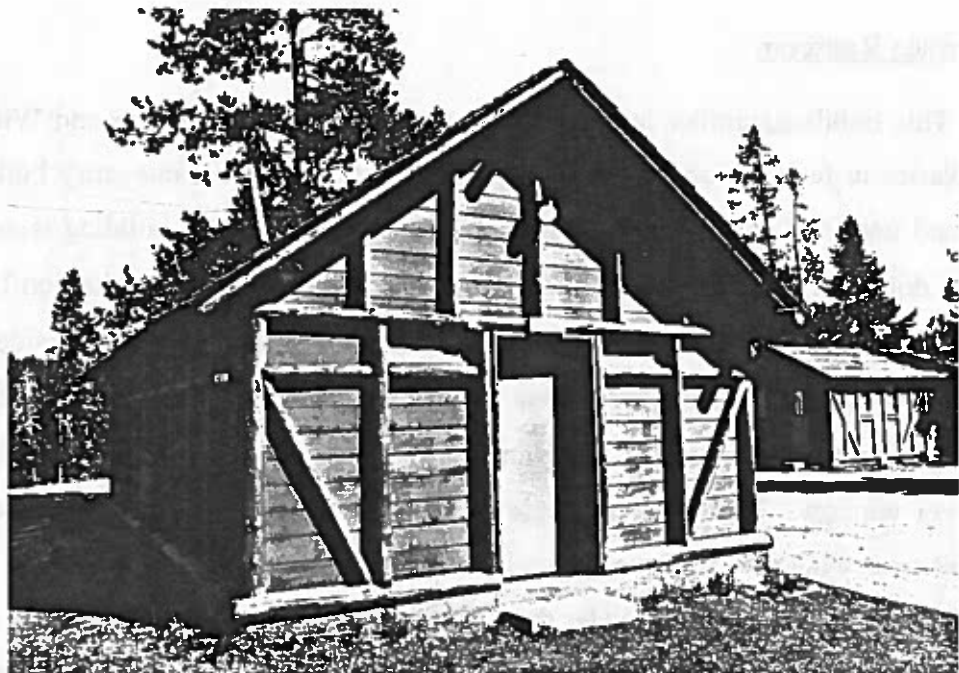
Figure 217: Looking west at the upper loop restroom/shower building. Note some sill log and purlin tip rot.

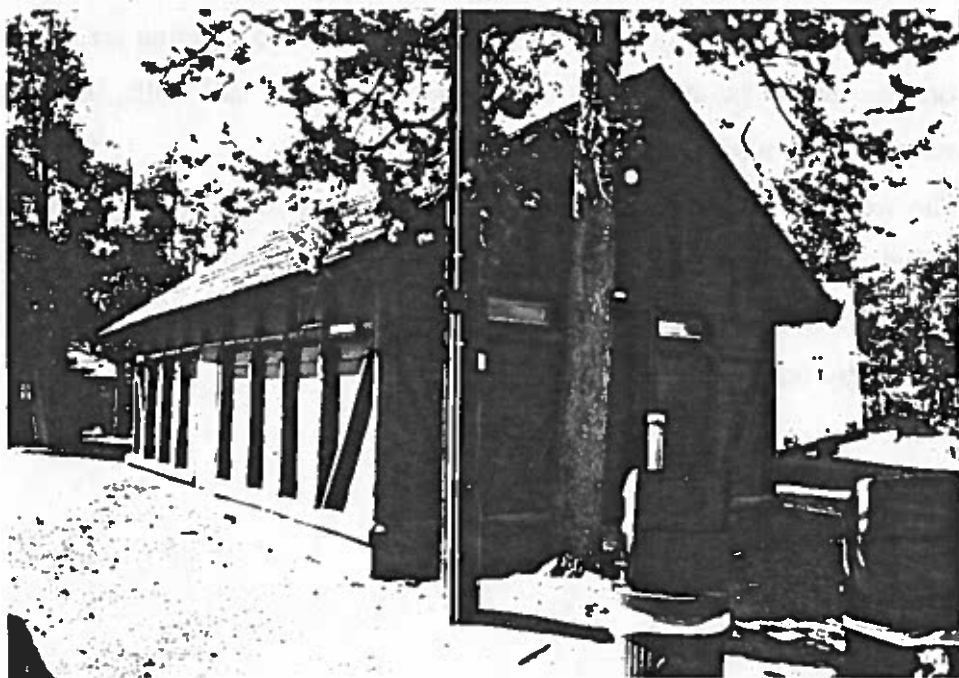
Figure 218: Looking east at the upper loop restroom/shower building. The interior has recently been remodeled.

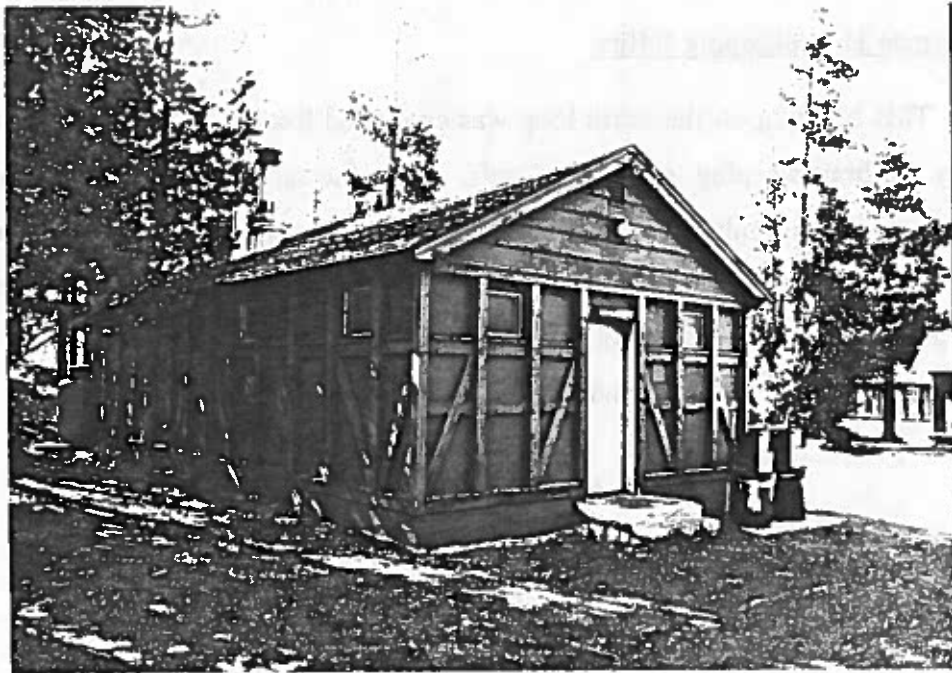
Figure 219: Looking northwest at the lower loop restroom/shower building. The building is in good condition with the exception of the concrete stoop which is deteriorating badly.

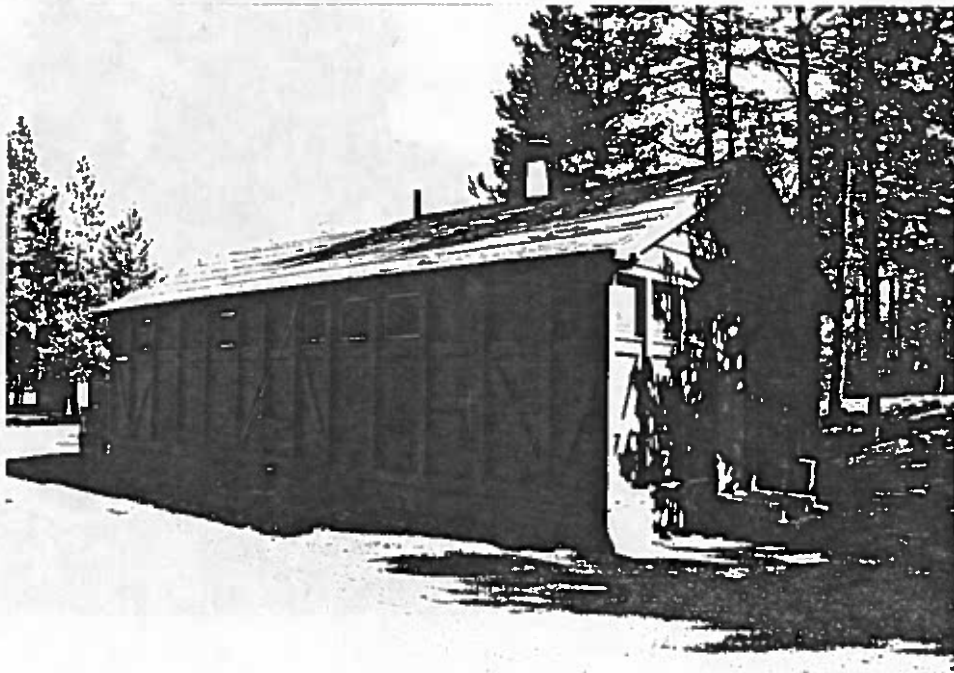
Figure 220: Looking southeast at the lower loop restroom/shower building. There are some curling and dislocated wood shingles on the roof.

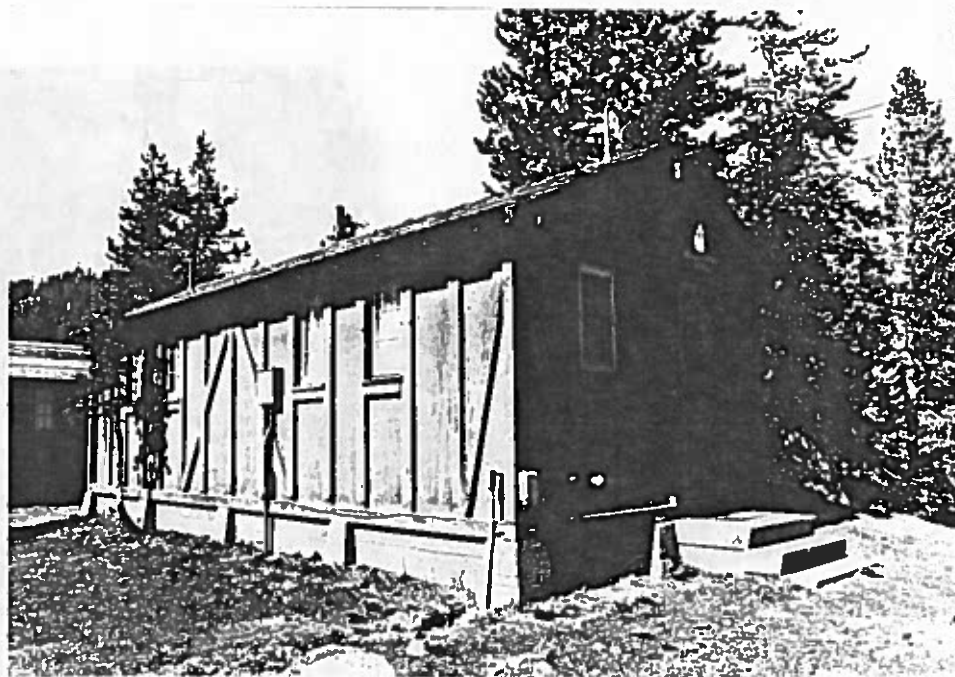
Figure 221: Looking north at the upper loop housekeeping building. The wood walls and details are weathered and dry.
