# SHAWNEE, OHIO

## Priority Property Asset Report

**Original Town Hall & Garage**  
**Address: 105 West Walnut Street**  
**Owner: Village of Shawnee**

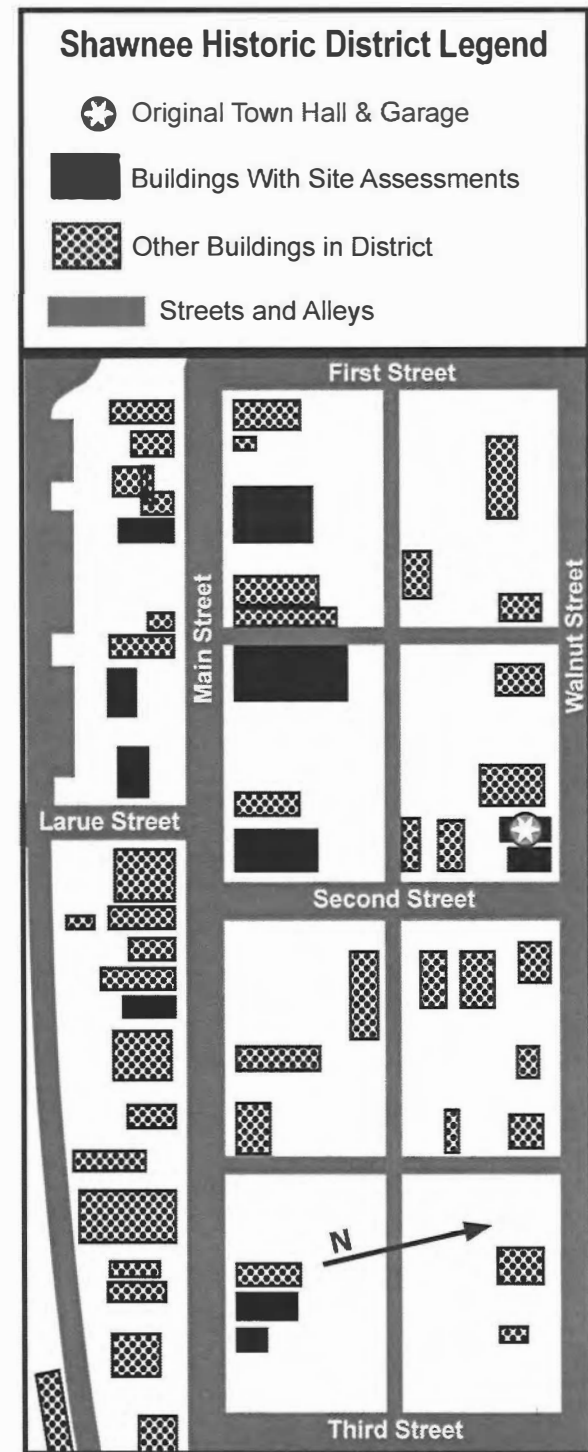
The exterior of the building is covered with a profiled horizontal wood lap siding. The condition of the siding varies from fair (needing cleaning, sanding and new paint) to poor (warped, bent, cracked, due to the settlement of the building). A considerable amount of the siding material is badly damaged or missing, especially in the one-story portion.

Double hung wood windows are similar to the windows in the adjacent Town Hall, but with simple wood trim. Some of the windows are either missing entirely, missing sash, glass or frames. The windows appear to be original and are in poor to fair condition, where present.

The attic/roof space was not accessible but roof framing can be assumed to be wood rafters or trusses spanning east-west (20'). The slate roof shows a lot of staining. There are no gutters remaining on the building so no means of intercepting roof run-off. There are old downspout leader brackets remaining in some places on the building. This has likely contributed to the deterioration of the stone foundation and settling. This is not a good situation especially on this hillside site, as drainage may undermine foundations on this property and other downhill properties.

Overall the building is in poor condition. Floors are not level and walls not plumb. As noted previously there are areas of concern that should be addressed soon to prevent further decay that may make the building more difficult and/or more expensive to repair at a later date.

The at-grade wood entry doors are likely allowing storm water run-off to enter the building during hard rains. The previously mentioned lack of gutters only adds to this concern.

Demo rear addition. Repair stone foundations. Repair/replace windows. Salvage, clean, paint, re-install lap siding and trim. Provide new roof. Provide new gutters and downspouts and run out to acceptable discharge point. Repair belfry shutters, trim, etc.

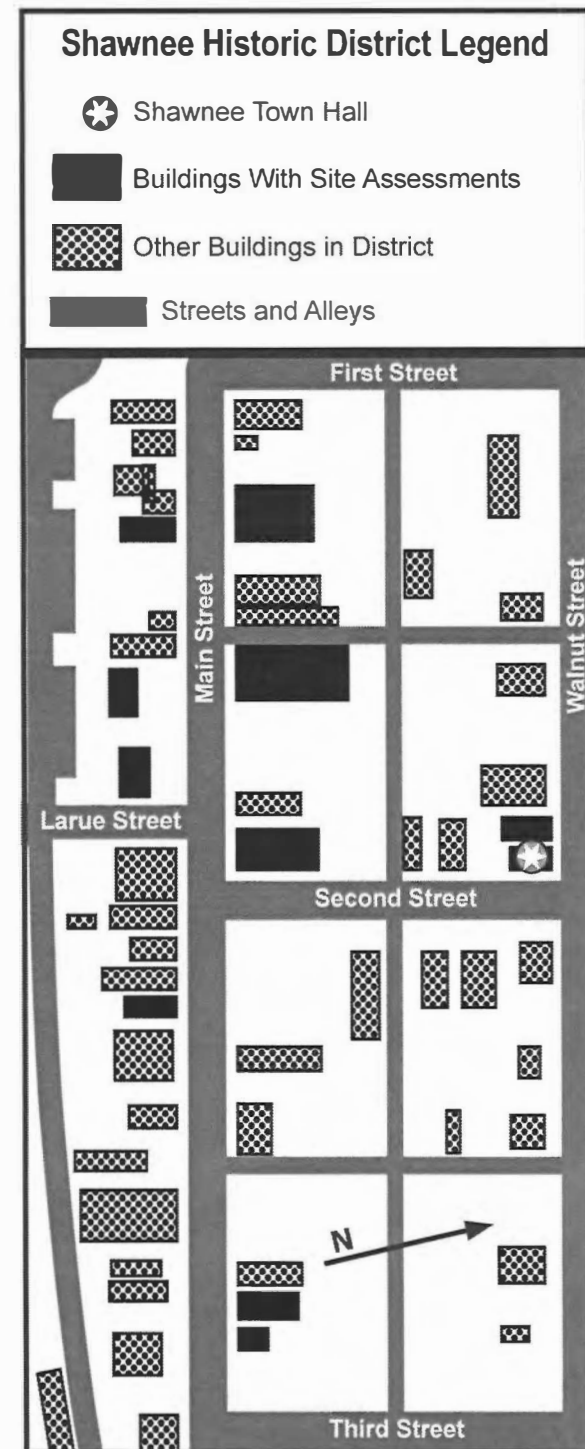
The exterior of the building is brick painted dark red. The brick is generally in good condition with no large areas of missing mortar, etc. The west side of the building was difficult to observe and should be looked at more closely.

Double hung wood windows have sandstone lintels, some peaked, some flat, and jamb drops. Some lintels have been painted white, some are exposed sandstone, similar to the lintels on the K.of P. Hall. The windows in the jail room have closely spaced iron bars over the openings on the outside. Some are painted white. The windows appear to be original and are in fair condition. As to be expected, deteriorated exterior frames (especially the sills) are evident. Each sash is glazed with two panes of glass, side by side. Some glass is broken or missing and has been covered for weather protection.

The attic/roof space was not accessible but roof framing can be assumed to be wood rafters or trusses spanning east-west (20'). The slate roof covering is not clearly visible but the hip ridges appear to be missing flashing in some areas. It appears that the soffit has been modified at some point and the original box gutter removed, leaving no means of intercepting roof run-off. Existing downspouts are not connected. This is not a good situation especially on this hillside site as drainage may undermine foundations on this property and other downhill properties.

Overall the building is in fair to good condition. Floors are generally level and walls plumb. As noted previously there are areas of concern that should be addressed soon to prevent further decay that may make the building more difficult and/or more expensive to repair at a later date.

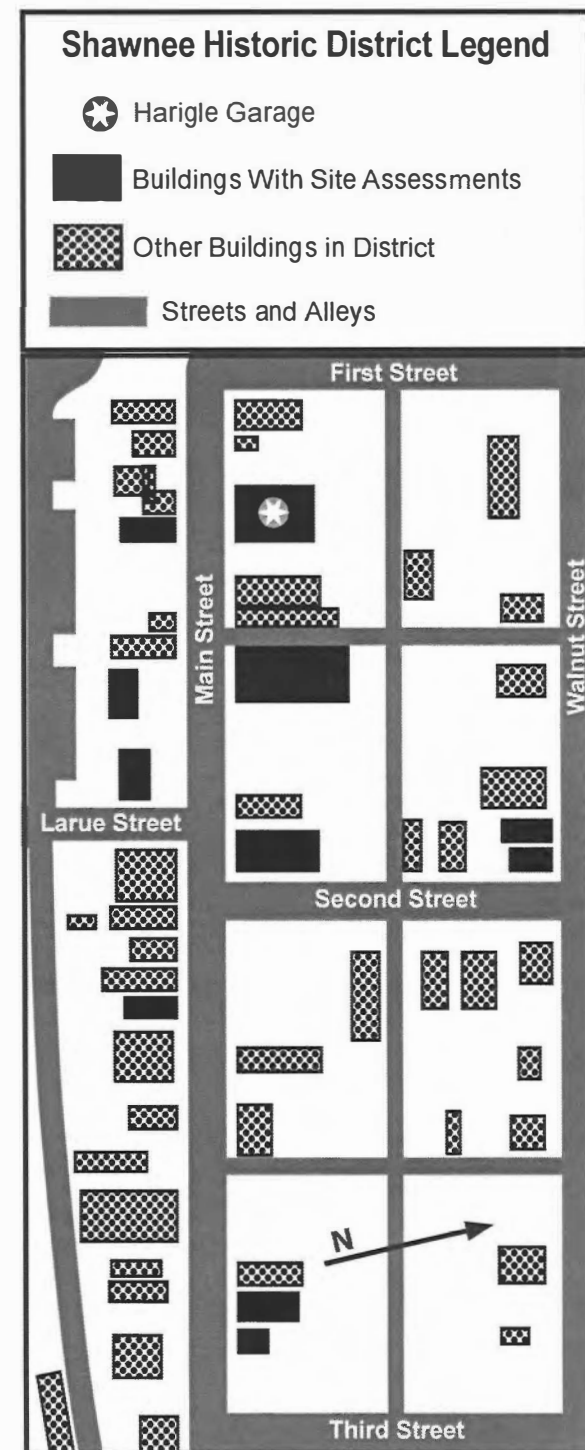
An area of concern is the condition of the back portion of the first floor which extends beyond the back wall of the second floor, thus the ceiling in this area is also a roof. Over time water infiltration and ground moisture has caused the steel beams to rust. A section of steel form decking (installed to allow placement of the concrete roof) is hanging down into the space. Portions of the back wall have been replaced or braced with newer concrete masonry unit construction. There is an area of about one square foot where daylight is visible through the roof/ceiling. A window in the room in the northwest corner of the first floor has earth up against it.

On the front façade there is a noticeable bulge in the brick at the second floor line towards the west end door leading to the stairs up to the apartment. It appears that the brick mortar in this area has been replaced/repared as all joints appear tight. On the inside of the first floor the masonry wall separating the main space from the stair to the apartment has extensive cracks at mortar joints and evidence of some settling or displacement of about 1-1/2". The stairway side of this wall is faced with plaster and has no cracks.

The roof of the eastern portion of the building is a rubber membrane installed within the last 3 years and is in good condition. The apartment portion roofing is shingles and was not effectively visible from the ground. It is reported to have been installed 15 years ago.

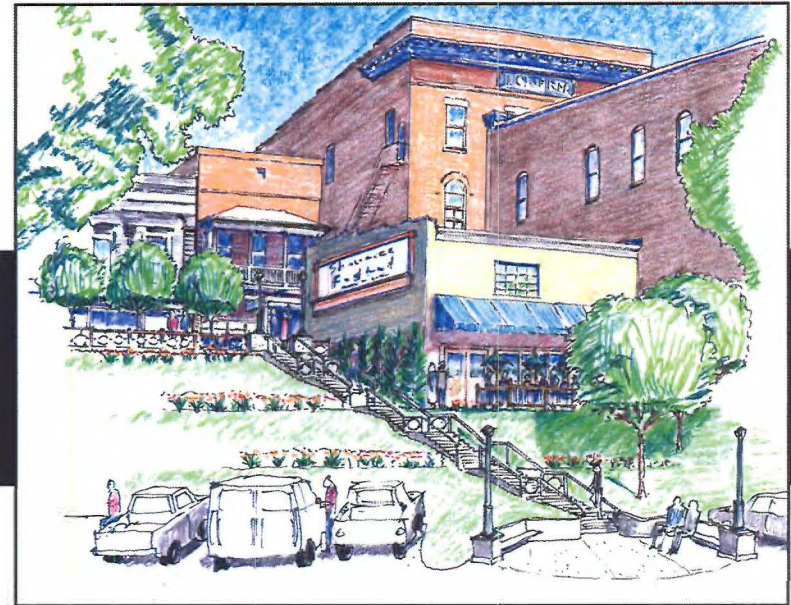
**Backtrack to Main St. Greenspace**  
**Address: 121, 123 West Main Street**  
**Owner: Brian Givens & Sunday Creek Assoc.**

Vacant lots (2) fronting on West Main St. and running through to the gravel "alley" to the south. Approximate dimension is a total of 50' wide frontage and 130' depth. (6,500 square feet). Existing buildings are on either side. The ground slopes down a total of about 20 feet from the sidewalk to the alley. The slope is approximately 10% starting at

the sidewalk for the first 75' of lot depth, then increasing to more than 20% for about 30', then decreasing to about a 3% slope to the alley center line.
