# NORTH PACIFIC HALL

## SOUTH FACADE RESTORATION

HISTORIC RESTORATION TEAM | Summer 2015

Sitka Fine Arts Camp | Sheldon Jackson Campus, Sitka, Alaska

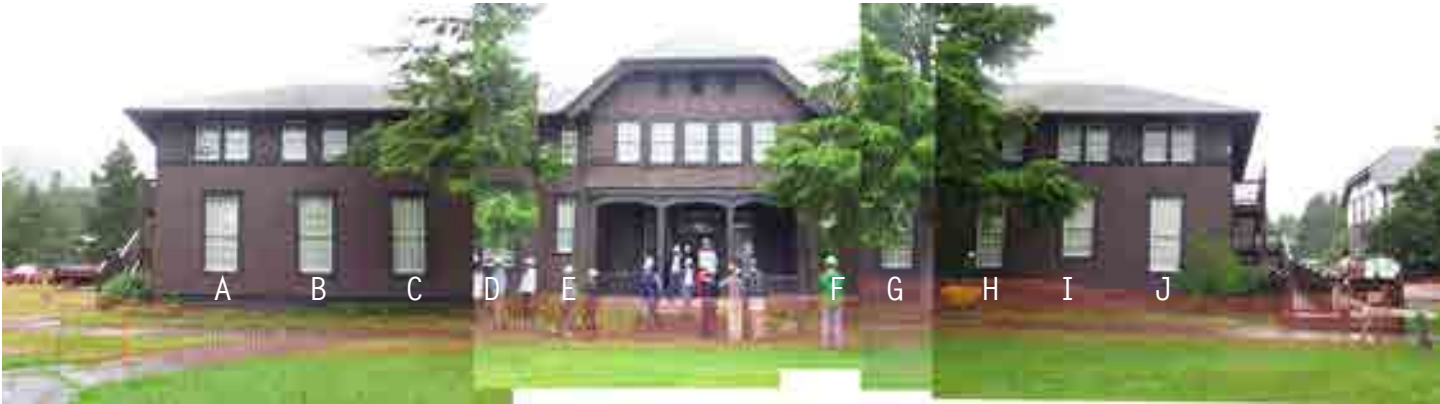
PRE FACADE REMOVAL

Work started at the building's foundation with the removal of the "belly band" - horizontal cladding - and its adjacent strips of molding and drip-cap. Following this removal, interns removed the cedar shingles below each first-floor window (labeled A - J, left to right, in chalk) to expose previously covered decorative paneling.

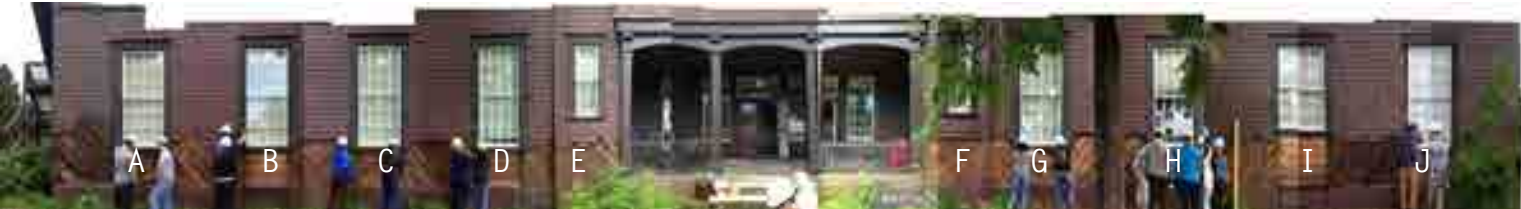
FRONT ELEVATION WITH ORIGINAL SHINGLES AND WATERPROOFING REMOVED.

Work began on Wednesday with the careful removal of the paneling below each ground level window, with care to protect the tongue-and-groove pattern of the boards' edges for proper fit. Sheldon Jackson College stencils and handwritten equations were discovered on some of this wood. With the paneling removed, sheets of Vycor waterproofing was applied to the wood underneath.

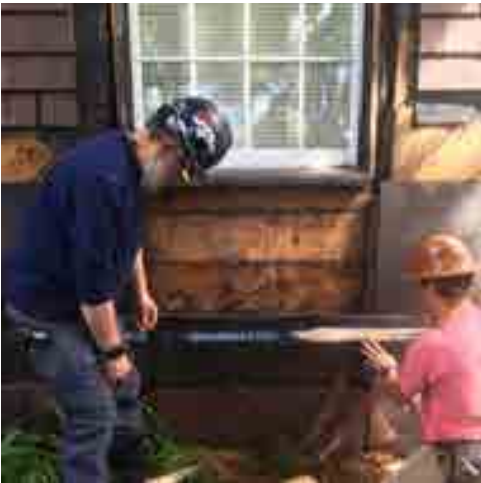
SHINGLE SIDING AND PANEL REMOVAL

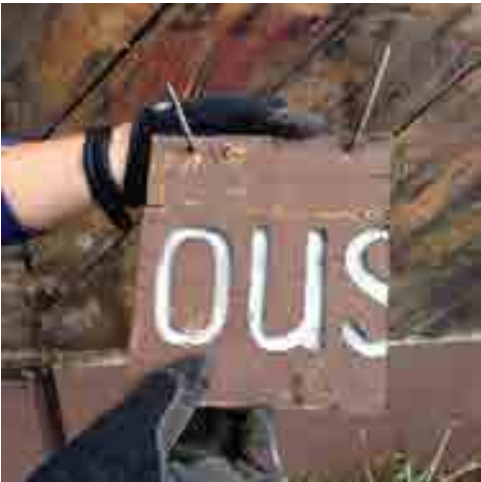
UNCOVERING THE PANELS

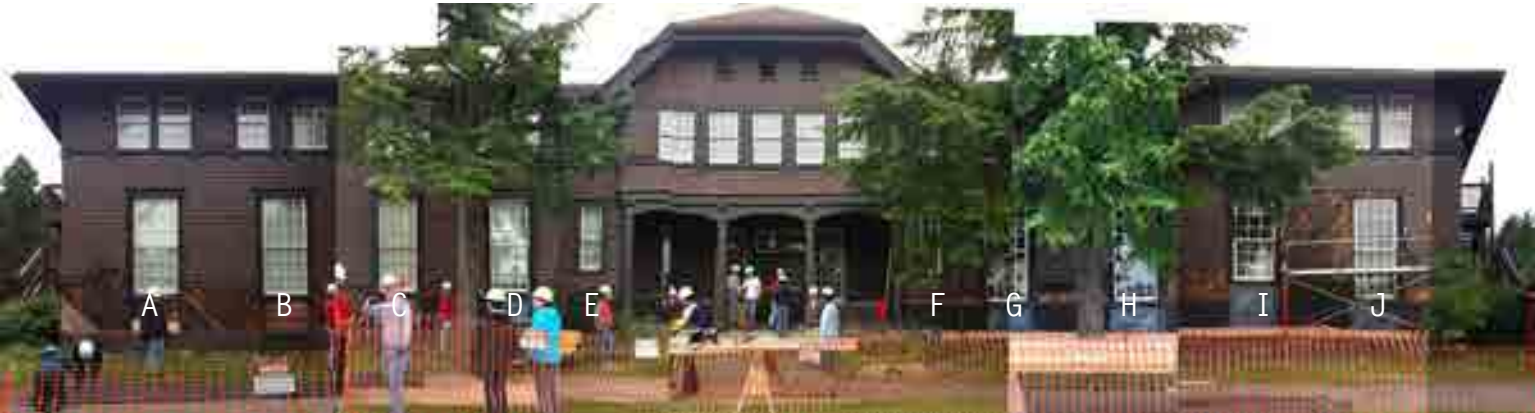
SIDING REMOVED AT FIRST LEVEL, WATERPROOFING TAR PAPER BEING STAPLED ON

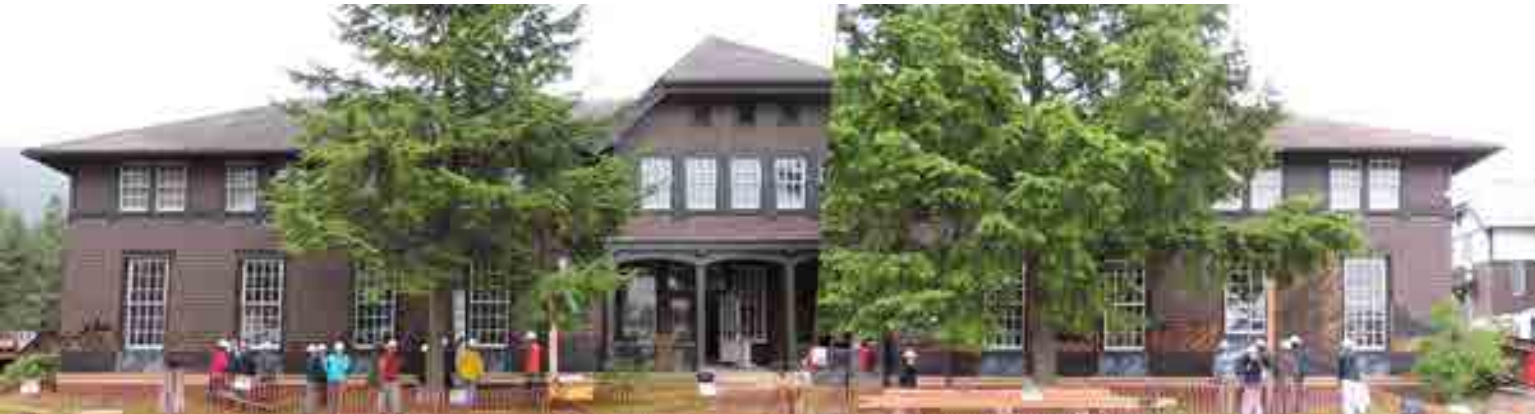
WATERPROOFING INSTALLED AT FIRST LEVEL

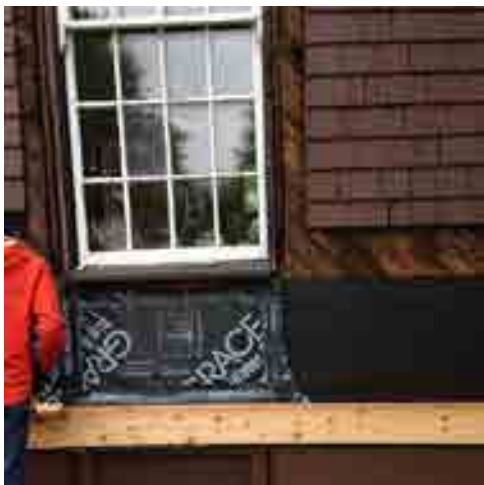
BELLY BAND INSTALLATION

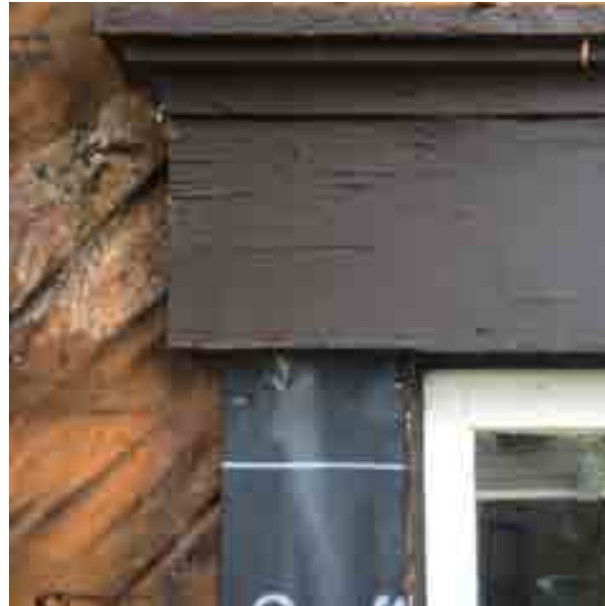
WATERPROOFING: VYCOR WATERPROOFING BENEATH CASINGS

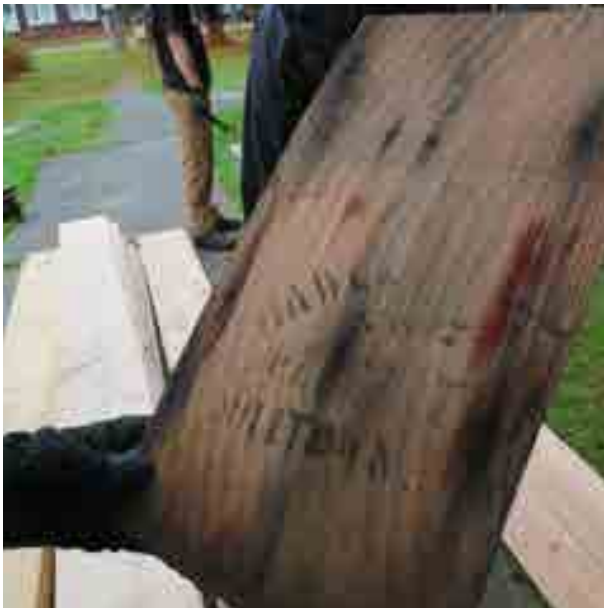
SHINGLE REMOVAL: SOME ORIGINAL CEDAR SHINGLES HAVE BEEN STAMPED WITH THE NAME OF THE MILL, HAWLEY MILL CO. - PERFECTION - MILTOWN, WASHINGTON

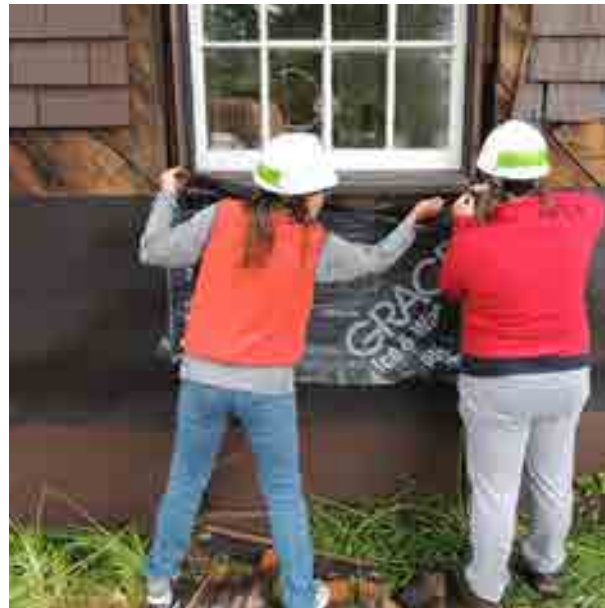
WATERPROOFING: RACHEL JONES AND ANNA PIOWAR APPLY TAR PAPER AND VYCOR TO THE PANEL AREA BENEATH THE WINDOW

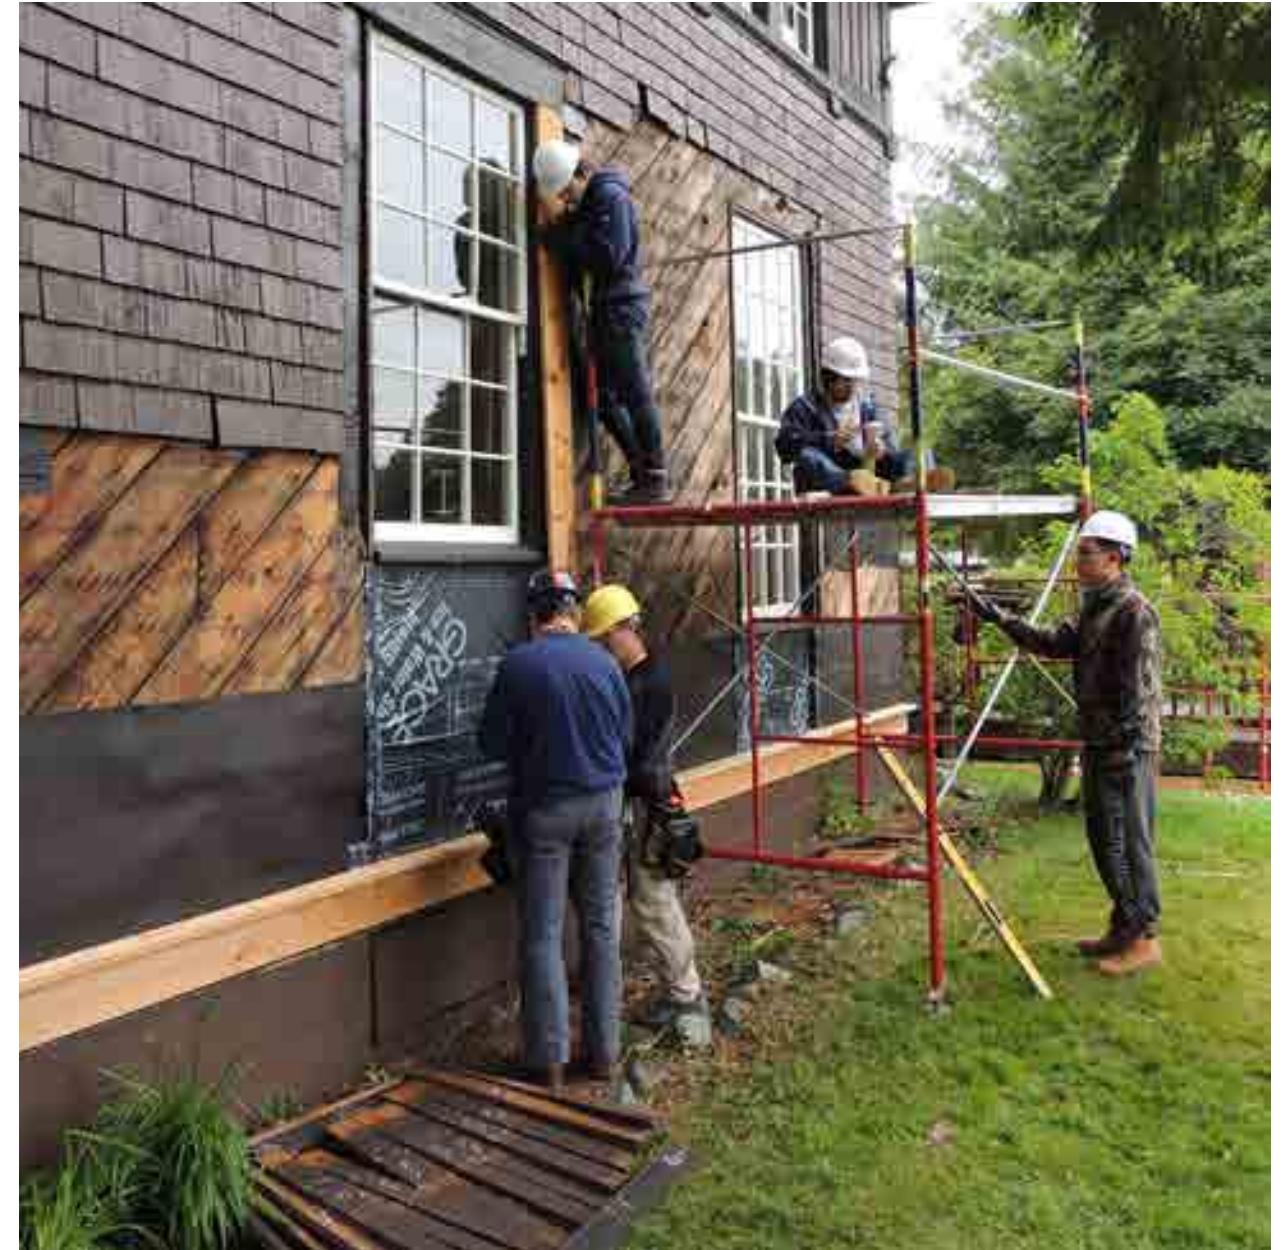
HRT MEMBERS ETIENNE DESBOIS, SAMIR WADHWANI, AND MIKE MCDONNELL WORK WITH LARRY JACKSON AND PETE WEILAND TO INSTALL WINDOW CASINGS.

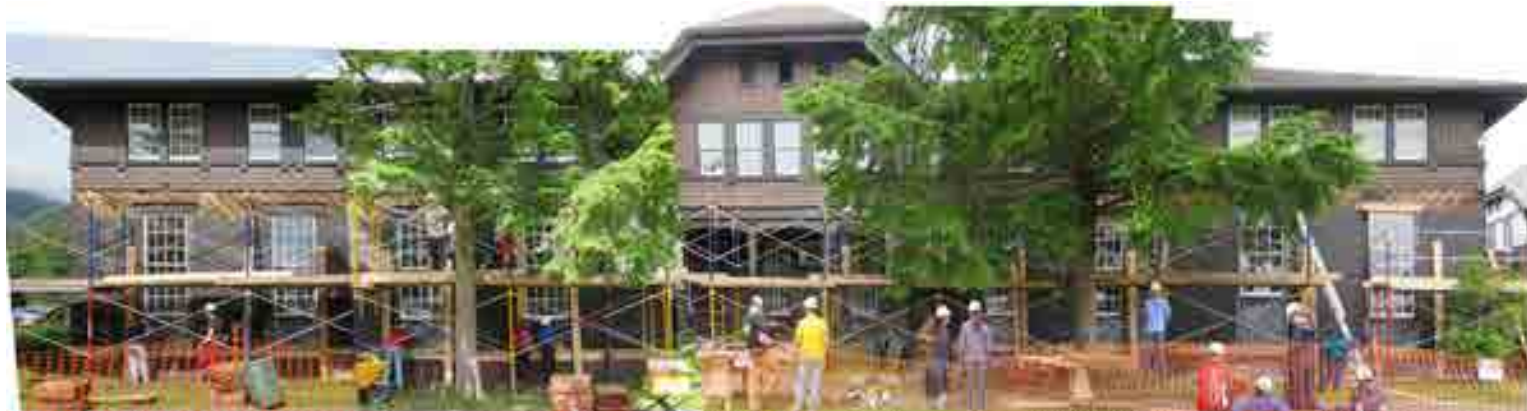
SHINGLES AND CASINGS REMOVED, TAR PAPER CUT AND STAPLED INTO PLACE UP TO MOLDINGS

Work on Tuesday concerned the reassembly of the tongue-and-groove paneling for below each window, followed by its reinstallation atop the Vycor sheeting. Shingles were removed up to about the level of the header of each first floor window, and tar paper was applied over the exposed original wood. Some of the new casings were fastened with finishing nails.

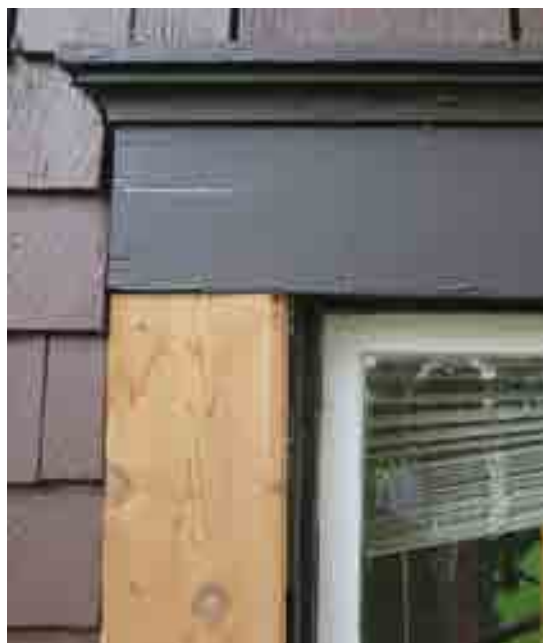
CHALK MARKERS ON THE WINDOW HEADERS TO NOTATE SHINGLE PLACEMENT BEFORE REMOVAL

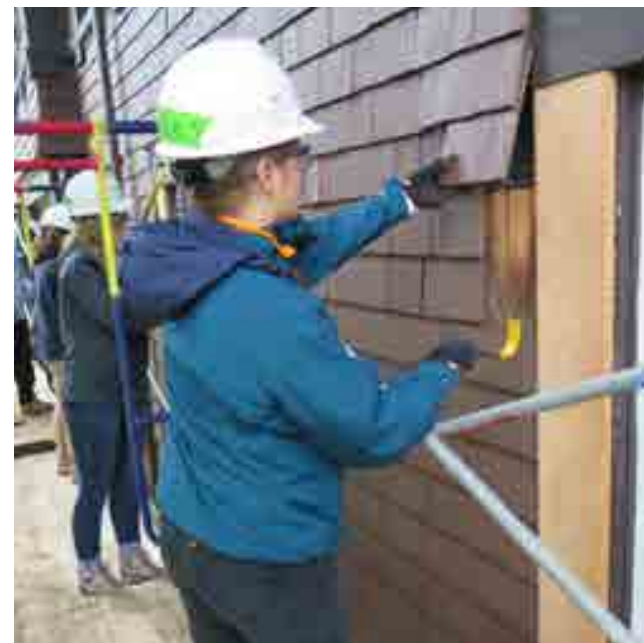
SHINGLE REMOVAL CONTINUATION

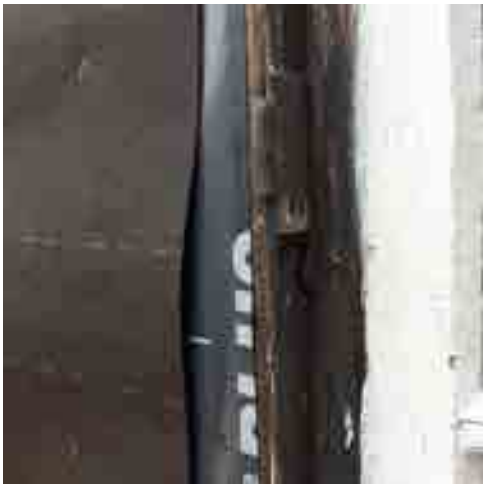
PANELS  
SCREWED INTO  
PLACE

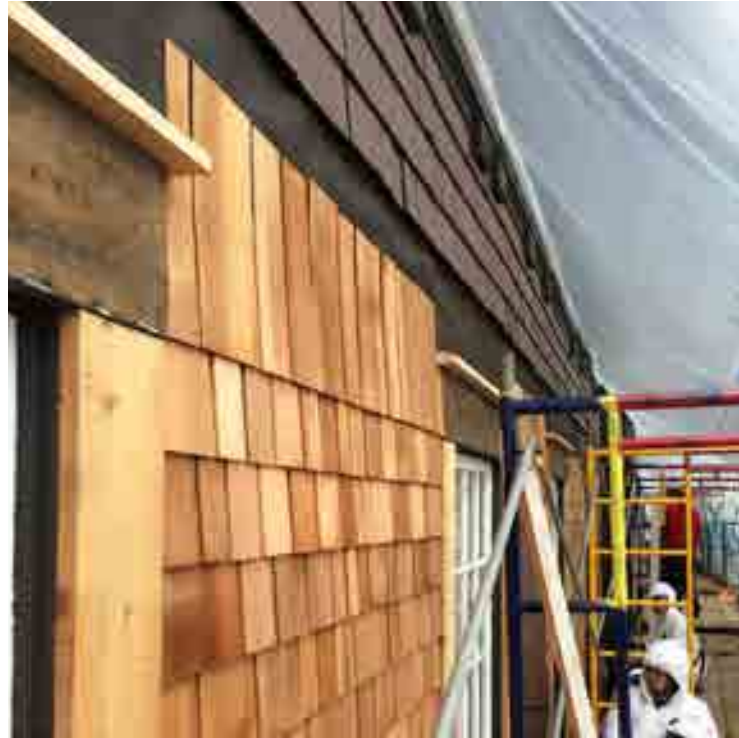
SHINGLE INSTALLATION REACHES TO TOP OF SECOND STORY WINDOW SILLS

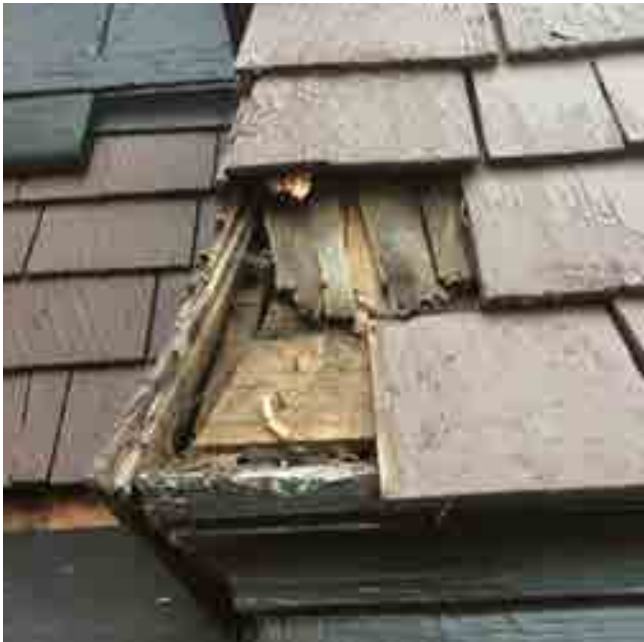
SHINGLE REMOVAL ABOVE PORCH

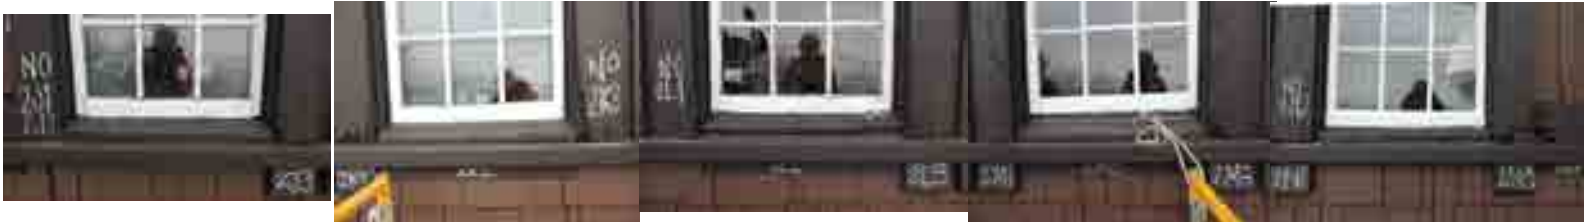
SECOND STORY  
WINDOWS, LABELLED,  
PRE SHINGLE  
REMOVAL

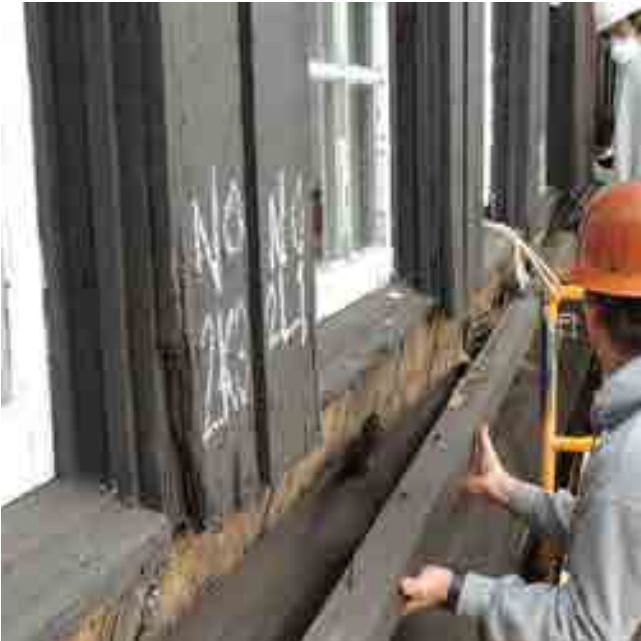
REPLACING WOOD TRIM

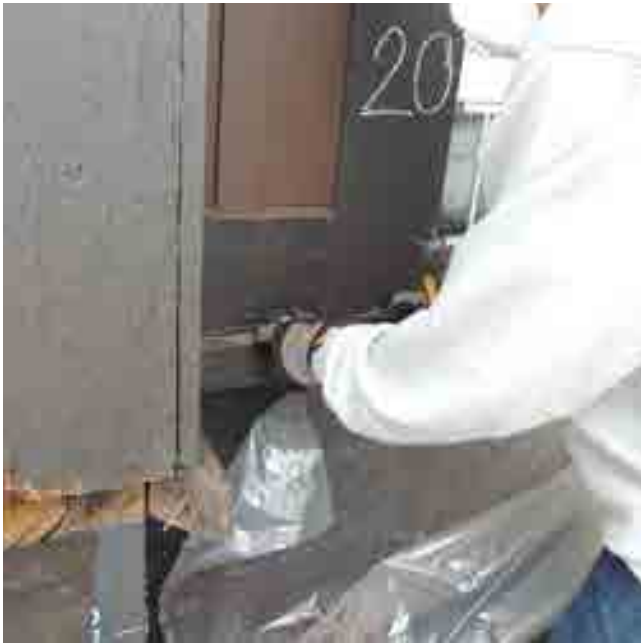
SCRAPING EXISTING PAINT TO PREPARE FOR NEW COAT

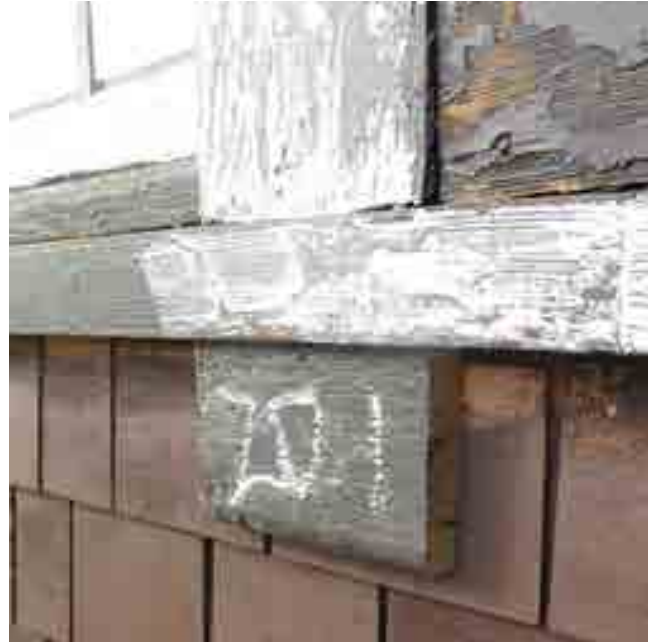
ORIGINAL BLOCKS WERE TRIMMED TO MATCH THE DIMENSIONS OF THE CASINGS ABOVE

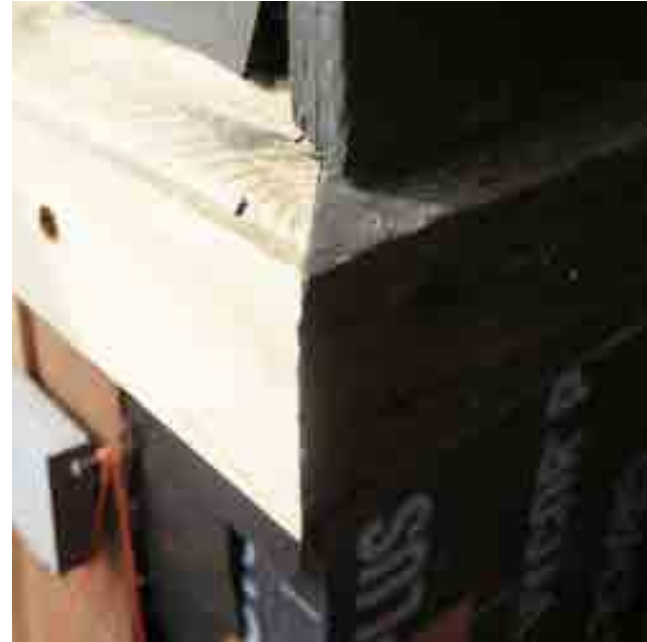
A NEWLY FABRICATED PIECE OF TRIM MEETS AN ORIGINAL THAT DID NOT REQUIRE REPLACEMENT

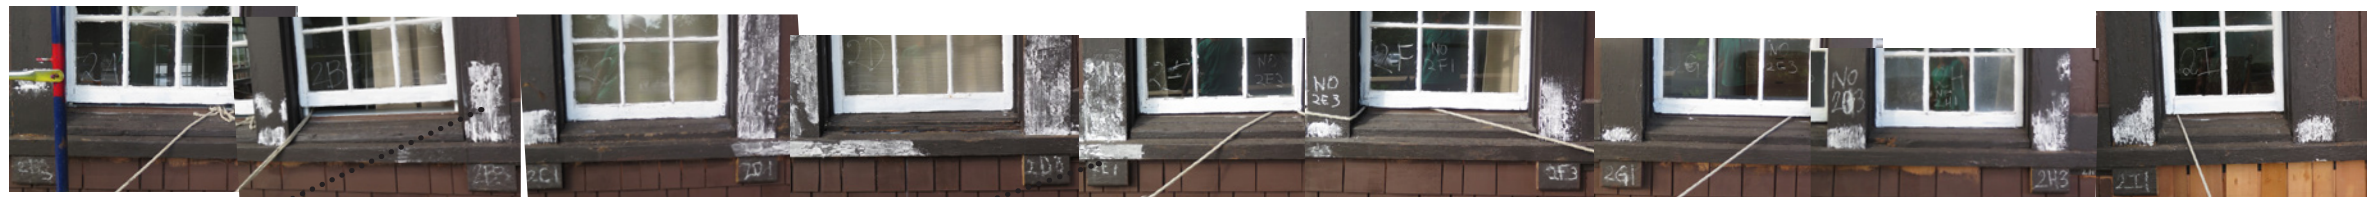
SECOND STORY WINDOWS, SHINGLES FULLY INTACT TO SILL

CAULKING SMOOTHS OUT ORIGINAL CASINGS THAT DID NOT REQUIRE REPLACEMENT

BELOW-SILL BLOCKS TRIMMED TO MATCH CASINGS WIDTH

NEWLY FABRICATED CASINGS

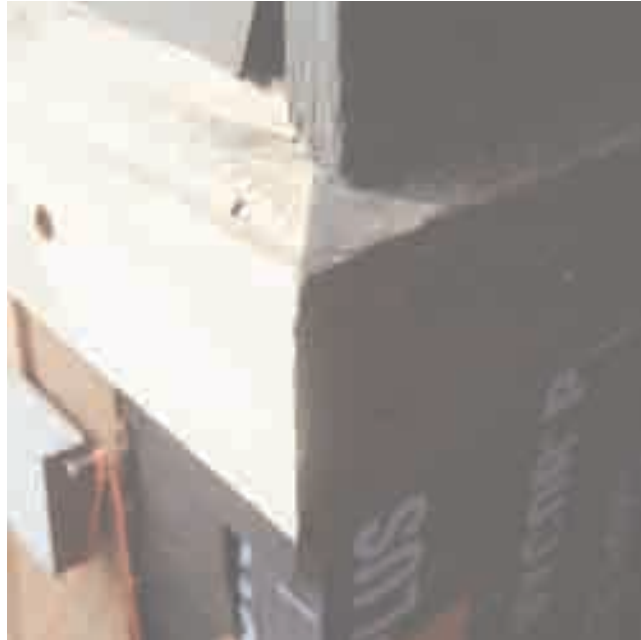
(DAY 13) A NEWLY FABRICATED PIECE OF TRIM MEETS AN ORIGINAL THAT DID NOT REQUIRE REPLACEMENT

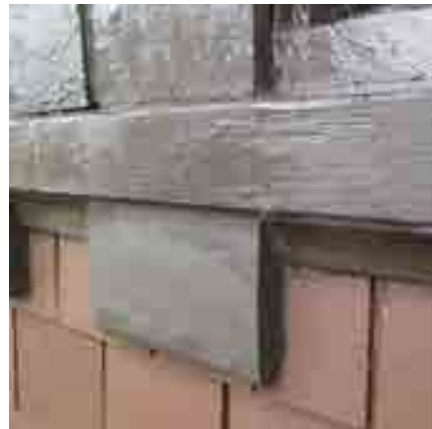
NEWLY FABRICATED BLOCKS  
BENEATH CASINGS

Missing blocks  
below 2nd story  
window casings  
are fabricated

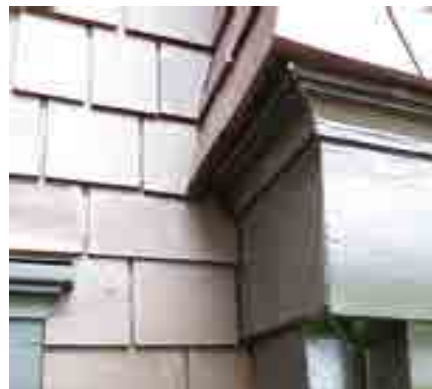
NEW SHINGLES MEET PORCH  
MOLDING

New shingles  
on south fa-  
cade are weaved  
with originals  
on east & west  
corners

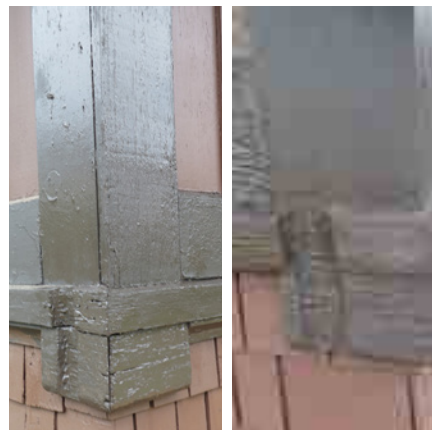
THE ORIGINAL EAST AND WEST  
CORNER BLOCKS HAVE CIR-  
CULAR CUT OUTS FOR WATER  
DRAINAGE PIPES WHICH NO  
LONGER EXIST. THE BLOCKS,  
HOWEVER, REMAIN.
