**ARCHITECTURAL ASSESSMENT, RECOMMENDATIONS & COSTS  
of  
HISTORIC STRUCTURES**

**MINERAL HILL MINE**

**JARDINE, MONTANA**

**OCTOBER, 2000  
(REVISED JANUARY, 2001)**

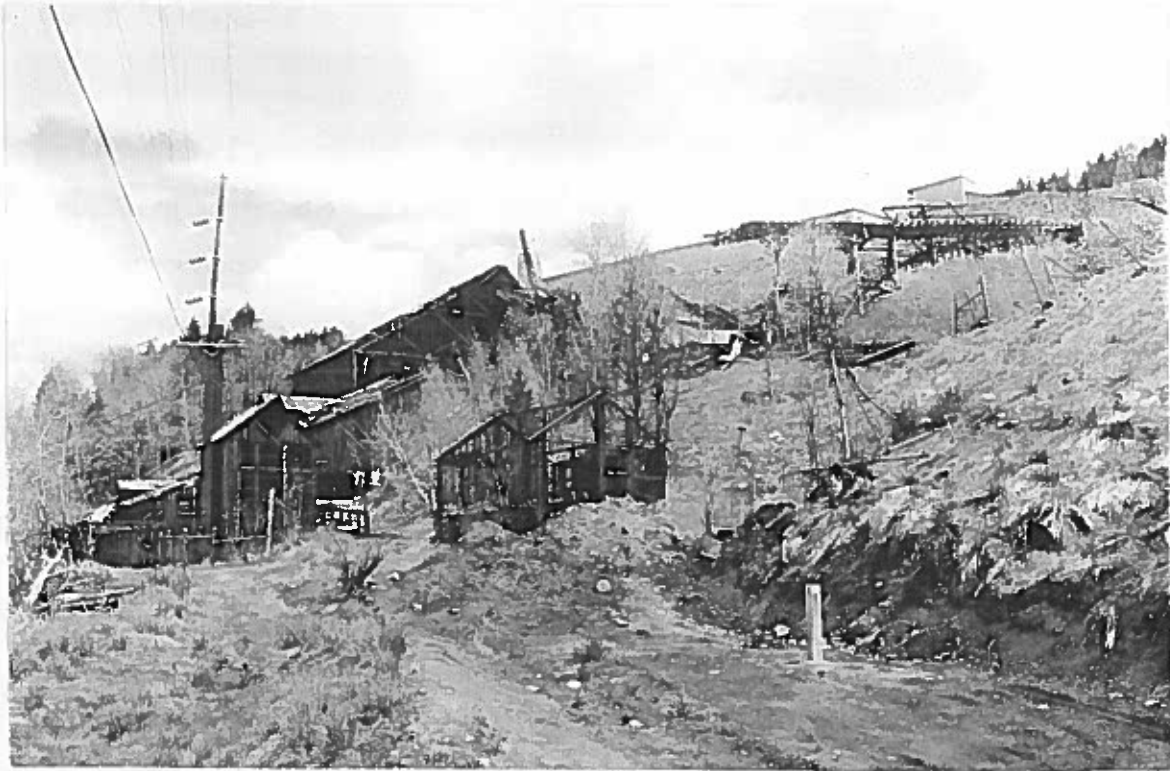
Figure 6: Looking northeast at the Revenue Mill area. Note that the upper parts of the ore bin and the connection to the tramway have collapsed.

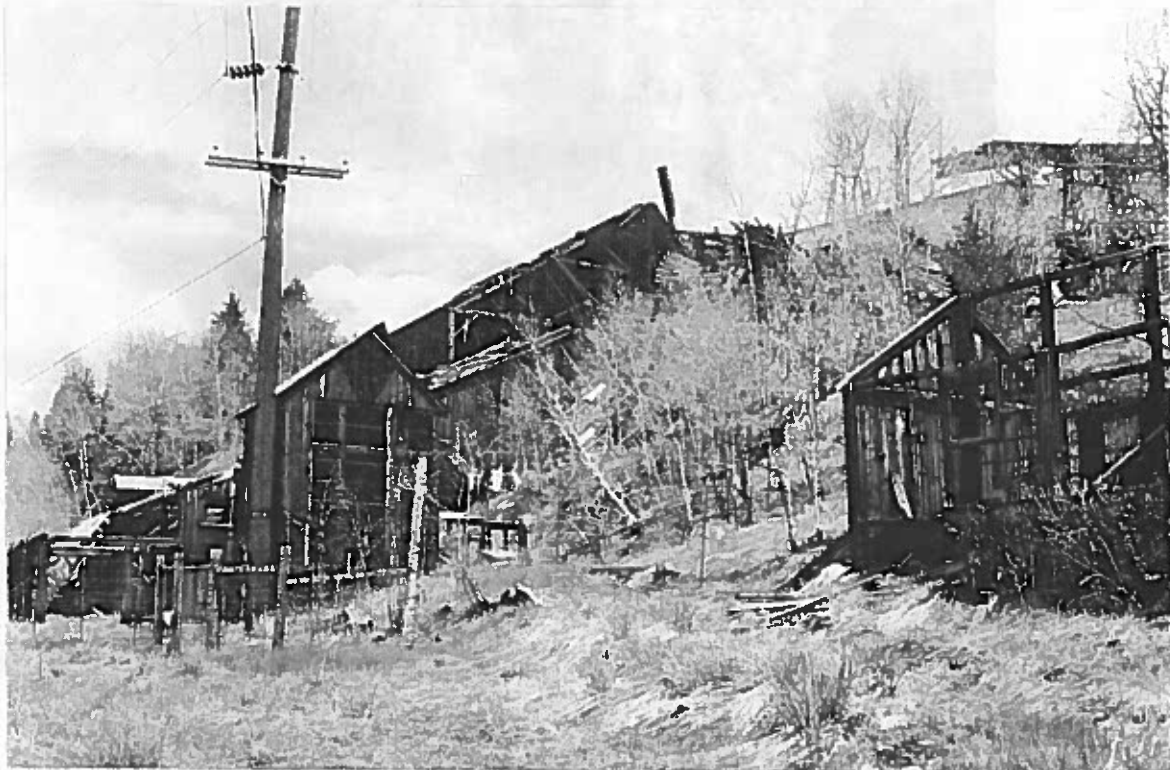
Figure 7: Looking northeast at the Revenue Mill. Note the fenced area around the mill to keep people out of the dangerous areas.

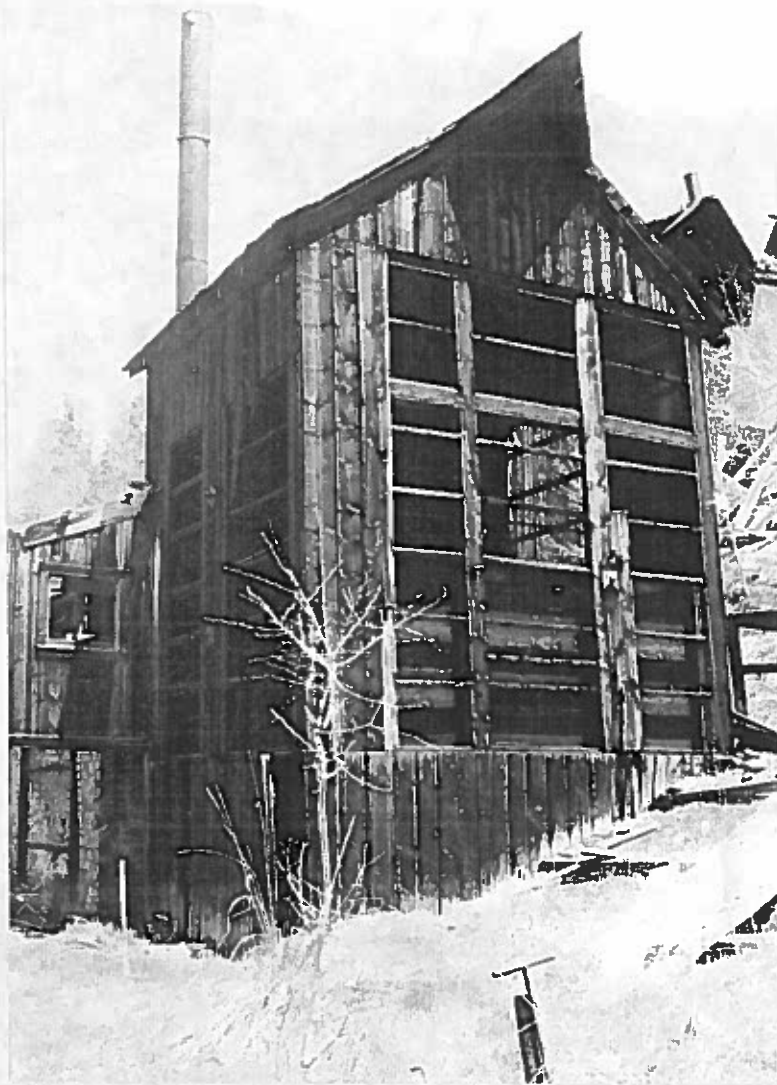
**Figure 8: Looking northeast at the coal bin for the lower boiler. Note the wood structure and siding which is in good condition. There is some rot at the bottom of the structure where the grade is against the building.**

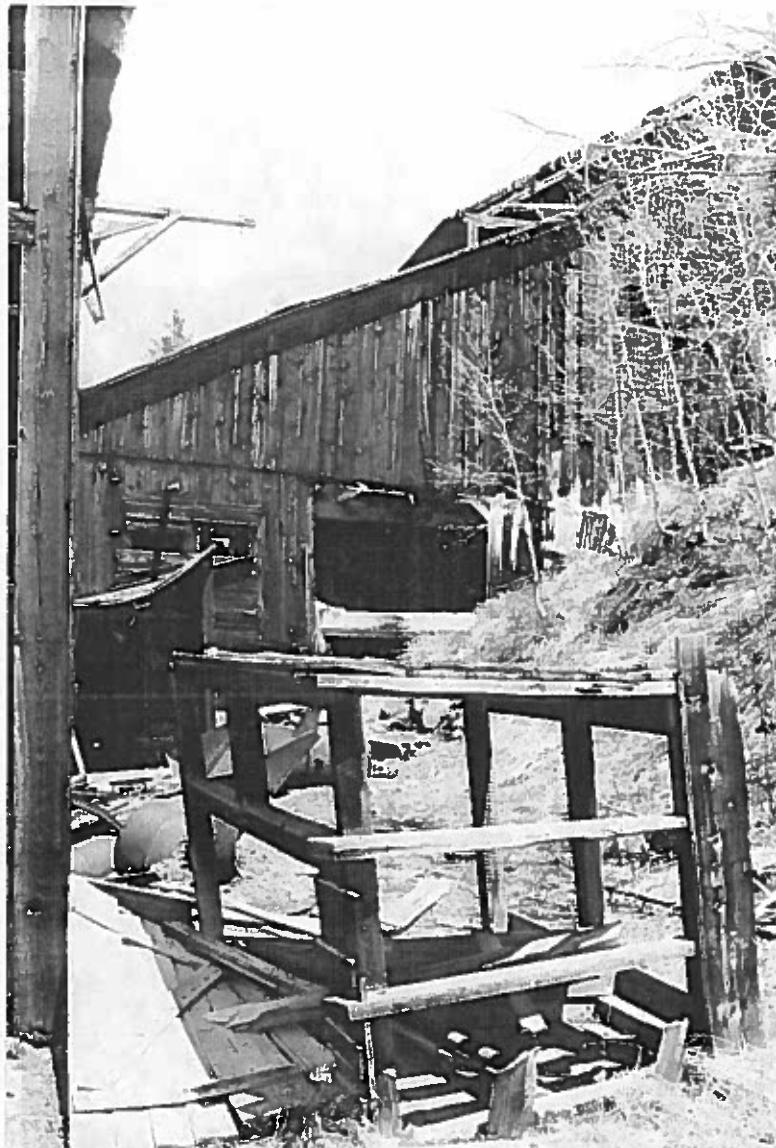
Figure 9: Looking northeast at the exterior of the floatation level of the Mill. Note the weathered wood on the siding but it appears to be dry and in good condition.

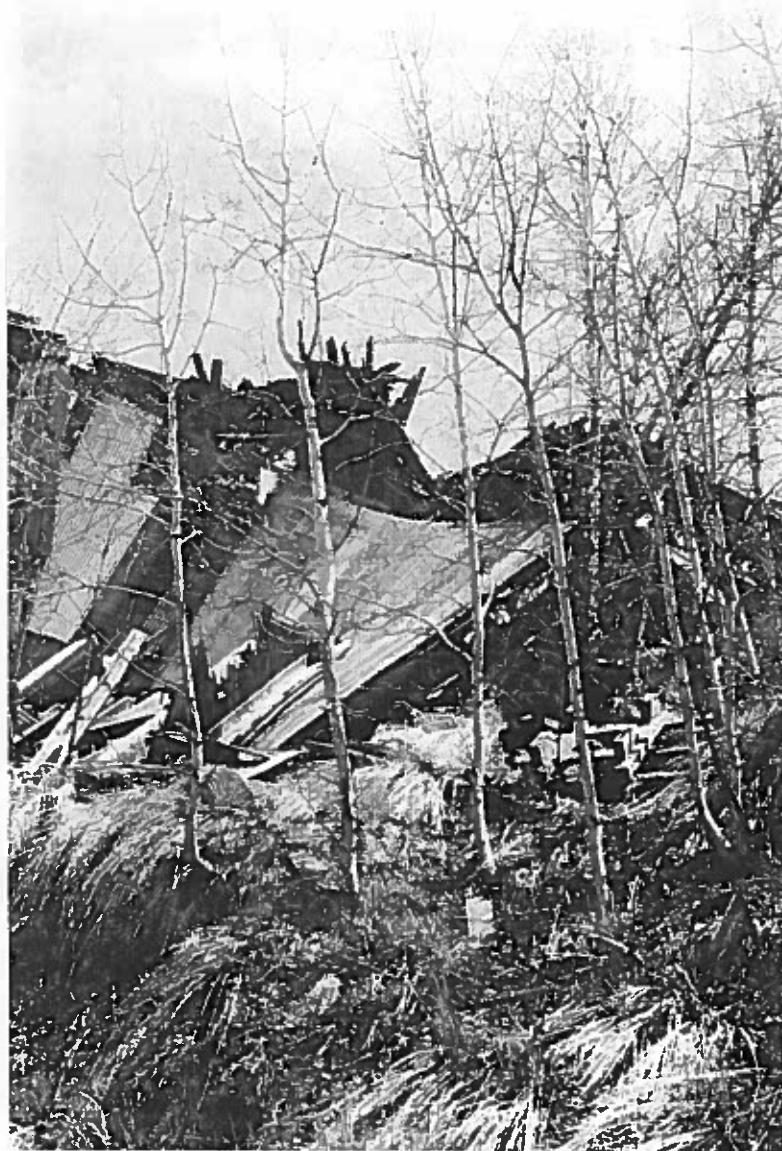
Figure 10: Looking east at the collapsed ore bin area of the Mill. Most of the roof structure and the top of the ore bins have collapsed on the south end of the building.

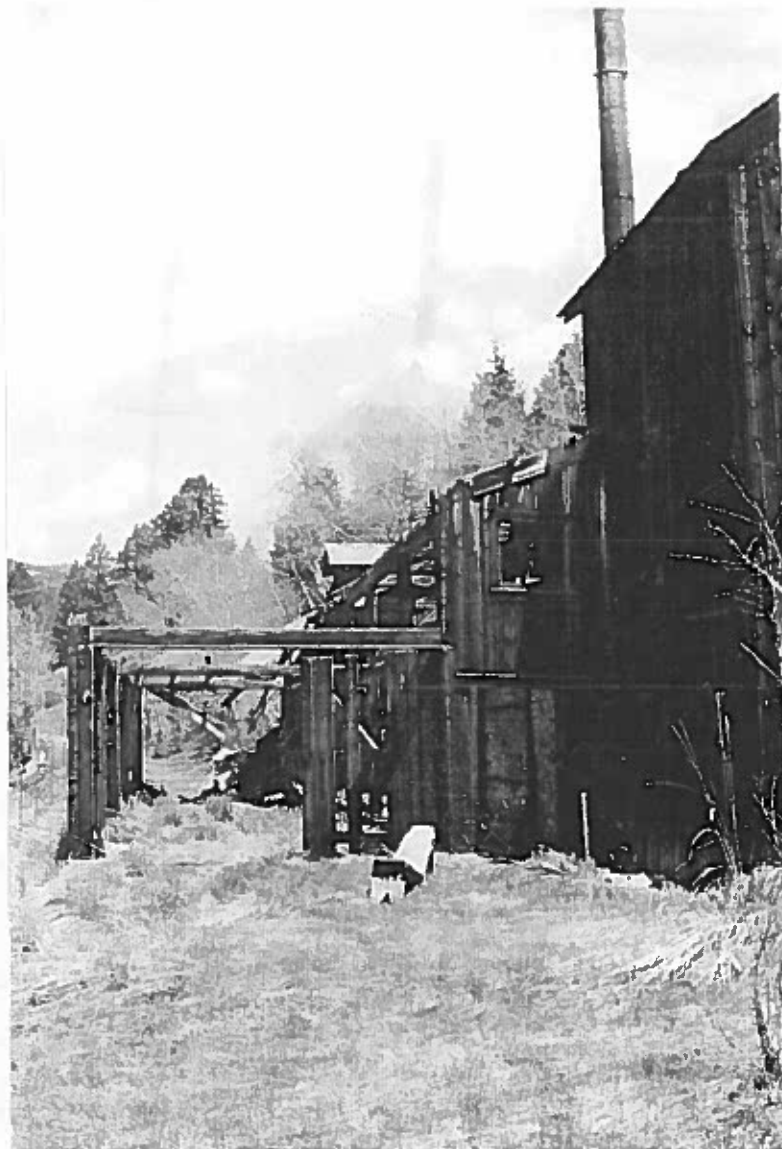
Figure 11: Looking north at the lower end of the Mill just past the boiler area. The structural timbers appear to be in good condition.

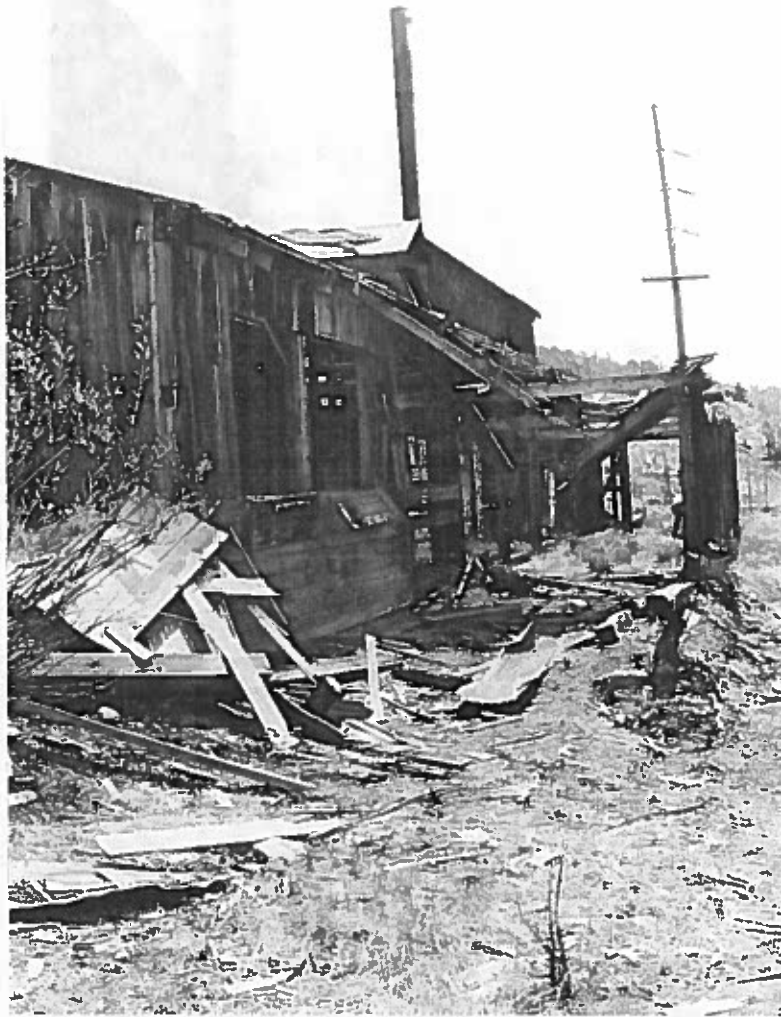
Figure 12: Looking south along the lower end of the Mill.  
Note the sections of collapsed roof and beams.

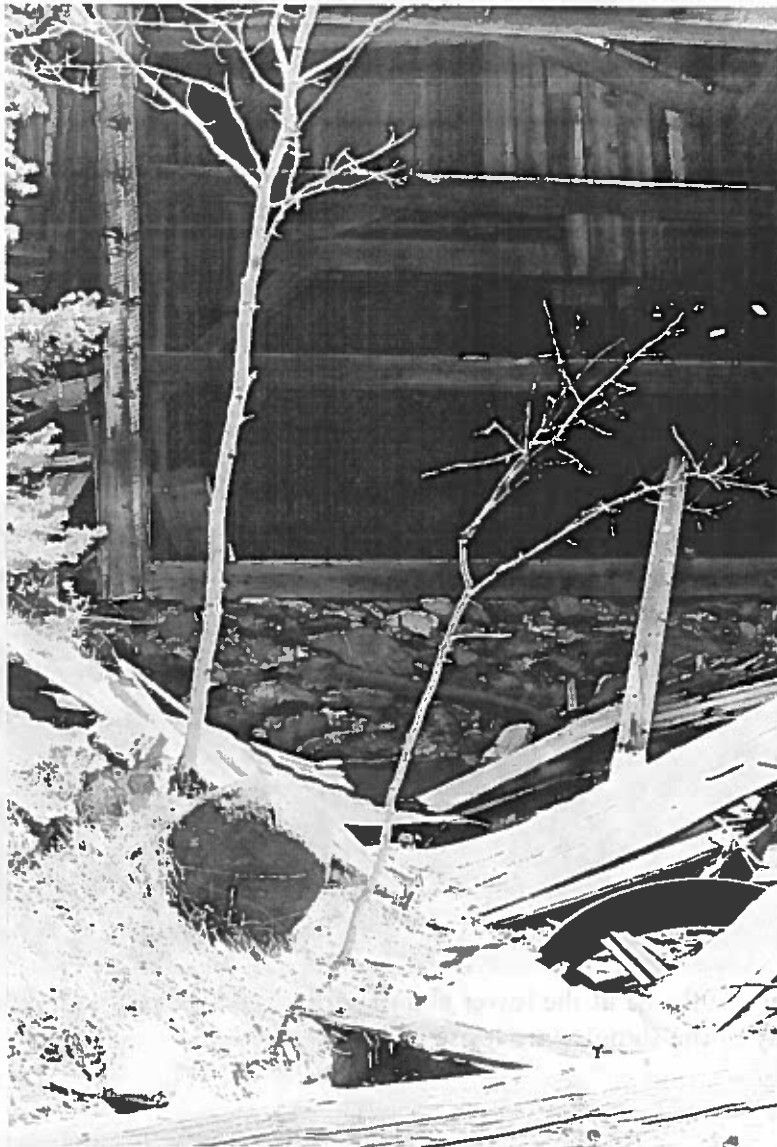
Figure 13: Looking east at a section of the wall at the lower end of the Mill. Note the stone foundation that occurs around the building. It is in good condition in this area with just some minor mortar loss.

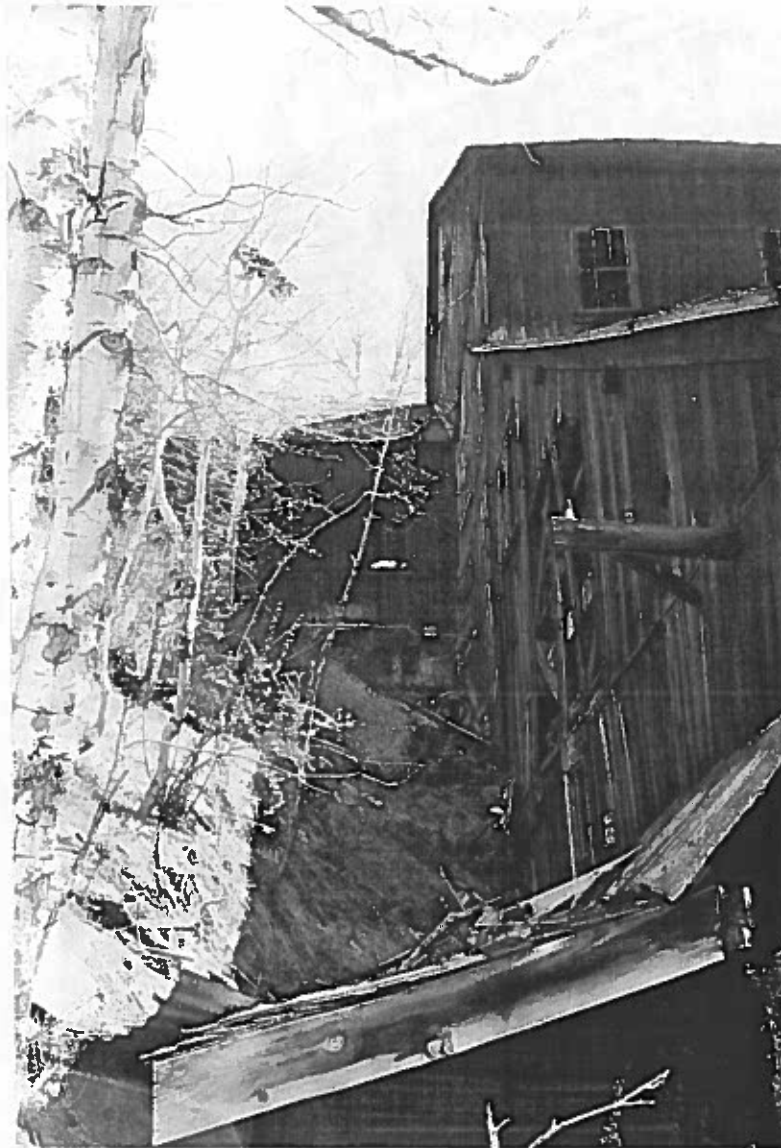
Figure 15: Looking east up along the north end of the Mill. Note the slope of the grade into the side of the building which is causing some deterioration of materials due to the water penetration.

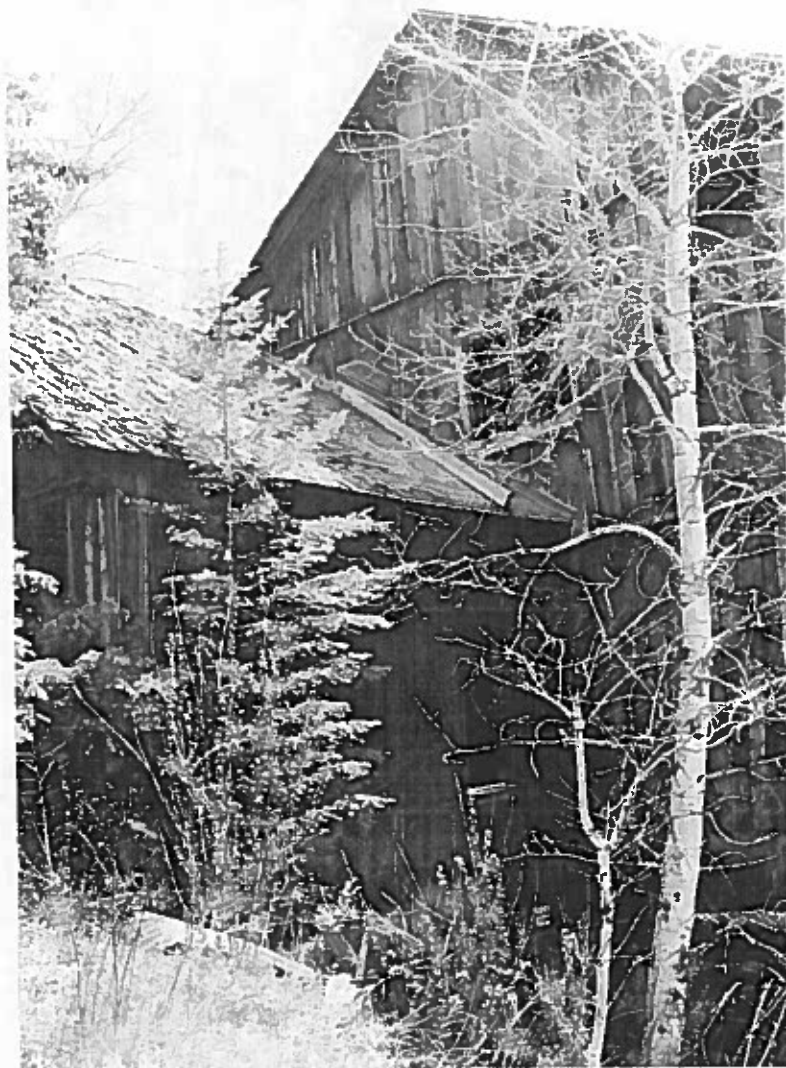
Figure 19: Looking southeast at the upper end of the Mill near the ore bins and the boiler area. The materials are very similar all around the building.

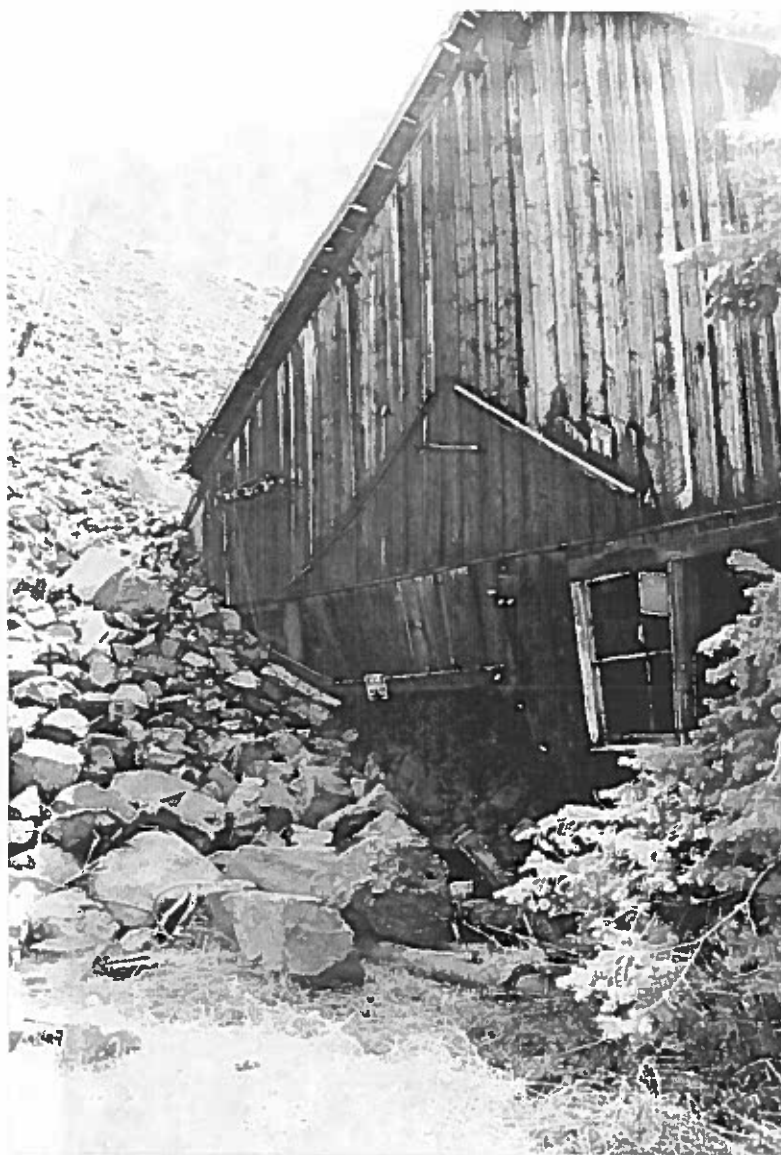
Figure 20: Looking southeast at the upper end of the Mill.  
Note the rock from the creation of the upper parking lot that  
has crushed the end of the building.

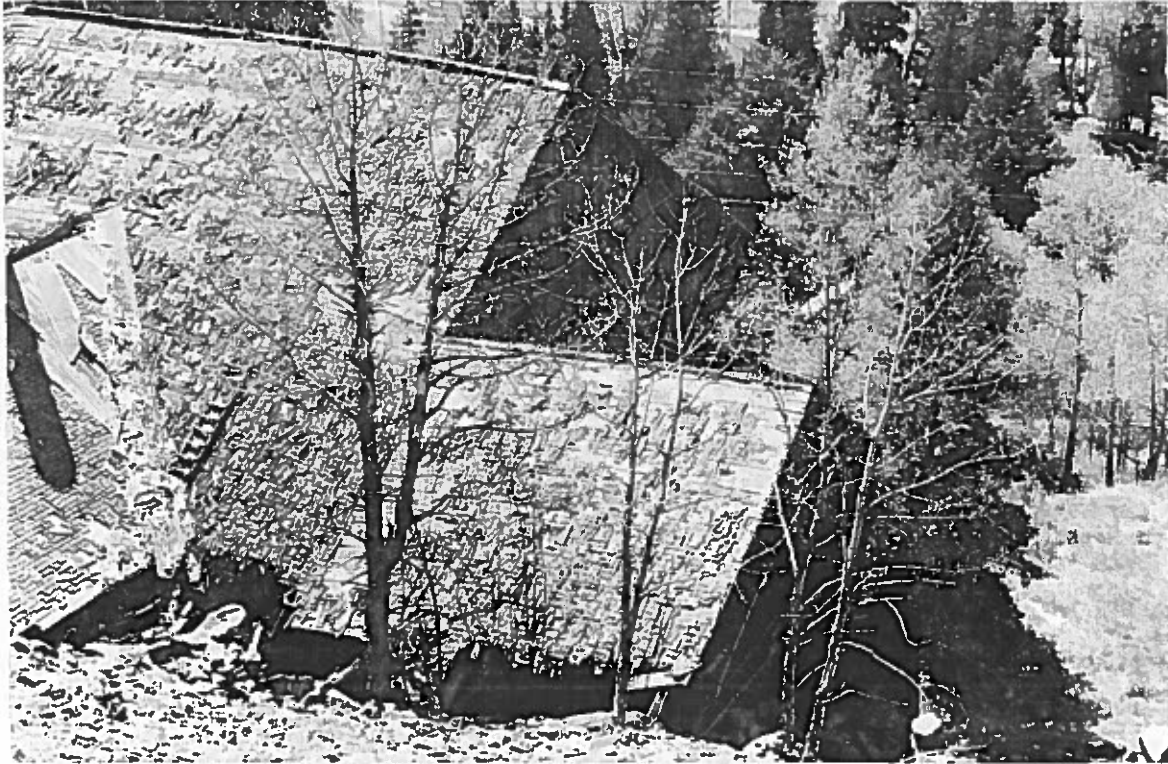
Figure 21: Looking southwest at the roof of the Mill from the upper parking lot. Note the missing and deteriorated wood shingle roof. The eave of the roof has been crushed from the rock.

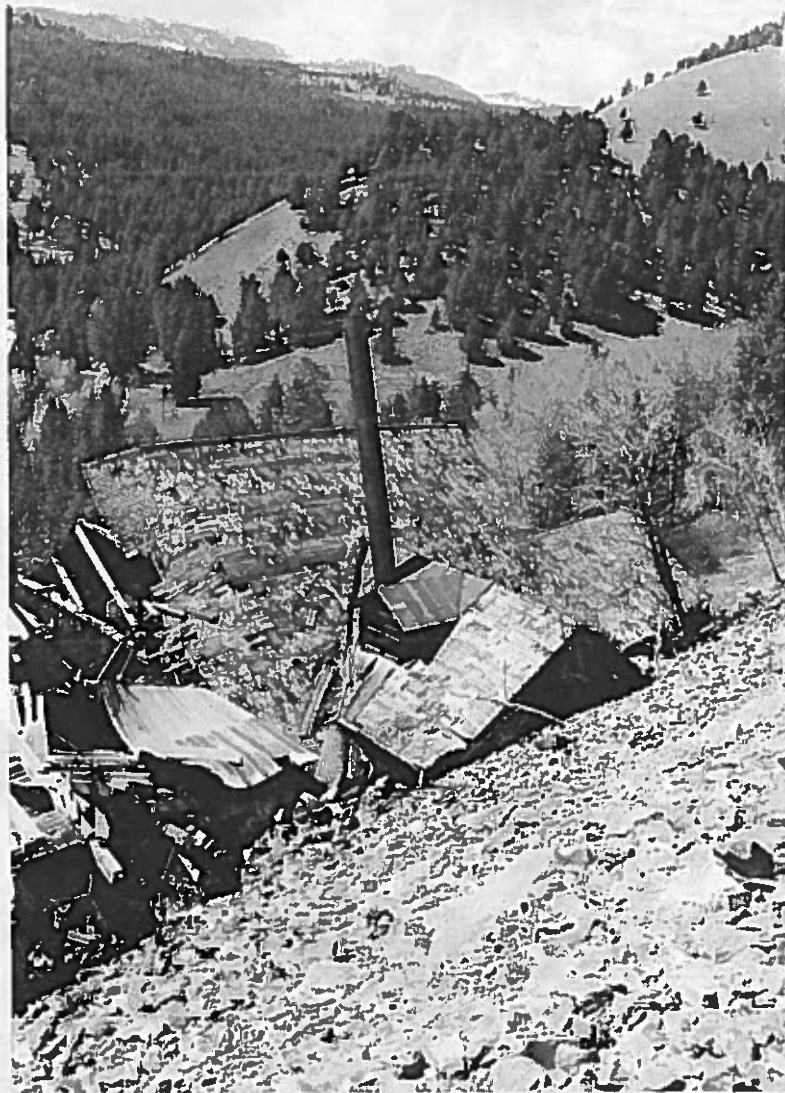
Figure 23: Looking northwest at the roof of the upper part of the Mill. Note the collapsed area around the ore bins to the left.

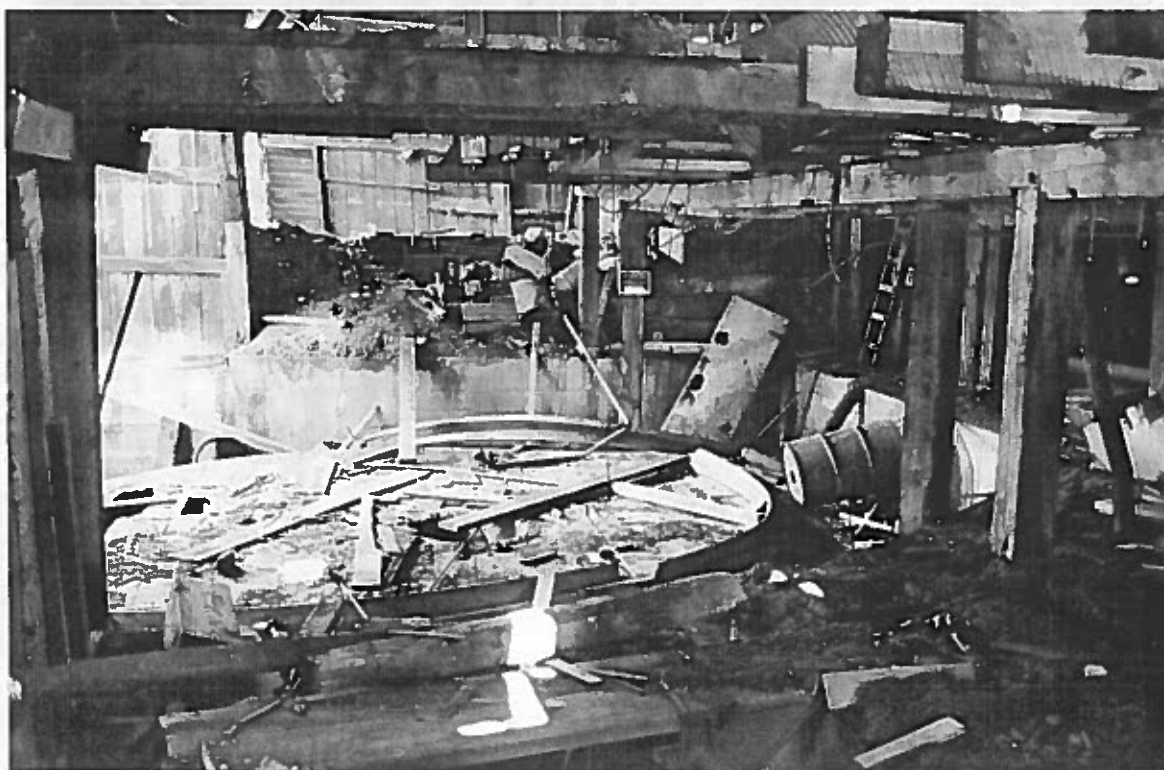
Figure 27: Looking west at the lower floatation area. The structure appears to be in good condition.

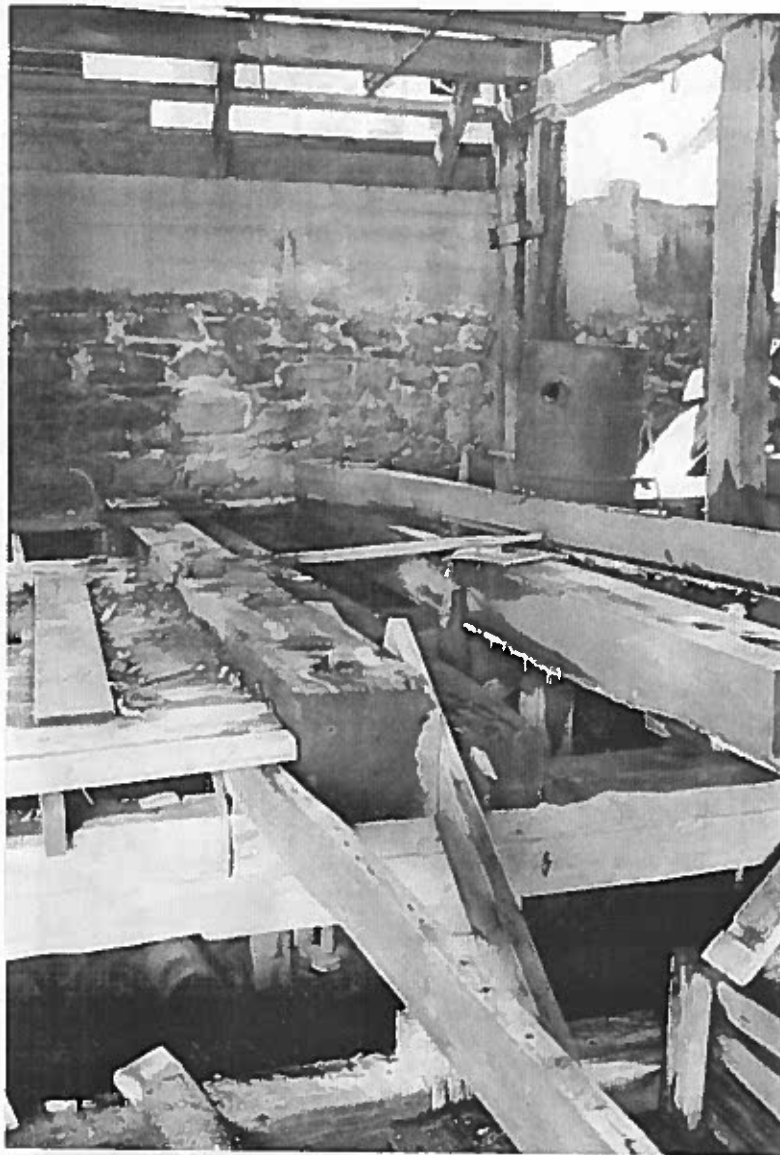
Figure 30: Looking northeast at some of the floor beams in the second level of the Mill. Also note the stone and concrete foundations that are in good condition.

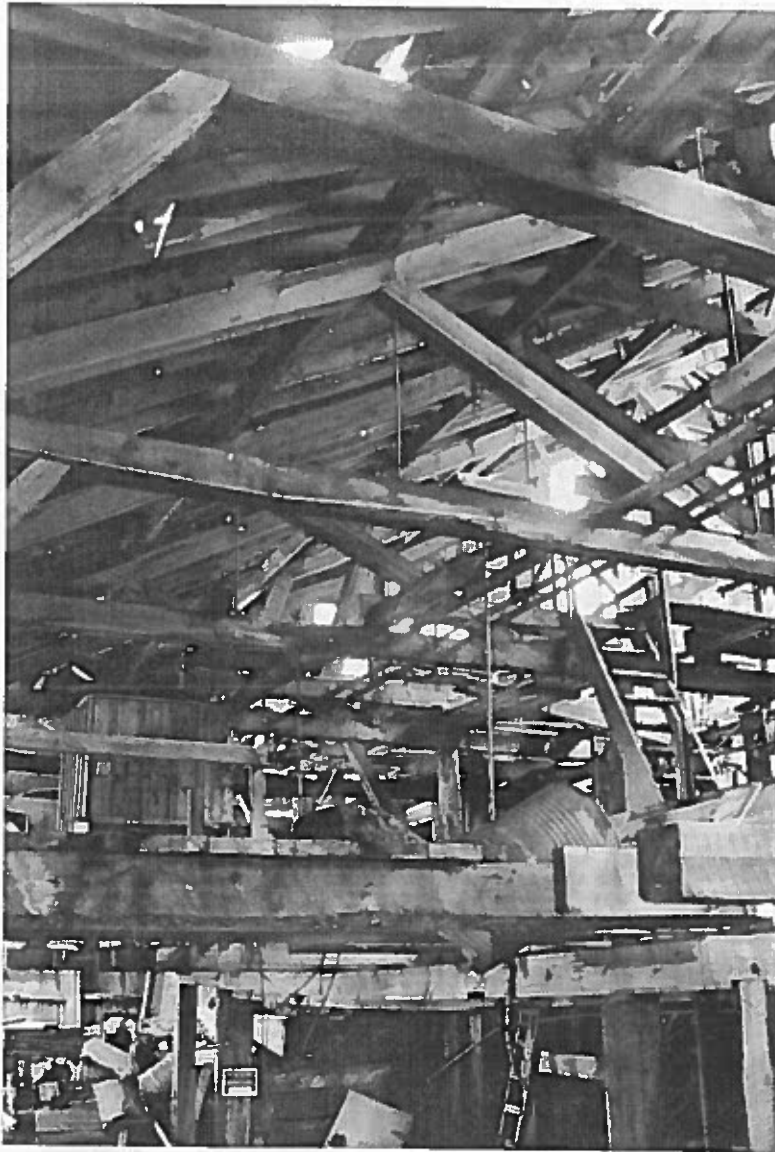
Figure 31: Looking northeast at the wood truss structure over the floatation area. The trusses appear to be intact and in good condition. There is some minor rot in the wood because of holes in the roof however it does not appear to be a problem.

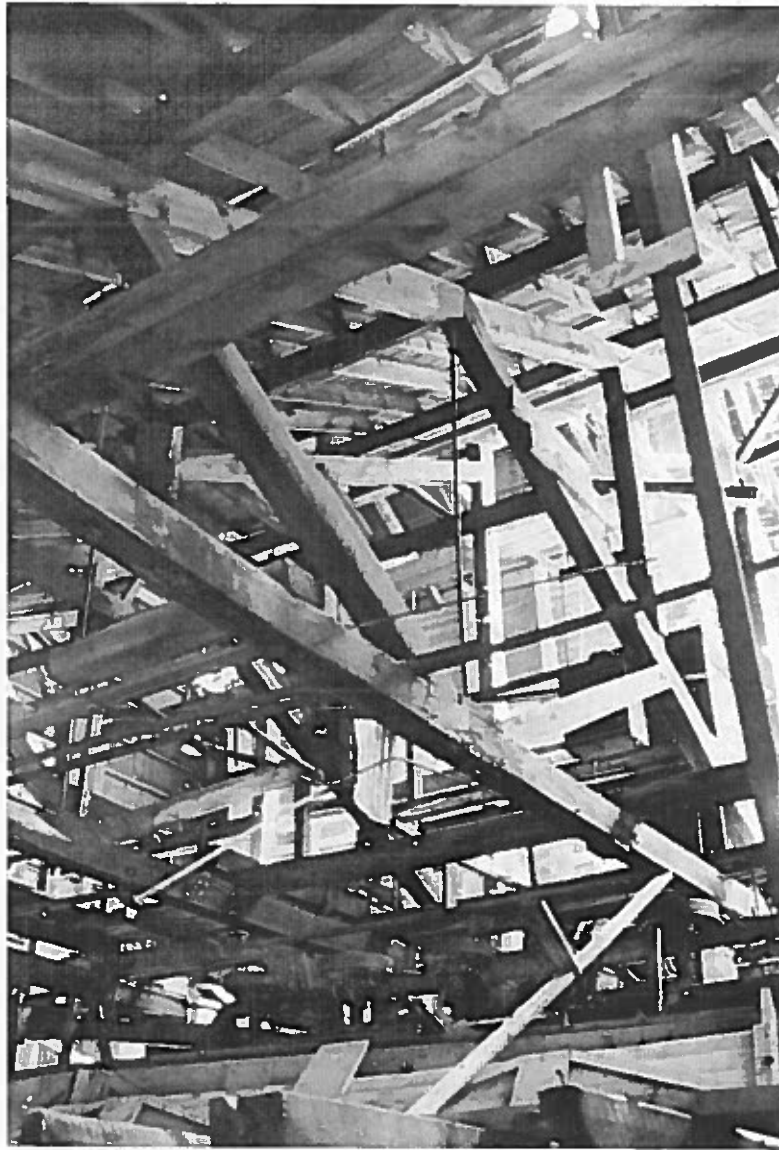
Figure 32: Looking east at the wood truss structure over the stamp and ball mill area. These trusses also appear to be in good condition with the exception of the south end that have collapsed.

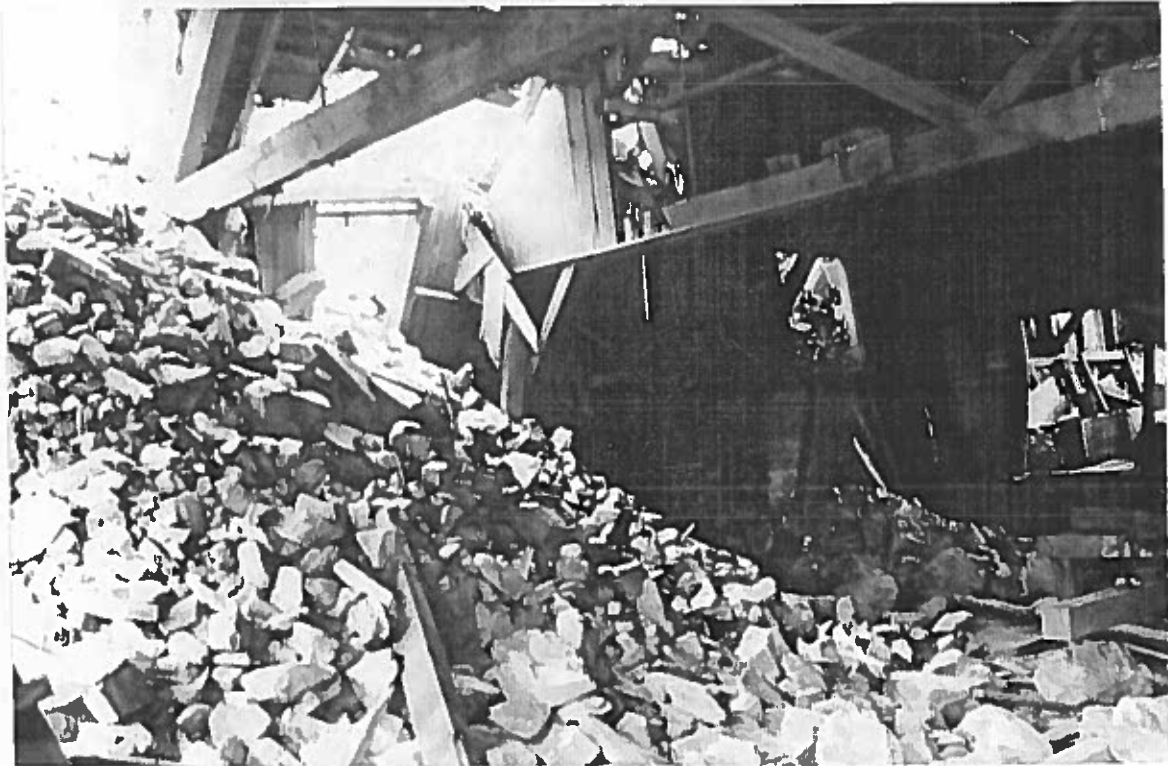
Figure 35: Looking southeast at the crushed wall on the upper end of the Mill when the rock was placed here for the parking area above. The main wall was pushed in and off its foundation.

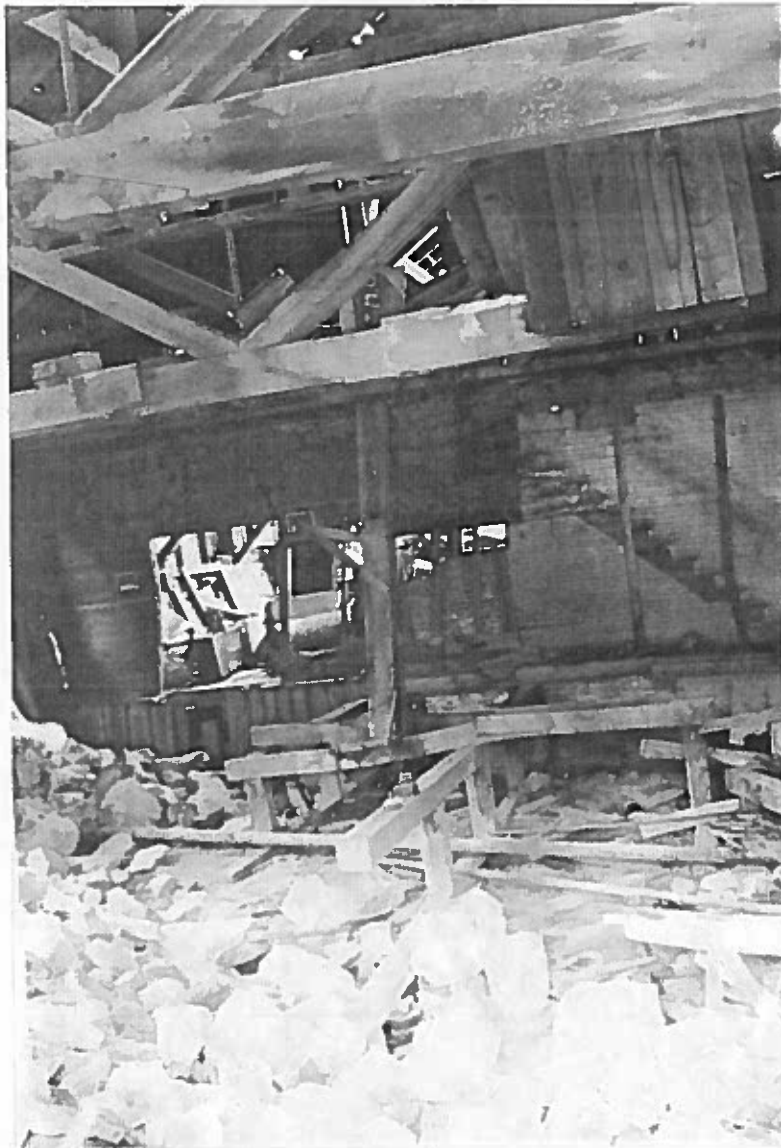
Figure 36: Looking south towards the upper boiler room on the upper end of the Mill. The rock is from the base for the parking lot that has rolled into the structure. The center section of the structure appears to be in good condition.

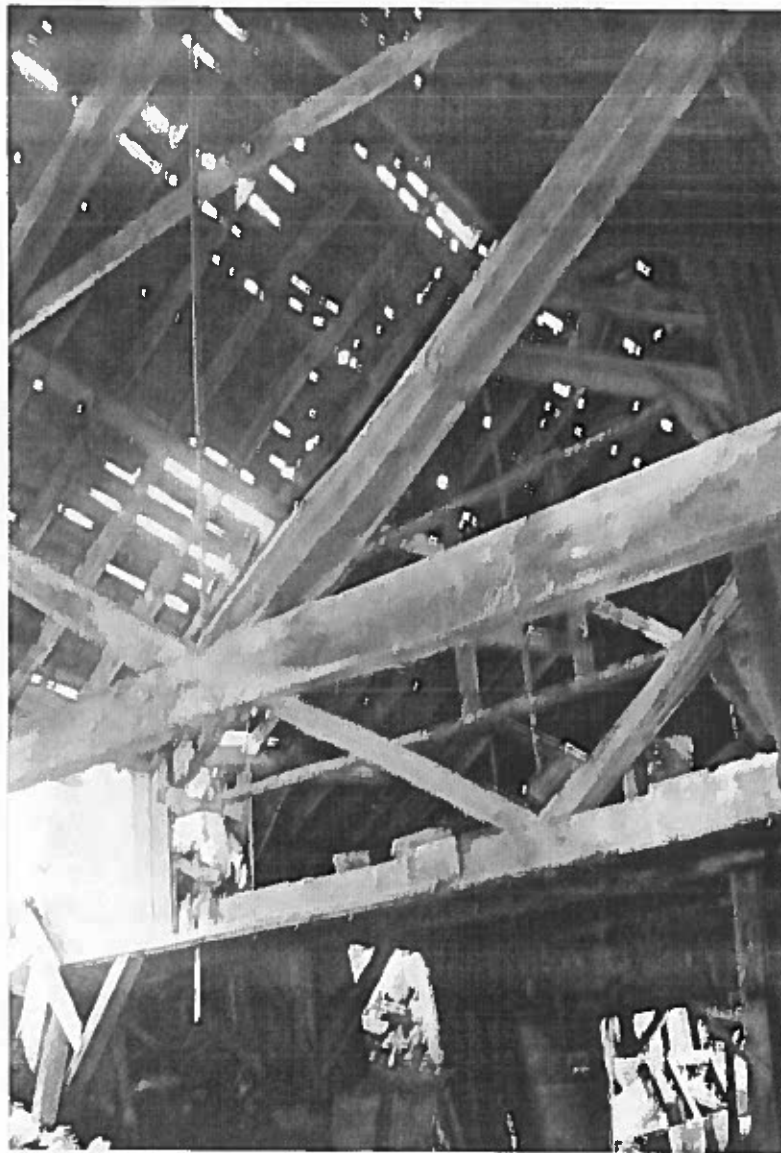
Figure 37: Looking south at the roof truss structure in the upper end of the Mill. The trusses even though not supported very well on the east end of the building, appear to be in good condition.

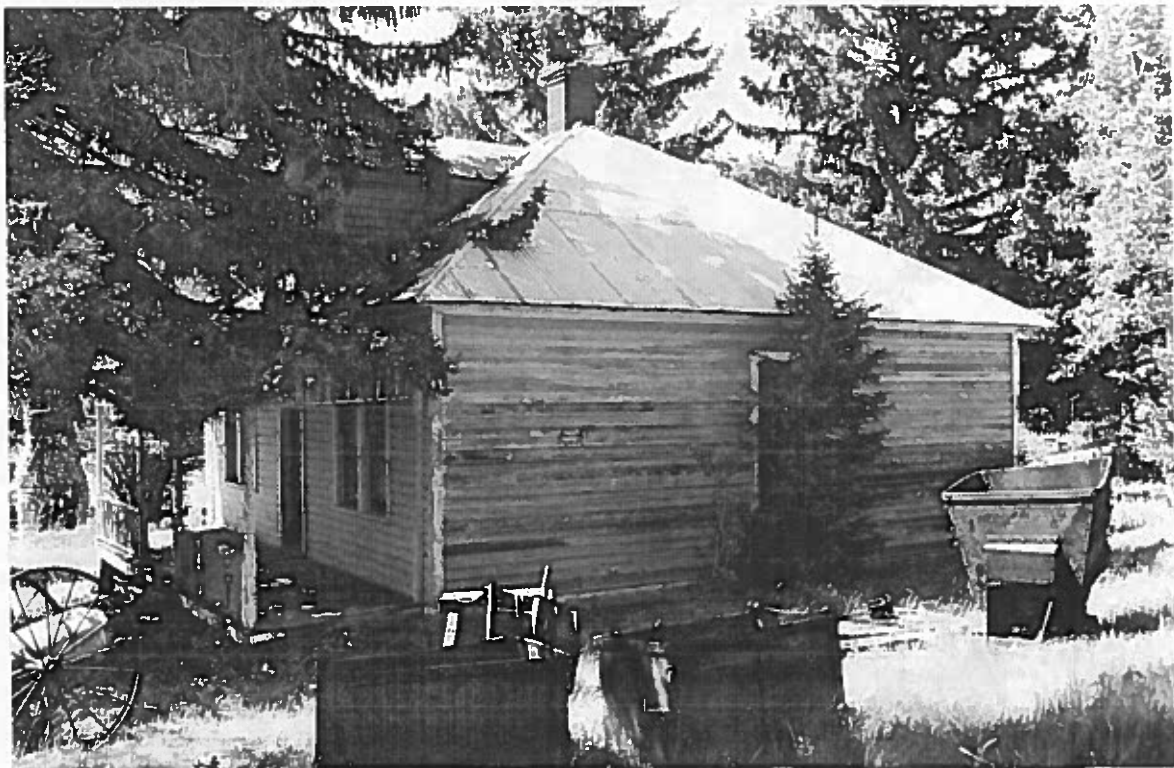
Figure 40: Looking northwest at the Bush Guest House. Note the high grade against this side of the building, the tree against the foundation, and the weathered siding.

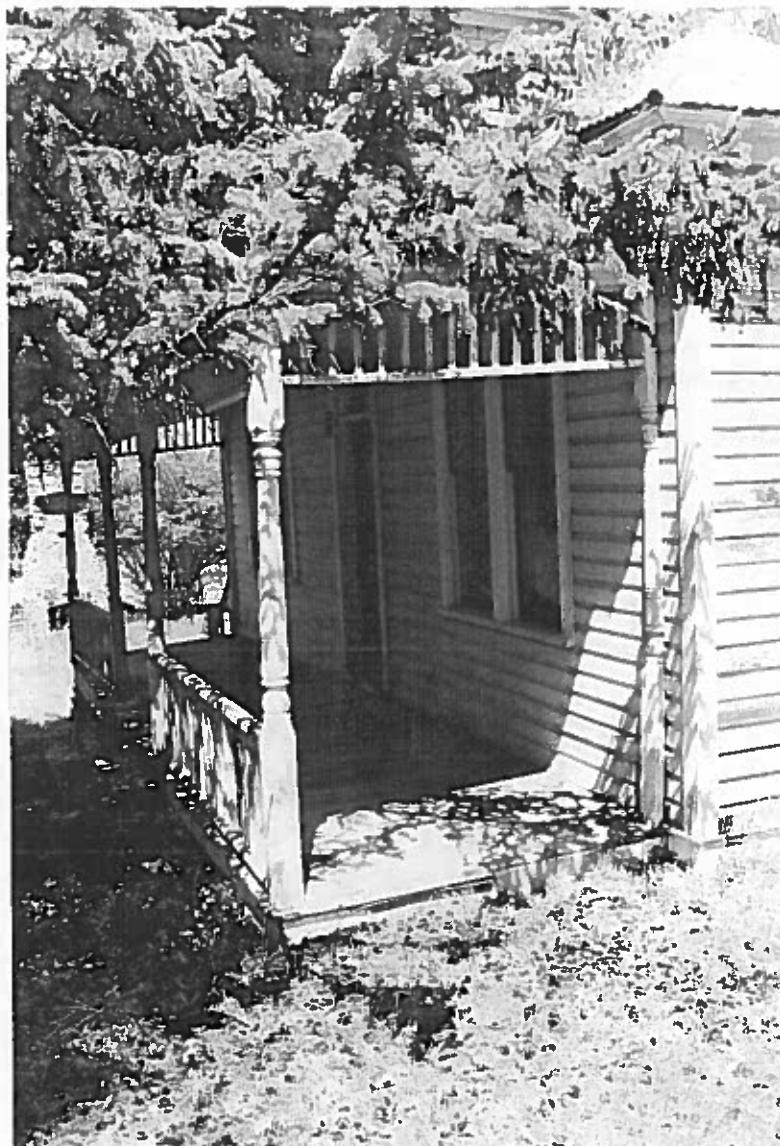
Figure 42: Looking west at the porch of the building. The structure is rotted due to the high grade around this end of the building. The turned columns, railings, and roof are in good condition.

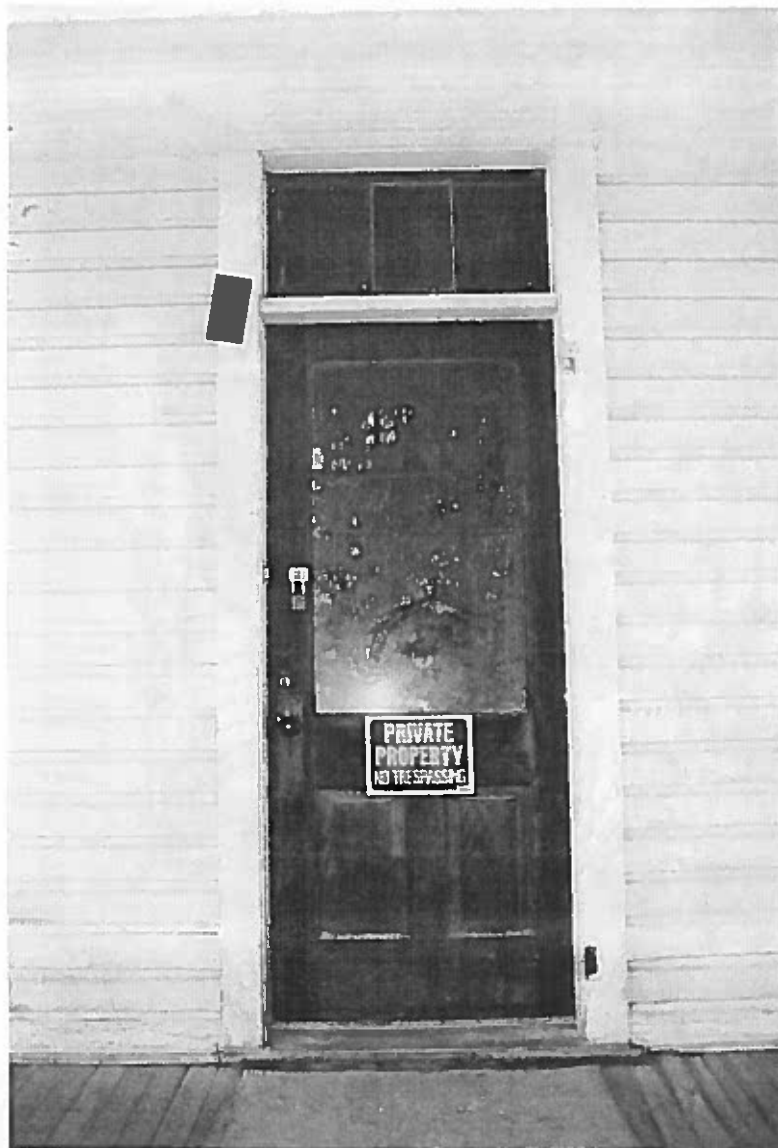
Figure 43: Looking north at the entrance door to the building. The door is worn and there is some minor deterioration at the base of the door and trim, due to moisture. Other than that the materials are in good condition.

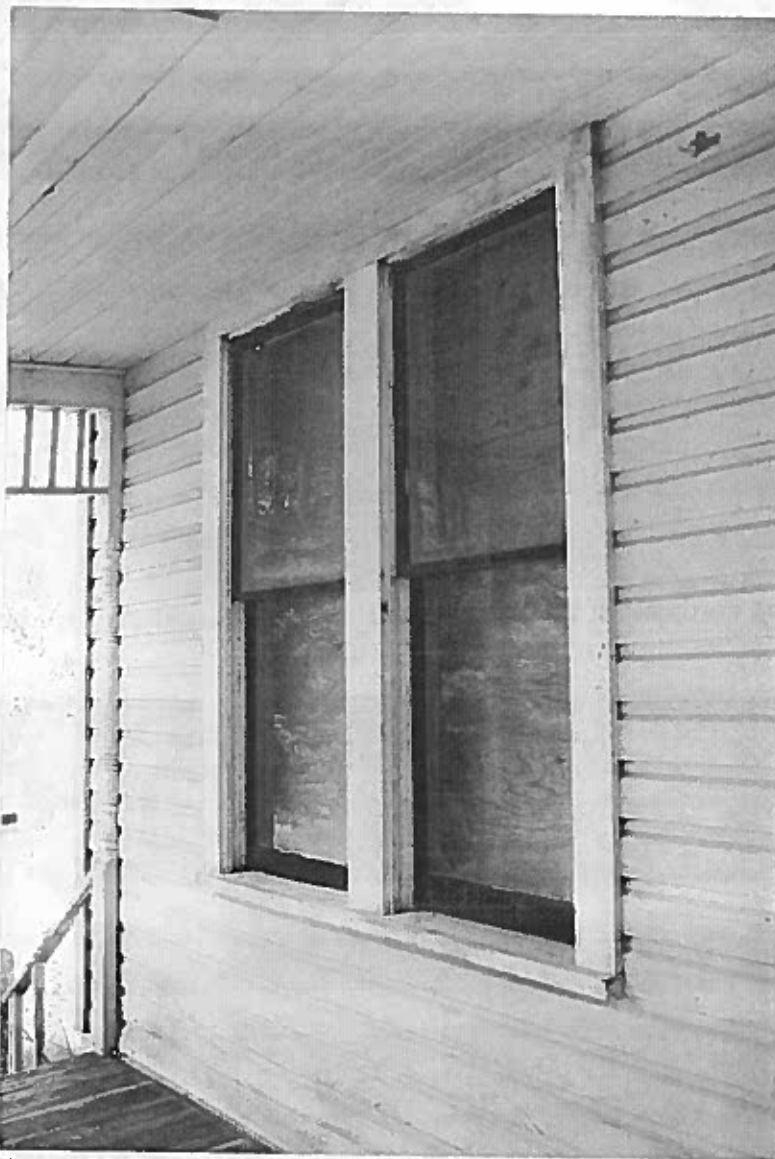
**Figure 44:** Looking northwest at a typical wood double-hung window on the porch. There is some weathering of the sill and bottom sash but is generally in good condition.
