**ARCHITECTURAL ASSESSMENT, RECOMMENDATIONS & COSTS  
of  
HISTORIC STRUCTURES**

**MINERAL HILL MINE**

**JARDINE, MONTANA**

**OCTOBER, 2000  
(REVISED JANUARY, 2001)**

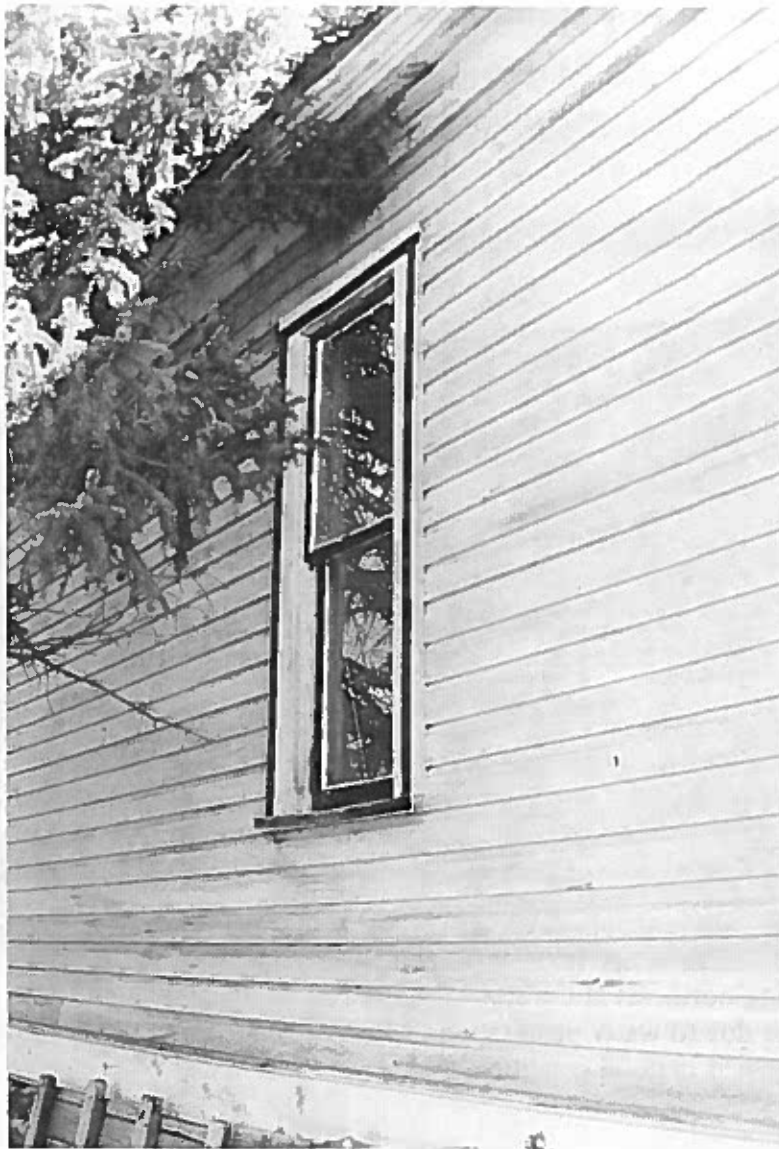
Figure 47: Looking northeast at a typical wood double-hung window on the house. Note the weathered sill, trim and wall siding.

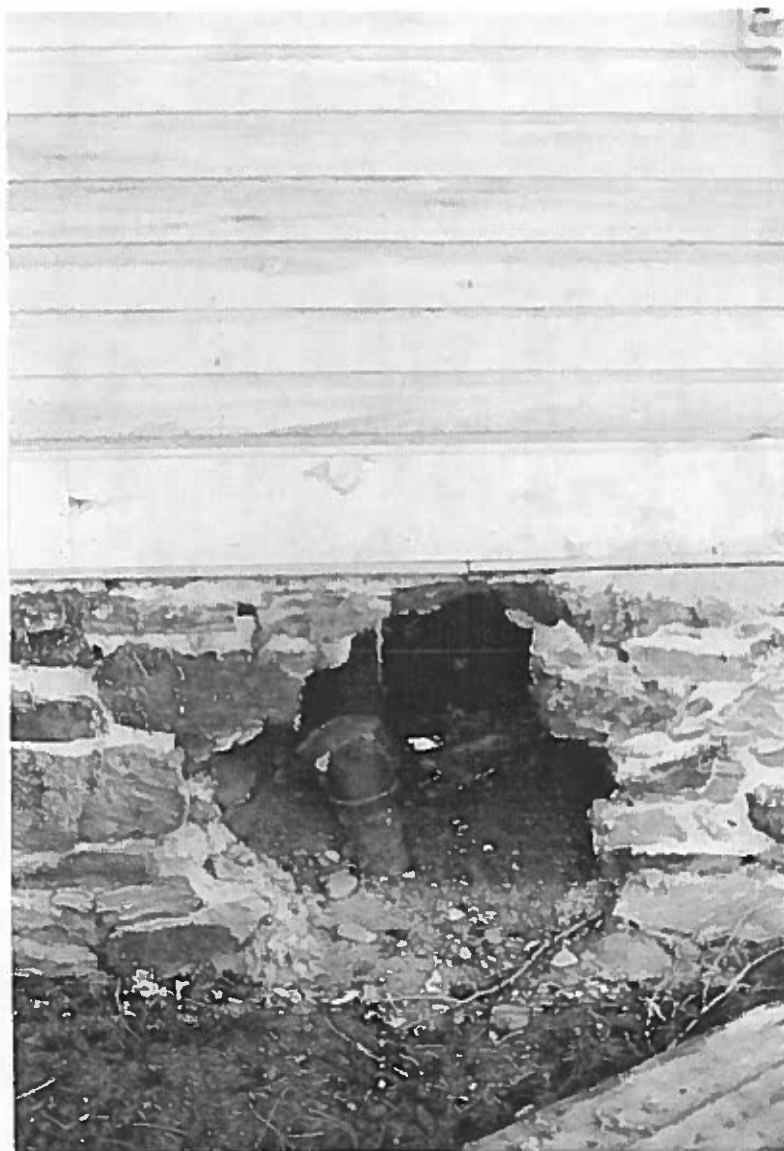
Figure 49: Looking east at the hole in the foundation on the west side where a later drainage system was added. Note the pipe in the opening. As the piping goes through the center foundation walls a large area of the stone foundation was removed causing the chimney structure to settle.

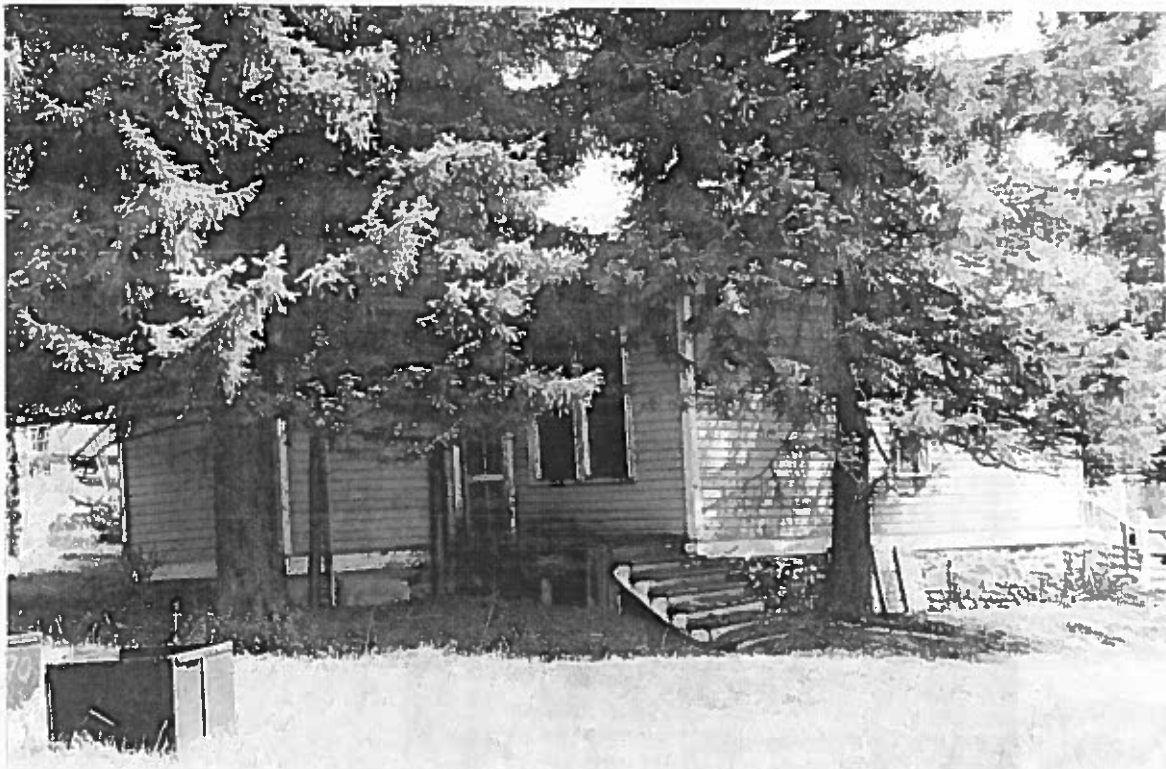
Figure 51: Looking southeast at the Bush House. The trees are causing some damage to the roof of the structure.

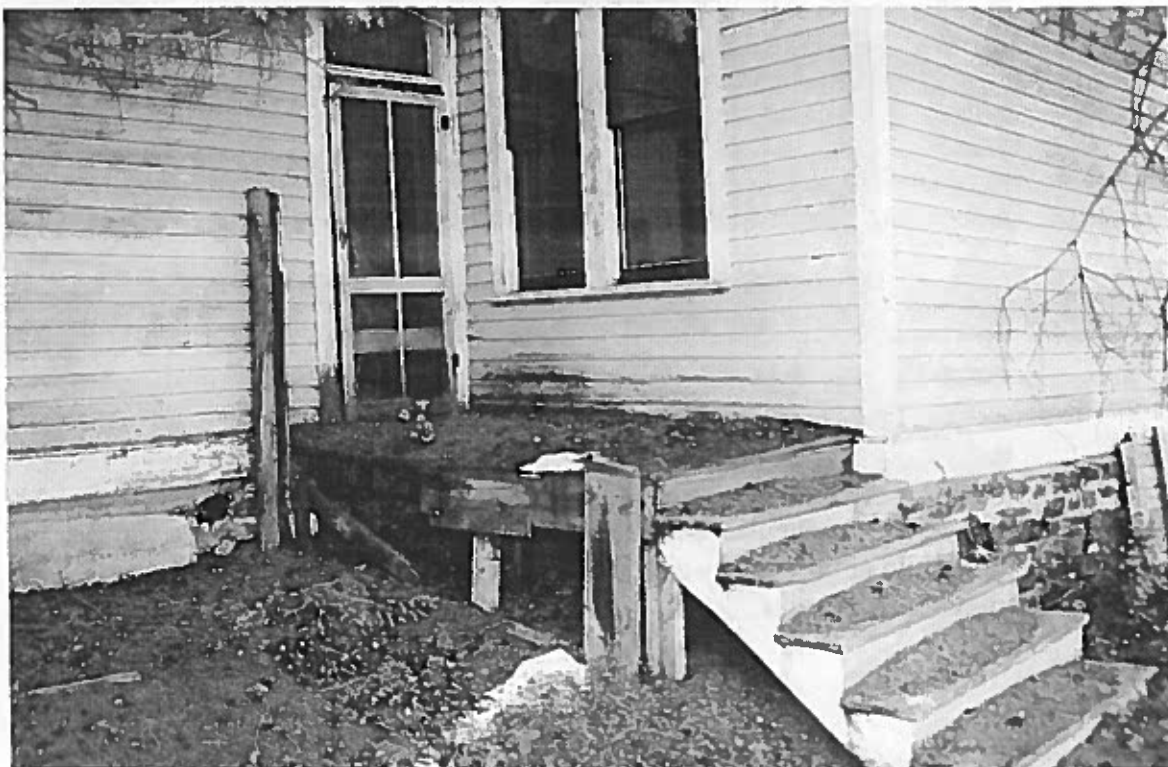
Figure 52: Looking southeast at the back porch of the house. Note the deteriorating porch and the rot along the siding and at the base of the door. The rest of the siding and trim is weathered.

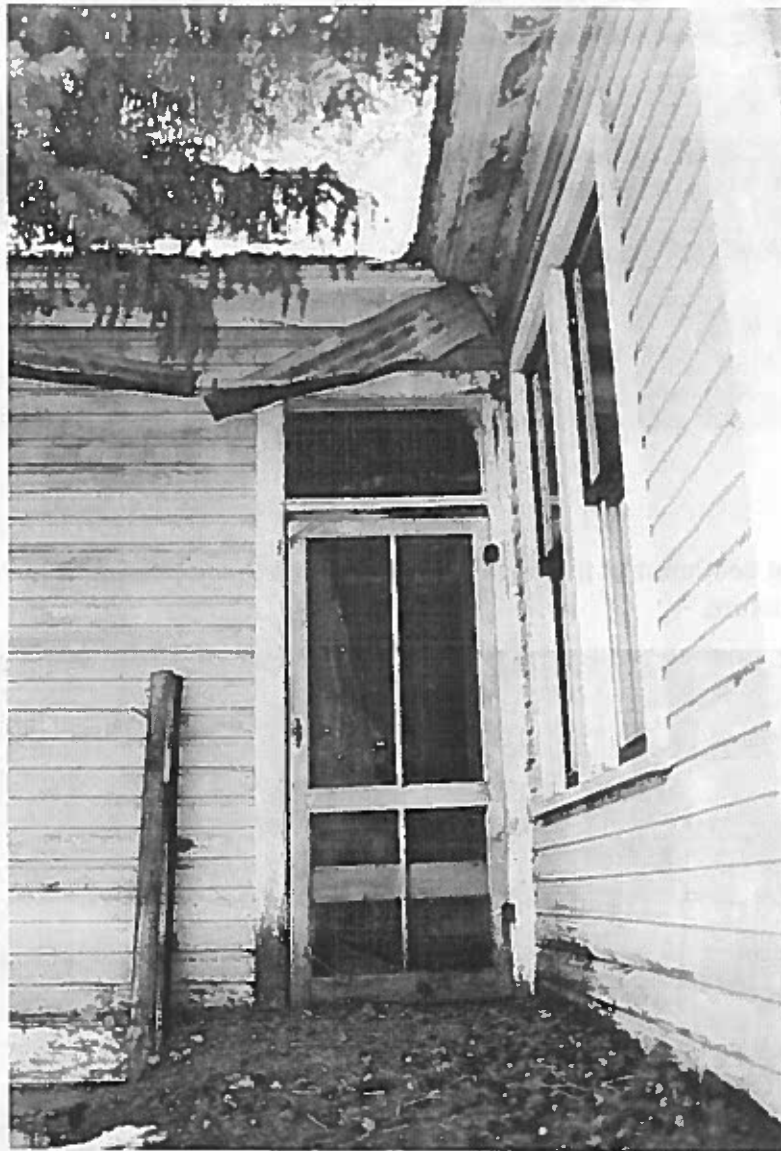
Figure 53: Looking east at the back door. Note the failing gutter along the eave and the rotted soffit due to some previous roof leaks.

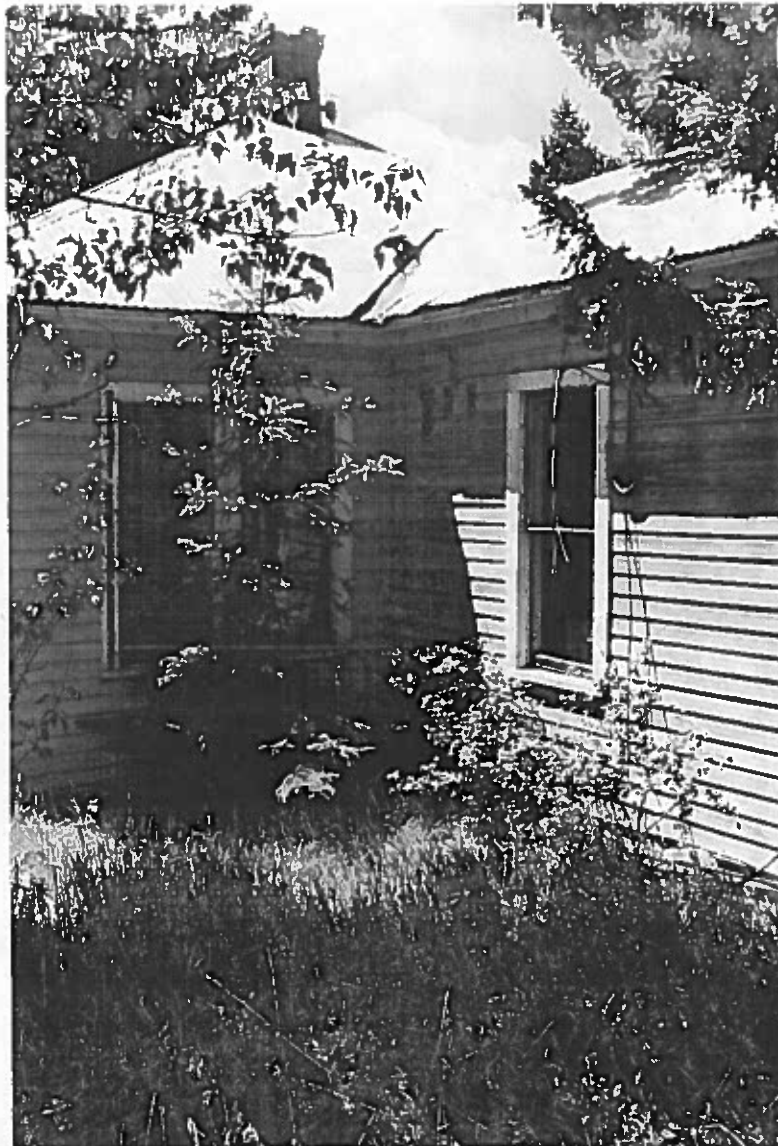
Figure 54: Looking southwest at the back of the Bush House. Note the shrubbery and high grade against the building. The base trim is coming off the building on the right.

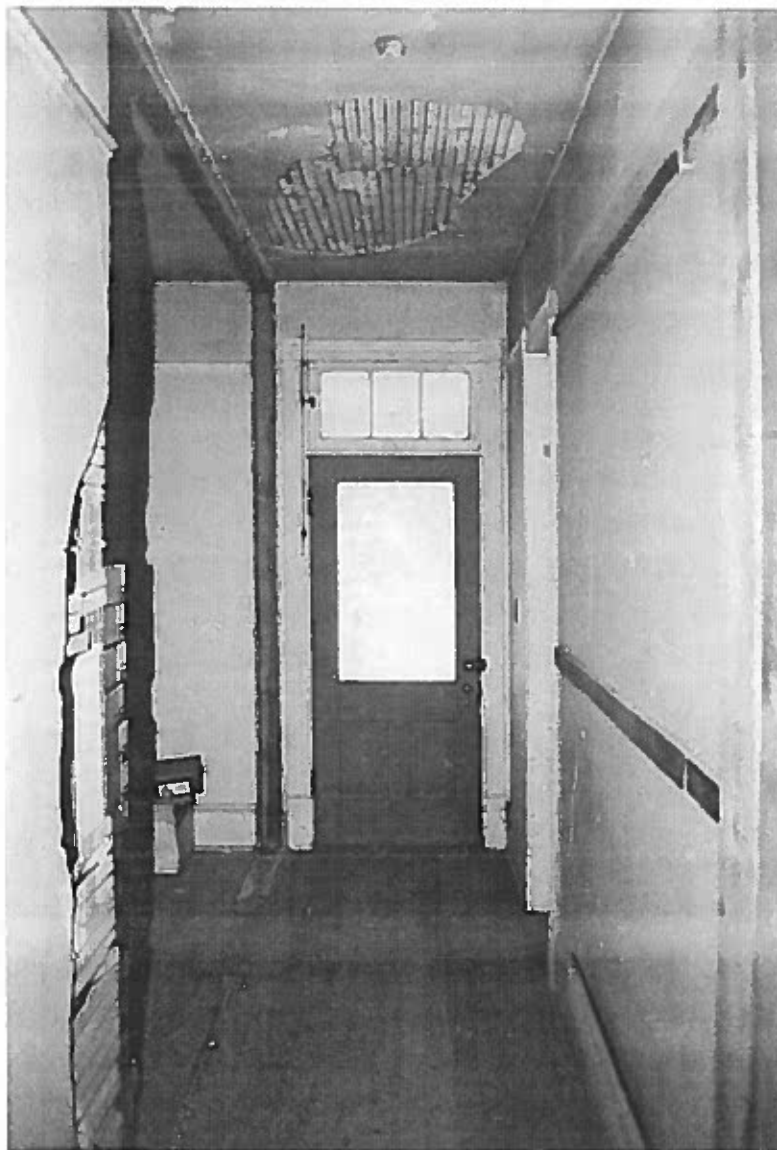
Figure 55: Looking south at the entrance to the building.  
Note the wall to the left that has been removed and the plaster  
missing from the ceiling.

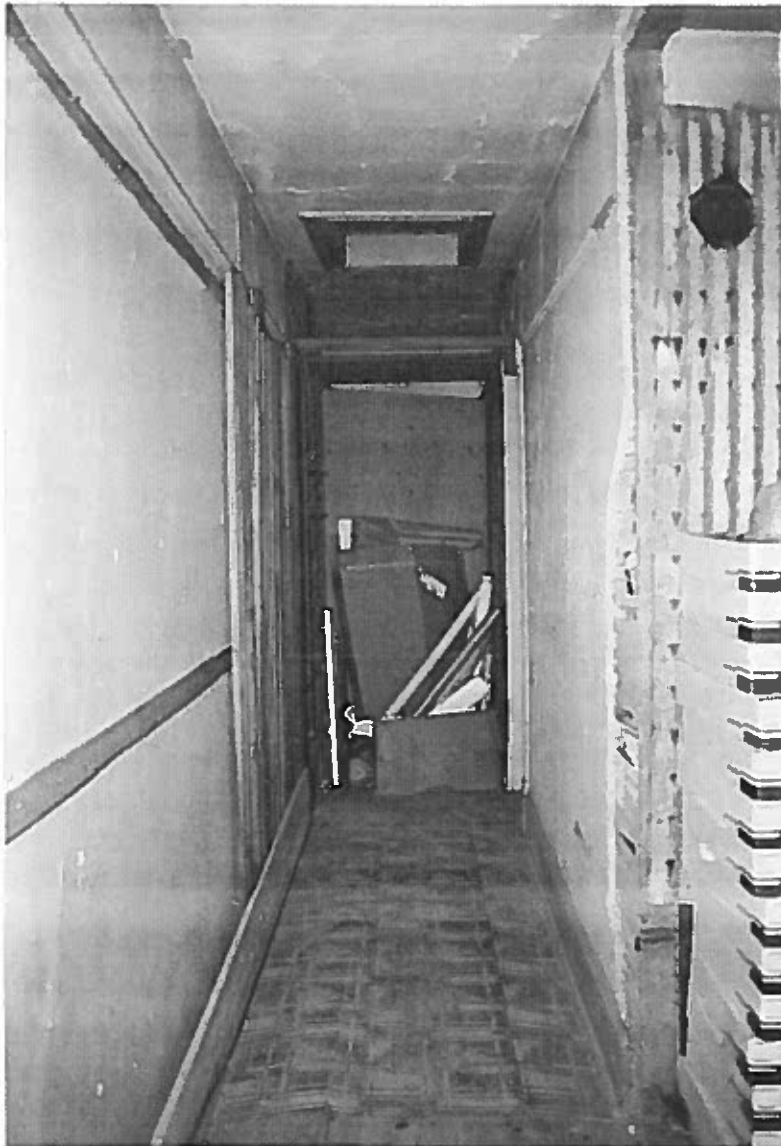
Figure 56: Looking north at the hallway through the center of the building. Both of the walls are structural especially in the center of the building because they hold up the chimney structure above. The foundation below the walls has been altered causing the walls to settle in the center.

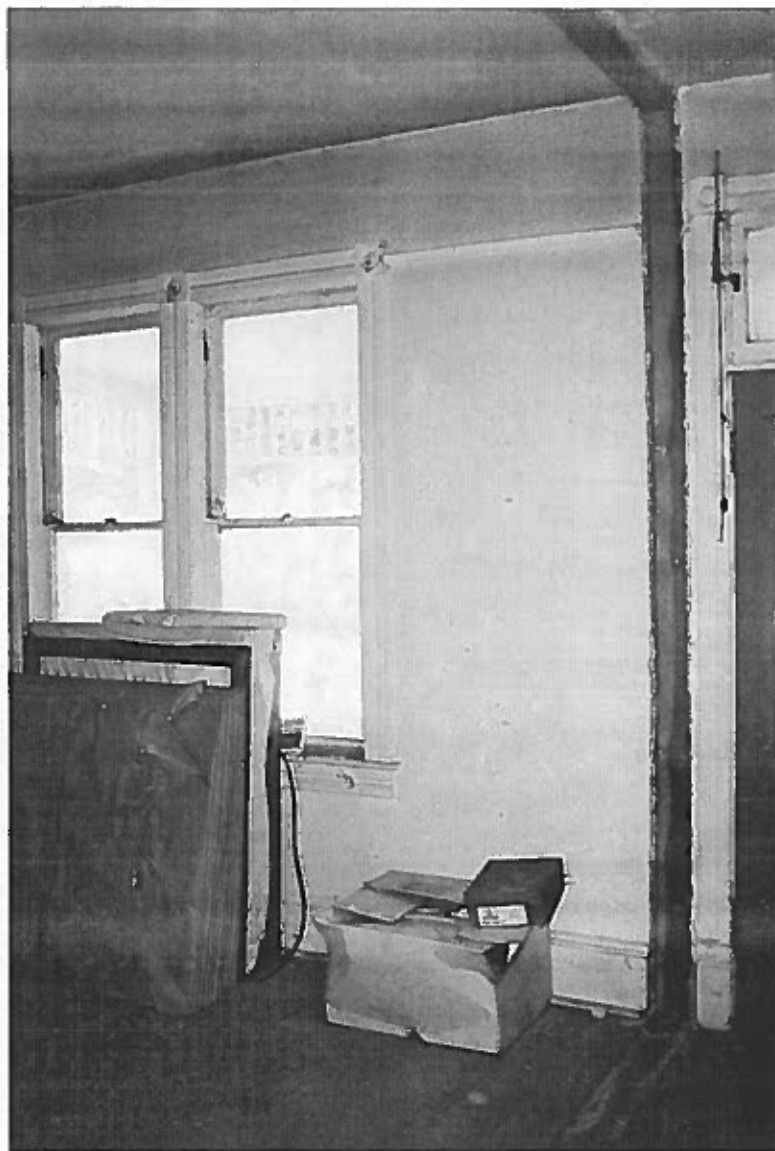
Figure 57: Looking southeast at the front room of the building. Generally the materials are in good condition with some minor plaster cracks because of the settlement. The windows are in good condition.

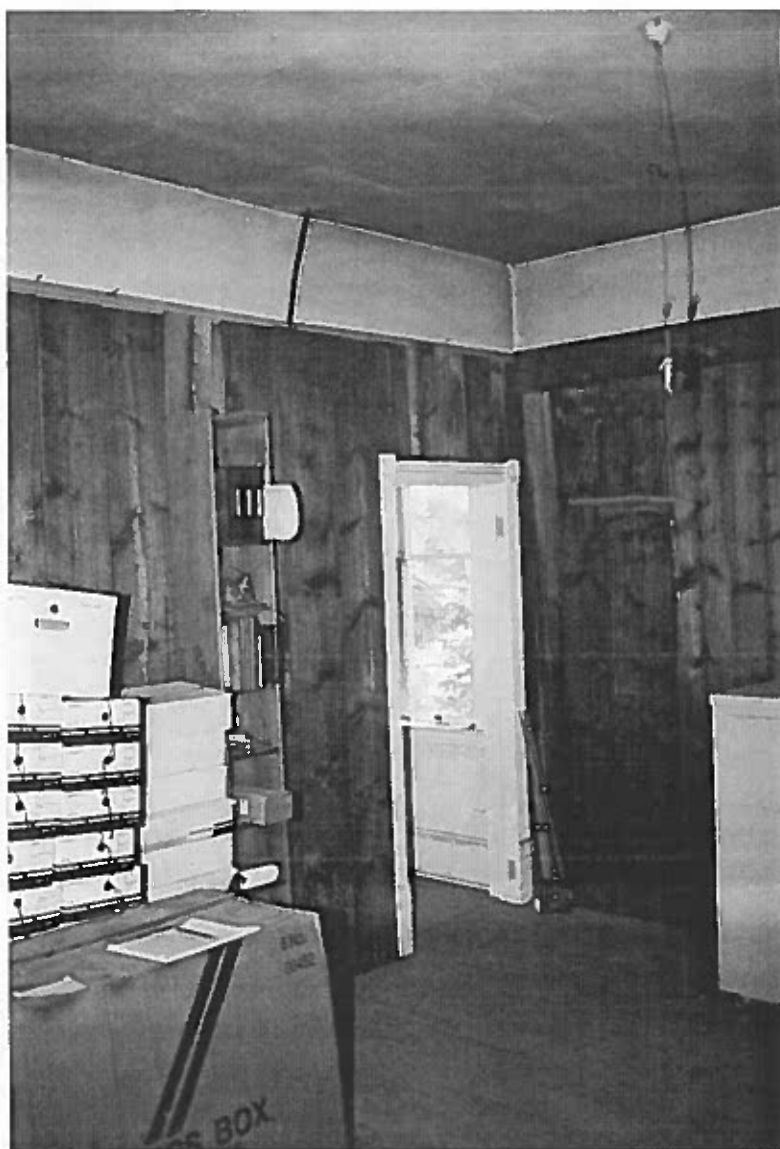
Figure 58: Looking northeast at the front room where it enters into the kitchen. The siding is from the mill and other buildings around the site. It is hard to determine the condition of the plaster behind the siding. The wood floor is worn but in good condition.

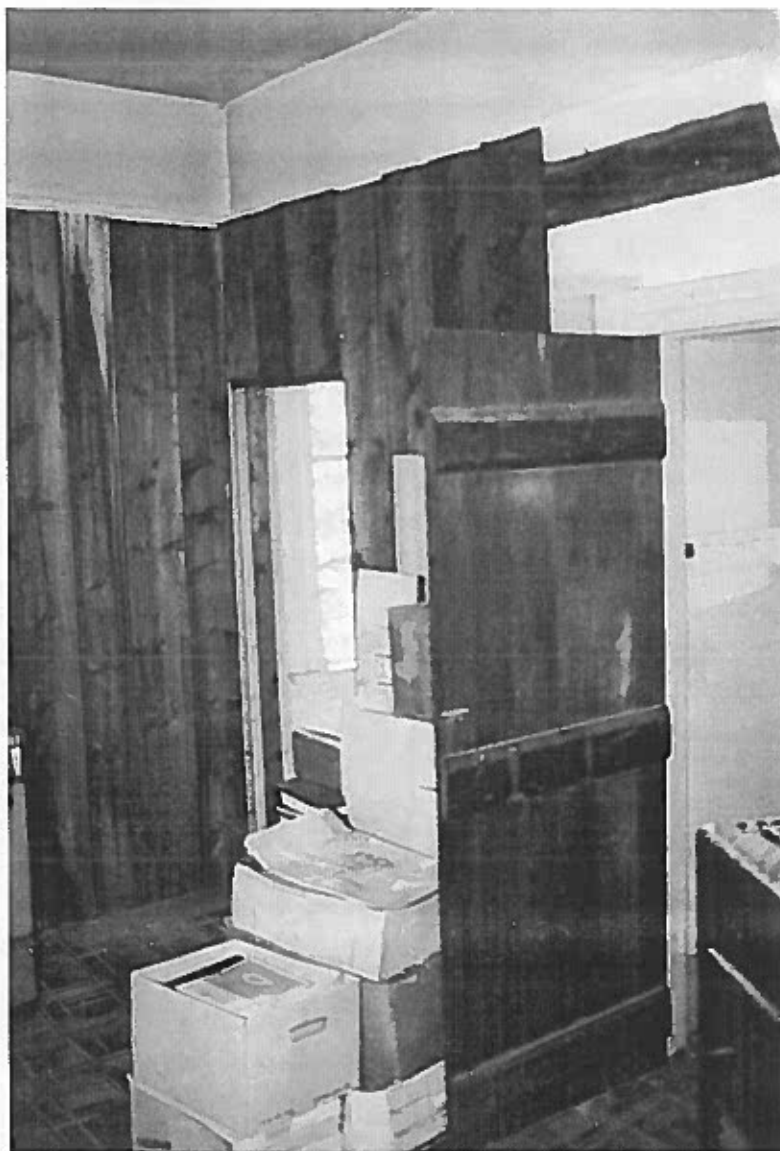
Figure 59: Looking southeast at the kitchen walls. There is settlement in the building on the outside wall to the left and it appears that the wood paneling is covering up the plaster damage. The floor has settled along this area.

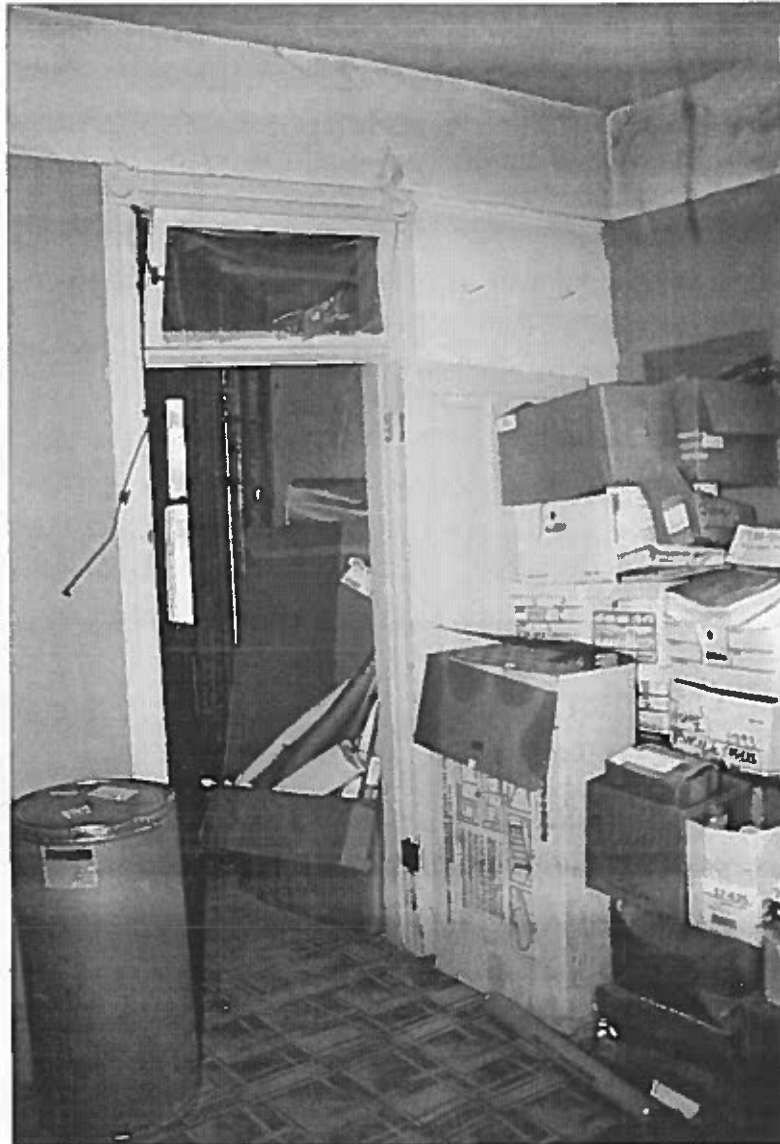
Figure 60: Looking northwest at the doorway to the hallway from the kitchen. The wall is settling to the left from the heavy chimney and limited support below.

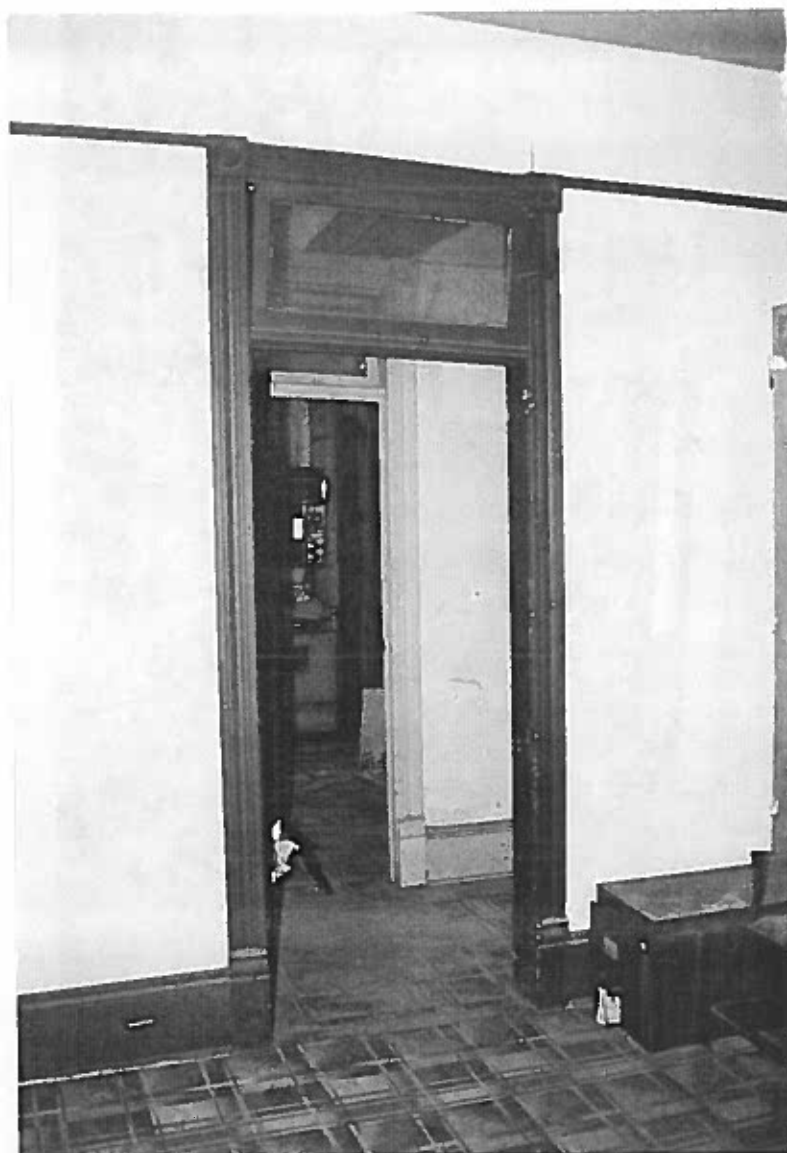
Figure 61: Looking east at the doorway to hallway from the northwest room. Note the settlement to the right of this wall also.

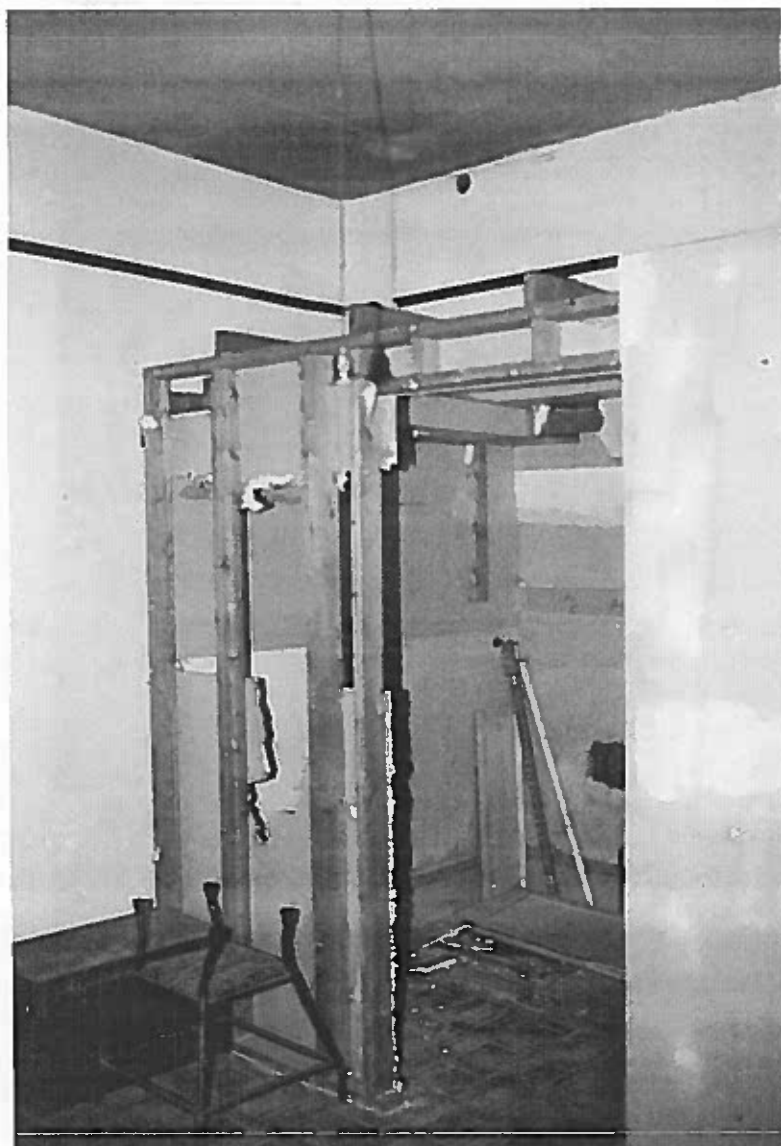
Figure 62: Looking southeast at a new wall for a bathroom that was added to the room. This can be easily removed. There are some holes in the floor though.

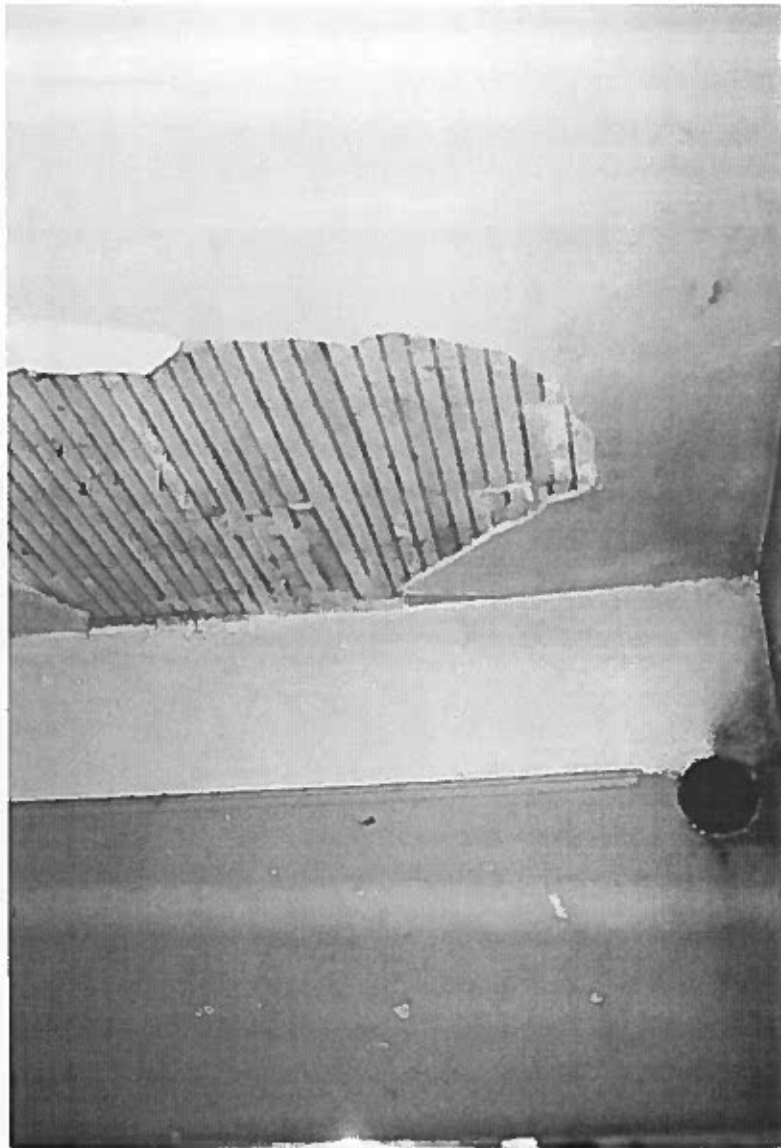
Figure 64: Looking at the missing section of plaster ceiling in the southwest room. Note the chimney hole for a wood stove. All four rooms tie into the center chimney at this point along the corridor sides of the rooms.

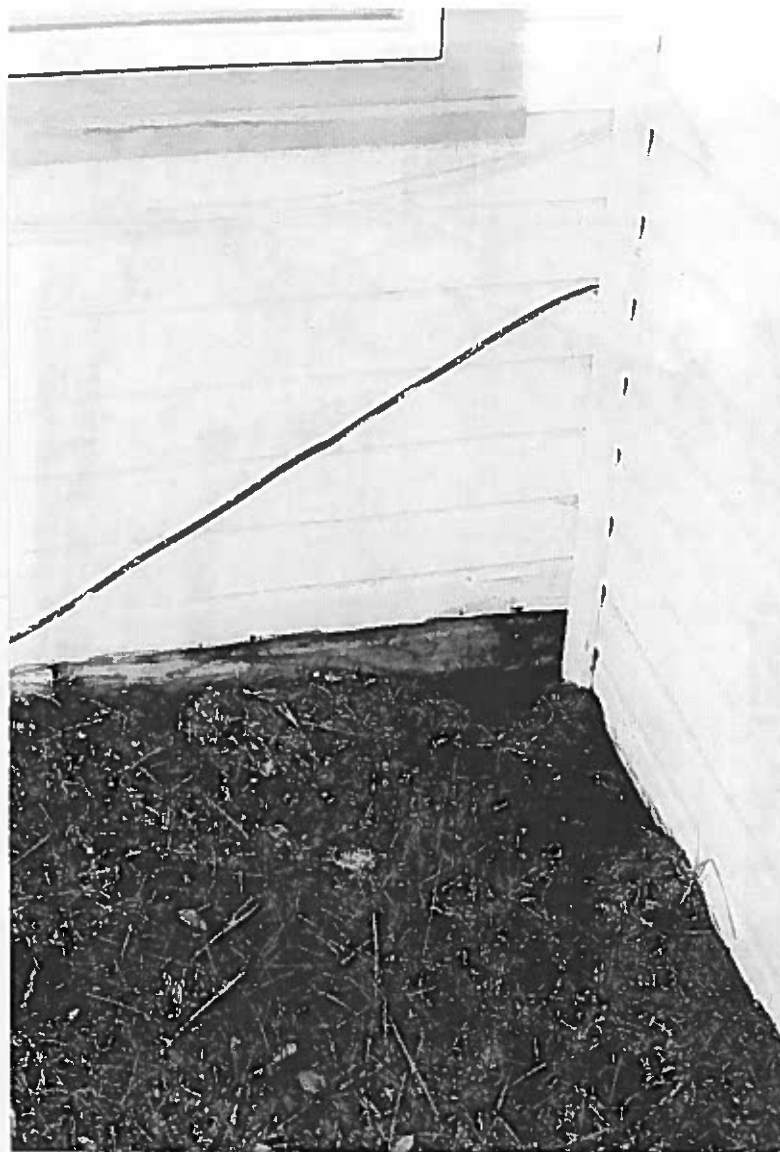
Figure 74: Looking southeast at the north wall. Note the rotted siding and base.

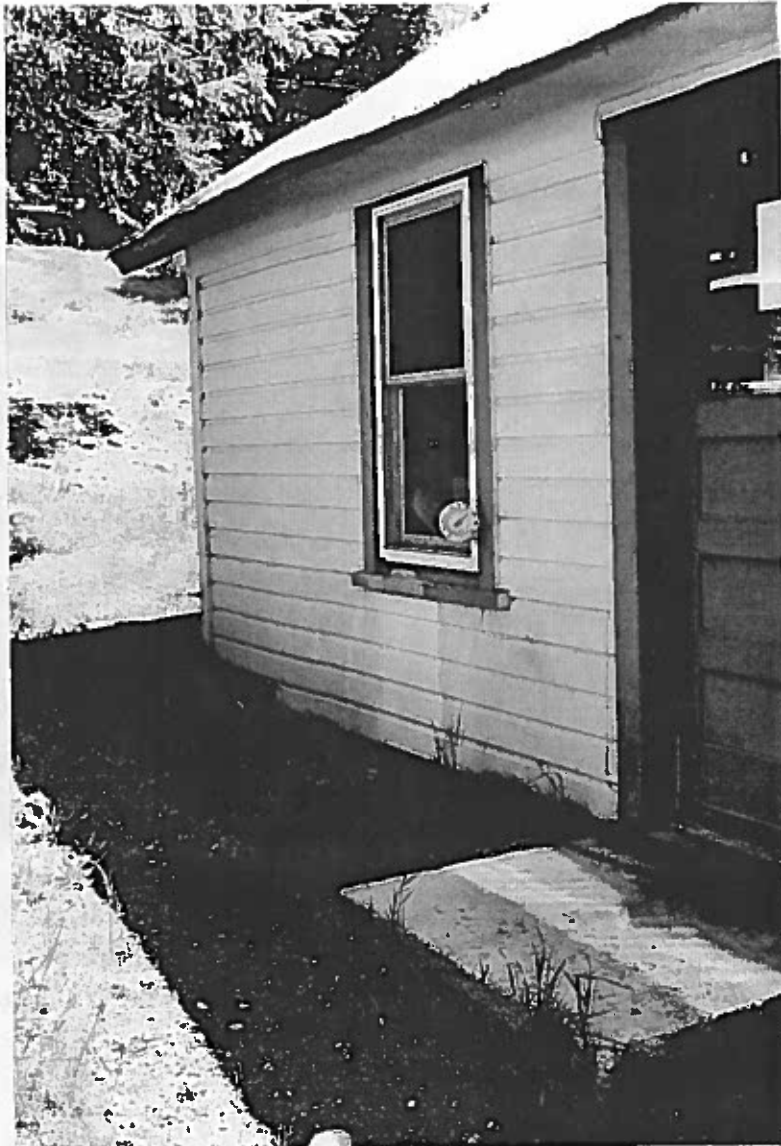
Figure 77: Looking southwest at the building. The metal roof is generally in good condition with the exception of some loose panels.

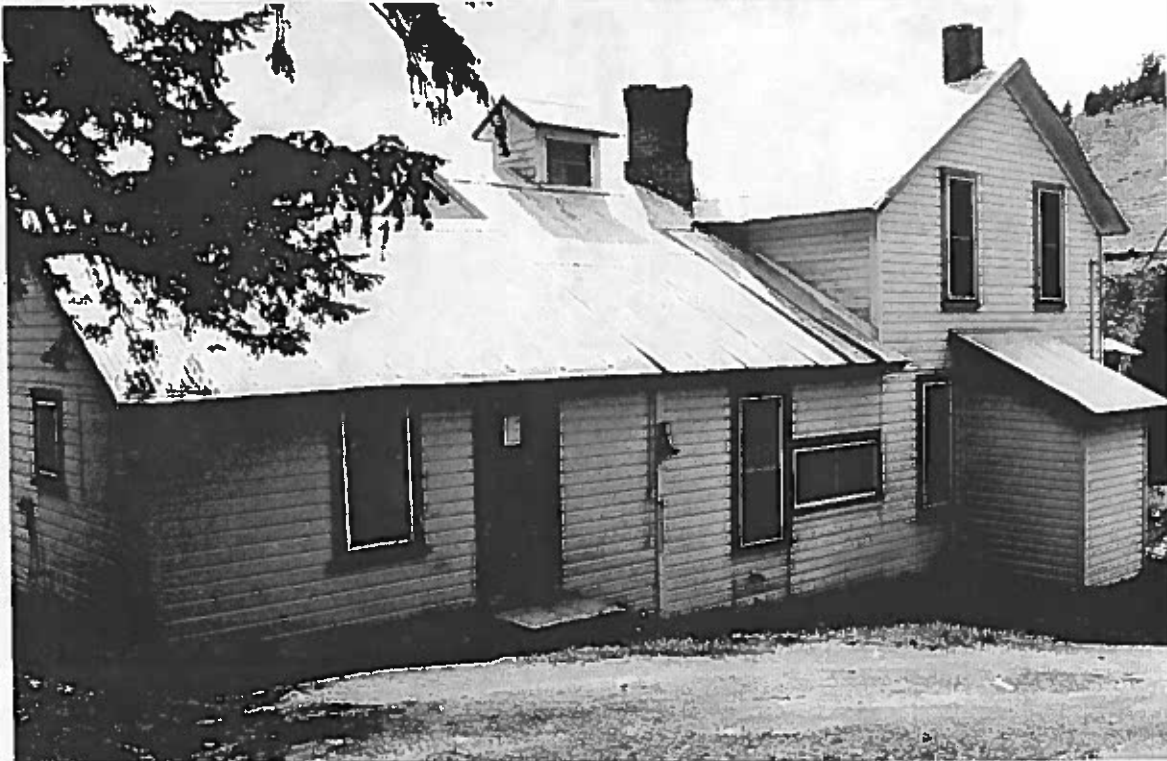
Figure 78: Looking southwest at the back of the building.  
Note the high grade around the bottom siding and sill plate.

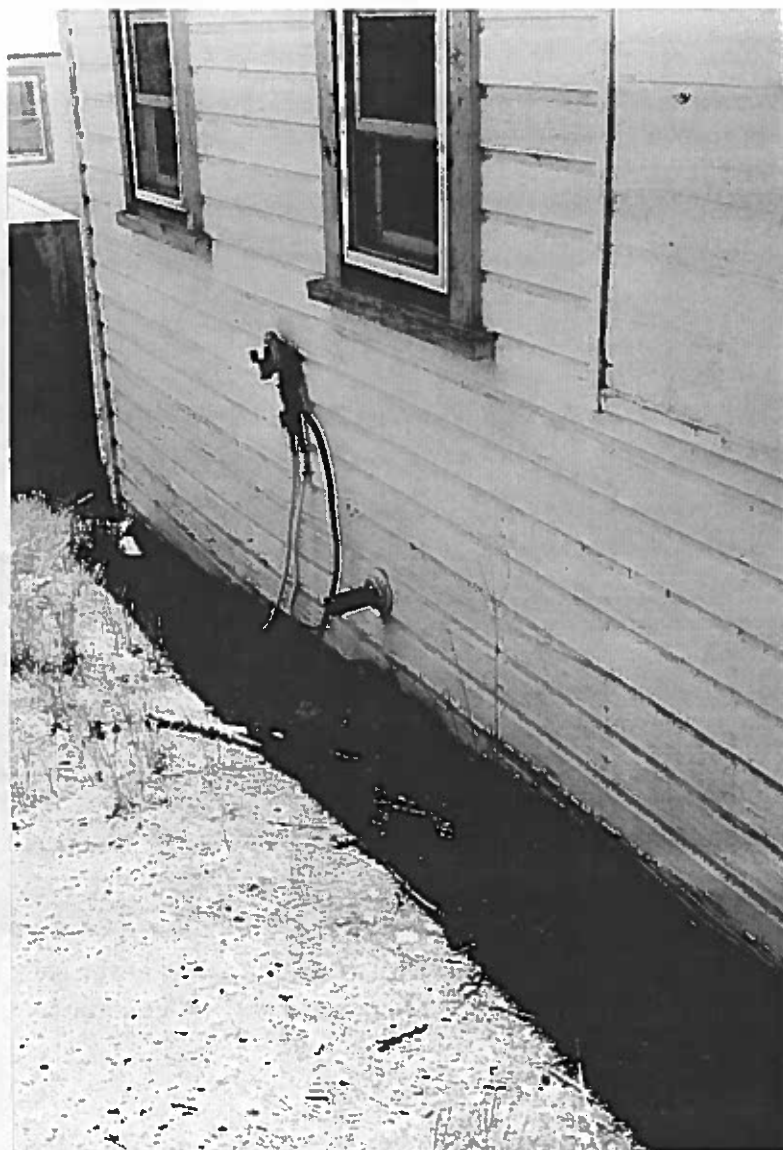
Figure 79: Looking northwest at the building. Note the high grade at the back of the building. Generally with the exception of the base the materials are in good condition.

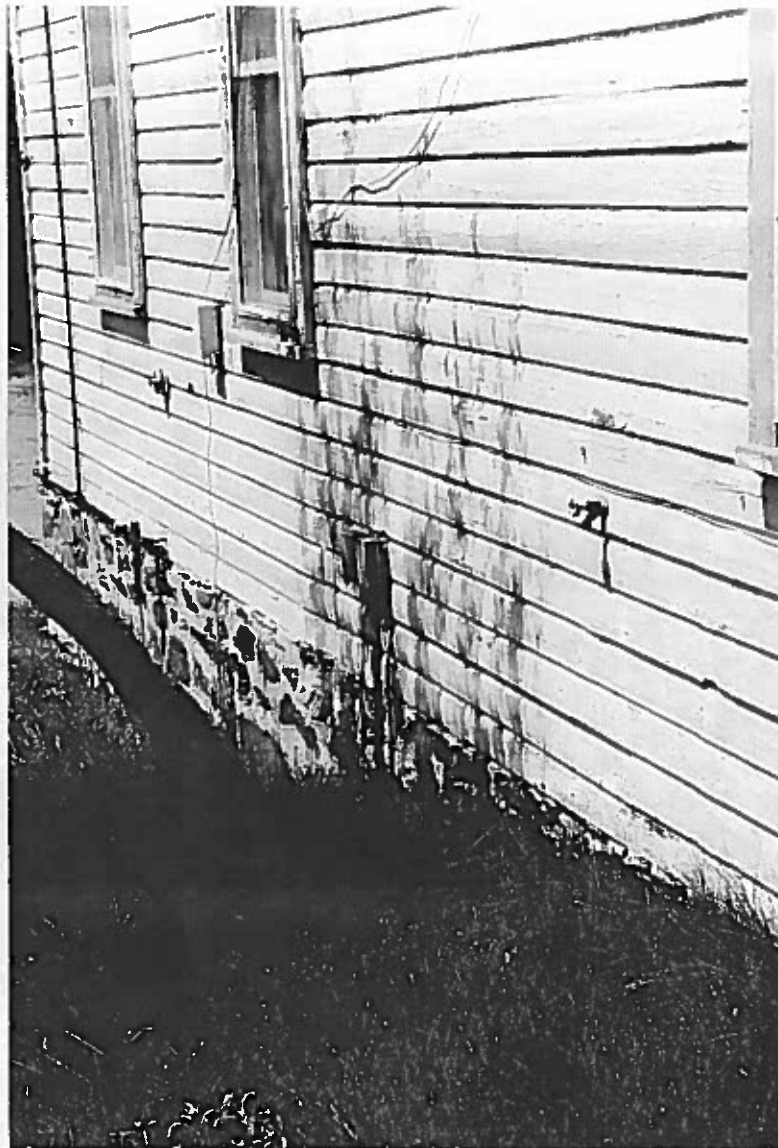
Figure 83: Looking northeast at the building. The wood siding is in good condition with some minor wear.

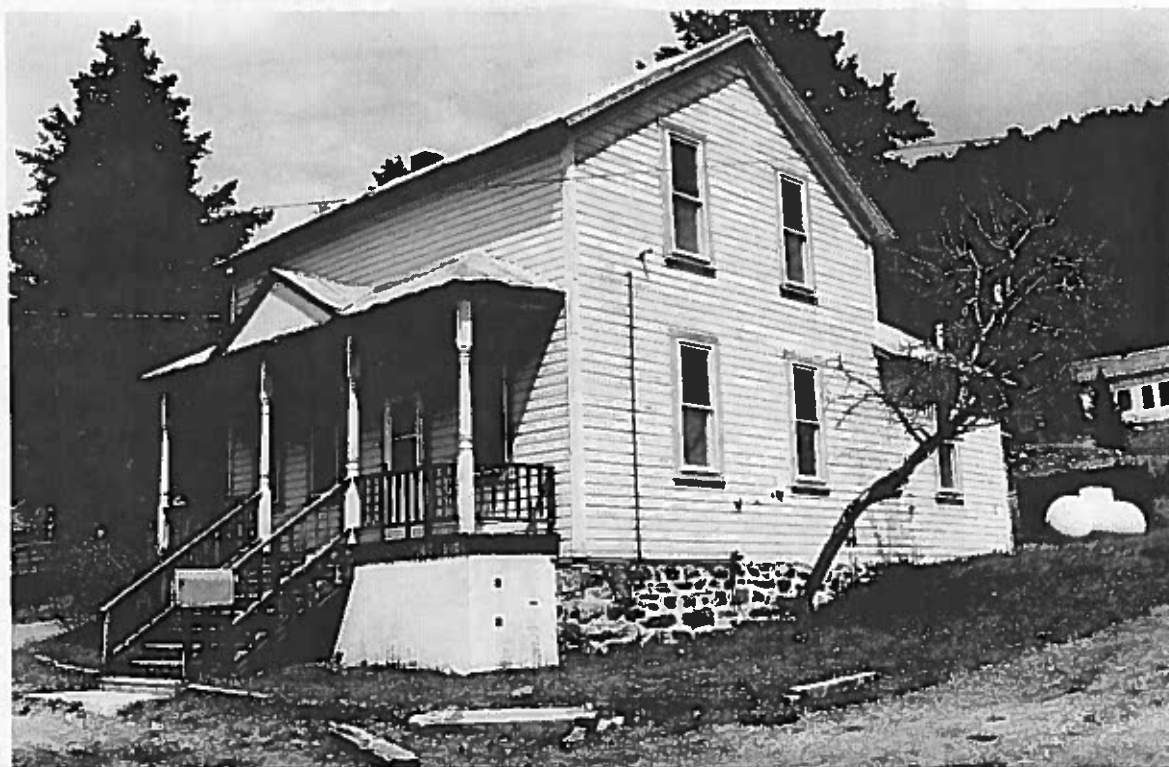
Figure 84: Looking northeast at the base foundation at the front of the building. There is some settlement in the foundation where it is cracked caused by water undermining the front of the building under the porch.

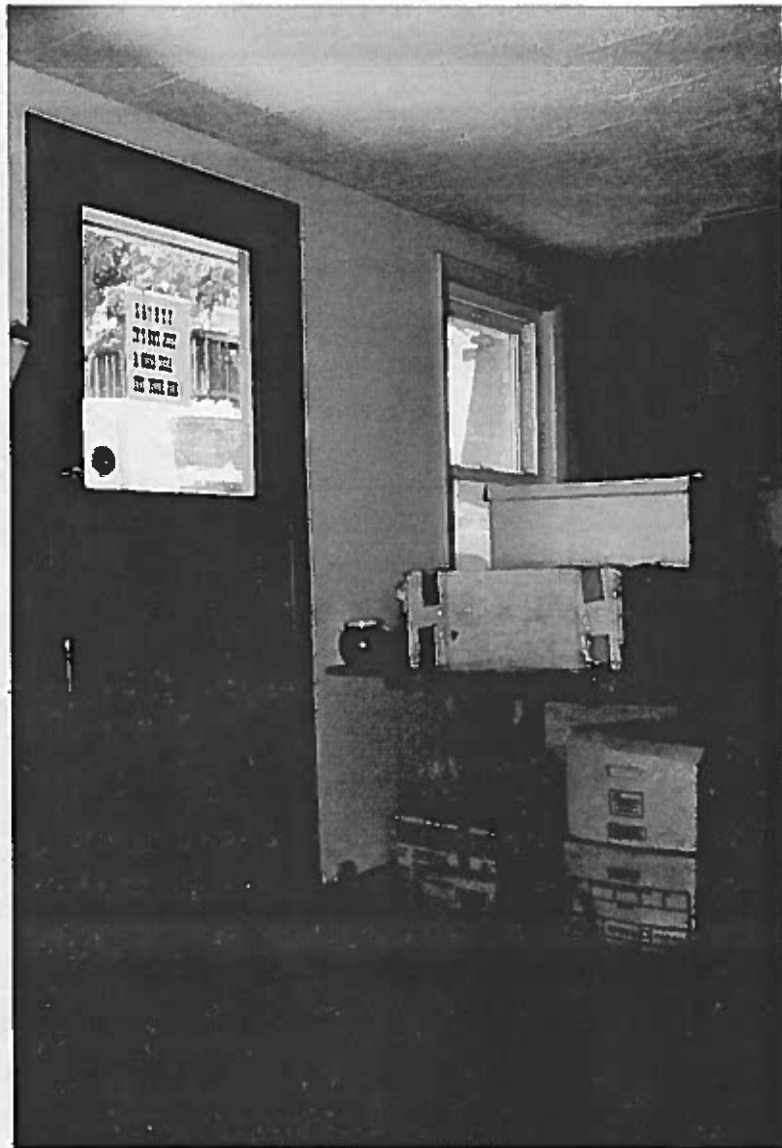
Figure 95: Looking northeast at the back door to the building.

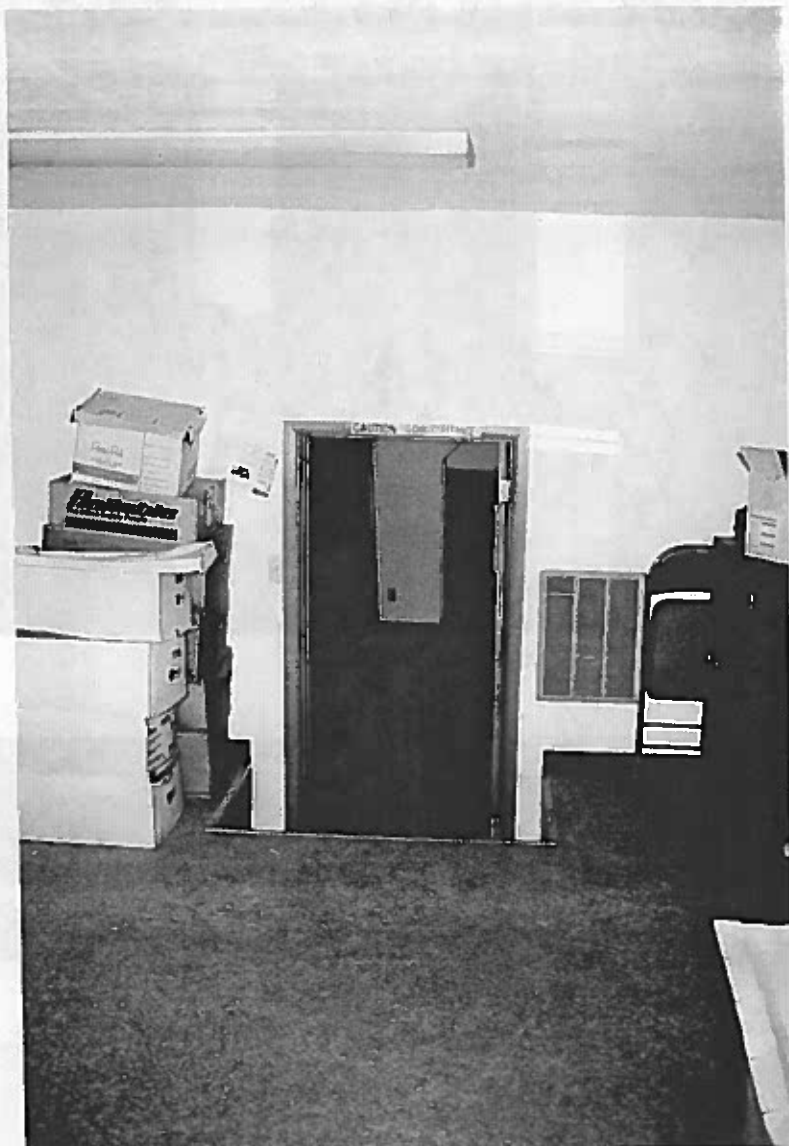
Figure 96: Looking west at the steps and doorway to the original building.

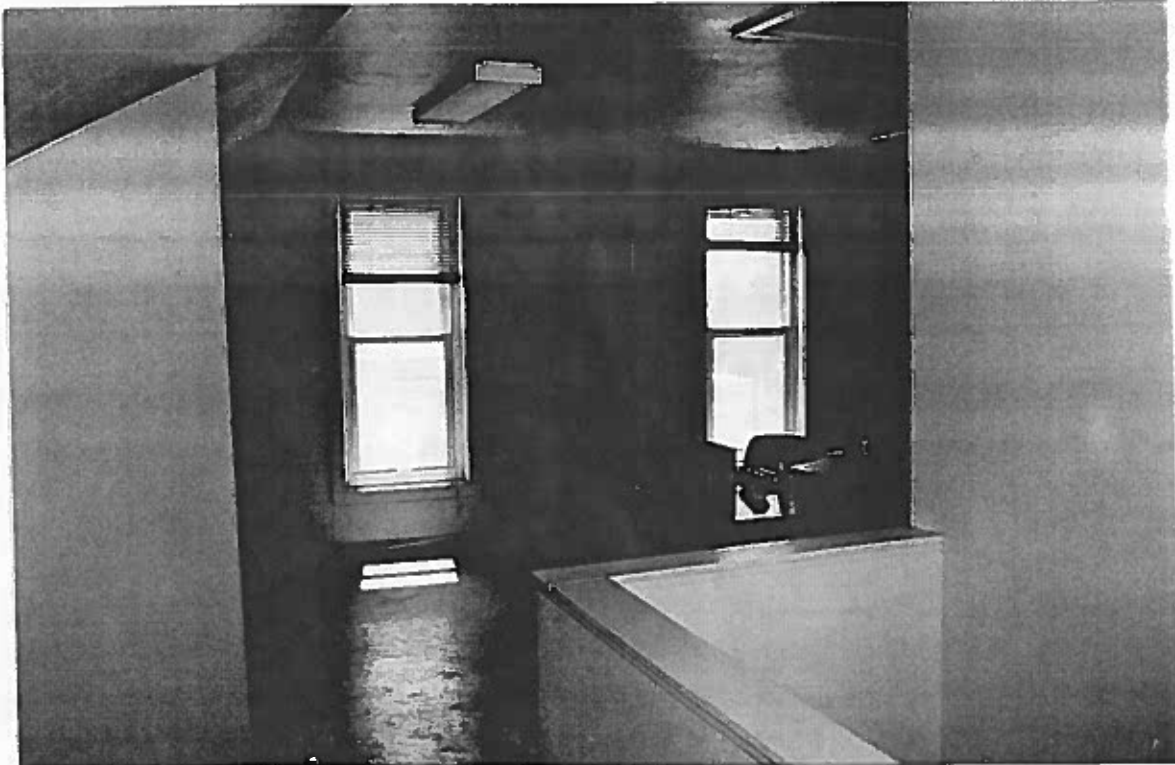
Figure 97: Looking south at the attic office space.
