**ARCHITECTURAL ASSESSMENT, RECOMMENDATIONS & COSTS  
of  
HISTORIC STRUCTURES**

**MINERAL HILL MINE**

**JARDINE, MONTANA**

**OCTOBER, 2000  
(REVISED JANUARY, 2001)**

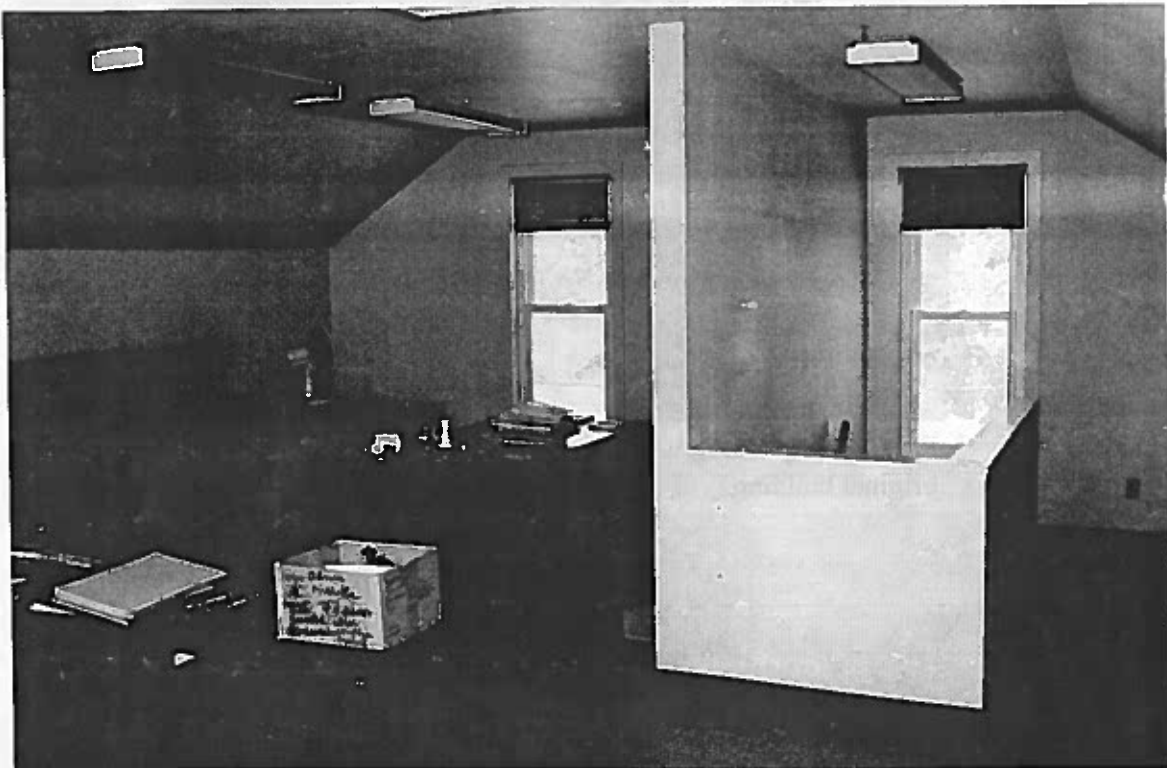
Figure 98: Looking northwest at the attic office space.

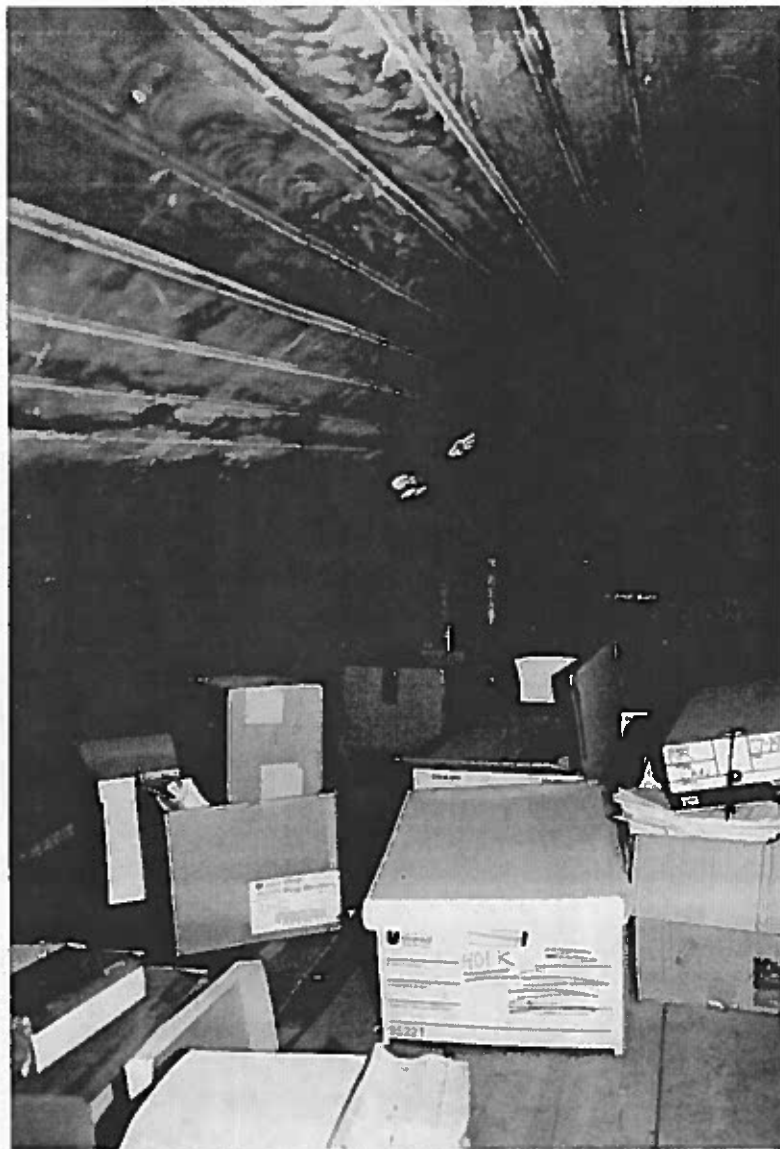
Figure 99: Looking east at the unfinished attic space used as storage.

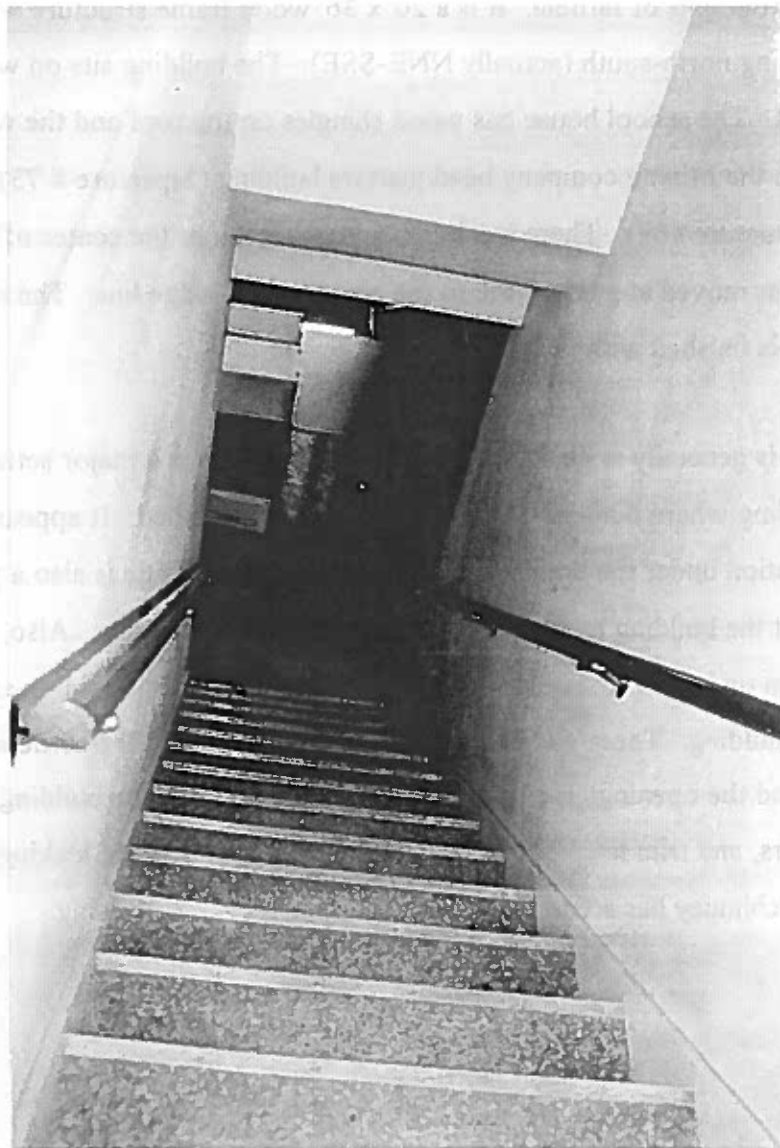
**Figure 101: Looking south down the stairway to the first floor from the attic.**

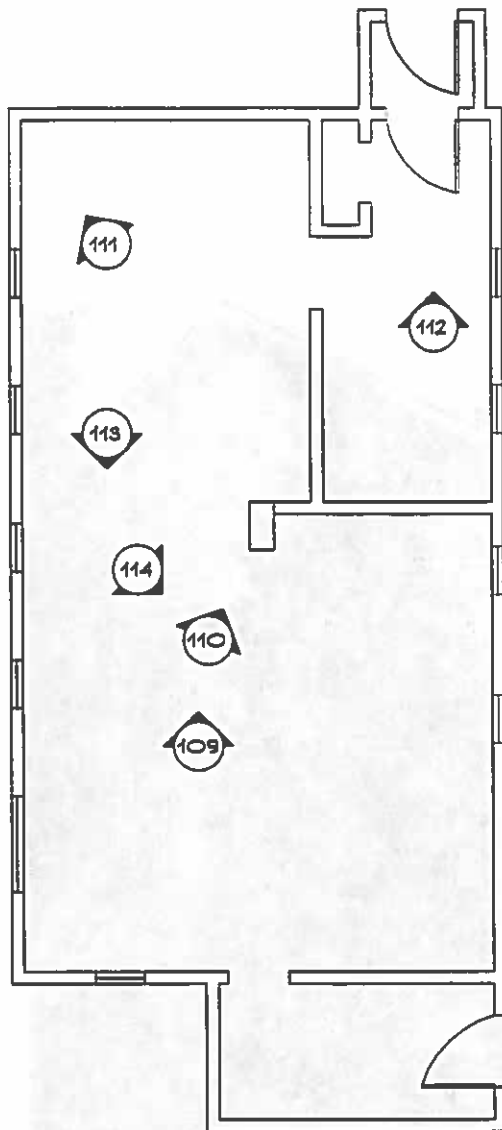
**FIGURE 102**  
**CONDITION ASSESSMENT**  
**SCHOOLHOUSE (HS 79)**

The school house is generally in good condition, however there is a major settlement problem in the center of the building where it appears that the foundation has failed. It appears that there may not be a major foundation under the building. The grade on the east side is also a problem causing water to move against the building and cause some rot in the sill and siding. Also, trees and shrubbery have grown up next to the building causing damage to exterior siding and holding moisture against the building. These elements may also be the cause of the settlement. The windows have been removed and the openings are boarded over. The sash is in the building. The exterior siding, windows, doors, and trim need paint. The wood shingle roof is not leaking but is in poor condition. The brick chimney has some loose bricks and the mortar is missing.

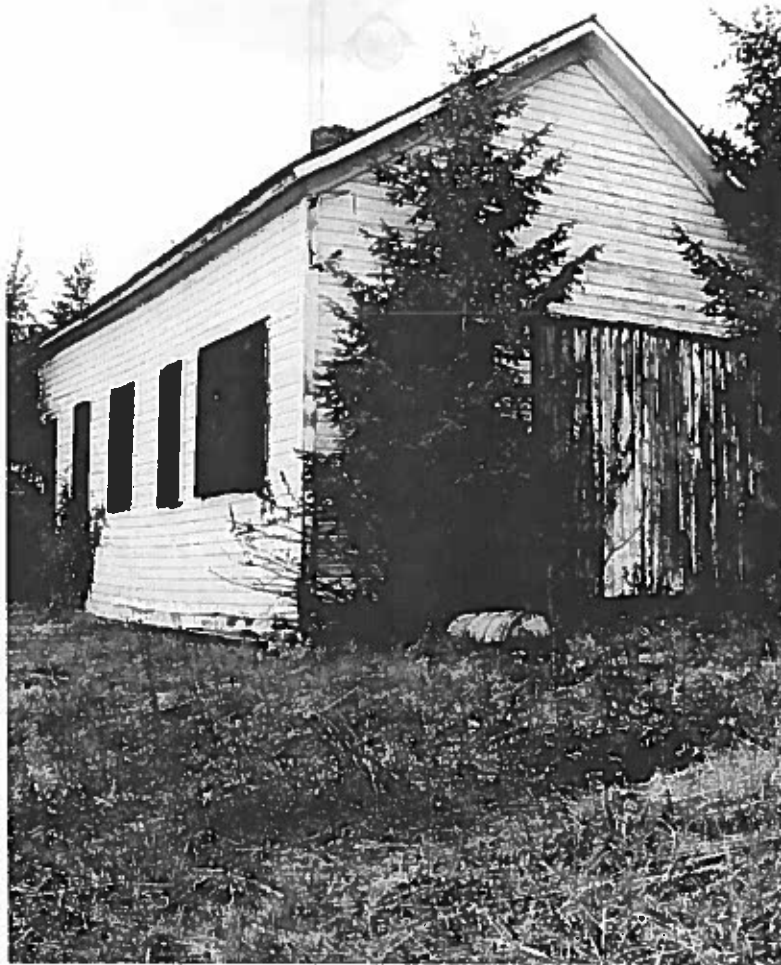
Figure 103: Looking northeast at the Schoolhouse. Note the deteriorated siding and the trees along the foundation and siding.

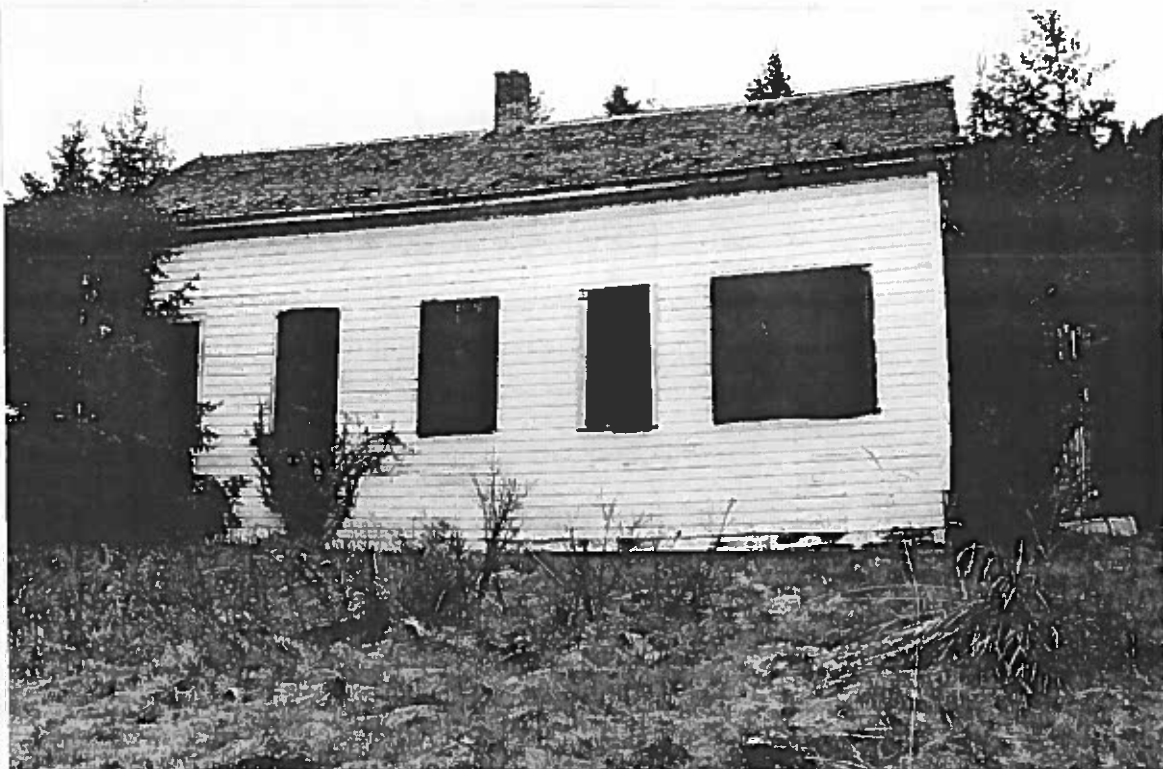
Figure 104: Looking east at the building. Note the settlement in the center of the structure. It does not appear that there is a foundation other than the wood base which appears to be rotted. The roof is in fair condition but it appears that there is potential for some water leaks.

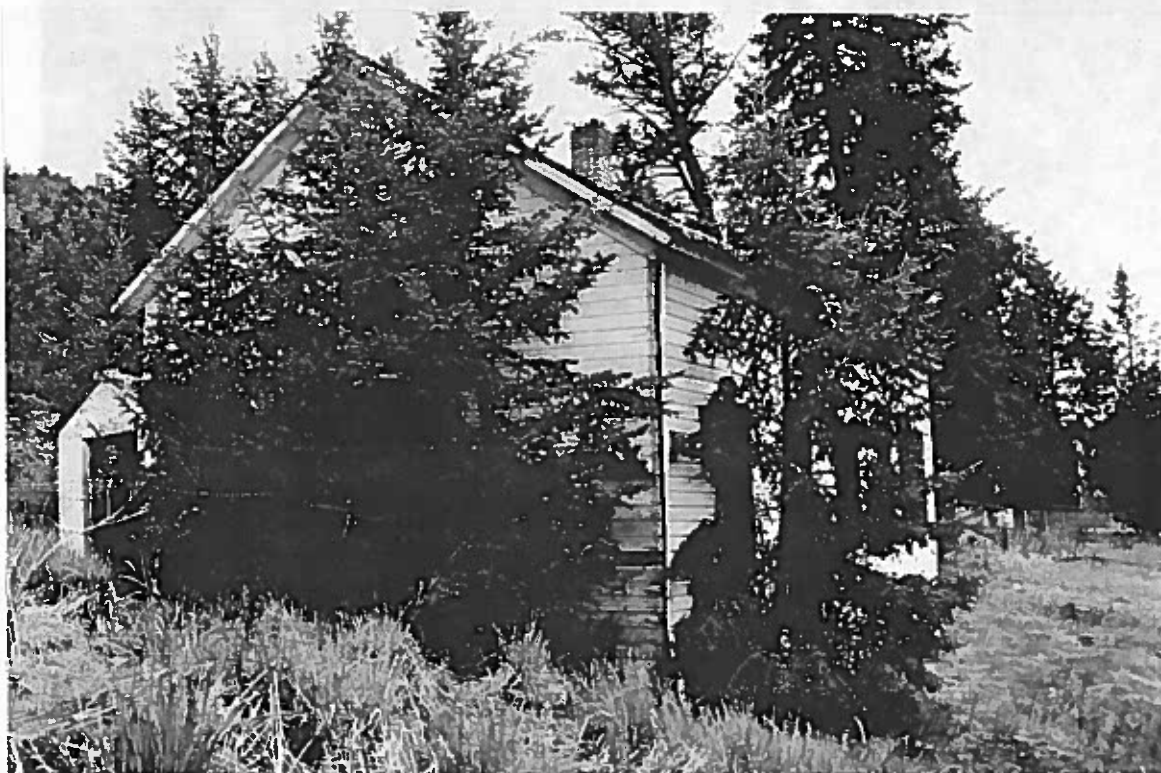
Figure 105: Looking southeast at the building. Note the trees that have grown up around the building which cause deterioration to the foundation and wall materials.

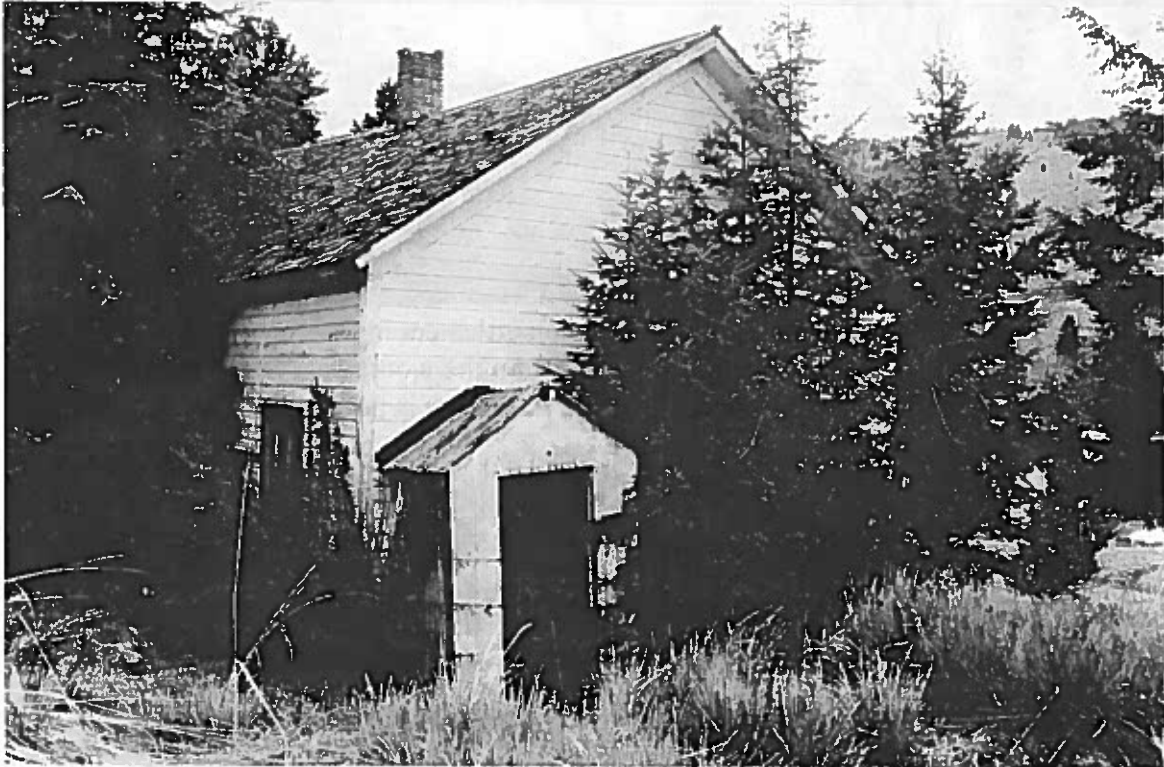
Figure 106: Looking southwest at the building. The grade around the building is causing rot in the base of the structure. The back door enclosure is deteriorating. Note the shrubs and trees against the building.

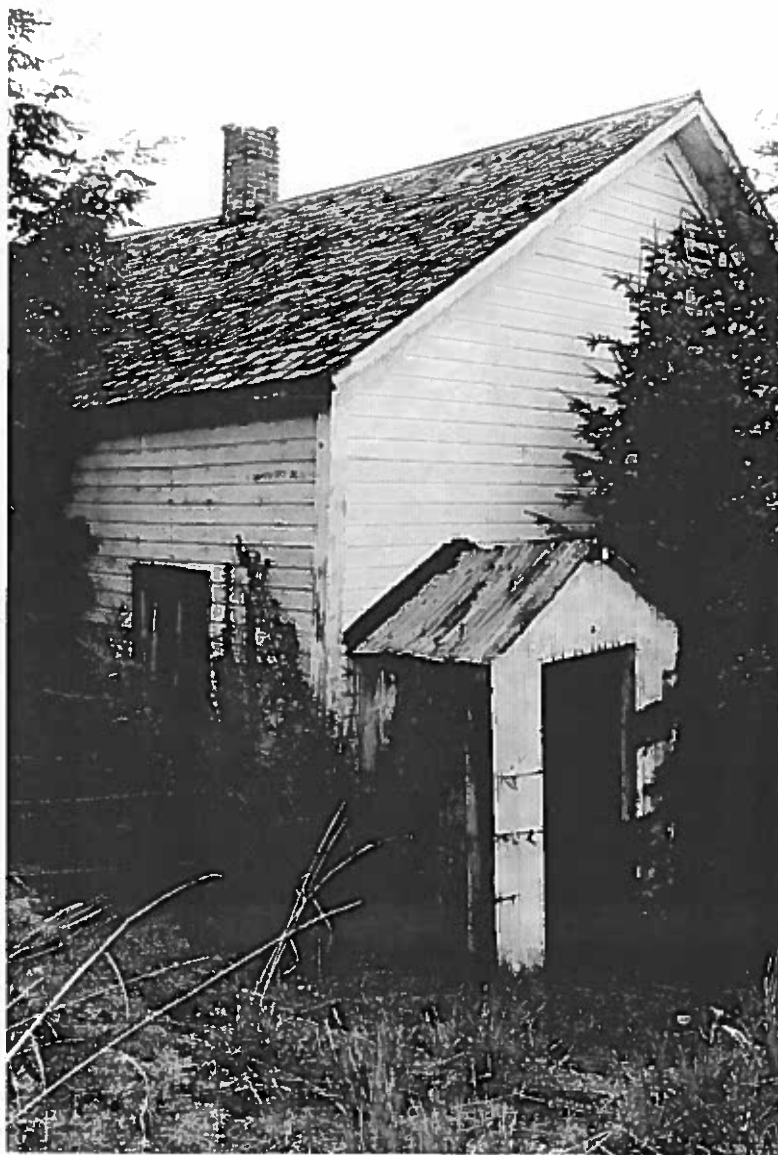
Figure 107: Looking west at the building. Note the wood shingle roof that is in fair condition. Also, note the deteriorating brick chimney on the top of the roof.

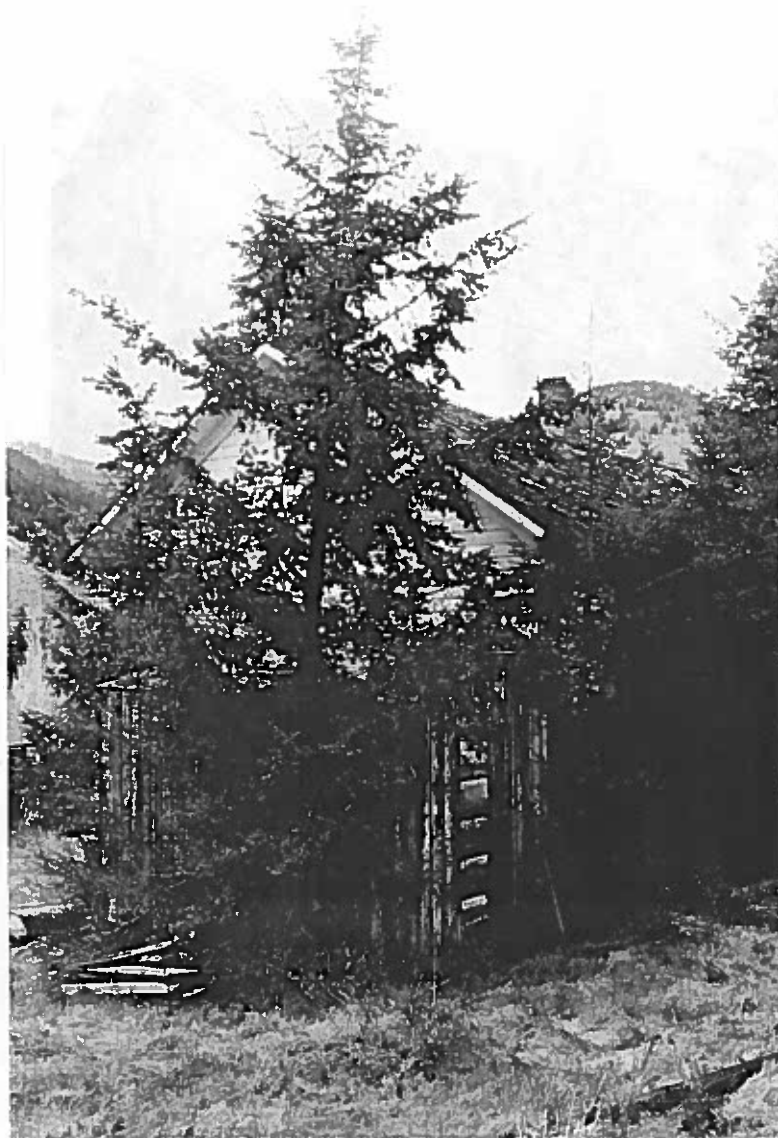
Figure 108: Looking northwest at the schoolhouse. Note the front entry door in the added vestibule to the schoolhouse. Also note the high grade around the building and trees growing up against the structure. The slope of the site on the right causes all water to flow into the base of the building.

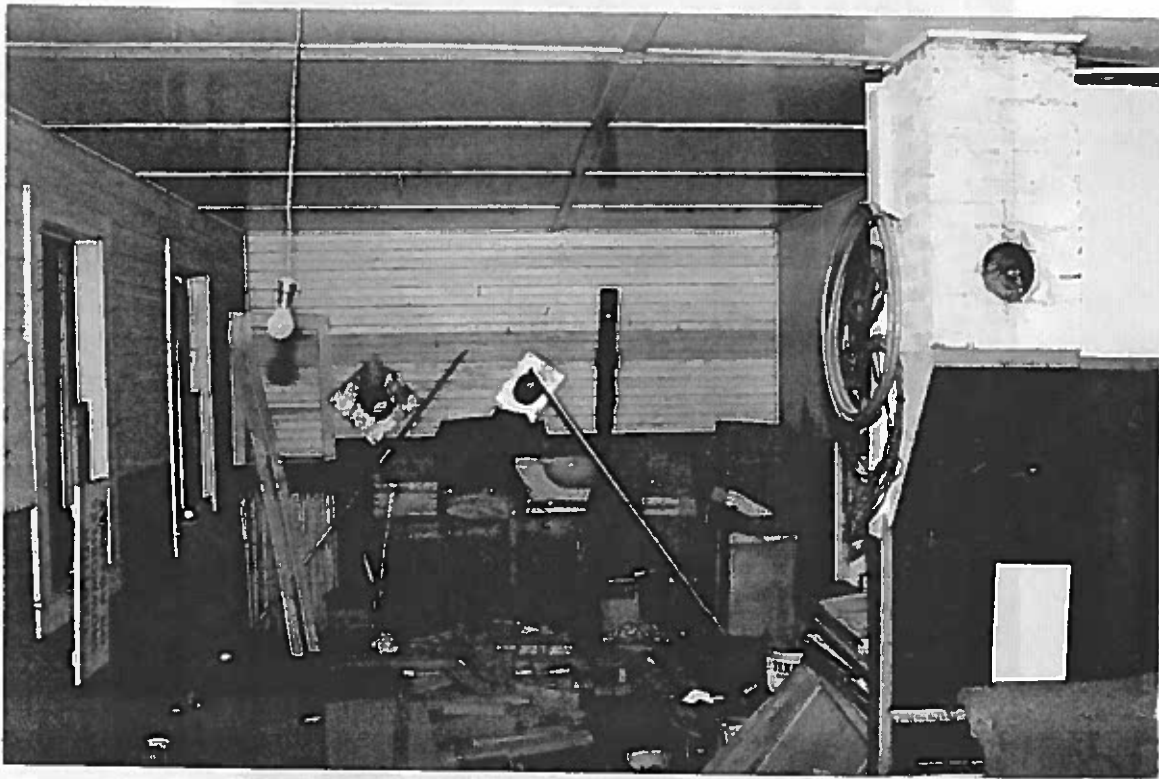
Figure 109: Looking north at the interior of the schoolhouse. Part of the center wall dividing the space into two rooms has been removed. There is some settlement in the floor at this point.

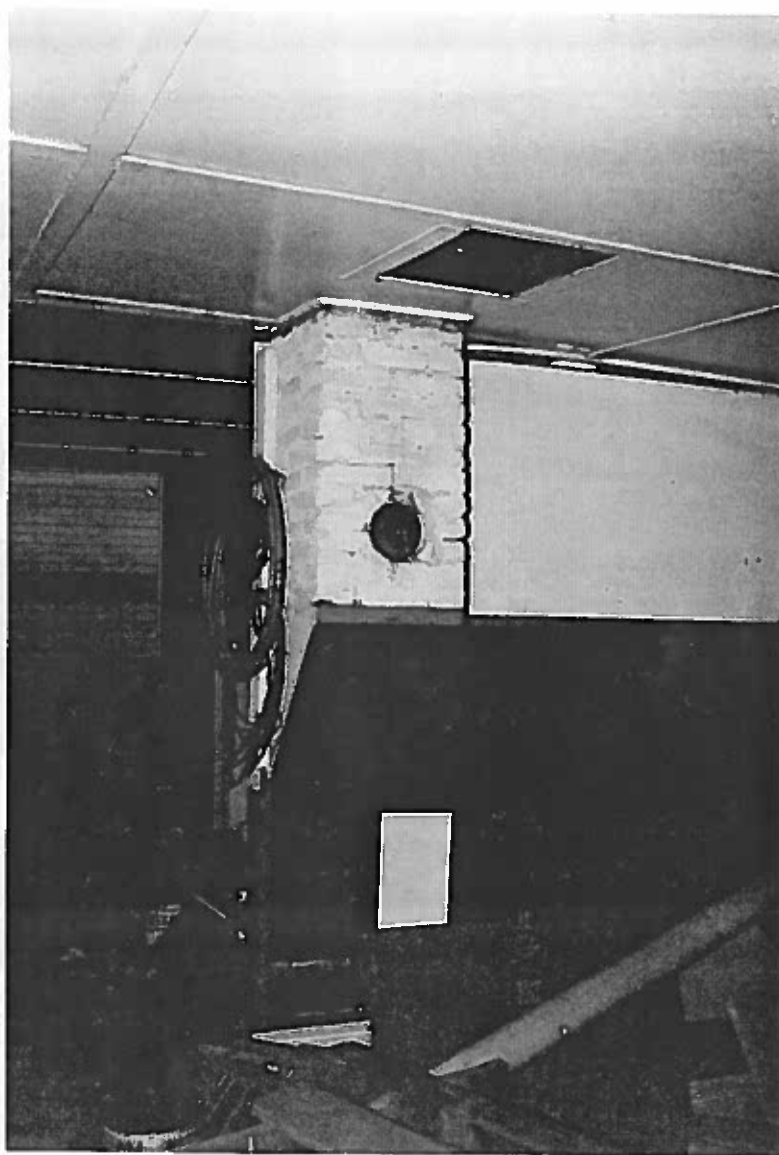
Figure 110: Looking northeast at the center chimney and hatch to the attic. The roof structure from the inside appears to be in good condition.

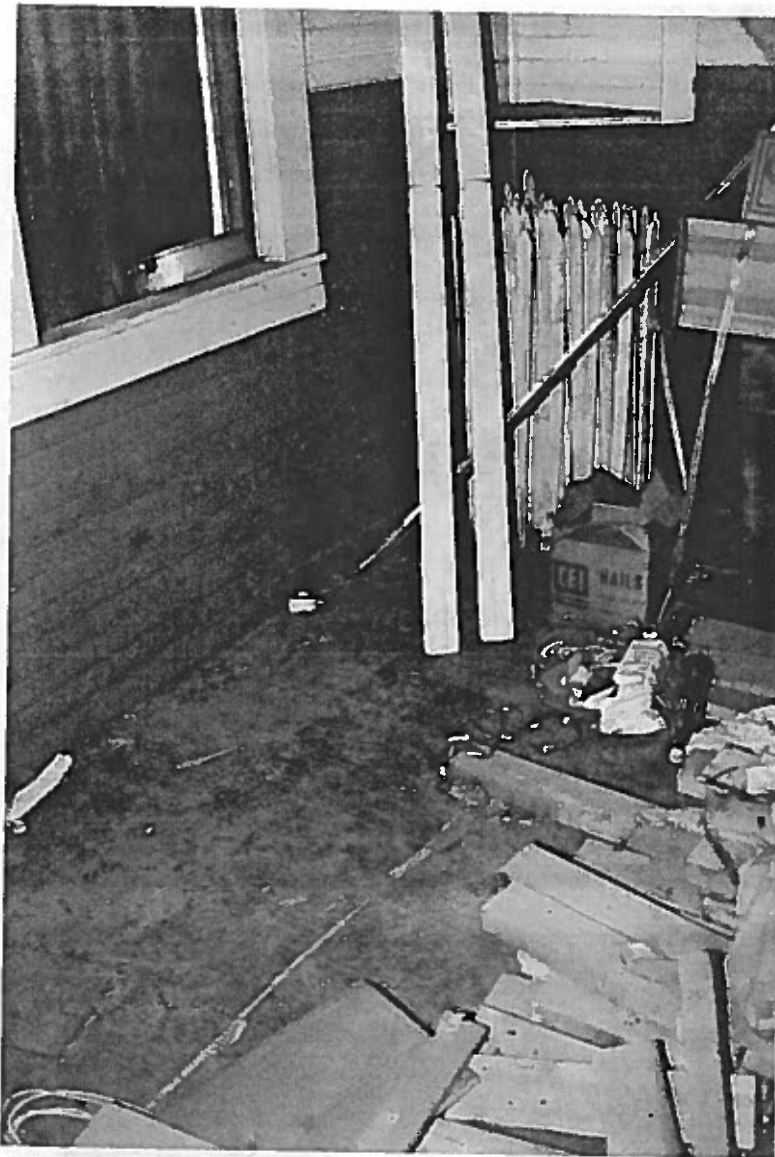
Figure 111: Looking northeast along the base of the walls. There is some deteriorating floor boards in this area.

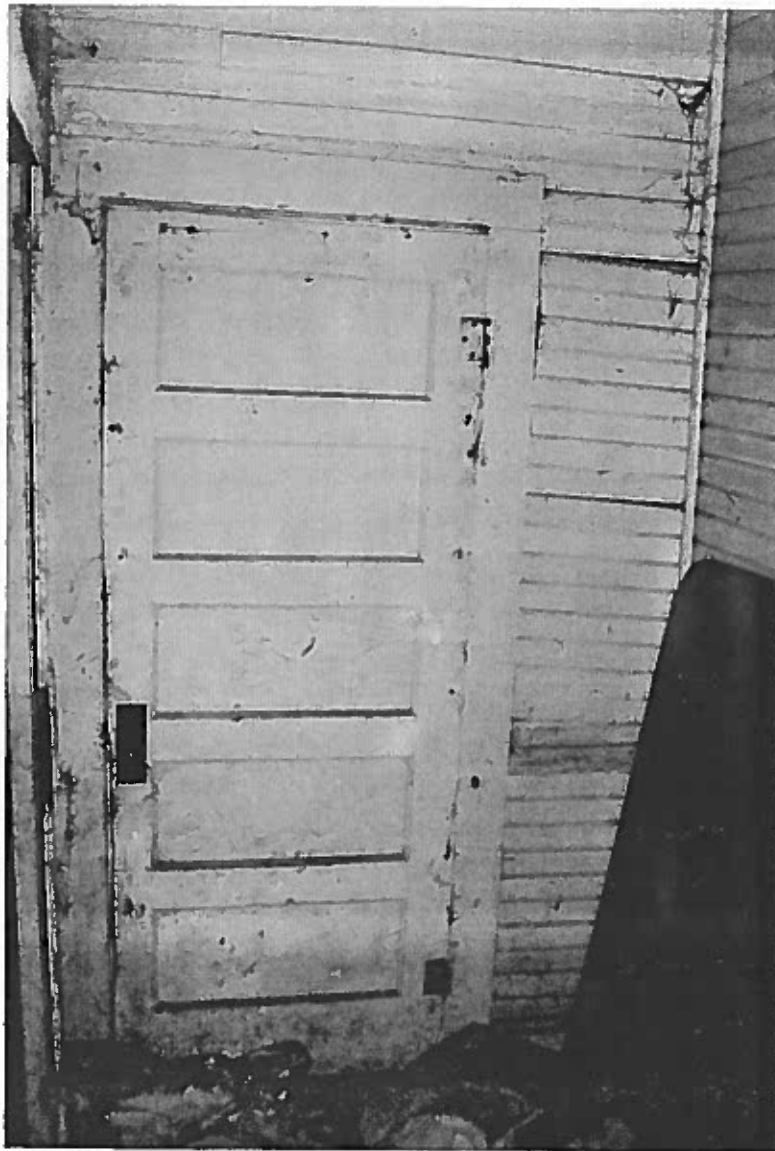
Figure 112: Looking north at the back door to the building.  
The door is worn and there is some rot at the base.

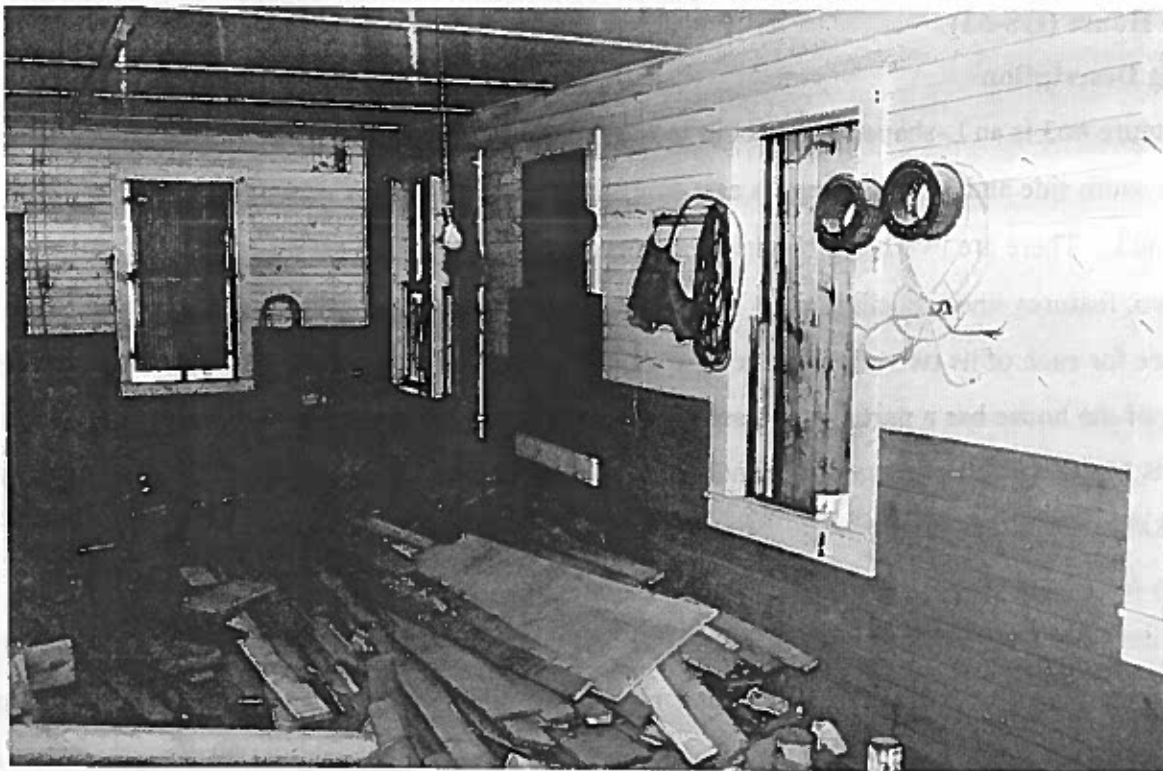
Figure 113: Looking southwest at the interior of the schoolhouse. The windows have been removed and the openings covered over. The window sash are still inside the building.

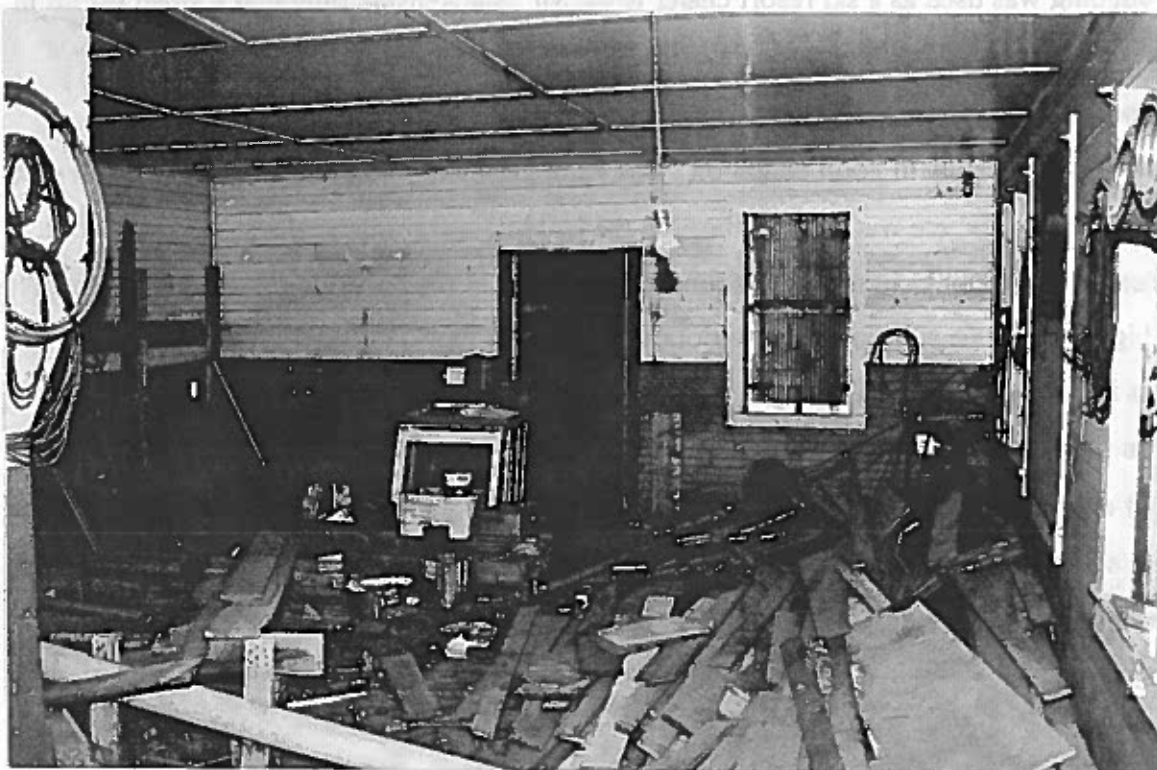
Figure 114: Looking south at the entrance to the room. Note the window sash on the floor. Most of the interior materials are in good condition with some minor wear.

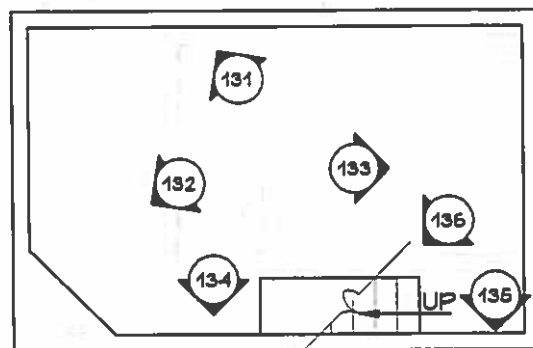
**FIGURE 115**  
**CONDITION ASSESSMENT**  
**A. C. JARDINE HOUSE (HS 63)**

The house is generally in good condition. The main problems occur with the foundation on the west and north sides where water flows through the building undermining the stone foundation. This has cause some cracks in the stone foundation and leaves the basement level very damp. The grade is high on the east side causing deterioration of the sill logs and the frame addition The addition is in poor condition. The logs are in good condition with the exception of some of the sill logs on the east and north sides, however the rest of the logs are dry. Some of the daubing is cracked or missing. The windows and doors are weathered and missing paint. The metal roof is good with some deterioration with loose bricks and mortar on the chimneys. The front deck and carport is also in fair to poor condition.

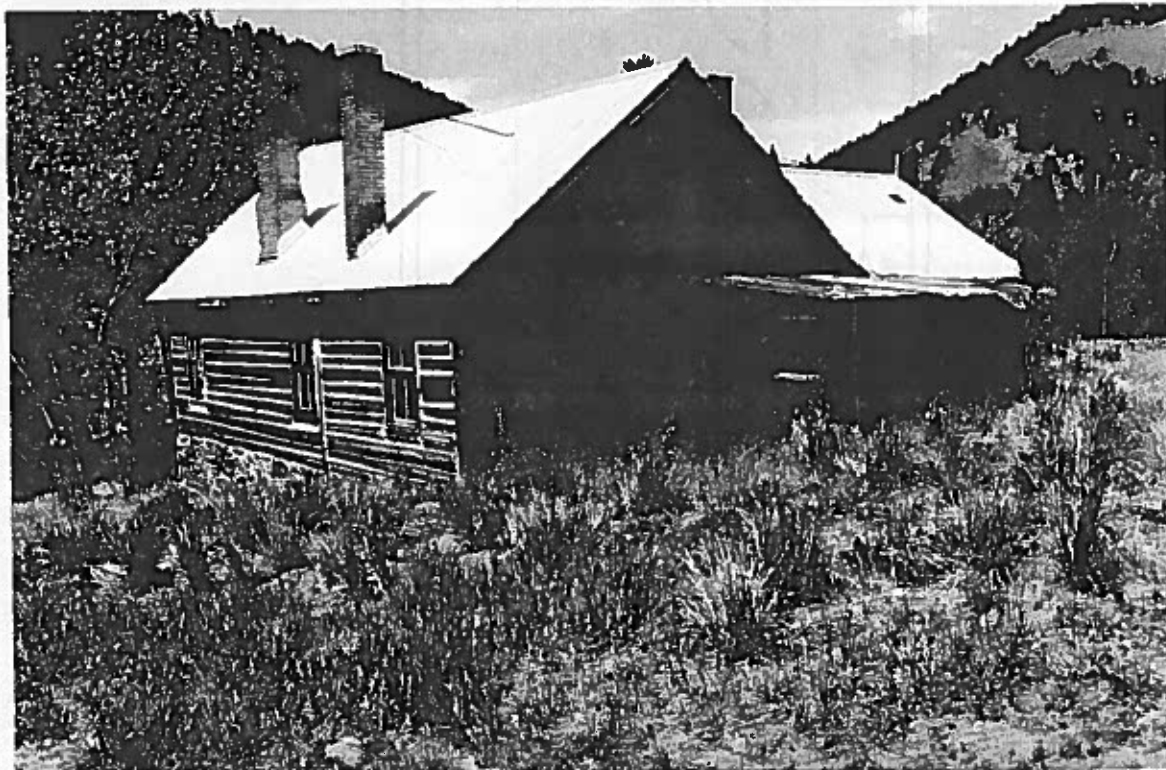
Figure 119: Looking northwest at the house. Note the galvanized metal roof which is covering the original wood shingle roof. The brick chimneys have some brick and mortar deterioration at the tops. The materials are generally in good condition.

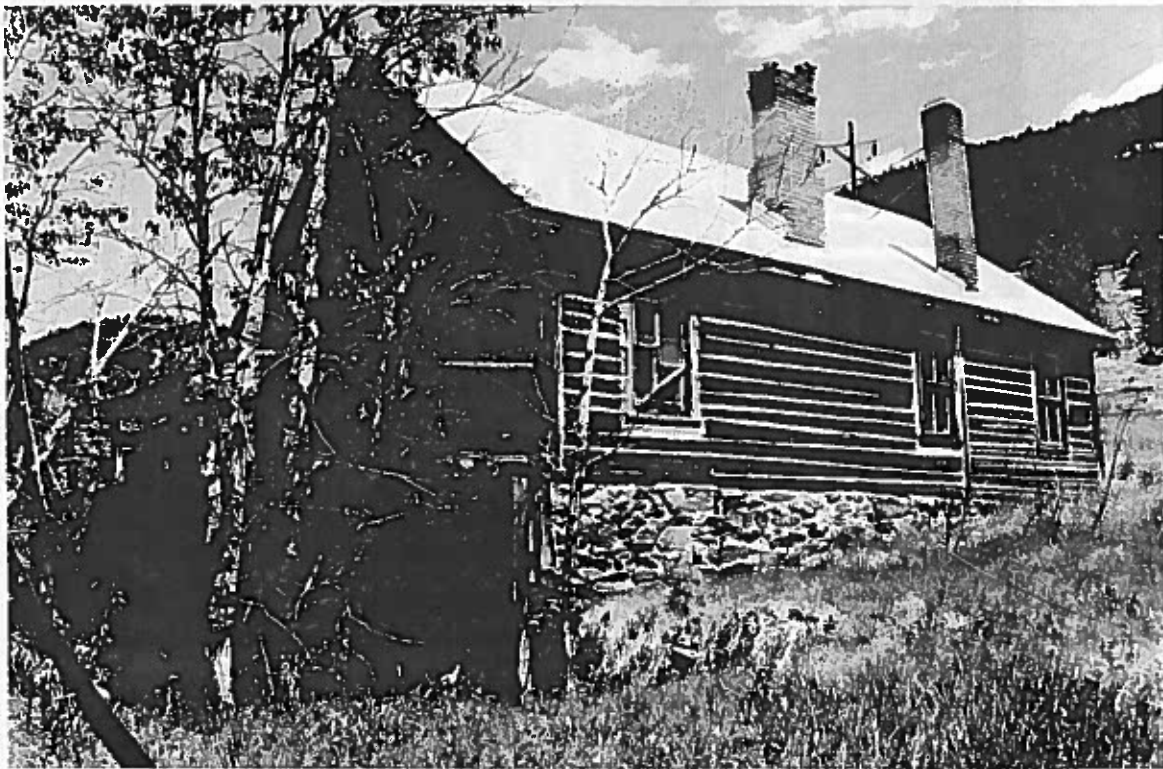
Figure 121: Looking northeast at the house. The sloped grade at this end of the house has been dug out to allow a vehicle to access the area under the deck. However this has also caused the foundation to be undermined on this end of the building where there are some settlement cracks.

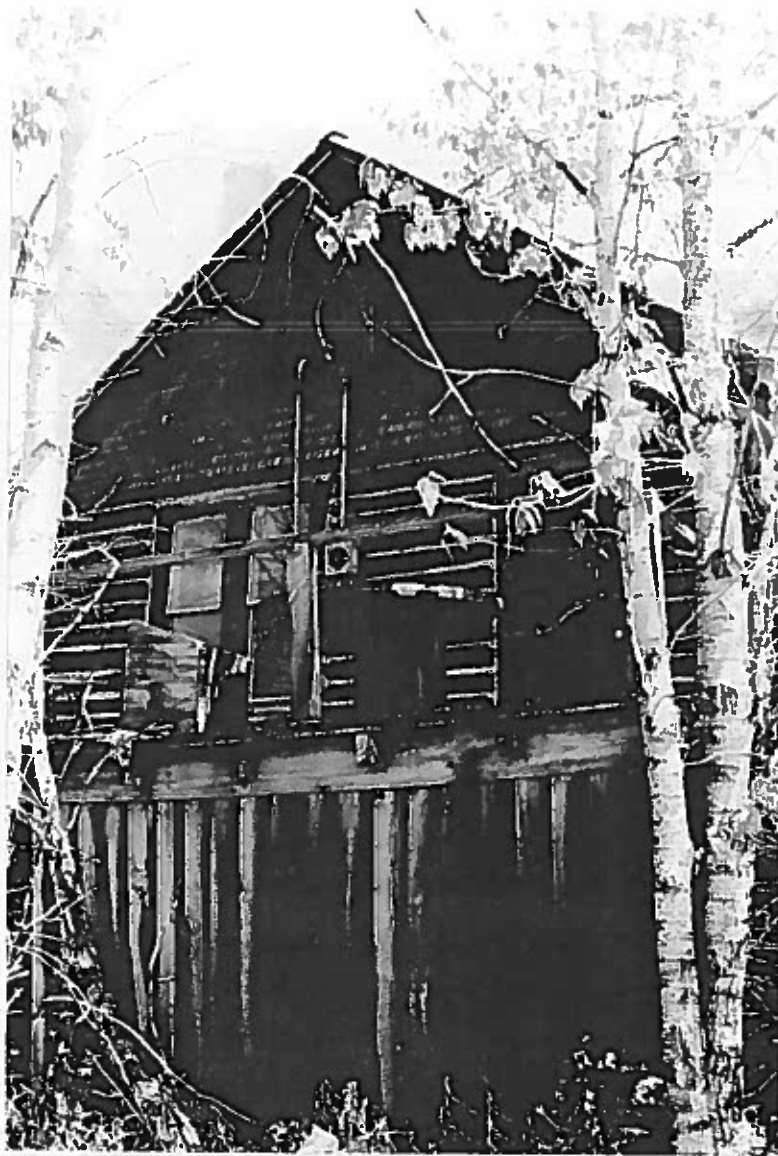
Figure 124: Looking east at the deck area on the west side of the building. Note the weathered wood and the simple railing around the deck.

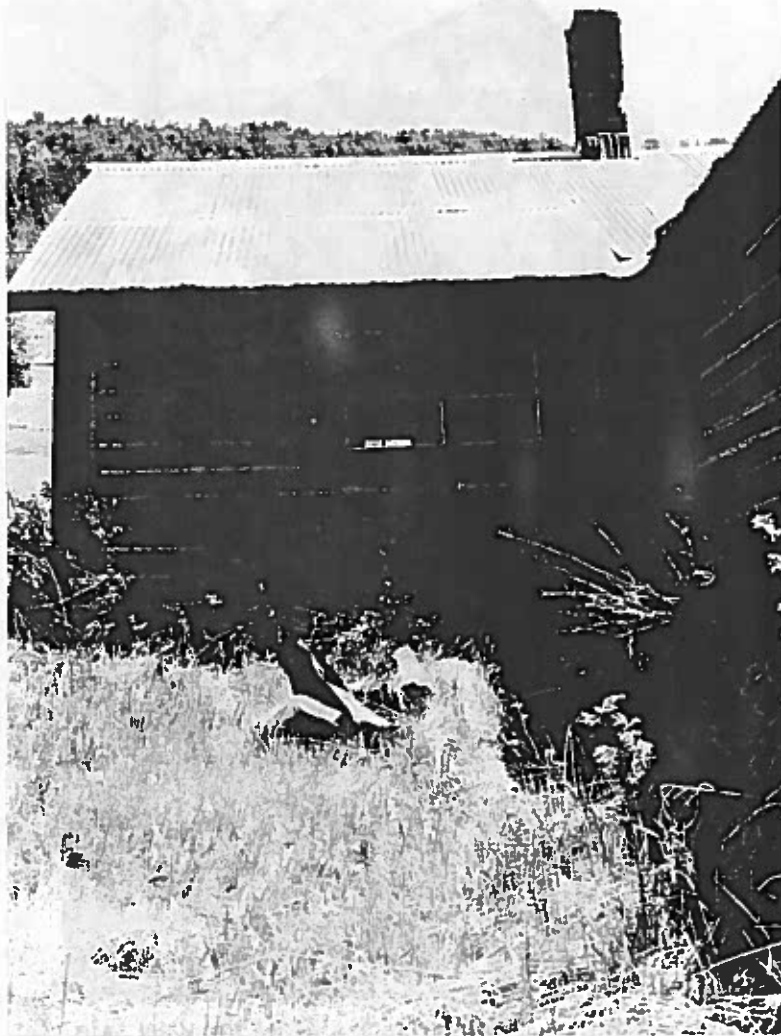
Figure 125: Looking east at the wing on the house. The materials are generally in good condition with the exception of the grade which allows water to flow against and into the basement of the building. The sill logs are rotted in some areas.

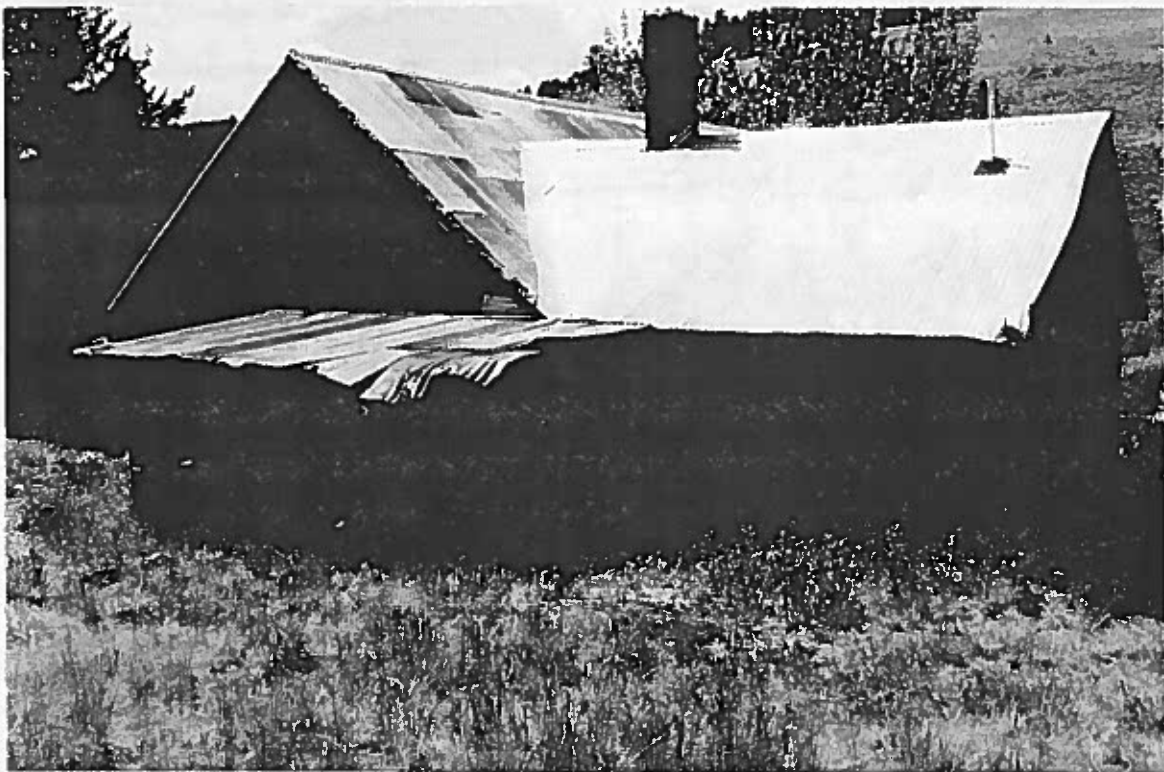
Figure 129: Looking southwest at the house. Note the deterioration of the shed roof structure.

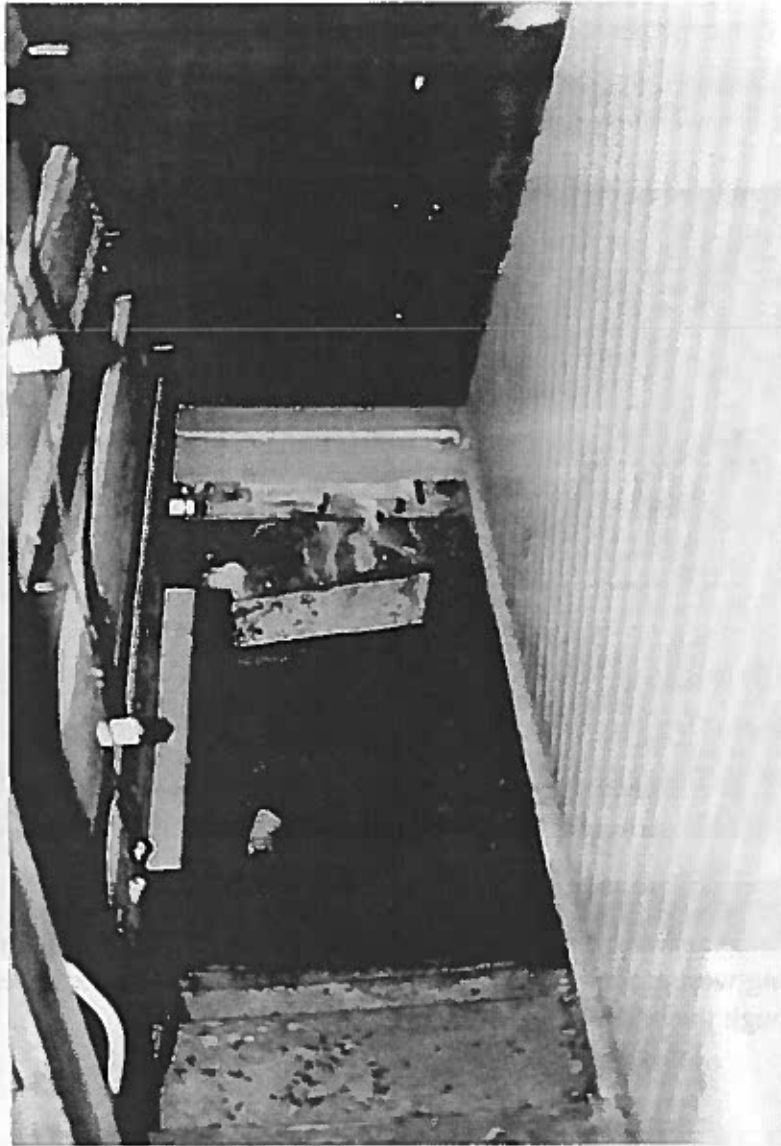
Figure 130: Looking down the steep steps to the basement.

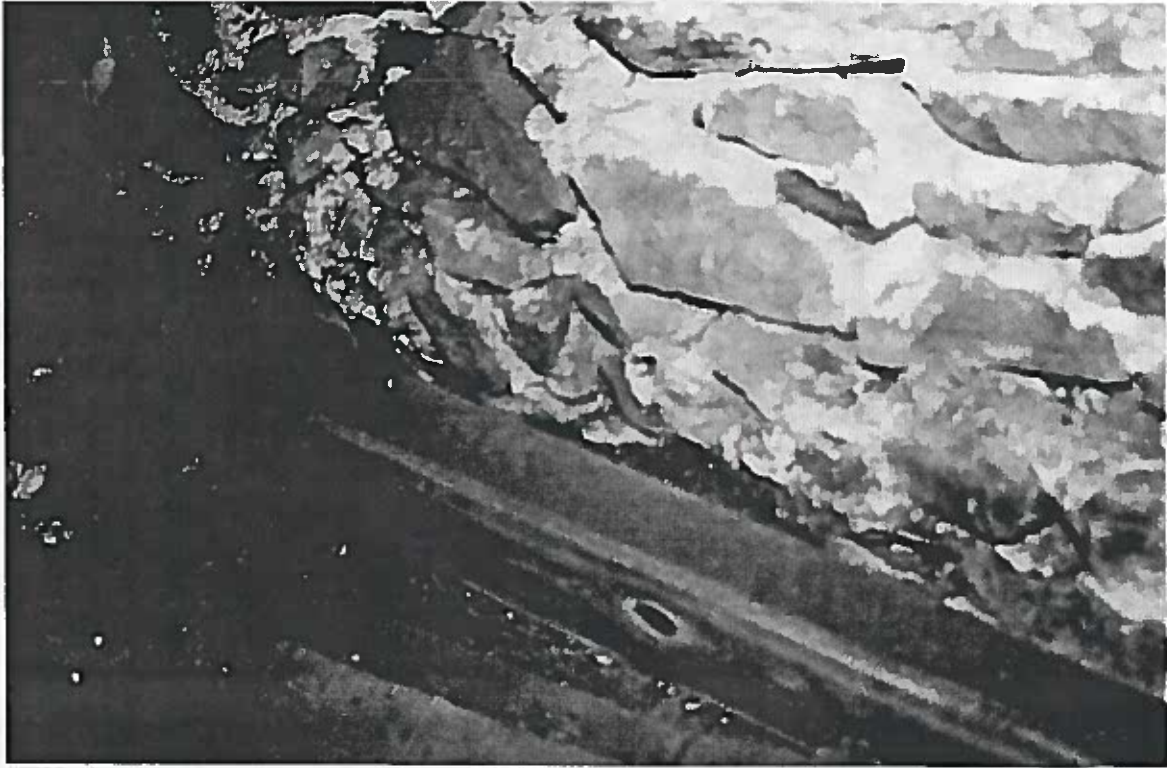
Figure 131: Looking west at the area of the foundation that is undermined because of the water flowing through the building.

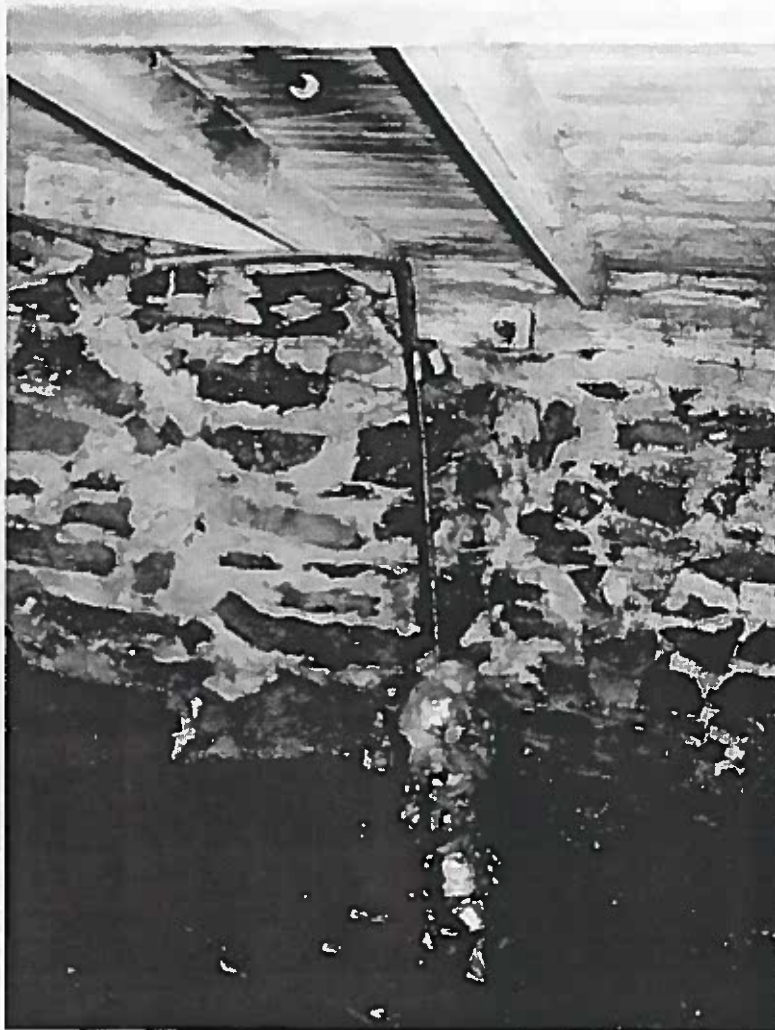
Figure 132: Looking south at the water line along the stone foundation for the fireplaces. There are some cracks in this wall due to settlement.
