**ARCHITECTURAL ASSESSMENT, RECOMMENDATIONS & COSTS  
of  
HISTORIC STRUCTURES**

**MINERAL HILL MINE**

**JARDINE, MONTANA**

**OCTOBER, 2000  
(REVISED JANUARY, 2001)**

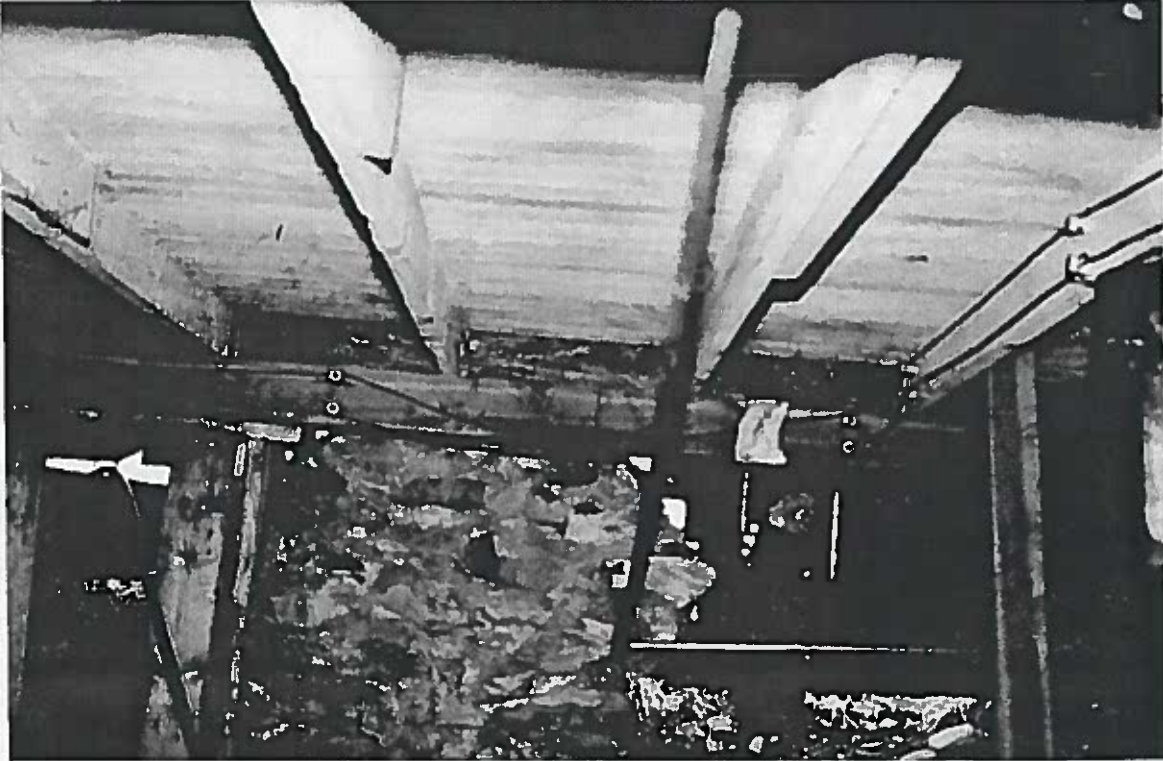
**Figure 133: Looking north at the foundation and the areas where the water penetrates into the structure. Note the area to the right where the slope drains water directly into the basement.**

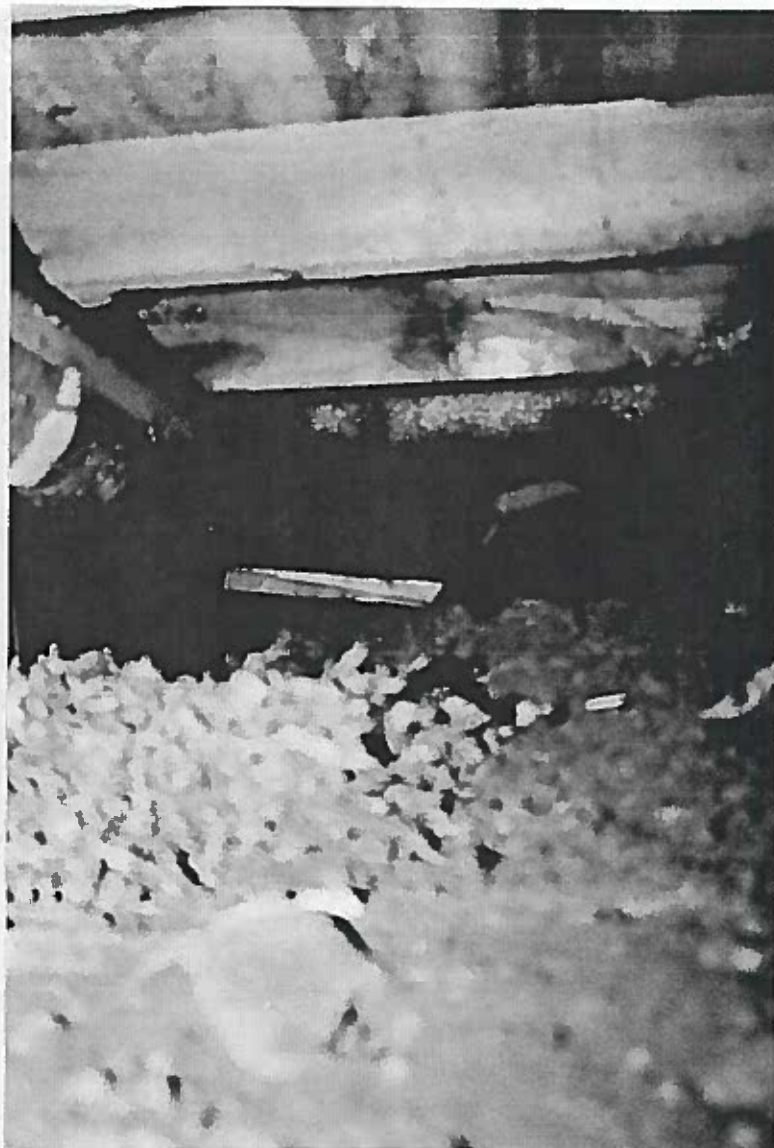
Figure 134: Looking east at the crawl space. The floor joists and structure appear to be dry.

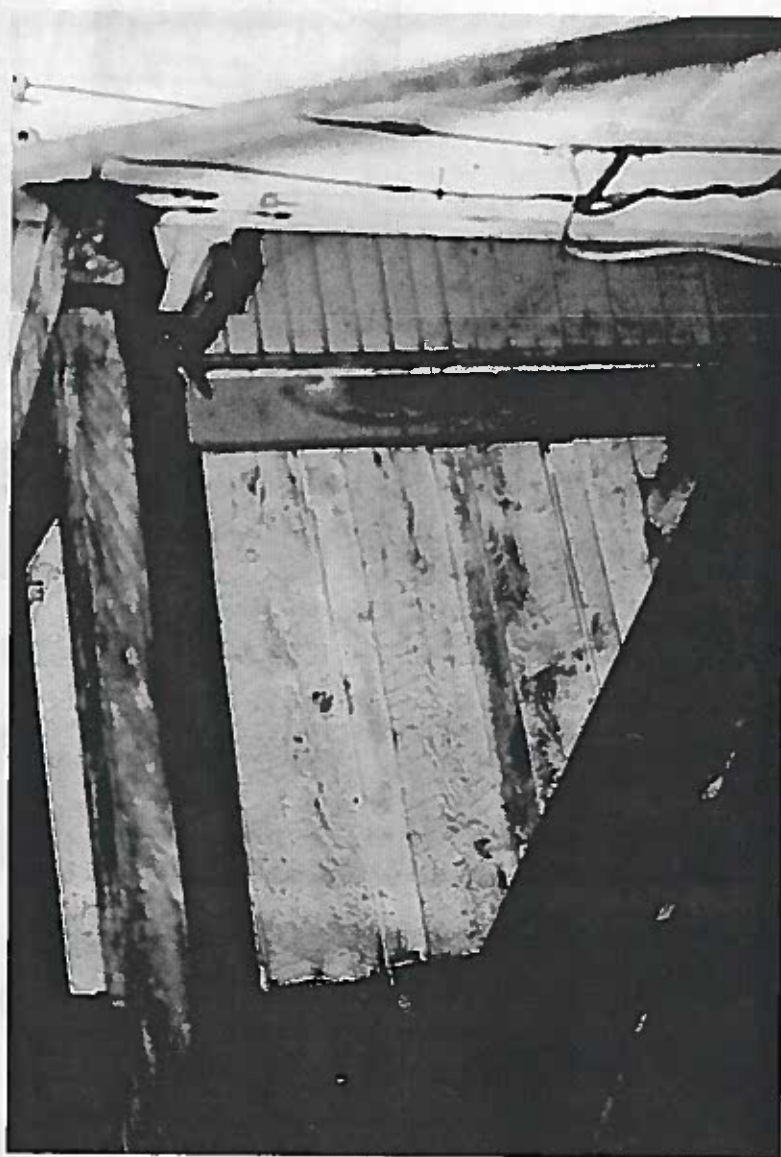
Figure 136: Looking east at the steep steps up to the first floor.

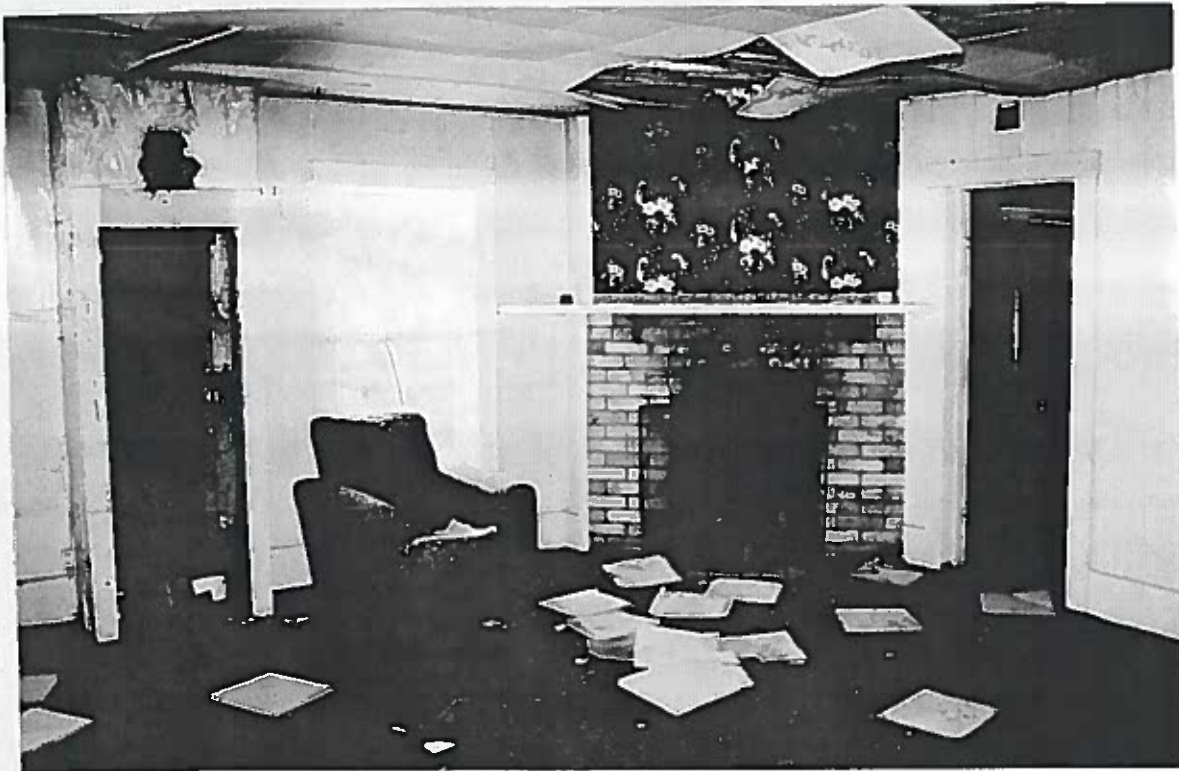
Figure 137: Looking southwest at the living room and fireplace. Note the newer materials that have been added to the walls and ceiling. Original wall and ceiling paper exists under the newer materials.

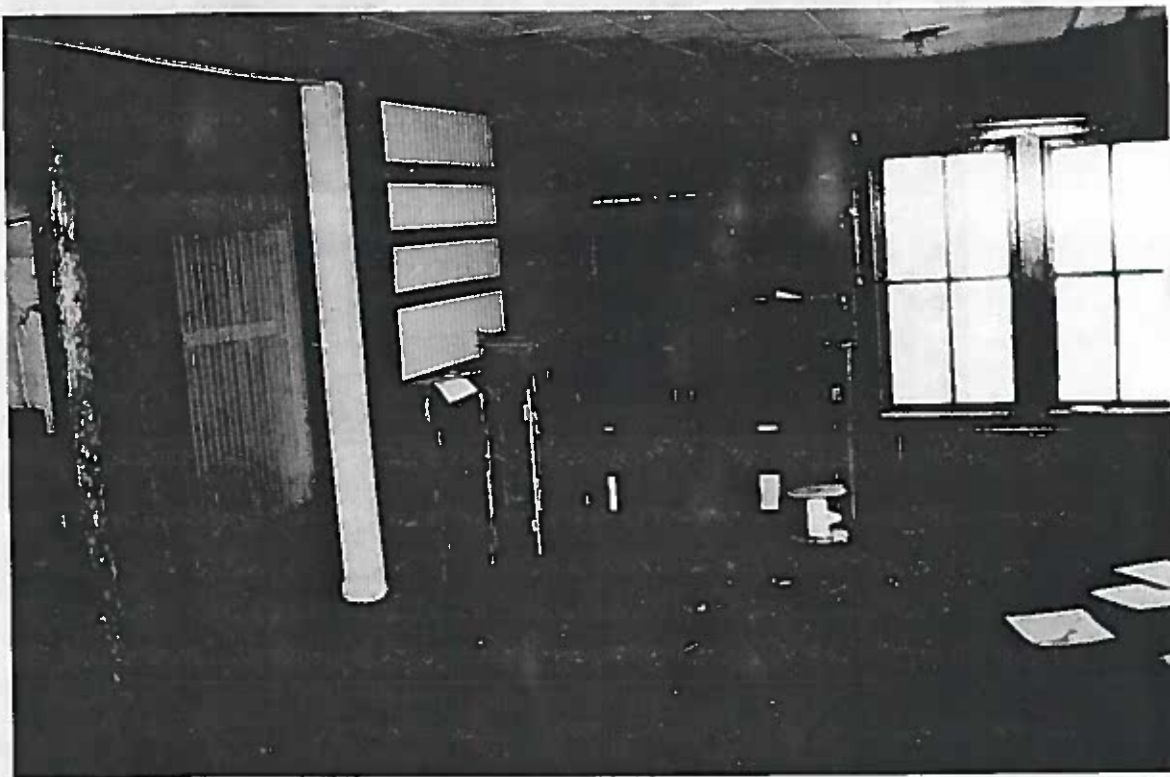
Figure 138: Looking northeast at the living room. Note the wood on the walls from the older buildings such as the mill.

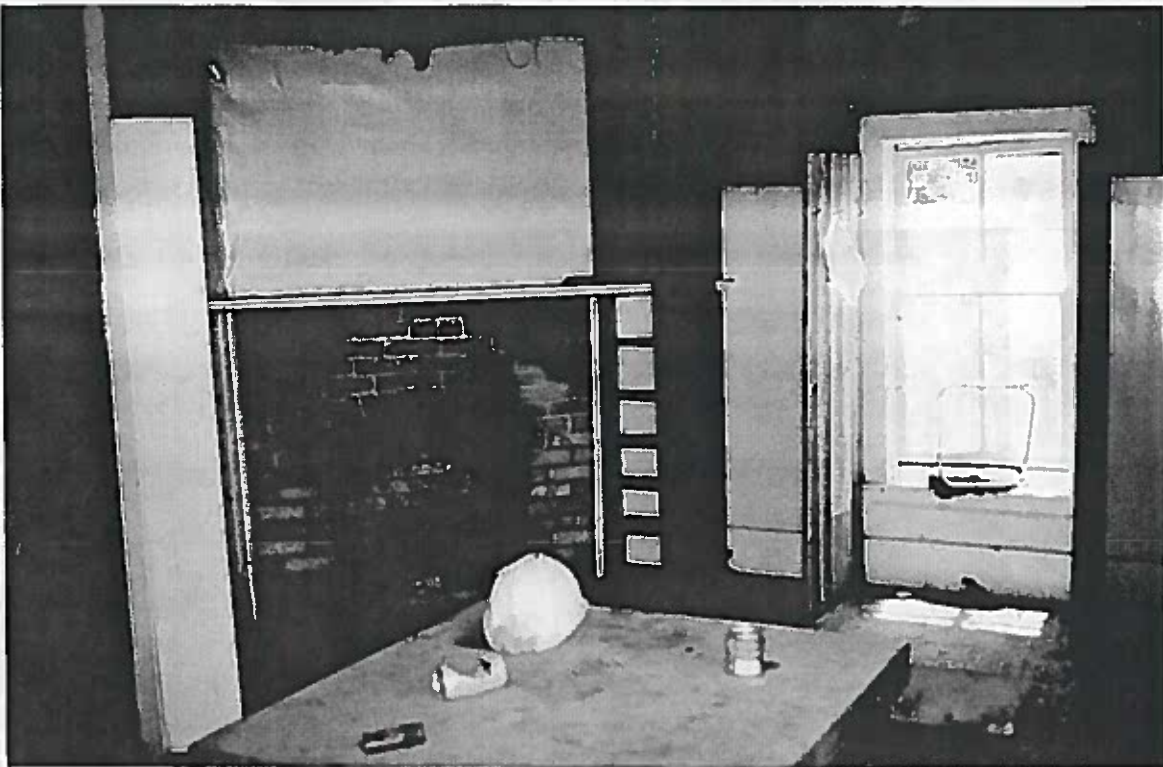
Figure 139: Looking south at the fireplace and window in the dining room. Some of the walls have been covered over with wood.

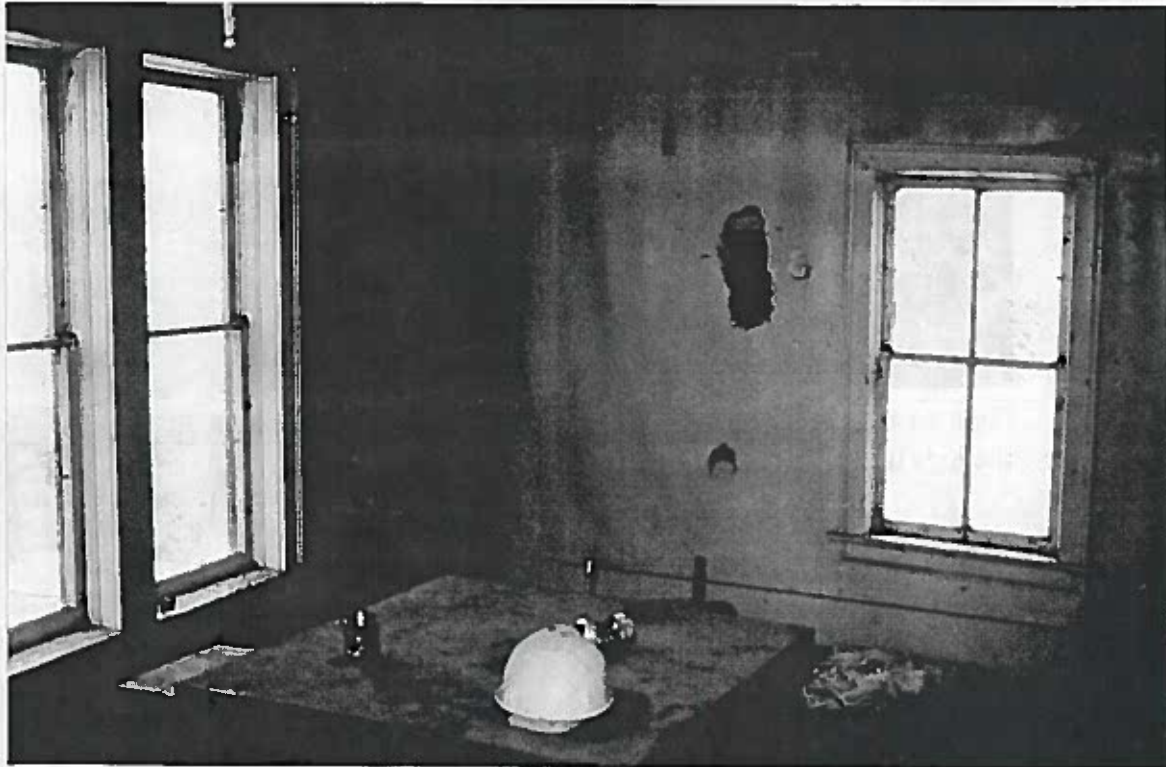
Figure 140: Looking northwest at the dining room. Note the hole in the wall.

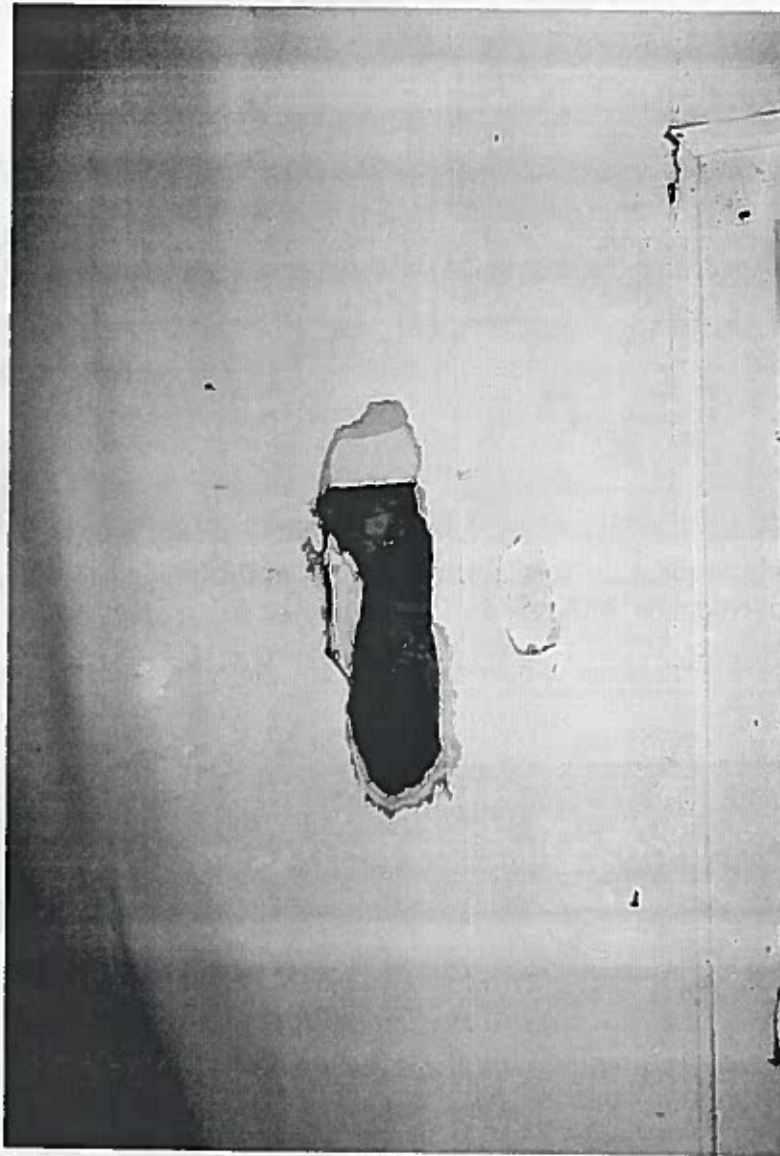
Figure 141: Looking northeast at the hole in the wall. Note the logs under the sheetrock.

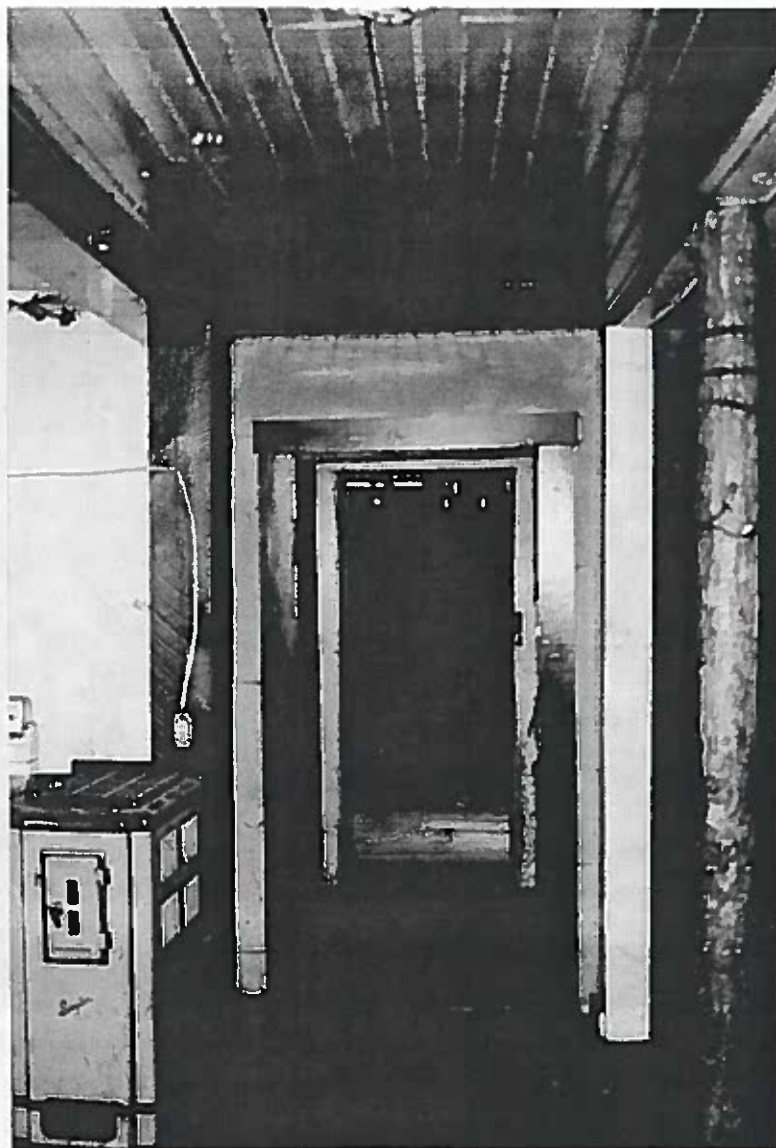
Figure 142: Looking west at the hallway from the kitchen to the dining room. Note the beaded board ceiling which appears to be original.

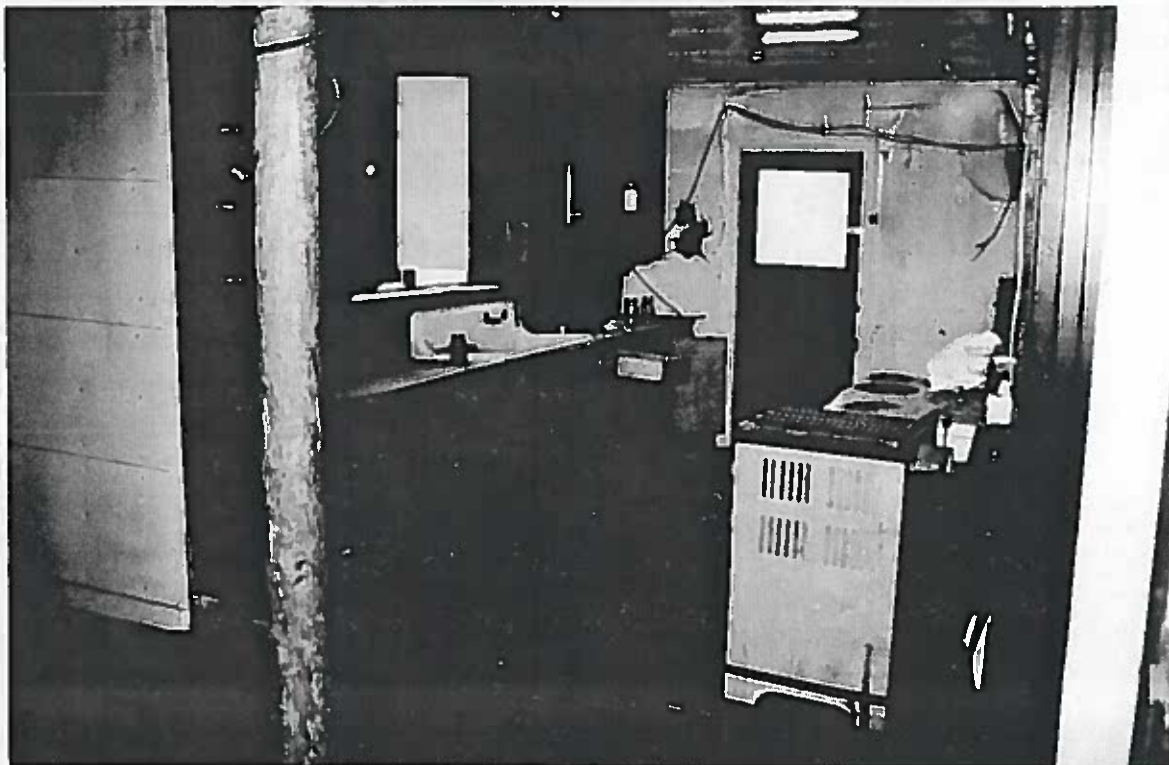
Figure 143: Looking north at the kitchen wing. Note the log column that supports the roof where a wall was removed to open up the spaces.

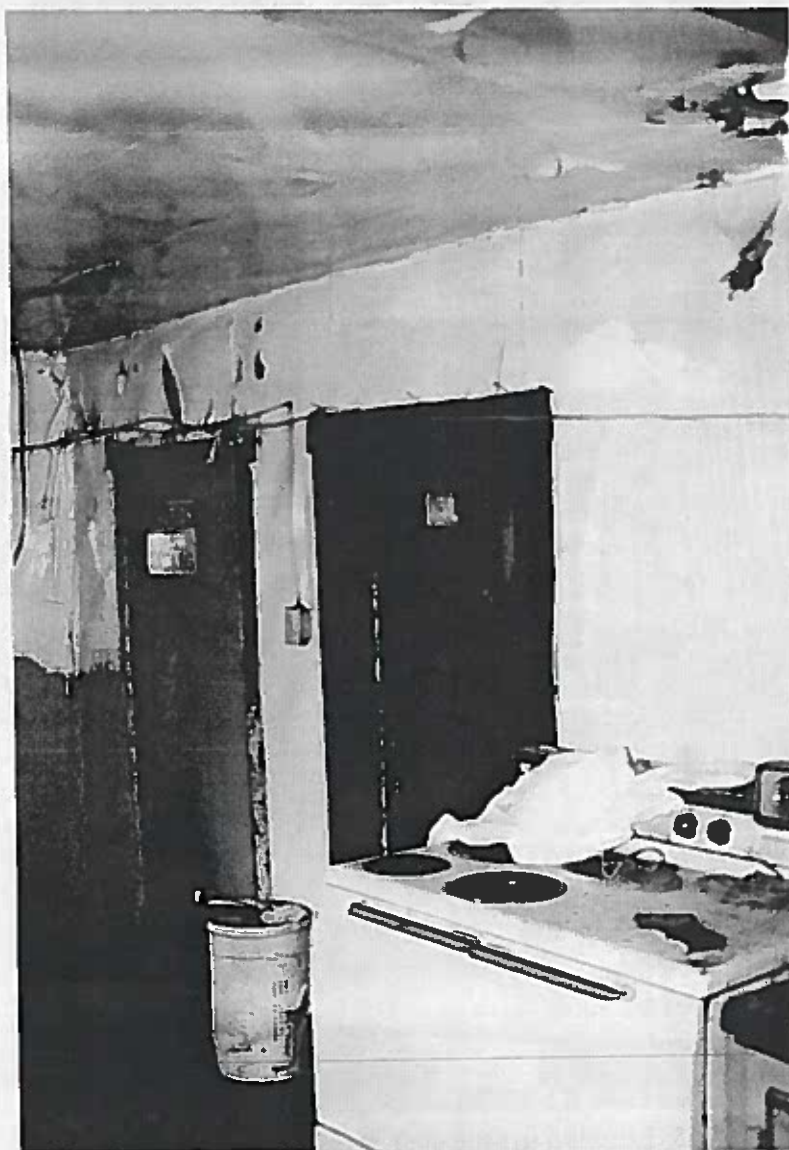
Figure 144: Looking northeast at the door to bathroom.  
The wall and ceiling papers have been painted.

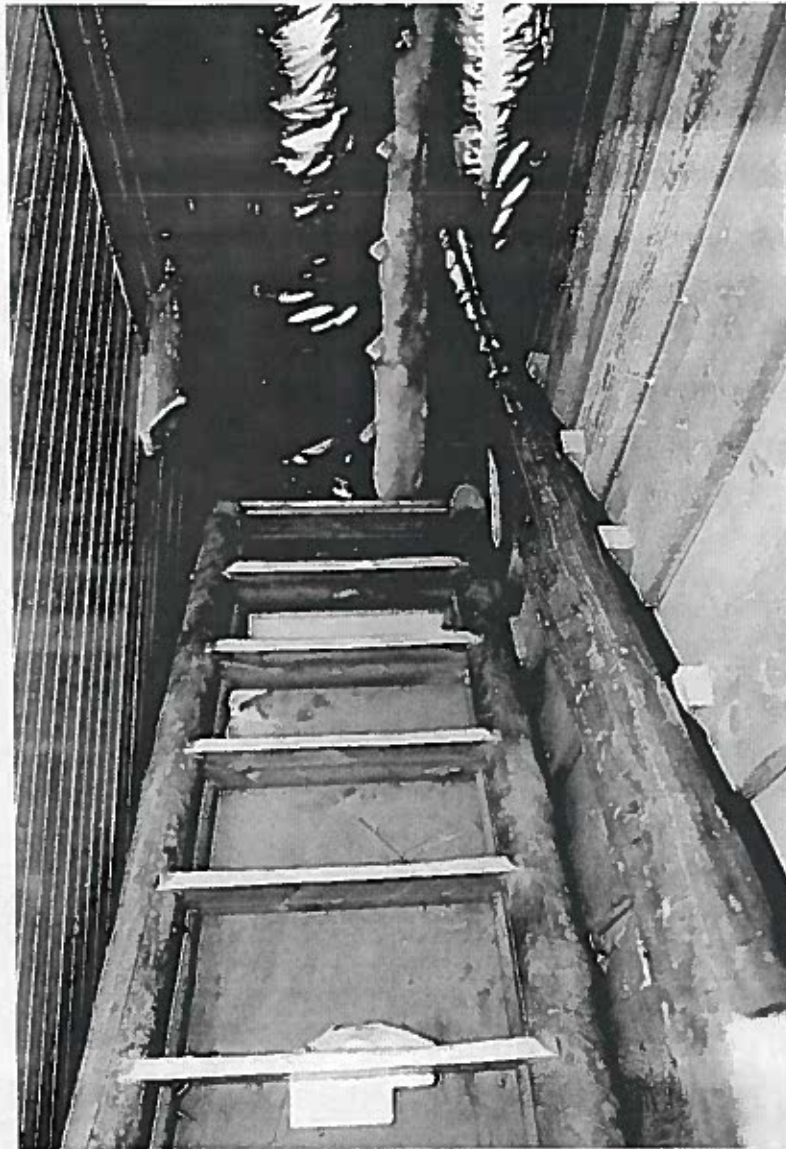
Figure 145: Looking up the stair steps to the attic space.  
The steps are very steep.

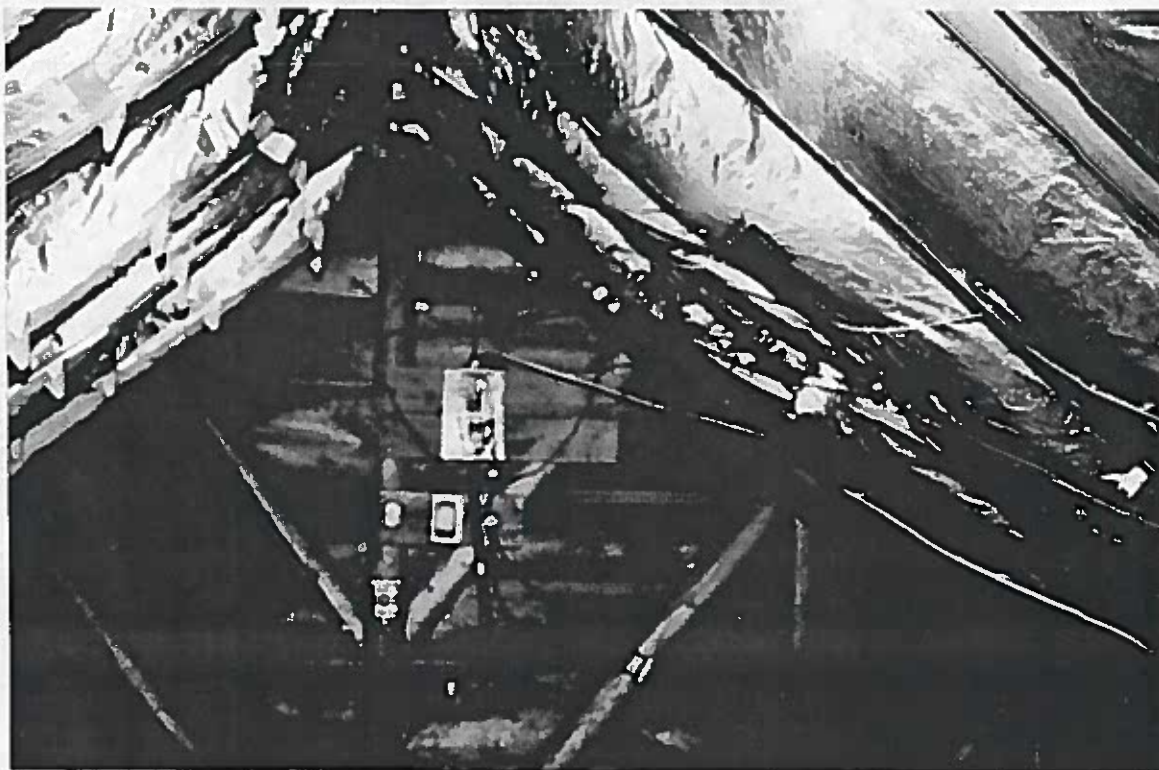
Figure 146: Looking west at the attic structure. Note the log structure on the gable end as well as the rafters. A new electrical panel has been installed over the years.

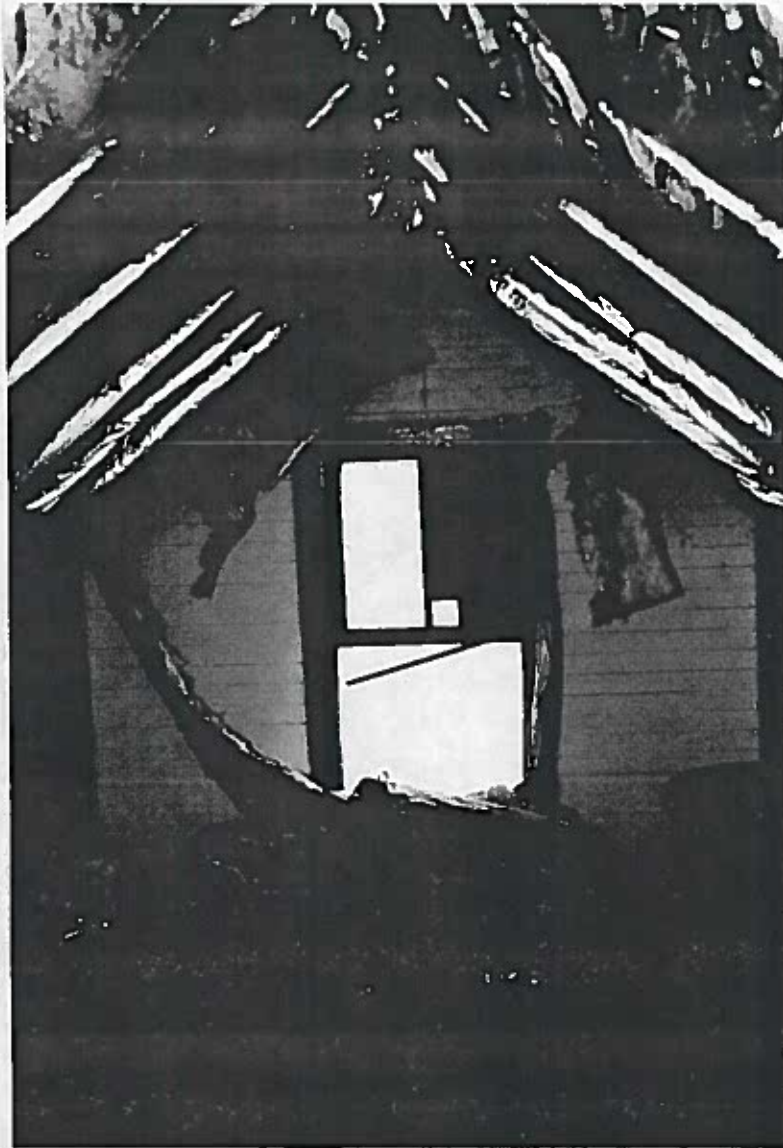
Figure 147: Looking east at the attic space at the finished space in the east half. Insulation has been added to the ceiling.

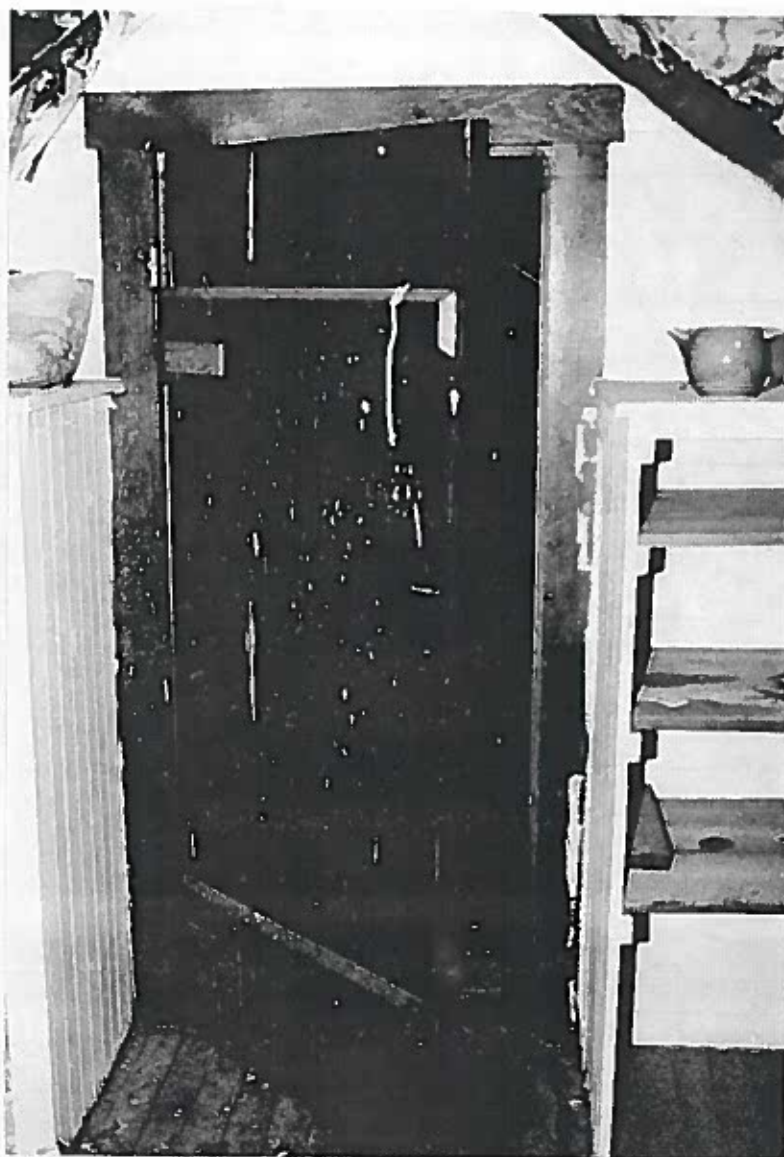
Figure 149: Looking west at the wood door leading out of the finished half of the attic.

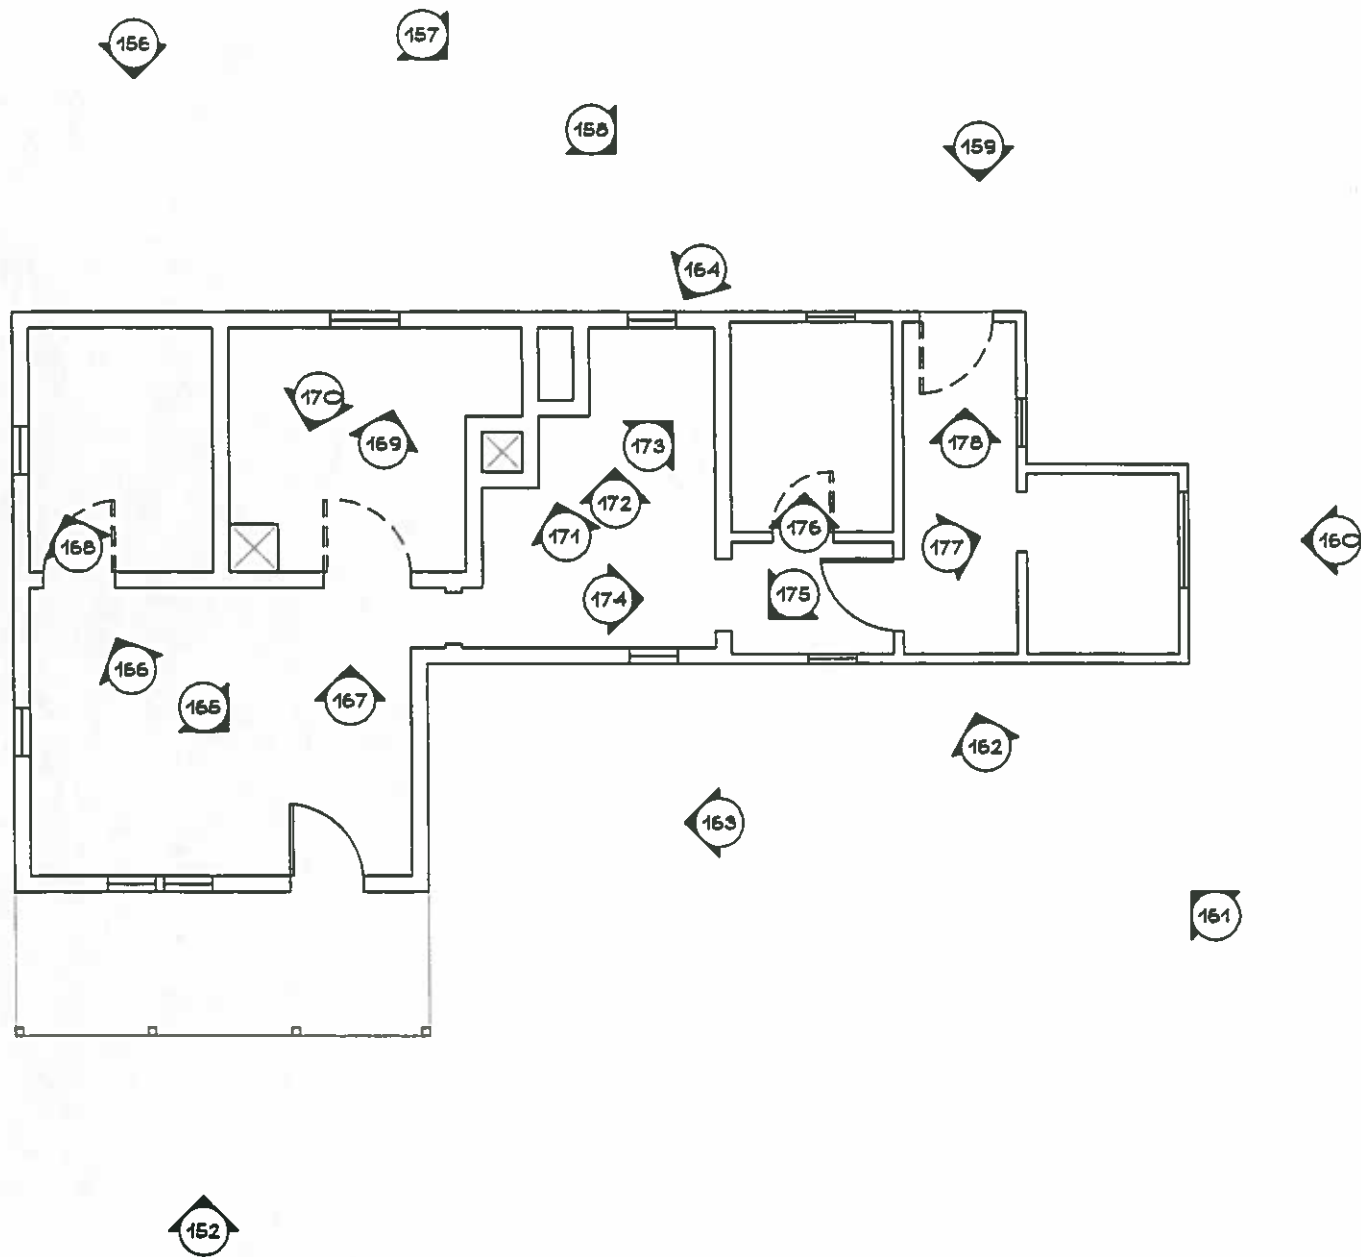
**1 FLOOR PLAN**  
SCALE 1/8" = 1'-0"

The cabin is generally in good condition. The main problems occur where the grade is high on the east side causing deterioration of the sill logs and the front porch. This has caused some settlement in the floor in the main room. There are also some floor problems in the kitchen area where the floor has been pulled out possibly because it was rotted. The addition on the west and north is in poor condition. The logs are in good condition however they are dry and some of the daubing is cracked or missing. The sill logs and possibly a second log around the front and north and south sides of the main building are rotted causing the settlement. The windows and doors are weathered and missing paint. The wood shingle roof is in poor condition. There is some deterioration with loose bricks and mortar on the chimneys.

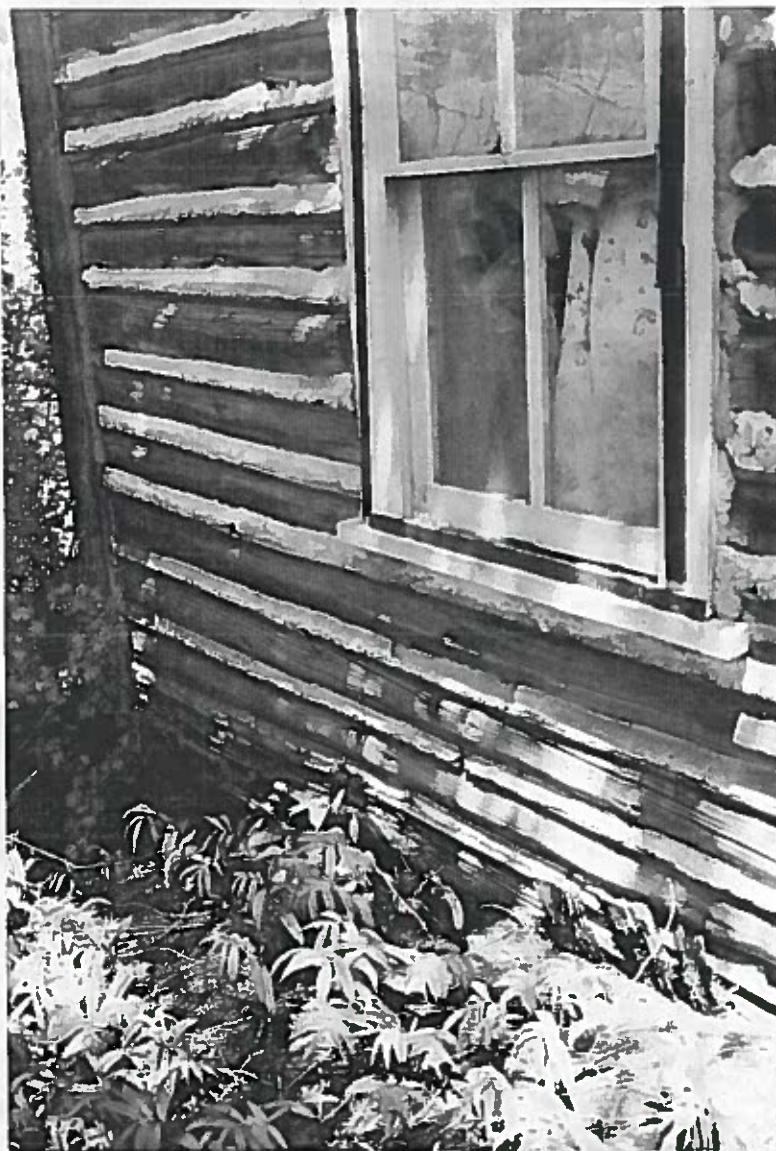
Figure 155: Looking northwest at a section of the log wall. Most of the log work is in good condition and some of the daubing is in good condition. However note the rotted sill log and the grade change along the building.

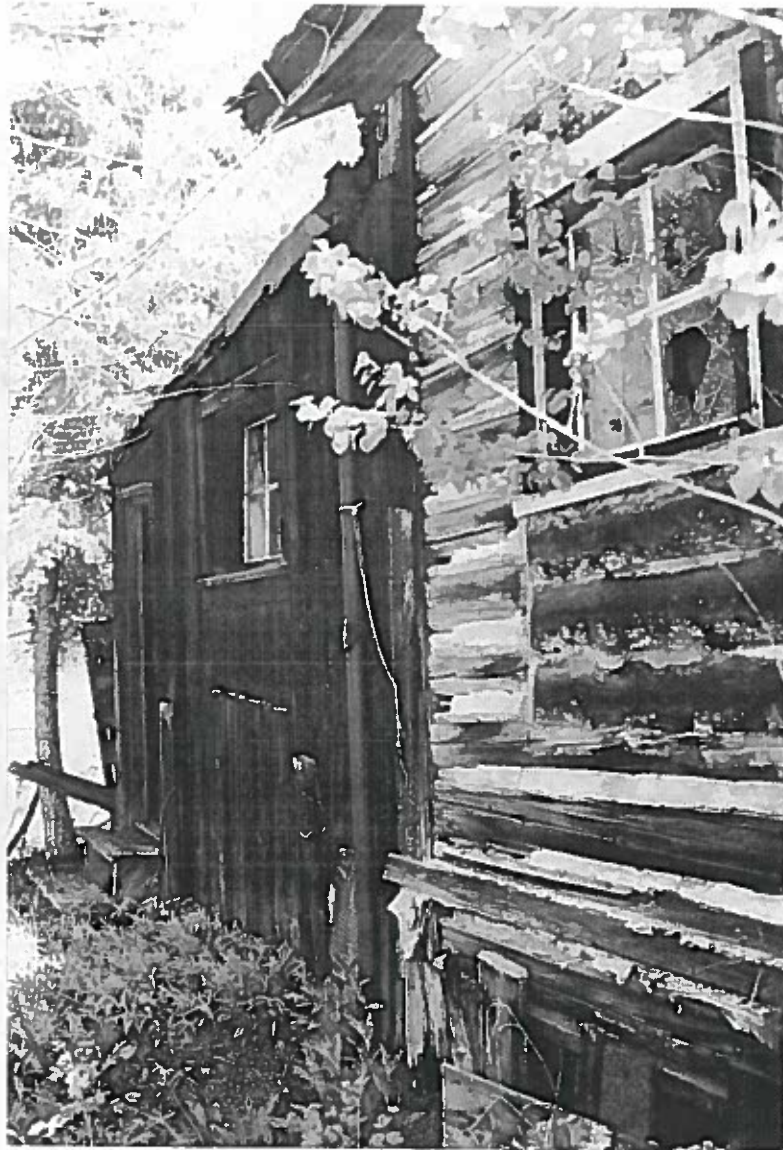
Figure 158: Looking northeast along the back of the building at the original log portion and the added frame buildings. The frame portion is in poor condition with rot at the base as well in the roof structure.

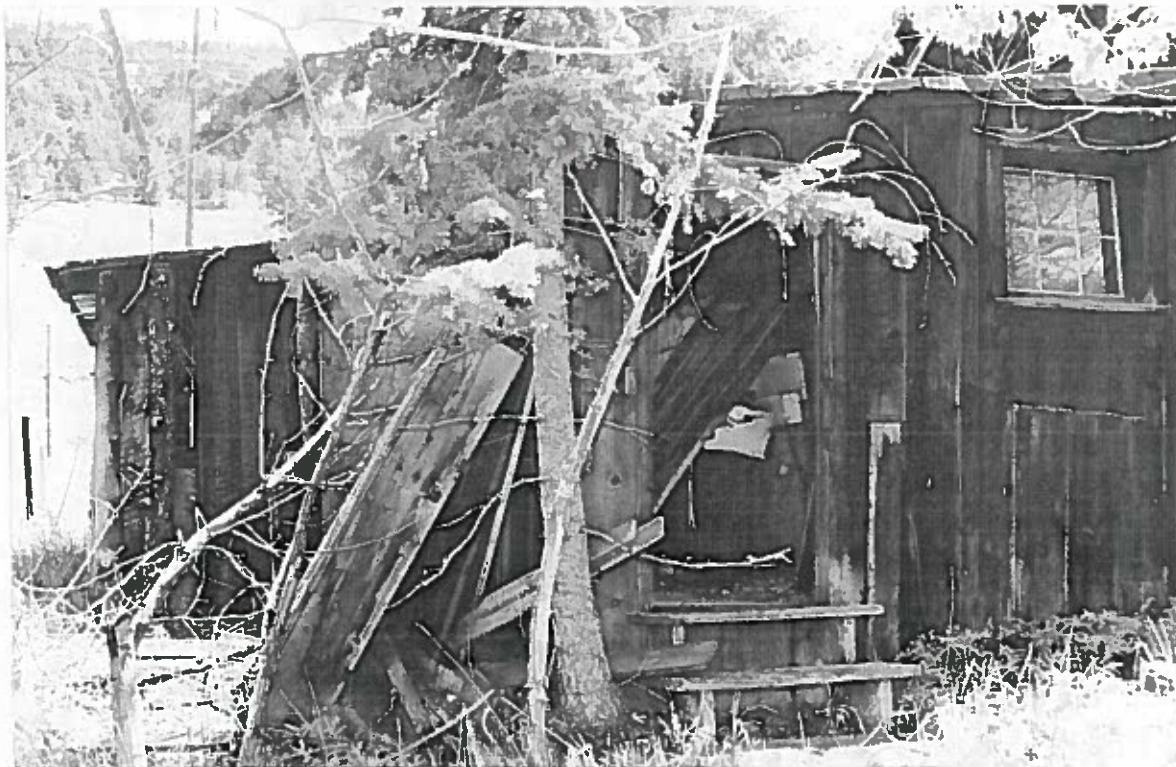
Figure 159: Looking east at the frame addition to the building. Note the collapsed area, missing walls and doors and settlement in the structure.

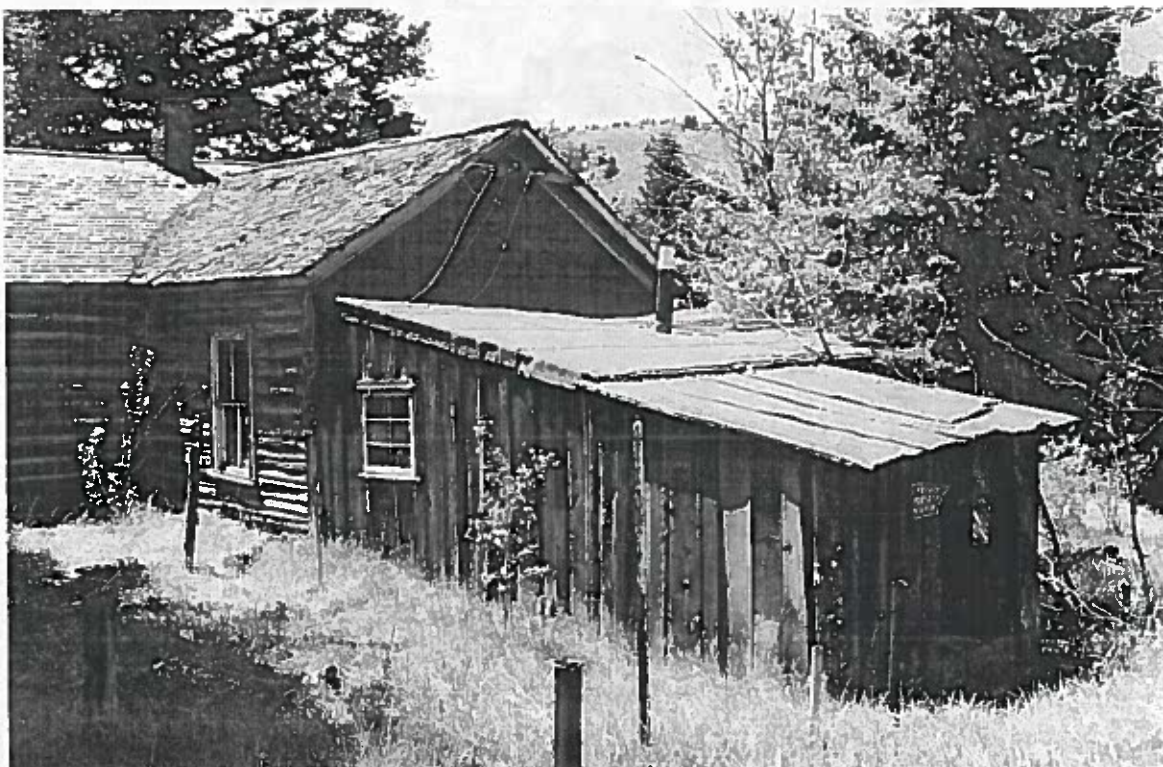
Figure 161: Looking southwest at the frame addition to the building. Note the metal and sheet asphalt roofs which are in fair condition.

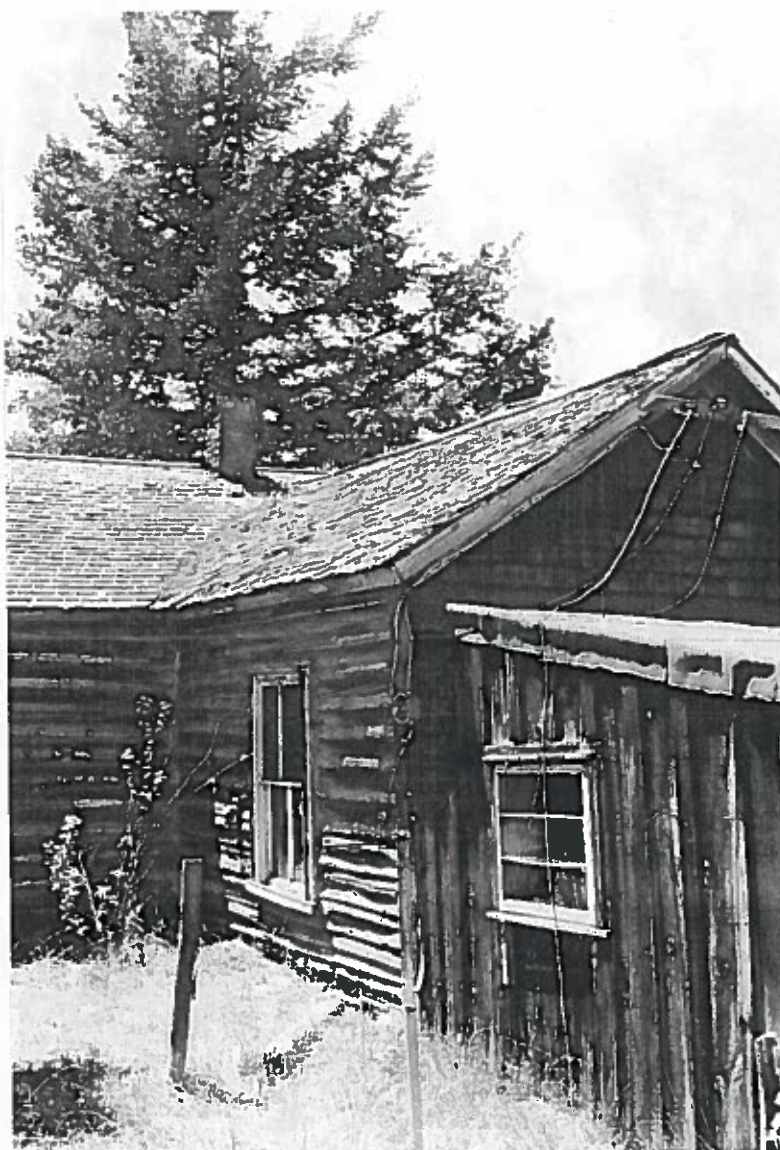
Figure 162: Looking southwest at the intersection of the frame structure and the log structure. Note the high grade around this section of the building.

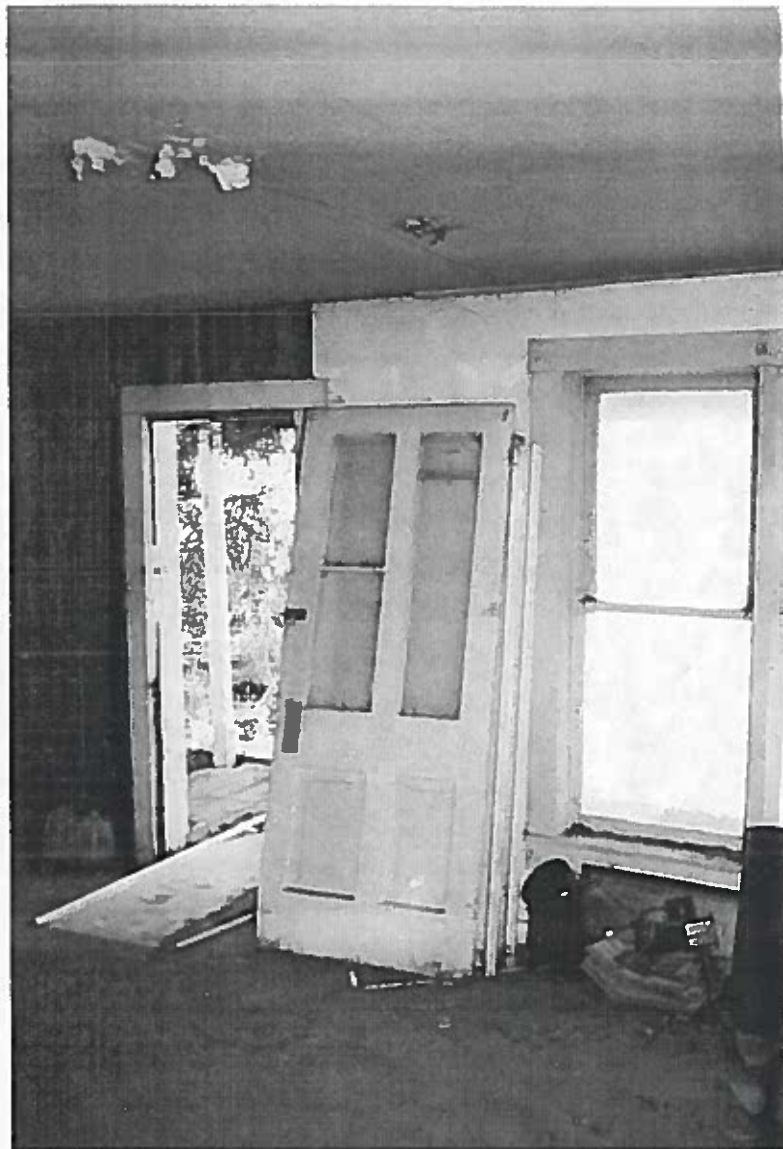
Figure 165: Looking east at the front entrance to the Cabin:  
Note the door that has been removed.

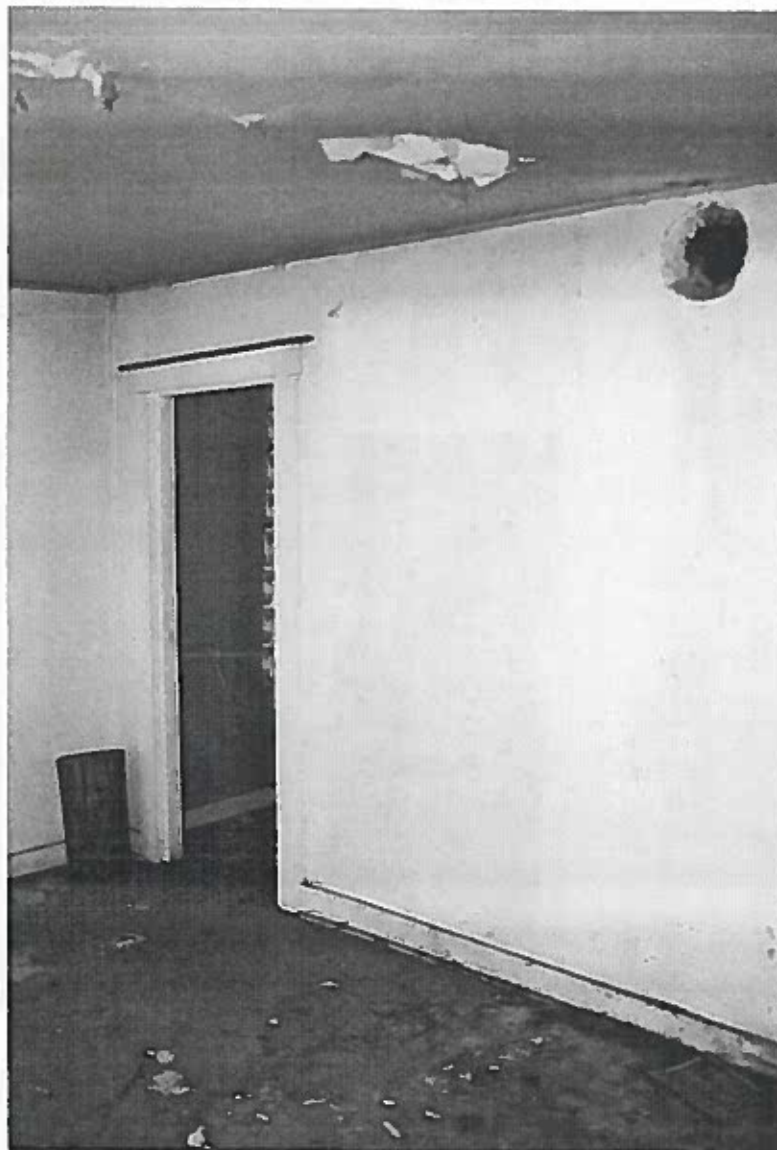
Figure 166: Looking southwest at the interior of the front room of the Cabin. Note the plaster walls and ceiling. There is some settlement along the outer wall on the left because of log deterioration has caused the plaster to crack. The fir floor also bulges in the center because of the settlement.
