**ARCHITECTURAL ASSESSMENT, RECOMMENDATIONS & COSTS  
of  
HISTORIC STRUCTURES**

**MINERAL HILL MINE**

**JARDINE, MONTANA**

**OCTOBER, 2000  
(REVISED JANUARY, 2001)**

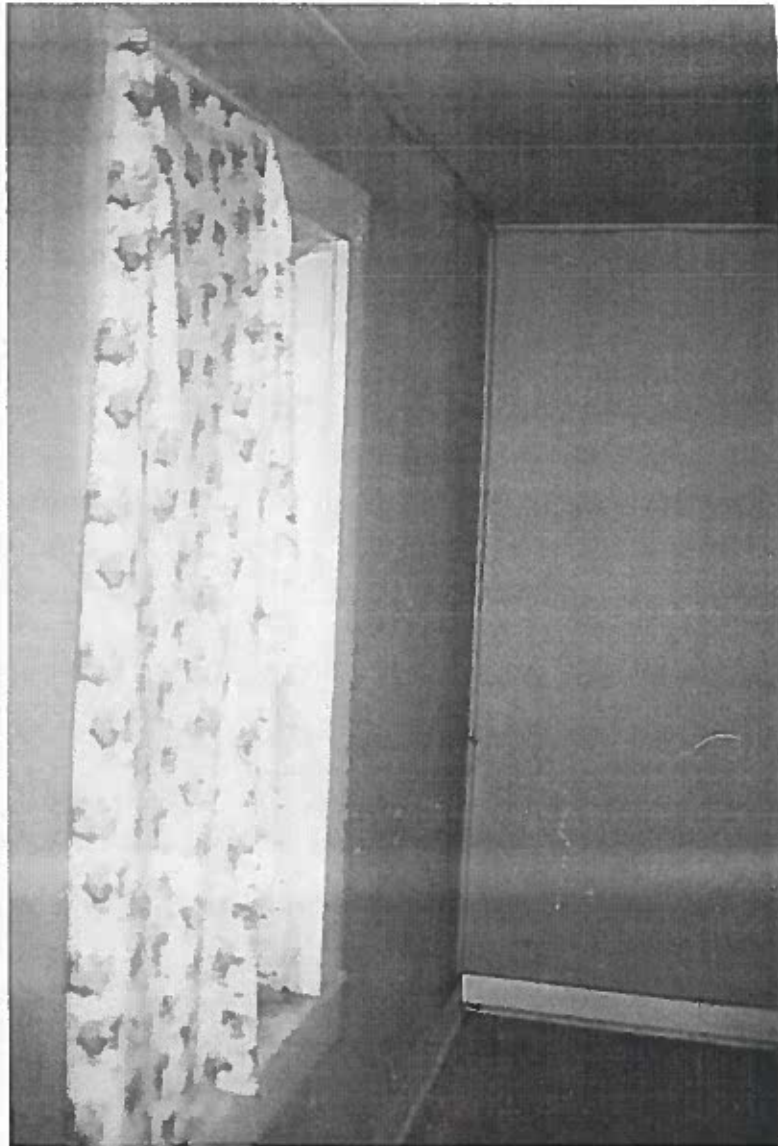
Figure 168: Looking west at the southwest bedroom. Note the good plaster on the walls and ceilings.

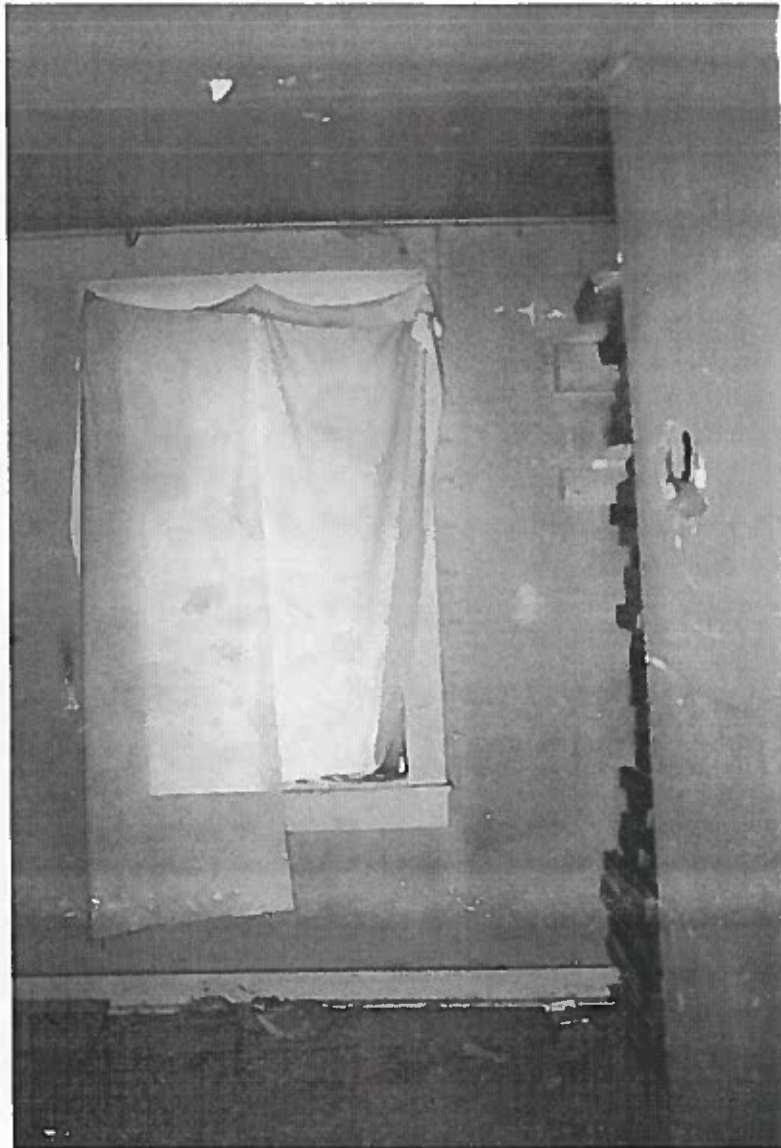
Figure 169: Looking west a the middle bedroom. Note the plaster deterioration due to vandalism.

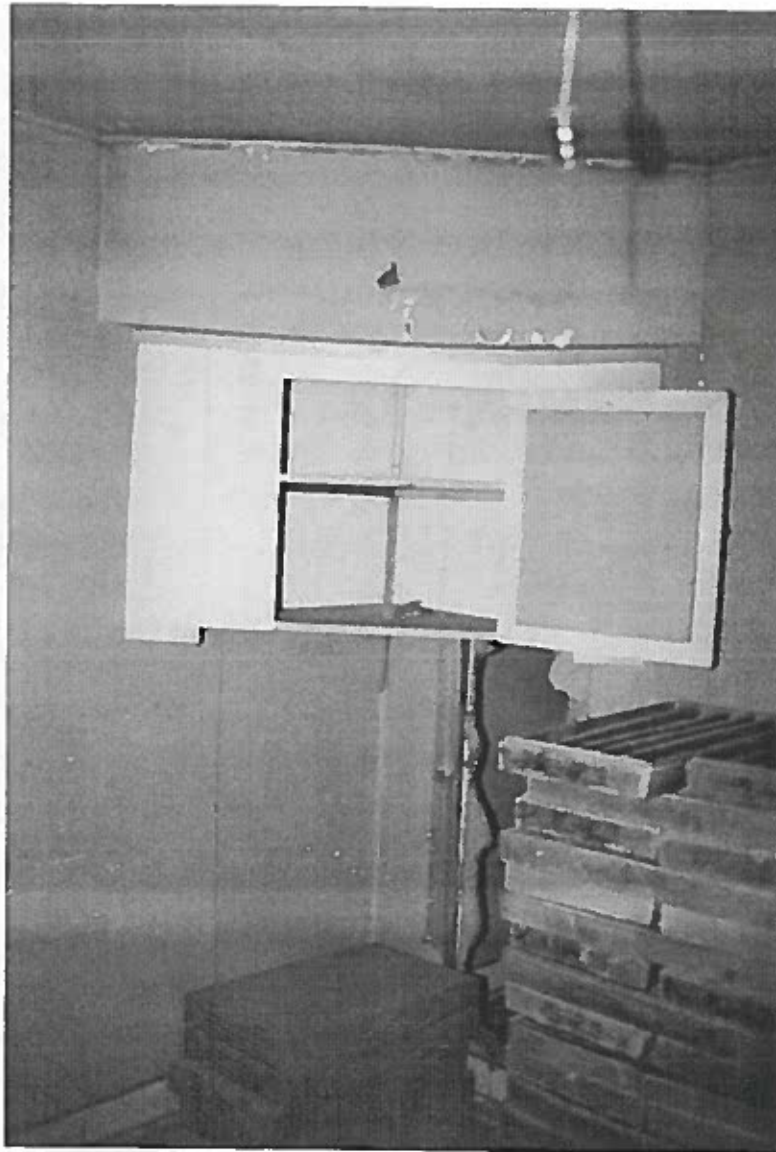
Figure 170: Looking southeast at the middle bedroom. A section of the wall has been removed into the other bedroom.

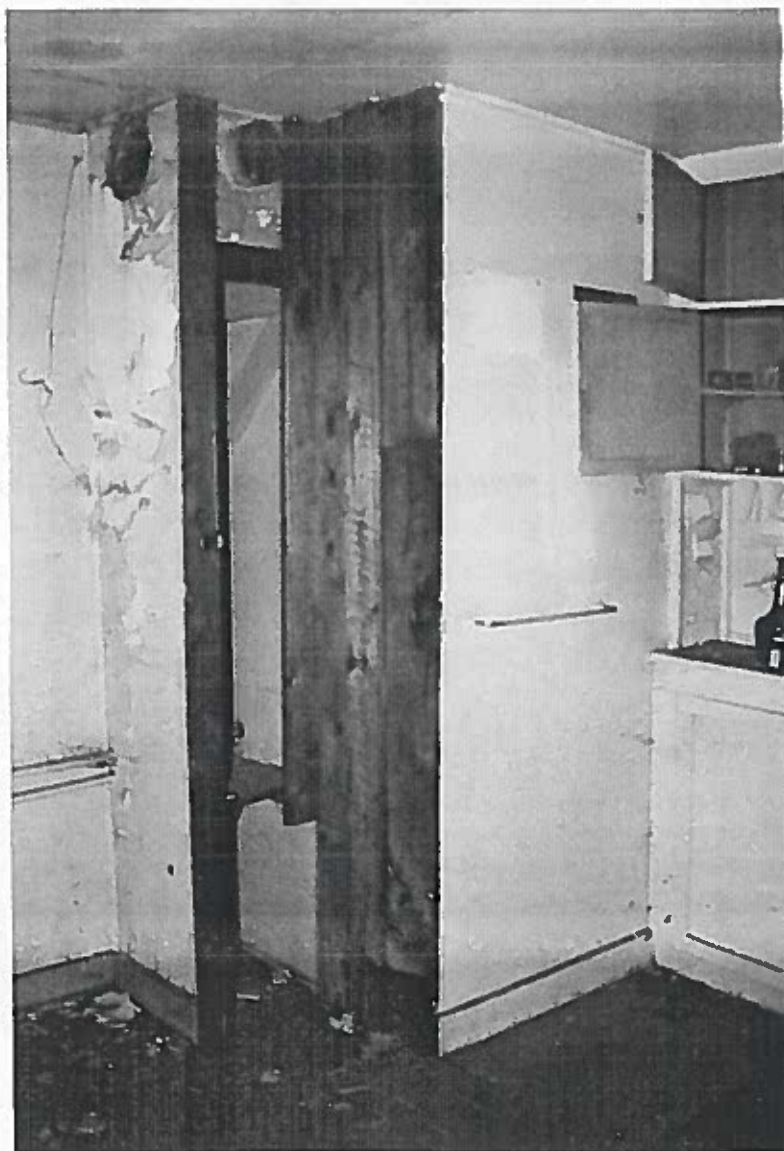
Figure 171: Looking southwest at the chimney area of the kitchen. There has been some water damage around the chimney.

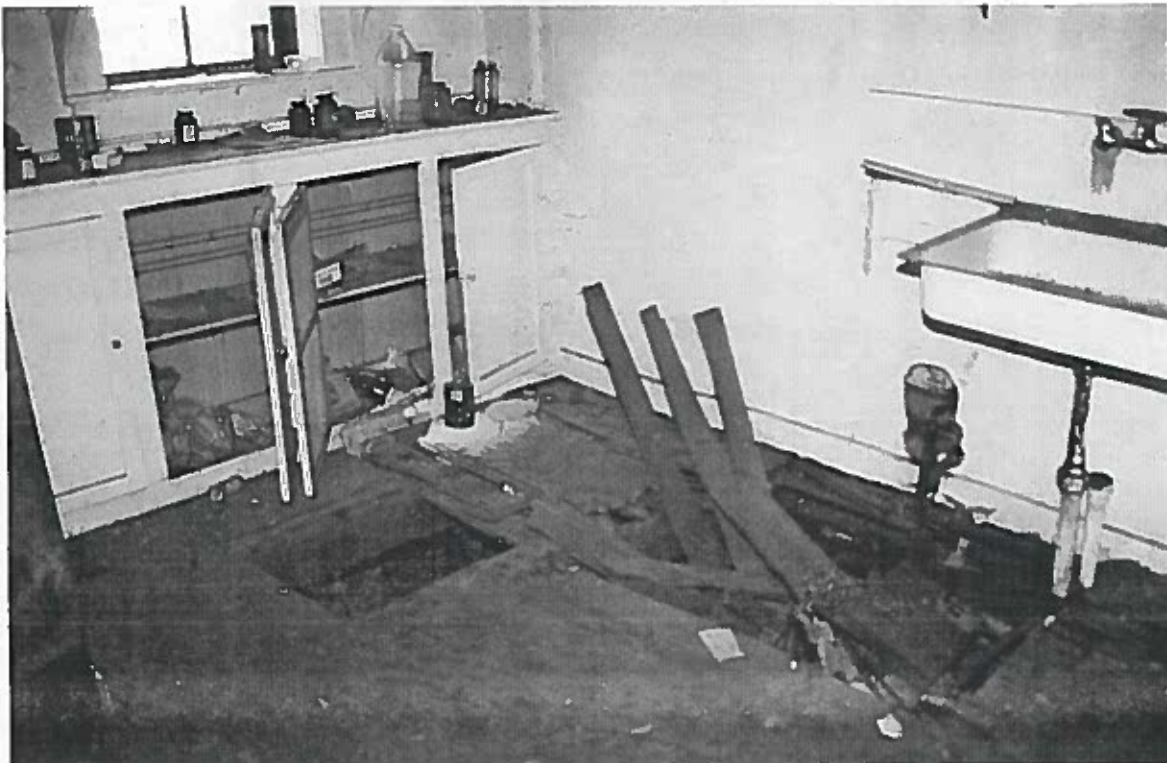
Figure 173: Looking northwest at the kitchen. Note the holes in floor where the wood has been cut out.

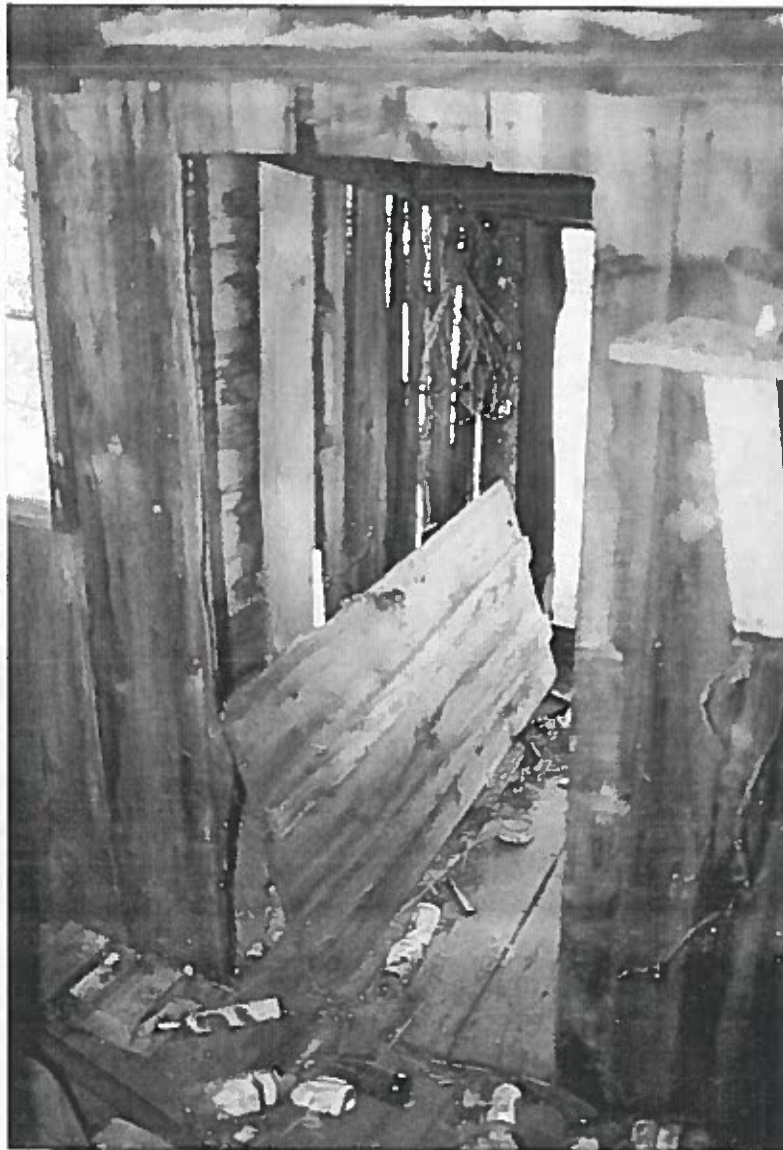
Figure 177: Looking north at the frame addition. Note the rotted floor boards, missing or removed doors, and open areas in the walls.

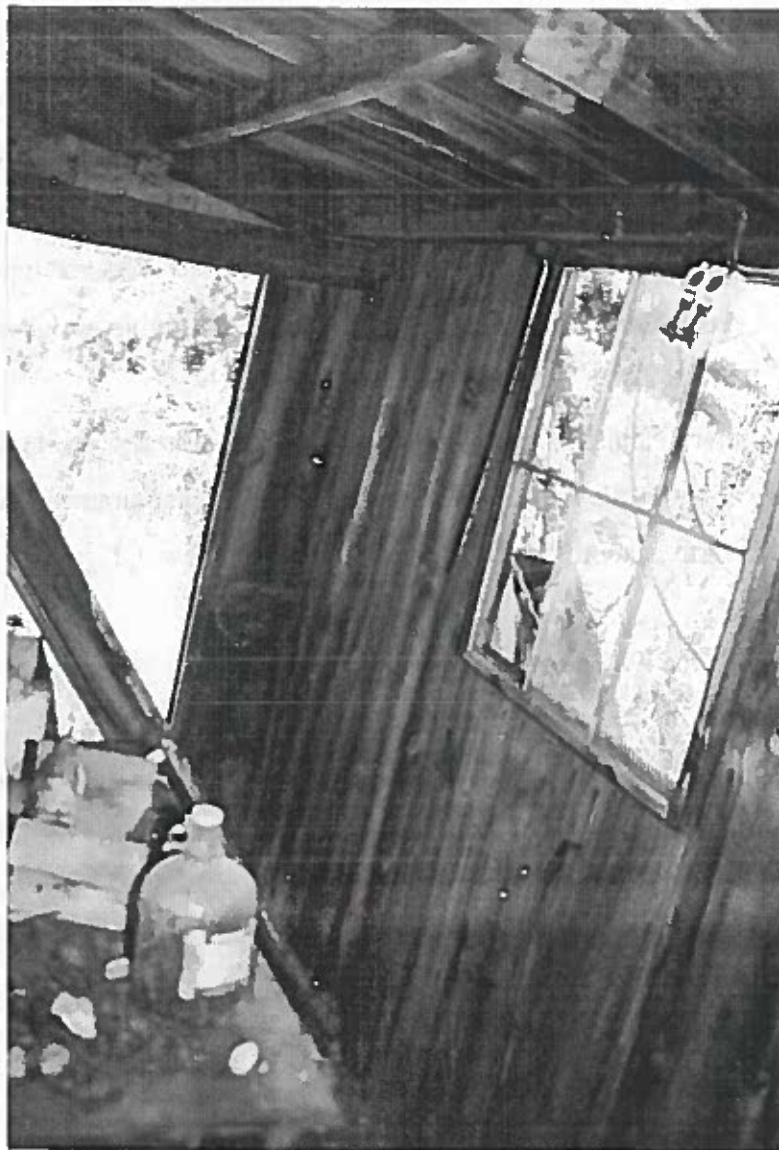
Figure 178: Looking northeast at a section of the frame addition. The base of the walls are deteriorating and the window is in poor condition.

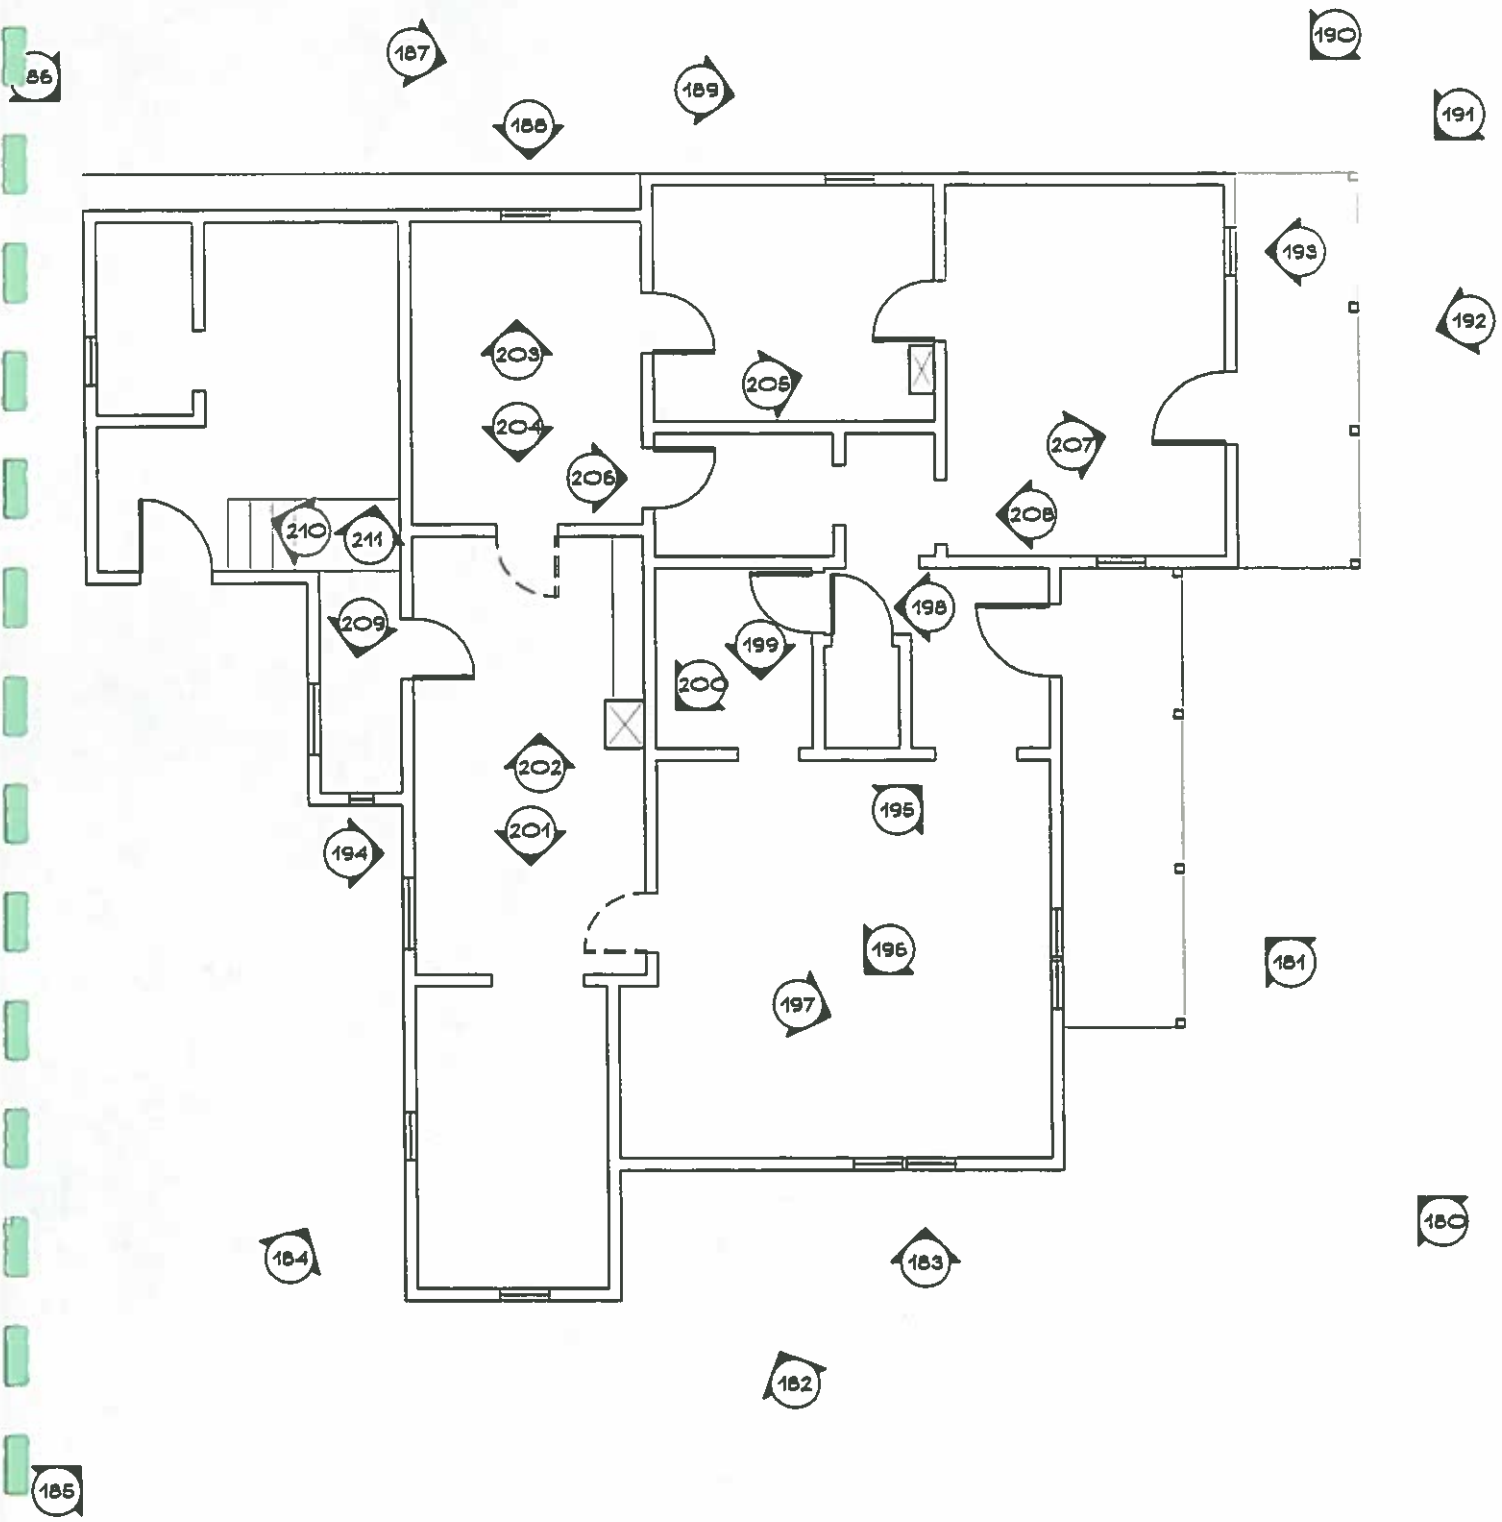
**1 FLOOR PLAN**  
SCALE 1/8" = 1'-0"

The building is in fair condition due to the problems with the wood piers set onto the ground. The major areas of rot and some settlement is on the east and north side due to the high grade. The wood porch is rotted and deteriorating, The wall singles are weathered and coming apart in some areas. The doors and windows are also weathered and need paint. The sheet asphalt roof is protecting the interior keeping the areas dry. The wood shingle roof over the porch is in poor condition. The brick chimneys have loose brick and some missing mortar. The later additions are in poor condition, having no foundations and the wall materials are rotted.

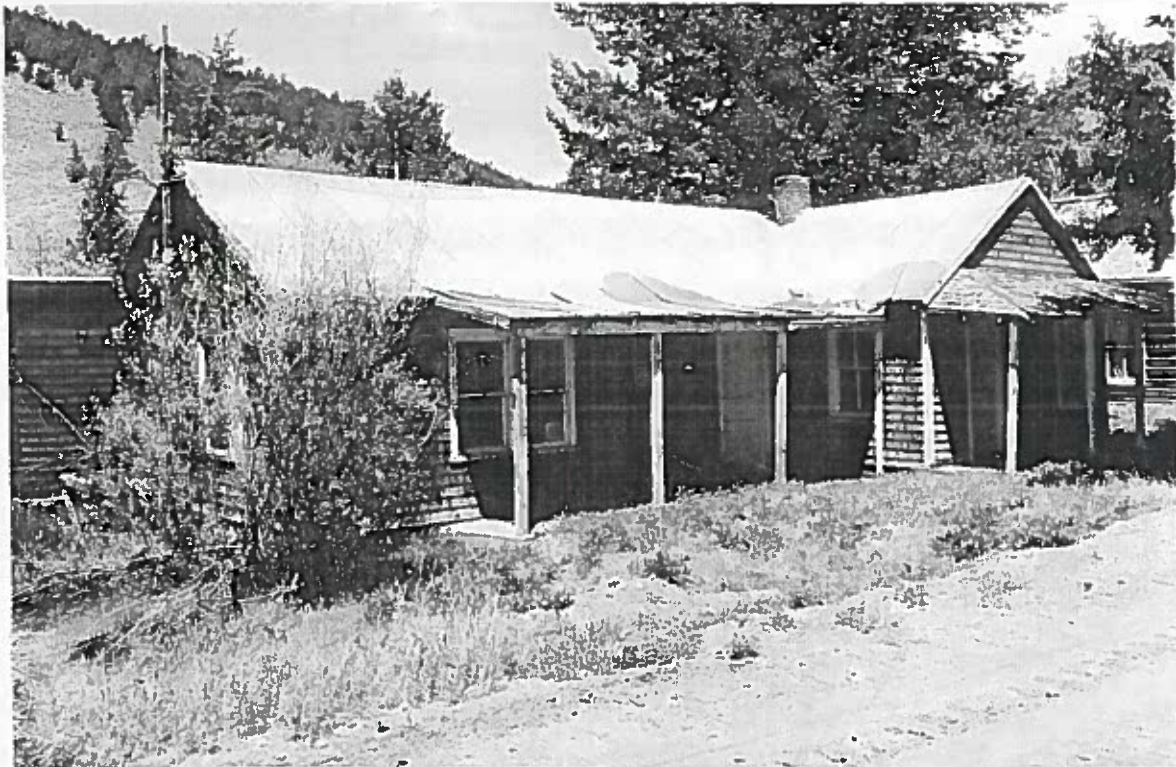
Figure 180: Looking northwest at the Cabin. Note the metal roof which is coming apart on the lower shed roof over the porch.

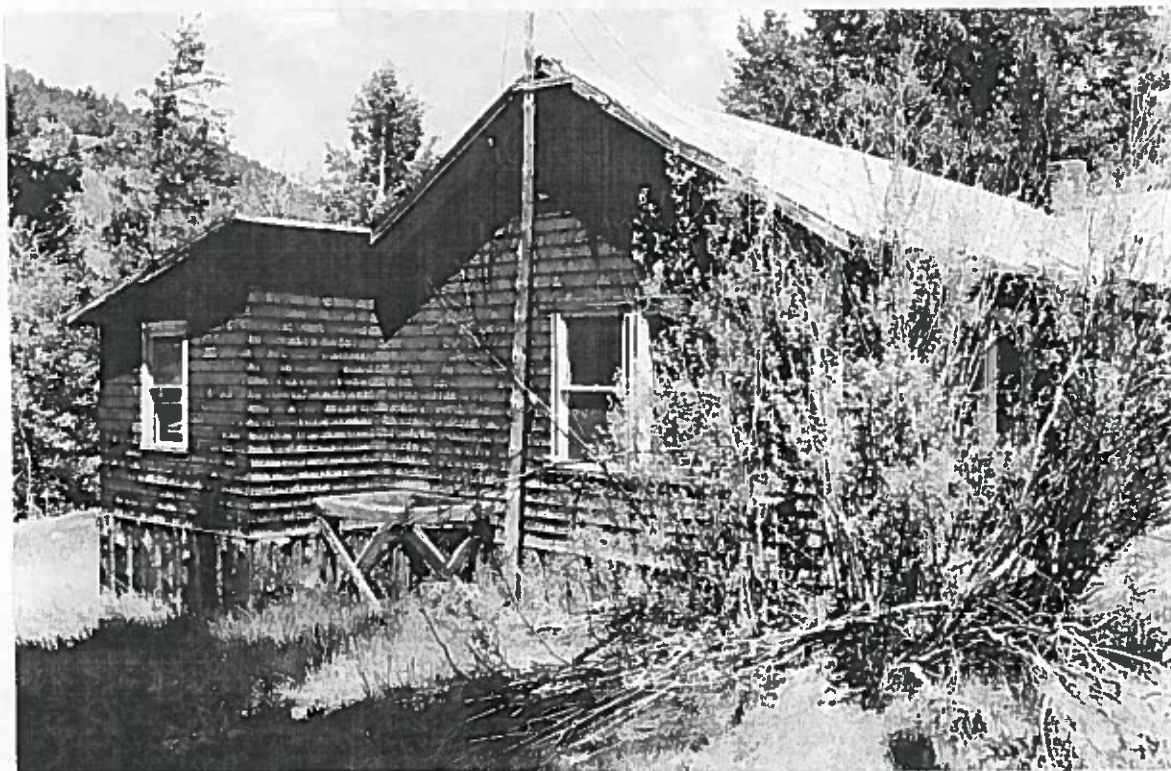
Figure 182: Looking northwest at the end of the building. Note the weathered shingles.

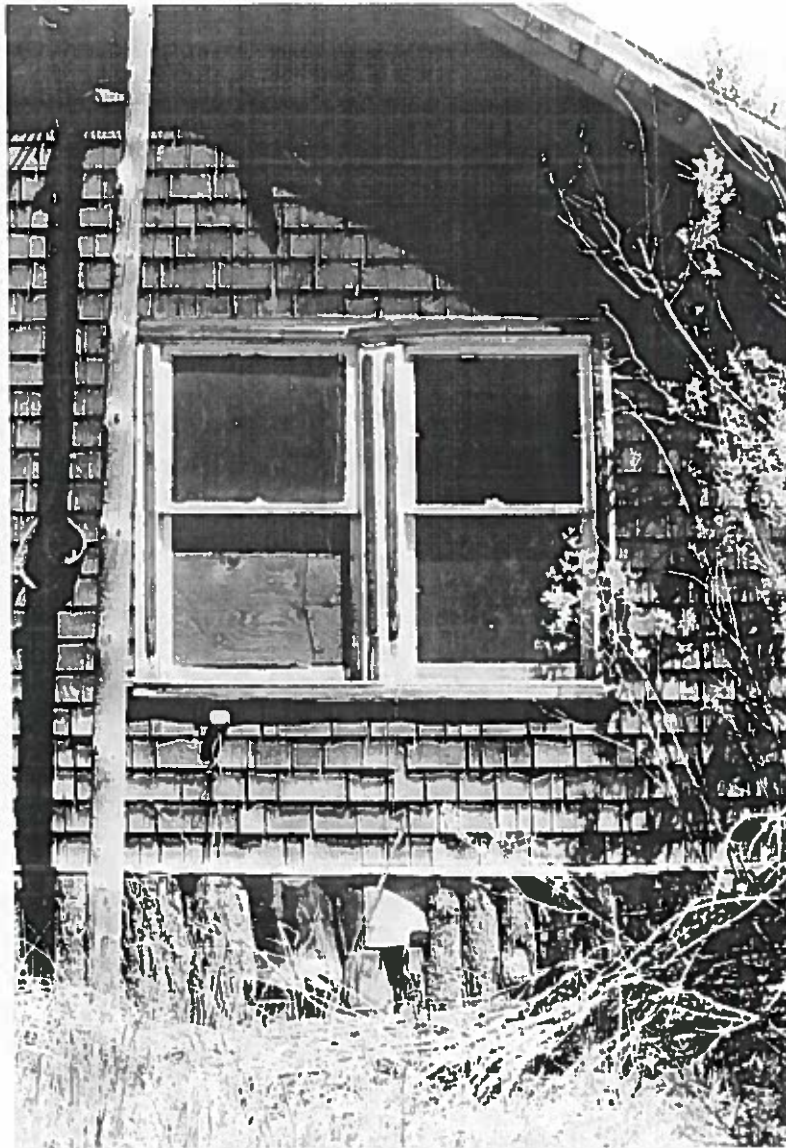
Figure 183: Looking north at a pair of wood double-hung windows typical to the building. The windows are weathered, glass is missing and the glazing is missing. Note the vertical logs that have been put around the base of the building to enclose the crawl space.

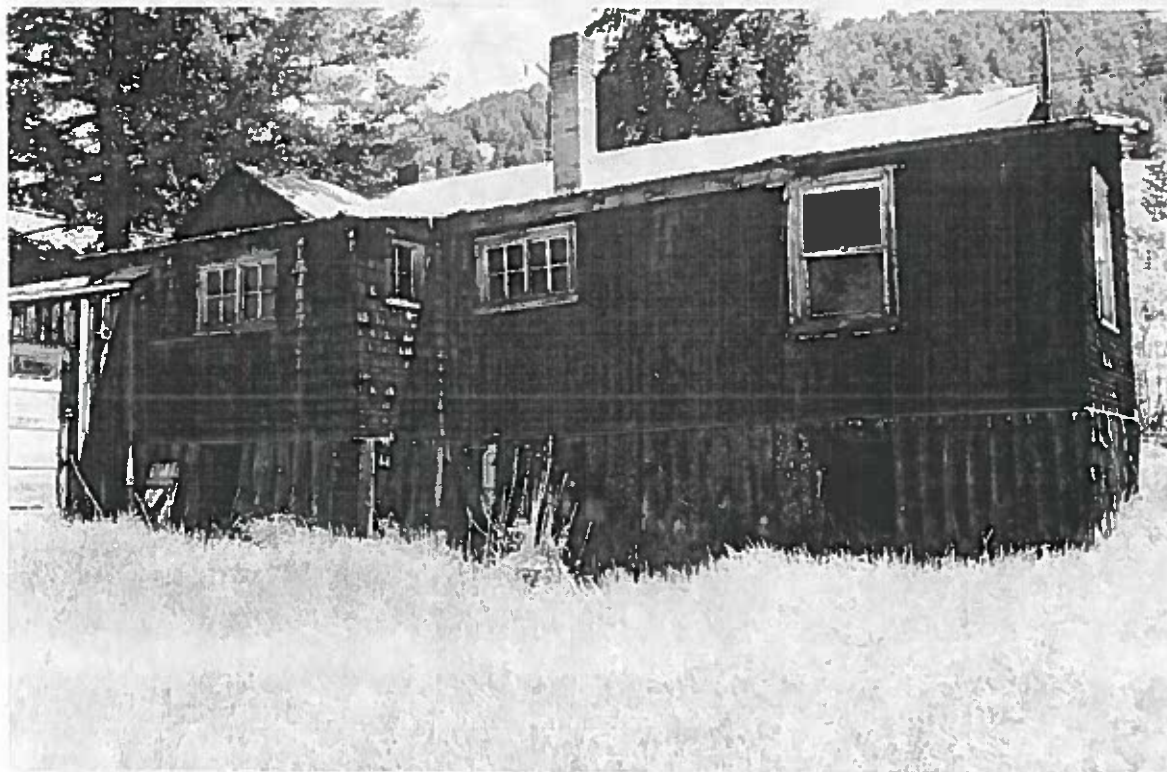
Figure 185: Looking northeast at the back of the Cabin. Note the deteriorating brick and mortar on the top of the chimney.

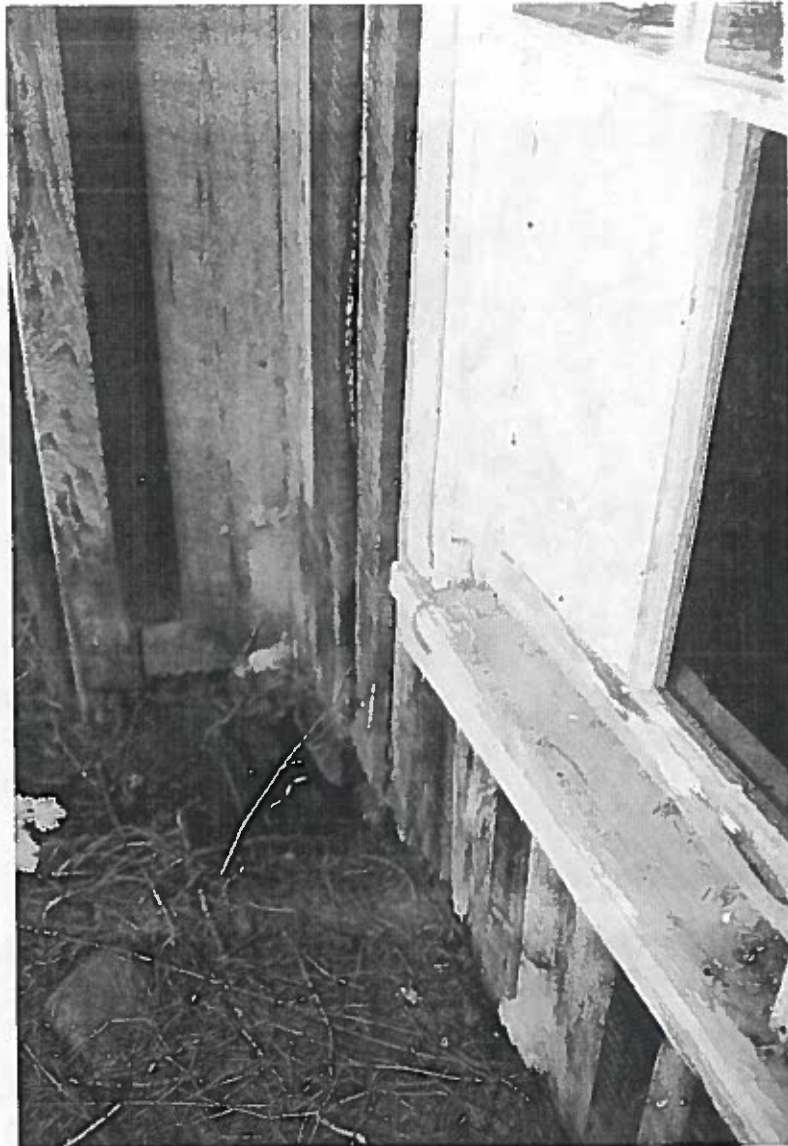
Figure 188: Looking southeast at the base of the frame additions to the Cabin. Note the rotted wood board and batten siding on the ground where there is no foundation. Also note the weathered window.

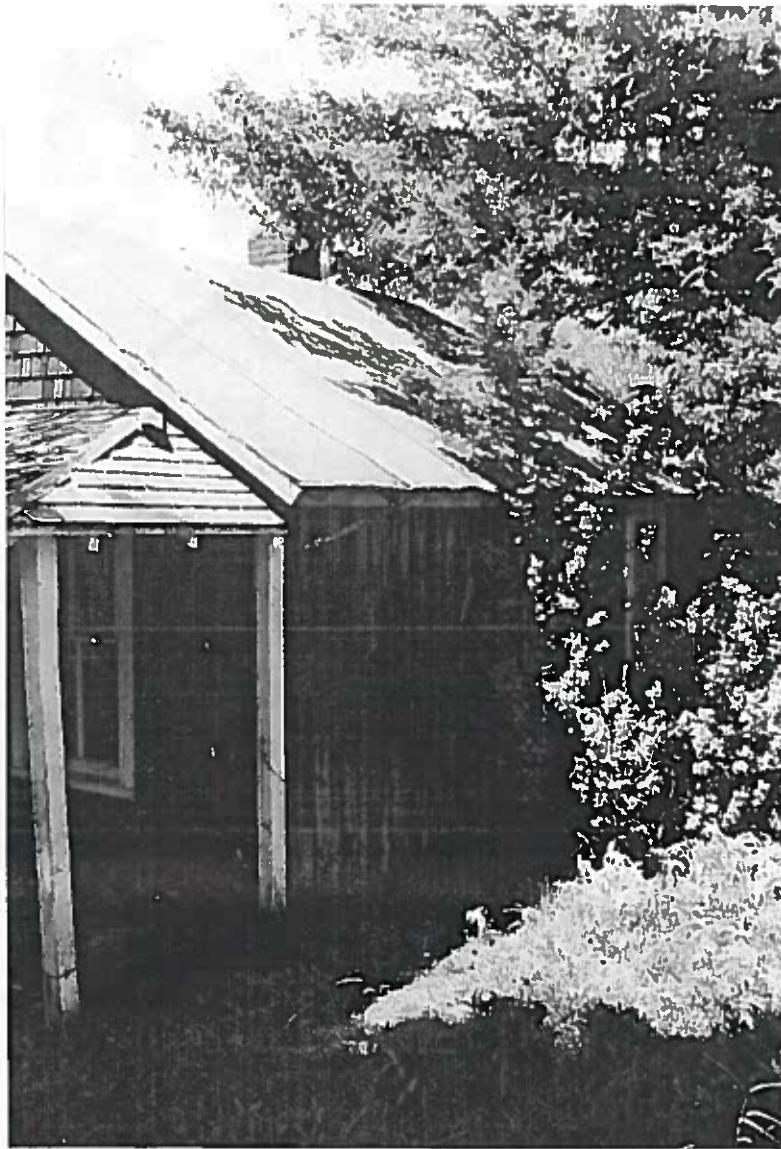
Figure 190: Looking southwest at the Cabin. The metal roof on this side of the building is in good condition. Note the brush and trees up against the building.

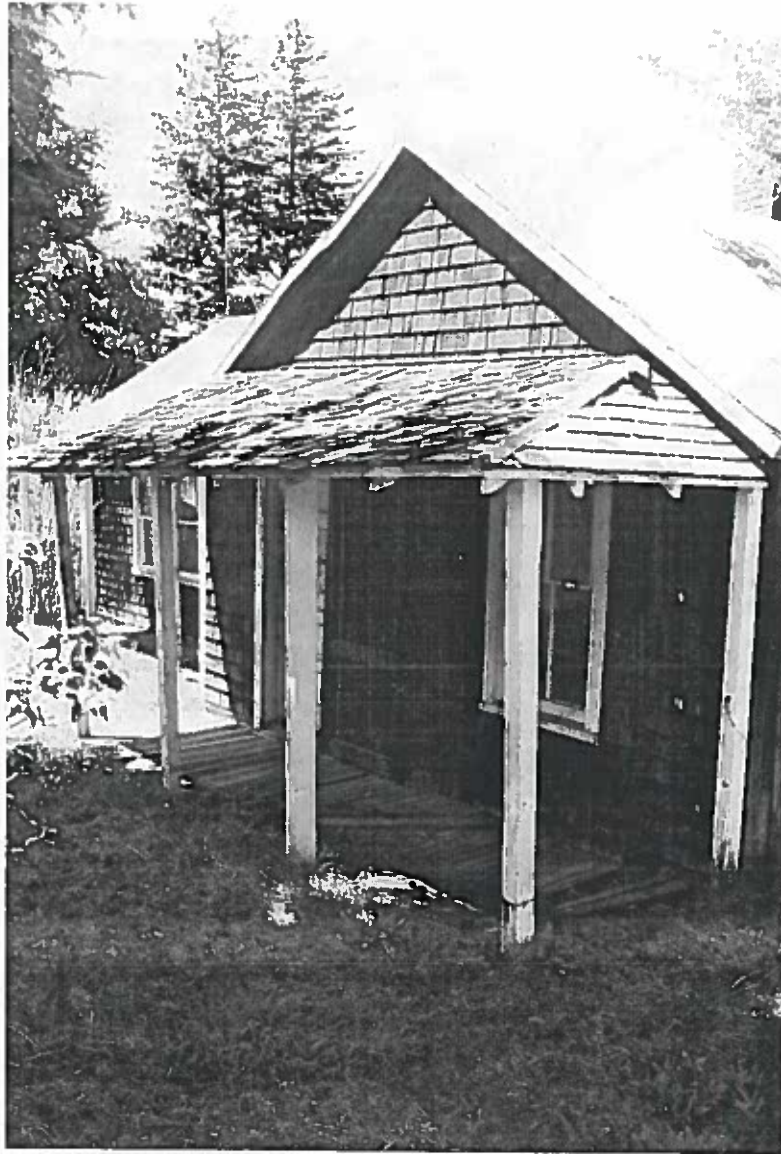
Figure 191: Looking southwest at the Cabin. Note the wood shingle roof over this porch structure which is in poor condition in some areas.

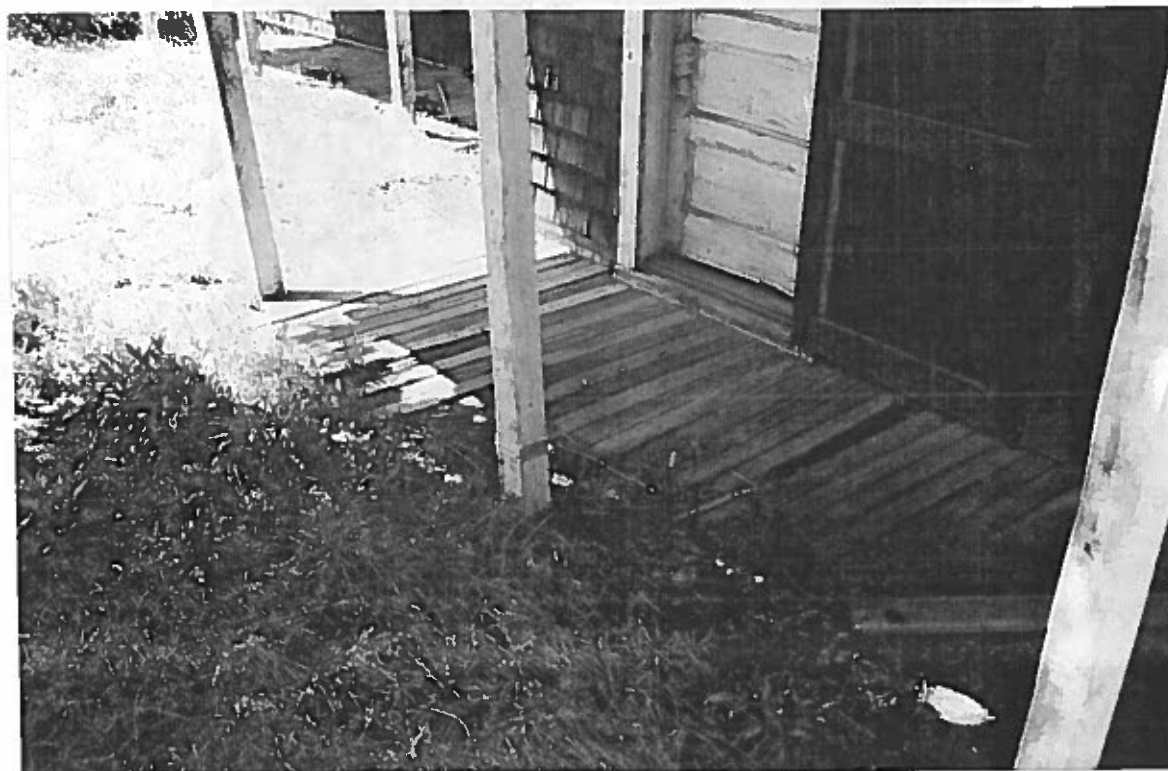
Figure 192: Looking southwest at the porch floor which is deteriorating badly because of the buildup of earth around the base and drainage of water from the road. Note the rotting bases of the columns also.

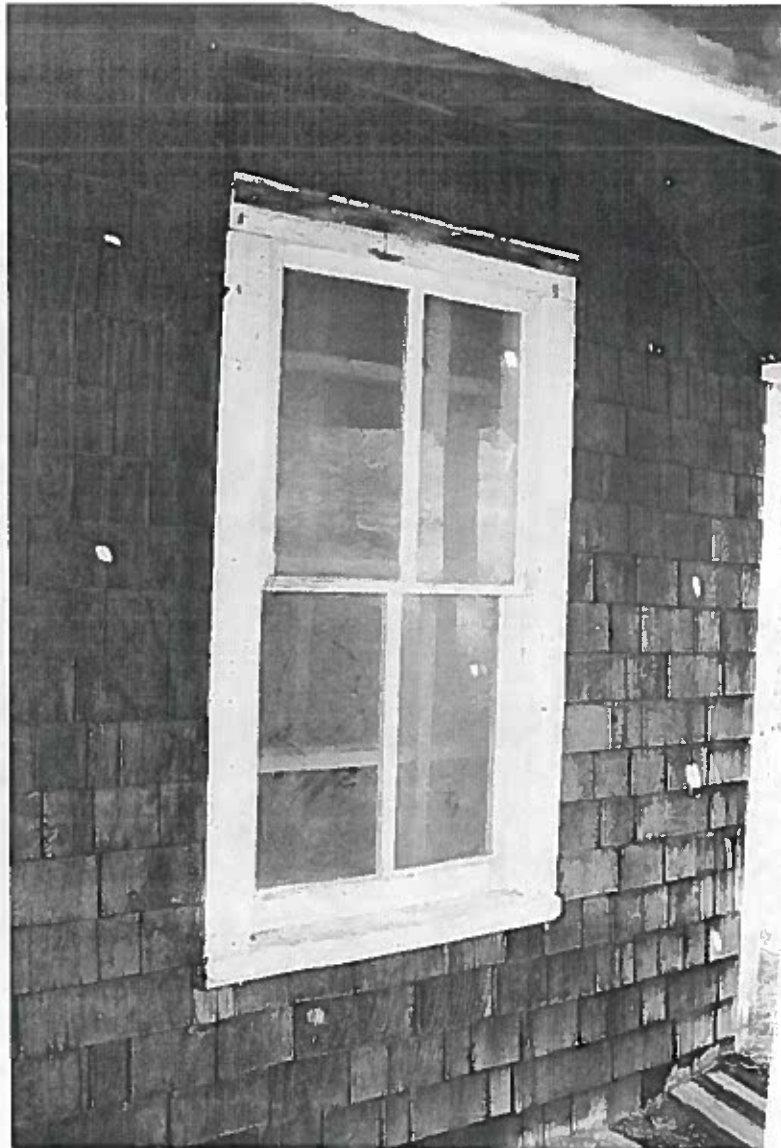
Figure 193: Looking northwest at a typical wood double-hung window under the porch. Note the weathered sill and missing glazing putty around the glass.

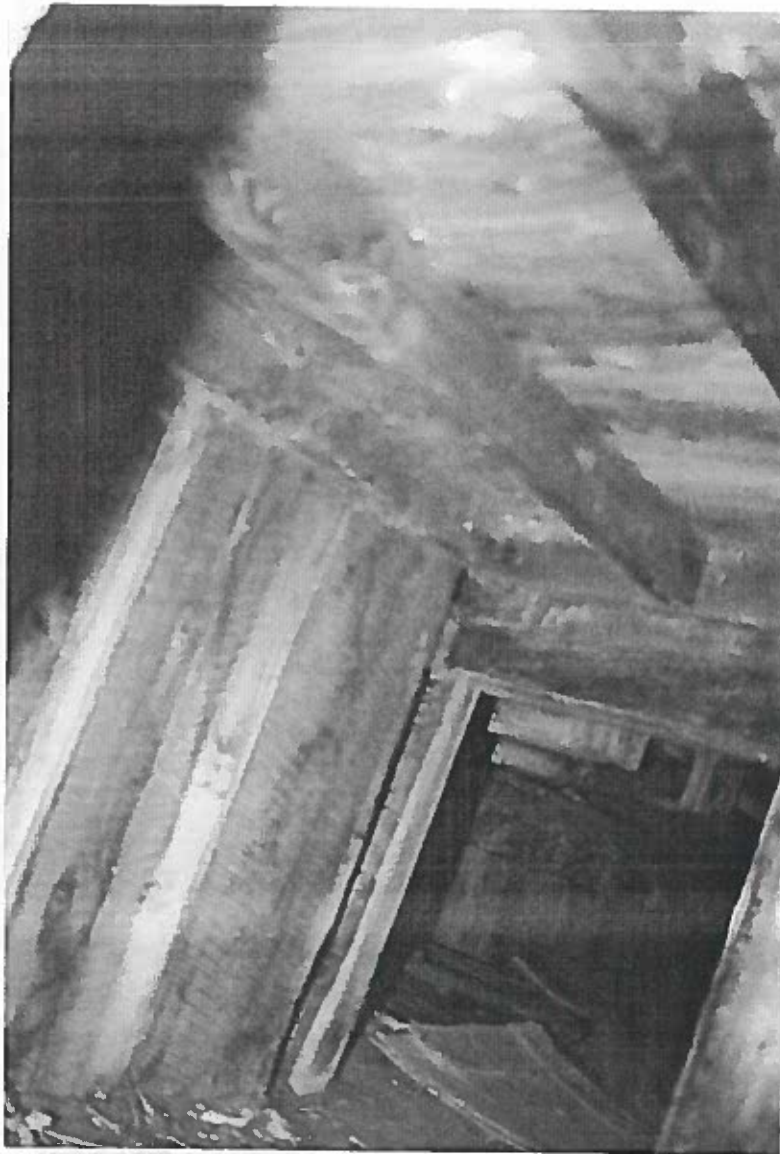
Figure 194: Looking east under the building at the main structure which appears to be wood piers on stone or wood footings. The area under the building in most cases appears to be dry.

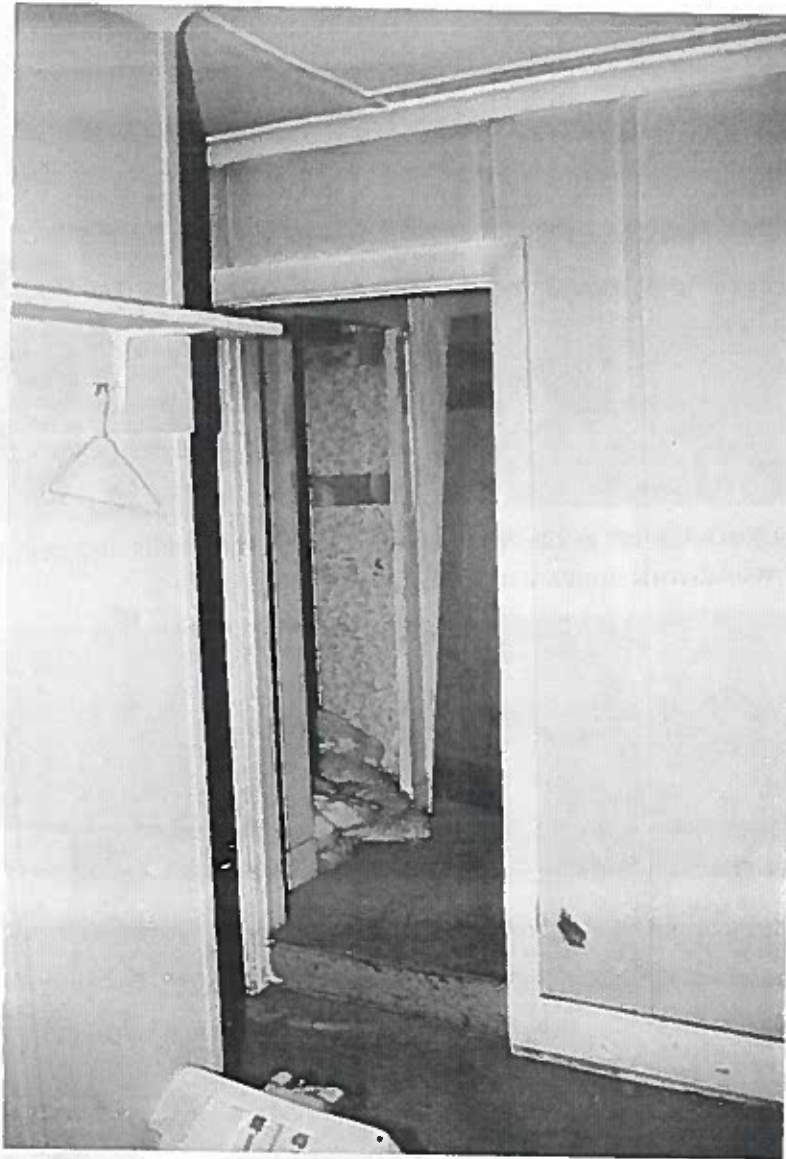
Figure 198: Looking west at the entrance to the north bedrooms from the front vestibule.

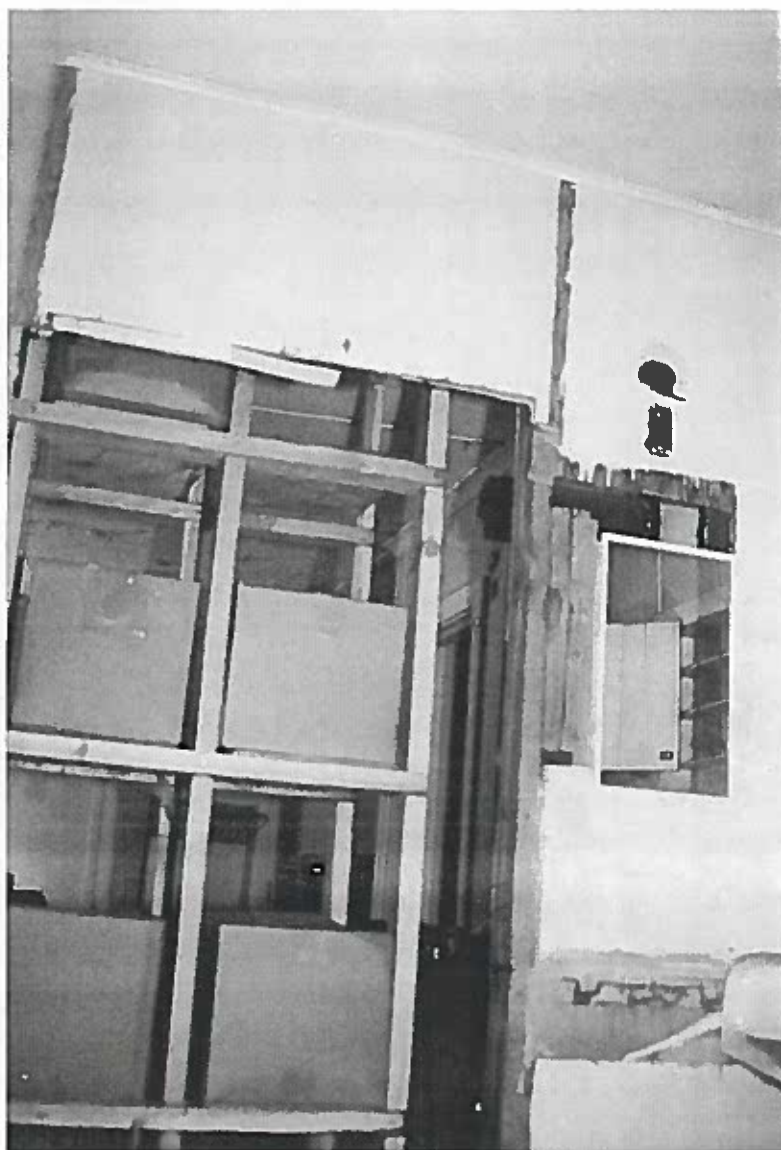
Figure 199: Looking south at the bathroom just south of the front vestibule. Note the removal of the wall materials in this area.

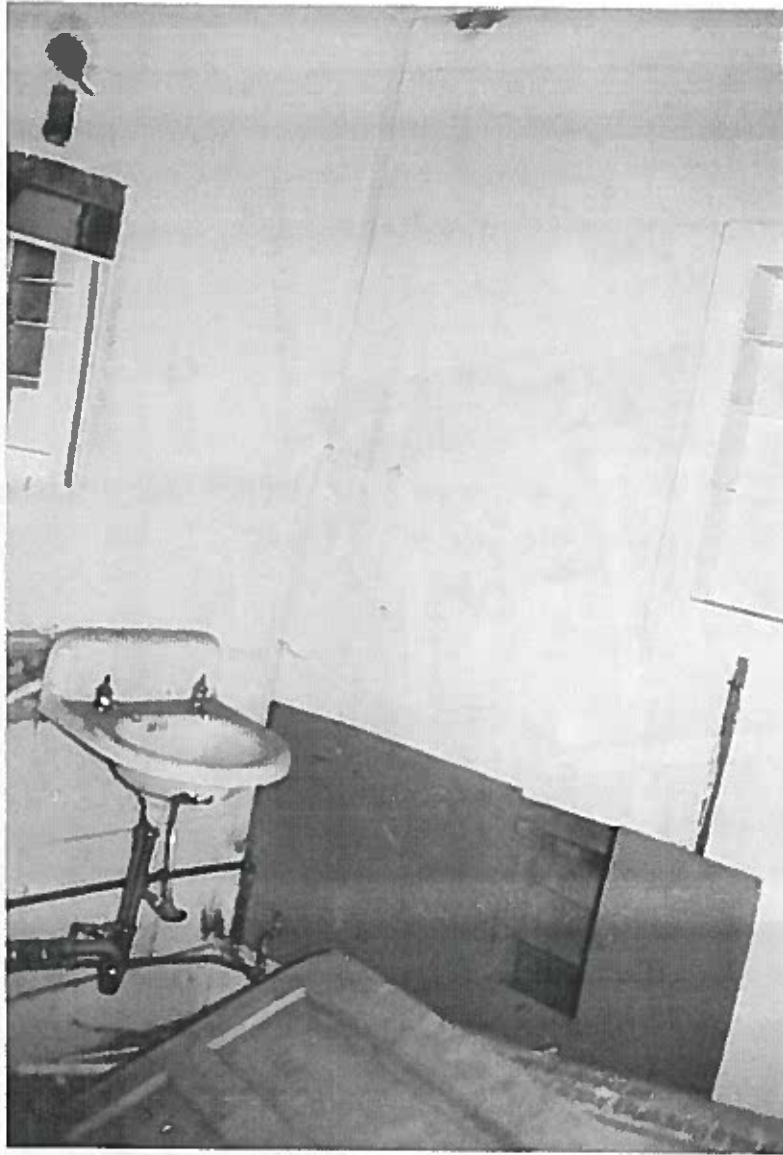
Figure 200: Looking west at the bathroom area. Note the sink and the wood paneled door on the floor.

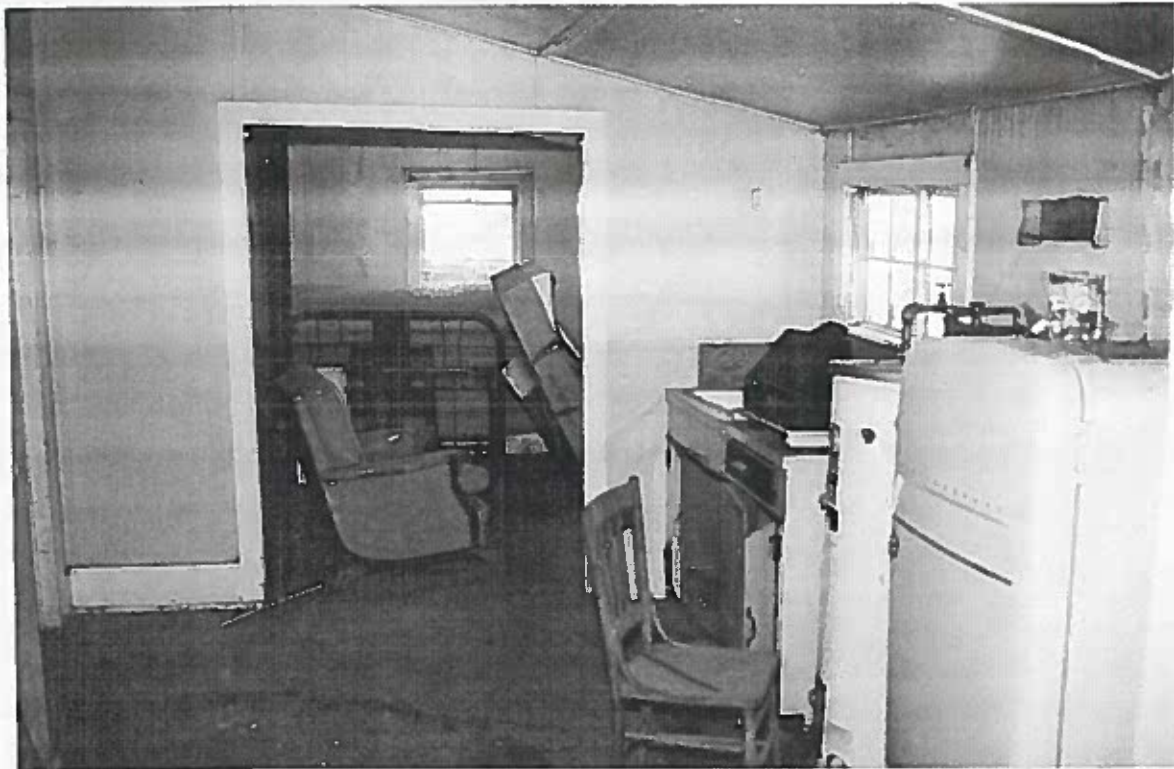
Figure 201: Looking south at the kitchen and dining room area on the back of the building. The materials are generally in good condition in these areas.

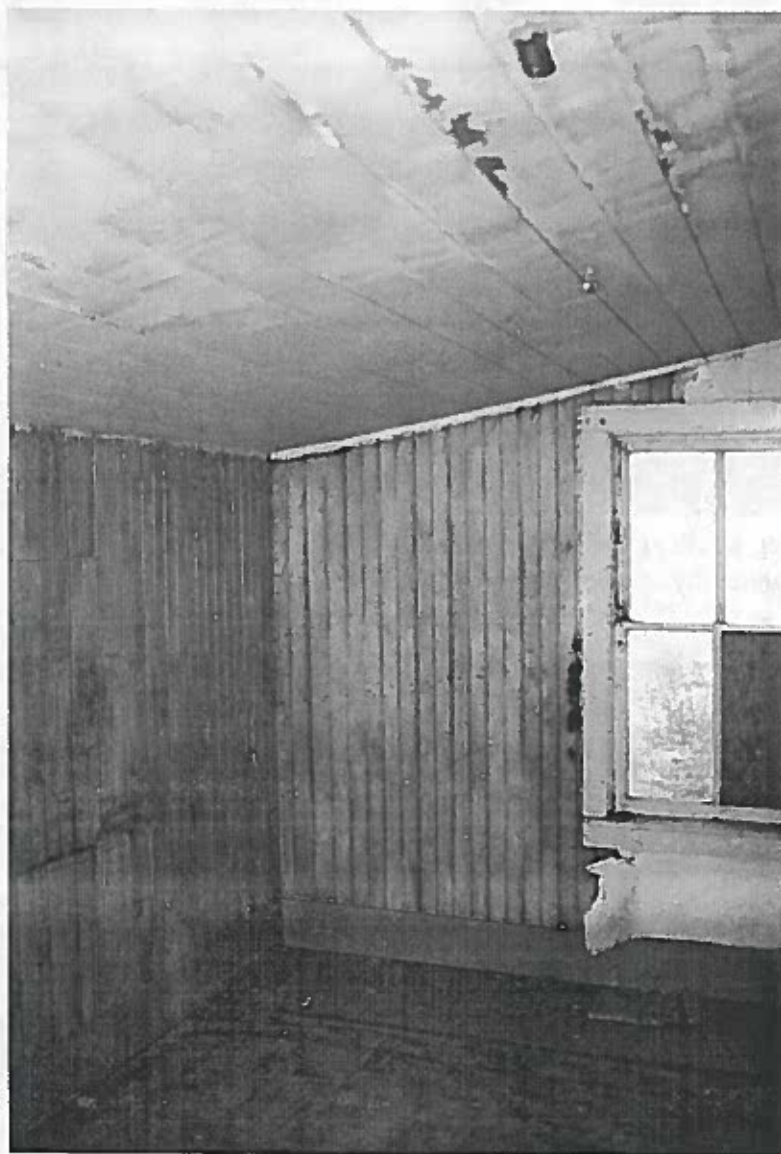
Figure 203: Looking north at the interior of the back bedroom. Note the wood bead board walls which had wallpaper covering the surfaces at a later date as seen under the window.
