**ARCHITECTURAL ASSESSMENT, RECOMMENDATIONS & COSTS  
of  
HISTORIC STRUCTURES**

**MINERAL HILL MINE**

**JARDINE, MONTANA**

**OCTOBER, 2000  
(REVISED JANUARY, 2001)**

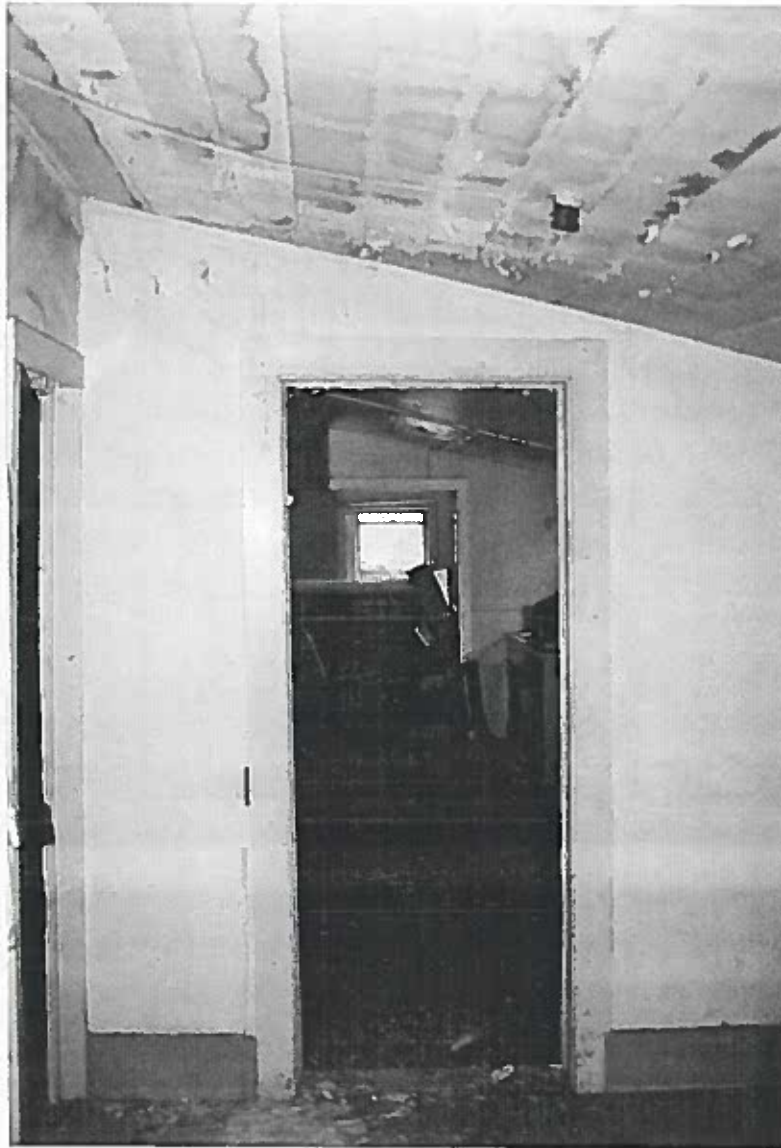
Figure 204: Looking south at the back bedroom. Note the water damage on the ceiling from the leaking roof. The roof appears to have been covered and there is no moisture penetration at this time.

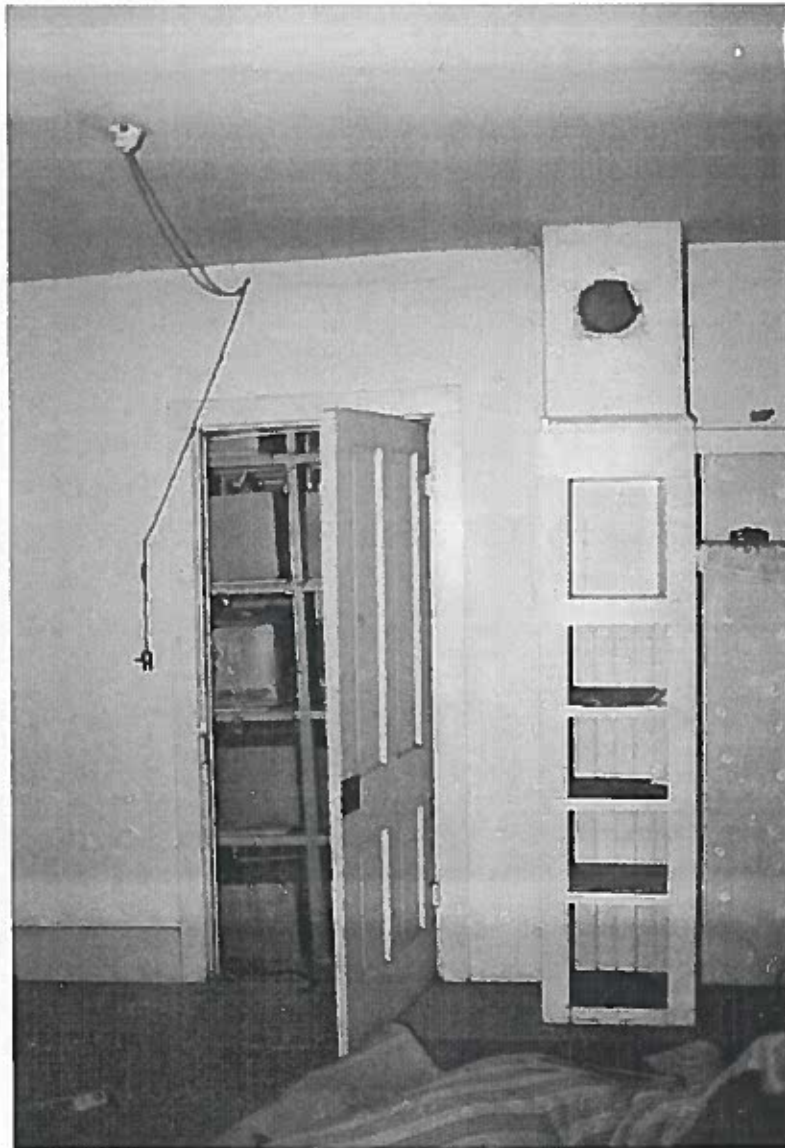
Figure 205: Looking east at the middle bedroom. The materials on the walls, ceiling, and floors are similar and in good condition.

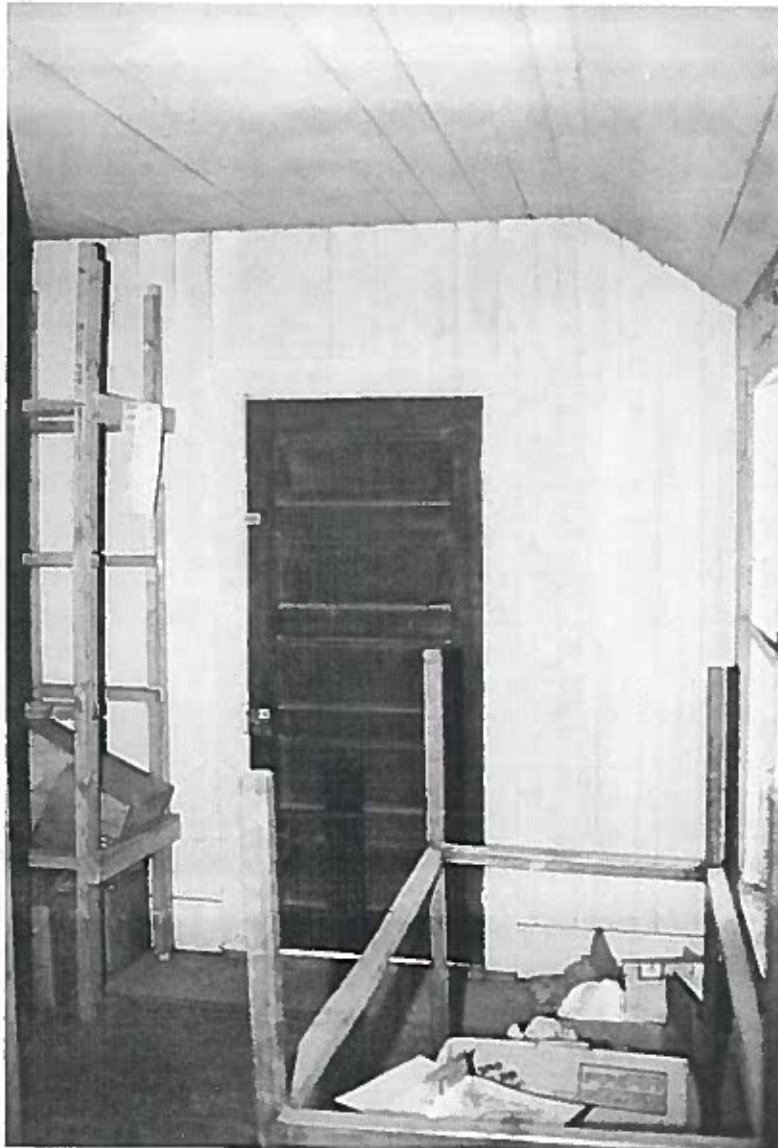
Figure 207: Looking east at the front bedroom and door to the porch. Note the wood walls and ceiling that appear to be in good condition.

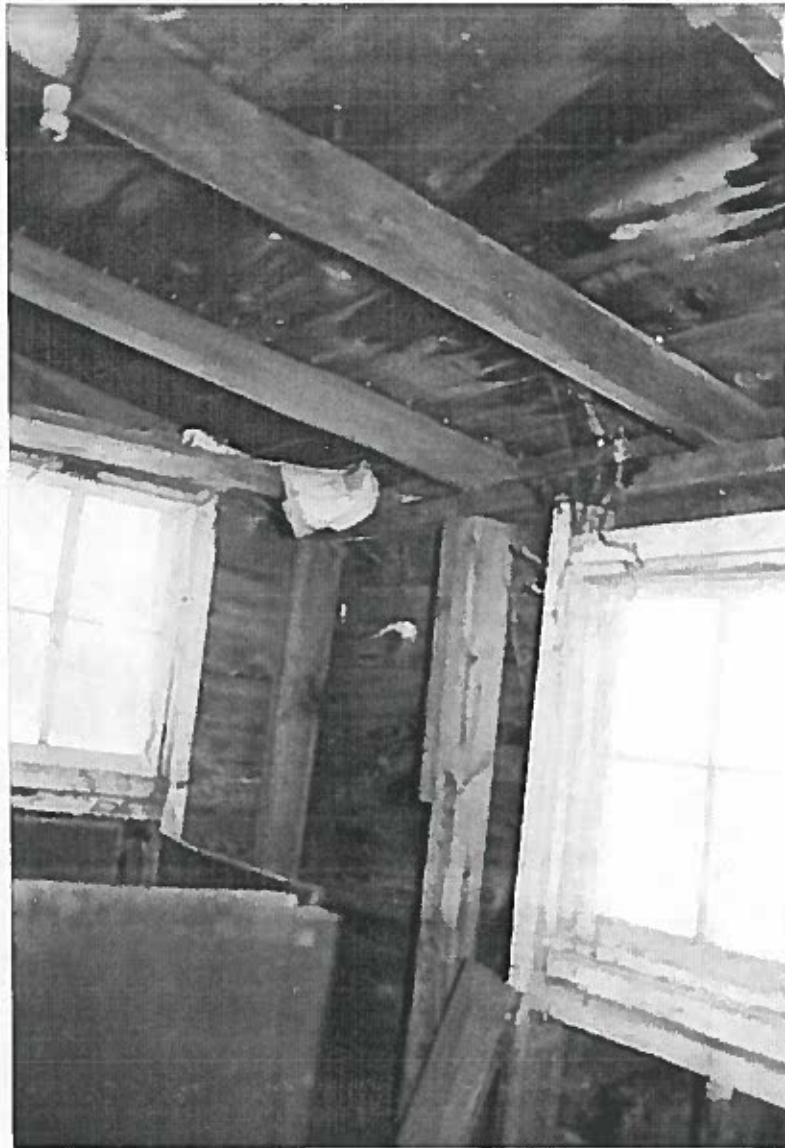
Figure 209: Looking southwest at the back wood frame addition. Note the water penetration on the roof and the weathering and rot along the base of the windows.

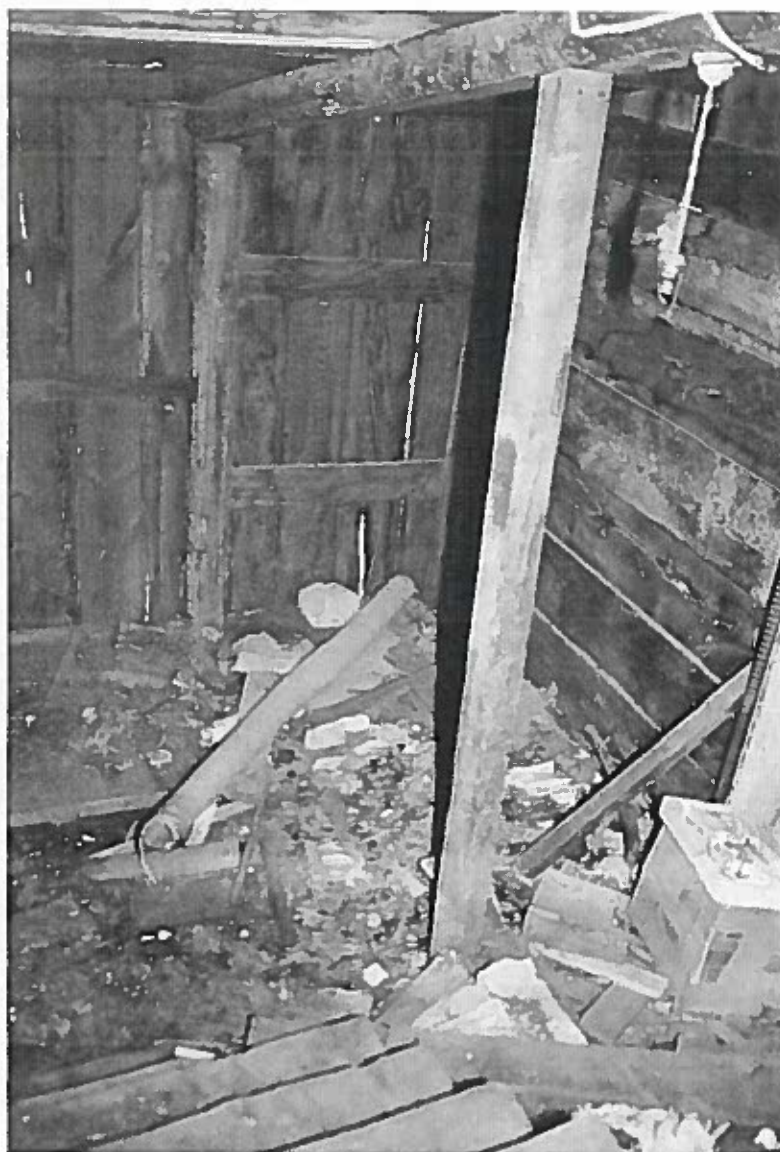
Figure 210: Looking west at the lower level of the frame addition. The wood floor is rotted out and the base of the structure is rotted. Additional posts have been added to help keep the roof intact from snow loads.

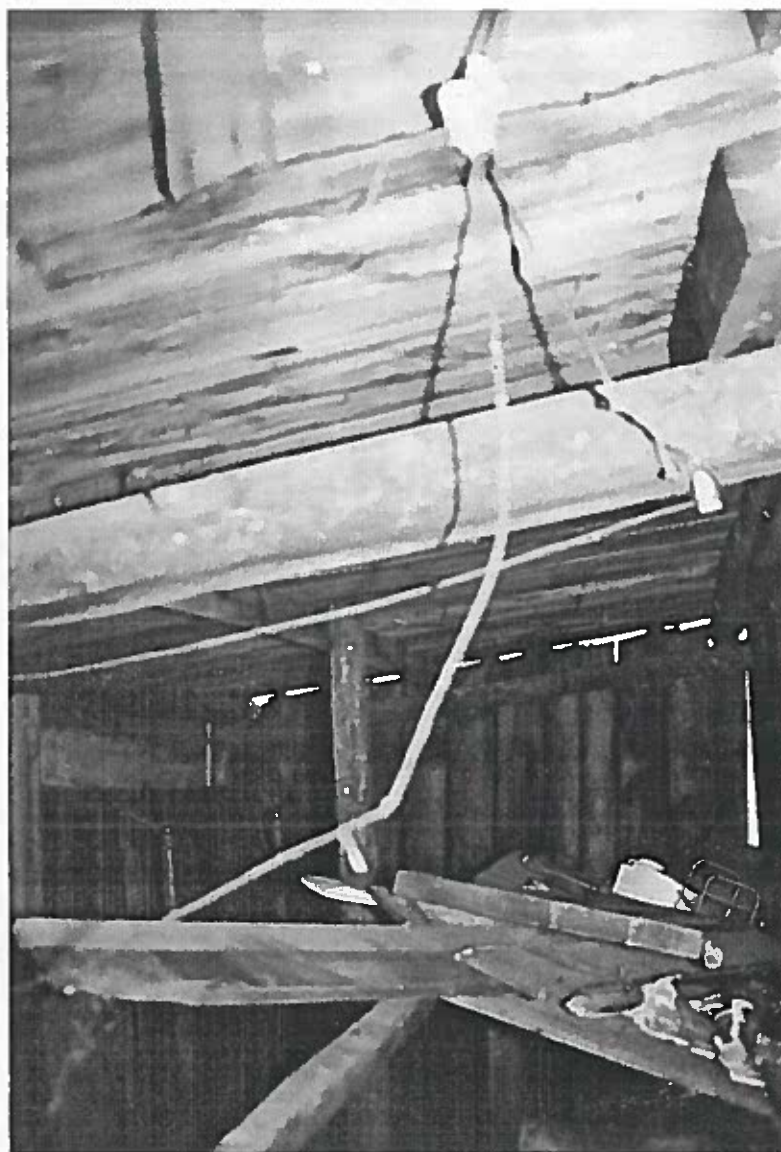
Figure 211: Looking north at the back wood frame addition. Note the additional supports which have been added to keep up the roof. Also note the exposed wiring.

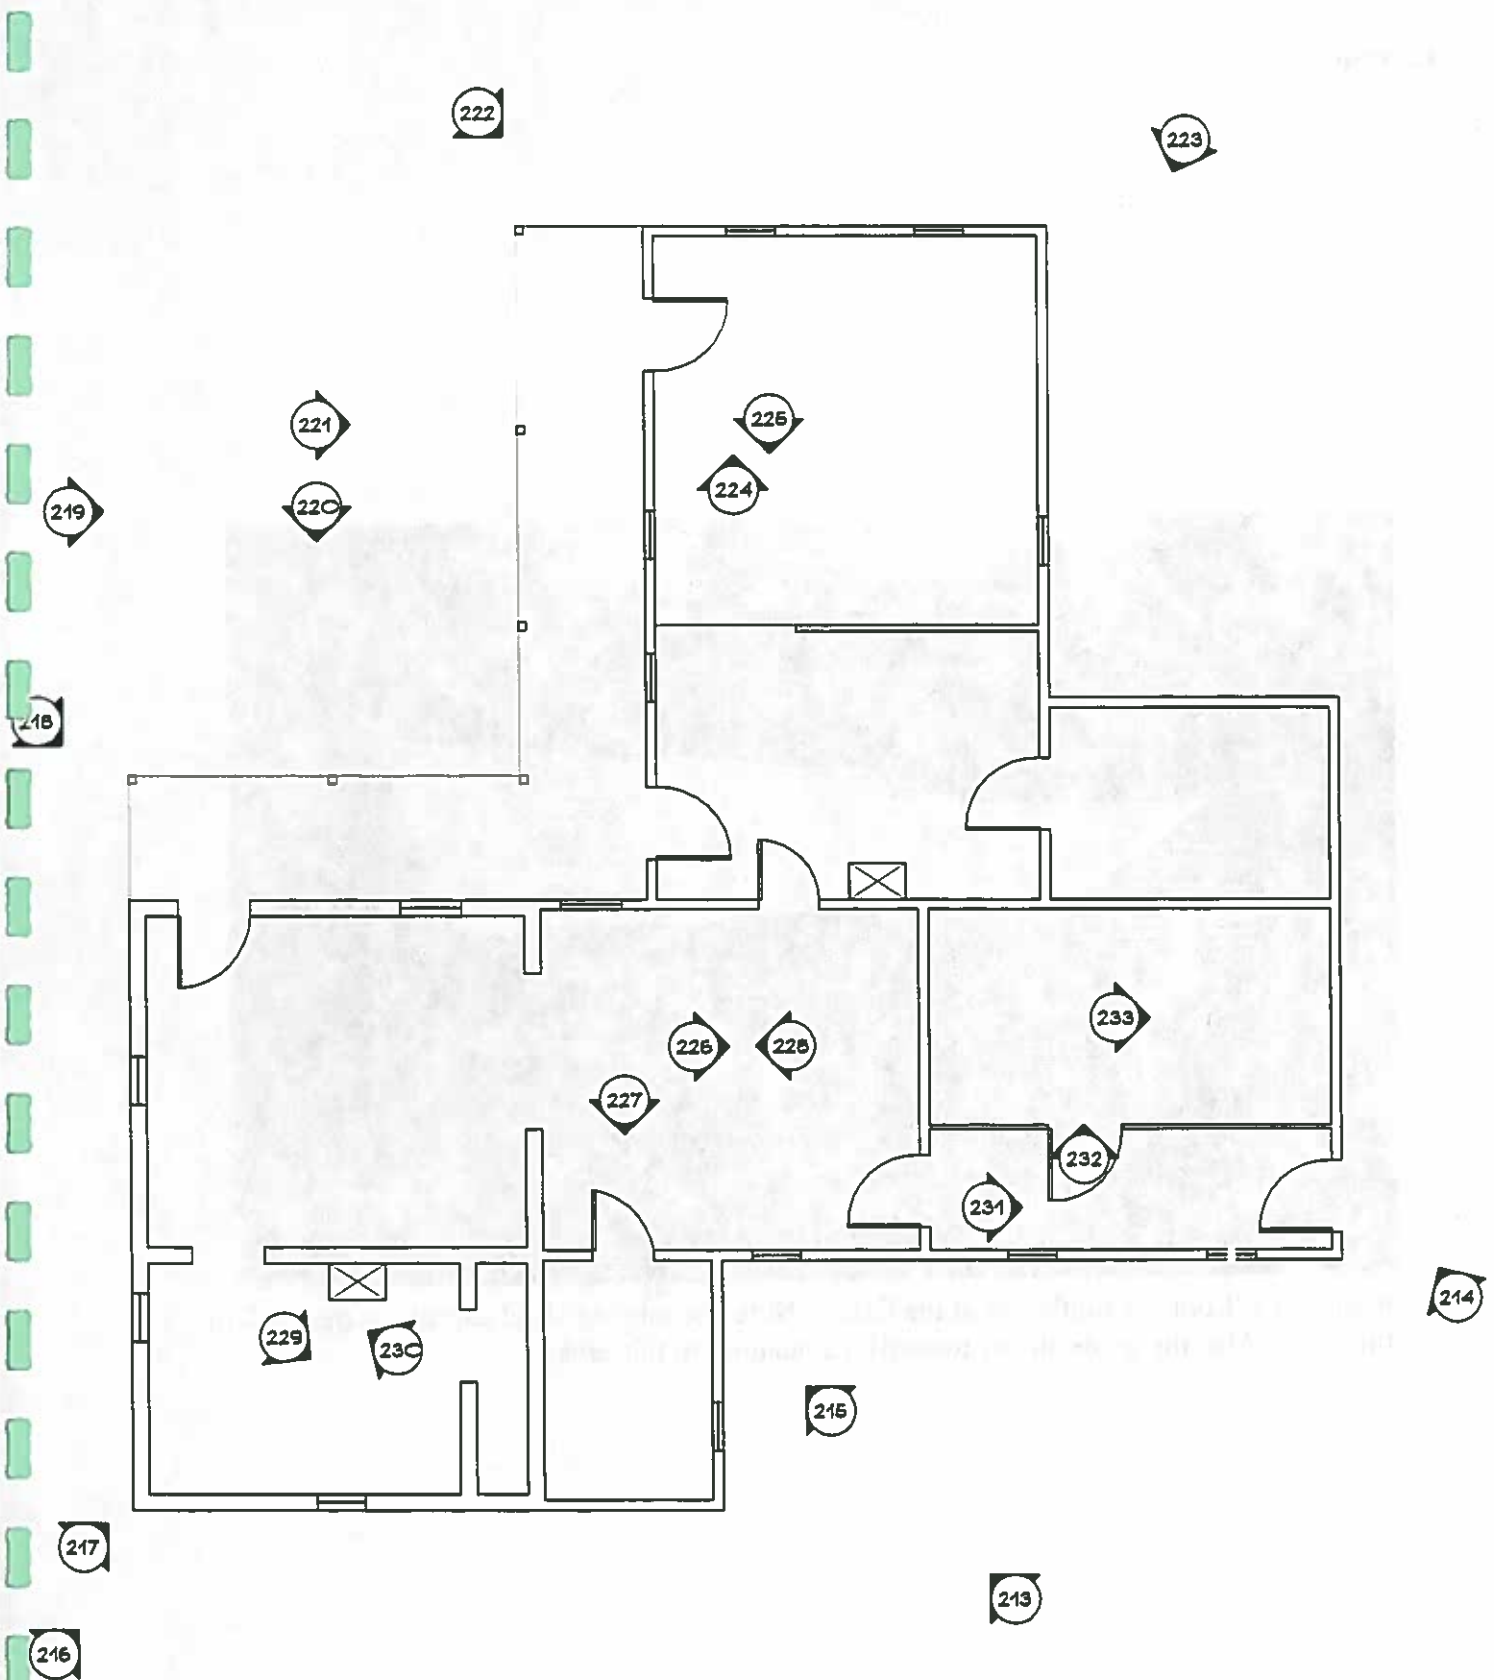
**FIGURE 212**  
**CONDITION ASSESSMENT**  
**RESIDENCE (HS 70)**

The log building is generally in good condition with the exception of the base two logs that are rotted causing some settlement in the building. This is due to the high grade and poor drainage around the building. There is also a significant amount of shrubbery against the building which is causing some deterioration. The daubing is loose and in some cases missing. The additions are in poor condition and do not appear to have any foundations but sit directly on the ground. This has caused the wood floors to rot out in the additions. The roof is good in that it is protecting the building. The doors and trim around the windows is weathered.

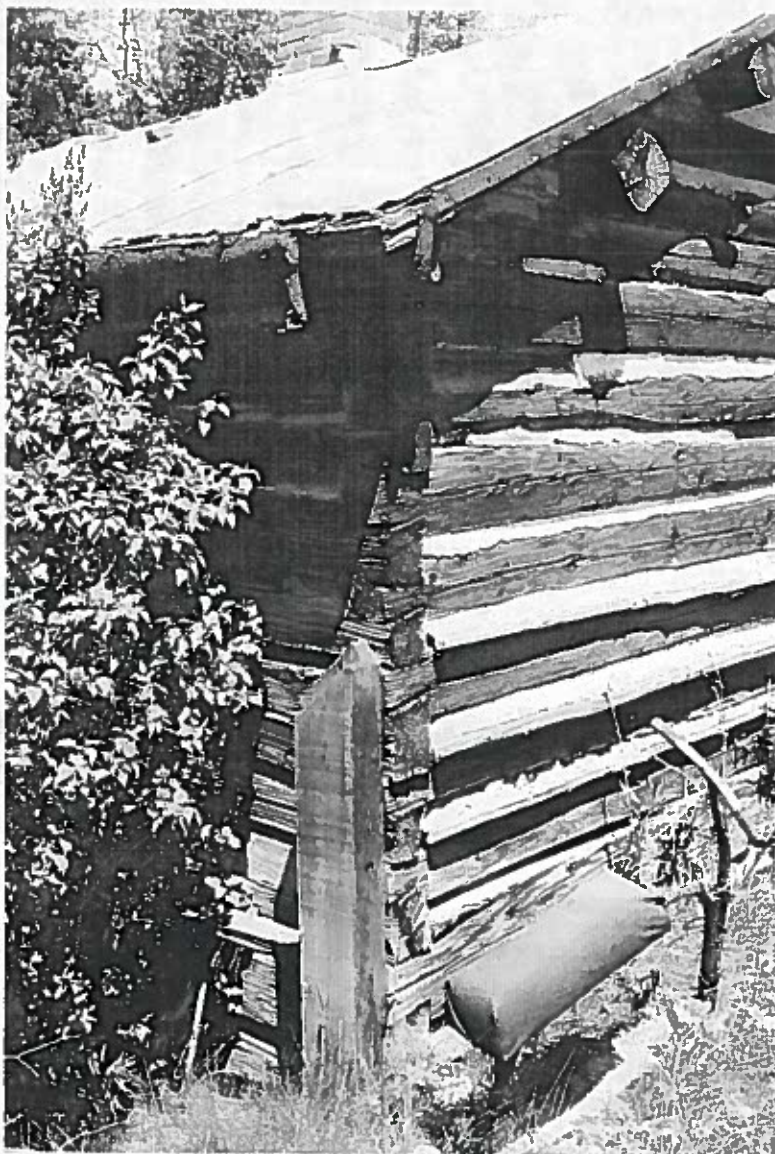
Figure 217: Looking northwest at a corner notch on the building. Generally with the exception of the base logs the wall logs are in good condition. Note the damage on the edge of the roof sheathing.

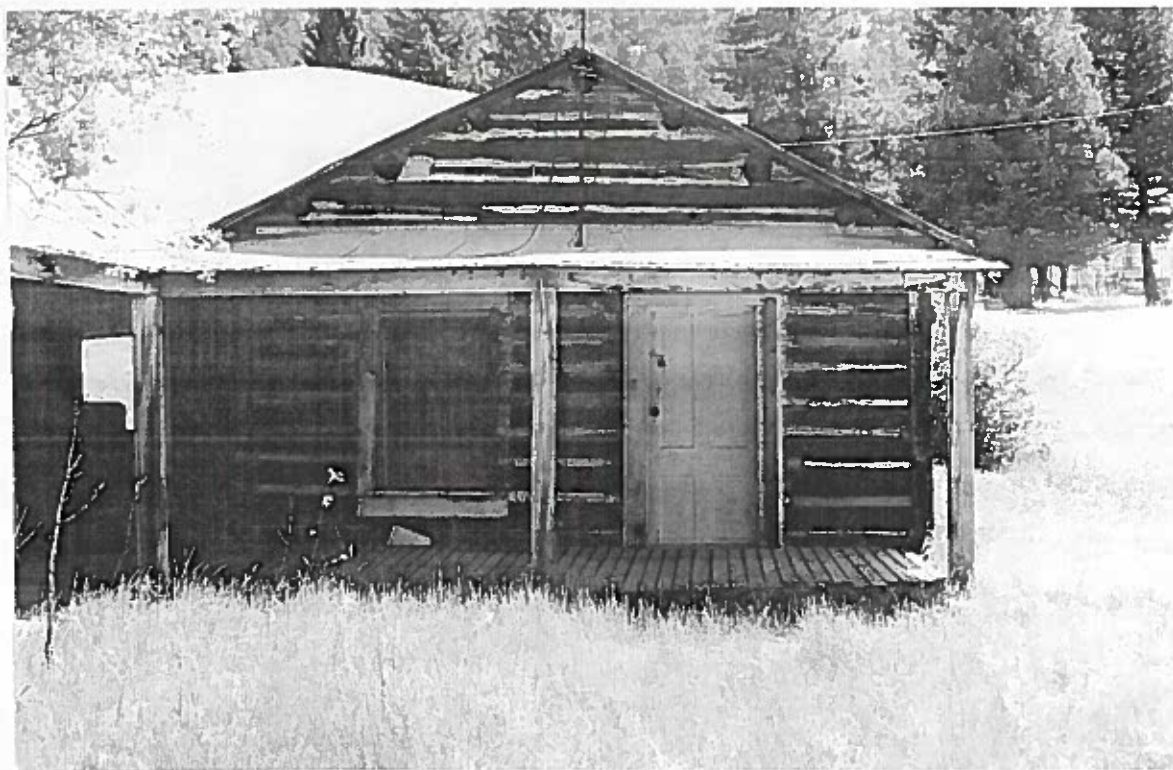
Figure 220: Looking east at the front of the log cabin. The wood paneled door and trim are weathered, and the window is missing its original double-hung sash.

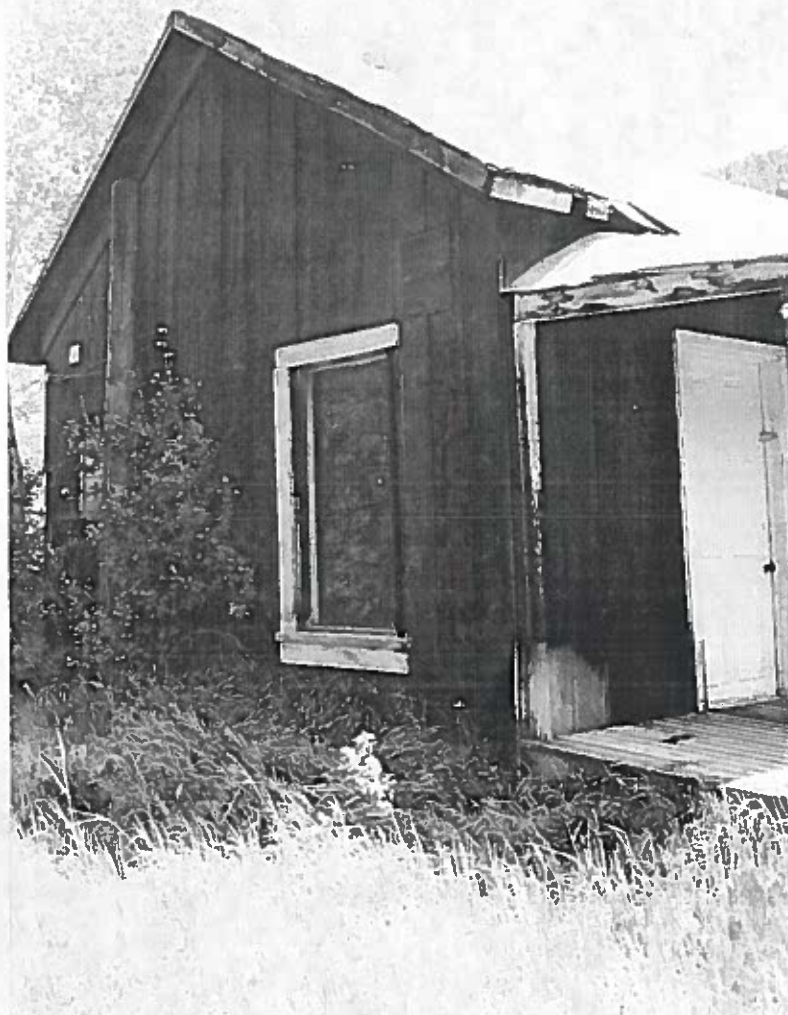
Figure 222: Looking northeast at the wood frame addition. The upper part is in good condition but the base of the building is rotting out.

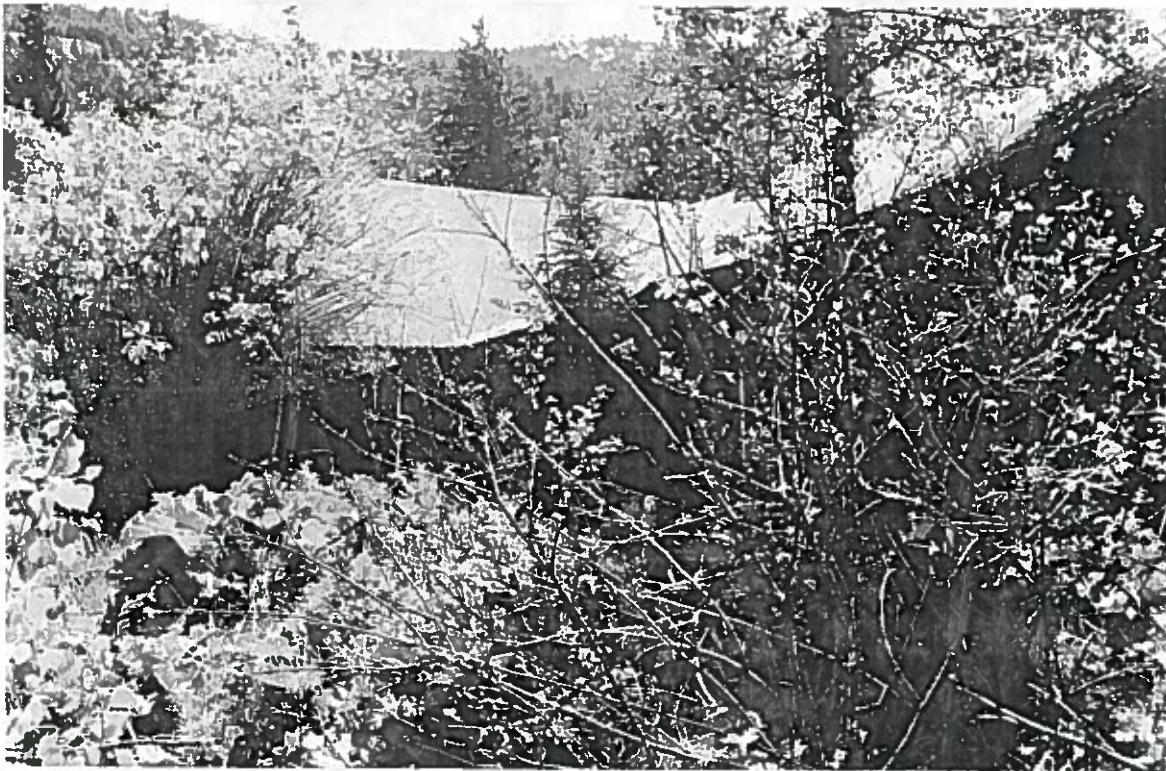
Figure 223: Looking east along the north side of the building. Note the shrubbery along the building and the high grade around this end of the building also.

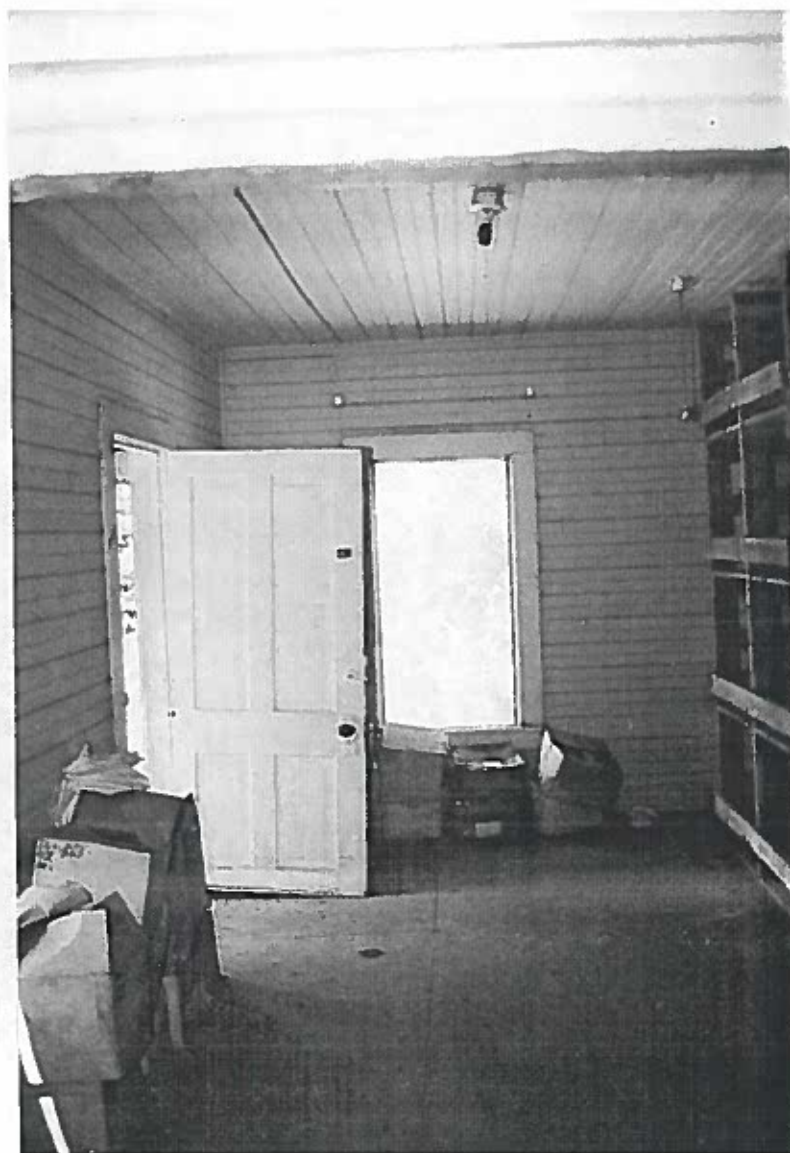
Figure 224: Looking west at the interior of the frame addition. The original floor has rotted out and is covered with a plywood sub-floor and frame.

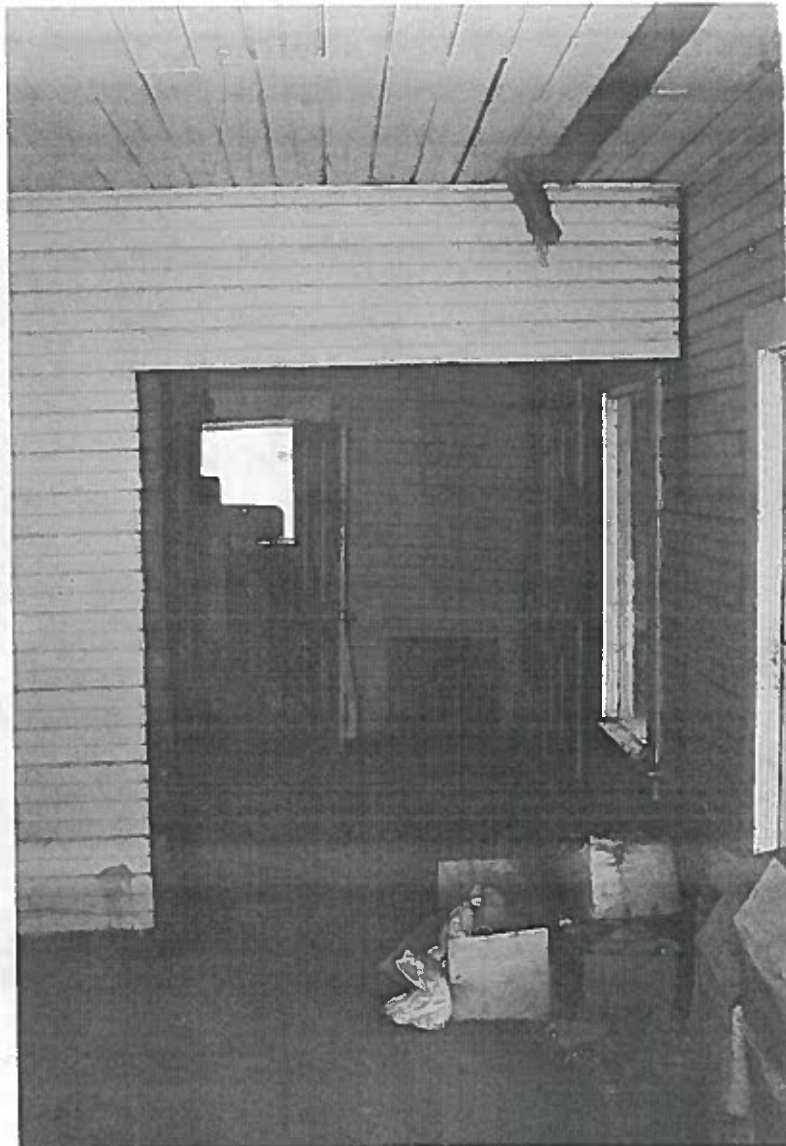
Figure 225: Looking east at the wood frame addition with its wood walls and ceiling. There is some settlement in the building because of the rotted floor and base. Also, the ceiling has some rot from previous water leaks.

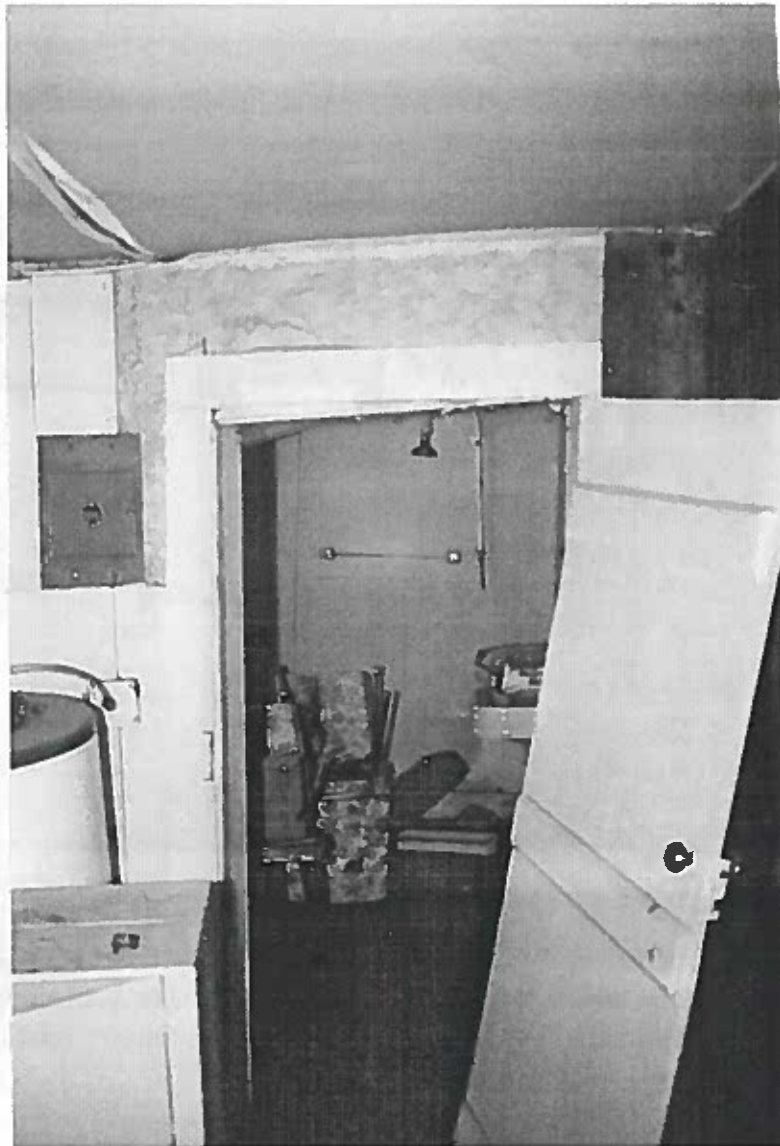
Figure 227: Looking east into the wood frame bathroom structure that was added to the log cabin. This area of the building is also in poor condition due to no foundation and the rot of the wood frame materials.

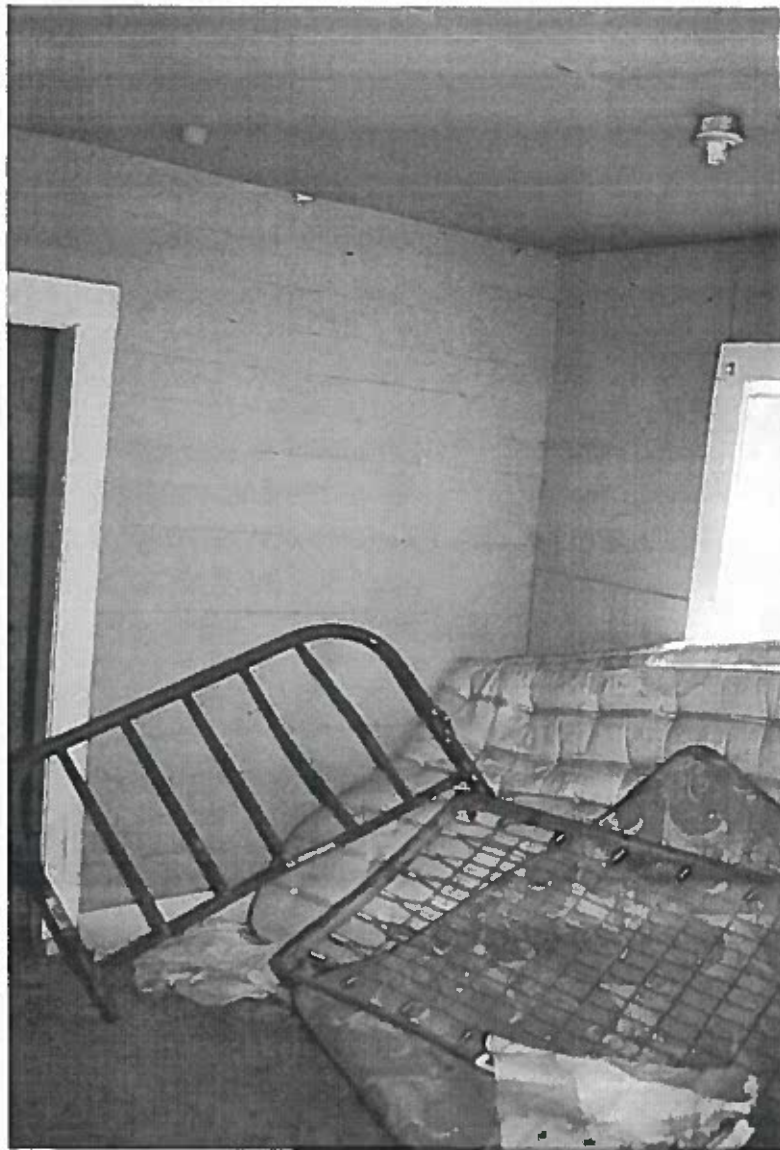
Figure 229: Looking northeast at the bedroom area. The celotex materials on the walls and ceiling are in good condition although they are later materials.

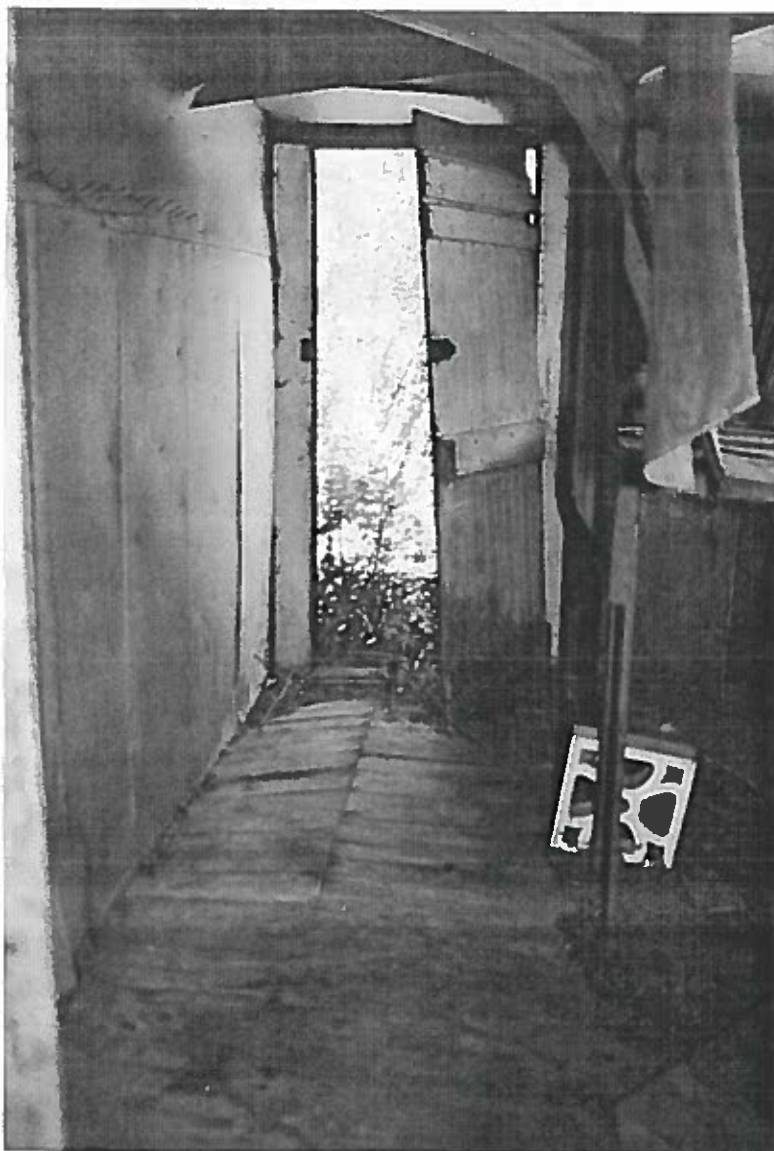
Figure 231: Looking north at the north wood frame addition to the building. Note the buckled floor built on grade. The walls are a thin frame with a hardboard siding.

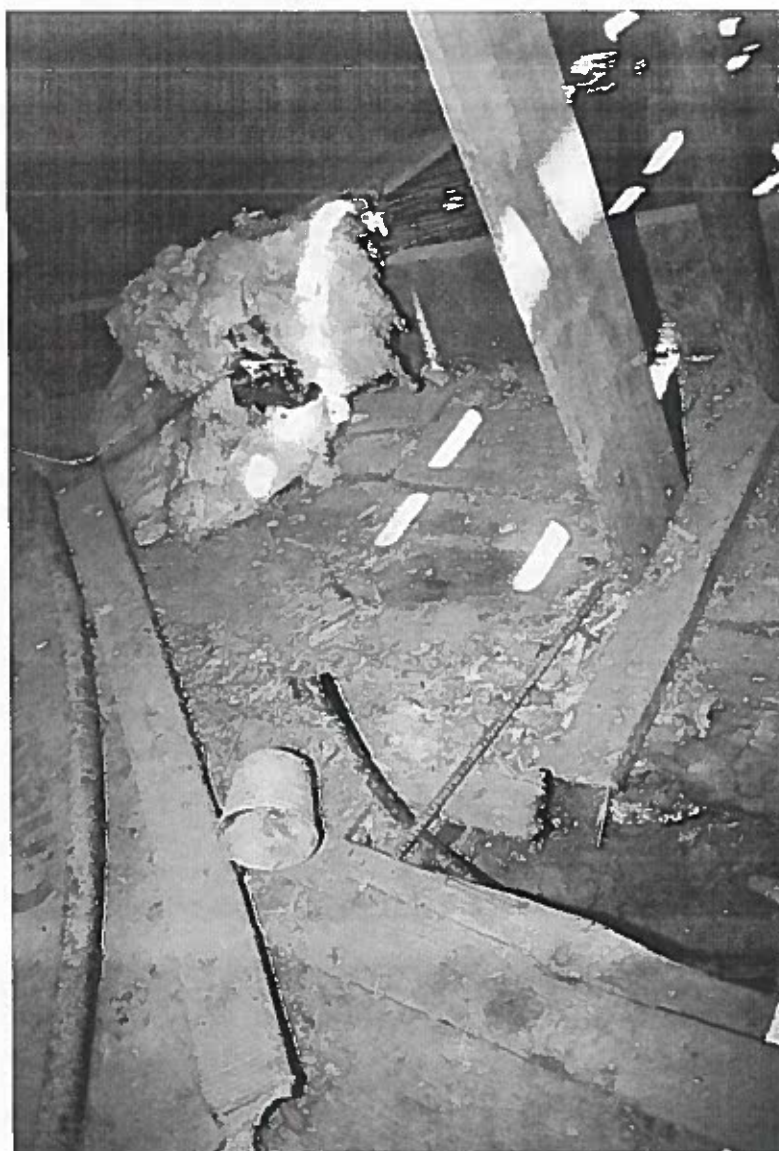
Figure 232: Looking west at the rotted wood floor in the north addition.

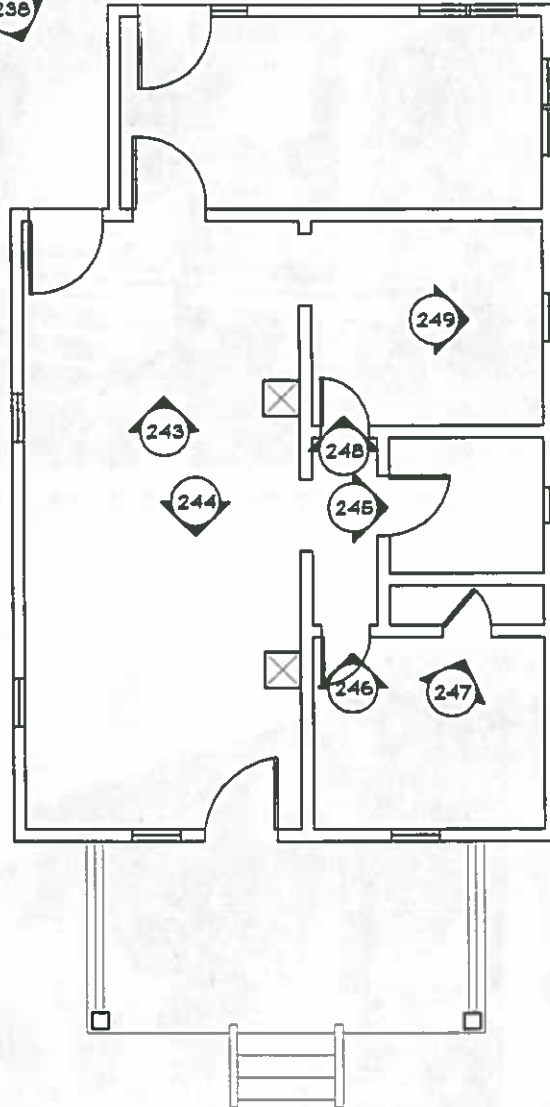
FIGURE 234  
CONDITION ASSESSMENT  
RESIDENCE (HS 82)

The building is generally in good condition. The addition on the back has some problems with high grade around it causing some of the base sill and siding to rot out and deteriorate.

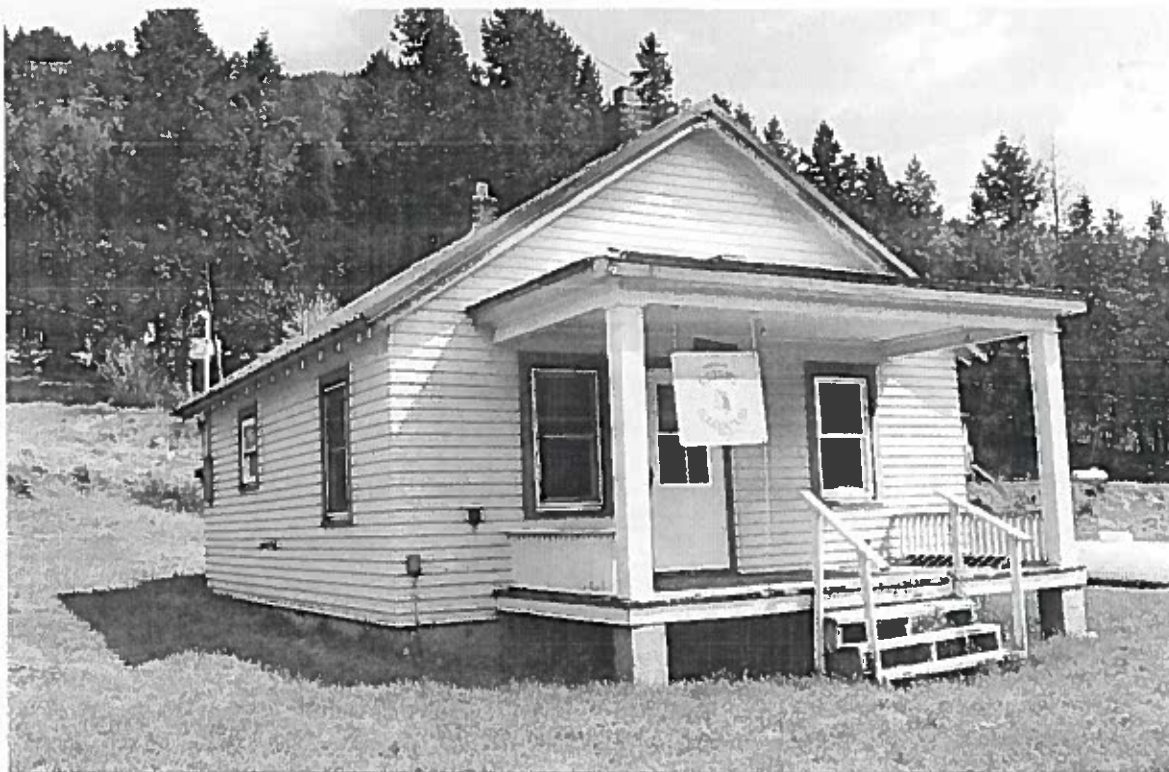
Figure 235: Looking southeast at the residence. The exterior concrete foundation, wood siding, and metal roof are in good condition.

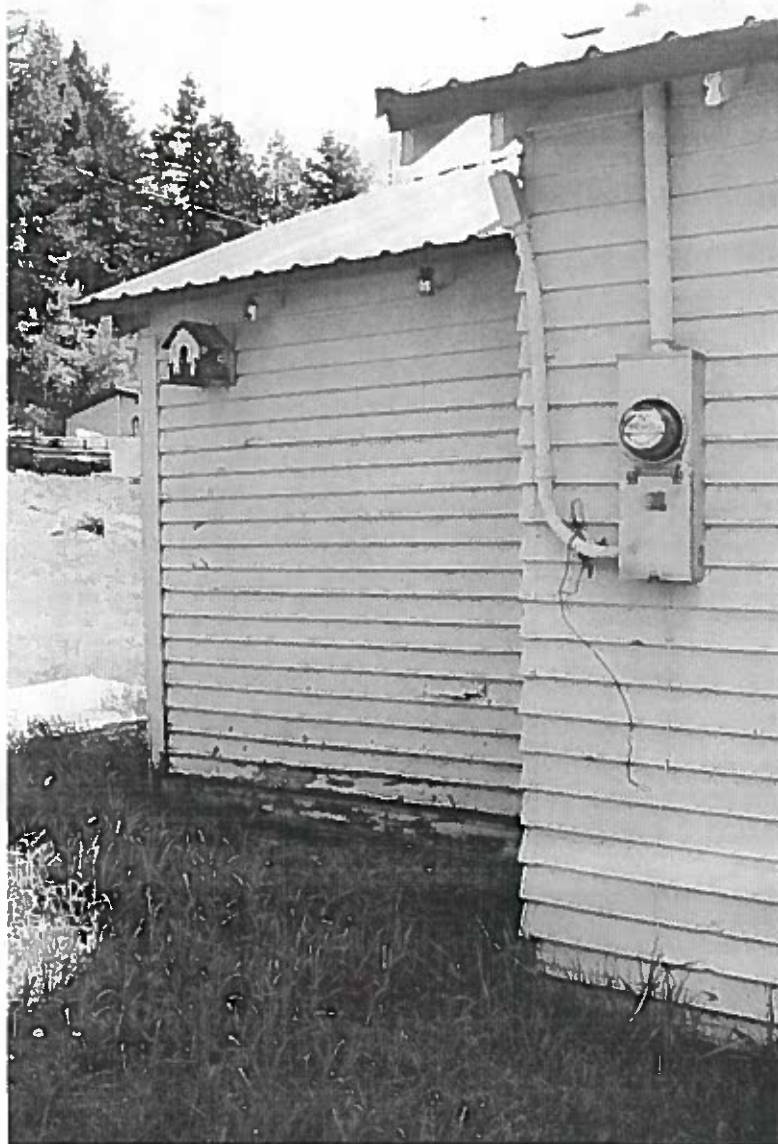
Figure 237: Looking southeast at the back addition to the residence. Note the rotted base materials because of the high grade around the back of the building.

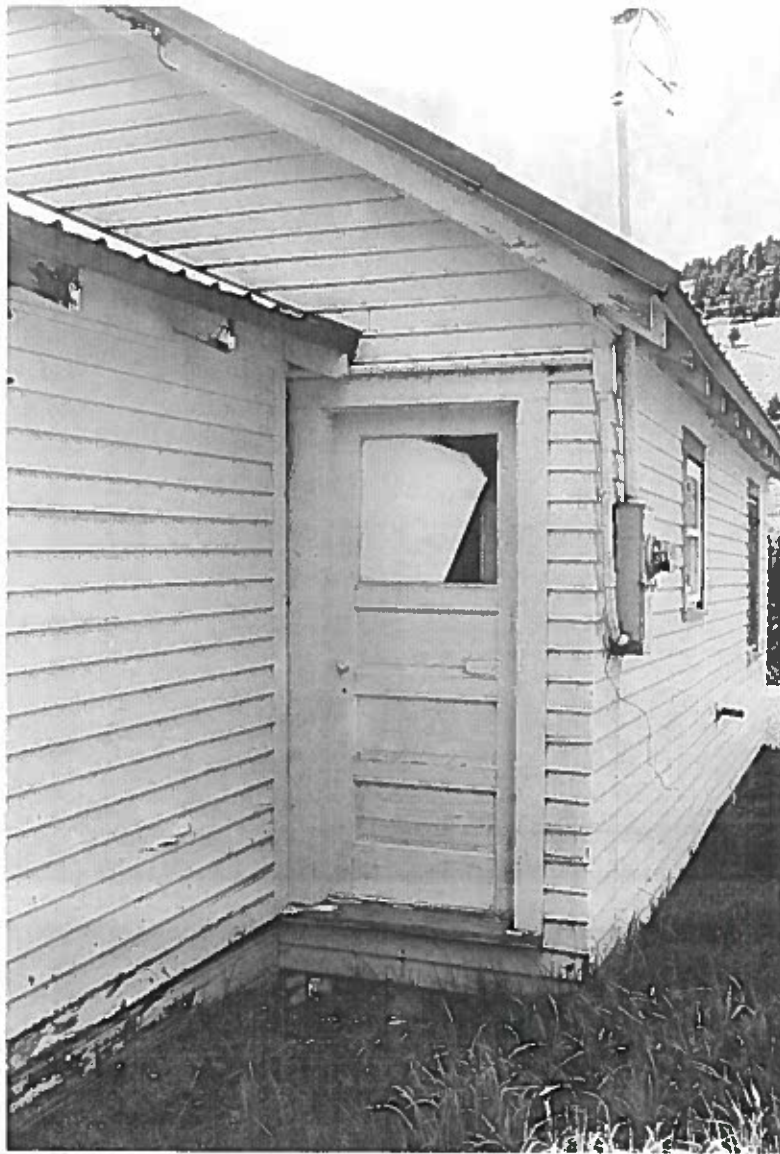
Figure 238: Looking west at the back door of the original structure. Note the weathered sill and base.

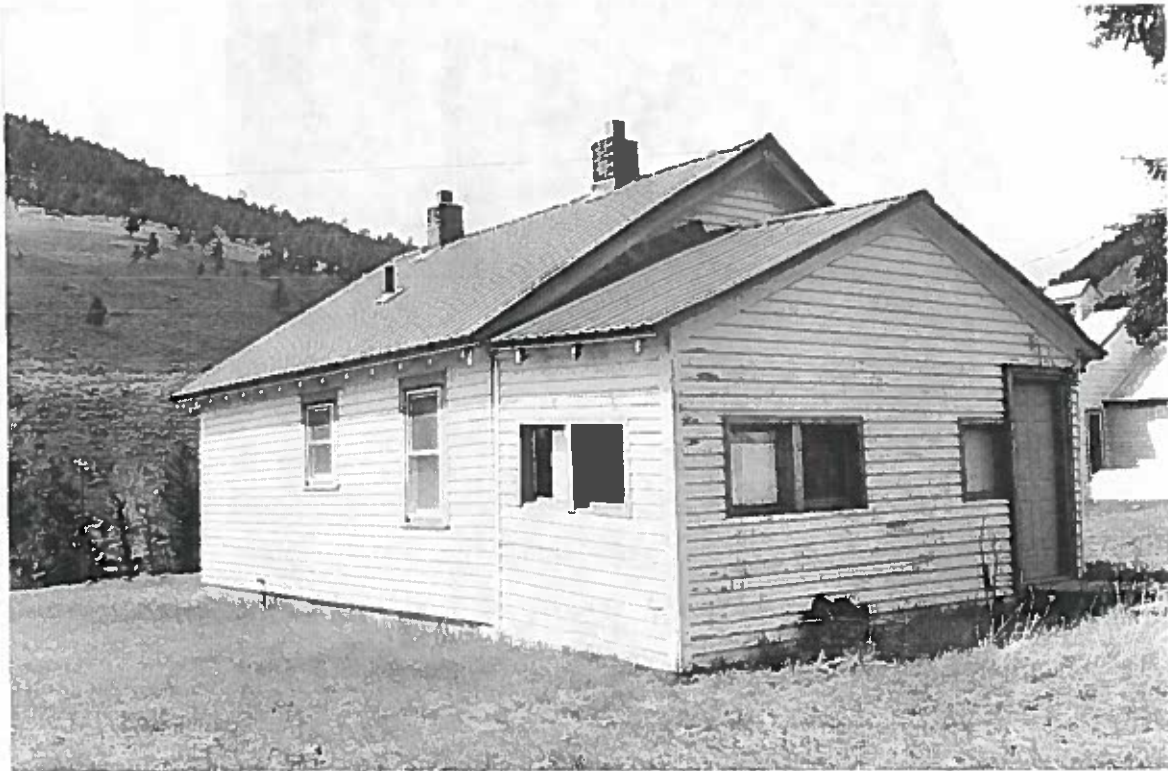
Figure 239: Looking northwest at the residence. Note the high grade around the base of the addition and the deteriorating paint on the walls.

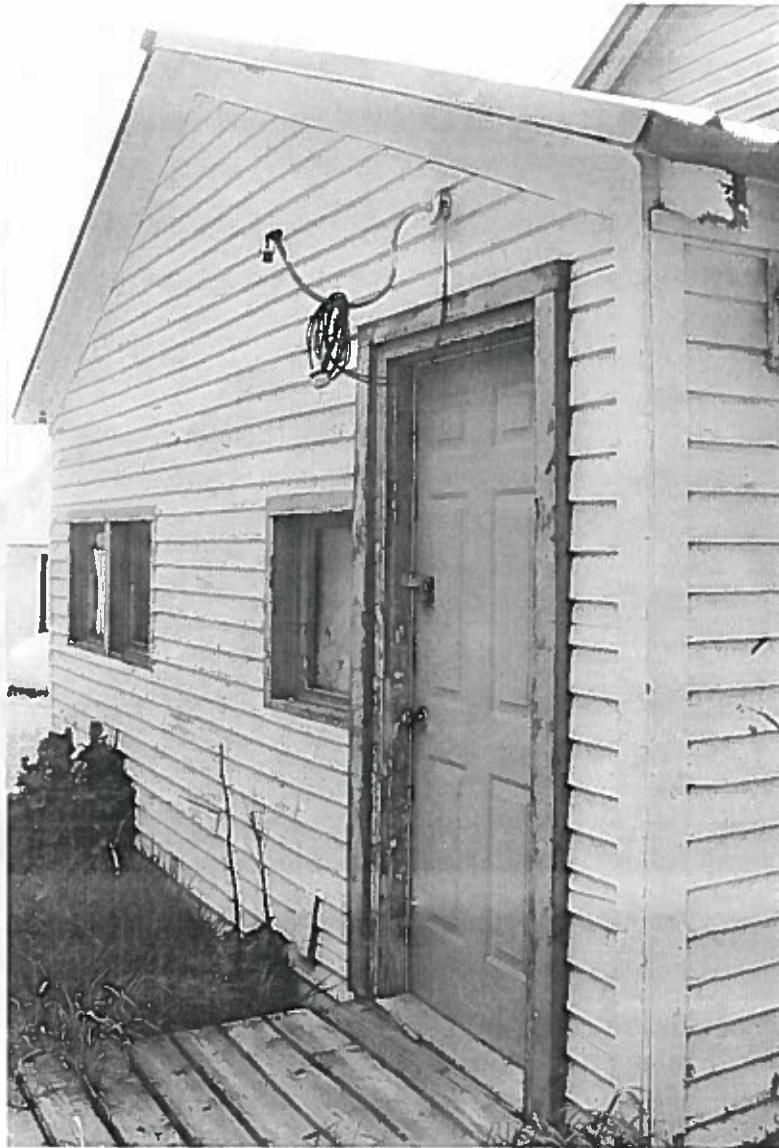
Figure 240: Looking southwest at the back door of the addition. This is a metal paneled door. Note the weathered wood frame around the door.
