**ARCHITECTURAL ASSESSMENT, RECOMMENDATIONS & COSTS  
of  
HISTORIC STRUCTURES**

**MINERAL HILL MINE**

**JARDINE, MONTANA**

**OCTOBER, 2000  
(REVISED JANUARY, 2001)**

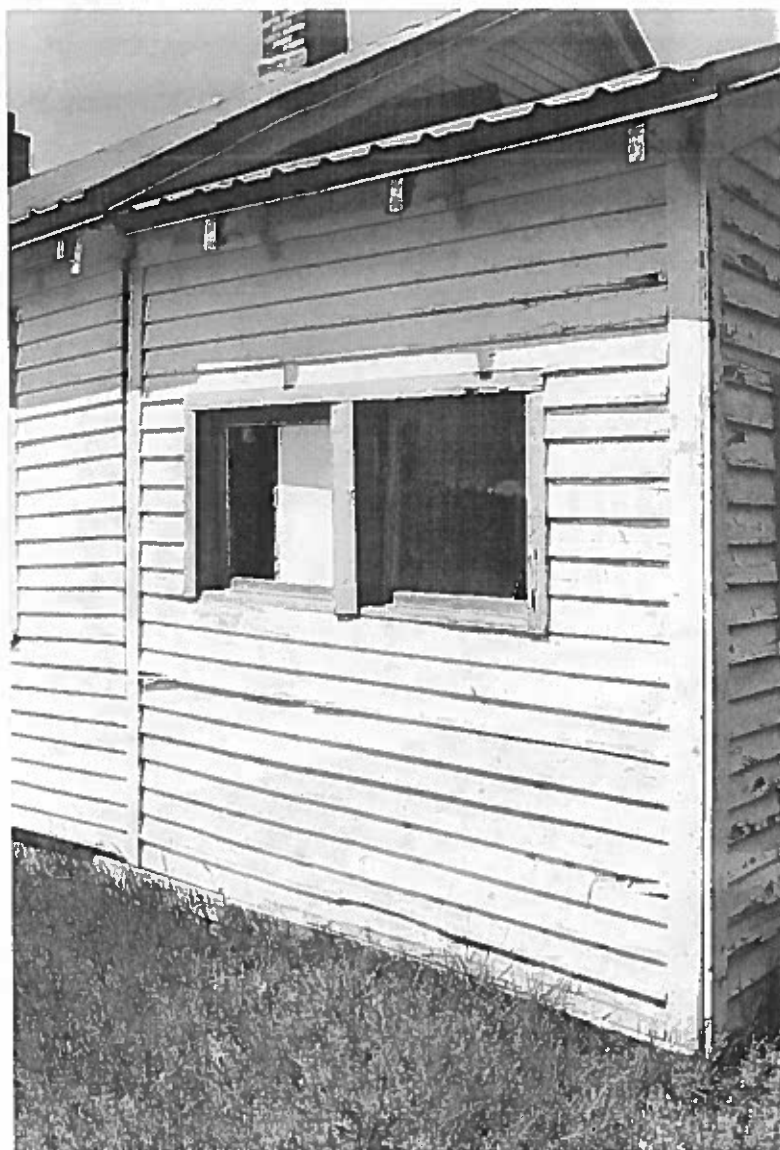
Figure 241: Looking northwest at the addition. Note the peeling paint and weathered wood around the window.

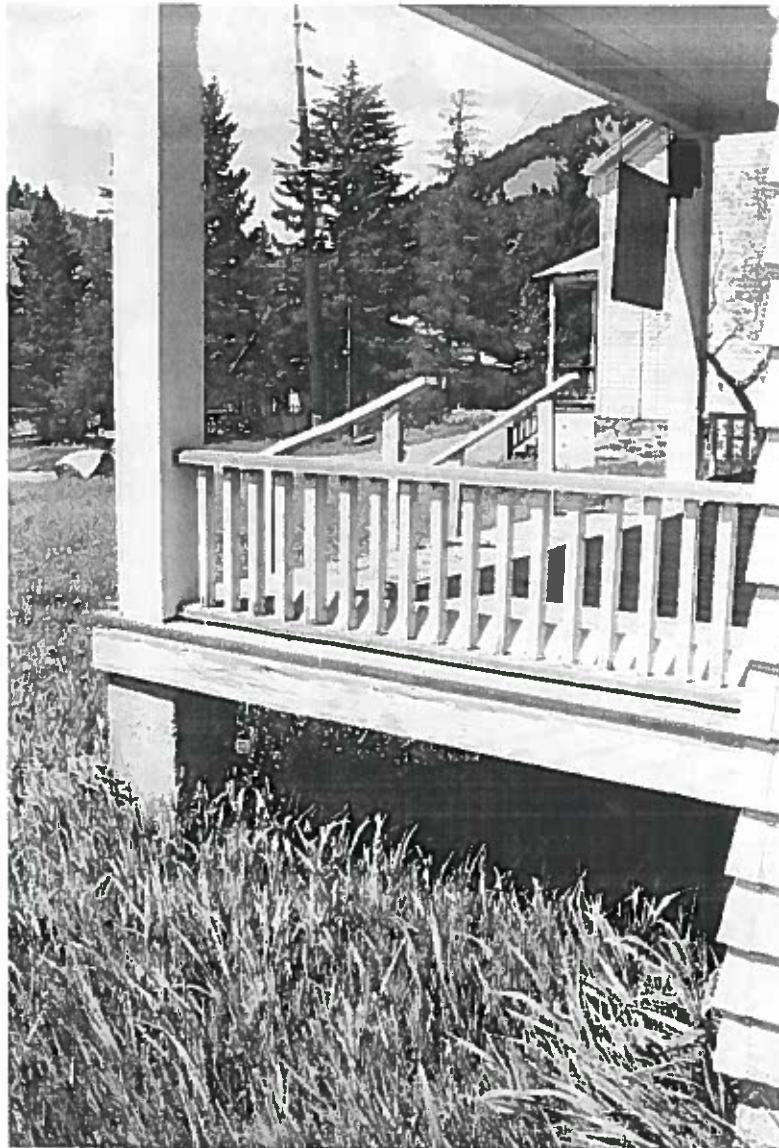
Figure 242: Looking northwest at the front porch. The base of the railing and base of the porch is weathered.

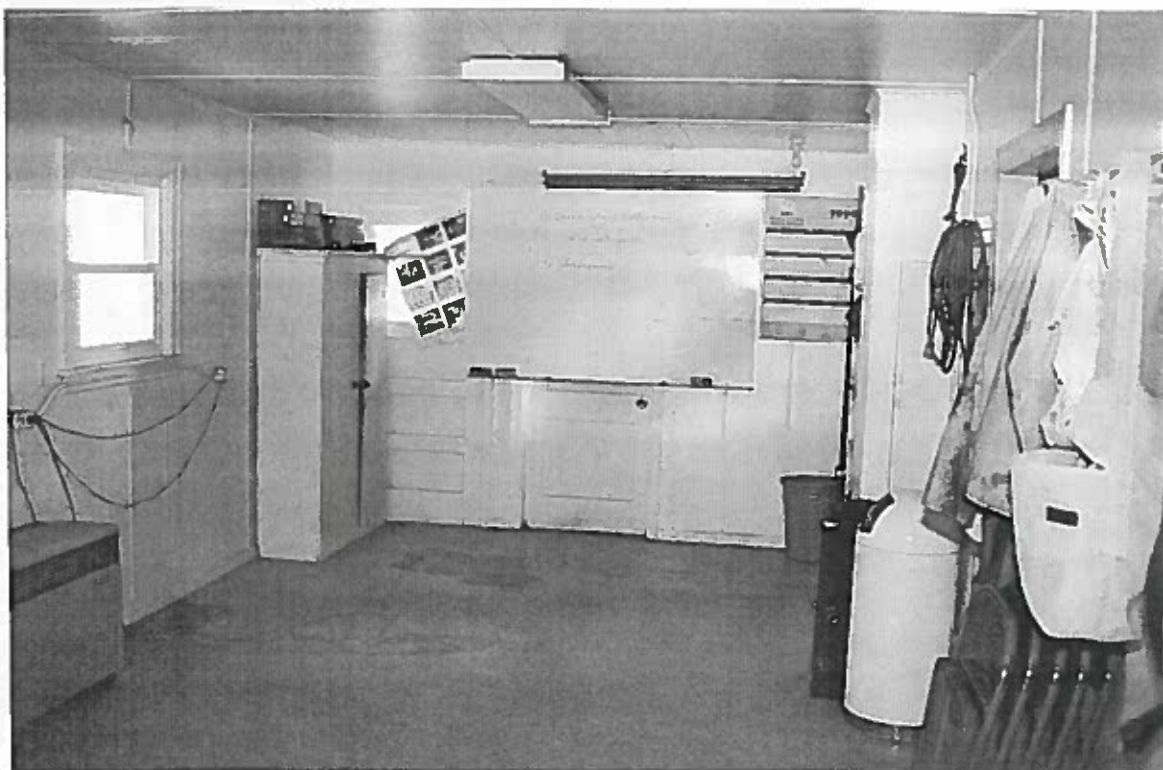
Figure 243: Looking east at the interior of the main room. The materials are in good condition with some minor wear.

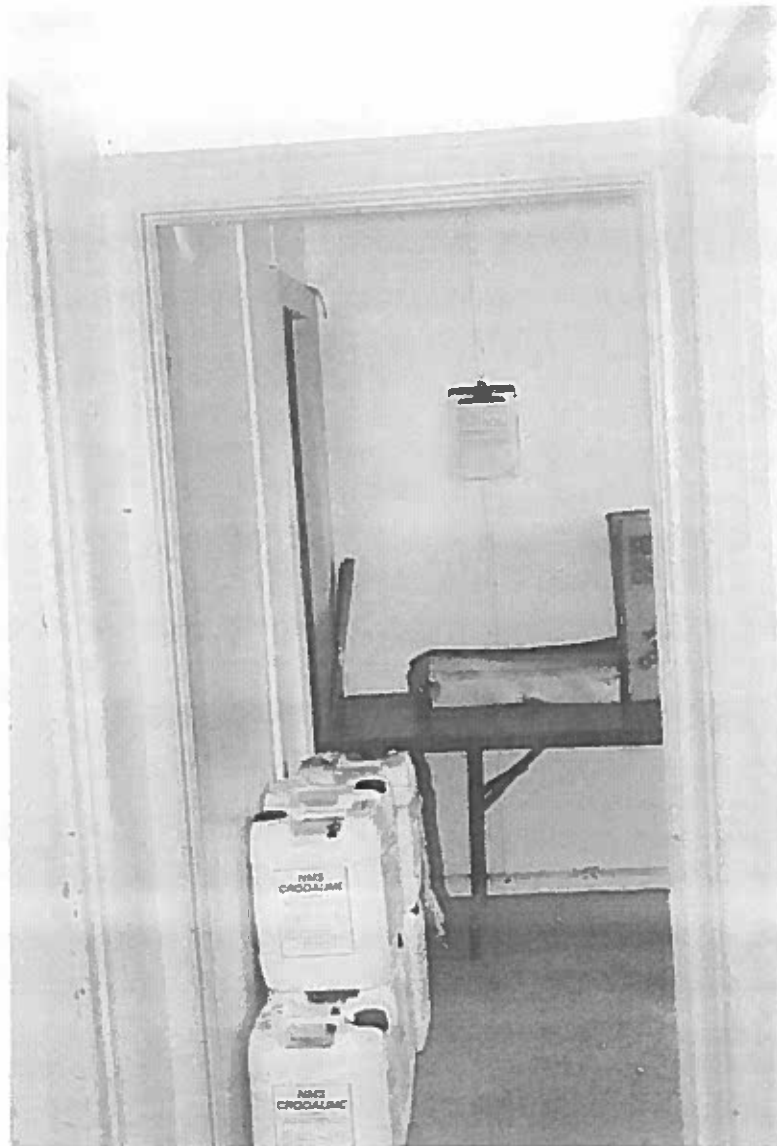
Figure 248: Looking east at the back room. The materials are in good condition.

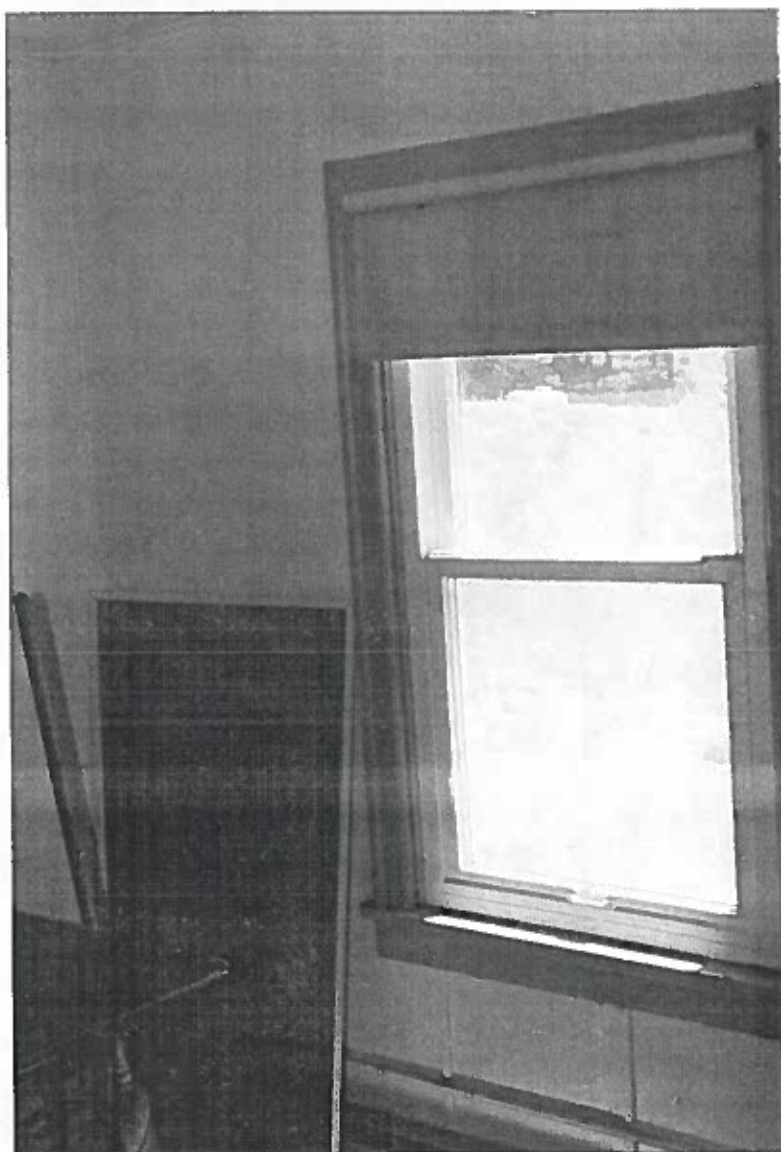
Figure 249: Looking south at a typical double-hung window in good condition.

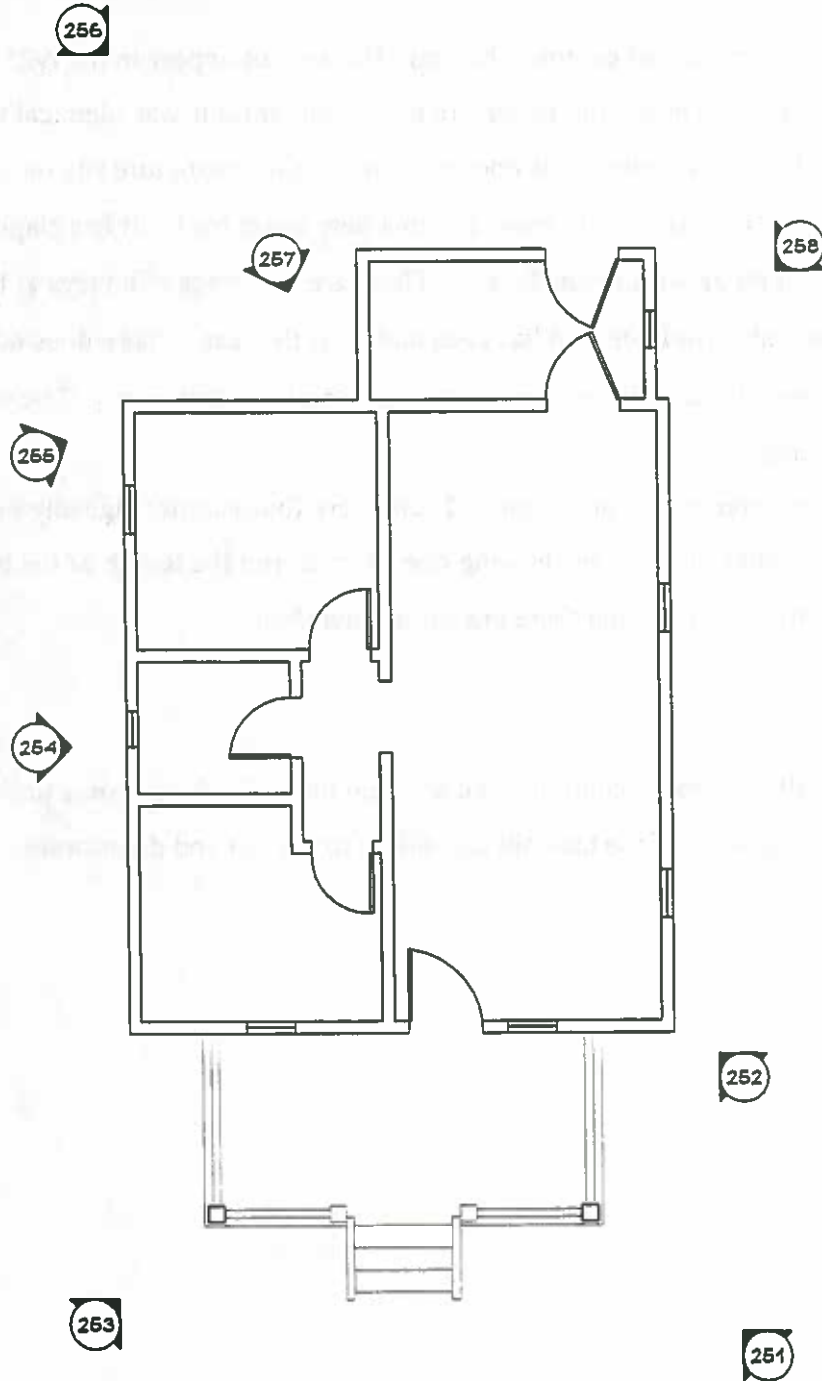
**FIGURE 250**  
**CONDITION ASSESSMENT**  
**RESIDENCE (HS 83)**

The building is generally in good condition. The addition on the back has some problems with high grade around it causing some of the base sill and siding to rot out and deteriorate.

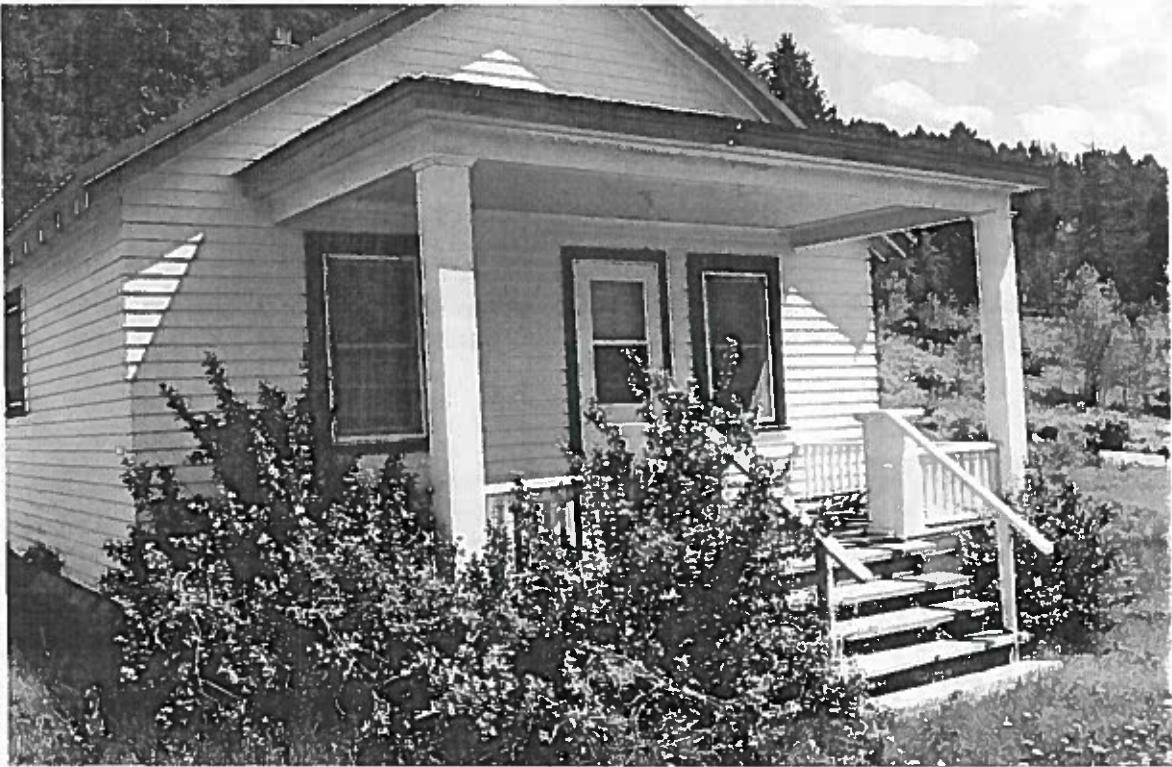
Figure 253: Looking southeast at the porch which appears to be in good condition.

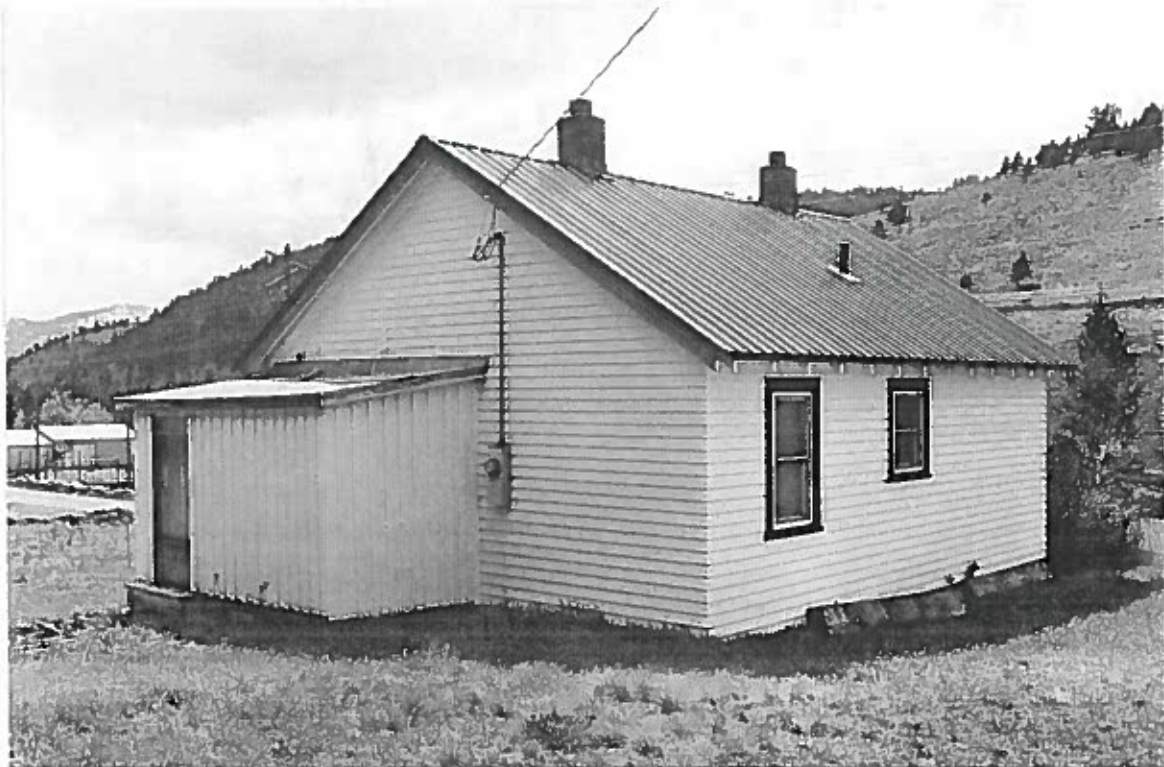
Figure 256: Looking southwest at the residence. Note the good condition of all of the materials on the exterior.
