# **Monument Fire**

## **BURNED AREA EMERGENCY RESPONSE PLAN**

**UNIT:** Coronado National Memorial

**DATE:** July 12, 2011

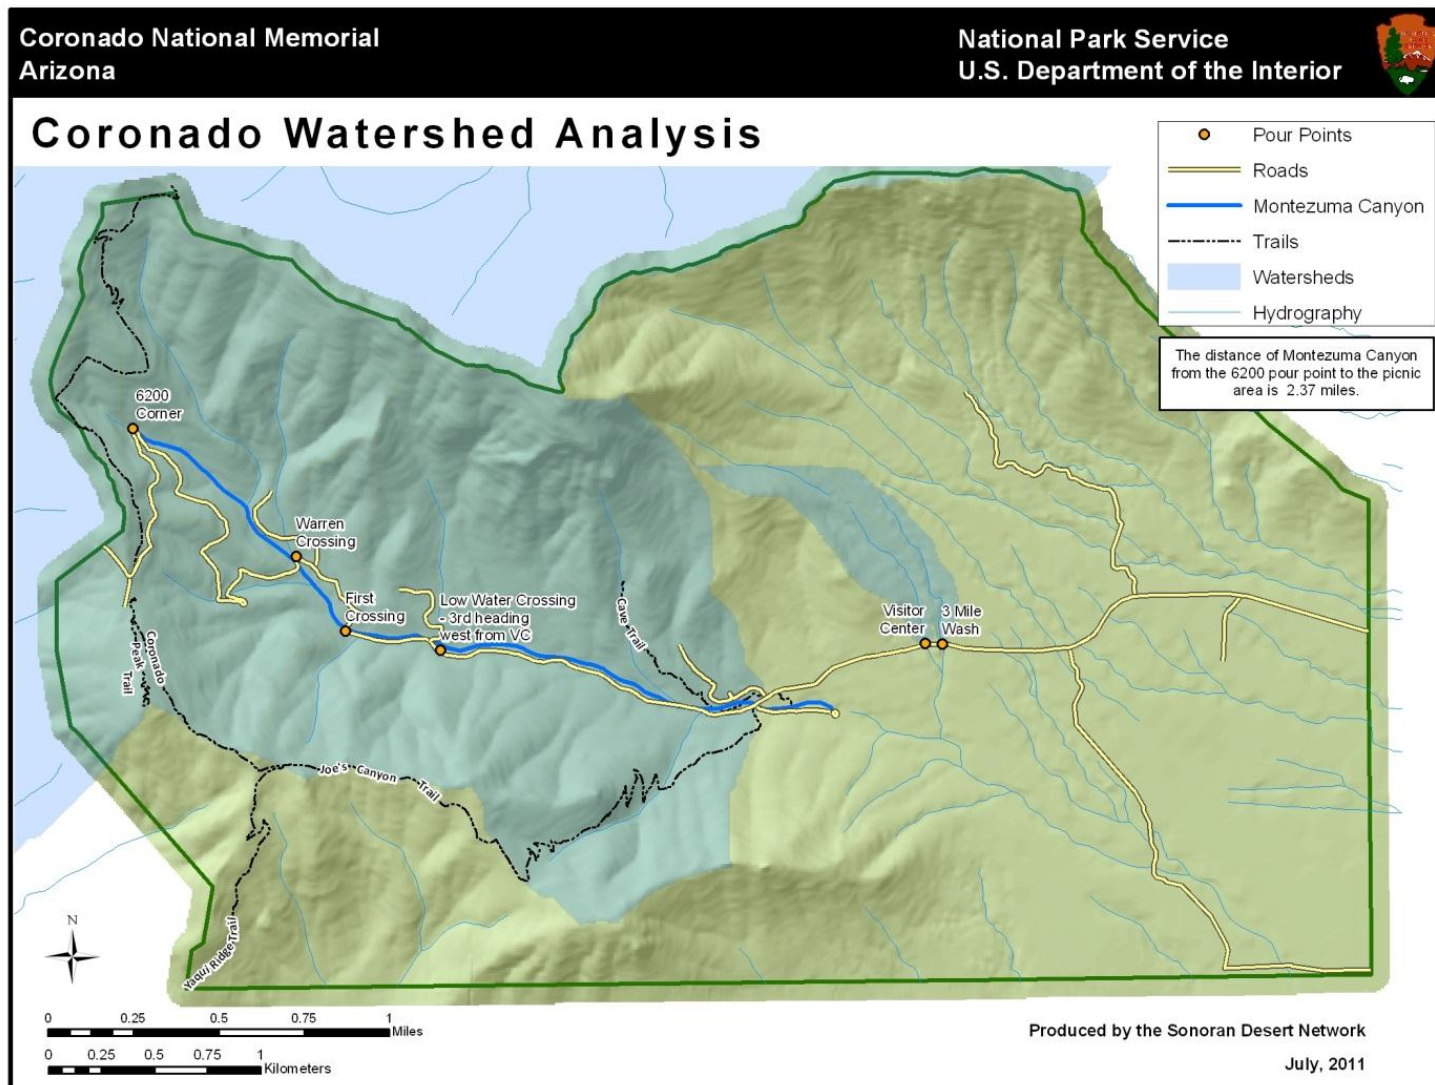
Figure 1: Coronado National Memorial Pour Points

Before an adjusted design flow can be determined for post-fire conditions, pre-fire design flow must be calculated. This is the flow expected to occur prior to the fire. This is the flow responsible for forming present day channel conditions and flows used to estimate proper performance of culverts and other drainage structures. Design flow estimates have been determined utilizing the Wildcat model. These estimates assume pre-fire ground infiltration and ground cover conditions. Tables 3, 4, and 5 display changes in flow for all pour points regarding pre-fire and post-fire storm events. Figure 1 shows all the pour points modeled with in the Memorial
