HISTORIC STRUCTURES REPORT

PART II

PRELIMINARY TO THE REHABILITATION OF  
THE ADAMS LIBRARY

Adams National Historical Site

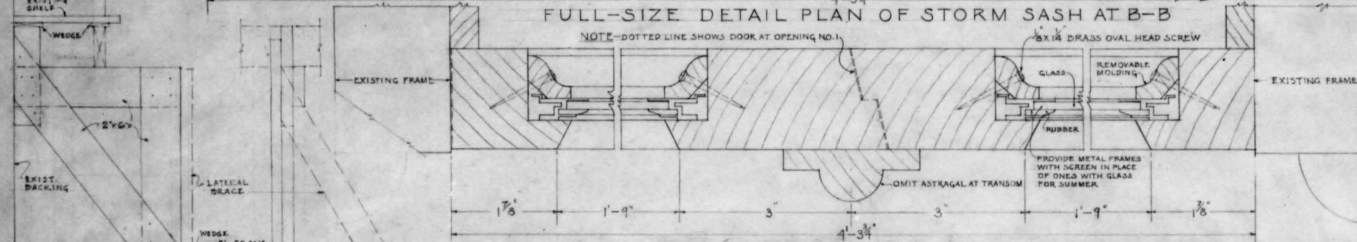
FULL-SIZE DETAIL PLAN OF STORM SASH AT B-B

NOTE-DOTTED LINE SHOWS DOOR AT OPENING NO. 1

All the doorways, with the exception of the one on the south side which is used for the main entrance, should have outside storm sash installed to match the doors and transoms in design. All the storm sash should be fixed, excepting one leaf in the south door (not the main entrance) which can serve as an emergency exit. All glass panes should be made replaceable with screen panels.
