HISTORIC STRUCTURES REPORT

ADAMS MANSION 1730 HOUSE

Adams National Historic Site  
Quincy, Massachusetts

Prepared by  
George L. Wrenn  
Architect  
June 1966

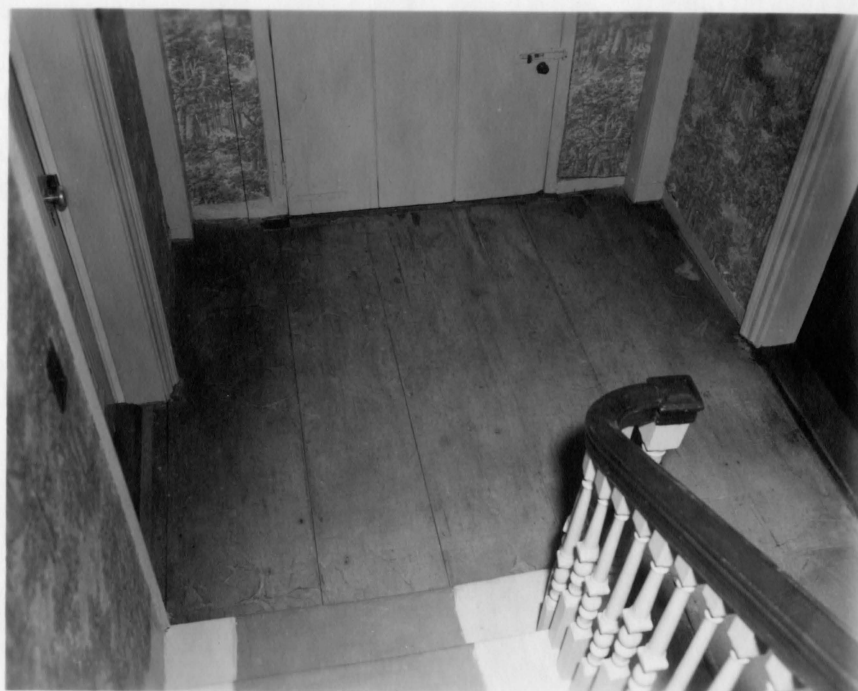
ILLUSTRATION NO. 15

1730 House, first floor, hallway, close-up view looking down in southwest corner at marbleizing found on floor boards after removal of linoleum.

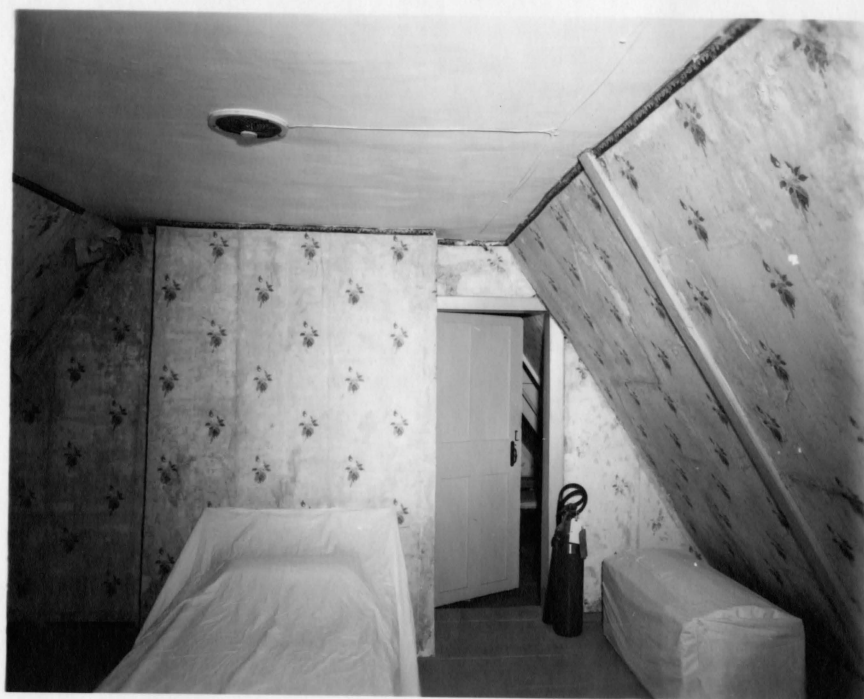
1730 House, third floor, east room,  
view looking east across room showing poor condition  
of wallpaper and large old-fashioned rosette of  
fire alarm system on the ceiling.
