# FISHING BRIDGE MEN'S DORMITORY Yellowstone National Park

June, 2012

Historic Structure Report

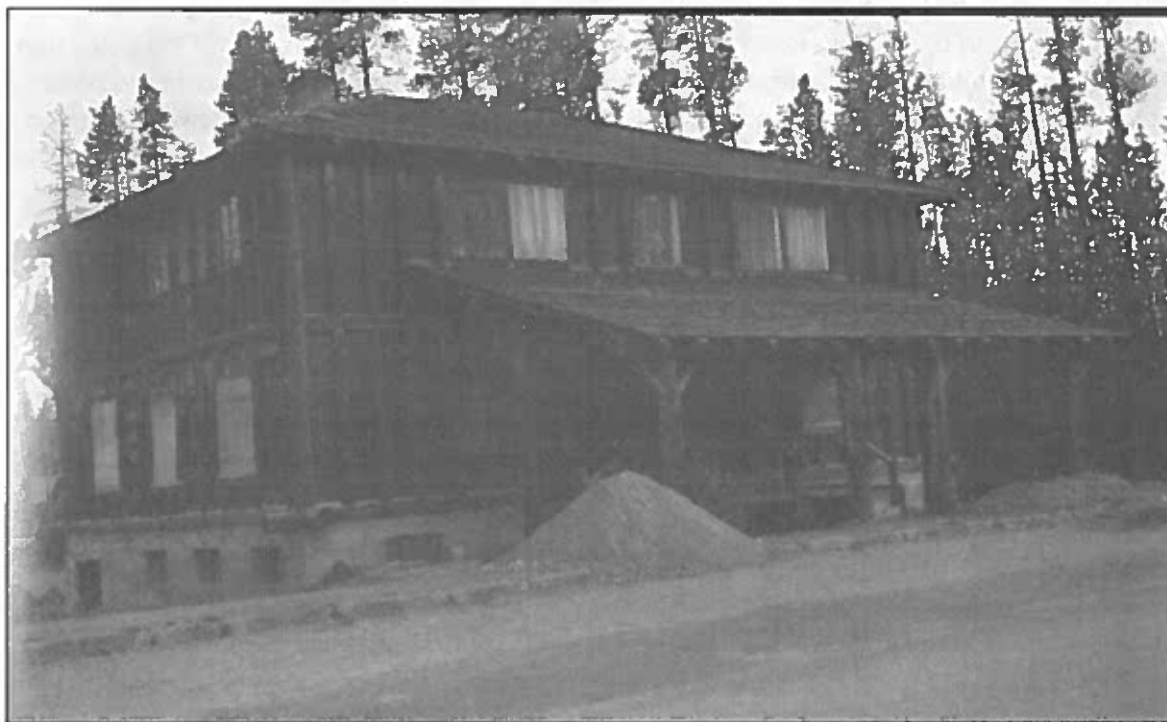
Form No. 10-768 Maintenance Form, completed in 1950, indicates that an original 17' by 29'6" log framed porch was replaced with the current, smaller, lean-to porch at an unknown date (Figure 2). Other, undated modifications include the removal of the log-out framing and replacement of windows on the north wall of the building.

Figure 2. Undated photograph of the original porch  
(Courtesy Yellowstone National Park Photo Archives, YELL 29938)

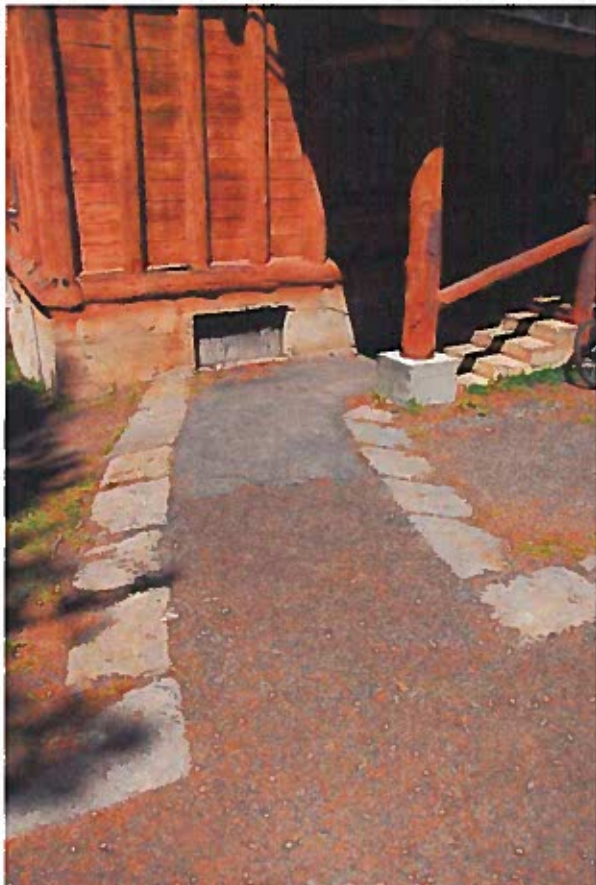
Figure 11: Looking north at the walkway to the building. Note the drainage towards the building and front steps.

**Figure 11:** Looking north at the walkway to the building. Note the drainage towards the building and front steps.

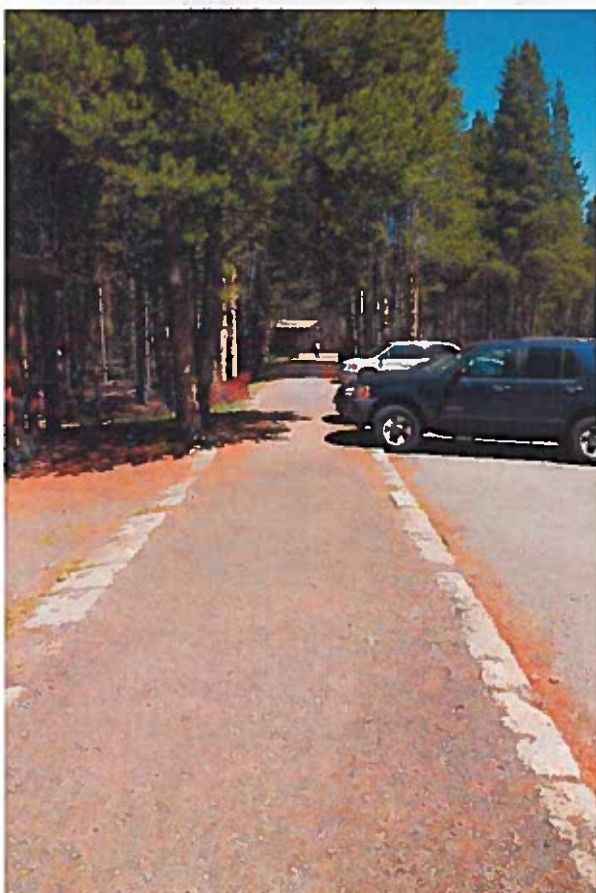
Figure 12: Looking east at the walkway and parking in front of the dorm. Some stone edges have settled. The parking lot asphalt is close to the top of the curb.

**Figure 12:** Looking east at the walkway and parking in front of the dorm. Some stone edges have settled. The parking lot asphalt is close to the top of the curb.

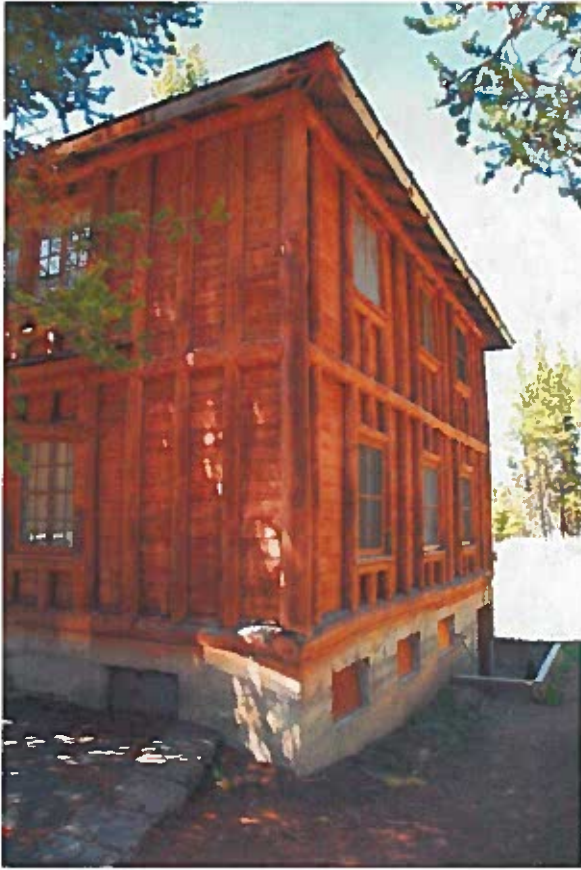
Figure 15: Looking northwest at the building and concrete stair to the basement. The stair does not meet code and there is some deterioration in the concrete walls.

**Figure 15:** Looking northwest at the building and concrete stair to the basement. The stair does not meet code and there is some deterioration in the concrete walls.

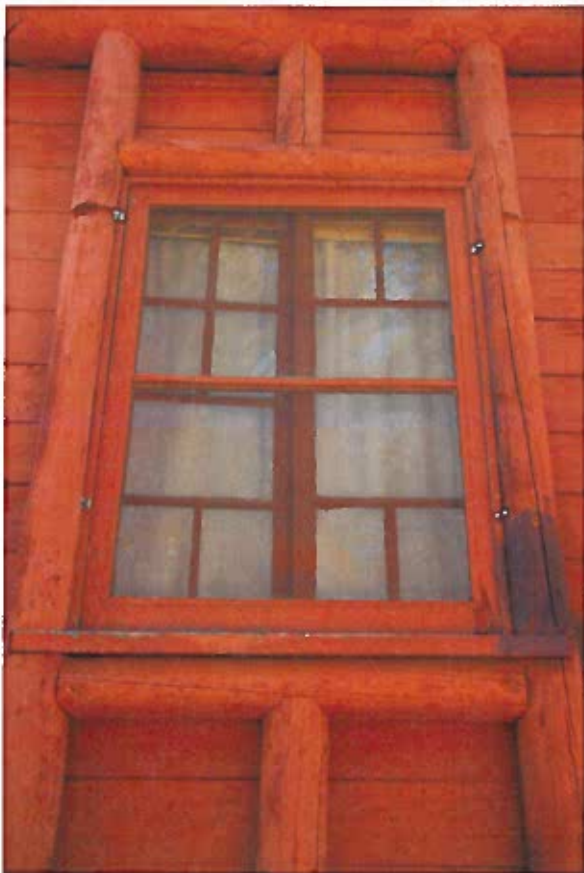
Figure 16: Looking west at a typical window and details of some of the logs. Note the weathered surfaces and some rot in the base of the columns and the weathered wood on the window, and also the missing muntins in the sash.

**Figure 16:** Looking west at a typical window and details of some of the logs. Note the weathered surfaces and some rot in the base of the columns and the weathered wood on the window, and also the missing muntins in the sash.

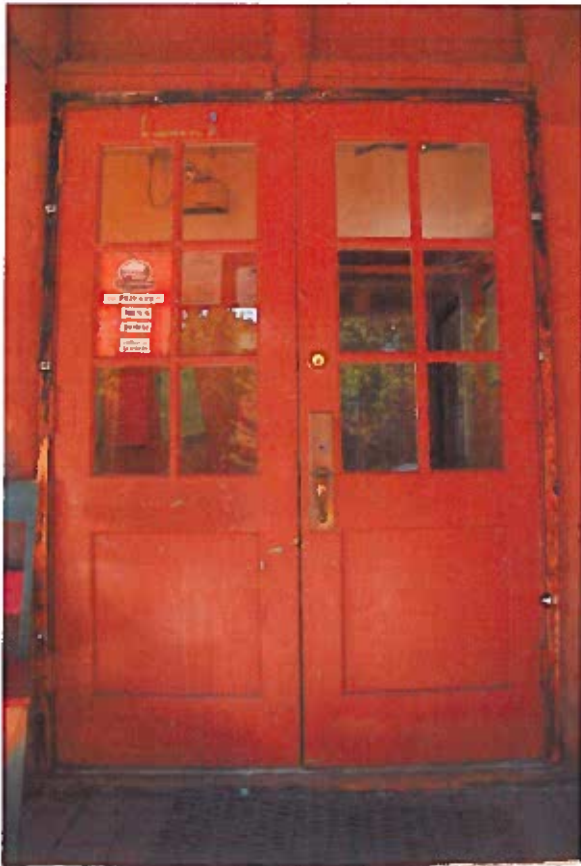
Figure 25: Looking north at the entrance. The wood paneled doors with lites are in poor to fair condition. The hinges are loose and the meeting styles have some wood damage. The doors do not close properly.

**Figure 25:** Looking north at the entrance. The wood paneled doors with lites are in poor to fair condition. The hinges are loose and the meeting styles have some wood damage. The doors do not close properly.

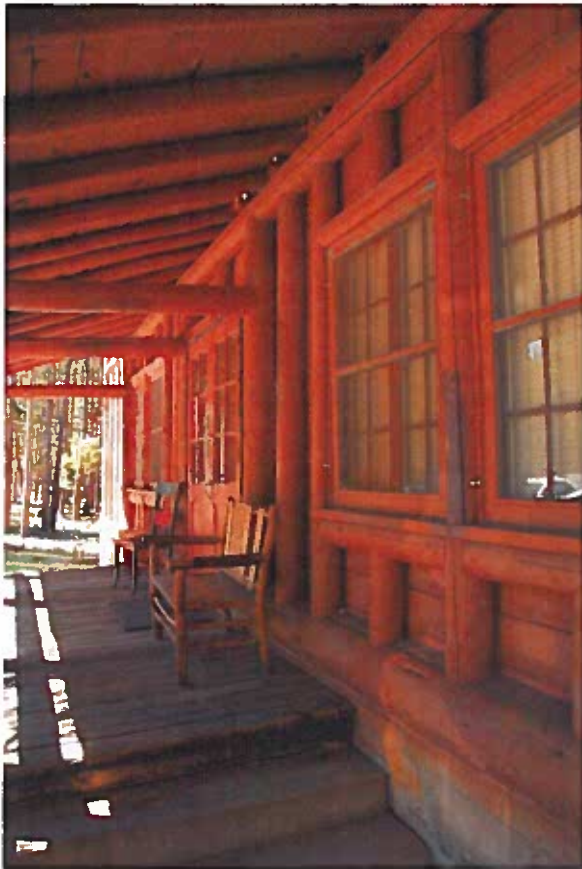
Figure 27: Looking northwest at the front porch and entrance. The porch roof has some deteriorated areas at the connection to the wall. Water penetrates into the horizontal logs causing some rot.

**Figure 27:** Looking northwest at the front porch and entrance. The porch roof has some deteriorated areas at the connection to the wall. Water penetrates into the horizontal logs causing some rot.

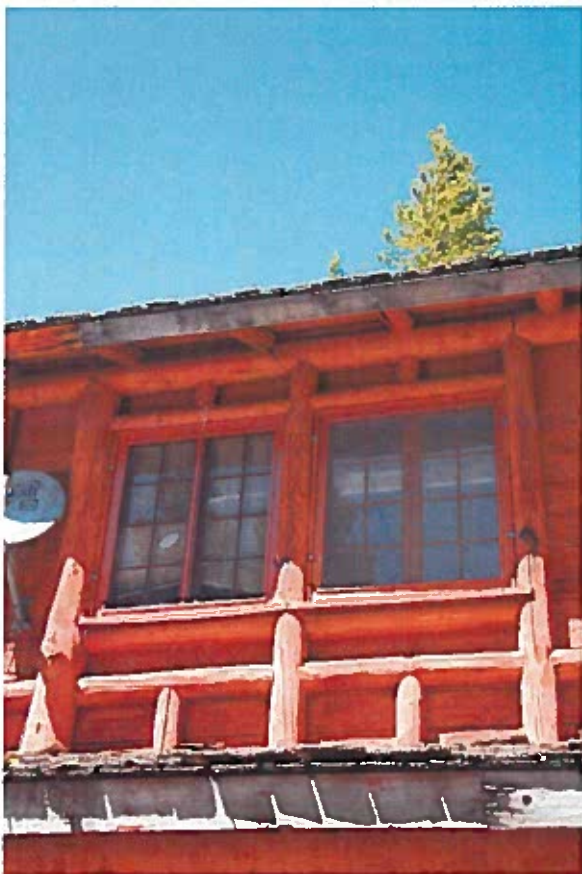
Figure 28: Looking north at a typical window above the porch roof. Water penetrates into the area below the window. Note the weathered fascia.

**Figure 28:** Looking north at a typical window above the porch roof. Water penetrates into the area below the window. Note the weathered fascia.

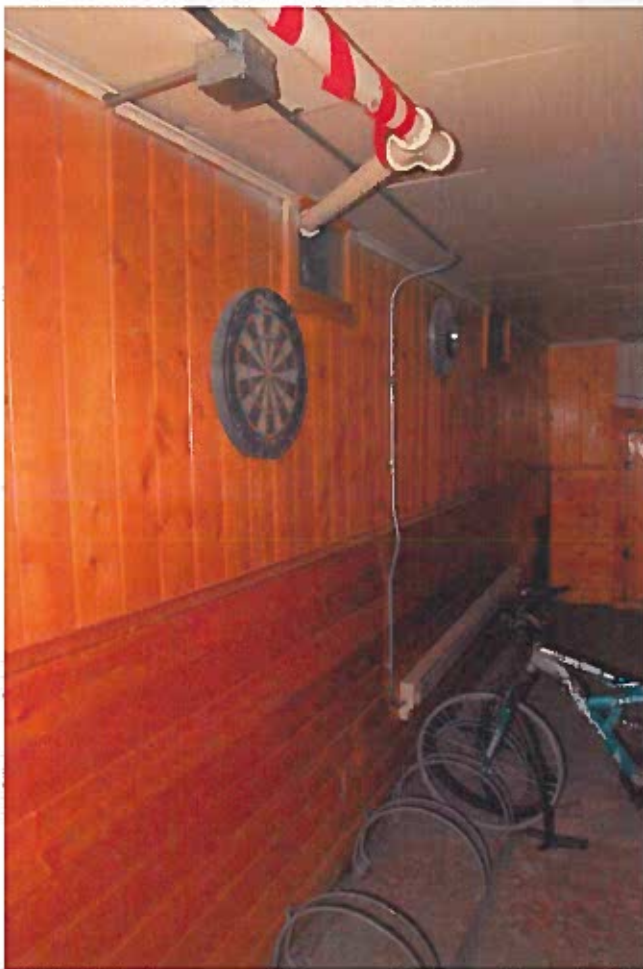
Figure 33: A wood partition wall is in good condition.

**Figure 33:** A wood partition wall is in good condition.

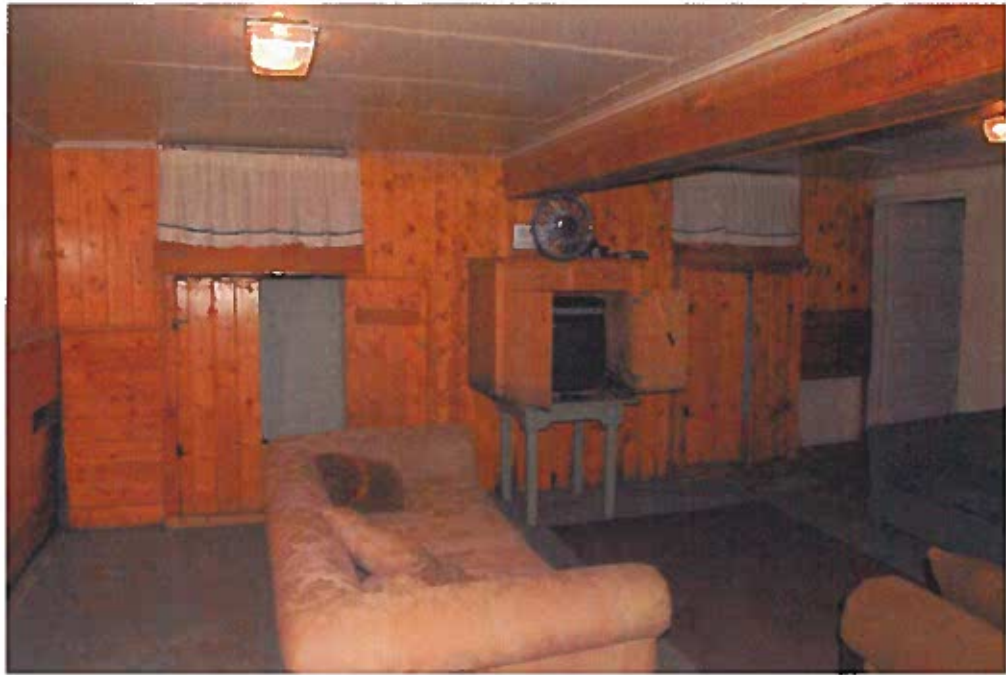
Figure 34: Knotty pine paneling is located on the south and west sides of the main room. It is in fair to good condition. The celotex ceiling is in good condition.

**Figure 34:** Knotty pine paneling is located on the south and west sides of the main room. It is in fair to good condition. The celotex ceiling is in good condition.

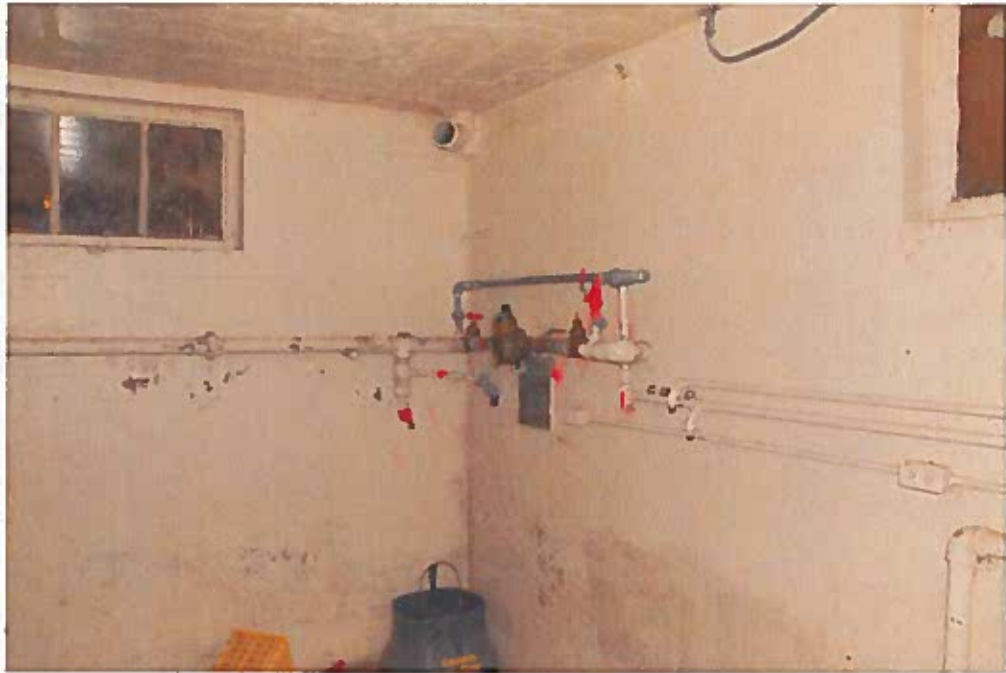
Figure 40: Water meter for the building. The plumbing appears to be in fair condition.

**Figure 40:** Water meter for the building. The plumbing appears to be in fair condition.

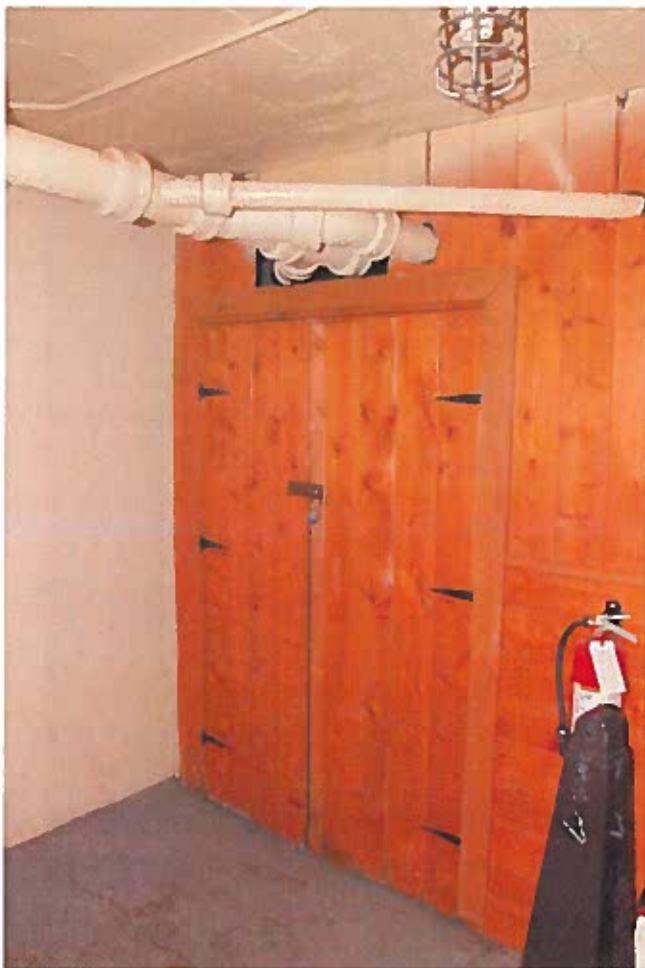
Figure 41: Entrance to the mechanical room. The wood is in good condition.

**Figure 41:** Entrance to the mechanical room. The wood is in good condition.

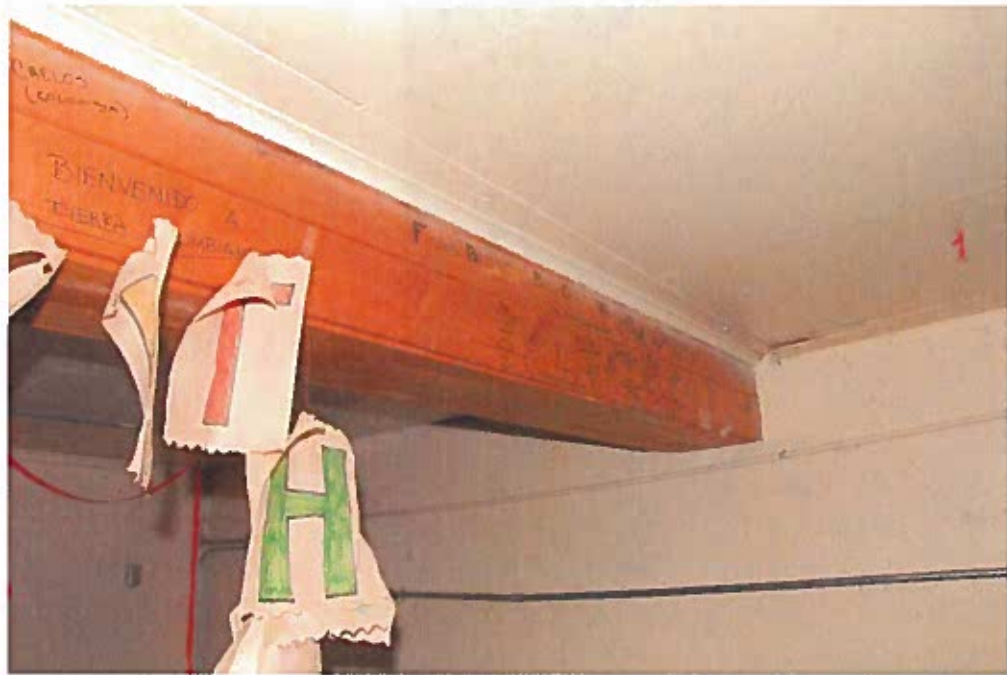
Figure 44: Concrete beam wrapped in wood.

**Figure 44:** Concrete beam wrapped in wood.

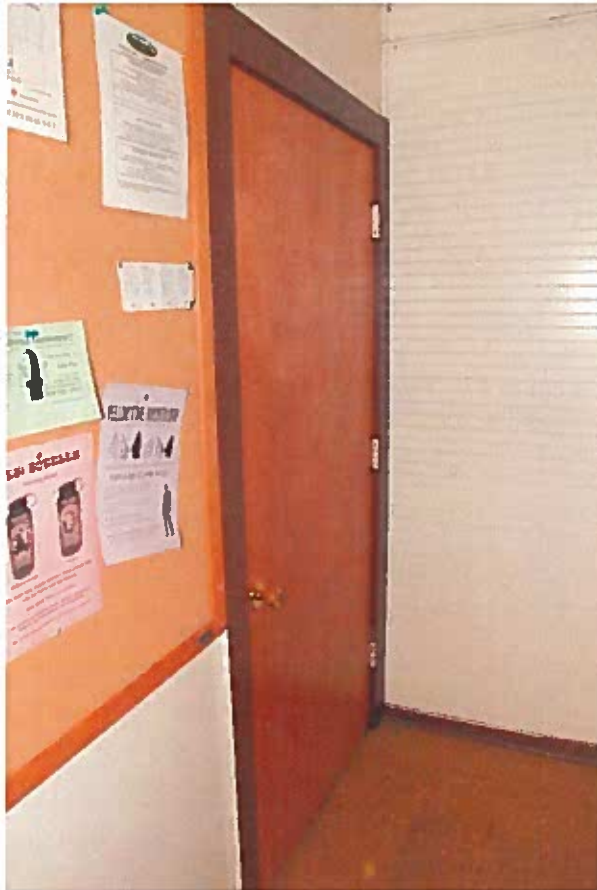
Figure 45: The interior first floor door swings into the exit corridor from the second floor.

**Figure 45:** The interior first floor door swings into the exit corridor from the second floor.

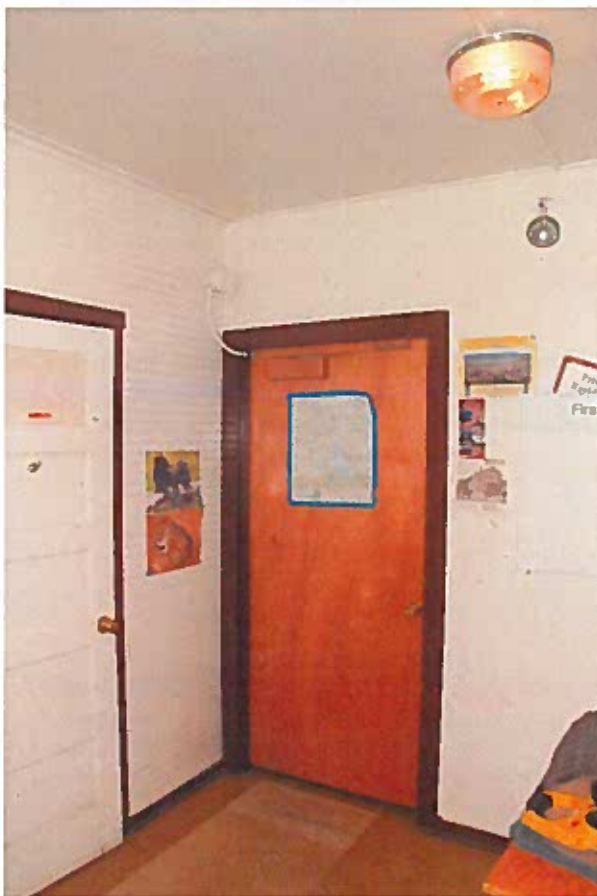
Figure 46: The wood exit door from the first floor does not meet the building codes because of the materials and frame. There is no exit hardware.

**Figure 46:** The wood exit door from the first floor does not meet the building codes because of the materials and frame. There is no exit hardware.

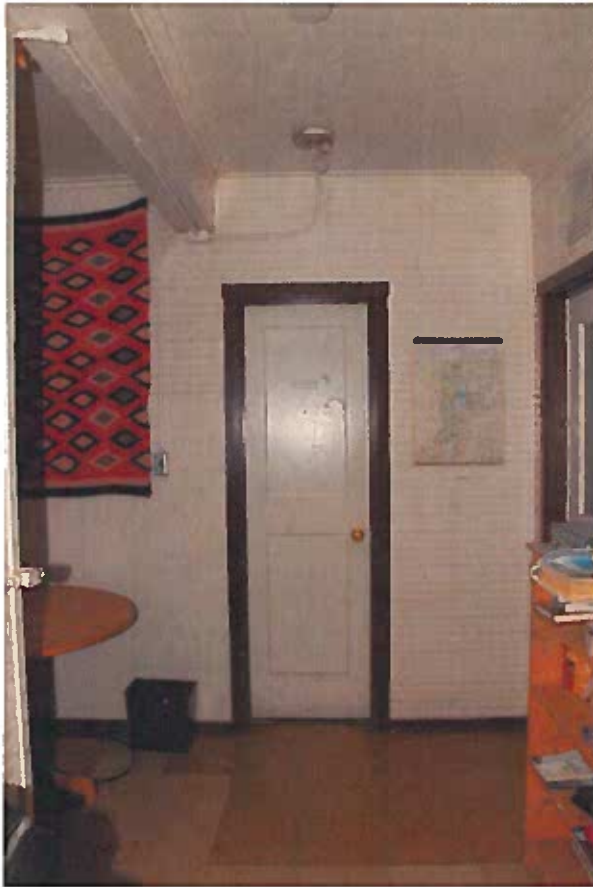
Figure 47: The original wood paneled door does not meet the width for ADA access to the bathroom.

**Figure 47:** The original wood paneled door does not meet the width for ADA access to the bathroom.

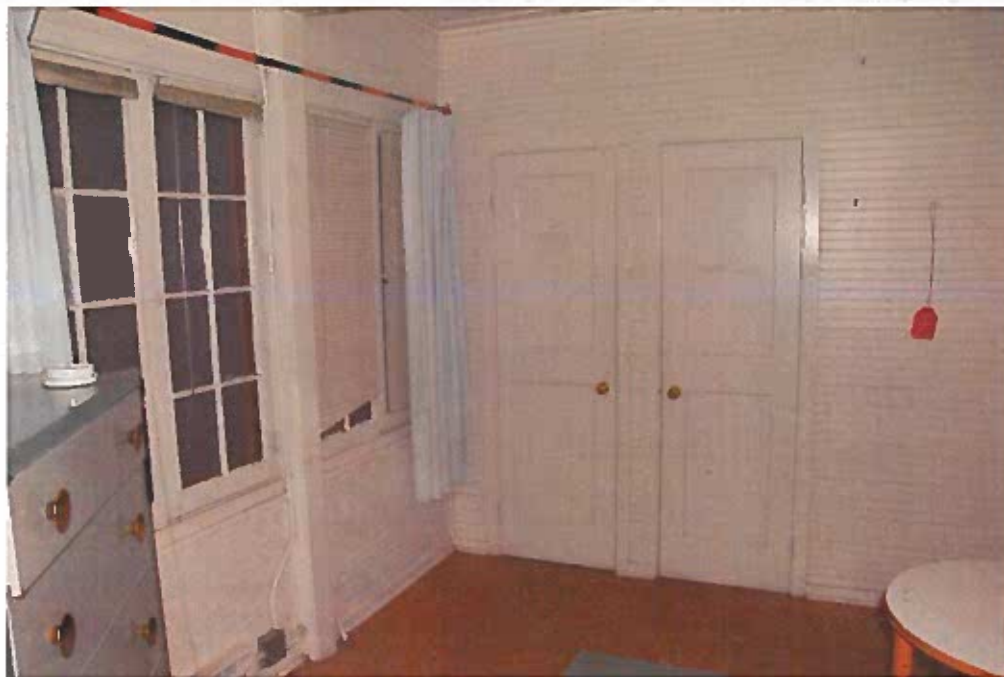
Figure 50: The painted woodwork and beaded wood walls are in good condition with some minor wear.

**Figure 50:** The painted woodwork and beaded wood walls are in good condition with some minor wear.

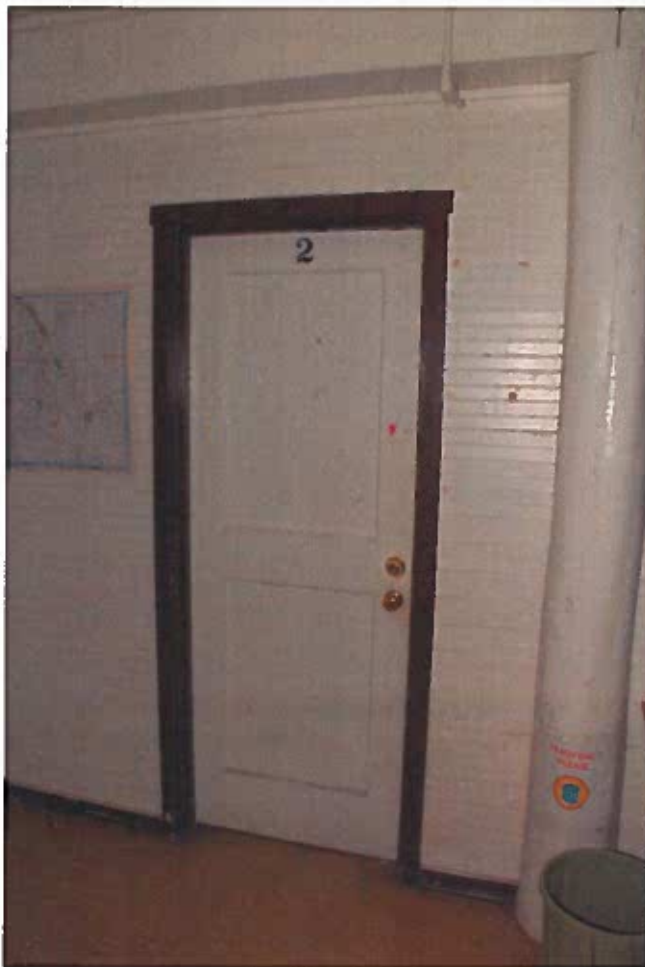
Figure 53: The original wood paneled doors still access all of the rooms.

**Figure 53:** The original wood paneled doors still access all of the rooms.

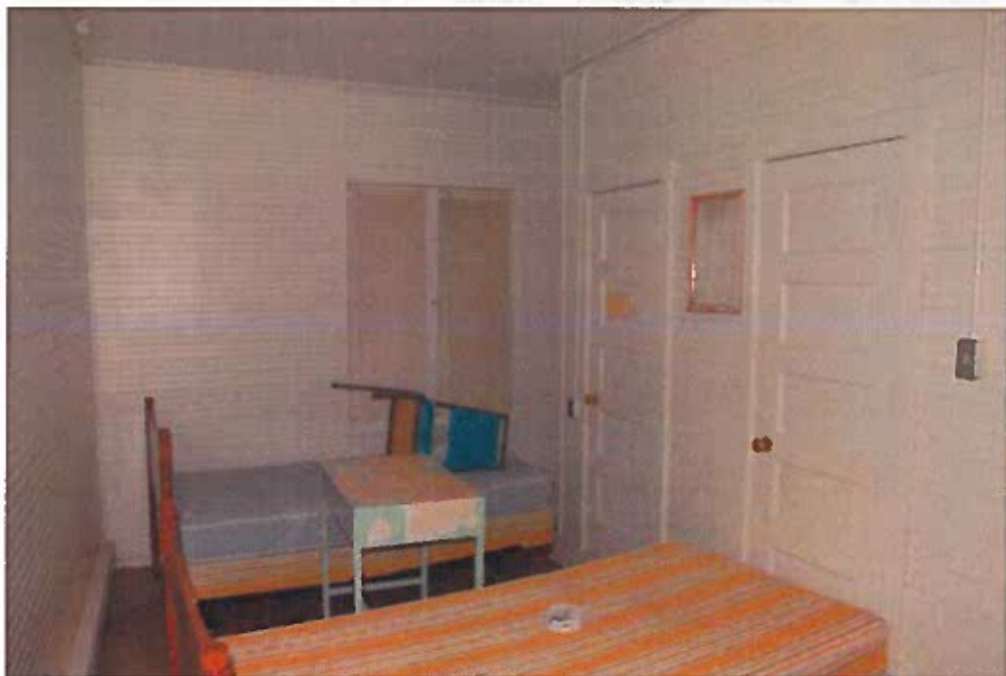
Figure 54: This room is used by several tenants and has a lot of wear on the walls and floor surfaces.

**Figure 54:** This room is used by several tenants and has a lot of wear on the walls and floor surfaces.

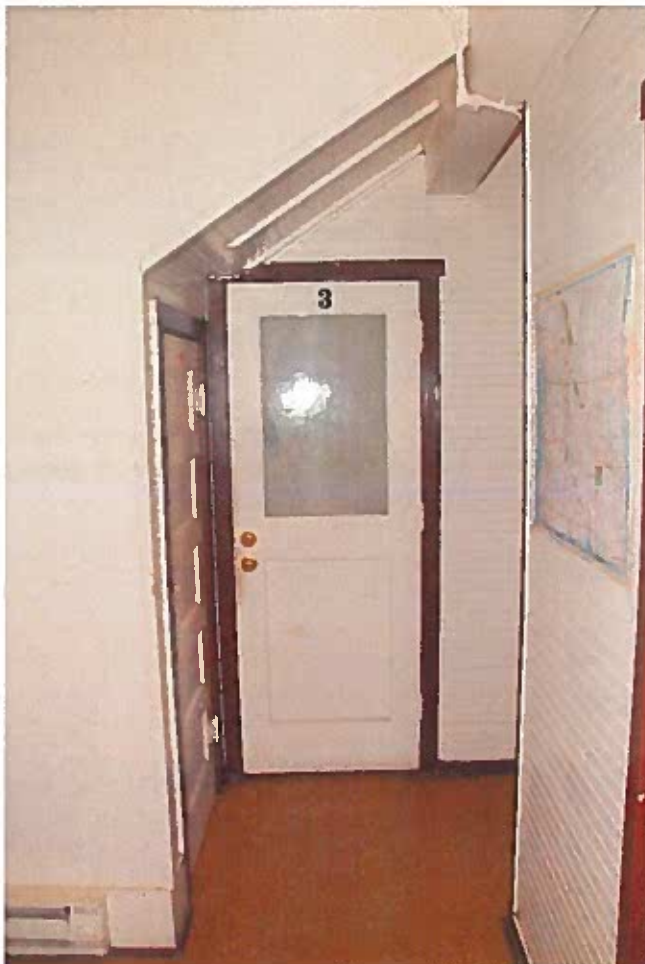
Figure 58: The original door has a half-glass lite and is covered over from the inside.

**Figure 58:** The original door has a half-glass lite and is covered over from the inside.

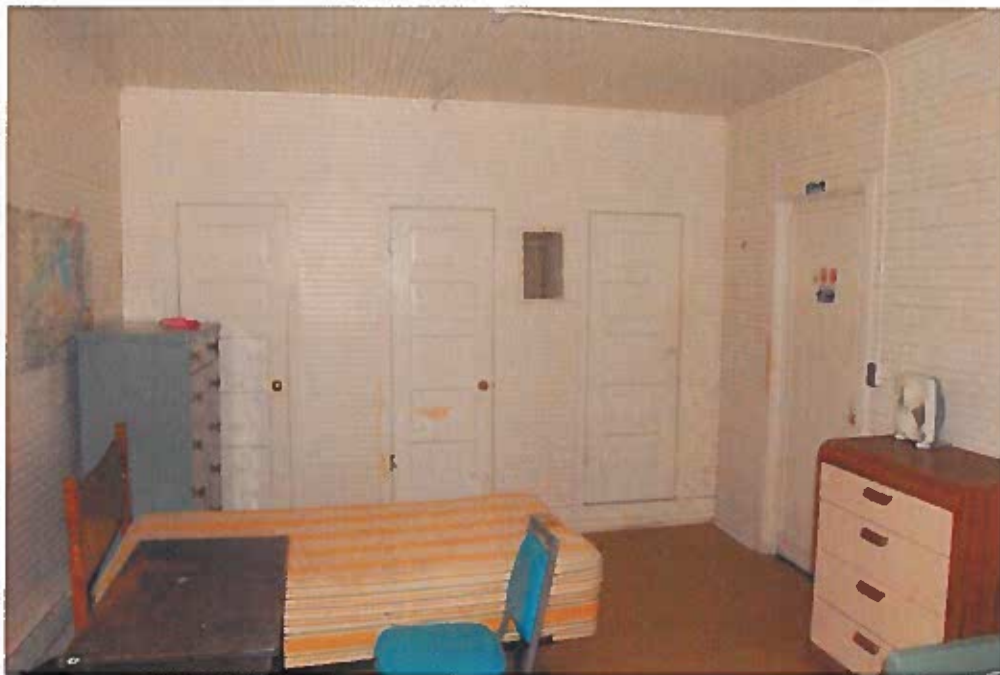
Figure 59: The painted woodwork and wood bead board walls are in good condition with some minor paint wear. Note the covered lite on the door to the right.

**Figure 59:** The painted woodwork and wood bead board walls are in good condition with some minor paint wear. Note the covered lite on the door to the right.

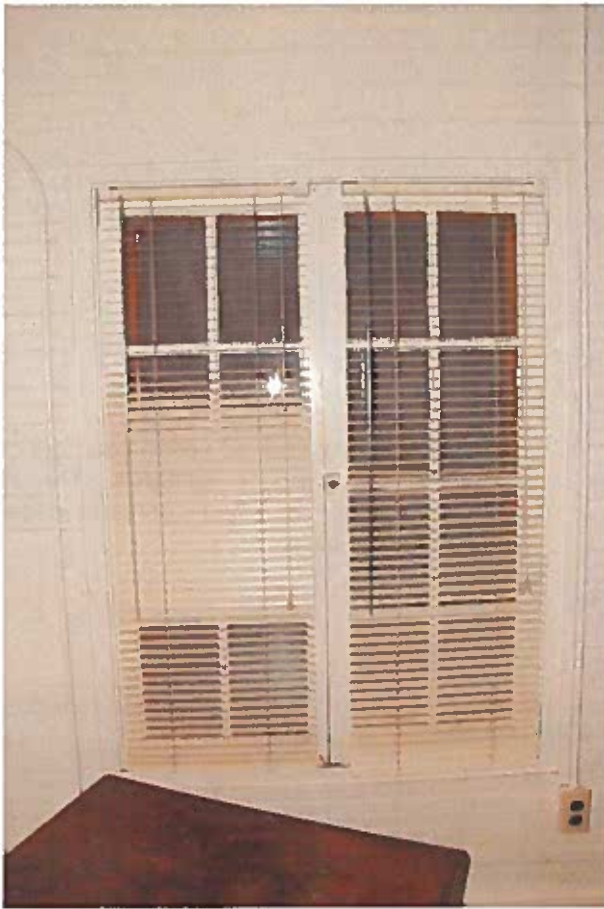
Figure 61: Generally the windows are in fair to good condition on the inside. They will have to be evaluated totally in the future.

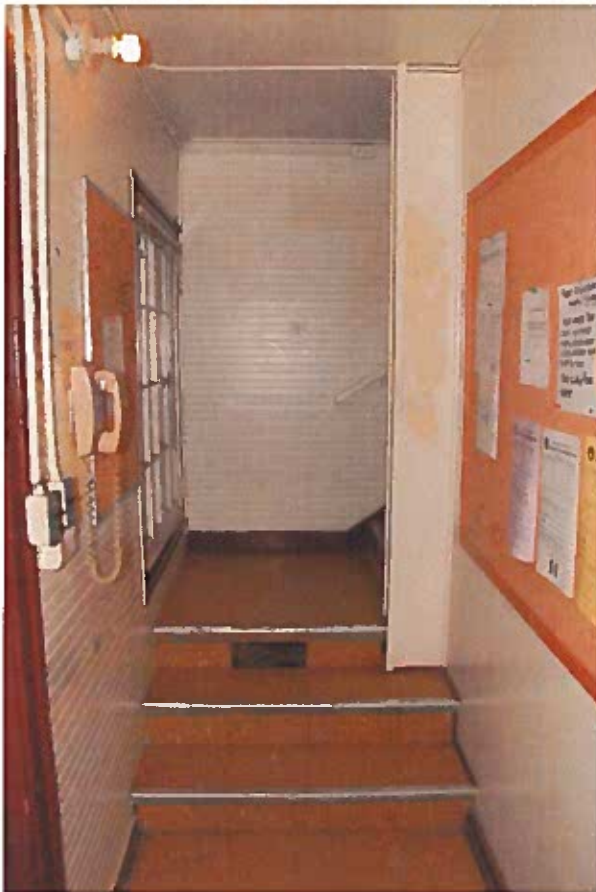
Figure 64: The stairway to the upper floor does not have proper railings.

**Figure 64:** The stairway to the upper floor does not have proper railings.

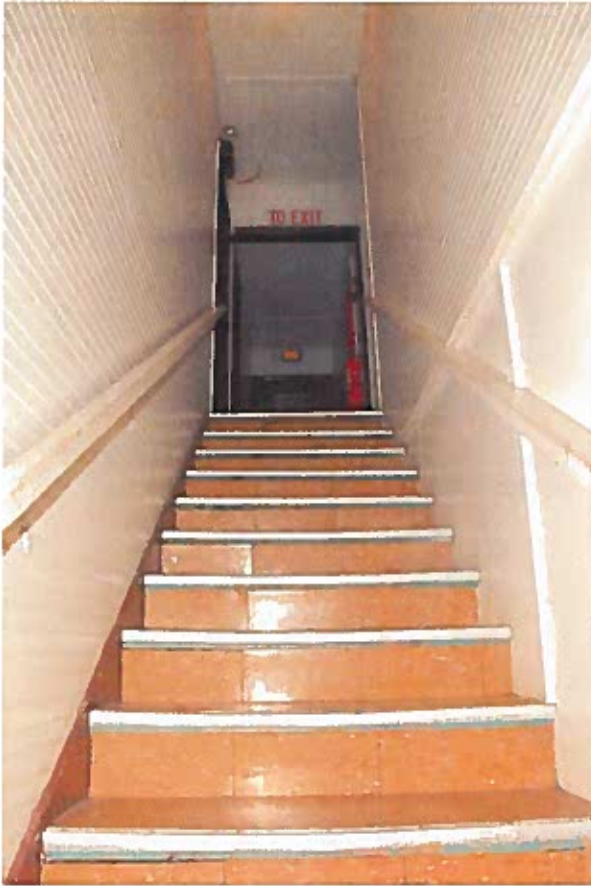
Figure 66: The stair is steep and the railings and lighting are poor.

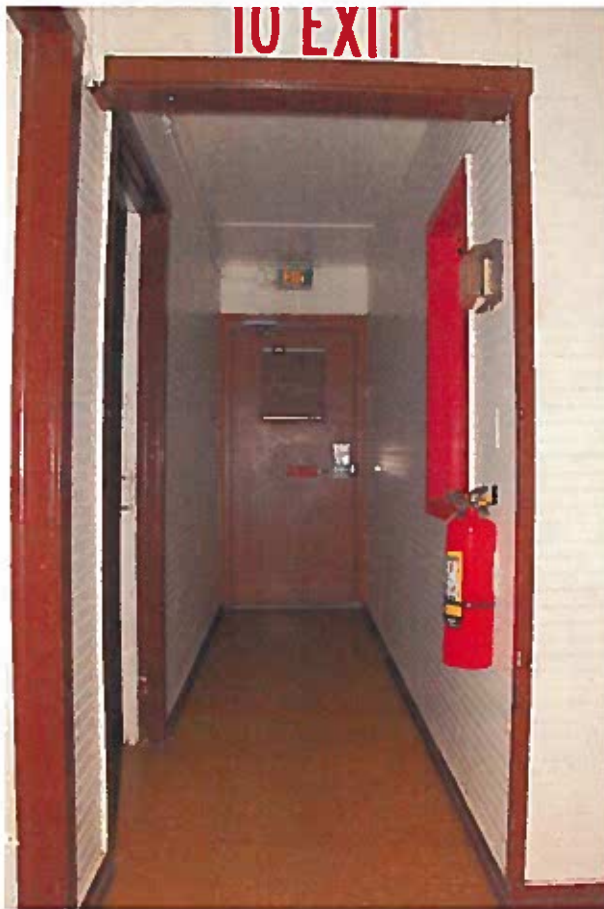
Figure 68: Note the second exit from the second floor. However the entrance to the stair corridor is too close to the main exit stair.

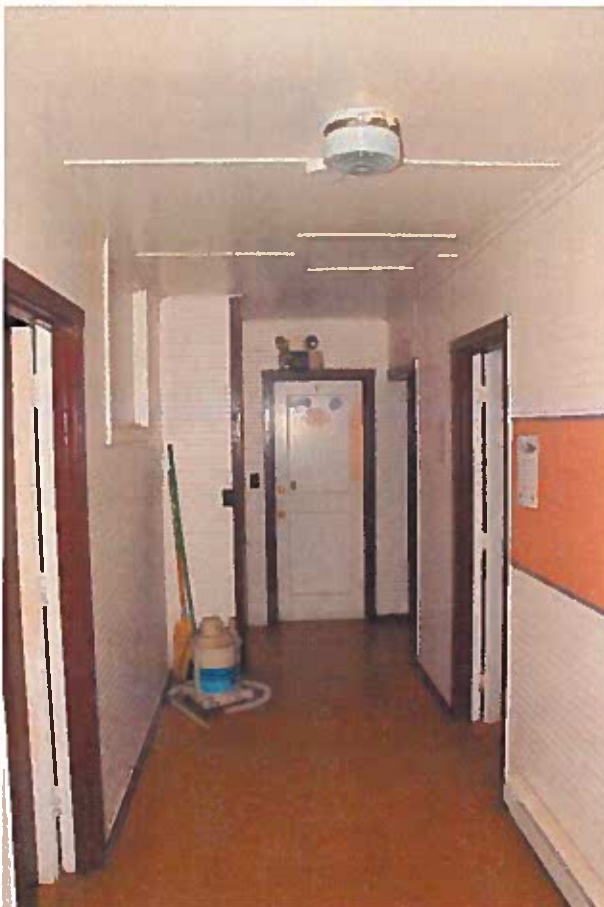
Figure 69: Note the typical hallway with doors to the bedrooms. The sheetrock ceiling is good.

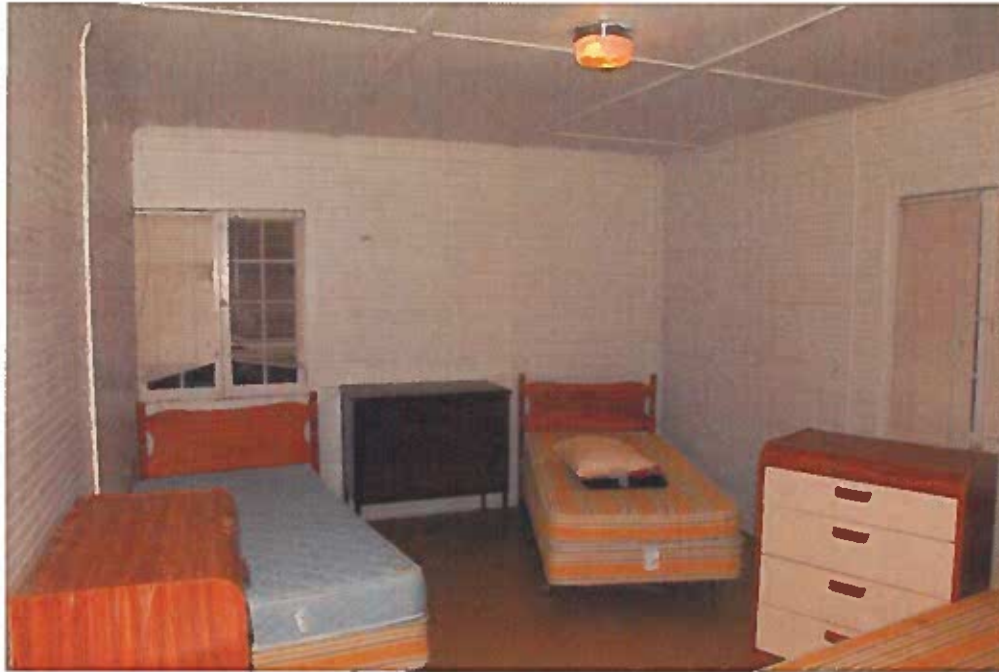
Figure 70: The painted wood bead board walls are in good condition with some minor wear. The sheetrocked ceiling has wood battens covering the joints. The windows are generally in good condition from the inside.

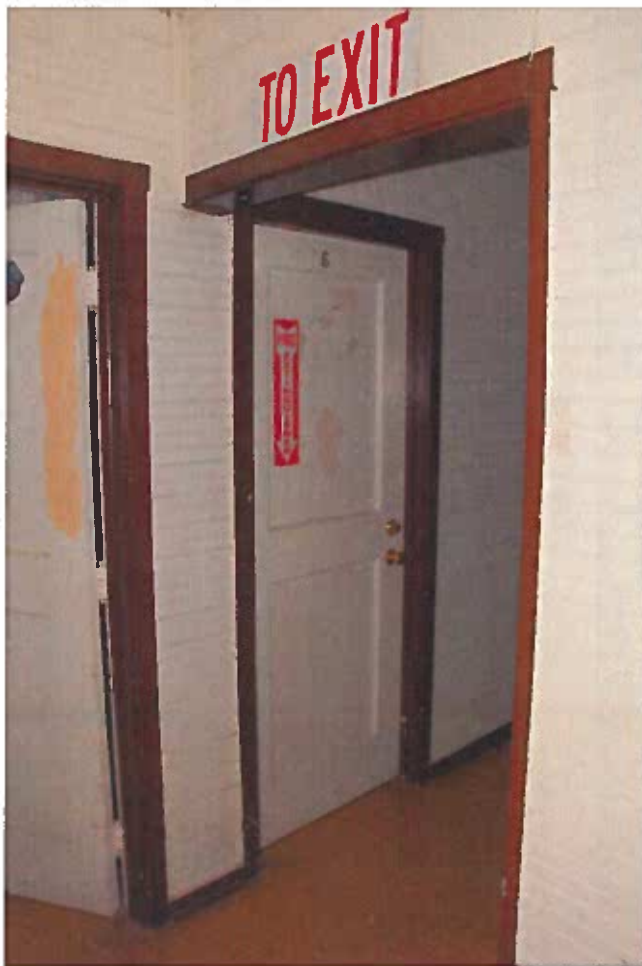
Figure 74: Typical wood paneled doors with a half lite. This door does not meet code in the fire corridor without a fire suppression system.

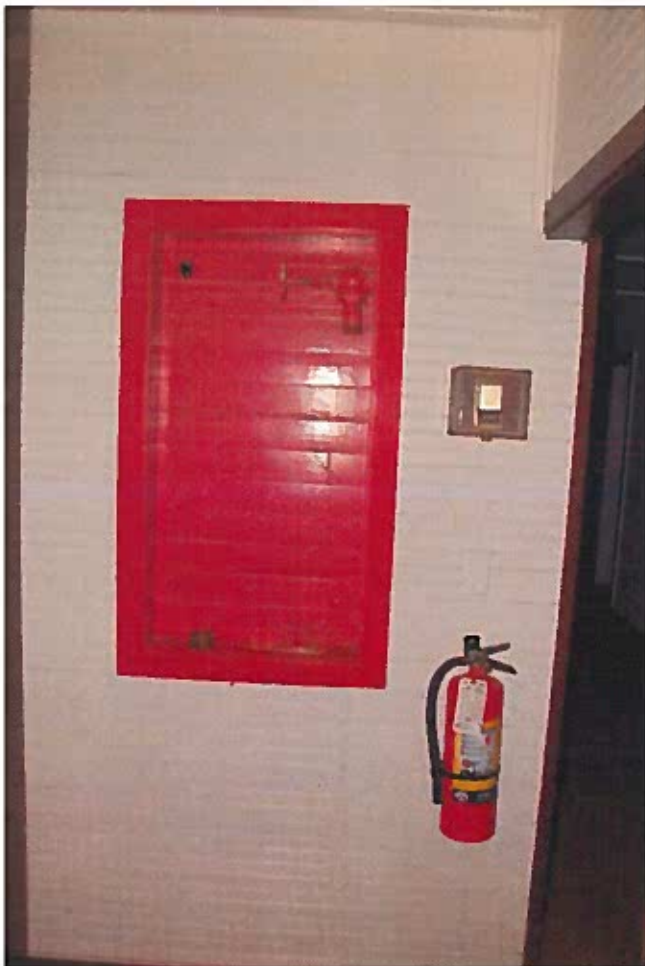
Figure 77: Fire hose cabinet and fire extinguisher.

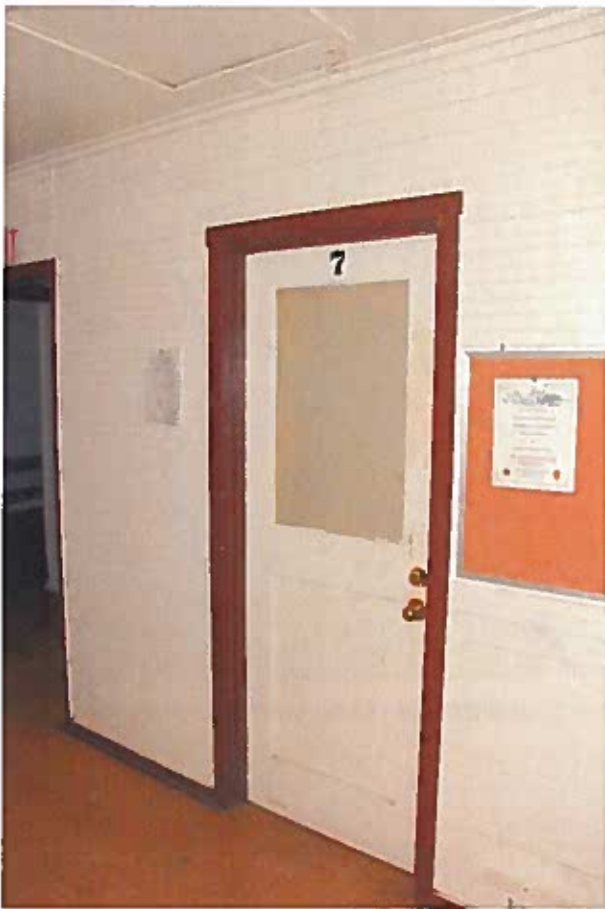
Figure 78: Typical wood paneled door with half-glass lite covered over from the room side.

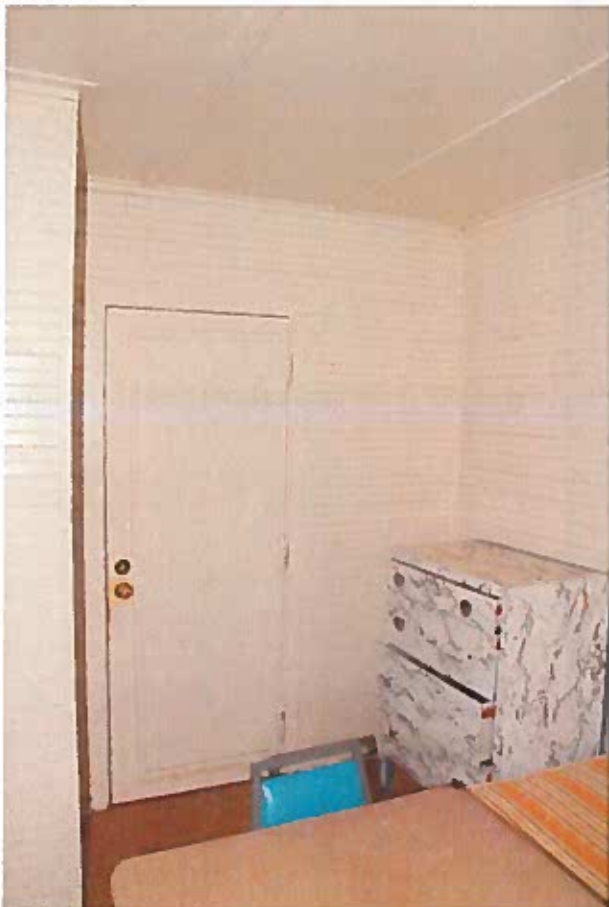
Figure 79: Typical wall, ceiling, and floor materials.

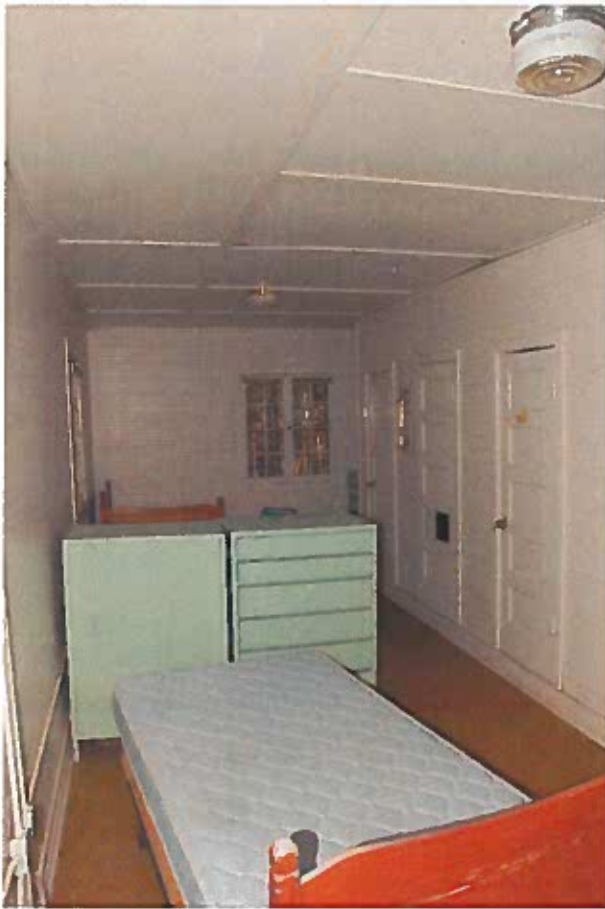
Figure 80: This room sees a lot more wear because of the number of tenants in the space.

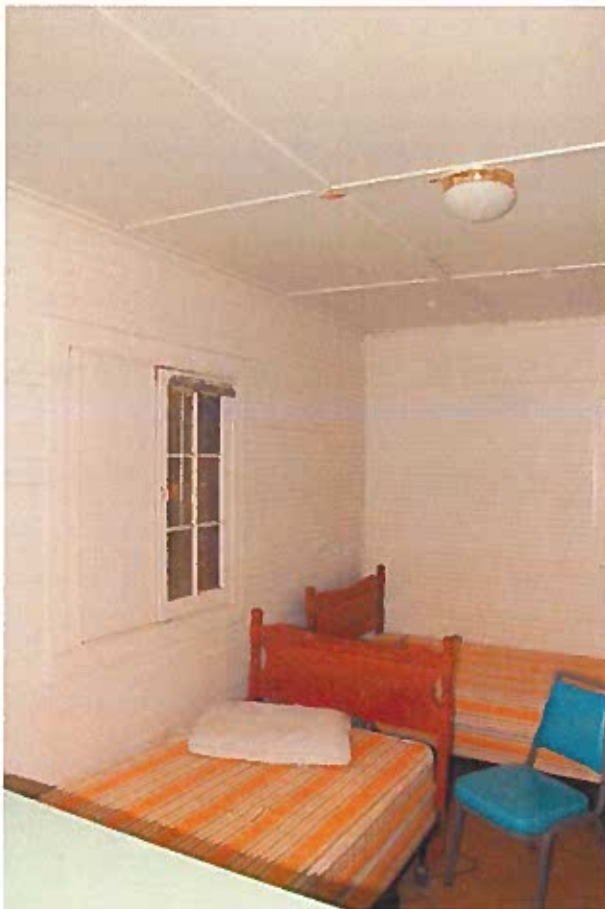
Figure 81: Typical materials.

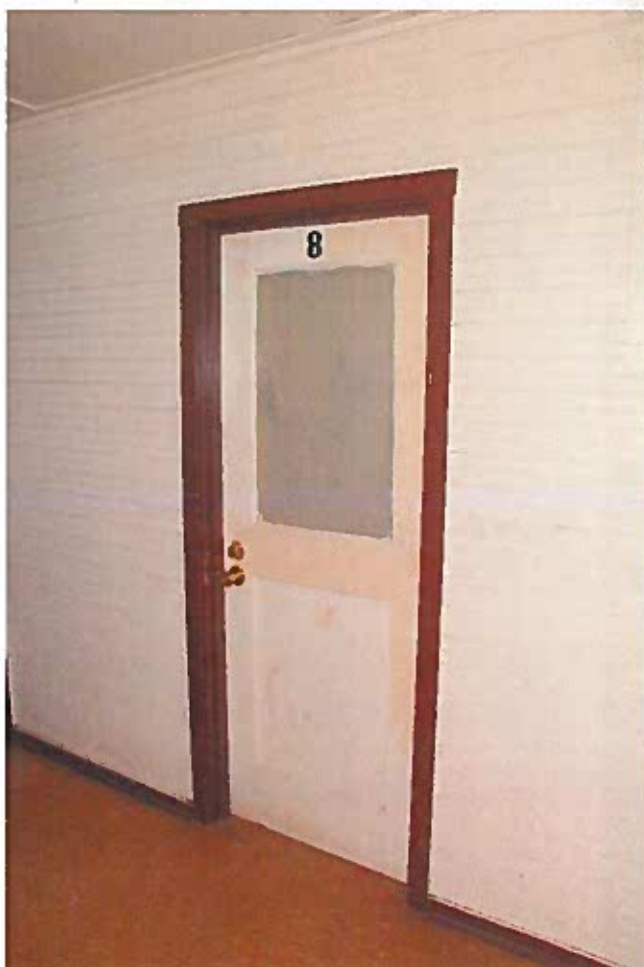
Figure 83: Another typical door that has seen some wear.

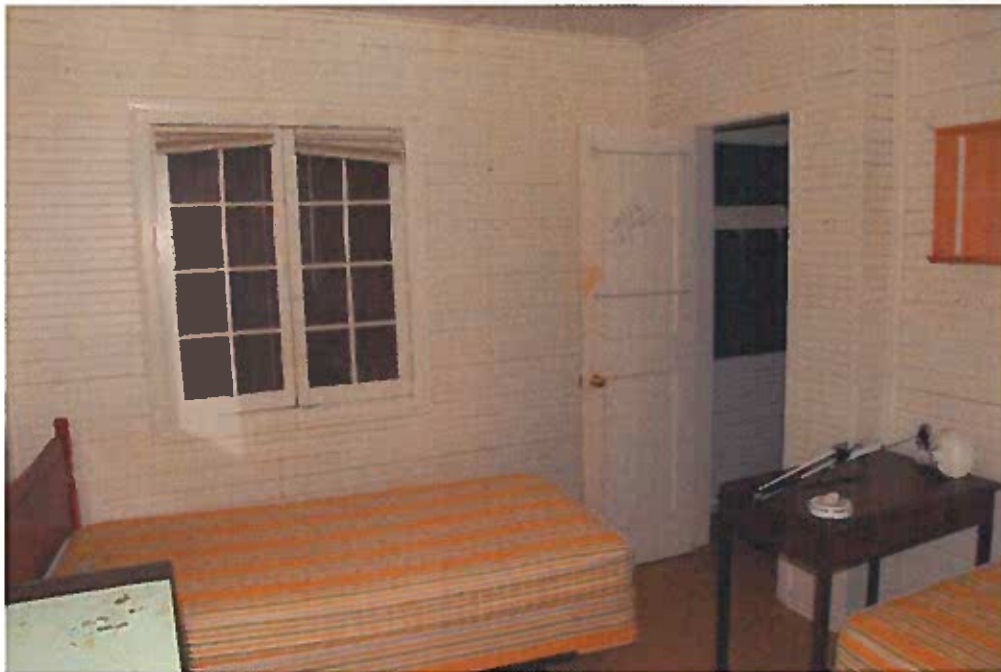
Figure 84: Typical room with the double wood hinged windows.
