# FISHING BRIDGE MEN'S DORMITORY Yellowstone National Park

June, 2012

Historic Structure Report

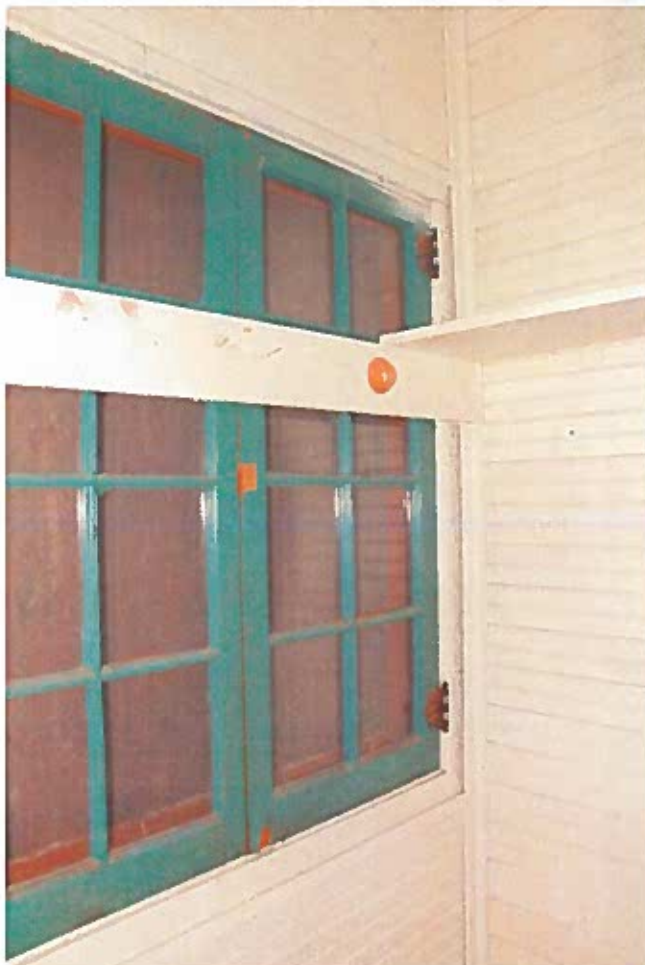
Figure 85: An original window that is located in a closet. It appears to have the original green paint. The wood bead board had a light varnish or stain, which was then painted white at a later date.

24. The existing finishes in the rooms should be repaired and maintained and a color applied to the beaded board walls and ceiling that is closer to the original stain. The window color should match the original green paint.

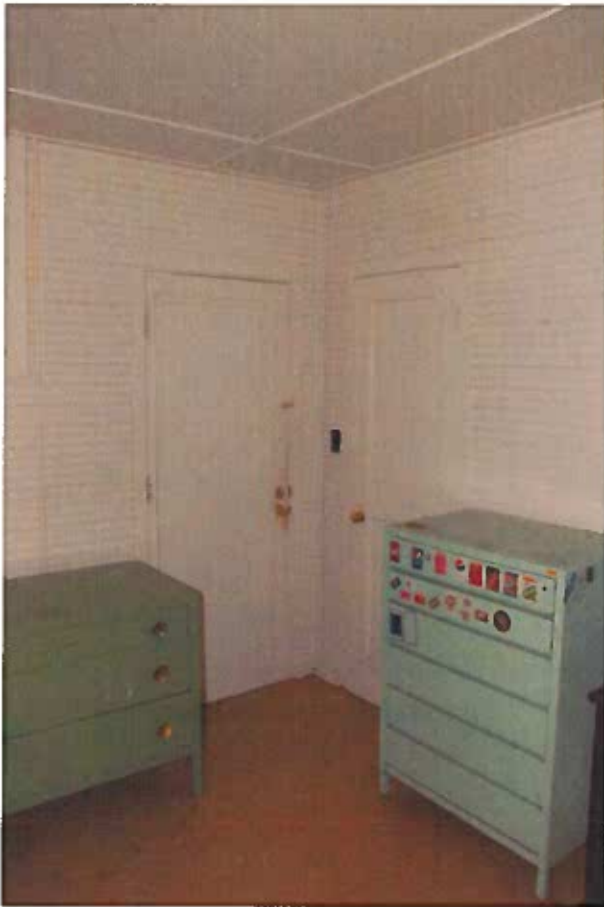
Figure 86: The materials are generally in good condition.

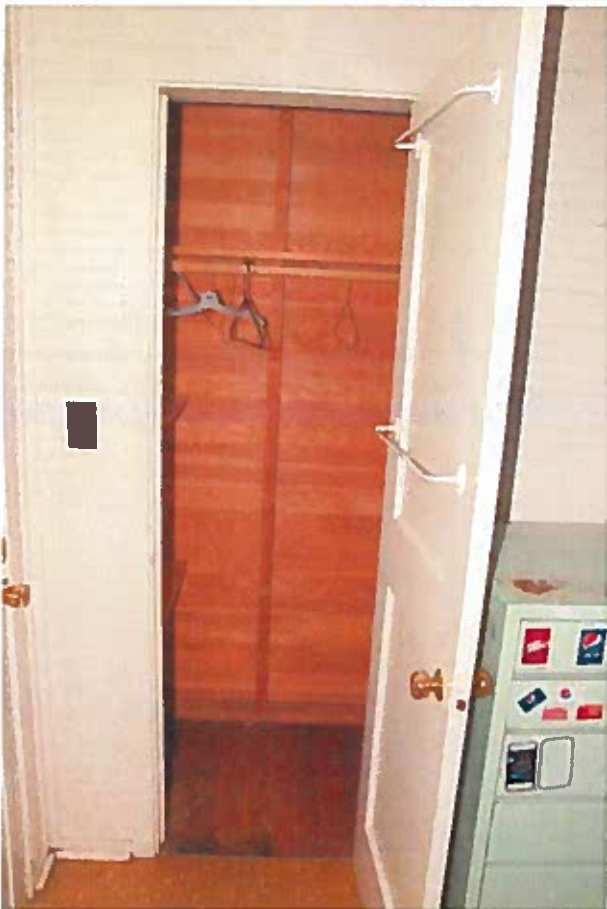
Figure 87: The unfinished wood that occurs in the closets.

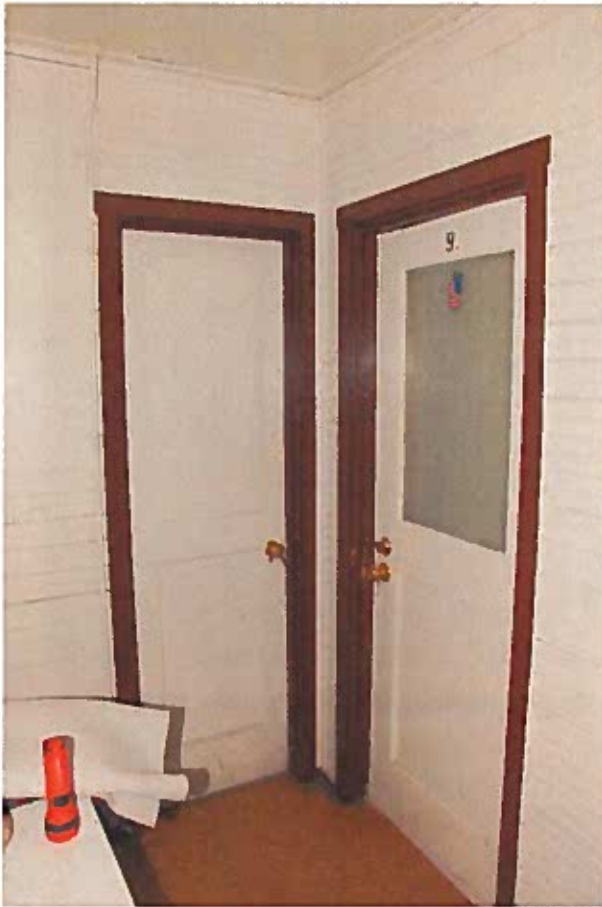
Figure 88: A typical narrow door to the bathroom on the second floor.

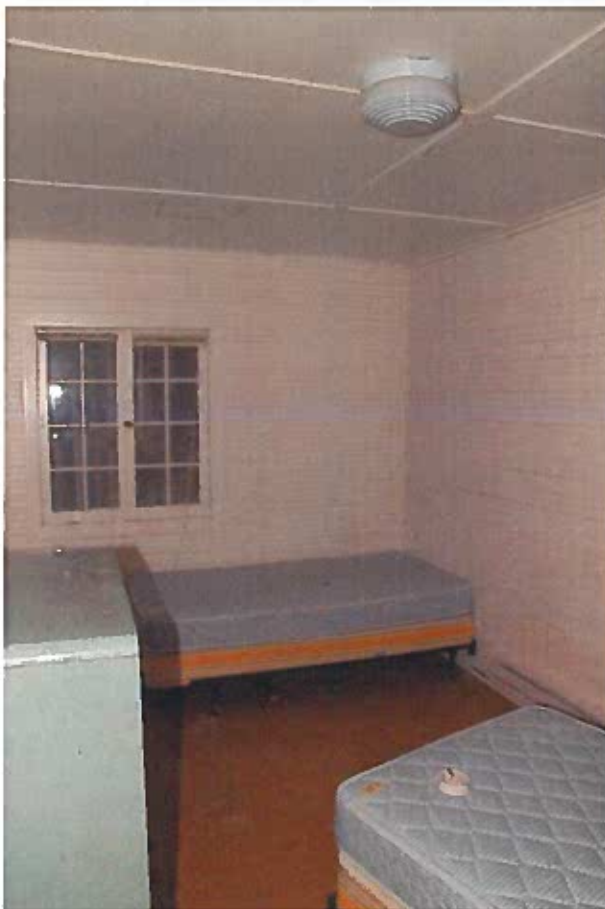
Figure 89: Typical dorm room and original materials with the exception of the sheet vinyl floor.

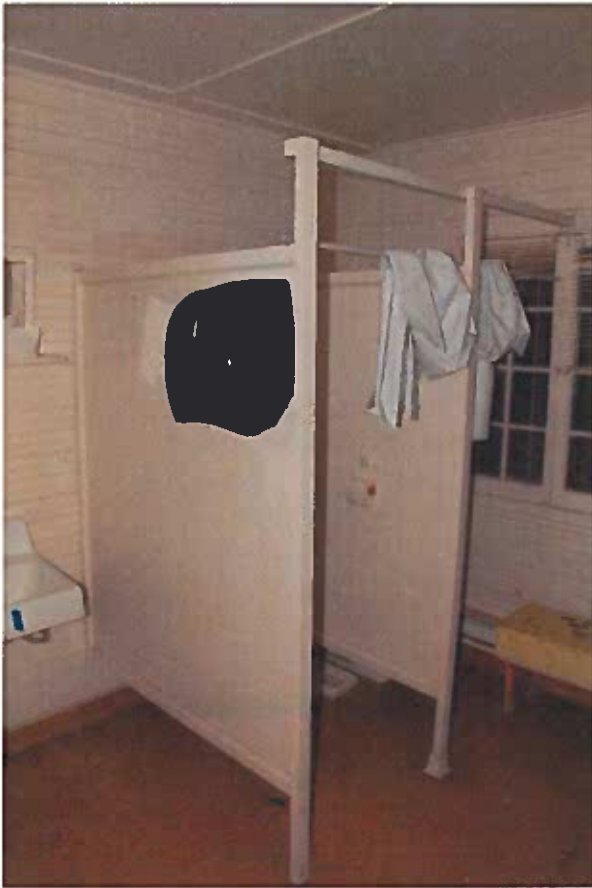
Figure 92: The partitions are in poor condition.

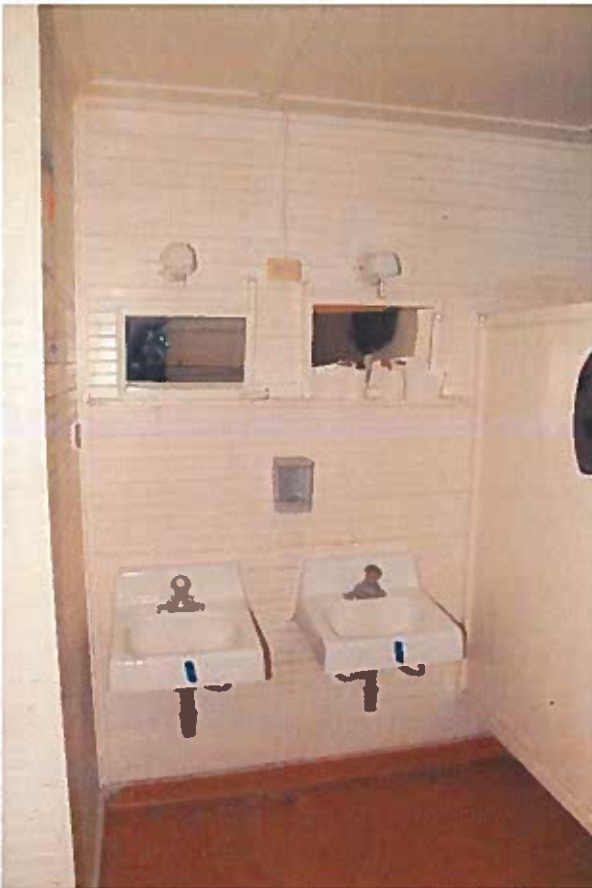
Figure 93: Typical wall hung lavatories.

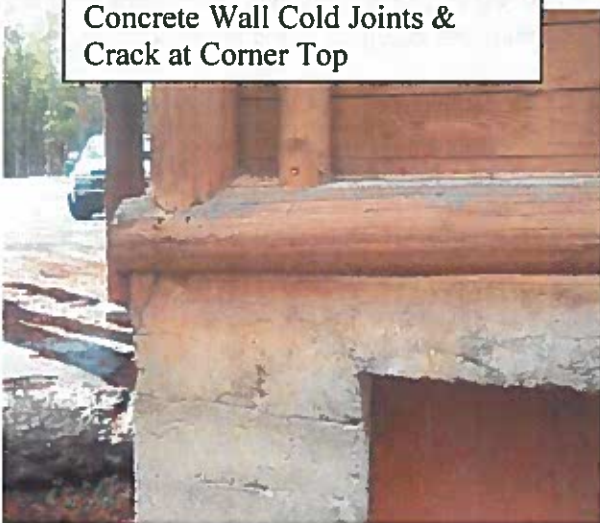
The concrete foundation is in good condition. There are consistent cold joint pour lines in the concrete walls, but these joints lines were original to the construction and have not affected the structural integrity of the wall. We note some minor wall cracks, not considered pour lines. The concrete walls for the stairs leading to the basement has spalled away.

Concrete Wall Cold Joints & Crack at Corner Top

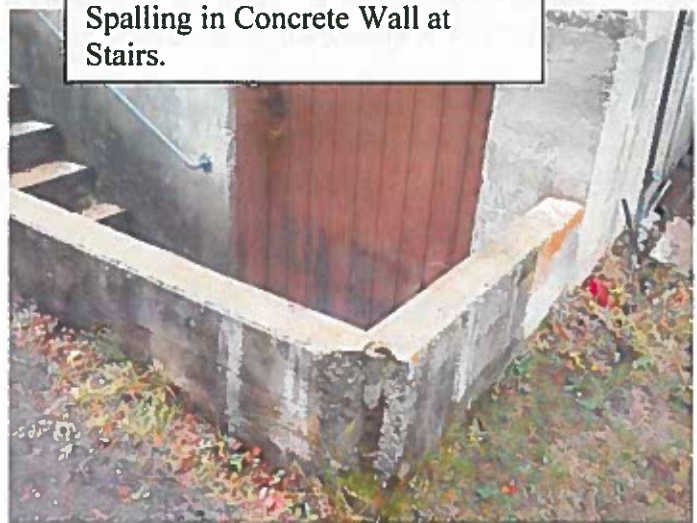
Spalling in Concrete Wall at Stairs.

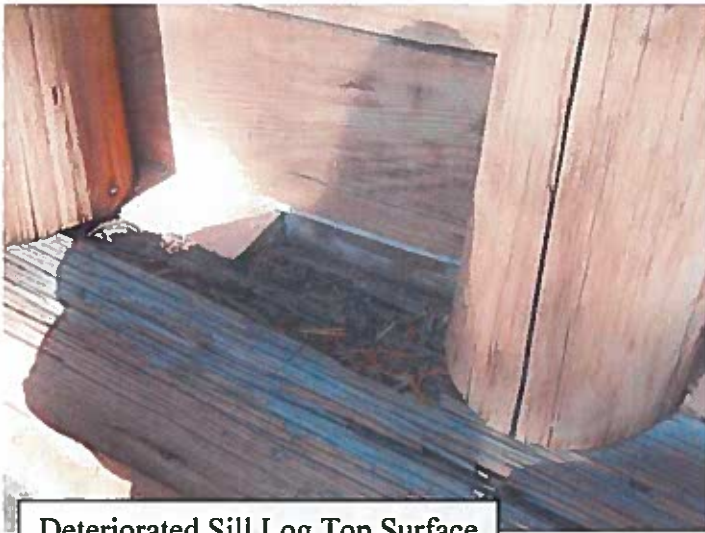
The front porch log plate beam has end grain deterioration at each end. We noted no positive connection of the south portion roof to the wall. We also noted isolated sill log deterioration at several locations along the base of the walls. A

probe test found the west side sill log consistently soft, while the east side was sound. Typically the log verticals are sound and only required cleaning, re-stained and sealed.

Deteriorated Sill Log Top Surface

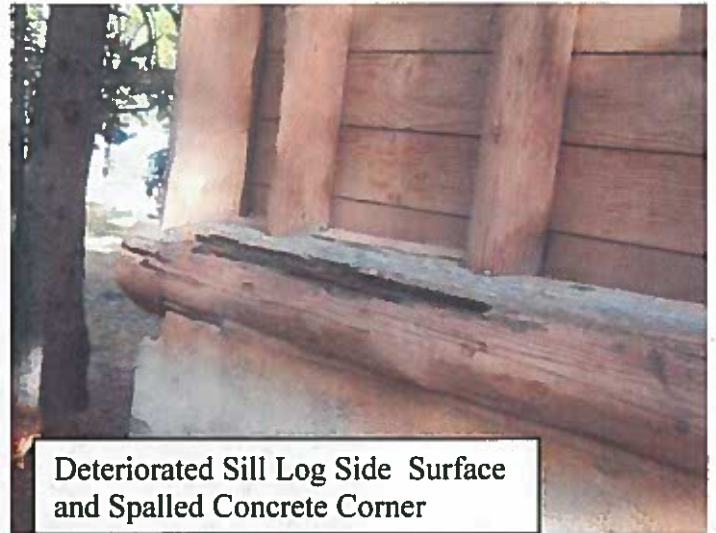
Deteriorated Sill Log Side Surface and Spalled Concrete Corner

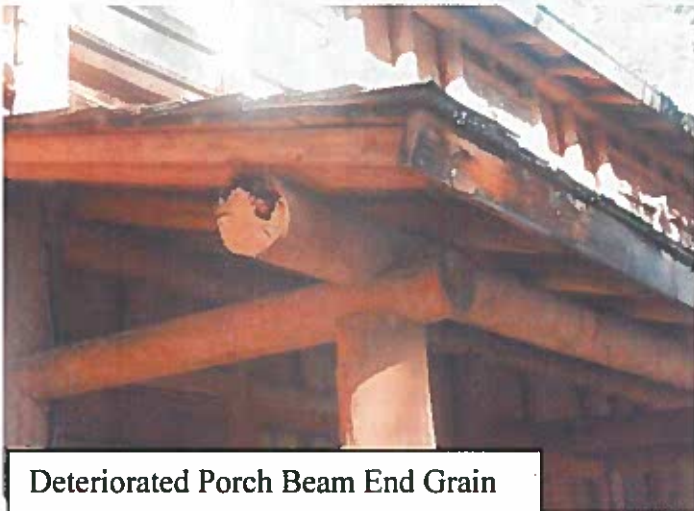
Deteriorated Porch Beam End Grain

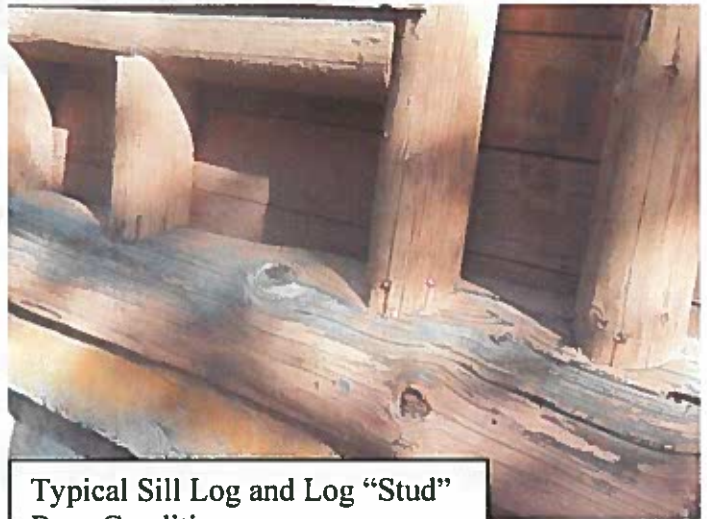
Typical Sill Log and Log "Stud" Base Condition

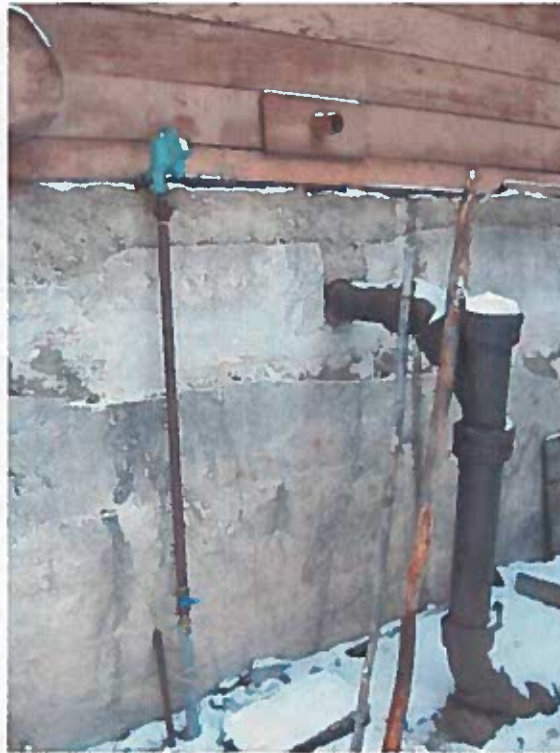
A mixture of galvanized, copper, pvc, and hub and spigot cast iron piping is routed throughout the facility serving the domestic hot and cold water, as well as, the sanitary sewer waste and vents systems for the facility. The sanitary sewer exits the facility above grade, causing potential freezing conditions.

**Sanitary Sewer Exiting Building**

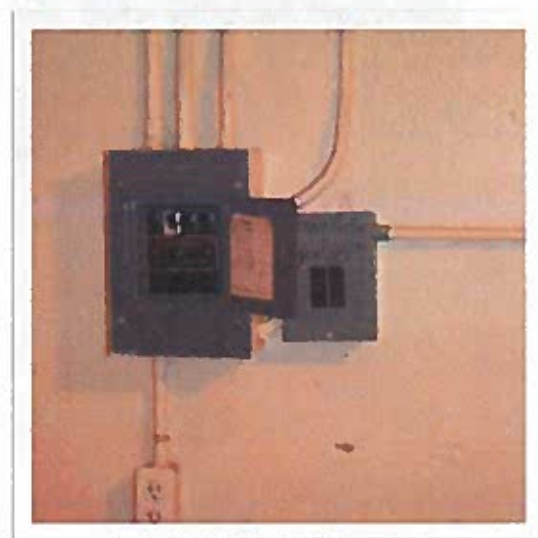
**Load Centers in Basement**

The exterior-mounted electrical panel is of fairly recent vintage and should serve the facility well for years to come. The older load centers inside the facility however are very old, located awkwardly and should be replaced. Our limited inspection uncovered several inadequacies in the electrical wiring:

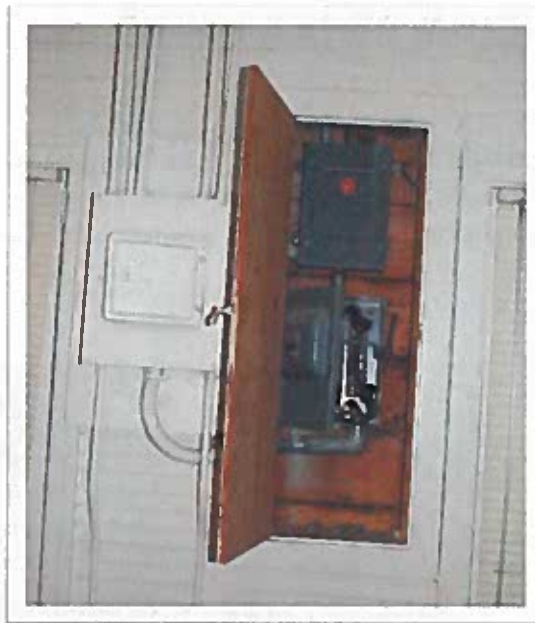
**Load Centers on Main Level**

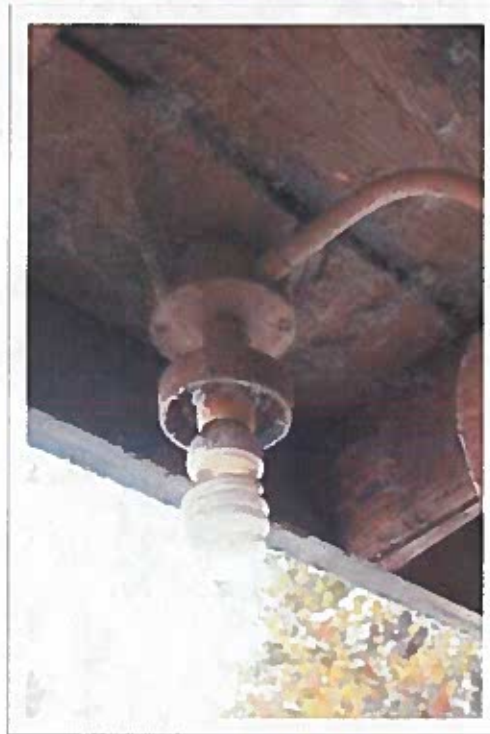
Lighting is primarily incandescent fixtures or simple incandescent lampholders. Some lamps have been replaced with screw-base compact fluorescent lamps. Some light fixtures are missing lens or globes.

**Light Fixture with Missing Globe**

- Light fixtures are all incandescent although some have compact fluorescent lamps. Incandescent fixtures are very simple devices and most of the interior fixtures are likely in good enough condition to be re-used. Exterior fixtures, however, are in many cases inadequate for exterior use as they are almost certainly not listed for wet locations or are missing globes or lens that would provide protection from the elements. See picture shown previously in report.

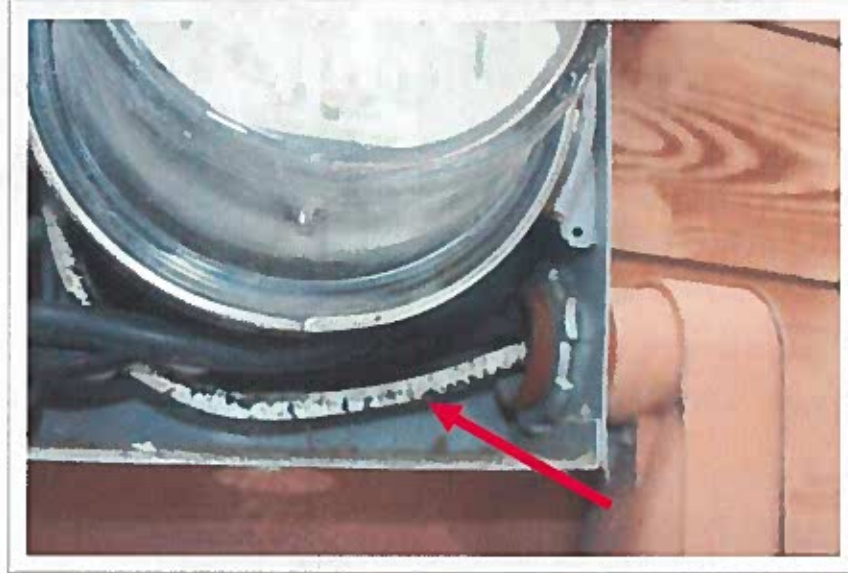
- The service conductors between the utility transformer and the meter base are significantly undersized and old. In fact they appear to be an older version of romex. In the short time we were conducting the inspection the metal service conduit (which is actually a pipe, not a conduit) grew noticeably warm to the touch from the overheating of the conductors. These conductors are likely rated for no more than 30-amps yet they feed a 200-amp distribution panel.

**Undersized Service Conductors**

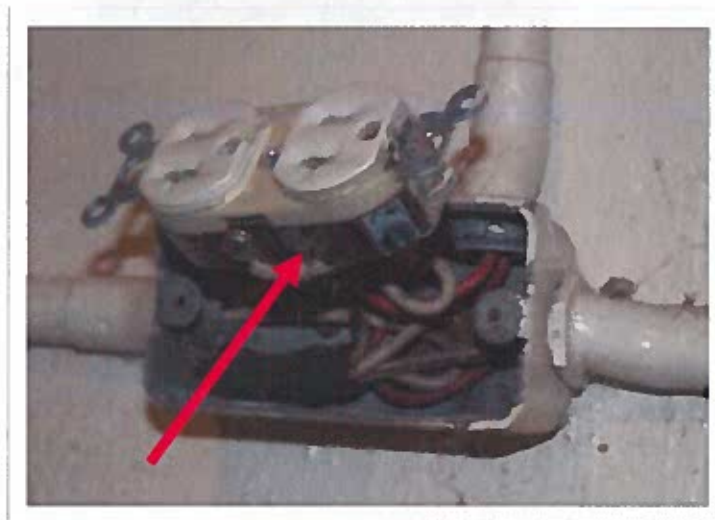
- Wiring does not include a separate equipment grounding conductor. Therefore all devices and boxes are only grounded through the EMT conduit and device straps.

**Receptacle - Arrow points to grounding terminal with no ground wire connected**
