# **HISTORIC STRUCTURE REPORT**

## **HAYNES AUTO CAMP PICTURE SHOP Old Faithful Yellowstone National Park**

**Department of the Interior  
National Park Service  
Yellowstone National Park**

Prepared by Sievert & Sievert Cultural Resource Consultants  
Great Falls & Bozeman, Montana  
January 4, 2007

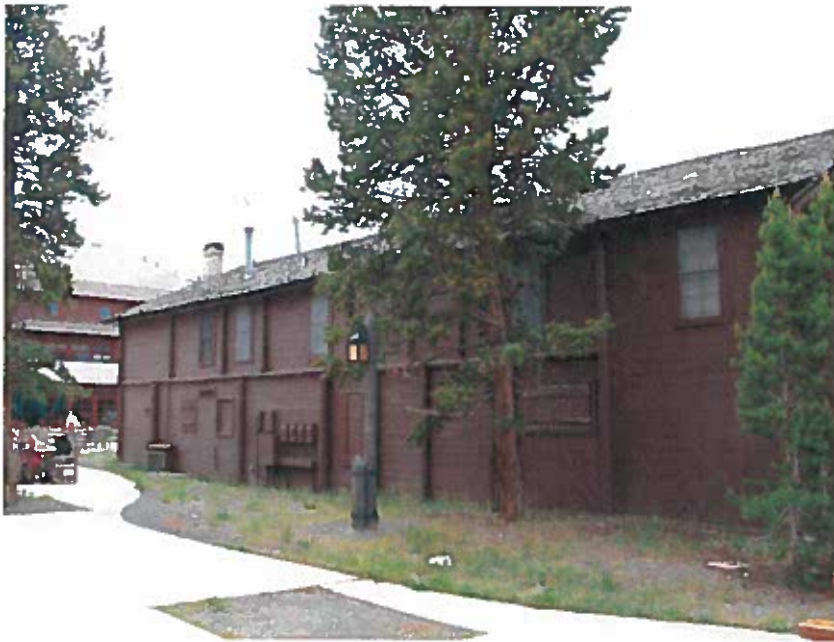
**EAST ELEVATION OF  
HAYNES AUTO CAMP  
PICTURE STORE**

Portion of Snow Lodge can be seen at the left side of the photo of the South end. Note that drainage could be improved around the South end of the Dormitory Wing (left end).

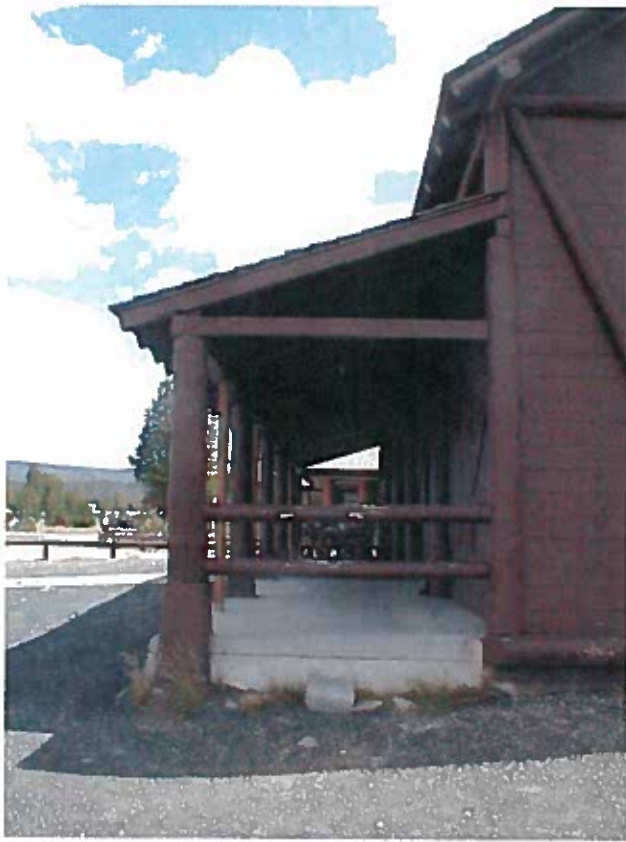
WEST END OF FRONT PORCH

#### DETAIL - FRONT PORCH

Note intermediate temporary supports between original porch columns for snow load. The supporting beams could be strengthened to eliminate the need for the temporary supports.

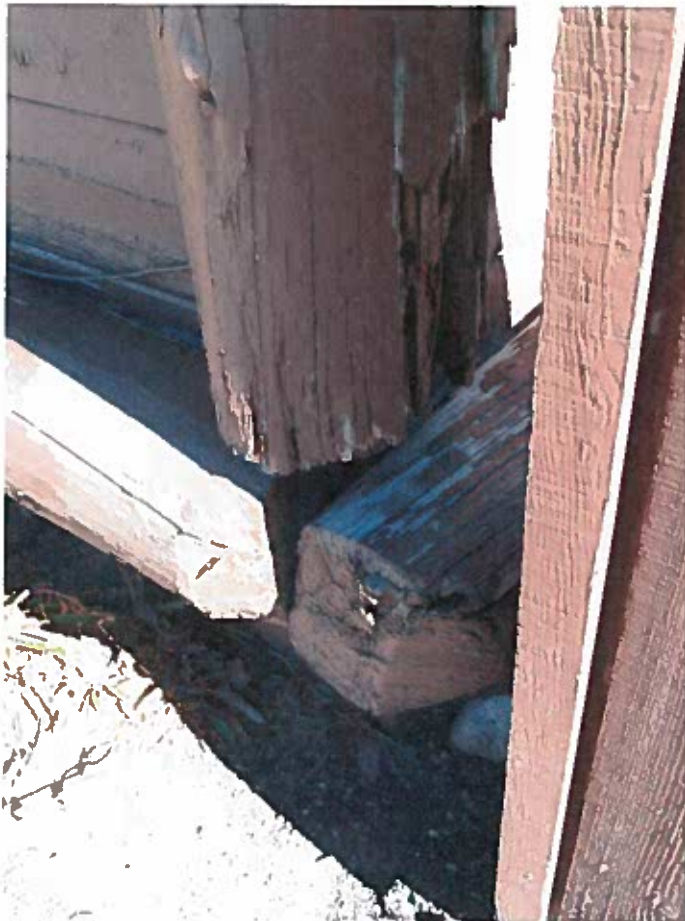
**SAME INTERSECTION - VIEW FROM EAST**

Note deteriorated log members that need to be replaced.

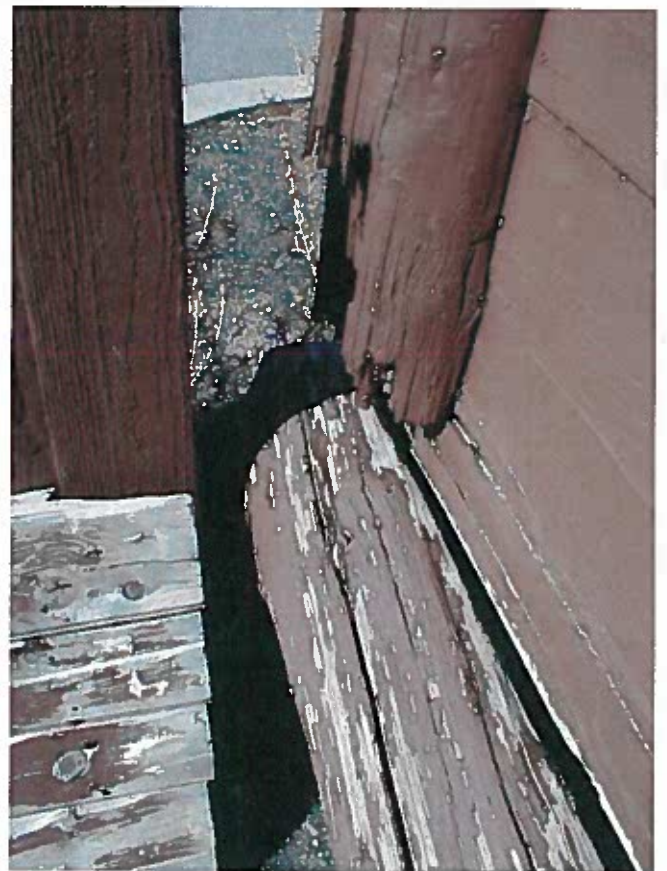
INTERSECTION - APPLIED LOG SILLS  
AND COLUMN

NE corner of Retail Wing of building.

EXAMPLE OF APPLIED COLUMN  
TO BE REPLACED WITH NEW  
LOWER SECTION.

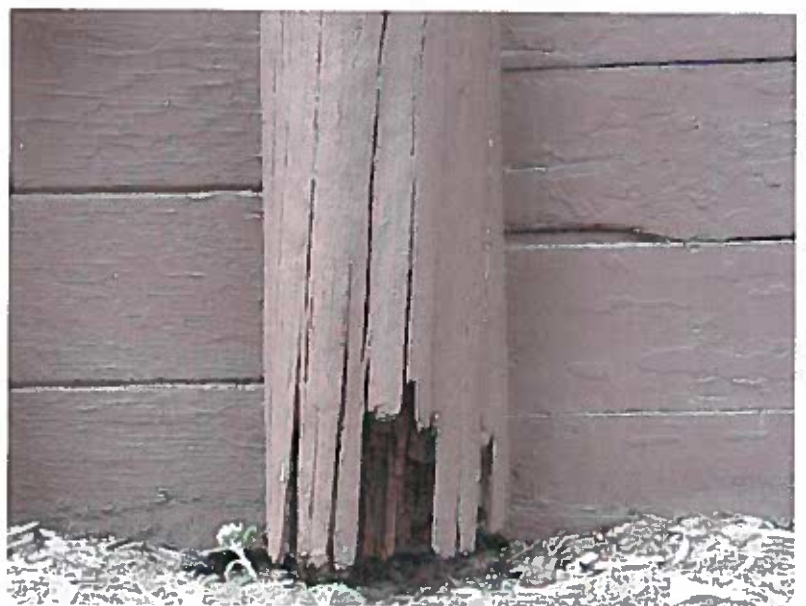
**NEGATIVE DRAINAGE -  
SE PORTION OF  
STRUCTURE**

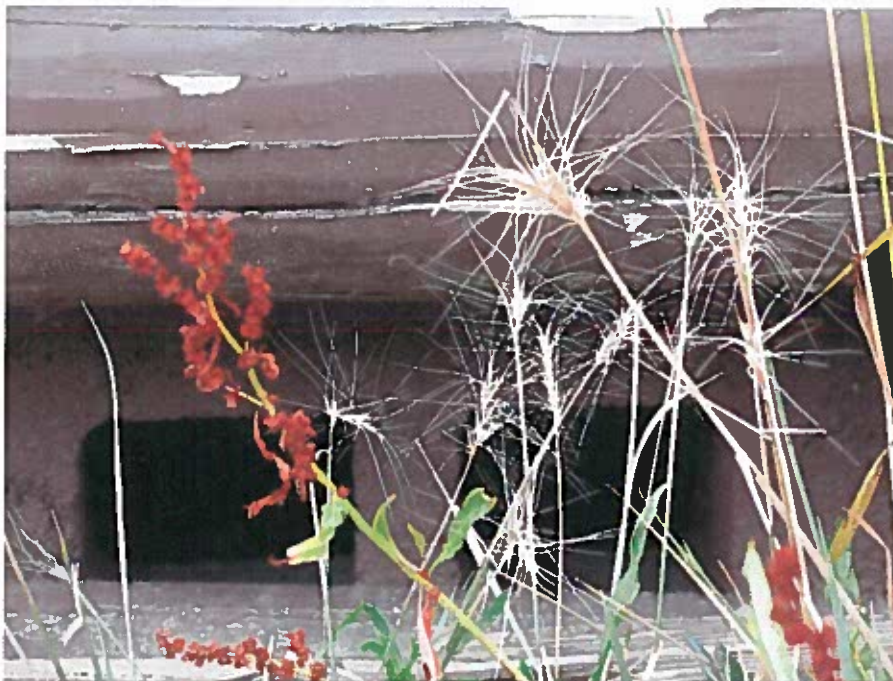
**UNKNOWN FEATURE -  
THIS MAY BE FOR CRAWL  
SPACE VENTILATION**

Located along East wall of  
foundation.

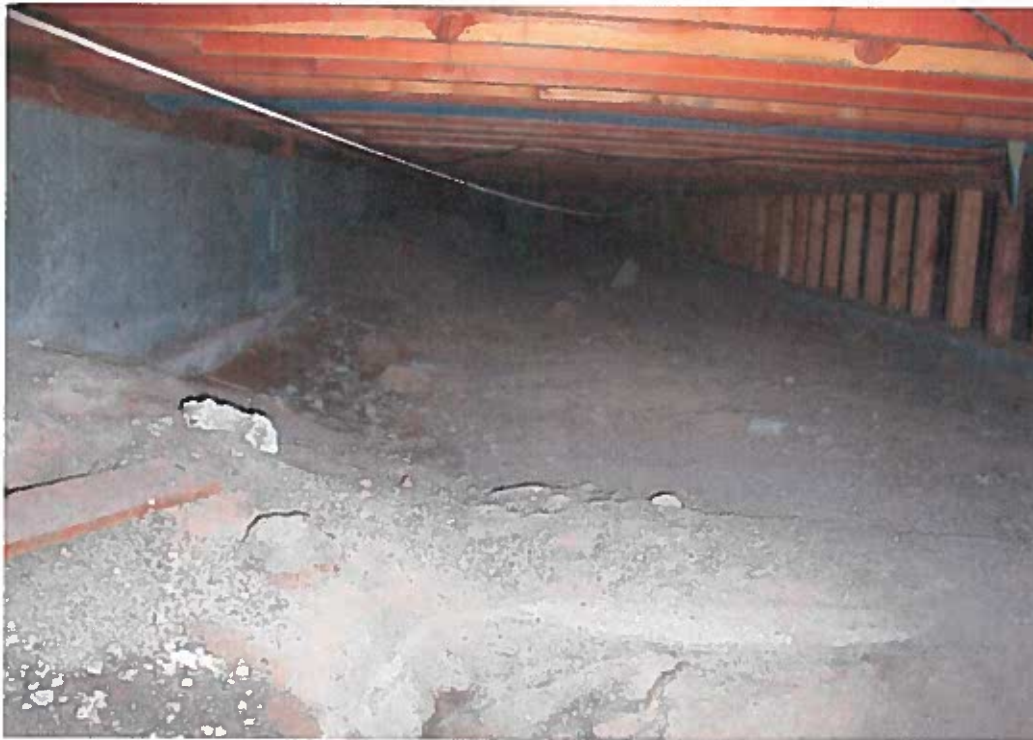
CRAWL SPACE BENEATH RETAIL WING SHOWING NEW REINFORCED CONC FOUNDATION

CMU could be removed in this area of foundation if required. Note the good condition of the existing floor joists as well as the new wood framed cripple wall in the upper photograph. These CMU blockouts are thought to have been used as pockets for girders during the moving process for the building.

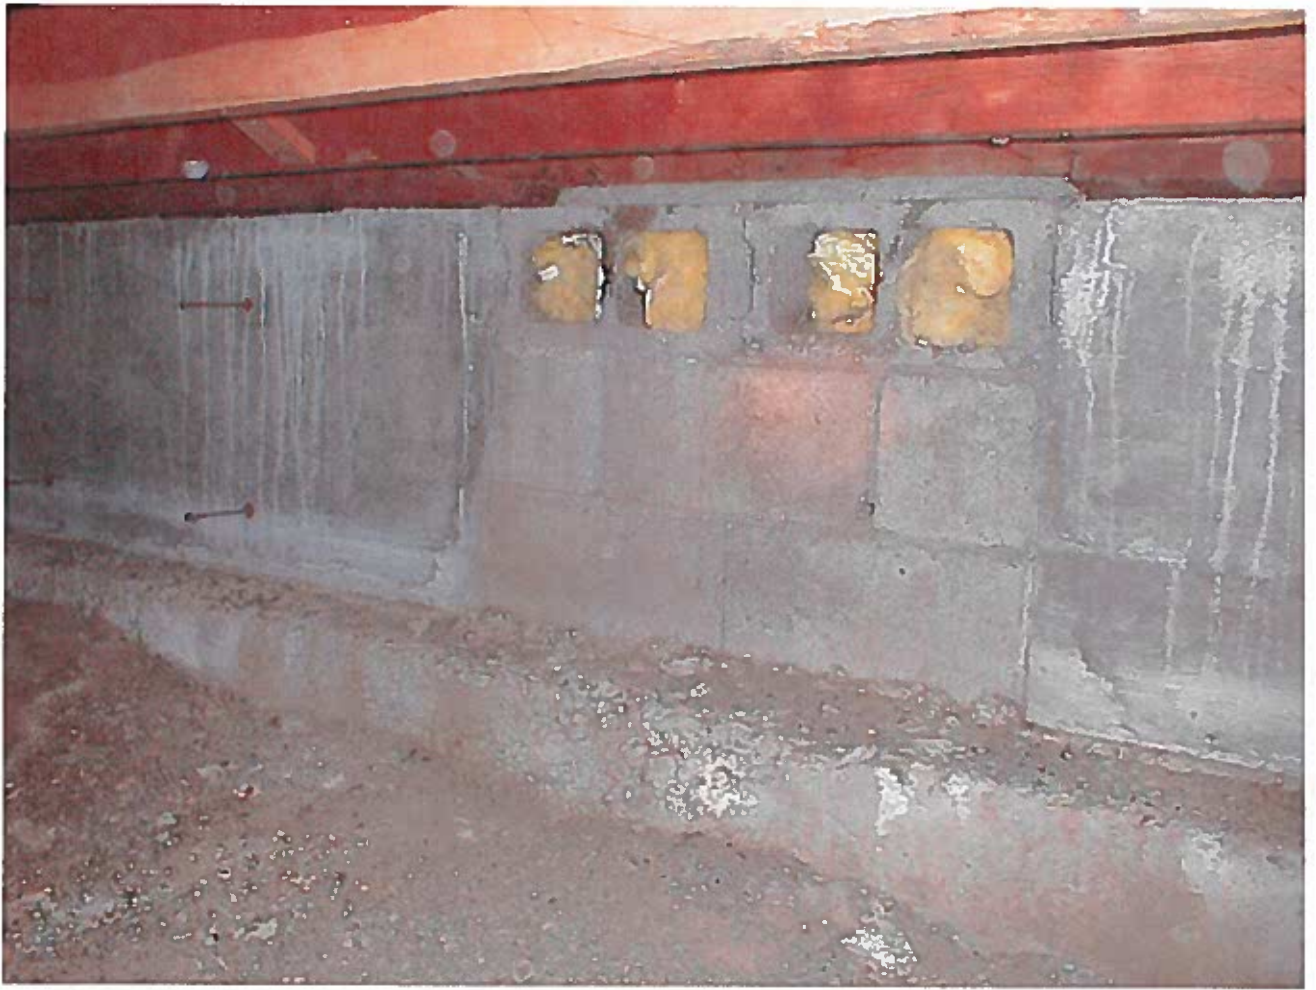
#### **CRAWL SPACE – TYPICAL OF BOTH RETAIL & DORMITORY WINGS**

Detail of Crawl Space ventilation (currently filled with insulation); the blockouts for the floor girders used during the moving process has been utilized as a way to ventilate the crawl space.

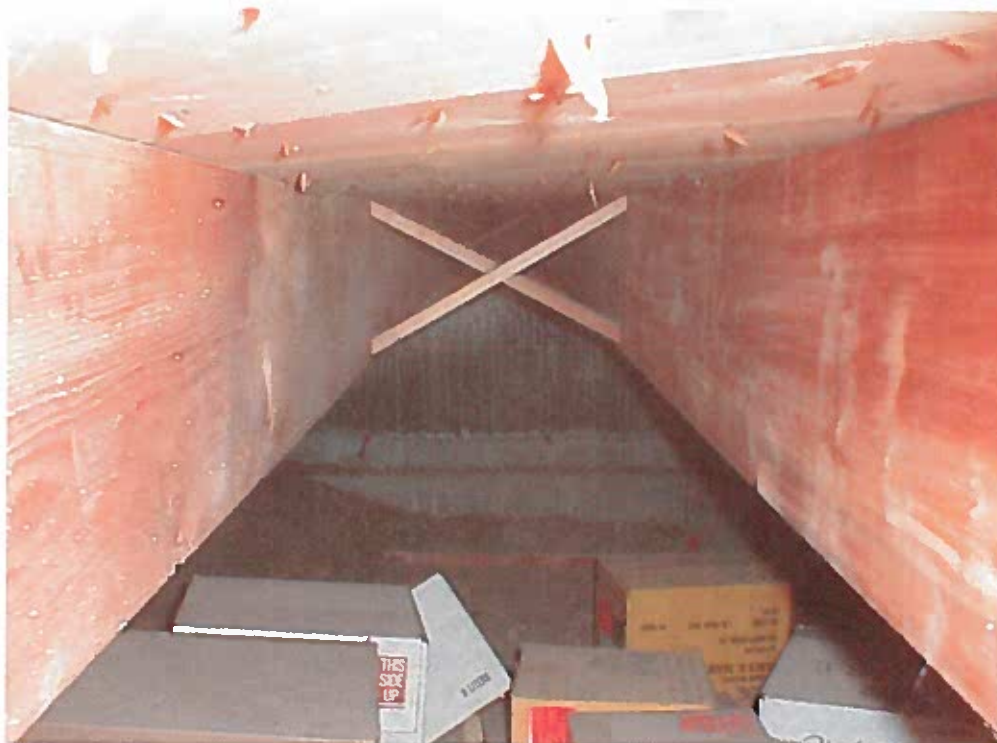
NEW FLOOR  
SYSTEM  
BENEATH  
DORMITORY  
WING

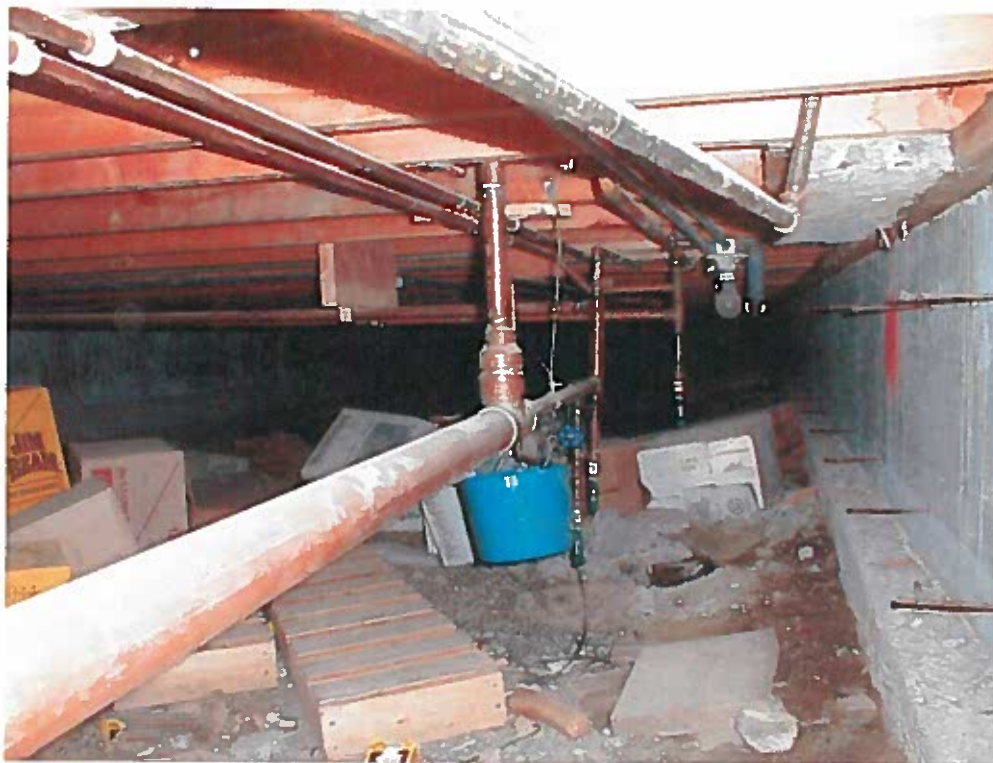
CRAWL SPACE  
BENEATH DORM  
WING

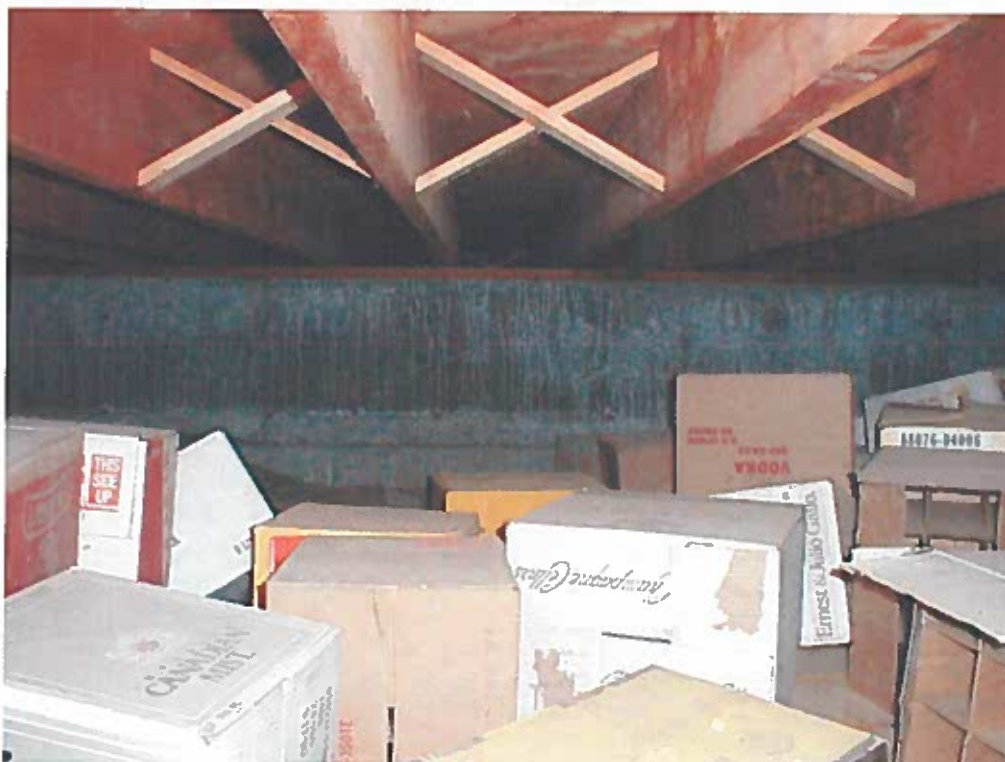
**CRAWL SPACE  
BENEATH  
DORMITORY WING**

New reinforced  
concrete stem wall  
and footing; new  
copper plumbing.

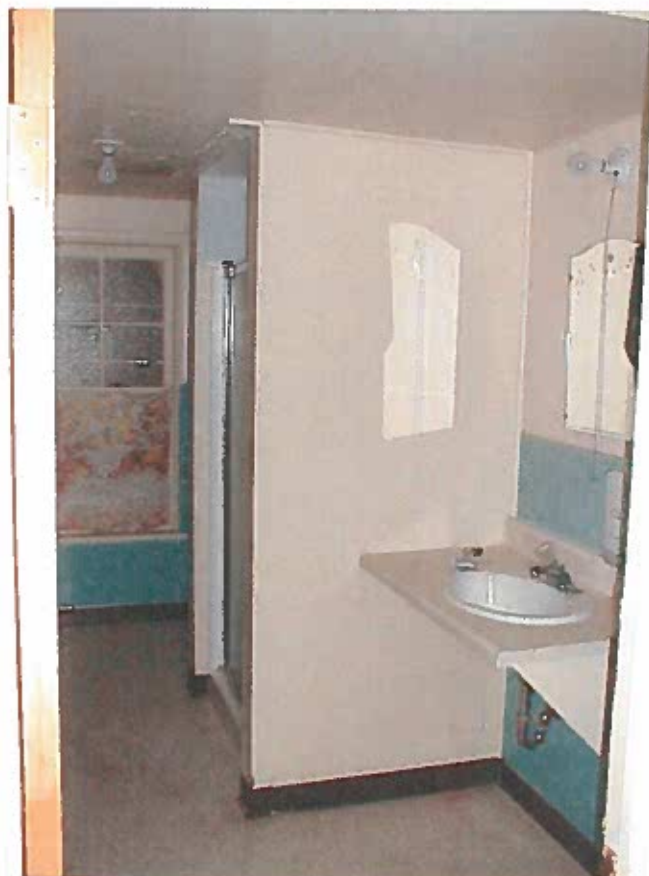
**WOMEN'S ROOM -  
FIRST FLOOR OF  
DORMITORY WING**

### **MEN'S ROOM - FIRST FLOOR**

**Note: None of the bathroom facilities within the building comply with ADA requirements - see commentary in the chapter on accessibility.**

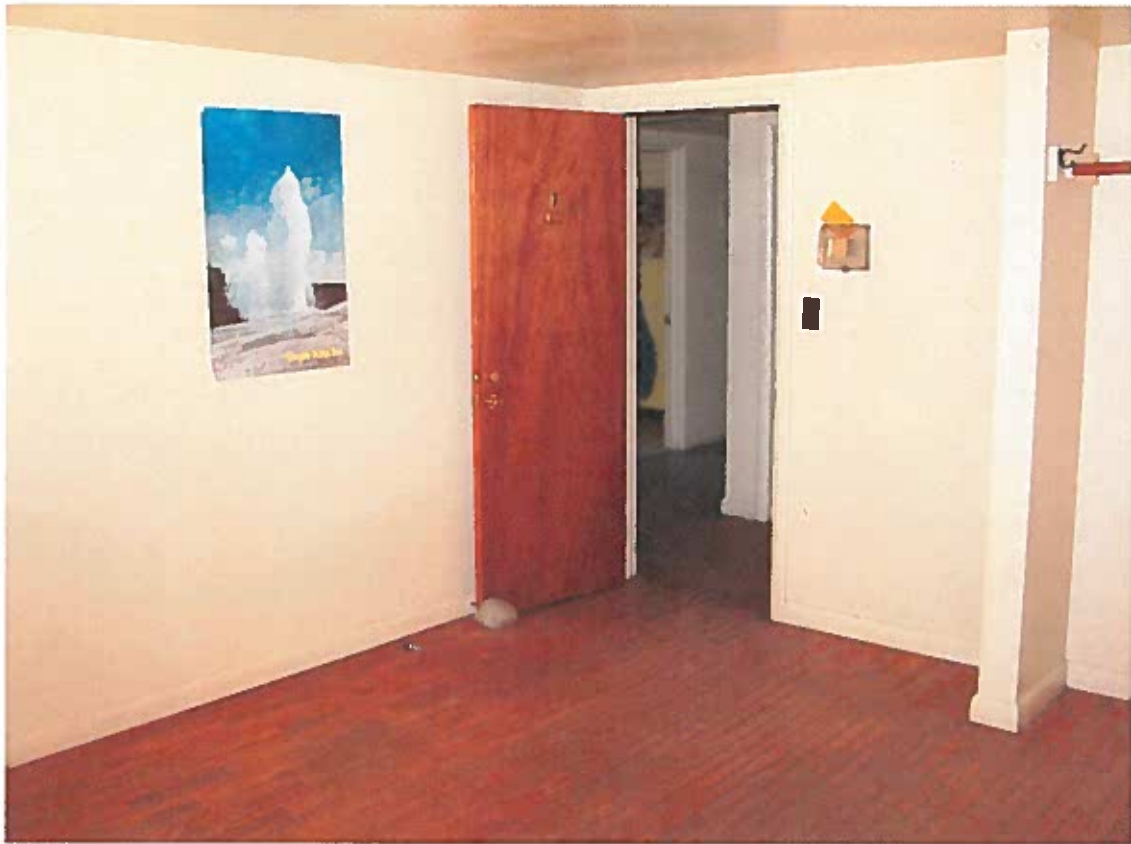
#### **SECOND FLOOR CORRIDOR - DORMITORY WING**

**Note: All walls and ceilings on this level are non-combustible (GPDW) materials and are in good condition; hardwood flooring on this level appears to have been water damaged and will require rehabilitation.**

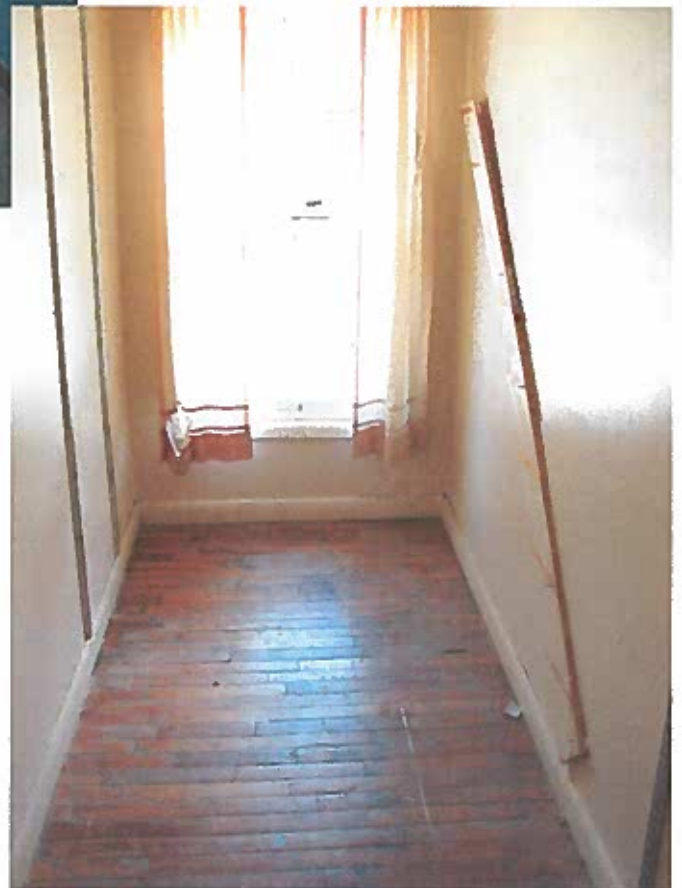
**STORE-ROOM FOR LINENS, BEDDING, AND  
LUGGAGE - 2ND FLOOR OF DORMITORY  
WING**

Note the poor condition of the hardwood  
flooring.

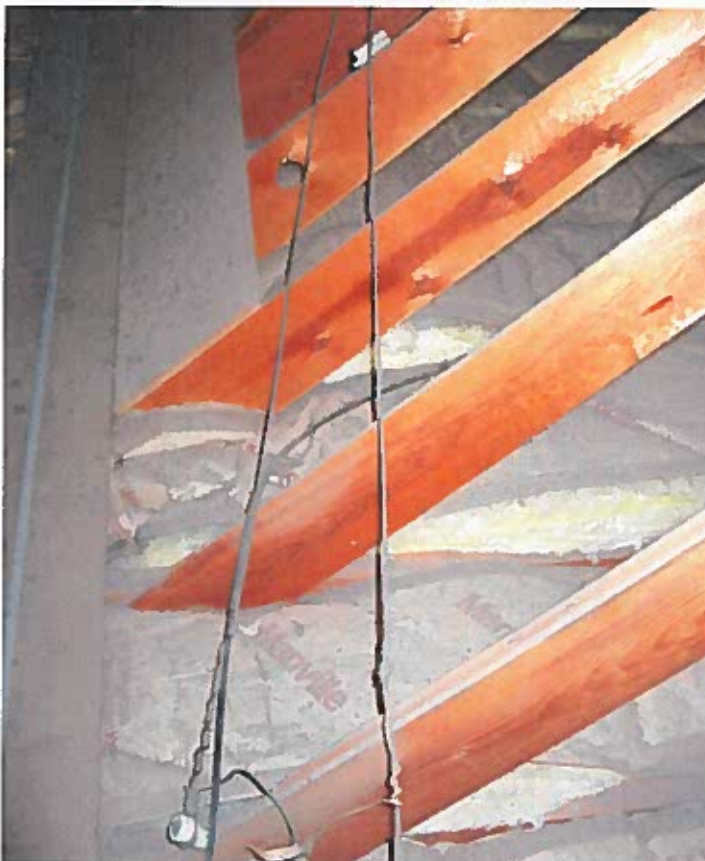
### ROOF @ RETAIL WING

Note: this roof has rafters, braces, king posts, and collar ties; see structural section of report.

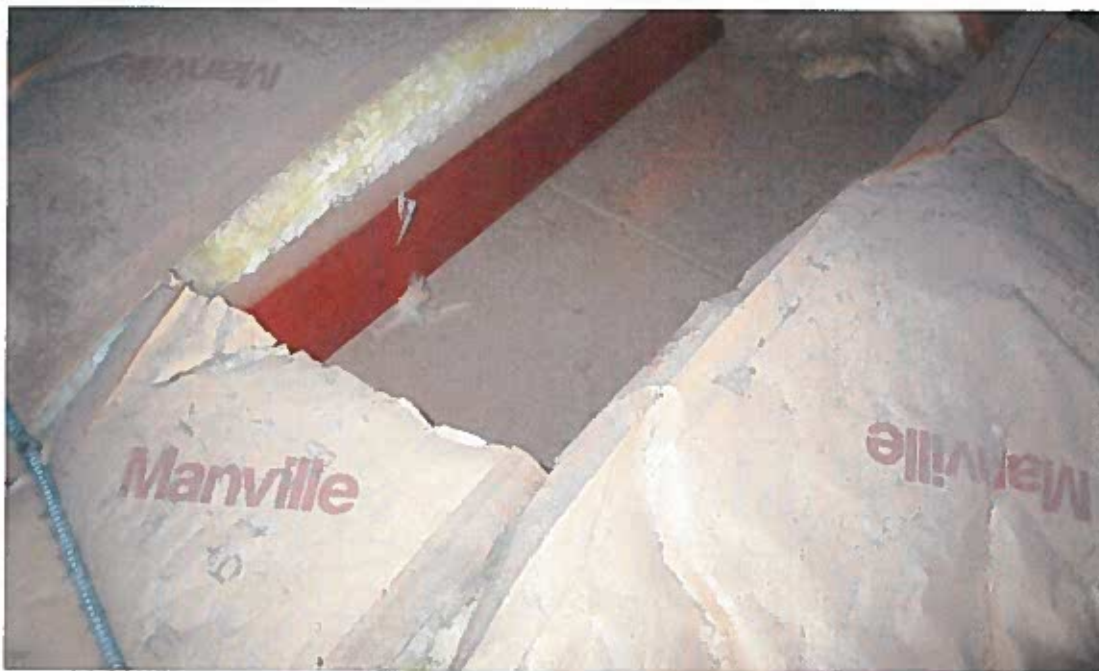
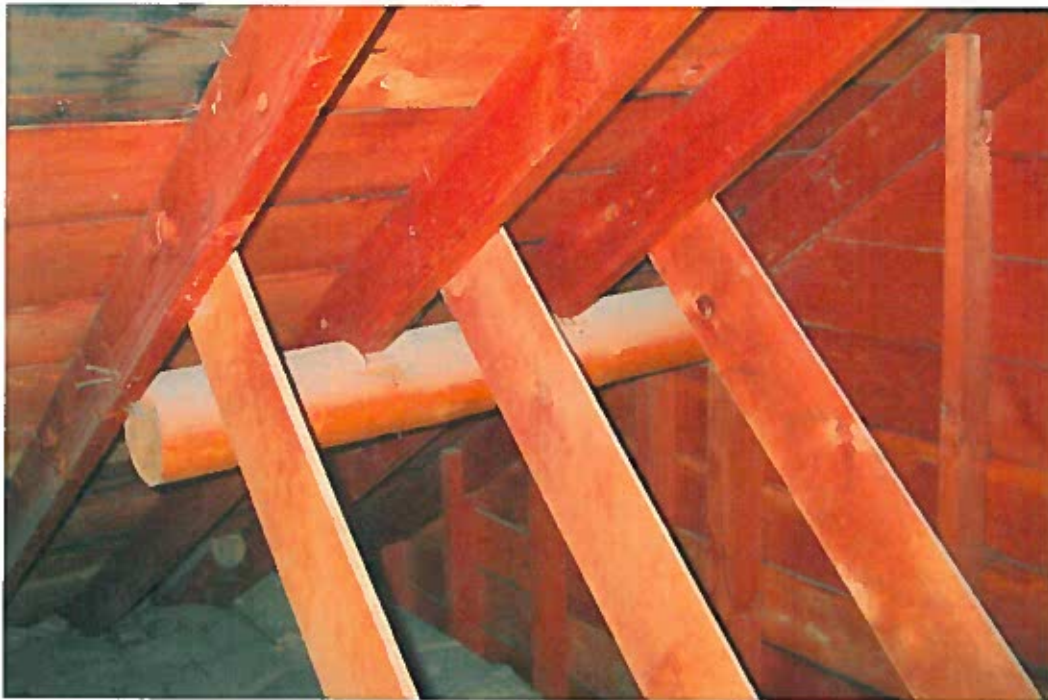
**RETAIL WING - PATTERN OF WOOD BRACES AND TIES WITHIN THE ROOF FRAMING ASSEMBLY.**

**Note the R-19 roof insulation, condition of the structure & sheathing, and the false decorative log rafter ends along the eave line.**

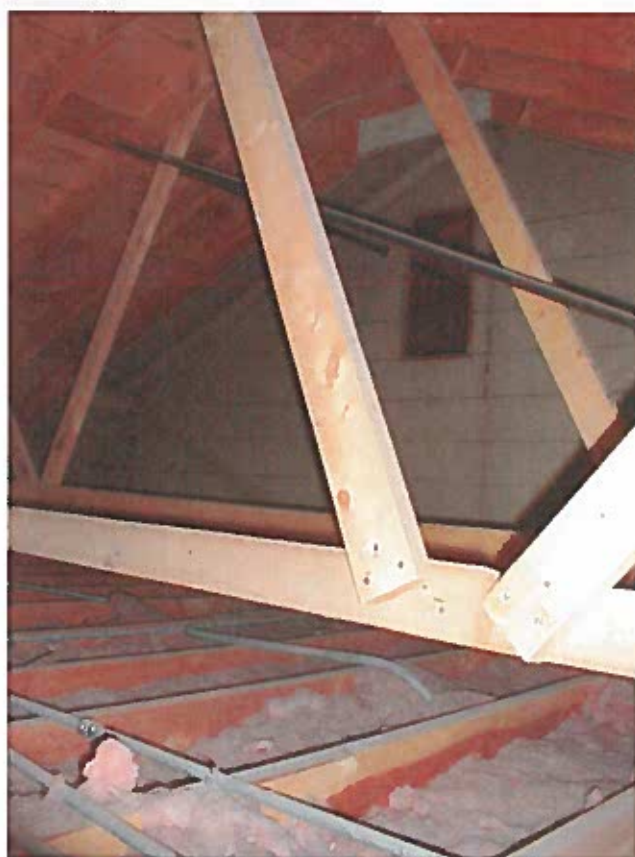
IN 1971 A SHORT CONNECTING TRANSITIONAL SECTION OF STRUCTURE WAS INSERTED BETWEEN THE RETAIL STORE AND THE DORMITORY WING TO ACCOMMODATE A DELIVERY CORRIDOR ON THE FIRST FLOOR AND A 2ND STAIRWAY BETWEEN FLOORS; THE ROOF STRUCTURE ABOVE THIS CONNECTING LINK IS A COMBINATION OF POSTS AND TRUSSED RAFTERS AS SHOWN ON THESE PHOTOS. THESE ELEMENTS REQUIRE SOME ADDITIONAL NAILING AND STIFFENING TO BRING THE QUALITY OF ROOF STRUCTURE UP TO A LEVEL COMMENSURATE WITH THE REST OF THE BUILDING.

Note: the bent web in the adjacent photo is from distortion - not from being overstressed.

TRANSITIONAL SECTION OF STRUCTURE - THESE ARE EXAMPLES OF TRUSS TYPE CONNECTIONS THAT REQUIRE ADDITIONAL NAILING AND GUSSETING. WORK ENVISIONED FOR THESE MEMBERS CAN BE DONE IN-PLACE.

Note the presence of insulation in this section of roof and the electrical work in the form of metallic conduit. It is recommended that the insulation be added to in the interest of energy conservation.

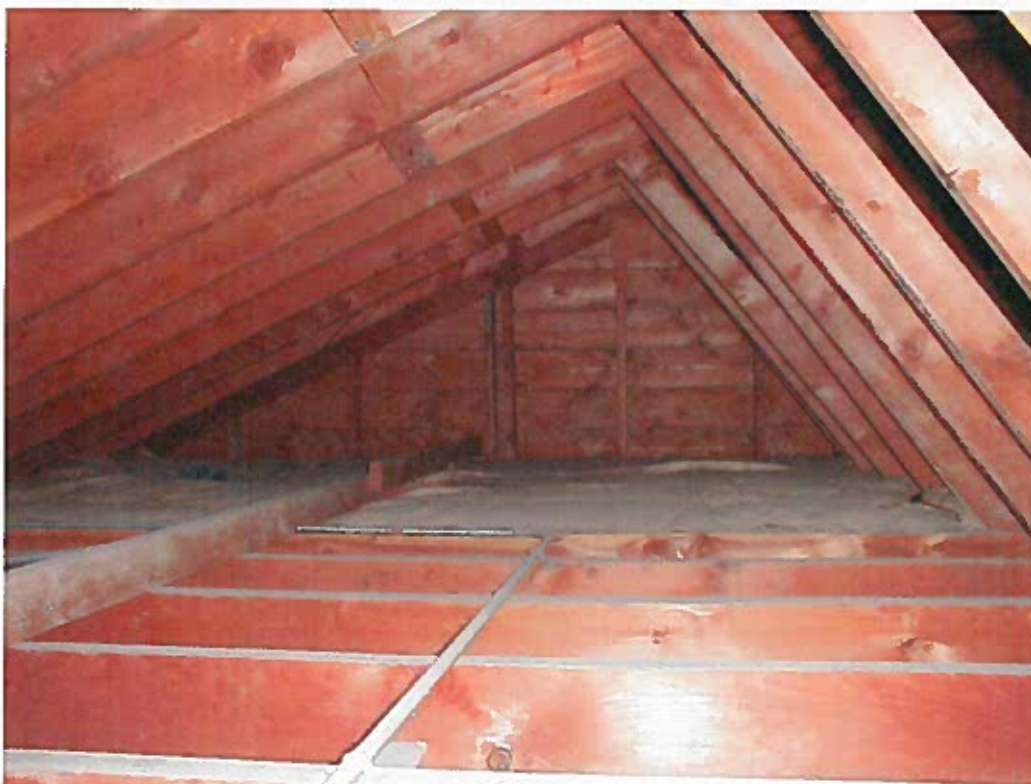
TYPICAL ROOF  
STRUCTURE  
ABOVE  
ORIGINAL  
DORMITORY  
WING - NOTE  
CONDITION OF  
RAFTERS,  
BRACES, AND  
JOISTS. THIS  
SECTION OF  
ROOF IS ALSO  
INSULATED  
ALTHOUGH IT IS  
NOT VISIBLE IN  
THIS PHOTO.

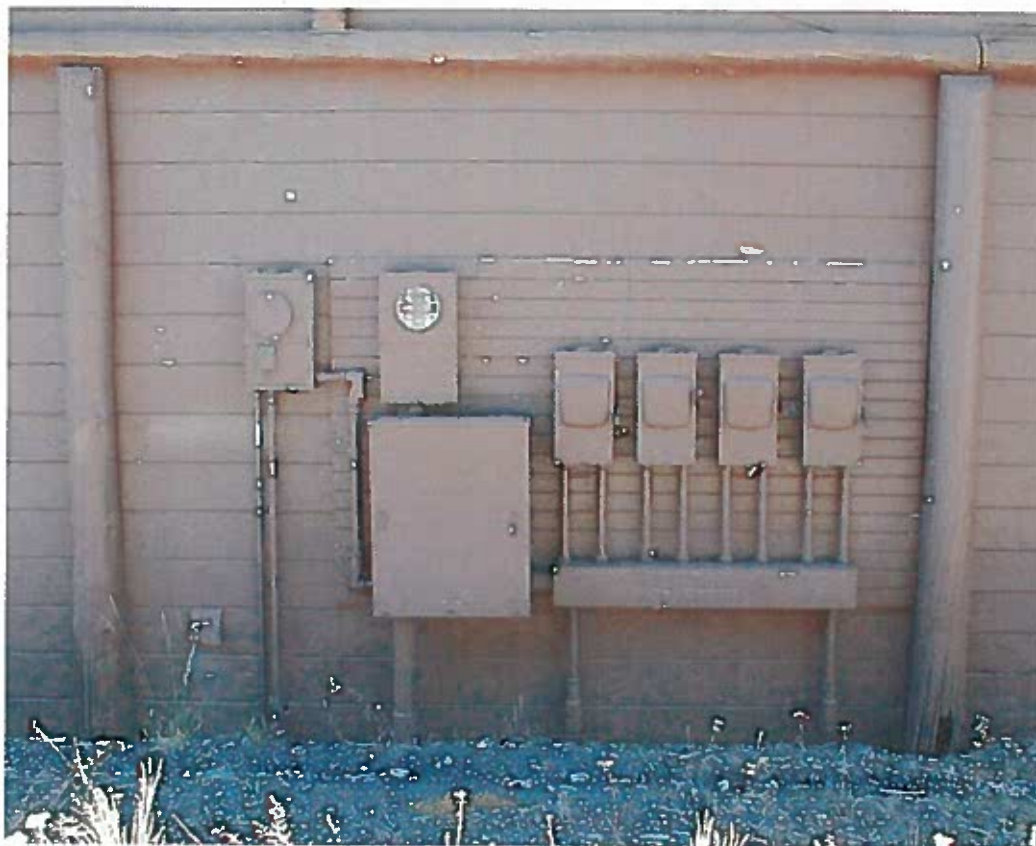
ELECTRICAL  
SERVICE  
CONNECTIONS  
LOCATED ON  
THE EAST WALL  
OF THE  
EXTERIOR OF  
THE  
STRUCTURE.

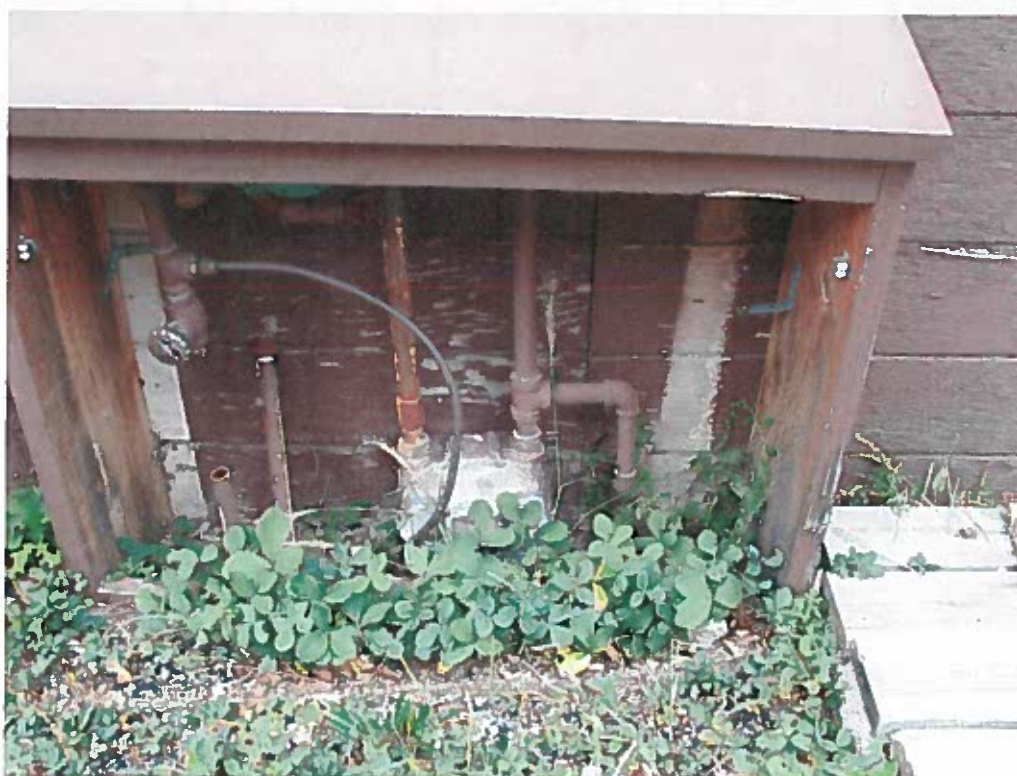
GAS METER  
AND  
CONNECTION -  
EAST WALL OF  
THE EXTERIOR  
OF THE  
STRUCTURE.

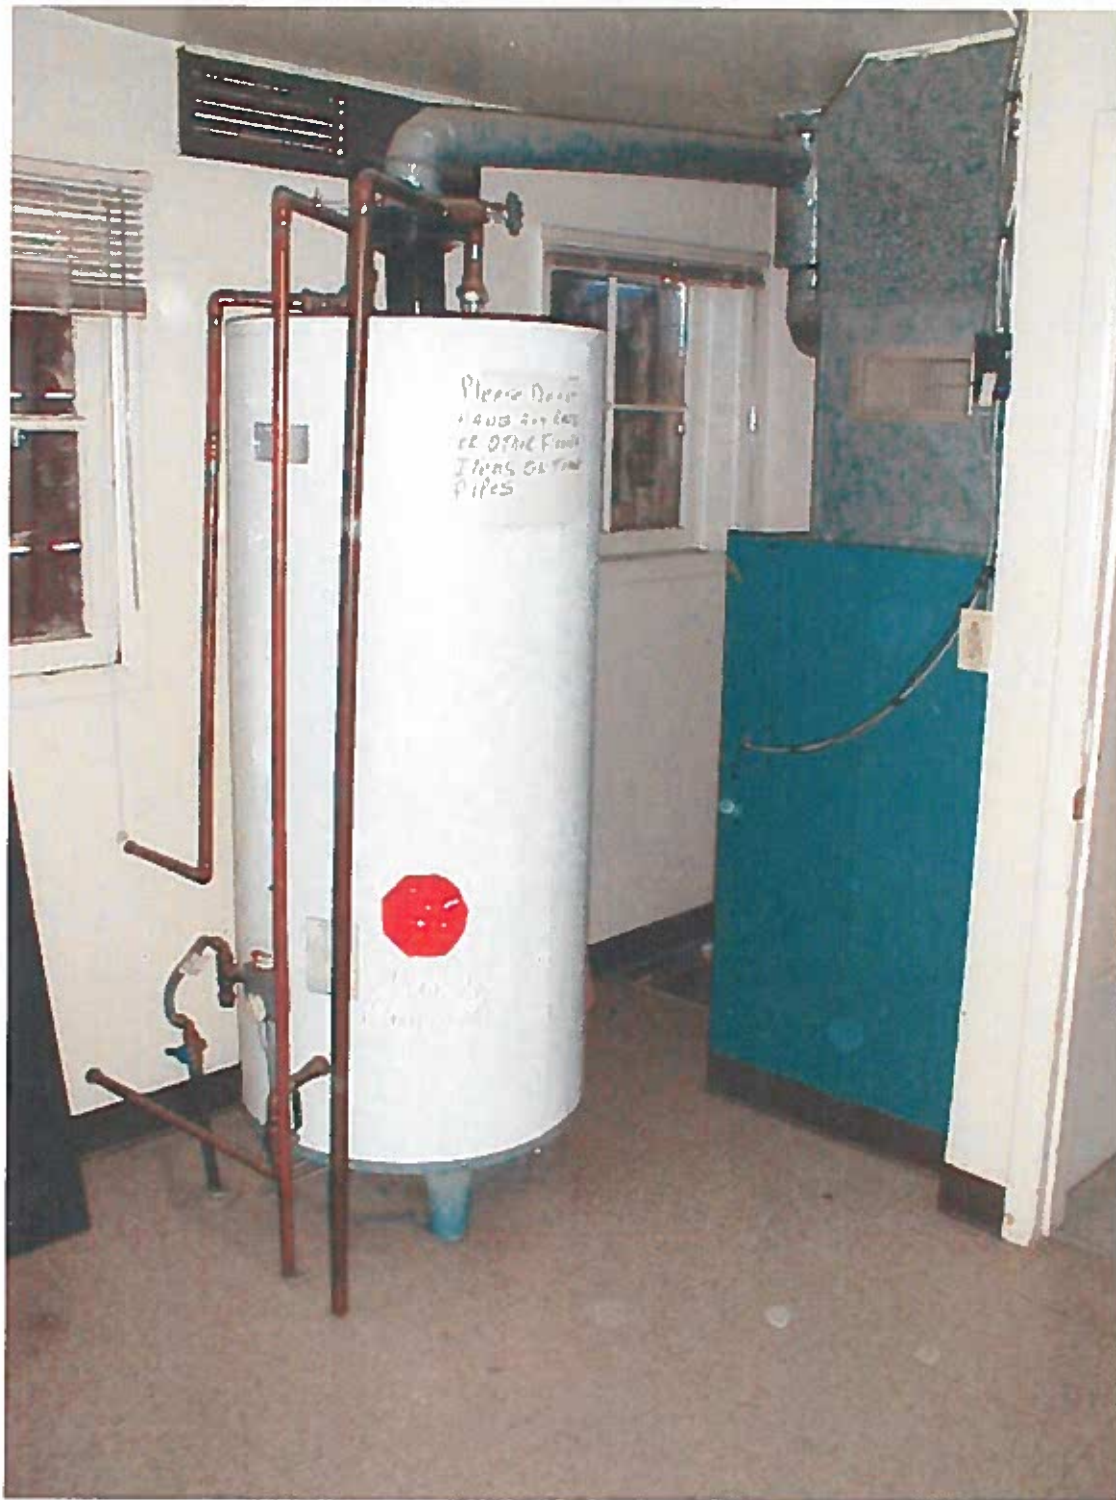
FIRST FLOOR MECHANICAL/UTILITY ROOM - LOCATED IN THE DORMITORY WING

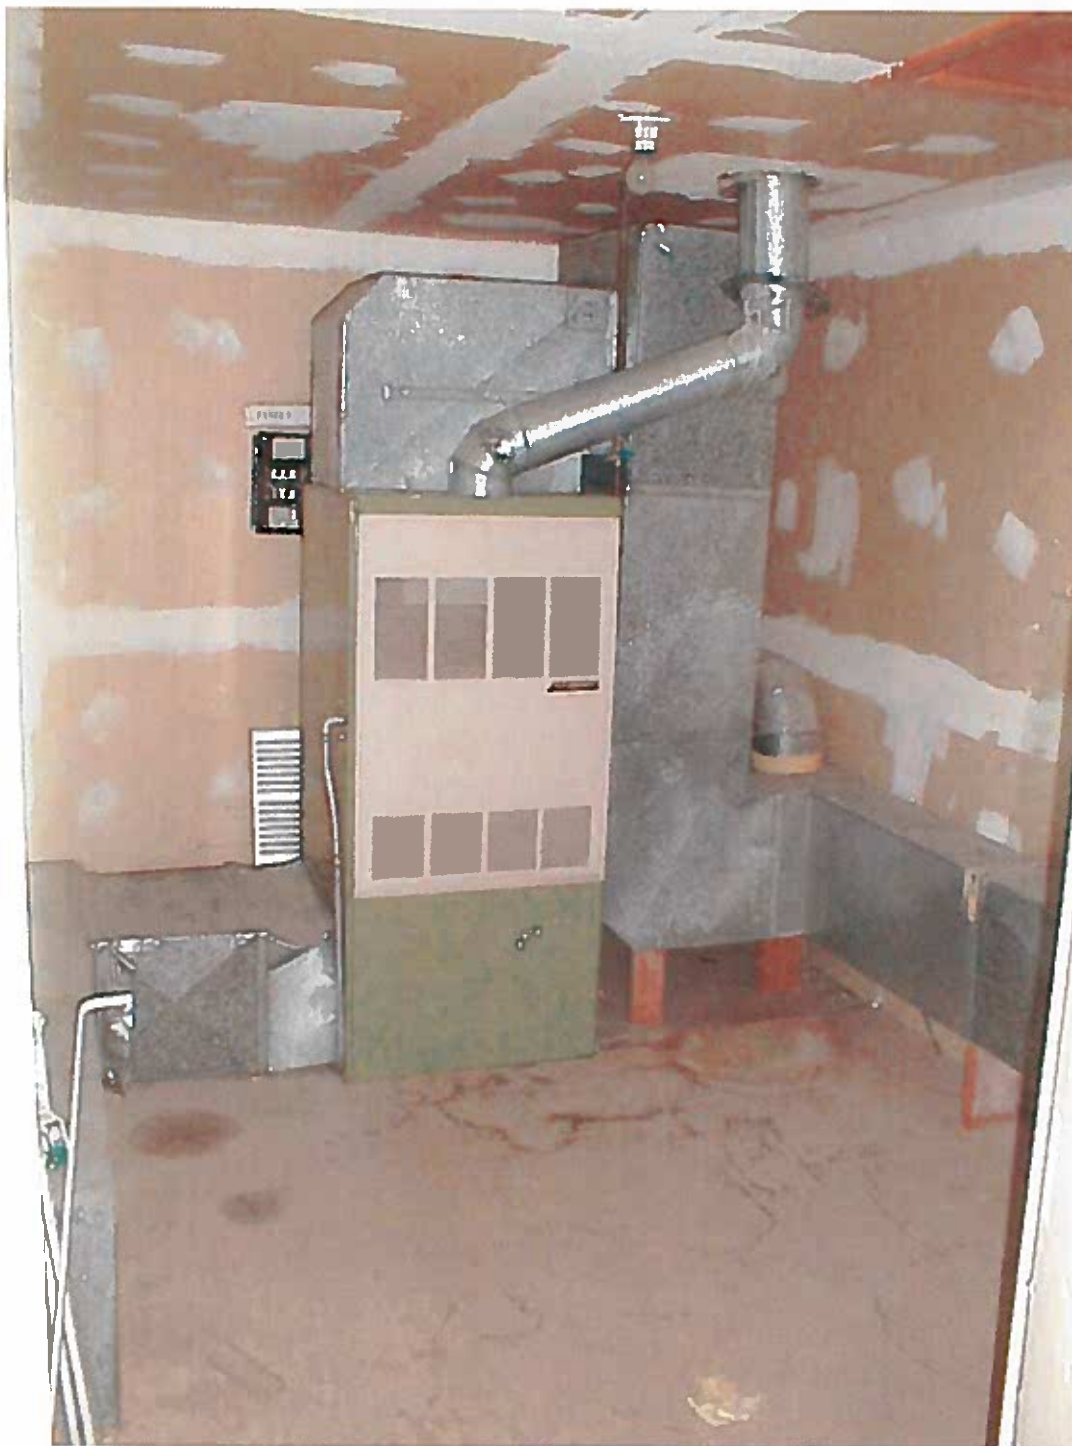
SECOND FLOOR MECHANICAL ROOM - LOCATED IN THE DORMITORY WING  
- NW CORNER.

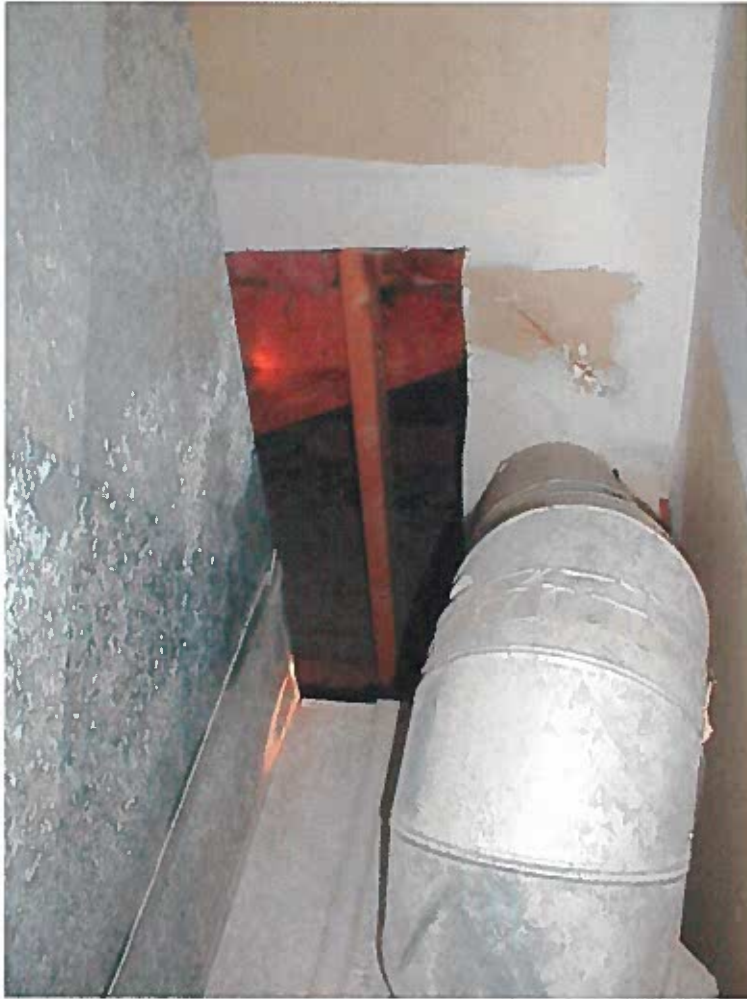
DUCTWORK FROM THE  
SECOND FLOOR MECHANICAL  
ROOM - ACCESS IS SINTO THE  
ROOF STRUCTURE OF THE SW  
ADDITION.

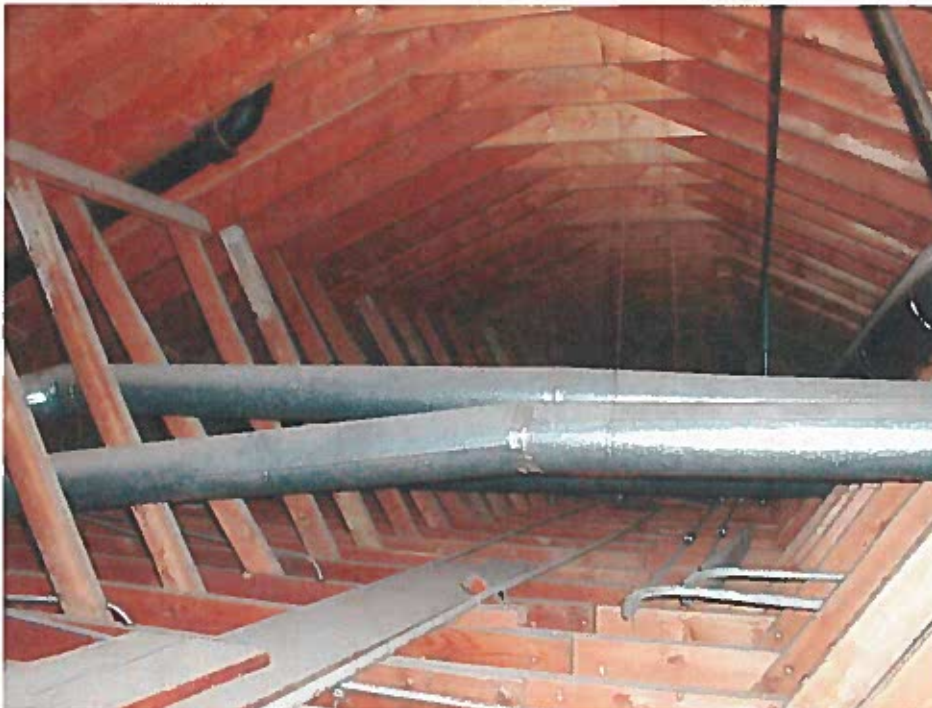
TYPICAL DISTRIBUTION  
DUCTWORK IN THE  
ATTIC SPACE OF THE  
DORMITORY WING.

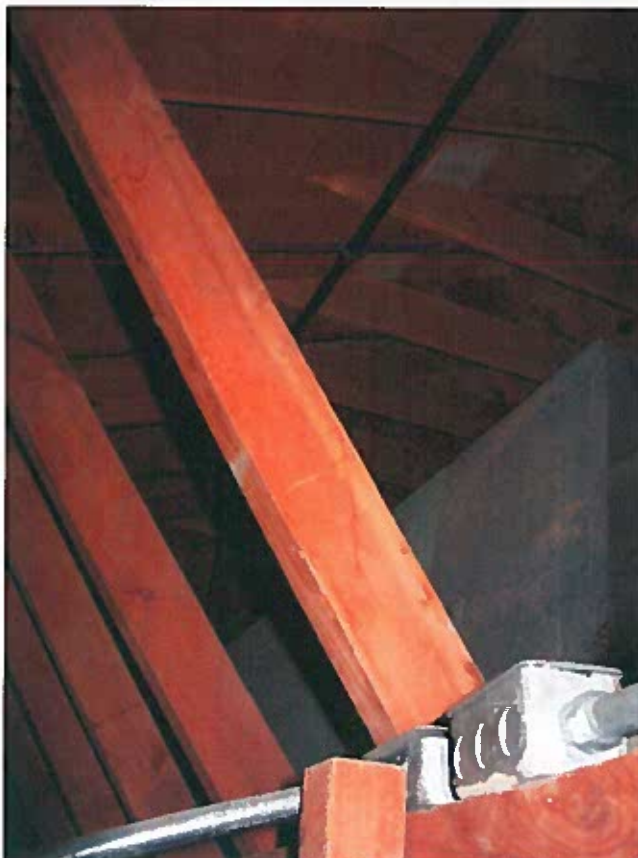
EXAMPLES OF ELECTRICAL BOXES AND CONDUIT WITHIN THE ATTIC OF THE DORMITORY WING.

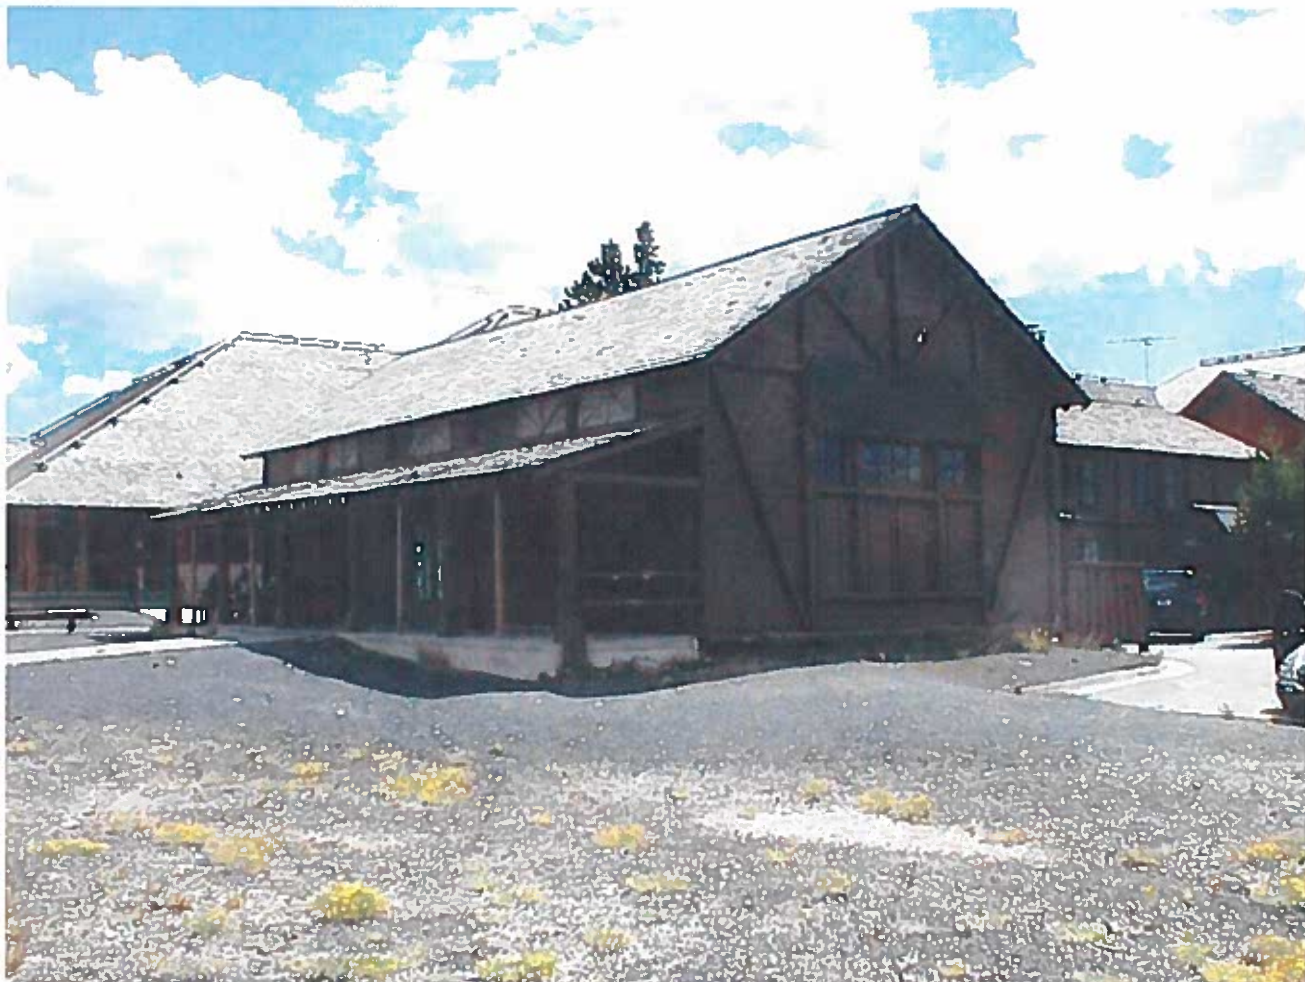
OVERALL SITE VIEW FROM THE NORTHWEST
