# **HISTORIC STRUCTURE REPORT**

## **HAYNES AUTO CAMP PICTURE SHOP Old Faithful Yellowstone National Park**

**Department of the Interior  
National Park Service  
Yellowstone National Park**

Prepared by Sievert & Sievert Cultural Resource Consultants  
Great Falls & Bozeman, Montana  
January 4, 2007

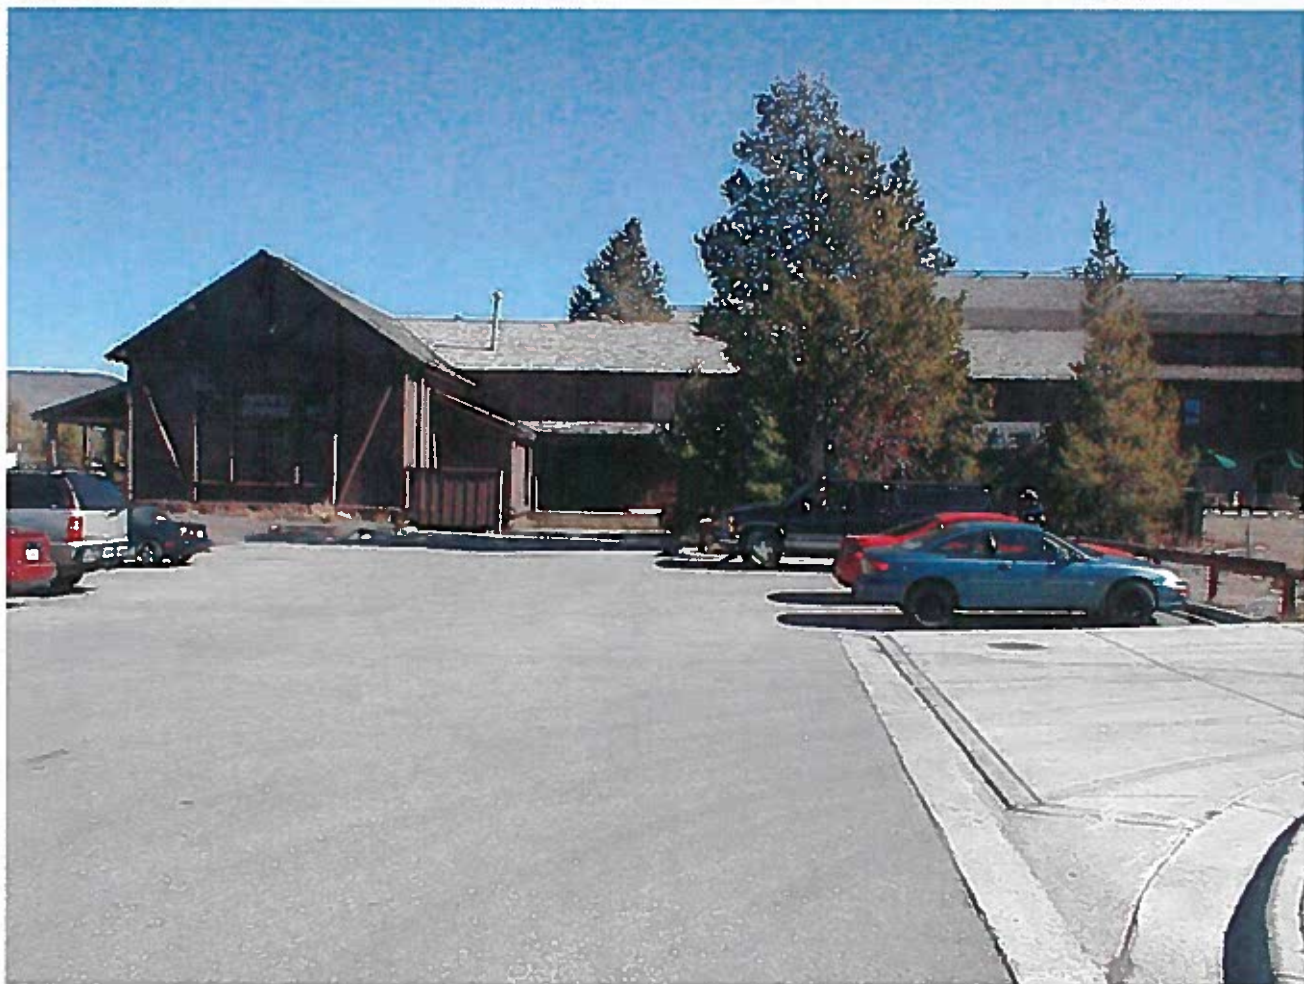
OVERALL SITE VIEW FROM THE WEST

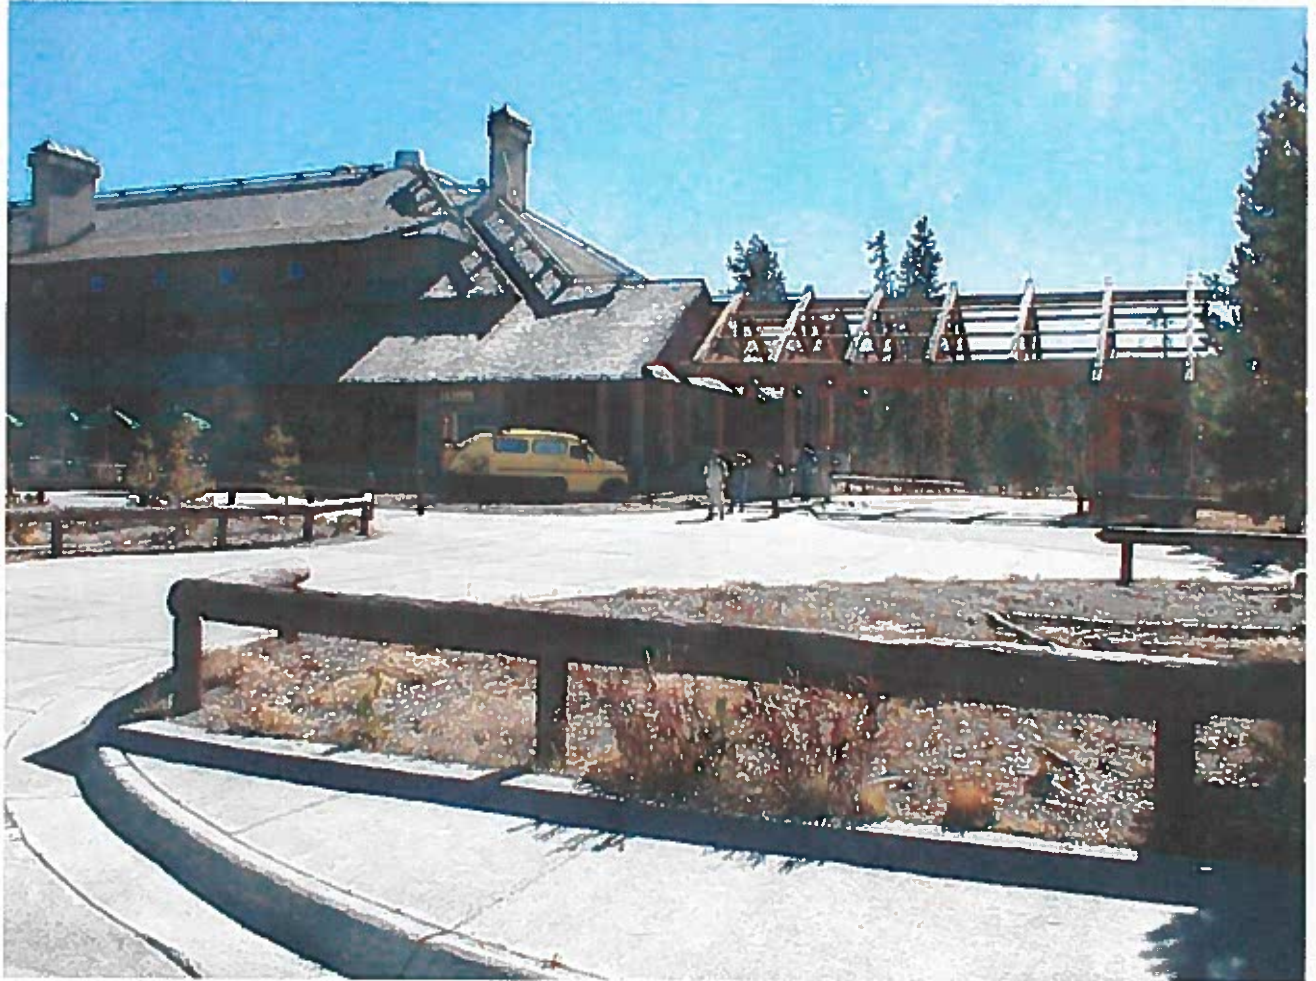
ADJACENT SNOW-LODGE STRUCTURE THAT FITS AROUND THE SOUTH AND EAST SIDES OF THE HAYNES HISTORIC PROPERTY.

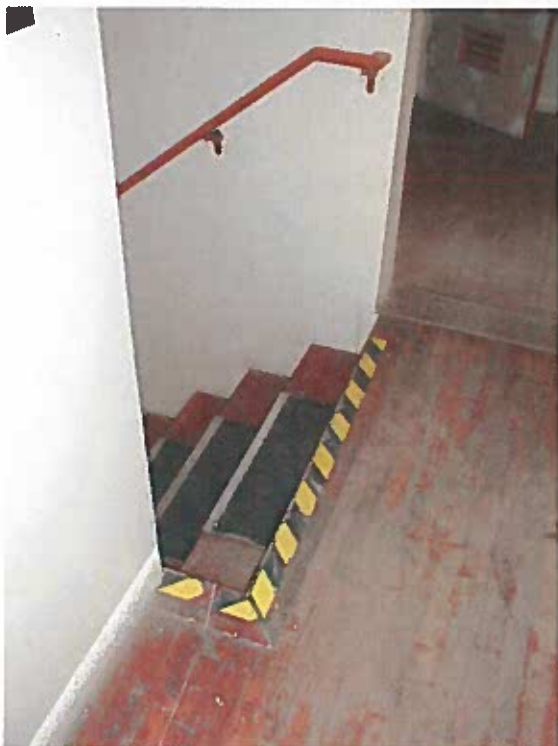
VIEWS OF THE CENTER EXIT STAIR  
BETWEEN THE TWO FLOORS OF THE  
DORMITORY WING.

Note the damage to the walls of the stairway from moving equipment and belongings up and down the stairs. All walls and ceilings of the stair are of fire-resistive materials. The South stair is similar in construction to this stairway albeit in better condition.

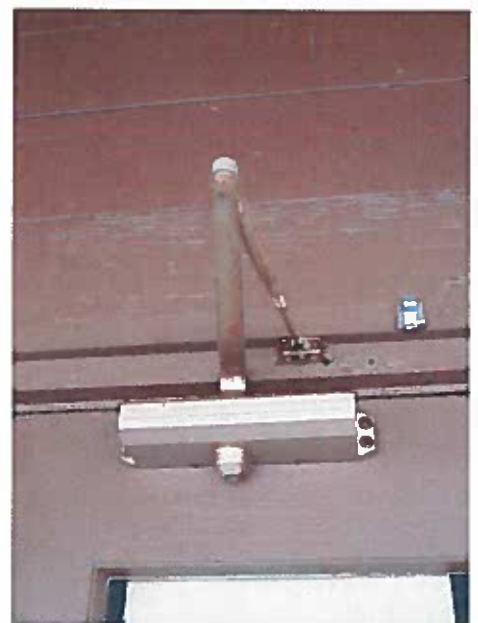
**MAIN ENTRANCE DOORS**

#### **HARDWARE DETAIL - MAIN ENTRANCE**

Doors comply with ADA clearances, swing, and direction of travel; automated closers could be added and the doorknob may have to be replaced with a lever lock.

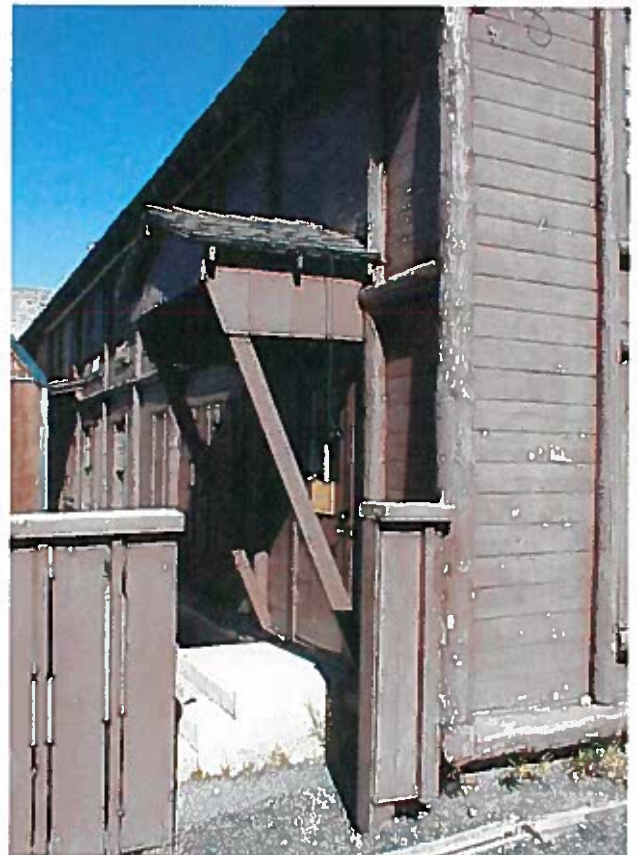
#### SOUTHWEST EXIT FROM DORM WING

There are (3) concrete steps with a minimal landing accessing this entry/exit. It is recommended that the step/landing arrangement be replaced with a code compliant landing and new steps or ramp. It is also recommended that the Gablet (recent) be replaced with an assembly that appears more permanent and that is more strongly related to the architecture of the structure.

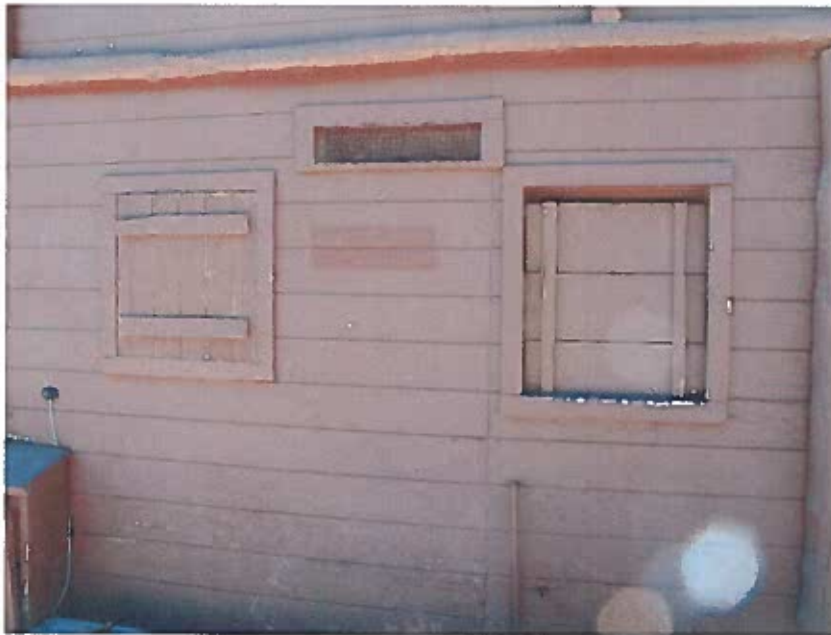
#### TYPICAL SIDING - EXTERIOR WALL

Siding application is T & G wood applied over standard wood framed stud walls.

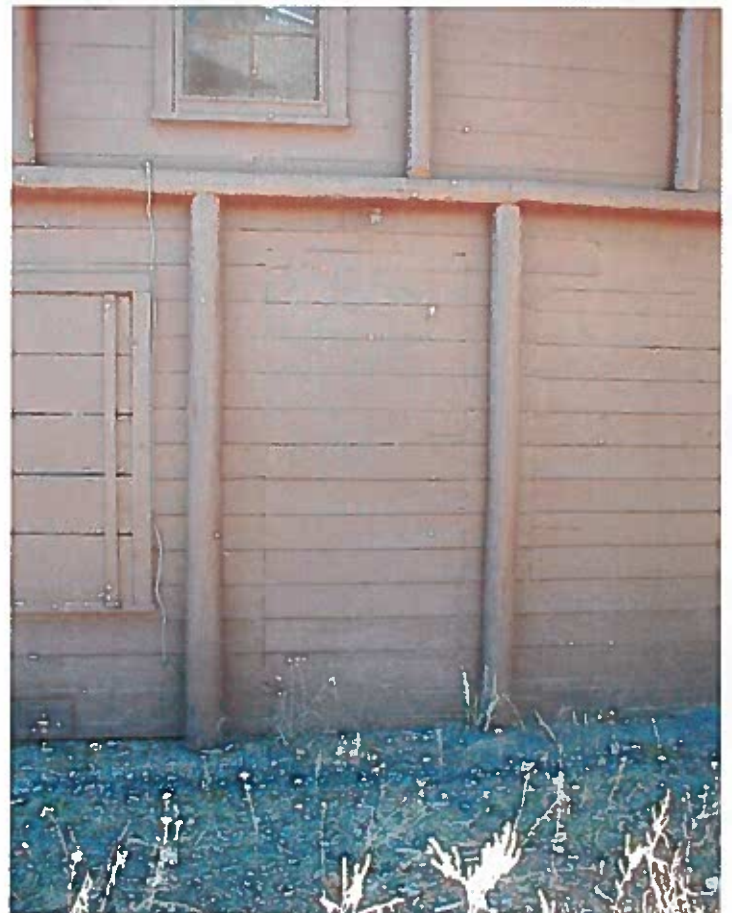
#### "GHOST DOOR"

The infill of a previous door opening can be seen in the siding pattern between the two log uprights - this opening was located midway along the East wall of the structure.
